NATIONAL REGISTER OF HISTORIC PLACES
REGISTRATION FORM

historic name: **Albert Cofta Farmstead**

Albert Cofta Farm
Richfield Township
Summit County, Ohio

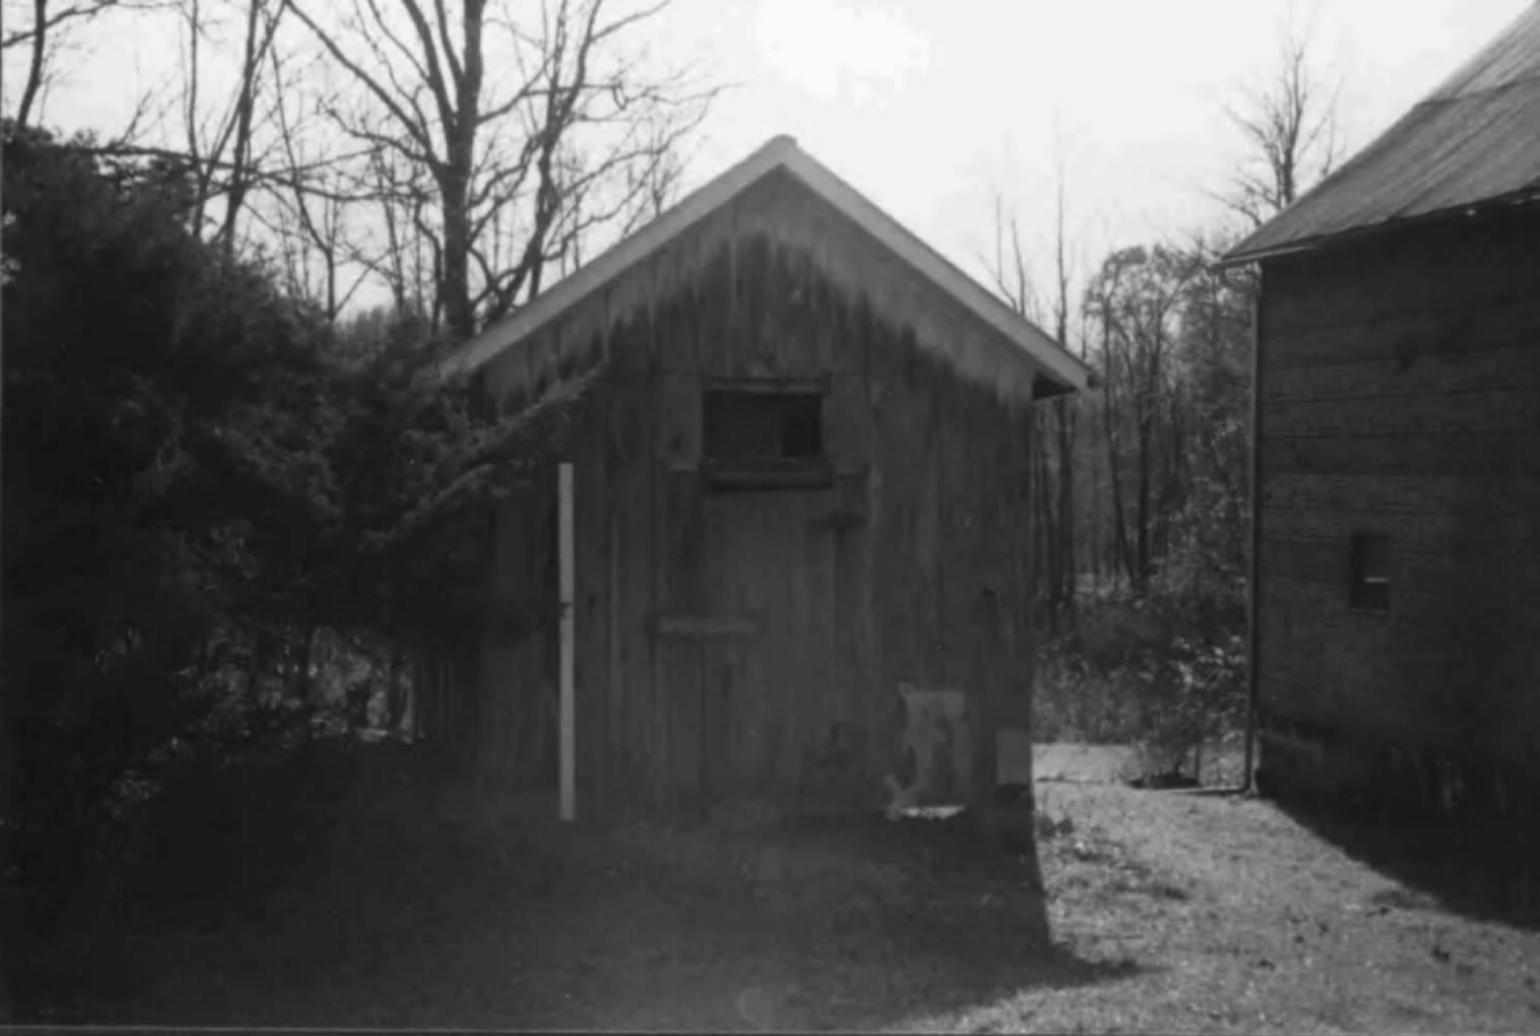
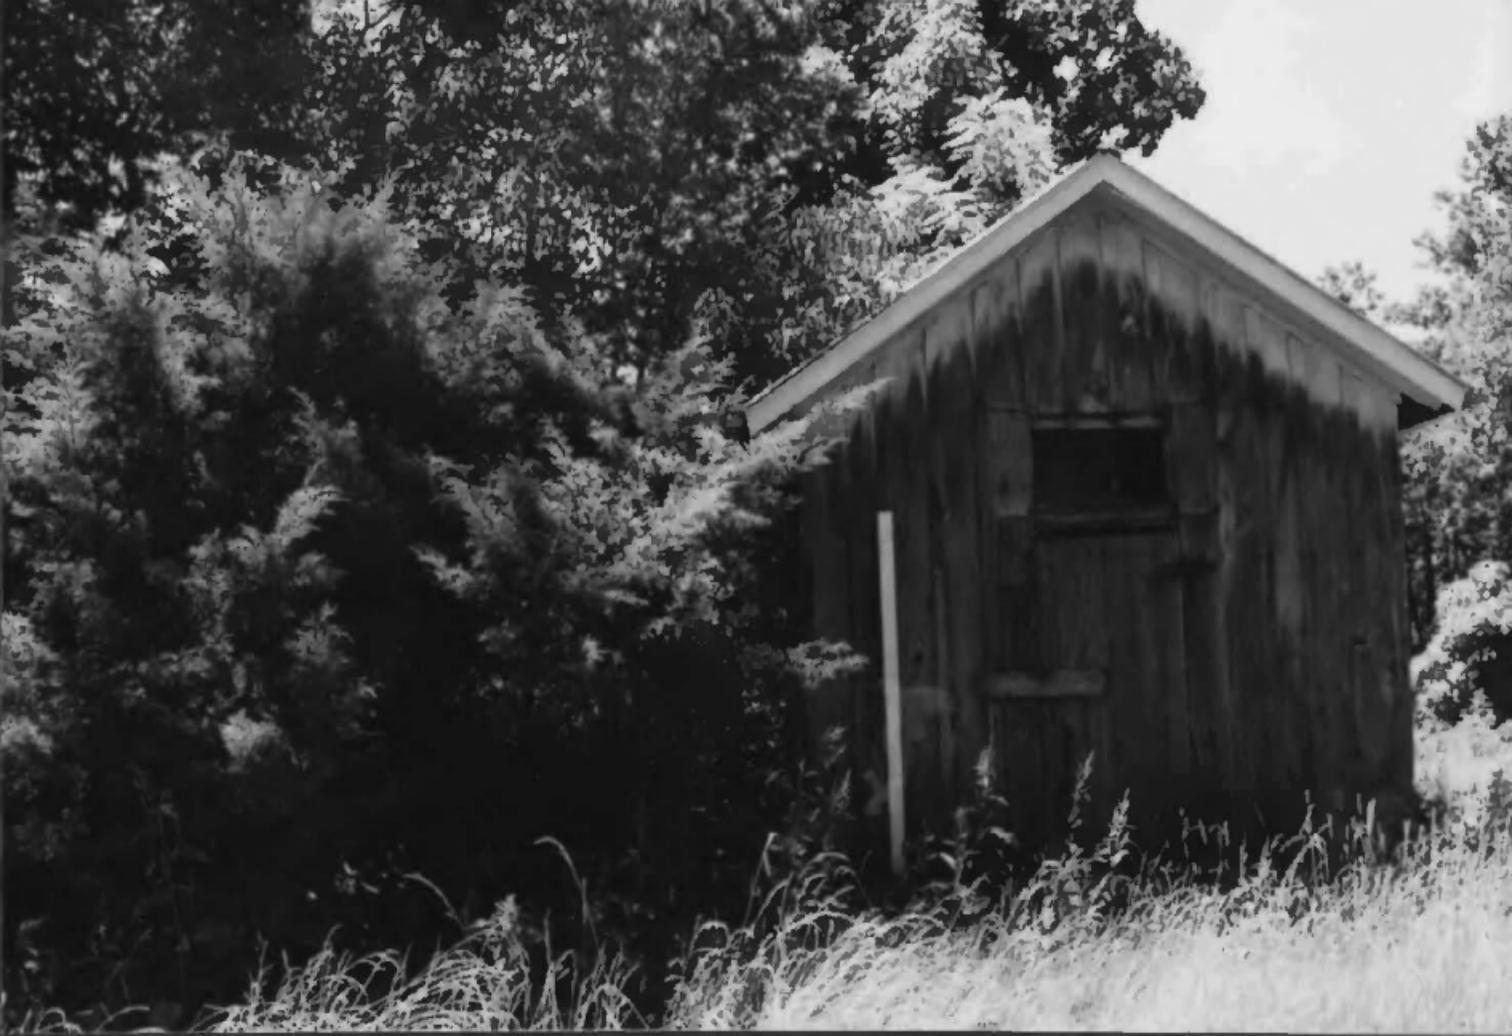
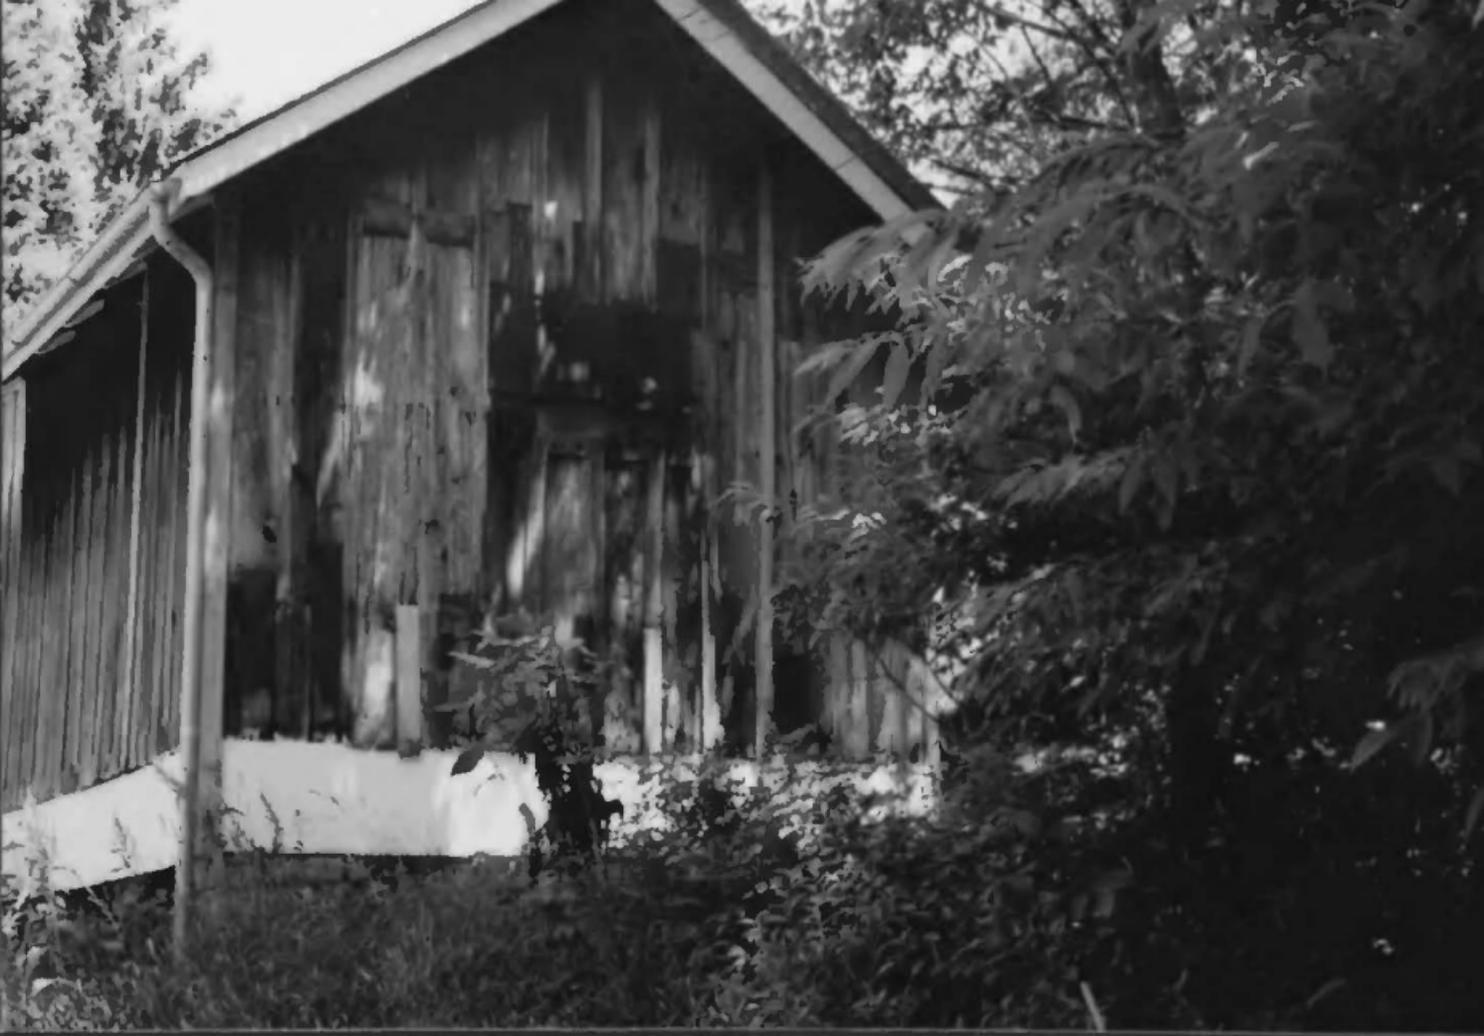
The granary (built circa 1908) is located approximately 100 feet southwest of the farm house (Photos 22-24). This rectangular, framed structure has a front gabled roof with sheet metal roofing. The walls are covered with wooden board and batten siding. The north side includes a vertical wood door and a mesh-covered three-light window in the gable end. The granary's wood sill rests on concrete block corner piers. The structure has a wood floor. The granary is in good condition.

The Cofta Farm's granary also contributes to the historic integrity of the farmstead. Like most granaries, the Cofta's granary is rectangular, with few windows or other openings and utilizes vertical board-and-batten construction to keep the structure as animal-proof as possible. The granary is also elevated on concrete piers to keep rodents out and eliminate moisture.³⁰

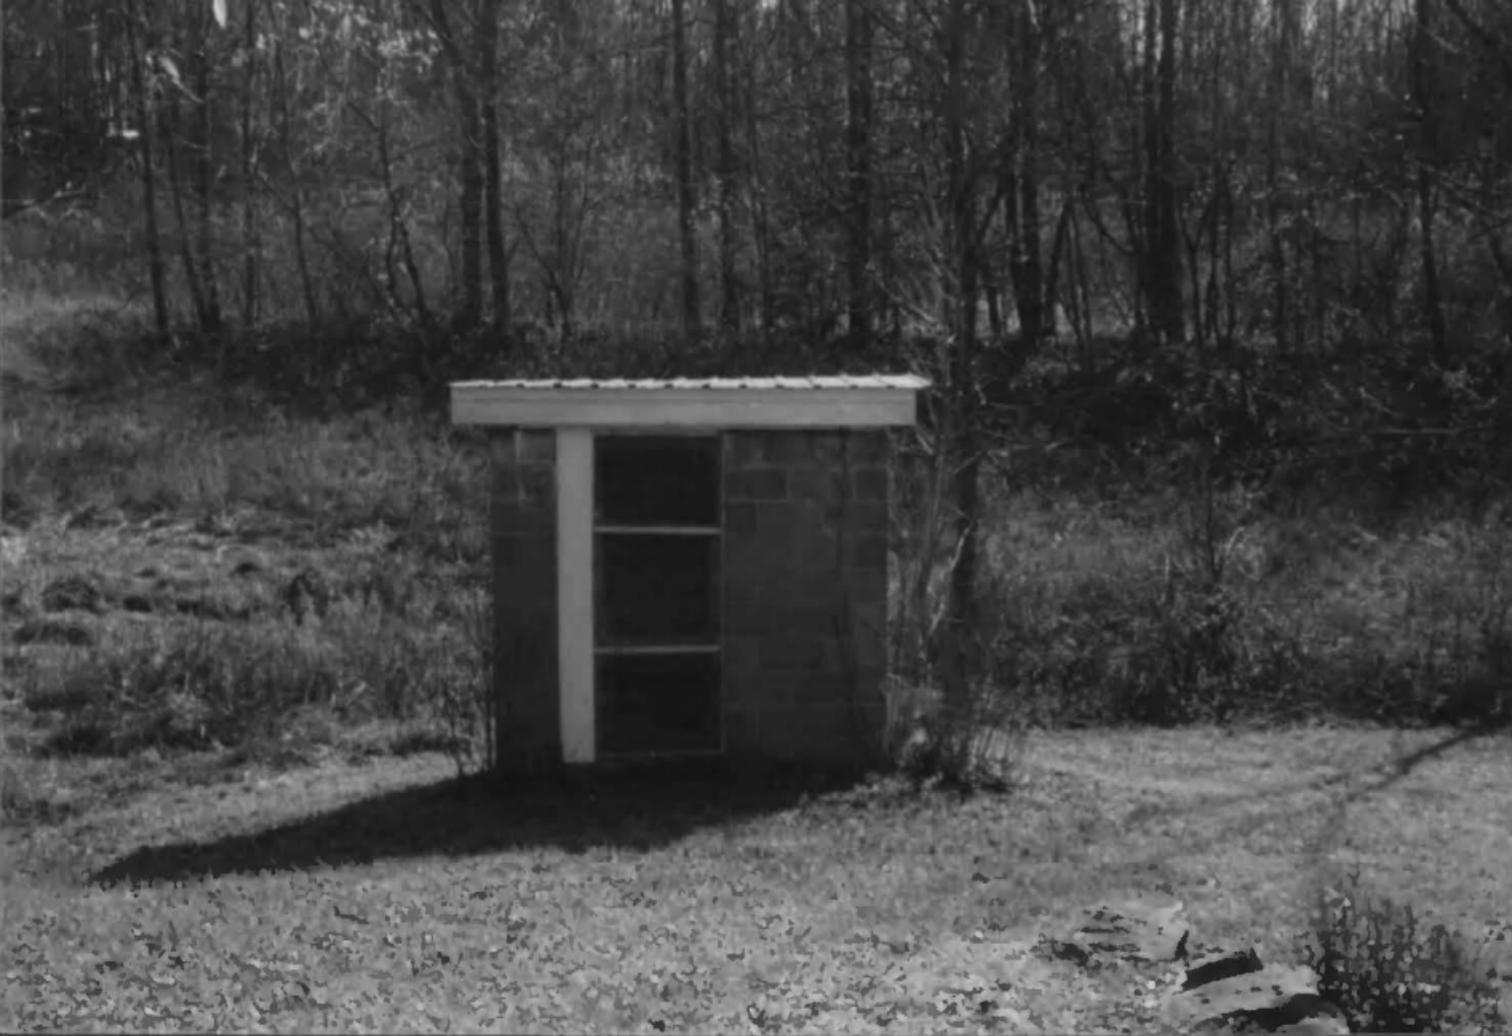
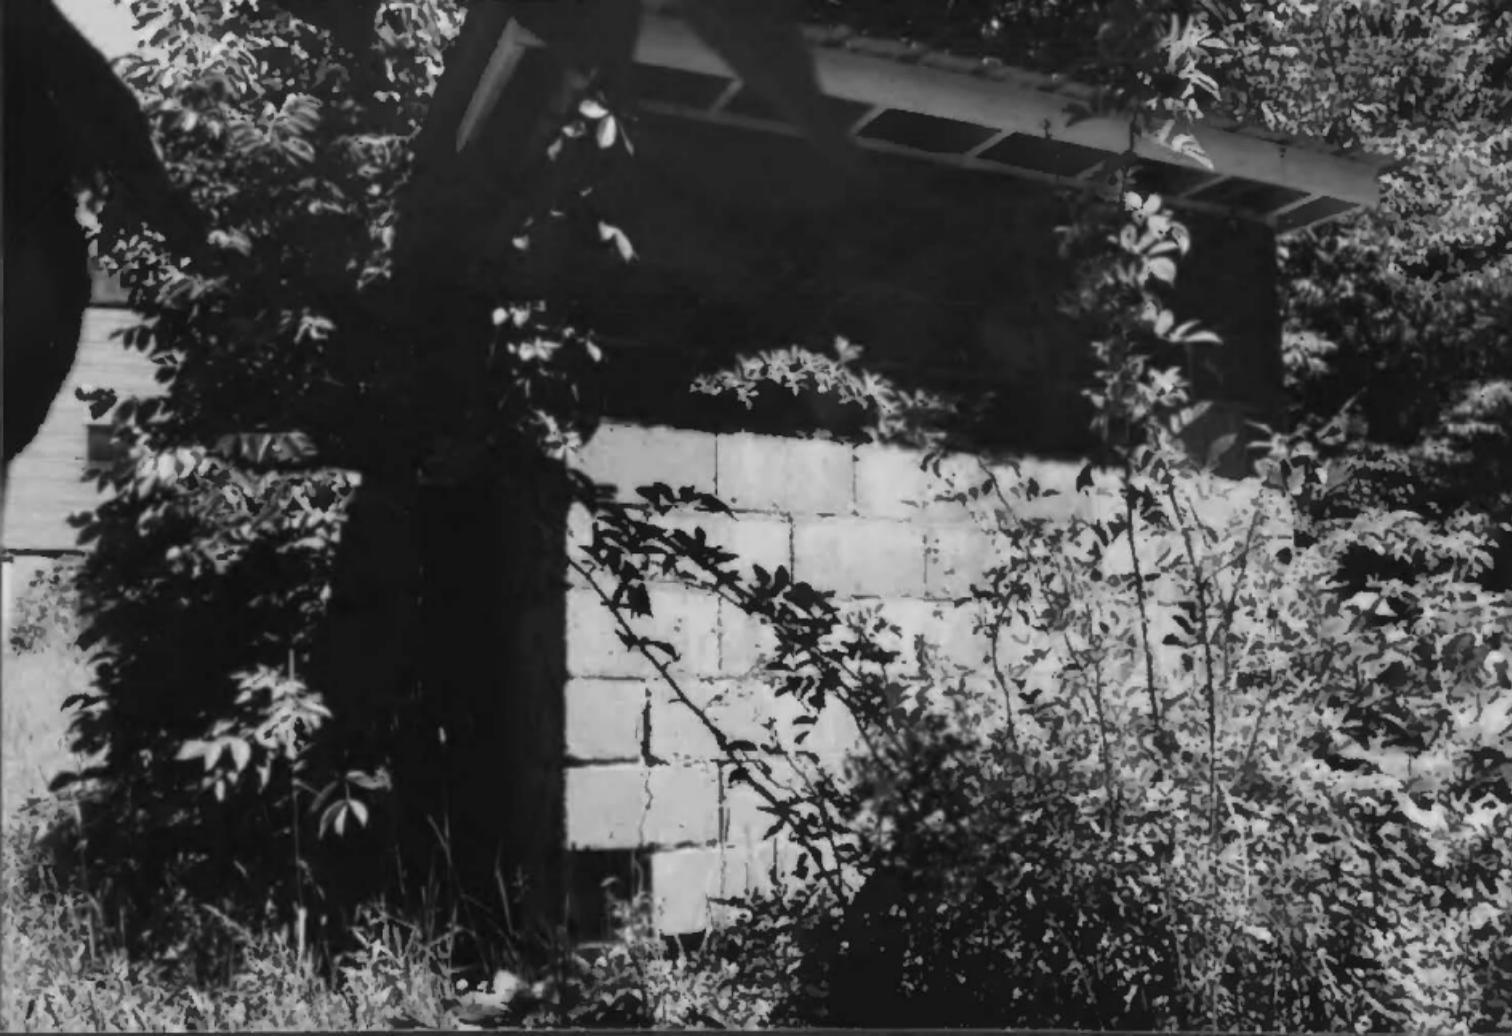
The milk house, built circa 1930, is located along the north side of a dry creek bed, approximately forty feet southeast from the barn (Photos 25-26). This small, concrete block building has a flat roof with corrugated metal roofing and eaves. Meshed wire covers the service door, which is on the north-facing façade. A stone ledge runs along the south interior wall that served as a wash basin. The milk house also contains a large water tank underneath the main floor that is constructed of poured concrete. The tank served as a holding tank to cool recently drawn milk. The south wall of the milk house contains a spigot to drain the tank. Originally this structure had a pyramidal roof; it was replaced in 1997 with the flat roof as an interim stabilization measure. The pyramidal roof will be replaced-in-kind when the outbuildings are rehabilitated.

The Coftas milk house's building materials are also indicative of its function. Typical milk houses were generally small with enough room to provide a cooling container, washing facilities, and storage space for the milk cans. Because of the use of water in the cooling process and the constant moisture, clay tile block or concrete block were often chosen as a building material. Built of concrete block, the Cofta milk house is characteristic of historic trends in agriculture buildings.

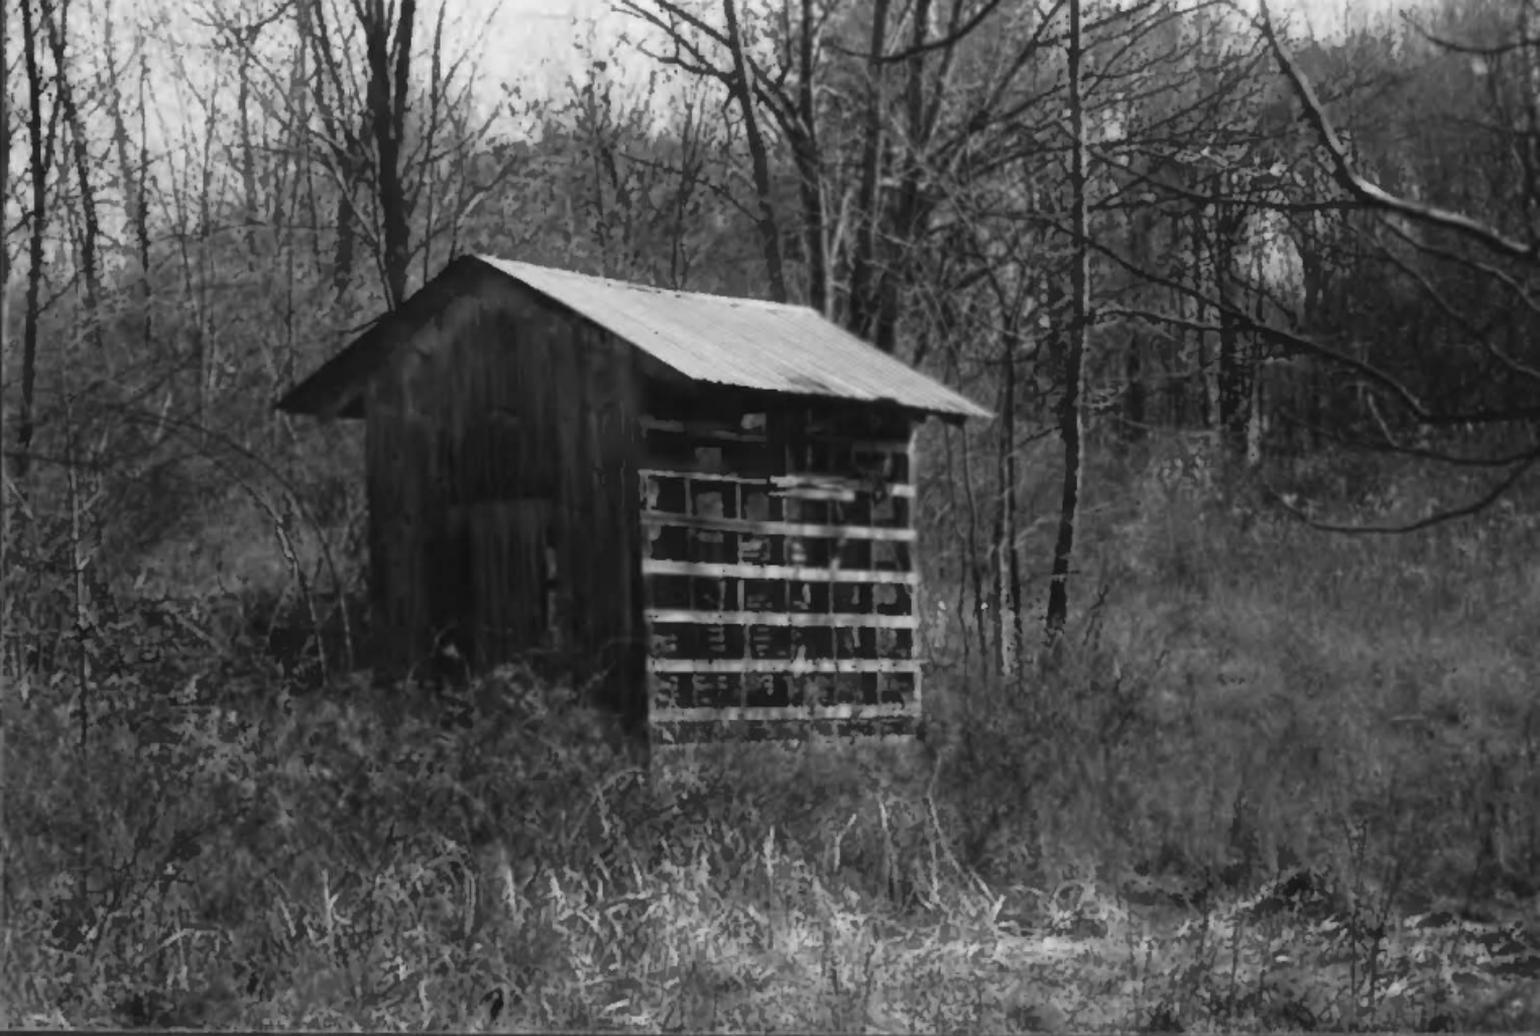
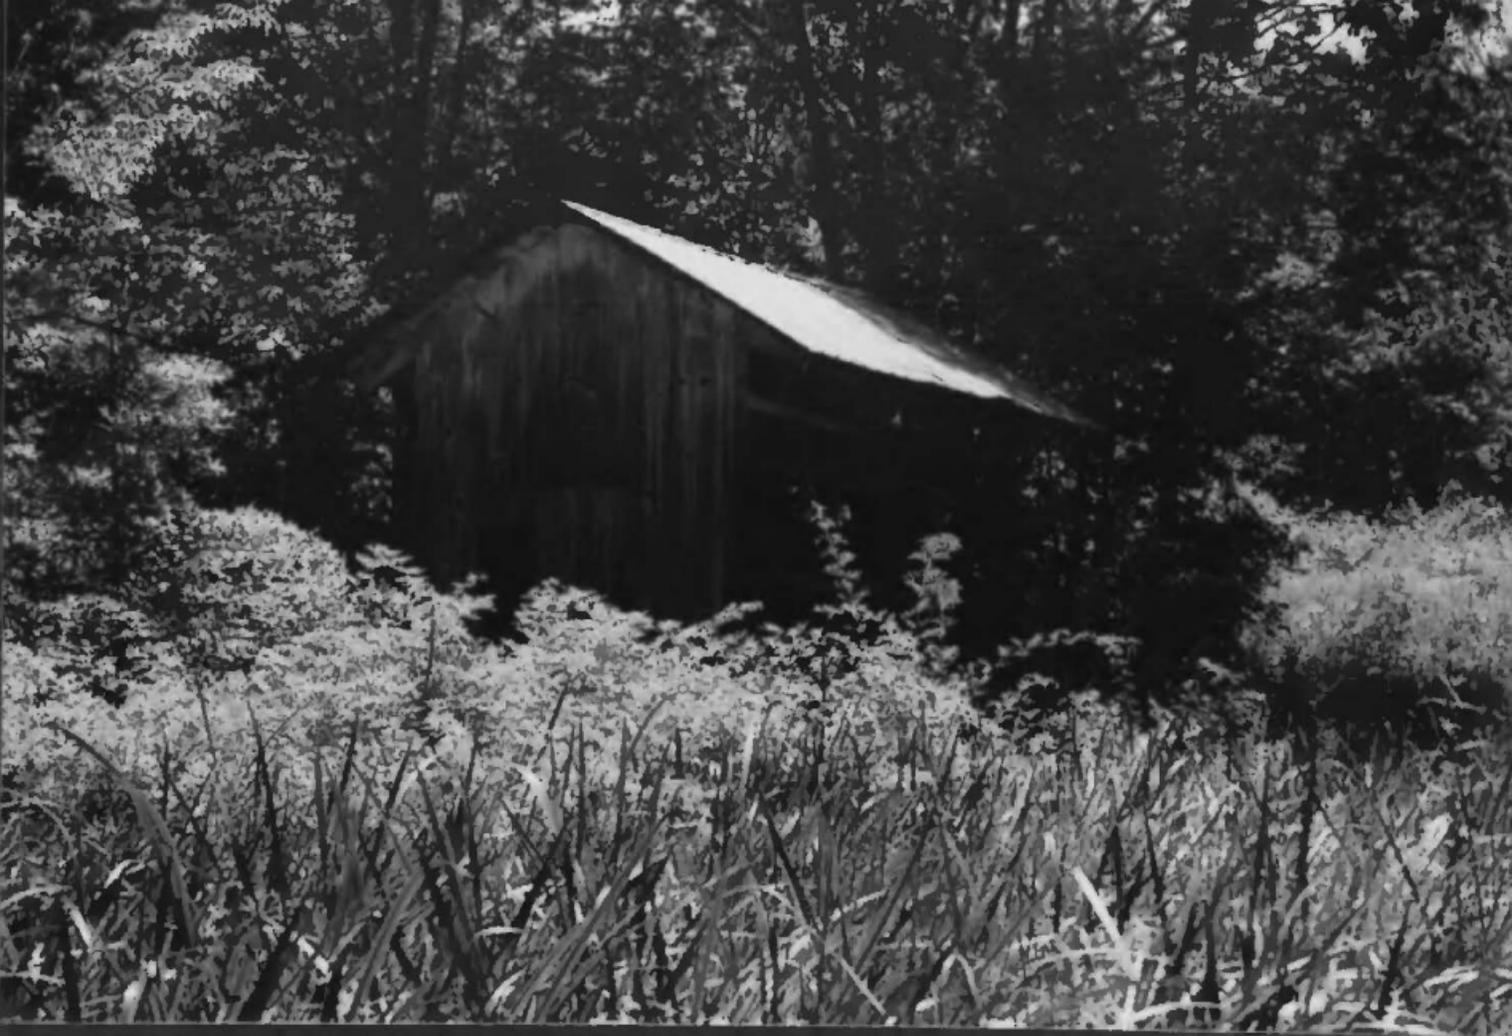
The corn crib, built circa 1908, (Photos 27-28) is located to the south of the dry creek bed, approximately seventy feet southeast of the milk house shed. This narrow, rectangular-shaped, wooden framed building has a front gabled roof with metal sheet roofing and overhanging eaves. The north wall is covered with vertical board siding. The south, west, and east walls are constructed of a wooden frame covered with metal screening. A vertical board service door is on the north side. The corn crib has a concrete block foundation.
