NATIONAL REGISTER OF HISTORIC PLACES
REGISTRATION FORM

historic name: Gleason, Edmund Farm, (boundary increase)

Edmond Gleason Farm
Valley View, Ohio
Cuyahoga County

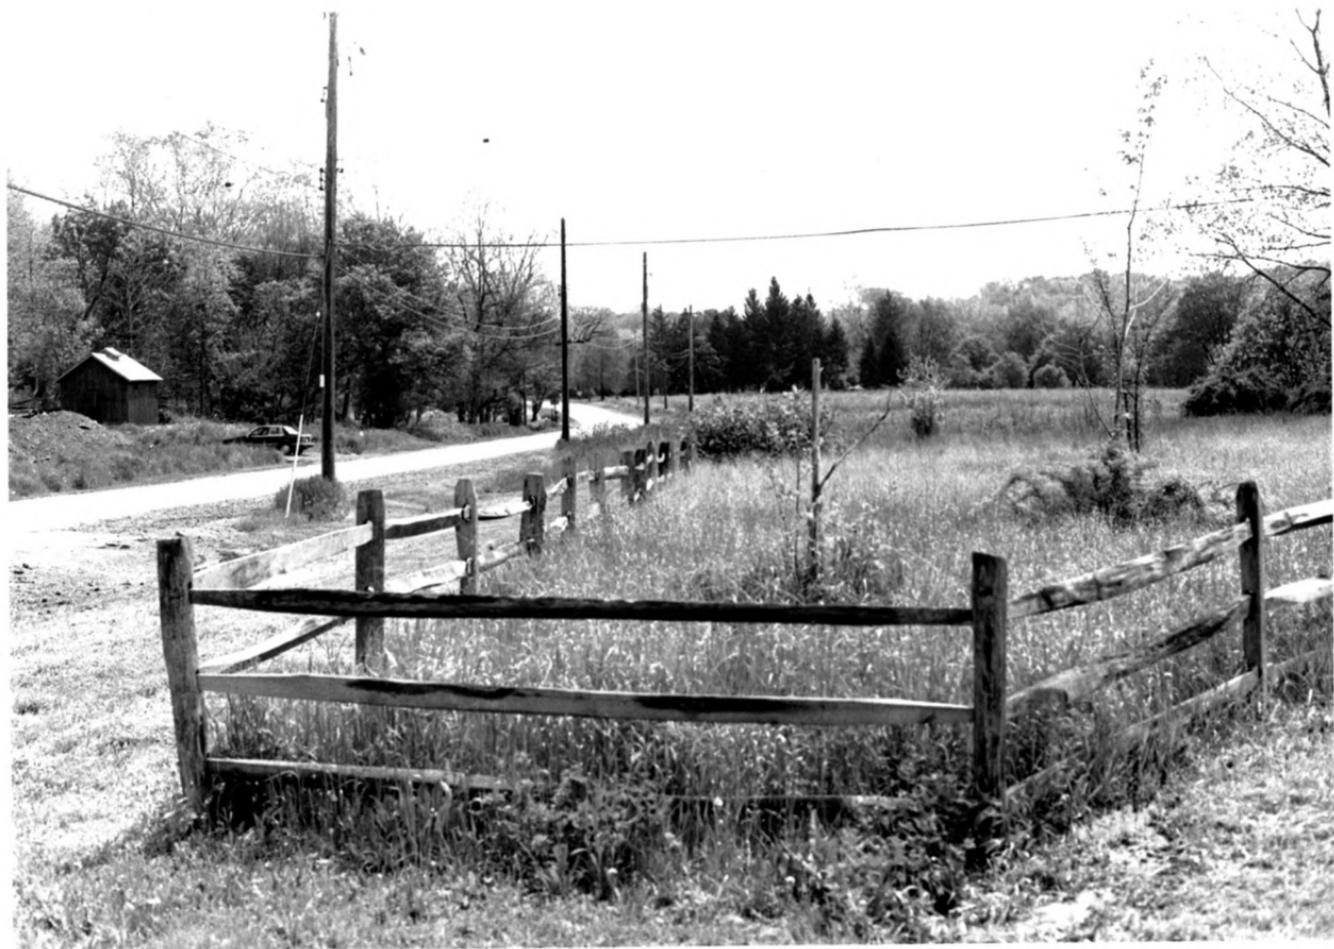
- 1) Edmond GLEASON, SOUTH of Tinkers Creek Road
- 2) Valley View, OHIO
- 3) Dean R. Dickerson
- 4) May 29, 1989
- 5) U.S. Department of Interior, National Park Service, Midwest Region, 1709 JACKSON, OMAHA, NE
- 6) camera direction: EAST

The second land parcel--Tract 4, Lot 8--is located across Tinkers Creek Road, to the southeast of the buildings. This parcel consists of 3.06 acres, making the combined acreage of the two parcels 13.5 acres. The only existing fence is a recently installed wood rail fence encompassing the northwest tip of the field. Although the fence is a noncontributing object, it does not distract from the visual appearance of the property. There are no additional fences on this smaller tract, but old property lines are distinguishable along tree lines to the south. Although now overtaken by sub-growth, it was here, on this bottom ground, where the Gleasons grew corn.

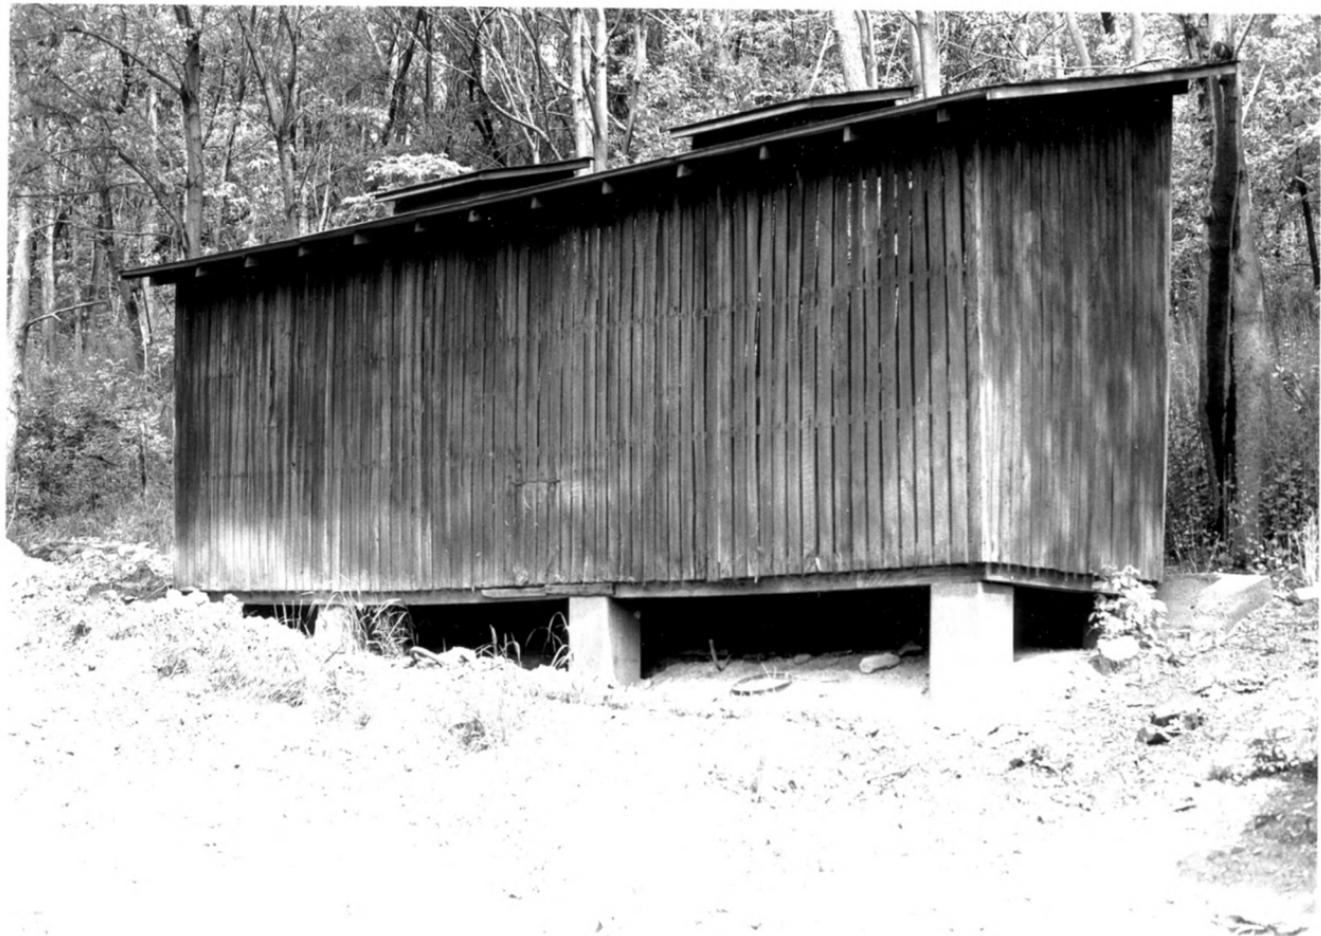
- 1) Edmond GLEASON, CORN CRIB
- 2) VALLEY VIEW, OHIO
- 3) DEAN R. DICKERSON
- 4) MAY 29, 1989
- 5) U. S. Department of Interior, NATIONAL PARK SERVICE,
Midwest Region, 1209 JACKSON, OMAHA, NE
- 6) Camera direction: Northwest

Similar building features are found on the corncrib-- the concern for ventilation and rodent abatement also being necessary. Unlike the granary, however, the corncrib also has slanted walls, making it more difficult for rodents to get in.

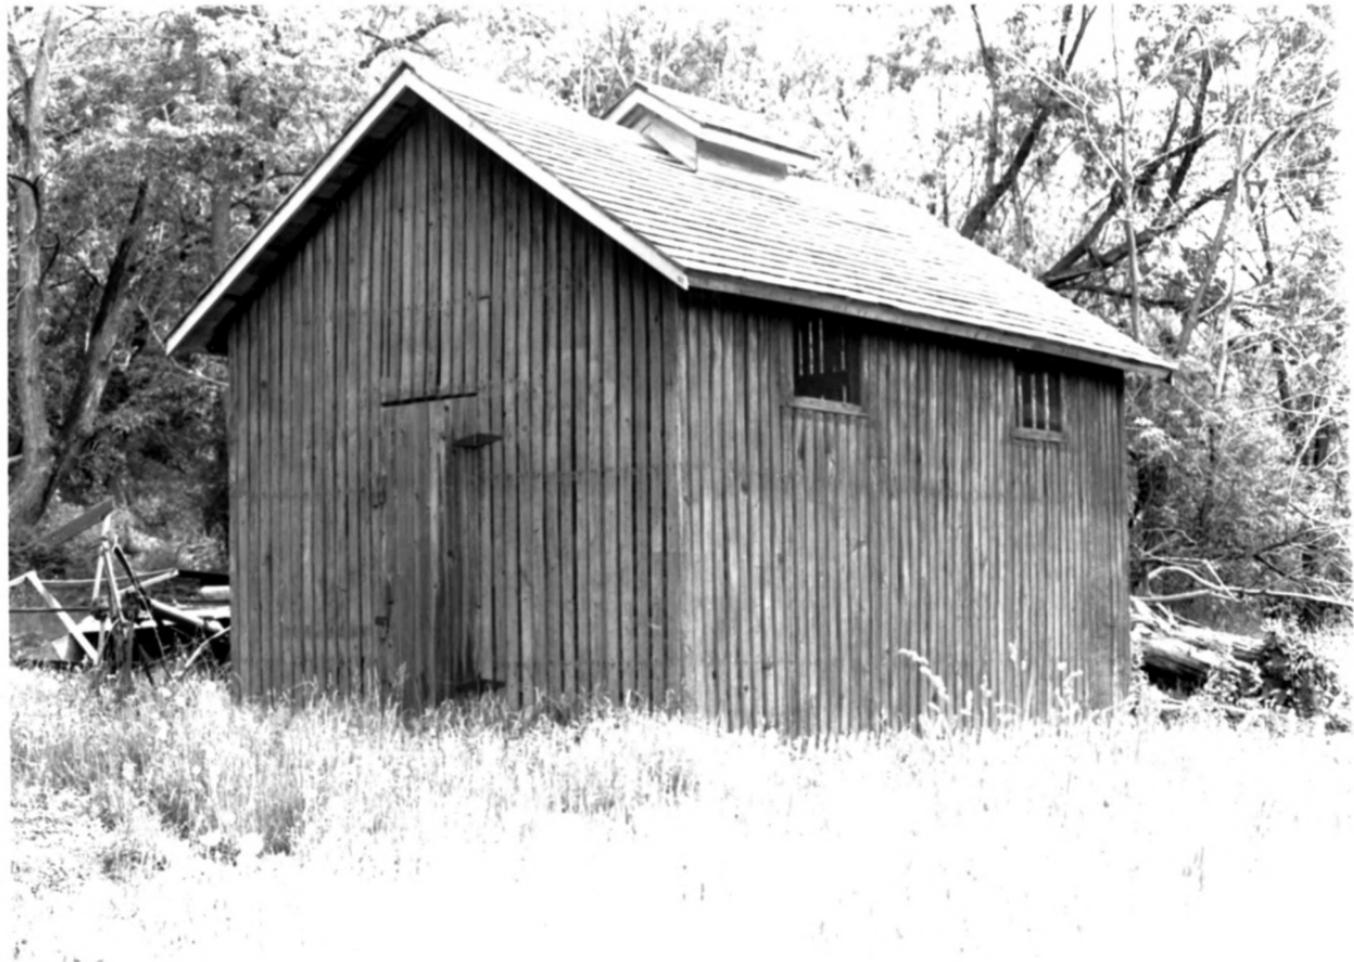
- 1) Edmund Gleason, CORN CRIB
- 2) Valley View, OHIO
- 3) Dean R. Dickerson
- 4) May 29, 1989
- 5) U.S. Department of Interior, National Park Service, Midwest Region,
1709 JACKSON, OMAHA NE
- 6) Camera direction: Northeast

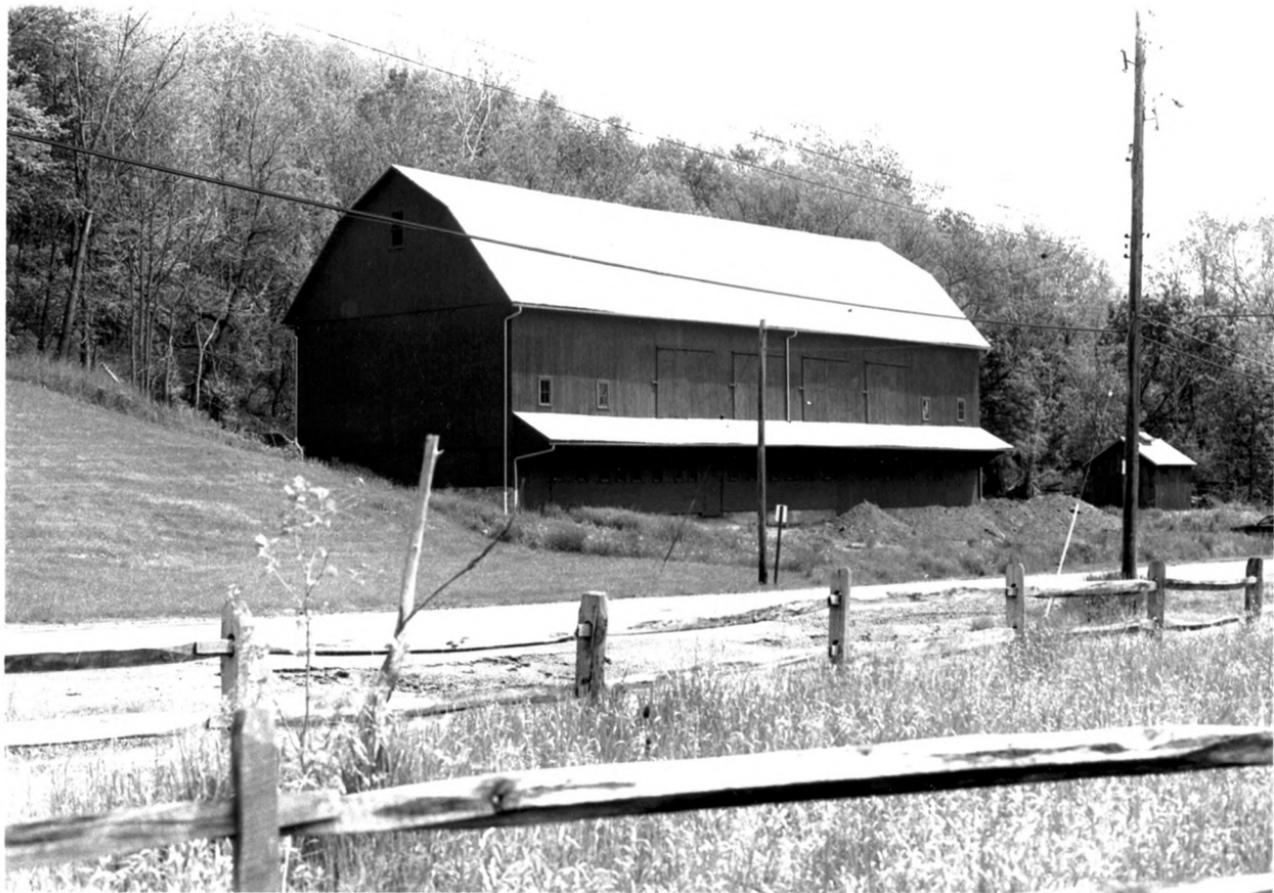
- 1) Edmund Gleason, Barn
- 2) Valley View, OHIO
- 3) Dean R Dickerson
- 4) May 29, 1989
- 5) U.S. Department of Interior, National Park Service, Midwest Region,
1709 JACKSON, OMAHA, NE
- 6) CAMERA direction: South east

Located approximately one hundred yards southeast of the house at the bottom of the hill is the Gleason barn (NR 1979). Built in 1905, this large 2 1/2-story barn has an gambrel roof covered with corrugated sheet metal. Its exterior walls are vertical wood siding. The south side, facing Tinkers Creek Road, has a sheet metal, pent roof overhang running the full one-hundred and eight-foot length of the barn. The foundation of this structure is concrete. Numerous doors and windows line the facade wall under the pent roof. Four large hay doors are located above the pent roof and are flanked by two symmetrically spaced windows. The other side of the barn is banked into a hillside and contains two large tracked doors.

The Wisconsin Dairy Barn contains architectural features associated with this building type. The rectangular massing, double pitch roof line, light lumber trussing, and rows of hay doors are characteristic features of this barn type developed at the Agricultural Experiment Station at the University of Wisconsin, Madison. The narrow width and rows of small windows are design features that maximize light for the lower livestock area. The gambrel roof profile provided more storage space needed for hay to feed the livestock.

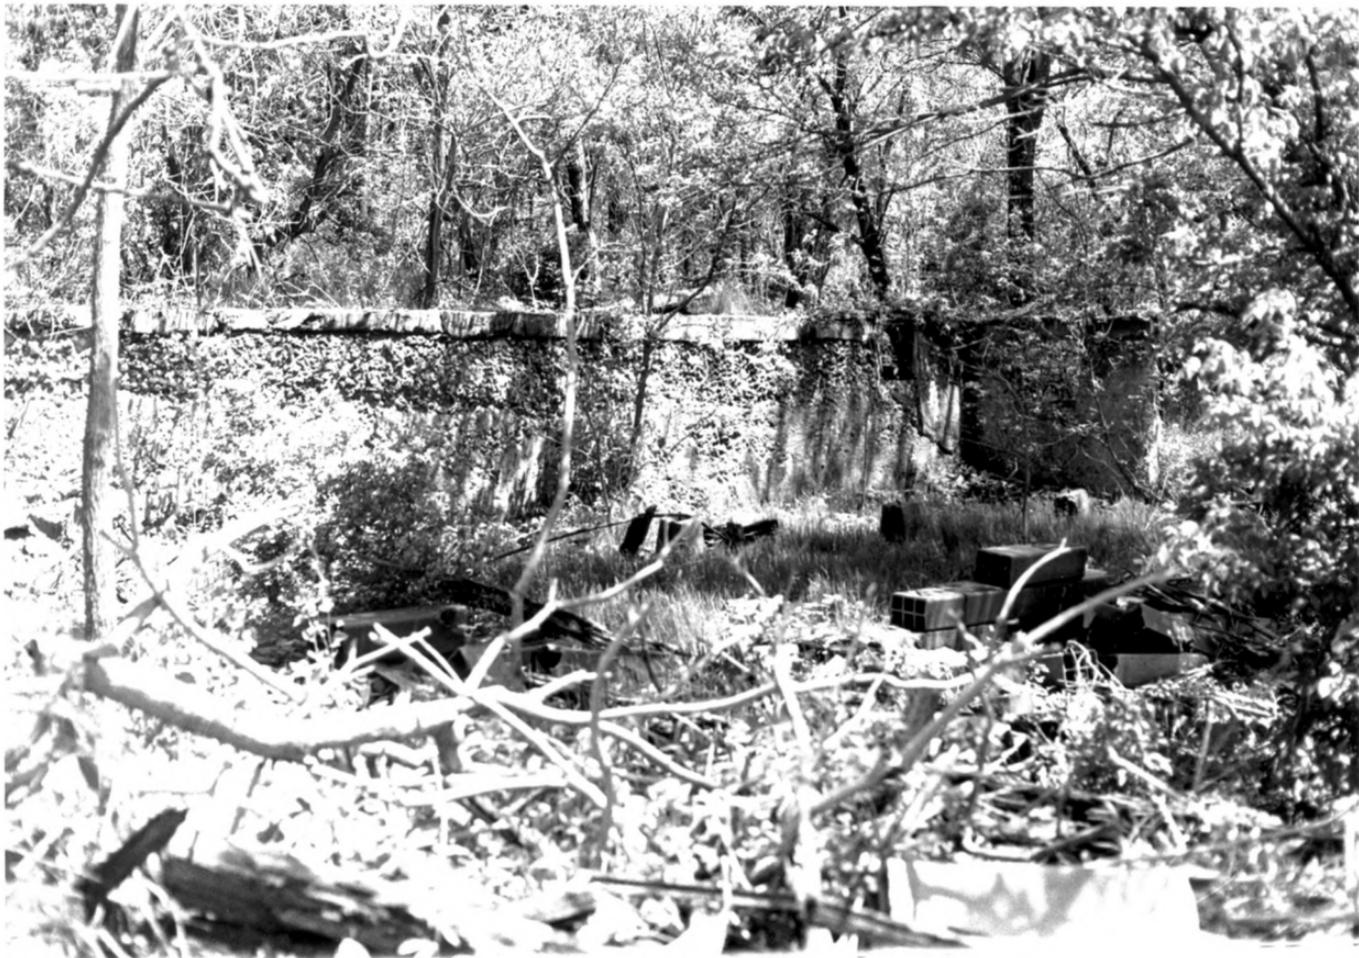
- 1) Edmond Gleason, old barn foundation
- 2) Valley View, OHIO
- 3) Dean Dickerson
- 4) May 29, 1989
- 5) U.S. Department of Interior, National Park Service, Midwest Region,
1709 Jackson, OHAMA, NE
- 6) Camera direction: North east

Located approximately fifty yards east of the barn, and almost entirely hidden by brush and trees, is an old stone foundation approximately 60 by 40 ft. wide. Very little information about this structure is available. However, it appears to be the remnants of an old barn. Possibly this is the location of the first barn built on the Gleason farm. The foundation, and what is left of the basement walls, consists of stone and stone rubble. There is a large opening on the east end of the foundation which appears to be the principal entrance. Inside the foundation are several concrete stubs which, at one time, supported the main floor.
