**NATIONAL REGISTER OF HISTORIC PLACES
INVENTORY -- NOMINATION FORM**

Edmund Gleason House (Edwin Carey House)

STREET & NUMBER 7243 Canal Road

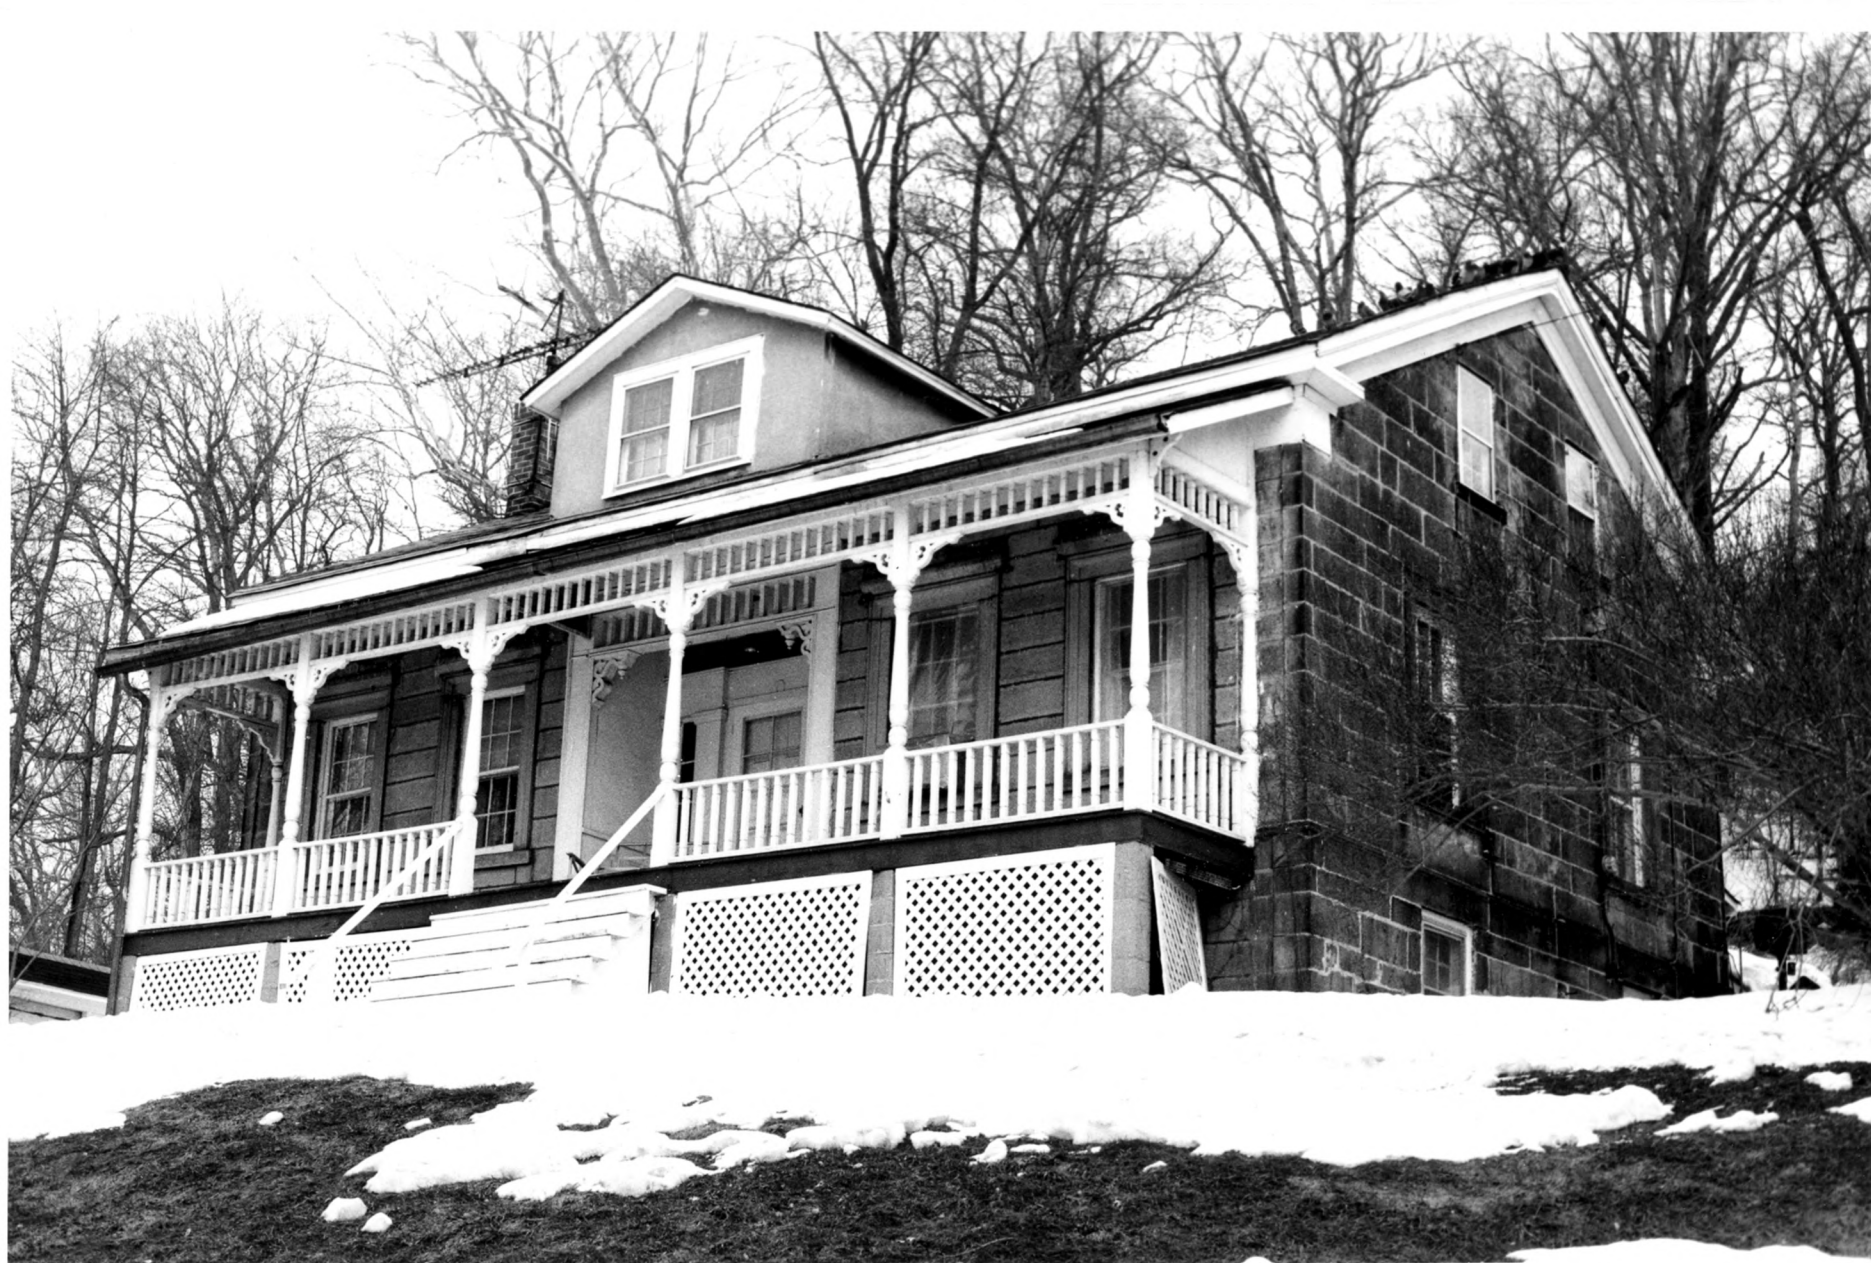
Gleason House photo #1 of 5

Facade and south elevation looking
northeast

The Edmund Gleason House is a one-and-one-half-story rectangular sandstone house in the Greek Revival style. It is built into a steep hillside overlooking the Ohio and Erie Canal. The house is five bays wide by two bays deep, and features a central entrance, a wide, plain frieze, and a gable roof with gable returns. The house is constructed of plain ashlar sandstone and has a cut stone water table with beveled edge. There is a basement. The windows are double-hung, with 6/6 lights. Those in the side and rear elevations have dressed stone sills and lintels. In contrast, the facade features tooled stone with margins laid without vertical joints. The front windows are much larger than the others and feature acanthus leaf acroteria.

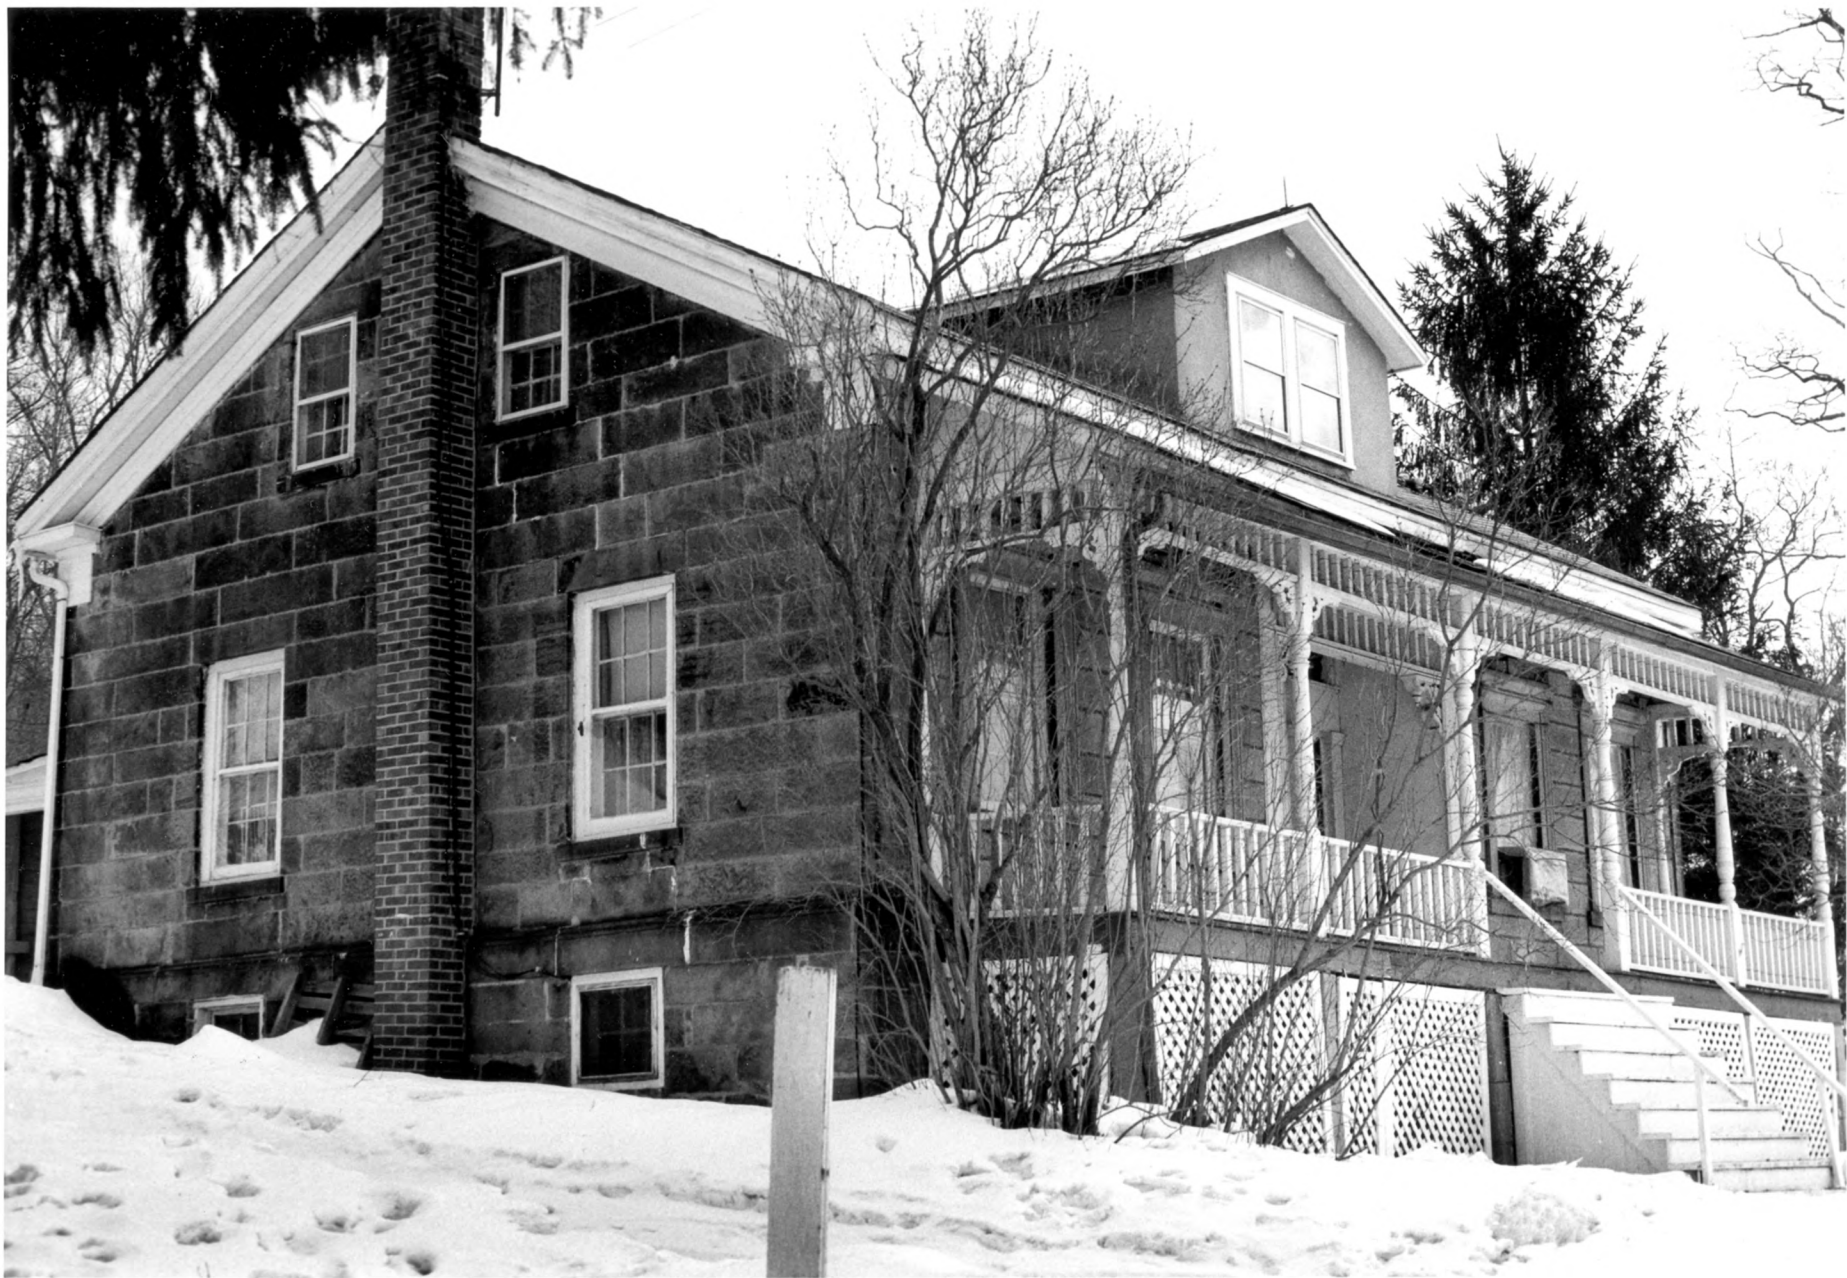
Gleason House photo #2 of 5

Facade and north elevation looking
southeast

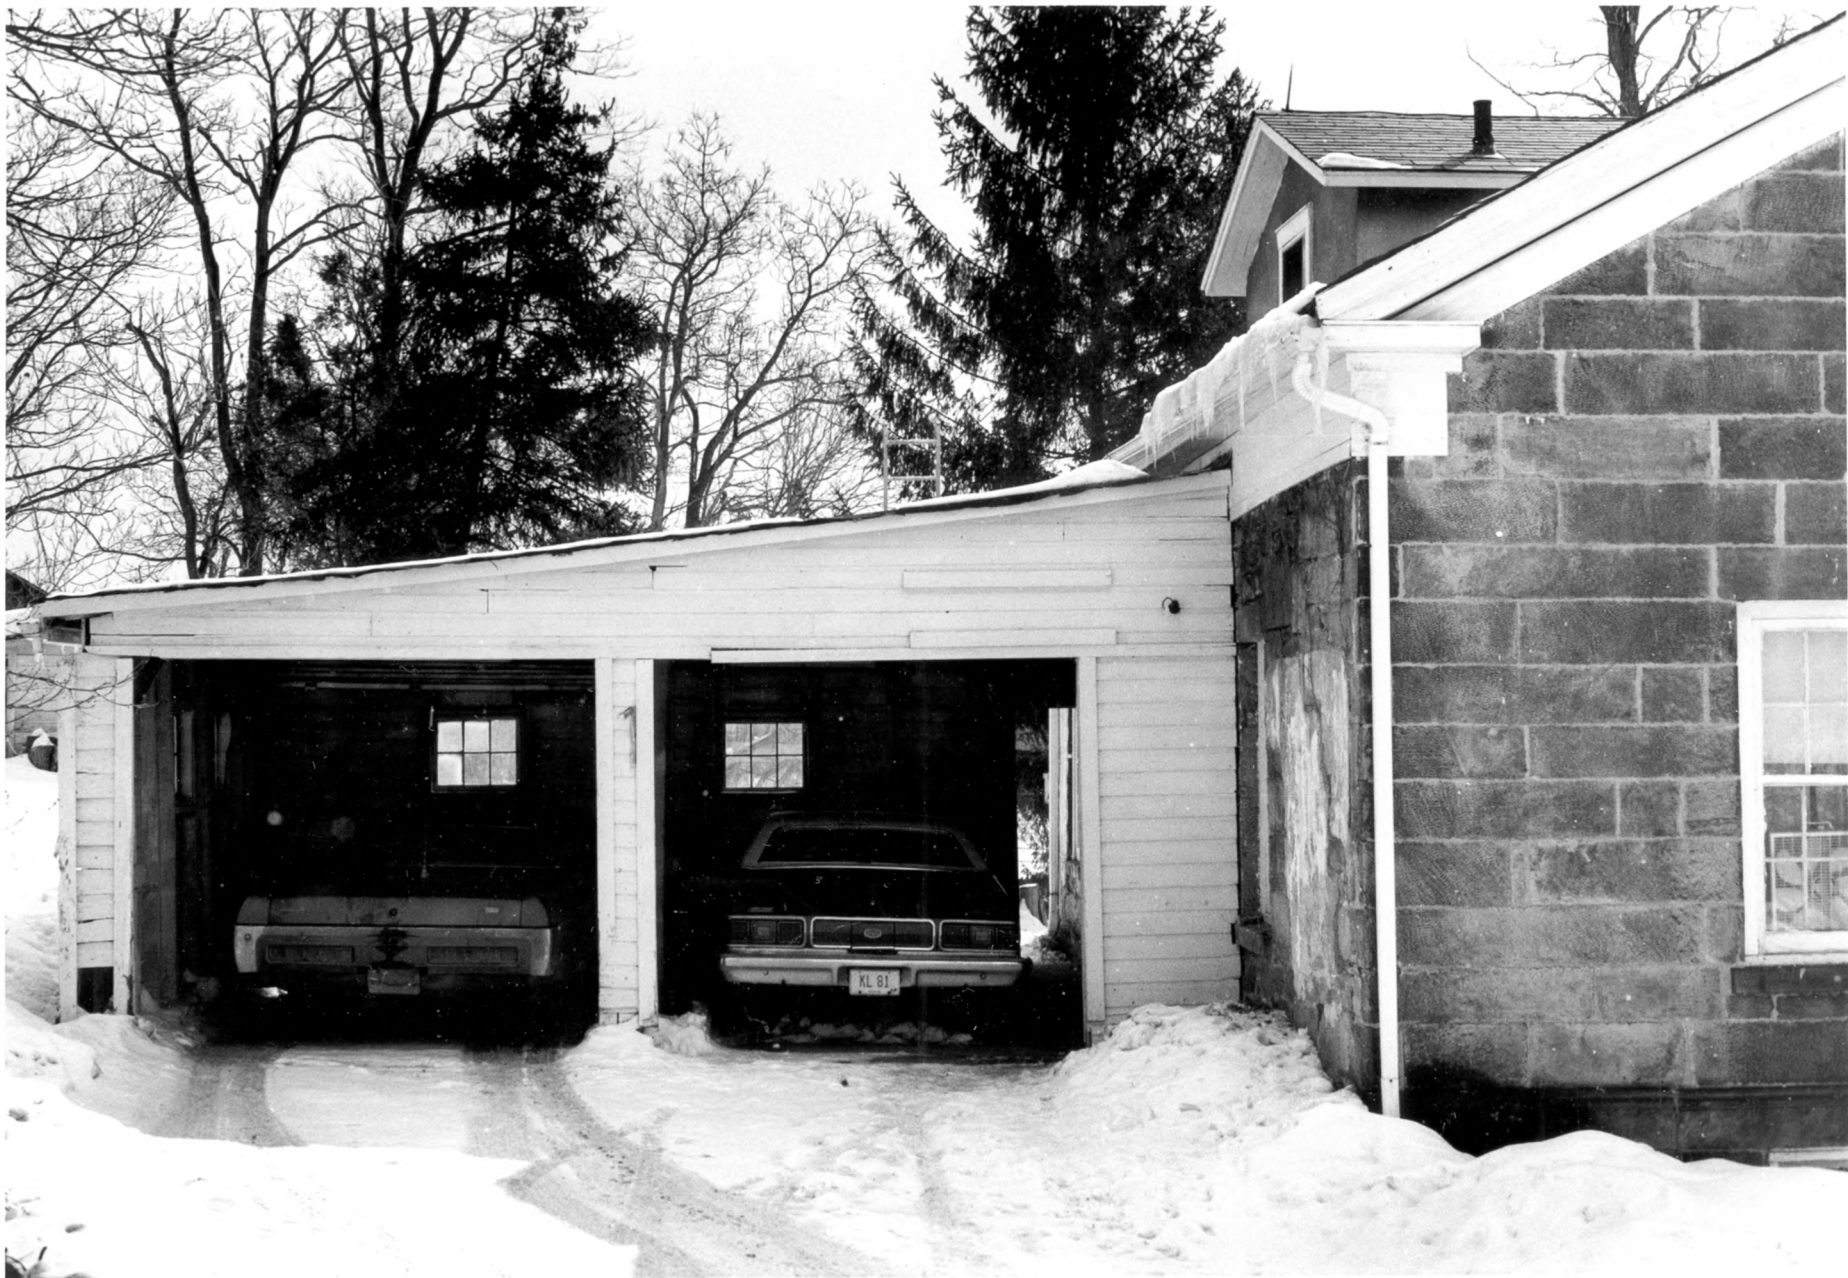
Rear (east) elevation looking south
Gleason House photo #4 of 5

A five-room wood frame addition that was attached at the rear of the house as early as 1892 was removed in 1939.² The house underwent considerable remodeling that year: gabled dormers were added at both the front and rear of the house; the original chimney tops at each end of the roof were removed; a new outside end chimney was built against the north wall; and several closets were installed. There is a two-car, wood frame garage attached at the rear. A large

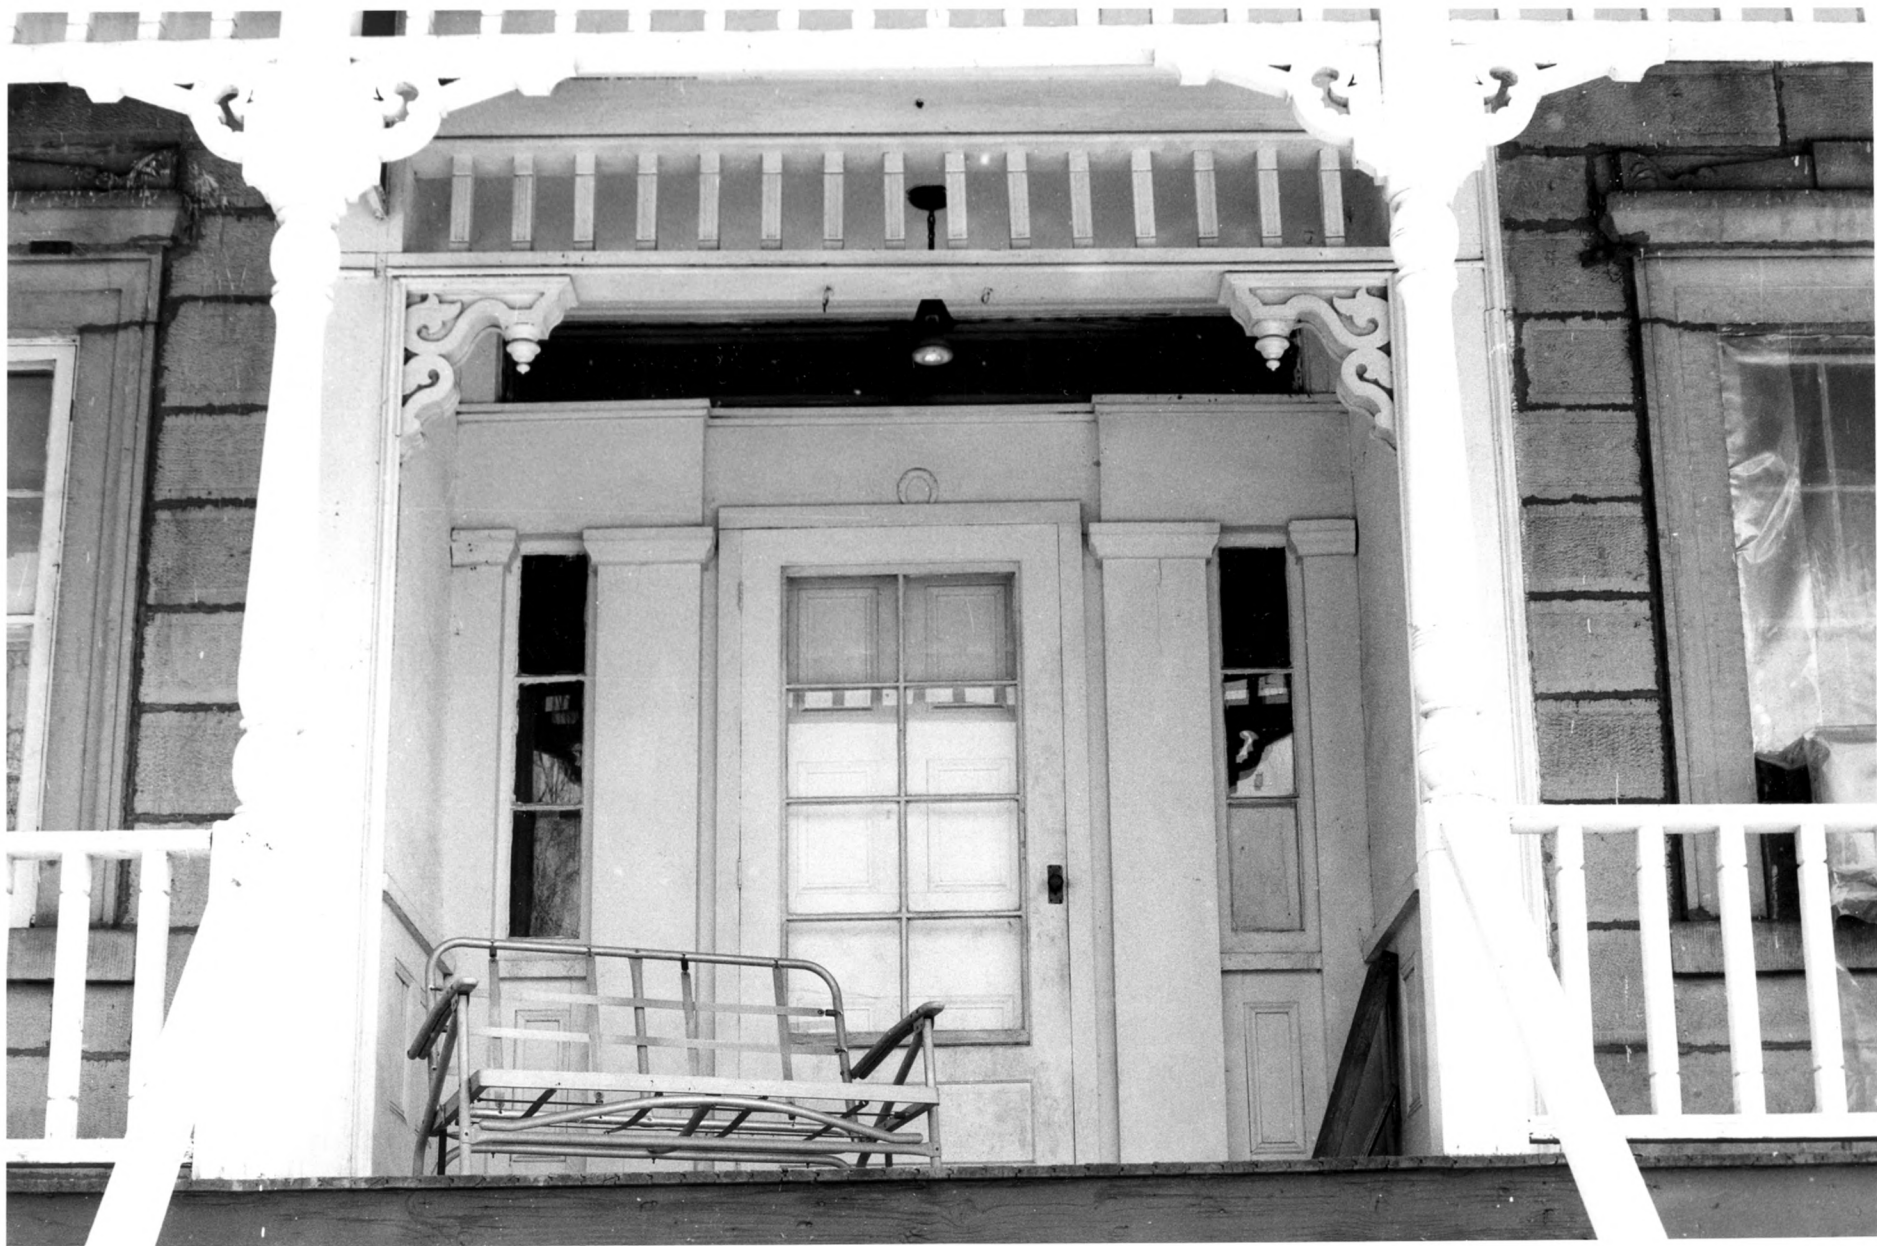
Entrance detail
Gleason House photo #3 of 5

The central entrance is broad and deeply recessed. A rectangular six-panel door is flanked by two full and two half pilasters. These frame three-light sidelights and carry a broken entablature. The door features a rectangular transom divided by five mullions. The recess features the same paneled wainscoting that appears beneath the sidelights.

A wood spindle porch with a shed roof was added c. 1880. The porch features turned posts and a square spindle railing and frieze with scroll brackets. The same spindles appear across the front entrance recess, where they are supported by foliated scroll brackets with pendants. The porch is reached by a flight of seven wooden steps; these originally were stone, according to the present owner.¹ The porch rests on concrete block piers. Lattice skirts conceal the underside of the porch.

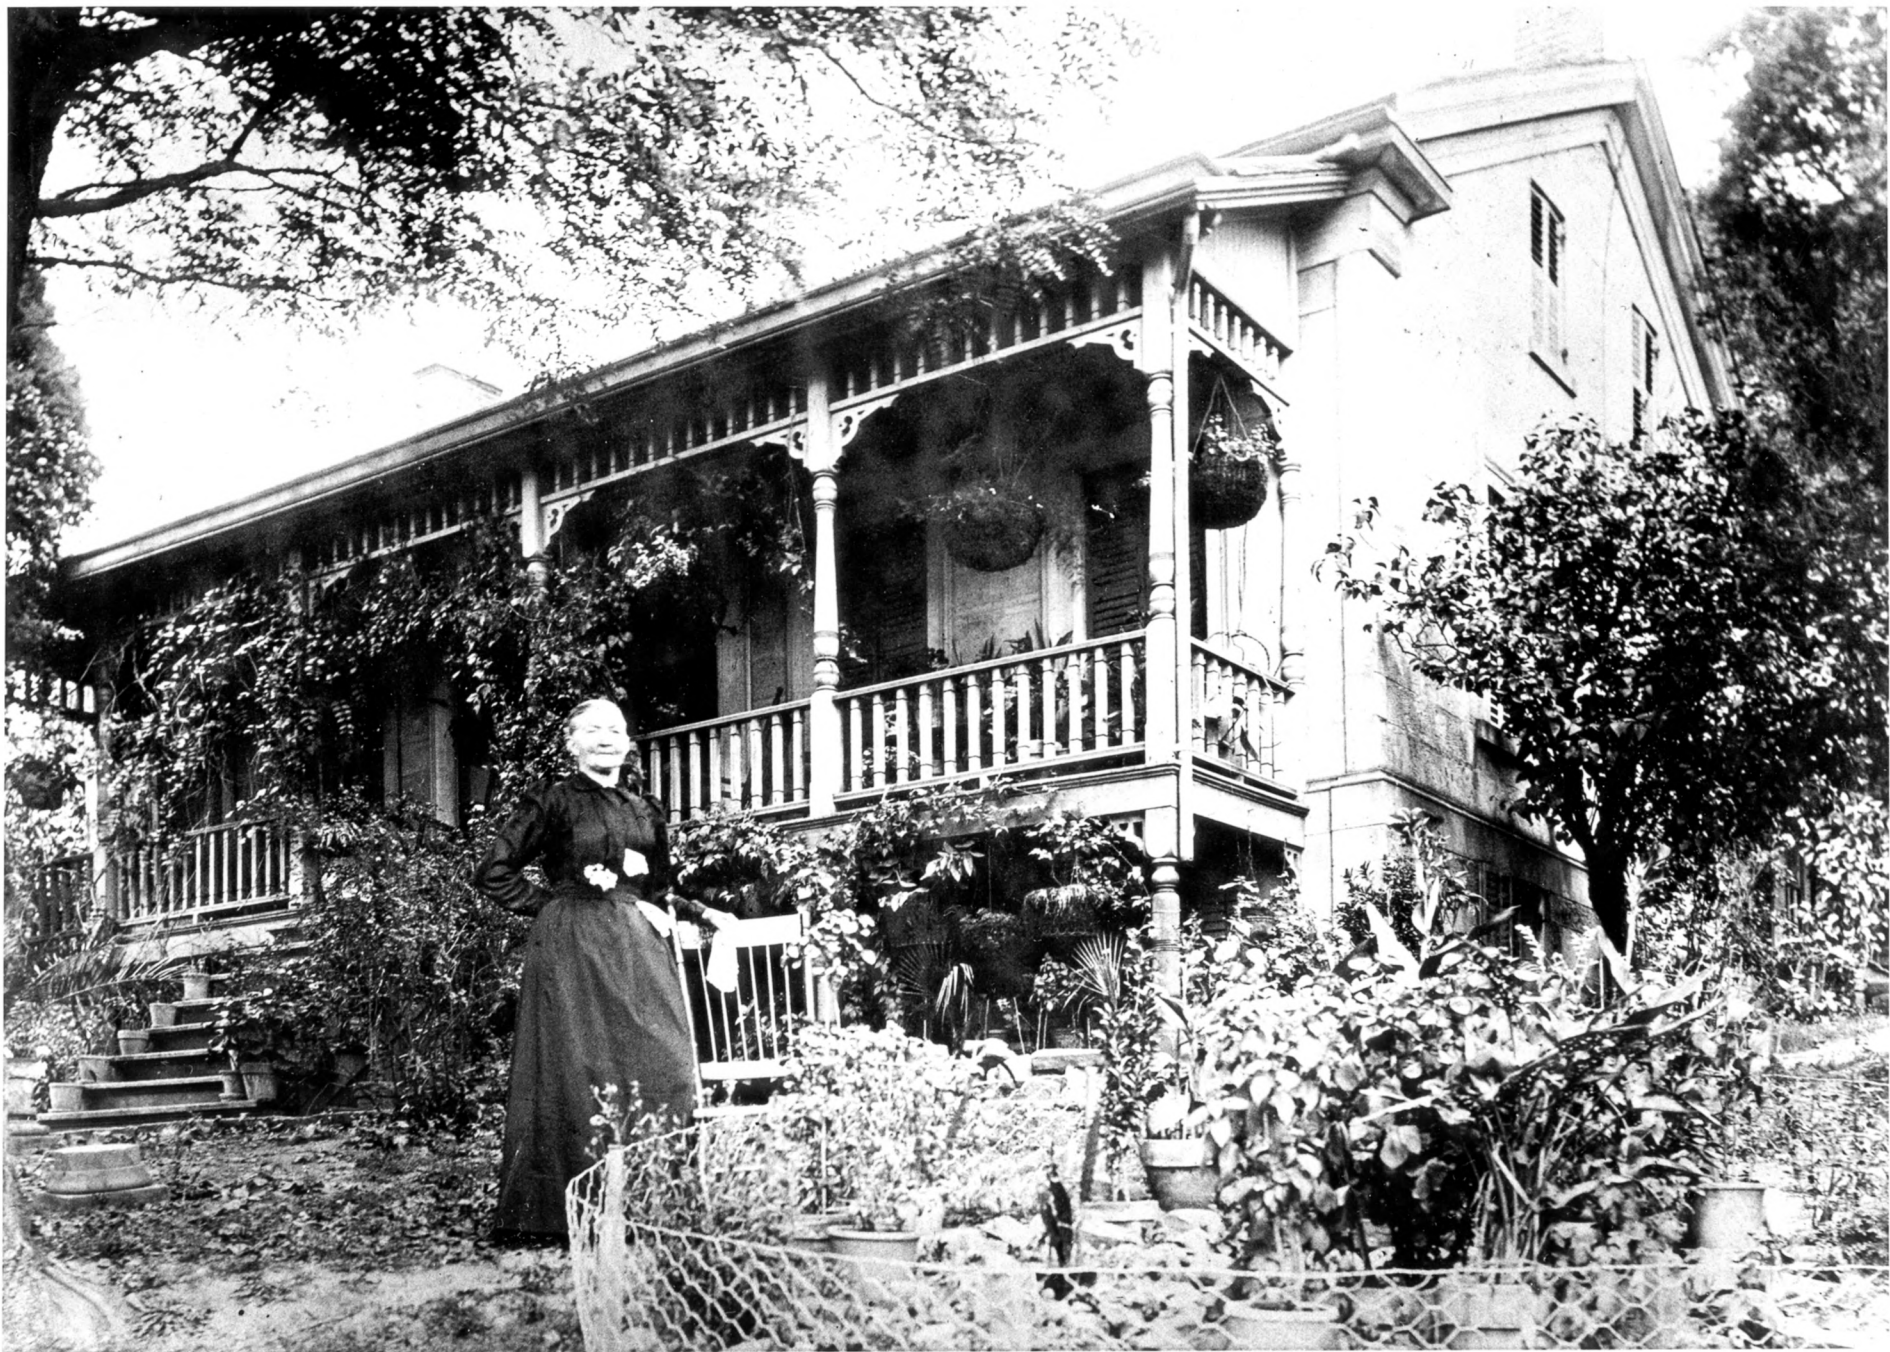
Gleason House photo #5 of 5

Edmund Gleason House, c. 1890. Photo-
grapher unknown. The woman in the
photograph is Charlotte Gleason.
Negative property of The Western
Reserve Historical Society,
Cleveland, Ohio
