OHIO HISTORIC INVENTORY

1. No. //	4. Present Name(s) "Jim" Brown Tavern	1. No. //
2. County Summit	5. Other Name(s)	
3. Location of Negatives OHS

Jim Brown Tavern, Ohio and Erie Canal
District, Cuyahoga and Summit
Counties, Ohio

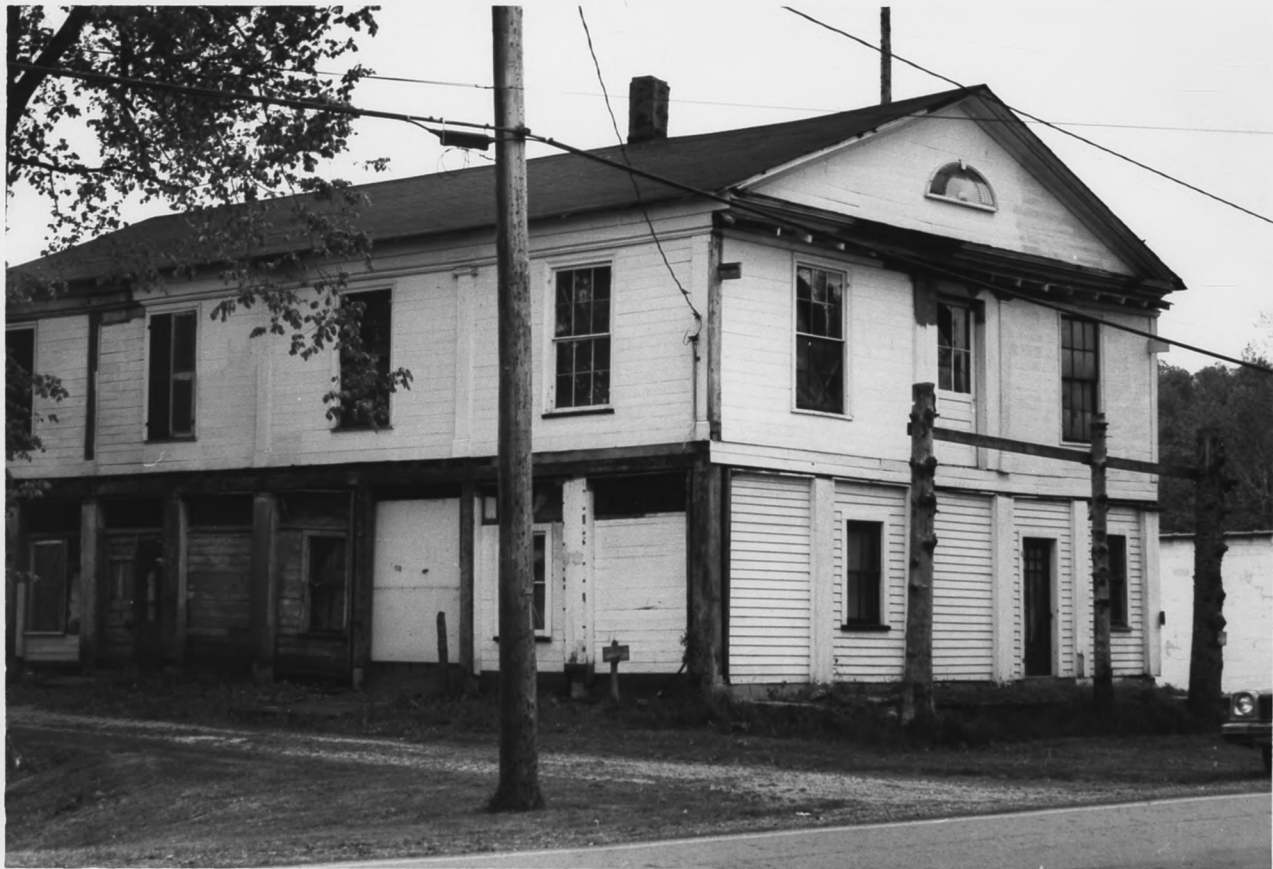
#11-718

Facade and east elevation looking
southwest

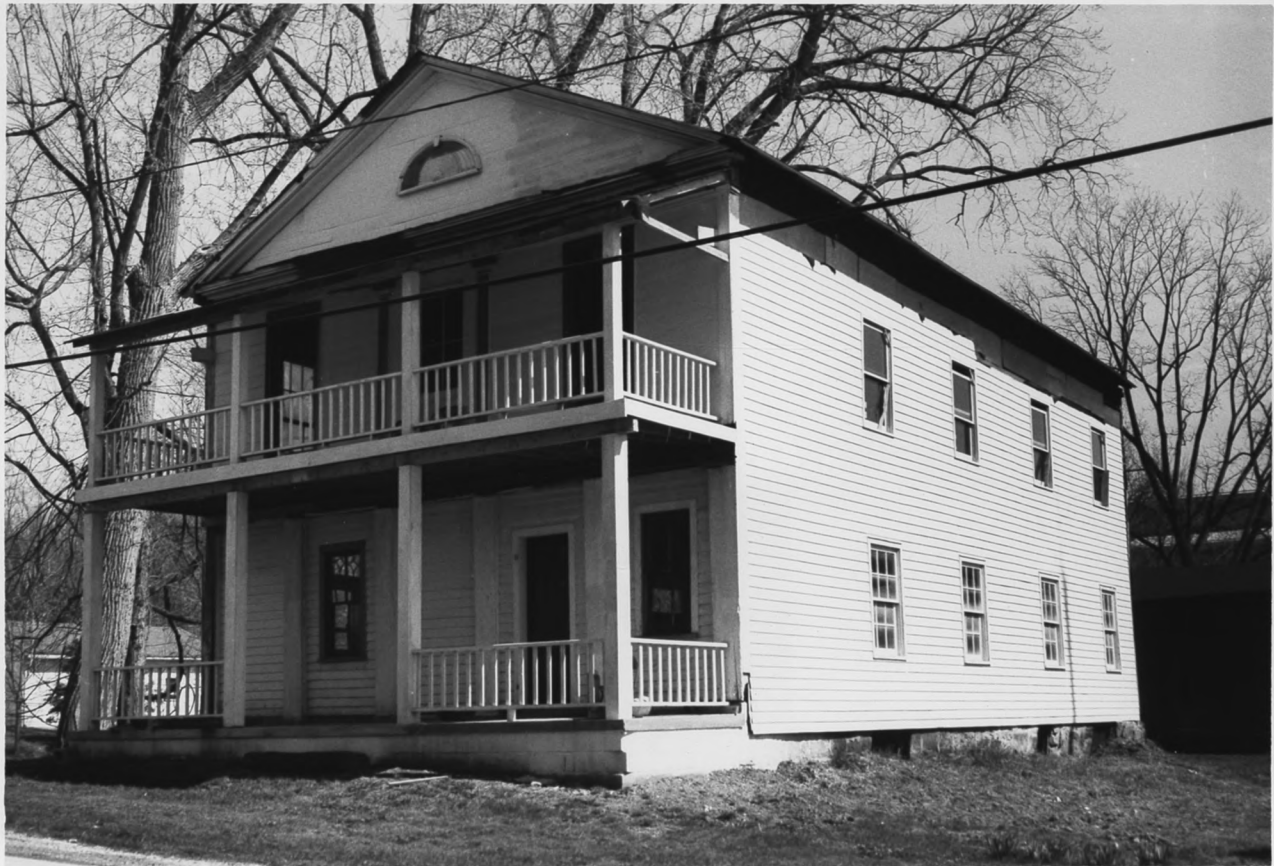
#5018

2. Further Description of Important Features Building is constructed in unusual rhomboid shape. Pilasters divide building into 3 X 4 bays, though west elevation has been unfortunately altered (probably in attempt to "restore" the building) by removal of pilasters and new clapboard siding (see photo, over). There is a handsome elliptical fanlight in the pediment, which features flush siding. Much of the delicate classical ornamentation has been preserved, despite numerous alterations.	27. Other Surveys in Which Included	39. Endangered? By What? neglect, unsympathetic restoration efforts Yes <input checked="" type="checkbox"/> No <input type="checkbox"/>

Facade and west elevation looking
southeast. *POC*
