# OHIO HISTORIC INVENTORY

1. No. <b>8</b>	4. Present Name(s) <b>Lock No. 34 ("Red Lock")</b>
2. County <b>Summit</b>	5. Other Name(s)
3. Location of Negatives <b>OHS</b>

Summit County, Ohio  
Lock No. 34 ("Red Lock")

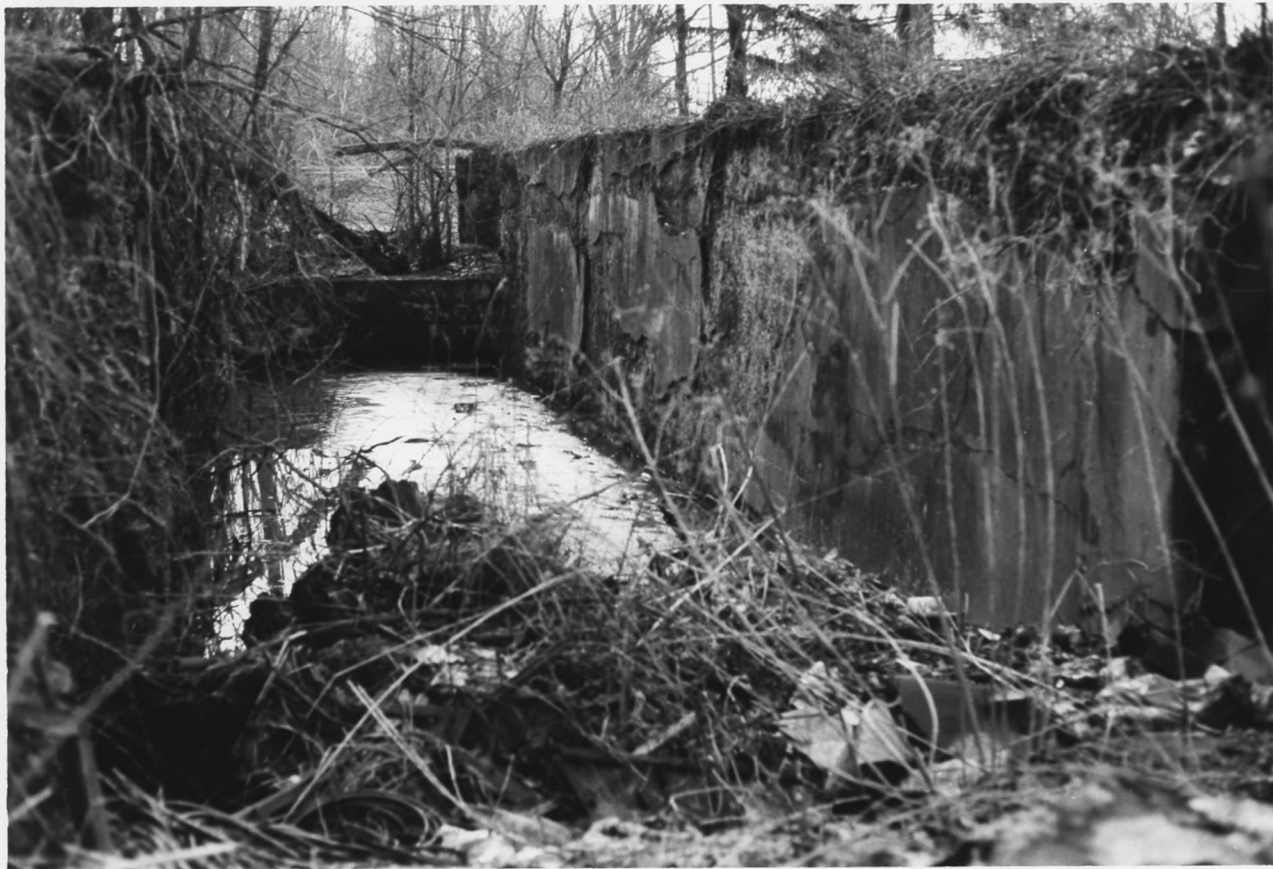
#8719

Lock No. 34 ("Red Lock"), Ohio and  
Erie Canal District, Cuyahoga  
and Summit Counties, Ohio

View looking north.
