Spanning the Gap

Isaac Van Campen Inn

Spanning the Gap
The newsletter of
Delaware Water Gap National
Recreation Area
Vol. 6 No. 2 Summer 1983

by Tom Solon

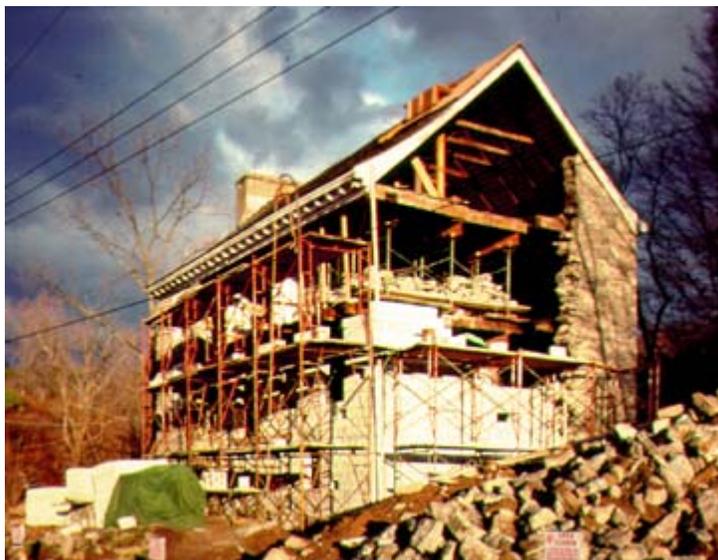
(Left, above) The Inn under restoration and stabilization in 1981. (NPS photo by Tom Solon)

Since its construction, the Inn has been suffered from a variety of structural problems. To correct these problems, two-thirds of both the front and the south end walls were dismantled and new foundations were constructed. In addition, the rear wall of the building was structurally reinforced, and the first floor support system was replaced.

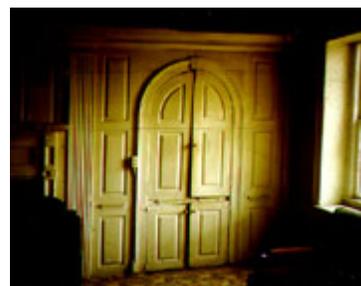
Panelled woodwork in Van Campen Inn, 1972.

The Inn is especially notable for its architectural detail. Its paneled rooms contain many handsome examples of the colonial woodworker's craft. These features are currently being restored as part of a major rehabilitation project.

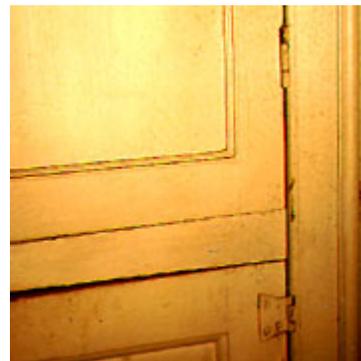
A closer look at the woodwork, showing an antique hinge on the bottom, and a modern hinge on the top, 1972.

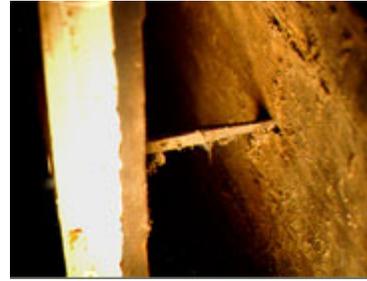
Newer panelling on the left, with older panelling behind it on the right, 1972. A nail runs between the two surfaces.

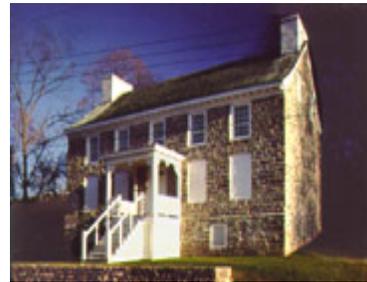
Van Campen Inn after restoration, in 1984.

Editor's Note: Restoration of the exterior of the house has been completed. (See photo at right)
