**NATIONAL REGISTER OF HISTORIC PLACES REGISTRATION FORM**

historic name: Mantle's Cave  
other names/site number: 5MF1

street & number: Dinosaur National Monument ( ) not for publication  
city, town: Dinosaur (XX) vicinity  
state: CO code: CO county: Moffat code: 081 zip code: 81610

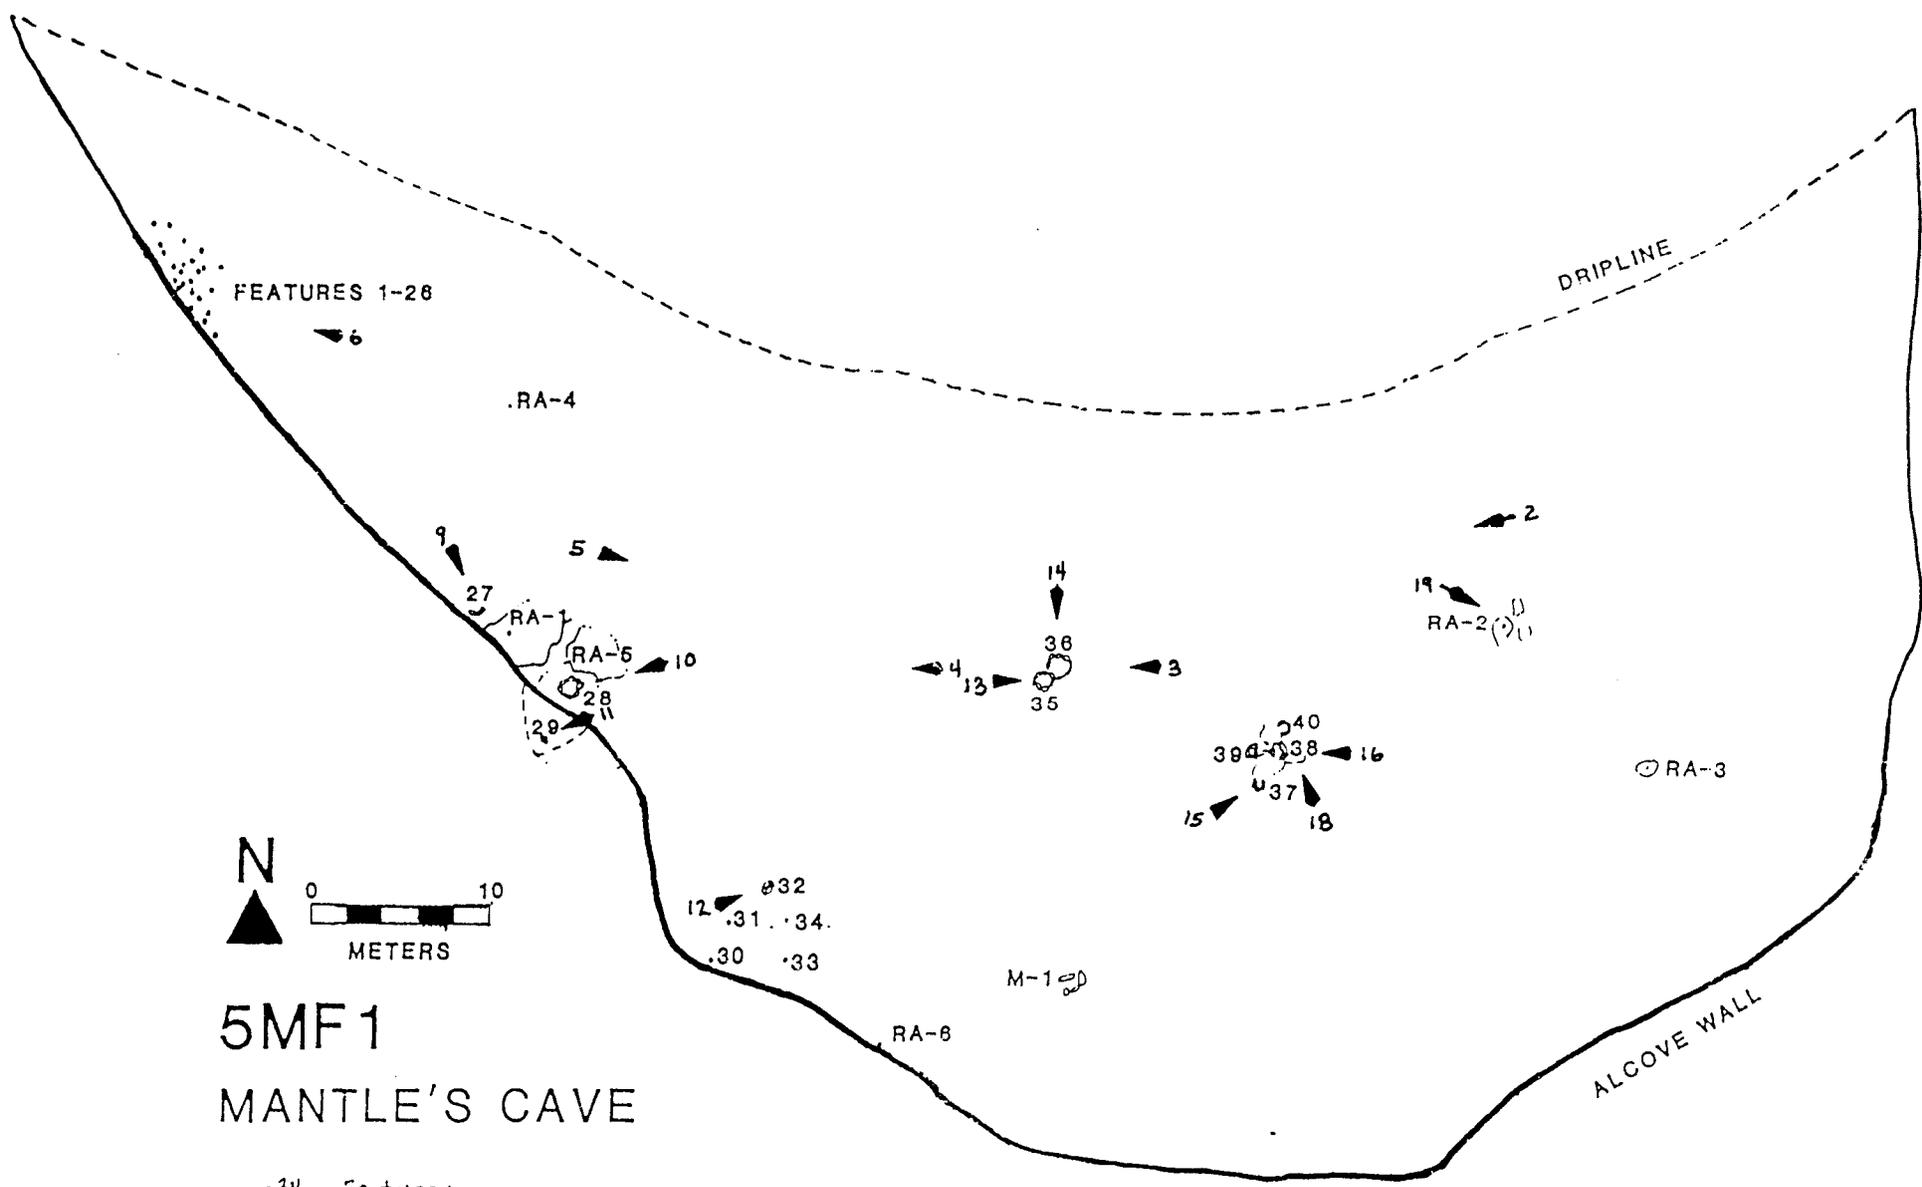
MANTLE'S CAVE / 5MF1  
MAP 1

Planview of Mantle's Cave, showing the distribution of site features.

Fifty-four prehistoric cultural features have been documented in Mantle's Cave (Map 1). Of this number, 36 are still visible, the others having been destroyed or covered over by sandy soils. All but one of the features can be classified as storage cists. The cists are scattered throughout the alcove, except for the eastern end, where none occur. A very high concentration is present in the small pedestal of consolidated silt at the western extreme of the site (Map 2). Over 30 cists were uncovered in this 20 m<sup>2</sup> area. Only 26 can be discerned today. The one prehistoric cultural feature which is not a storage cist is a small rock art panel located near the east end of the cave. While the features are an integral part of the site, the cave itself and the area around the features are considered as one contributing element. (Table 1 indicates the contributing and non-contributing elements at the site.)

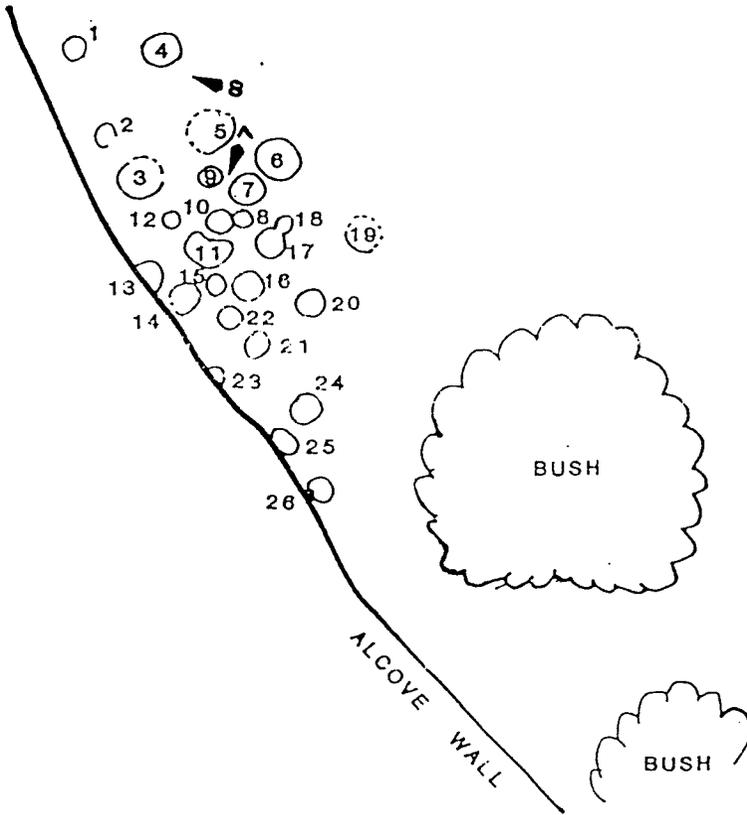
The distribution of earthen cists at the western end of the site.

Features 1 through 26 are presently visible and are located in the silt deposits at the western end of the site. The silt is consolidated, permitting the construction of earthen cists. Features 1, 8, 9, 10, 11, and 15 were stabilized in 1989.
