## Totten Shutters

## Project History

## Work in Progress

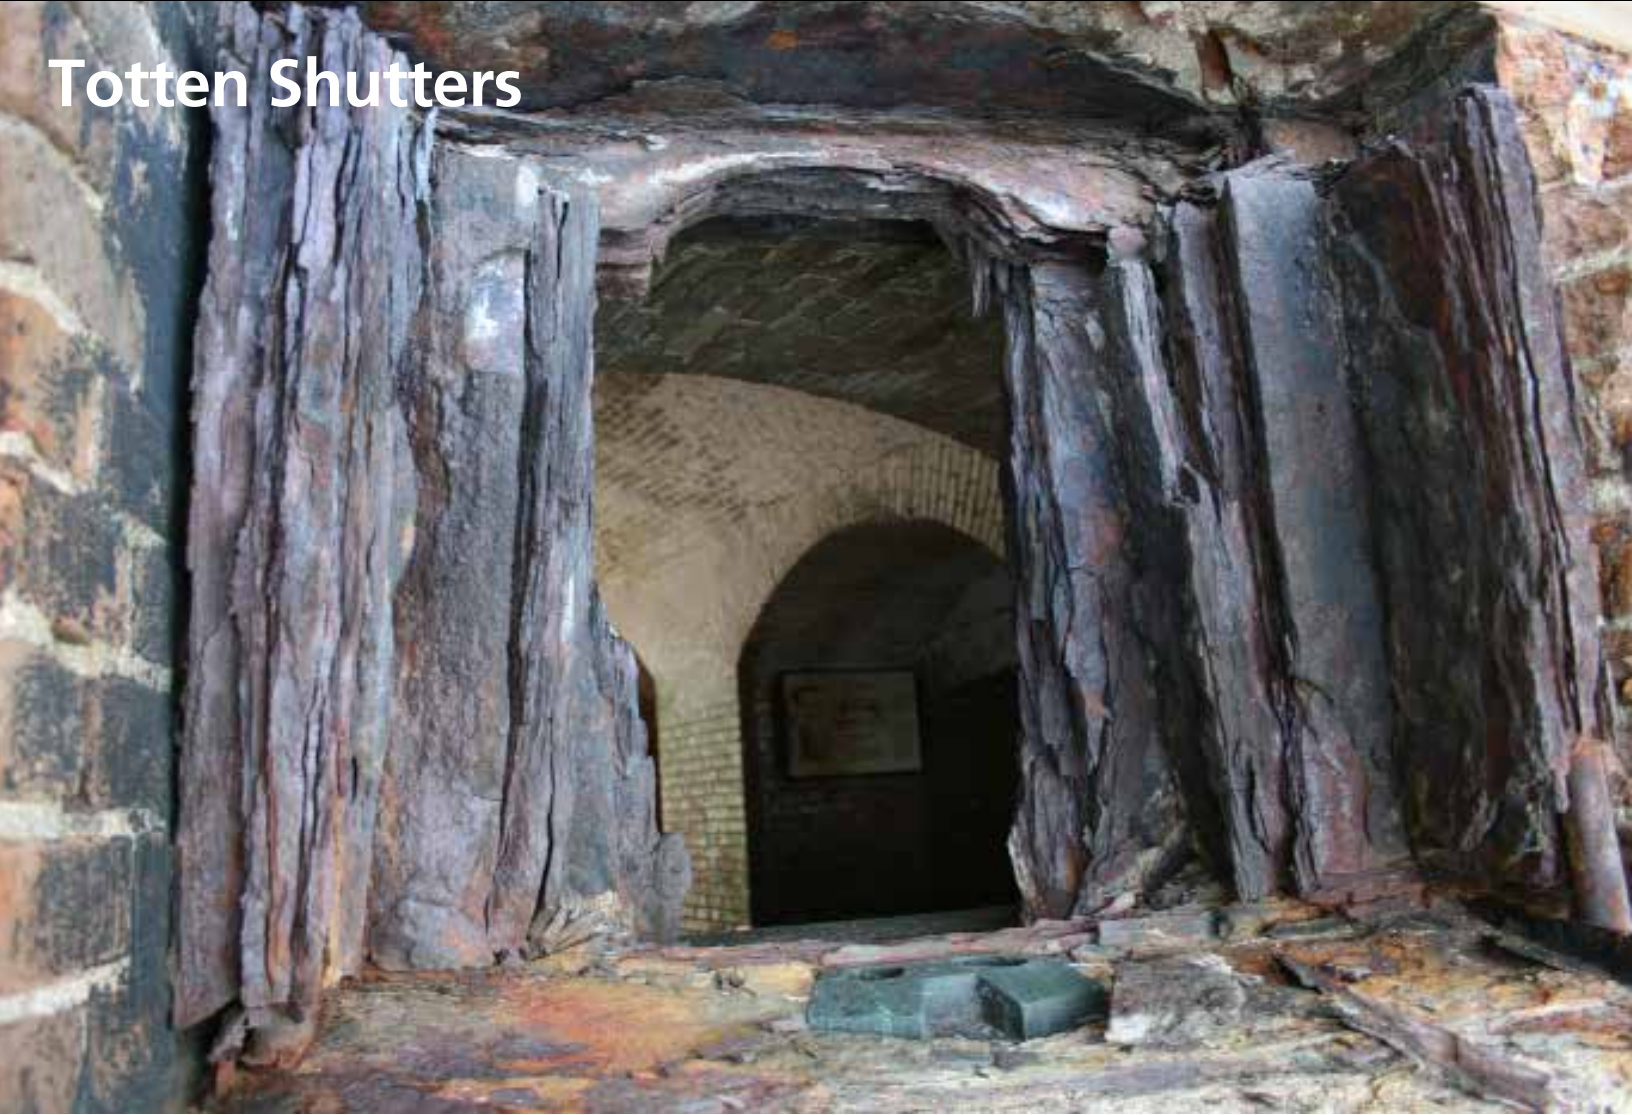
Construction of Fort Jefferson began in 1846 and continued through the Civil War until the 1870's. Fort Jefferson is part of the Third System of seacoast fortifications defined by systematic and refined casemate details. One of the most important features of Fort Jefferson is the original iron Totten Shutter; a uniquely designed and highly engineered defense feature. Ultimately the Totten Shutter became the first time that armor became a standard element of harbor defenses as a result of extensive experimentation and exhaustive study by one man; Joseph G. Totten

and simultaneously allowed the guns to swivel on a 60 degree angle laterally providing an optimal firing range. Additionally, he developed a shutter system that instantly opened upon firing of a projectile and then immediately slammed shut which protected the guns and personnel from return fire while they prepared the next round of ammunition. This incredible engineering innovation is referred to as the Totten Shutter. The basic elements that make up a Totten Shutter assembly consist of exterior and interior elements and the swinging doors. On the exterior face of

the scarp wall an iron breast plate frames the opening, while a header, sill, and side jambs frame the exterior side of the smaller opening. It is here that the two shutter doors are hinged to fly open when a projectile is fired and then shut immediately. Finally, armor blocks line the interior throat of the opening. Look for the original Totten Shutter elements around the lower tier embrasure openings as you move around Fort Jefferson and see if you can identify the original elements.

Due to the extreme marine environment at the Dry Tortugas the original iron Totten Shutters have severely rusted and expanded which in turn has created severe delamination of the brick from the scarp wall and loss of original historic material.

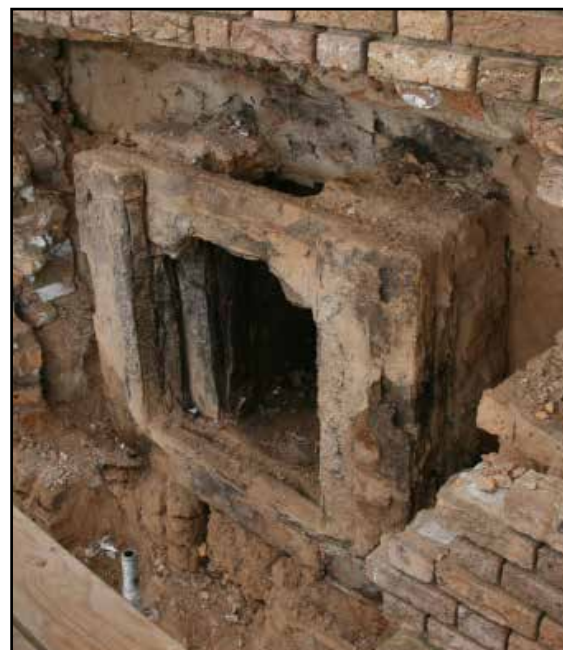
*Original iron Totten Shutter assembly embedded within the scarp wall*

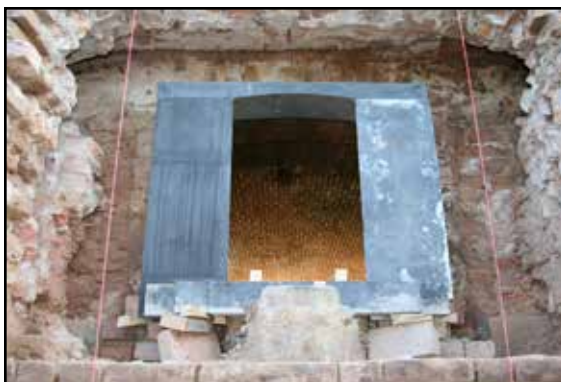
*Replicated Totten Shutter components to be embedded within scarp wall*

On site today you will witness tradesman installing new replicated Totten Shutter pieces such as the armor blocks, headers and sills. They are also repointing unreconstructed sections of the scarp wall.

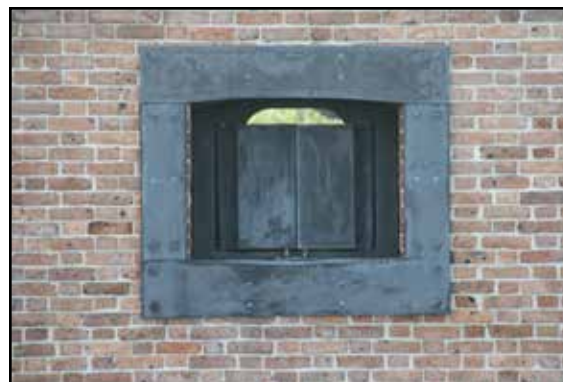
*Replicated Totten Shutter assembly embedded in scarp wall with shutter doors and an exterior breast plate*
