# National Park Service Cultural Landscapes Inventory 2022

**Fort Jefferson Landscape  
Dry Tortugas National Park  
[2022 Condition Reassessment]**

Fort Jefferson Landscape

Dry Tortugas National Park

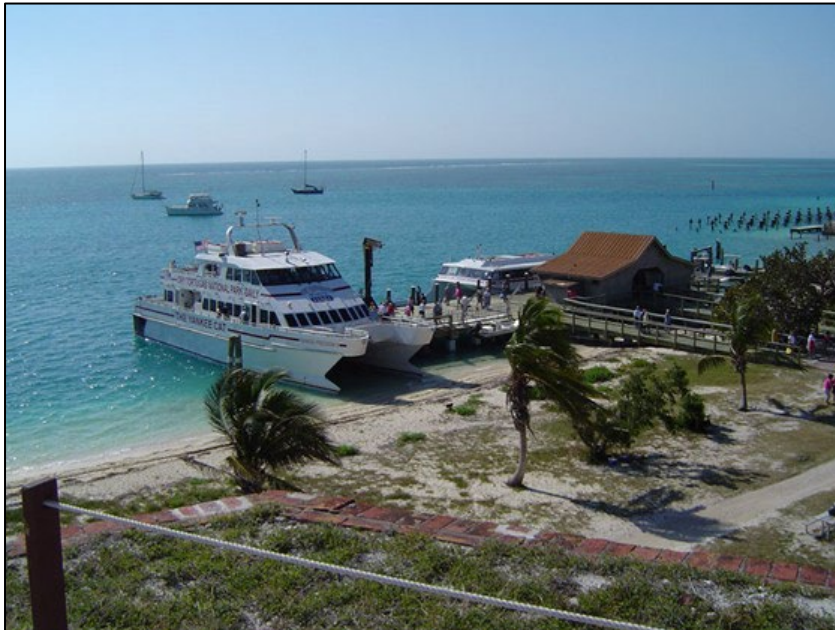
The rehabilitation of the timber boathouse docks, ramps, and moat bridge was completed in 2005. Phase 1 stabilization of the scarp wall reached ninety percent completion. The park suffered hurricane damage in 2004, but 2005 was a record year. Hurricanes Dennis, Katrina, and Wilma all struck the Dry Tortugas. At Fort Jefferson, damage occurred to the counterscarp wall, docks, employee quarters, the communications tower, and park utilities. After Hurricane Wilma, the park was closed for several weeks to allow staff to repair damages and remove downed vegetation. Finger piers remained partially unusable during 2005 (Federal Highway Administration, "Final Construction Report, Dry Tortugas National Park, Monroe County, Florida," May 2005, DRTO 4378, South Florida Collections Management Center, Everglades National Park; LAS, 163; Superintendent's Annual Narrative Report, 2000- 2006, SERO archives).

Fig 13. Boat dock, 2005.

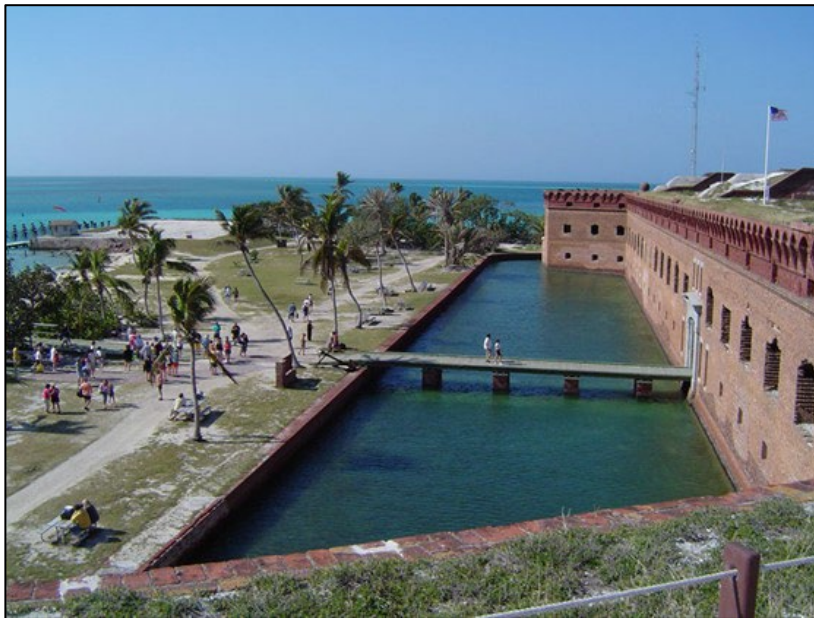
Fig 15. Moat and bridge, existing conditions, 2005.

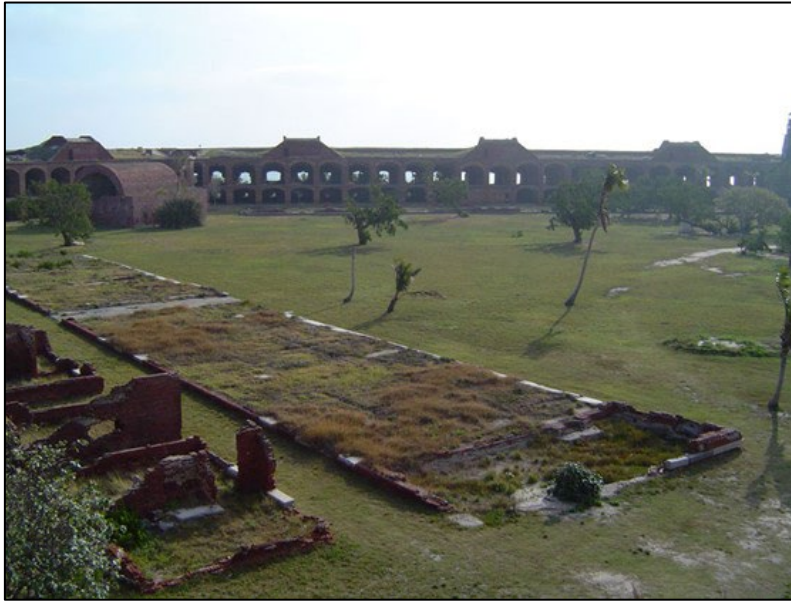
Fig 16. Officers ruins from terreplein, 2005.

**Officers' Quarters (ruins).** Along Front 4, the Officers' quarters (282'x43') remain as ruins. The barracks location and association remain intact, but only 1'-2' of the brick foundation are still present with ruins of the detached kitchens immediately behind the foundation (17'x35' and 31'x33'). The ruins have integrity of location, setting, and association.

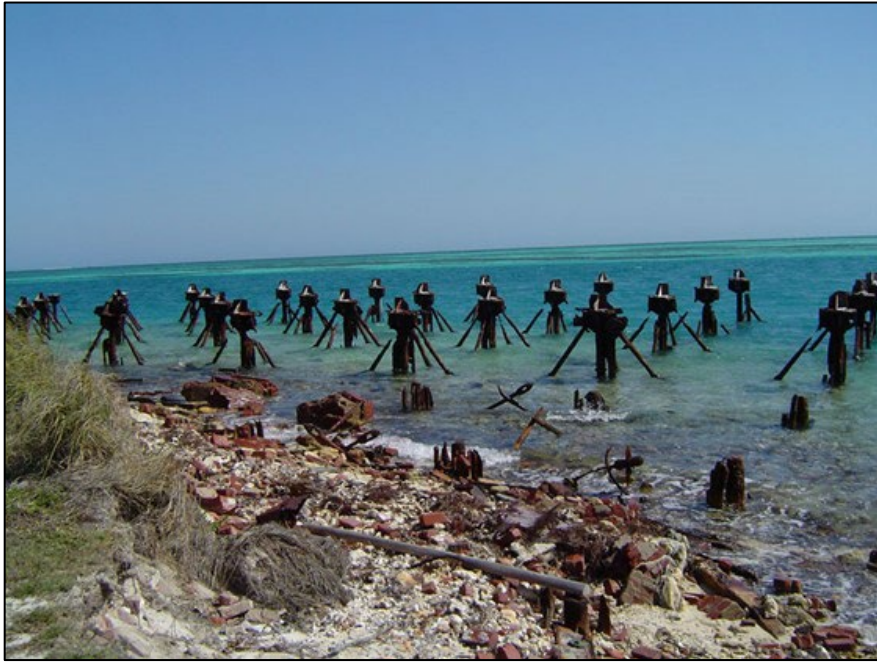
The tank and condensing plant used by the Navy were removed in 1906 and the wireless operations continued until 1909 (Manucy, 172). In 1908, Fort Jefferson was transferred to the Department of Agriculture as a designated breeding ground and sanctuary for native birds. Oral history notes that the barracks burned in 1912 and the officer's quarters were set ablaze in 1927 by Capt. Rice (Manucy, 173). The naval coaling facilities were removed after the transfer and hurricane damage, but the piers still remain on the north and south shore of Garden Key.

Fig 18. North coaling piers, 2005.

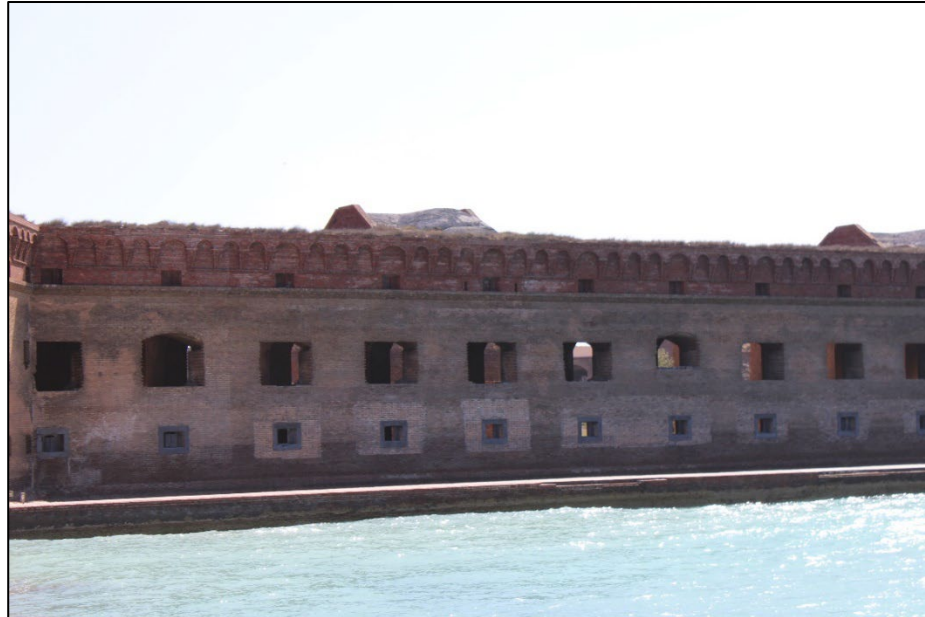
**Fort Jefferson.** The fort is a six-sided, three-tiered Third System seacoast fortification constructed of brick and concrete from 1846-1874. The elongated hexagon is surrounded by a moat and counterscarp with a perimeter of 0.6 miles. The foundation includes barrel vaulted cisterns with two lower tiers of arched casements. Each bastion contains a staircase to the upper tiers and access to the terreplein. Currently the terreplein is covered in grass and forbs with ten cannon still existing. The casements along Front 2 and 3 have been adapted to accommodate maintenance equipment and staff housing. Front 1 includes the park offices and visitor contact station on either side of the sally port. The exterior sally port is detailed in granite with a modern bridge providing access to the campground, boat dock, and remainder of Garden Key. The fort itself is significant for Criteria A and C and has integrity of location, setting, association, feeling, materials, design, and workmanship.

*Fig 19. Fort Jefferson (April 20, 2022, photograph by Elizabeth Koreman).*

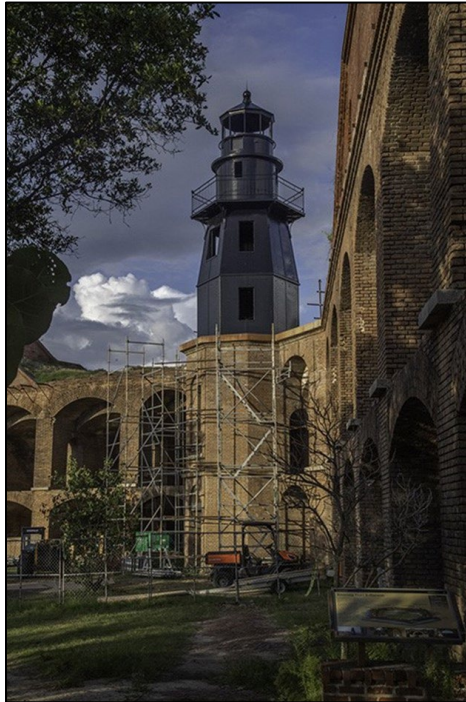
*Fig 24. Harbor Light Restoration (Photograph provided by Glenn Simpson, DRTO Park Manager).*

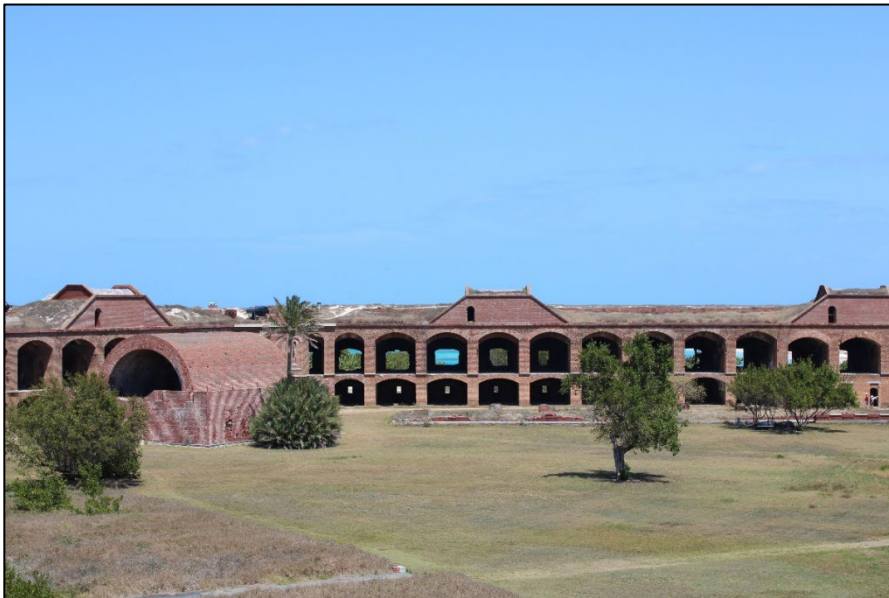
*Fig 28. Parade Ground and Enlisted Men's Quarter's Ruins (April 20, 2022, photograph by Elizabeth Koreman).*

**Enlisted Men's Quarters (ruins).** The Enlisted Men's quarters (335'x40') is located along Front 6. The once massive three-story barracks is currently only an outline of the building foundation but contributes to the location and association of the historic fort. The vegetation growing within the ruins is controlled.

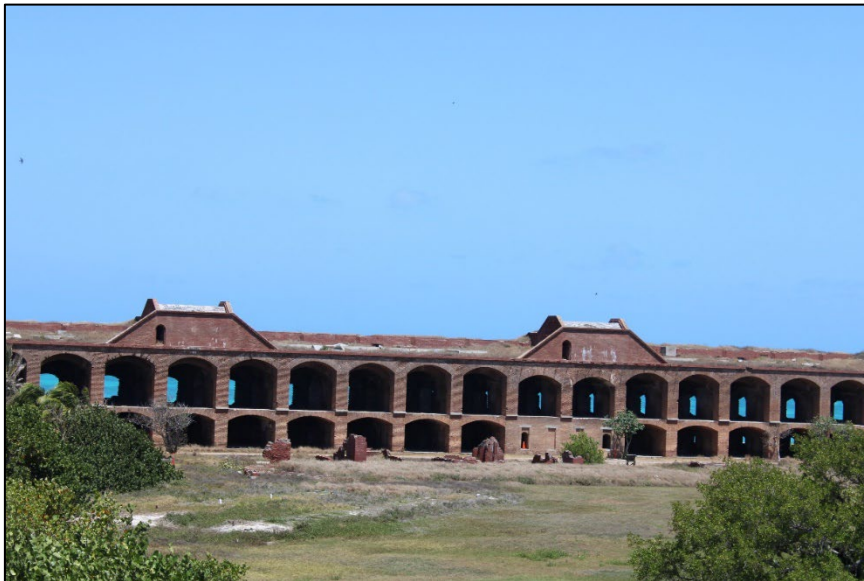
*Fig 30. Officers' Quarters Ruins (April 20, 2022, photograph by Elizabeth Koreman).*

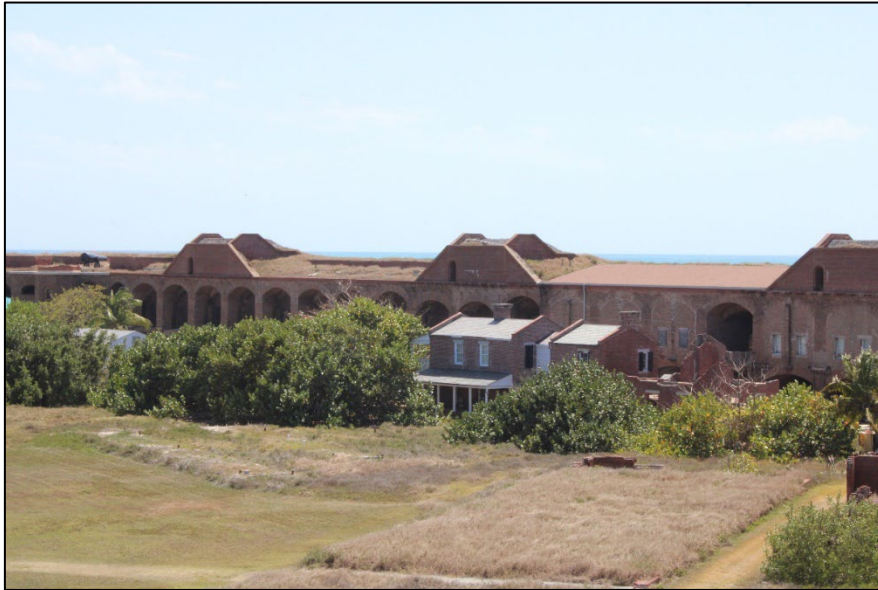
*Fig 31. Staff House (Engineer's officers' quarters) and Kitchen ruins from terreplein (April 20, 2022, photograph by Elizabeth Koreman).*

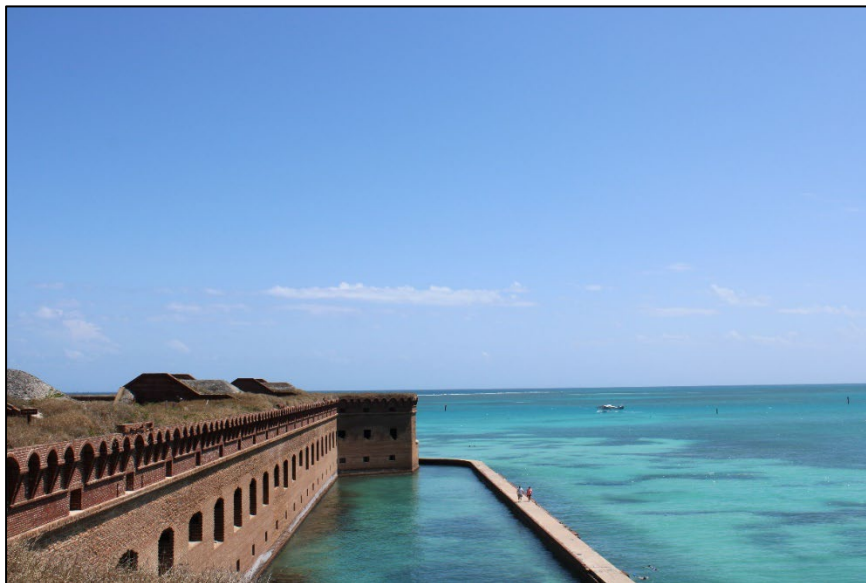
*Fig 34. Counterscarp and moat (April 20, 2022, photograph by Elizabeth Koreman).*

**Counterscarp and Moat.** The counterscarp and moat surround the exterior of Fort Jefferson with a total perimeter of 3068'. The hexagonal wall is constructed of brick with concrete infill (ranging from 3' to 8' in thickness) and encloses a moat, approximately 70' wide. The brick walk atop the counterscarp is intact on the south front. The counterscarp and moat have been restored and repaired several times and the feature has integrity of location, setting, association, and feeling. Hurricane Irma (2017) damaged the Fort Jefferson Counterscarp and filled the moat with sand at the northeast and southwest beaches.

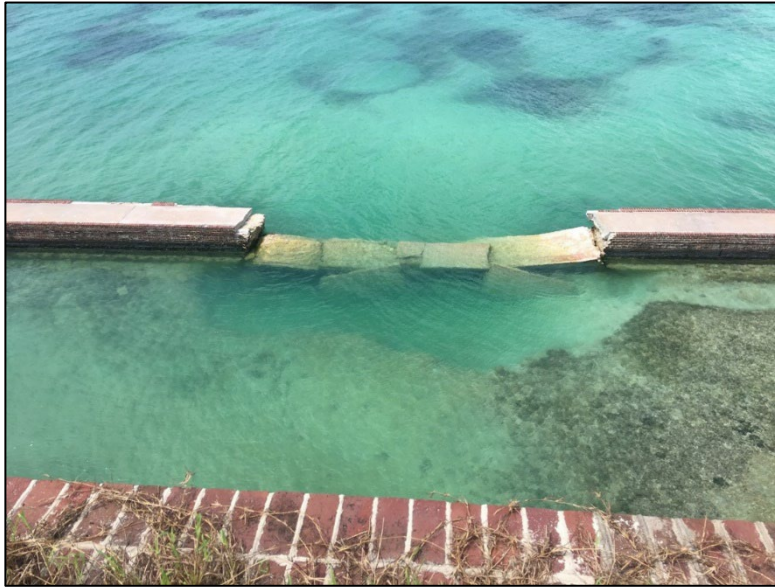
*Fig 35. Hurricane damage to counterscarp (Photograph provided by Glenn Simpson, DRTO Park Manager).*

<p>Exposure to the Elements</p>			<p>In 2017 Hurricane Irma damaged the counterscarp wall in multiple locations and caused a breach off front three (below Historic Bastion F, West-NW facing walls). Hurricane Irma additionally filled the moat with sand at the northeast and southwest beaches.</p> <p>Hurricanes and tropical storms have also caused destruction to historic vegetation. By 2008, 90% of the coconut palms had been removed from the parade ground due to hurricane damage. Tropical Storm Eta (2020) damaged a mature buttonwood adjacent to the old lighthouse foundations, causing its removal.</p>	<p>08/22/2022</p>
--	---------------------------------	--	--	--	-------------------

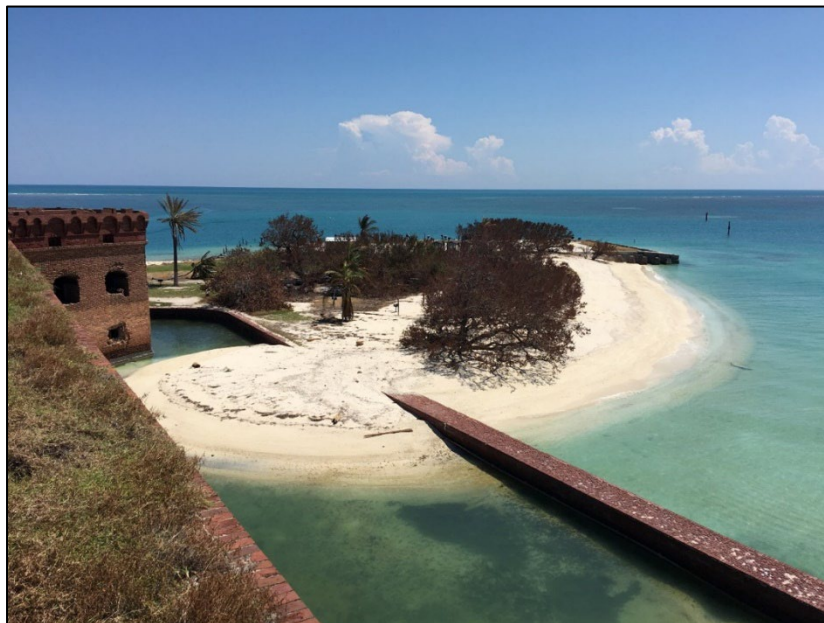
*Fig 35. Moat filled with sand, post-Hurricane Irma (Photograph provided by Glenn Simpson, DRTO Park Manager).*

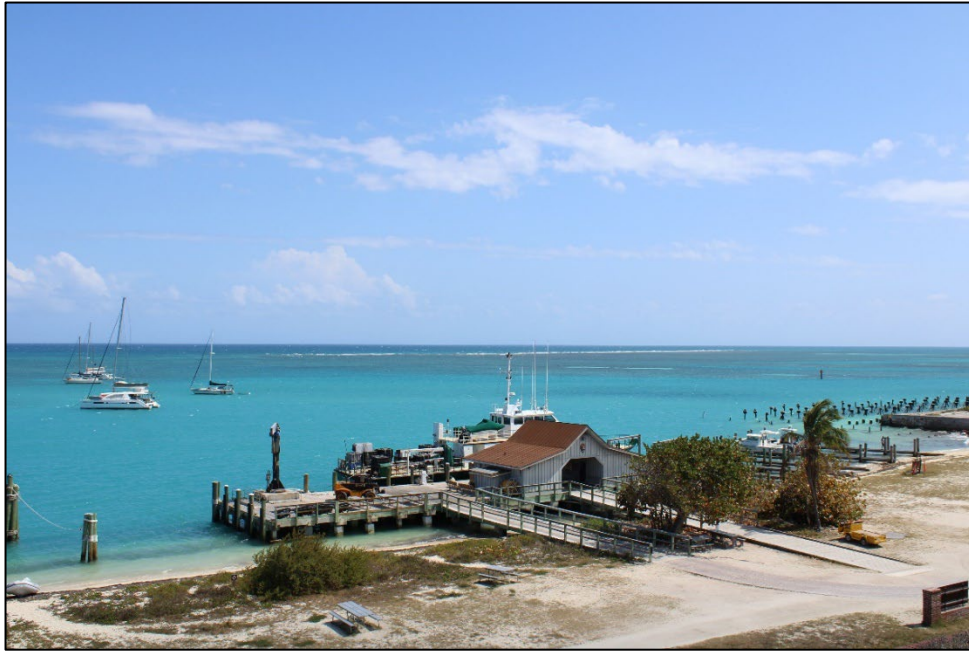
*Fig 36. Main Dock (April 20, 2022, photograph by Elizabeth Koreman).*

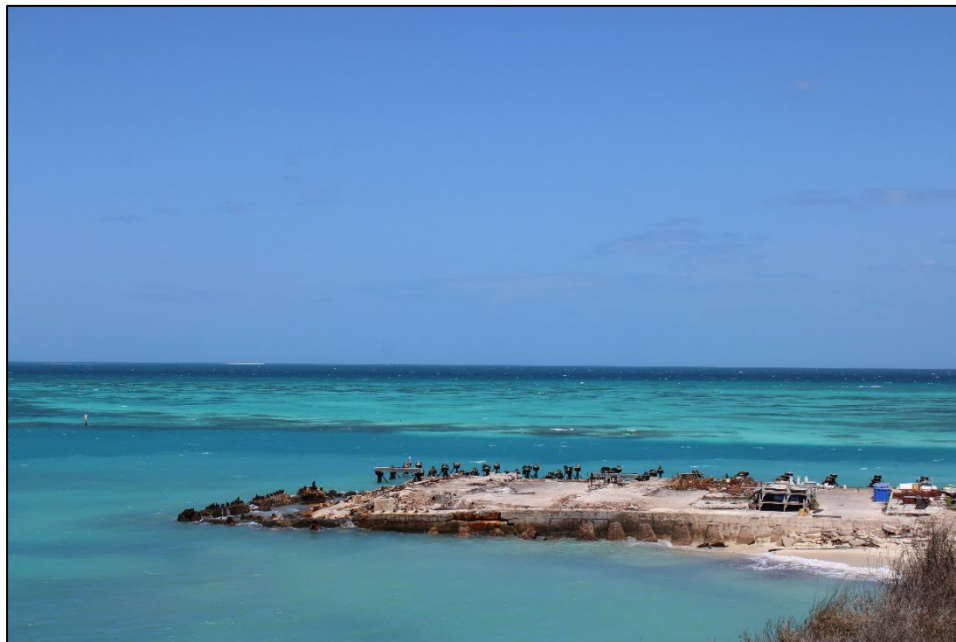
*Fig 37. North Coaling Dock (April 20, 2022, photograph by Elizabeth Koreman).*

**Coal Dock.** Two coal docks to the north and south of Fort Jefferson remain as extant features, but do not contribute to the period of significance. The metal foundations do not have integrity.

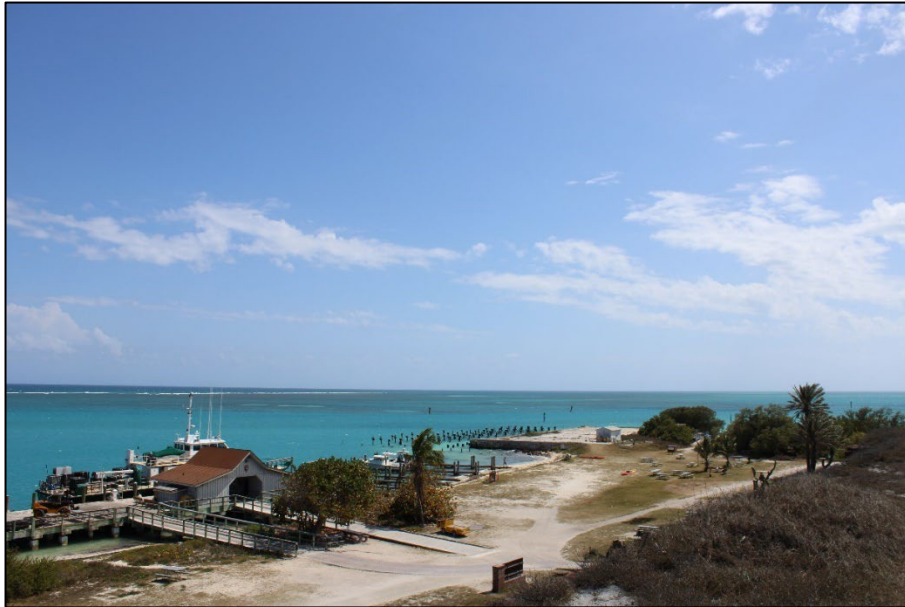
*Fig 38. South Coaling Dock (April 20, 2022, photograph by Elizabeth Koreman).*

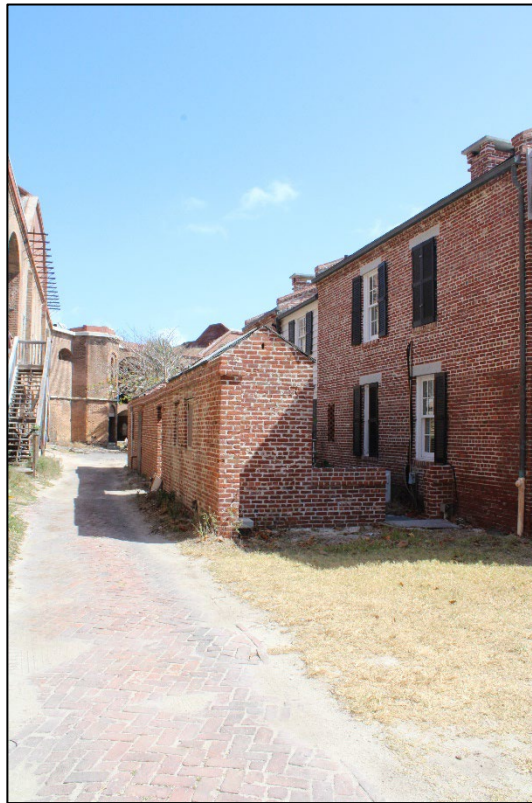
*Fig 44. Brick walkway (April 20, 2022, photograph by Elizabeth Koreman).*

A brick walk circumscribes the interior of the fort as the primary circulation pattern and contributes to the cultural landscape. The brick is laid in a herringbone pattern and extends to the inner fort walls at specific locations for staff and visitor access. The walkway was restored in 1970s and has integrity of location and association. Besides the brick walk, there are several informal sand pathways that traverse the parade ground, used mainly by the current staff. A series of perpendicular paths also surrounds the Major Smith monument, but no information about them was found during the CLI research. Intermittent portions of the historic brick-edged path are visible across the parade ground. This straight path originates at the sally port entrance and continues due north to the center of the fort, near the officers' quarters ruins. Evidence of

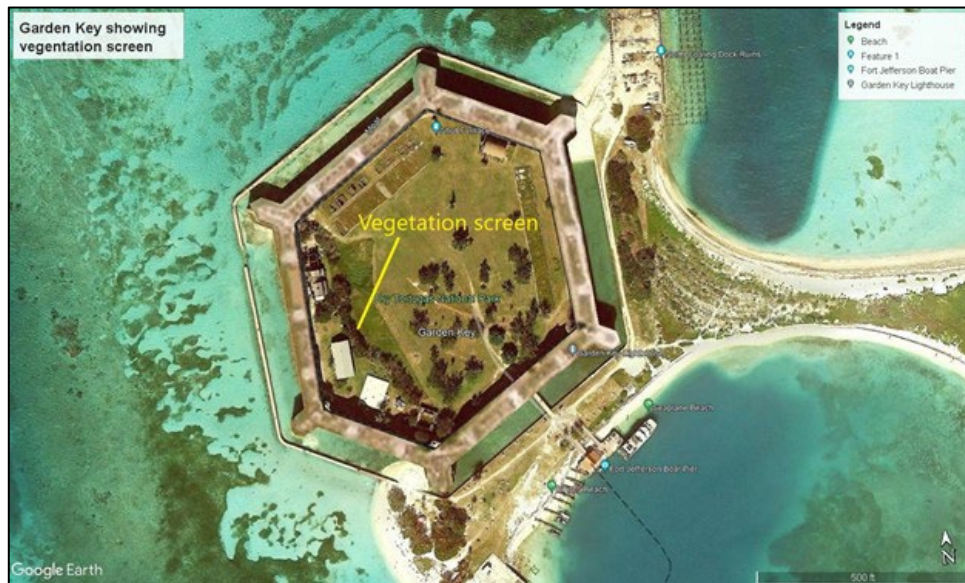
Fig 51. Aerial showing vegetation screen (Photograph by Glenn Simpson, DRTO Park Manager).

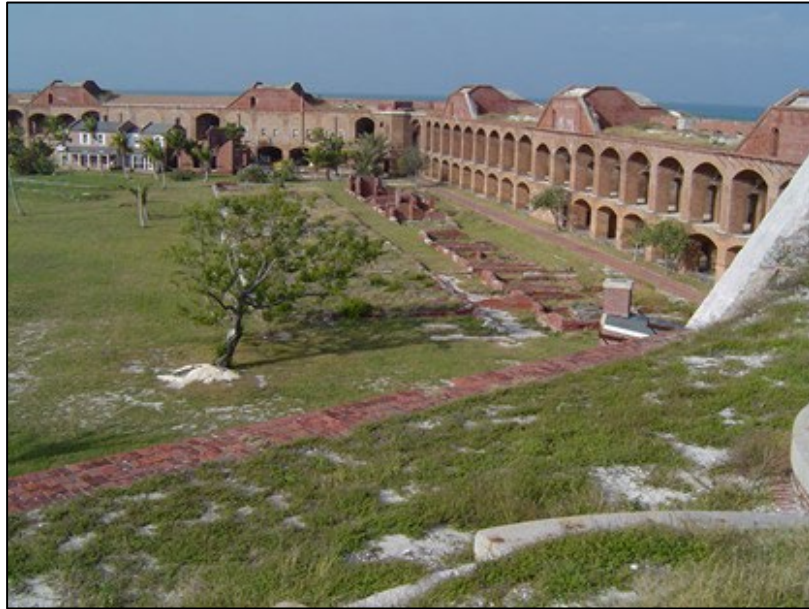
*Fig 57. Parade ground looking west from terreplein (February 2005).*

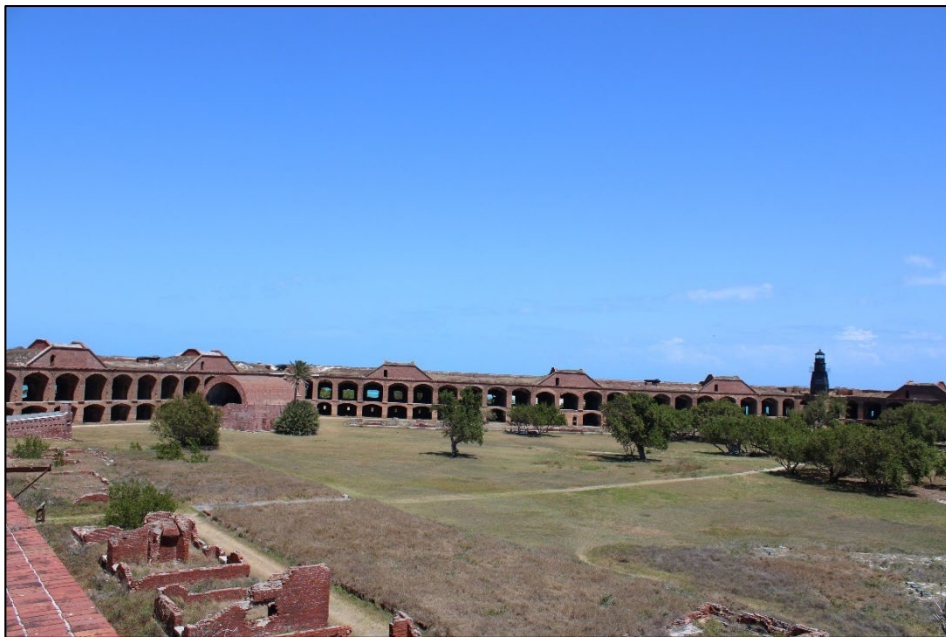
*Fig 57. Parade ground (April 20, 2022, photograph by Elizabeth Koreman).*

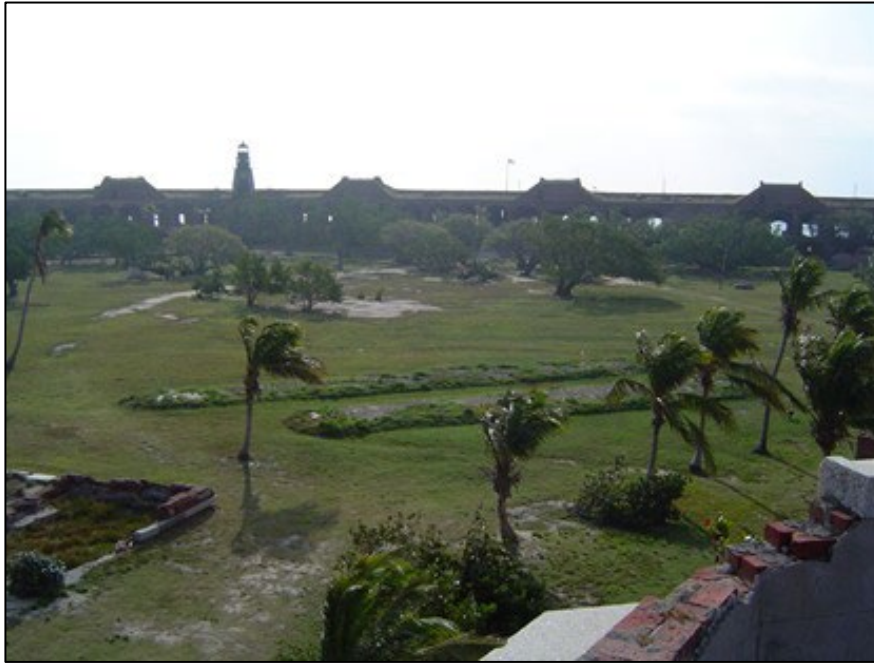
*Fig 58. Leaching fields (February 2005).*

Operations on Site		Yes	No	The treatment of wastewater at this remote site is an issue of serious concern, but the leeching fields recently added to the parade ground negatively impact the property in terms of materials, feeling and setting. These leeching fields are visible from most areas of the fort and their linear imprint on the parade ground is a clear departure from the historic scene.	08/08/2006
	Structural Deterioration				The iron drainpipes from the Terreplein to the cistern are corroding/expanding and causing damage to the fort.	8/22/2022
	Impending Development				In 2014-2015, a new 6-pack housing unit was constructed on the parade ground in front of Front 3. This has negatively impacted the historic integrity of the cultural landscape.	8/22/2022

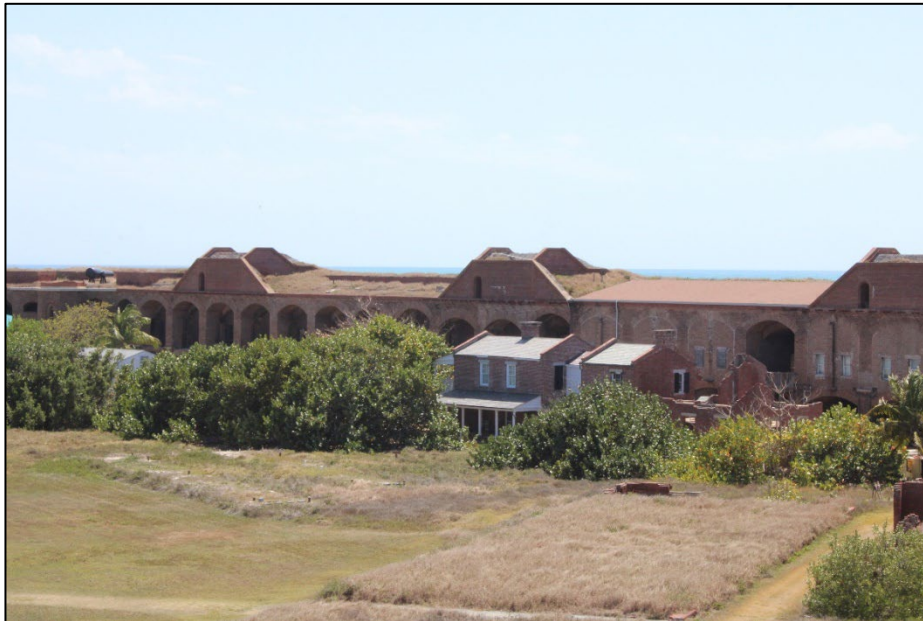
*Fig 59. Leaching fields (April 20, 2022, photograph by Elizabeth Koreman).*
