A Joint Publication of NCSEA | CASE | SEI

Rebuilding the Walls of Fort Jefferson

By Craig M. Bennett, Jr., P.E.

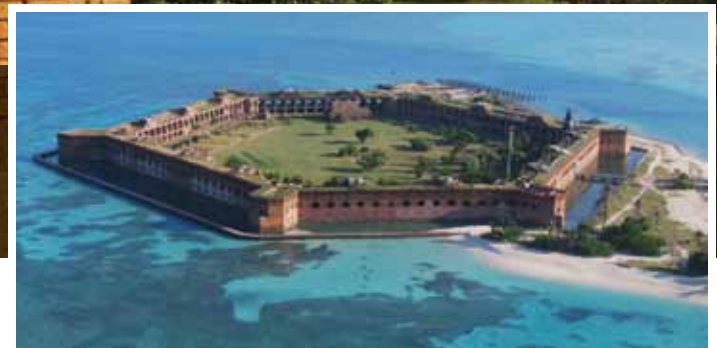
Figure 1: Fort Jefferson, in the Dry Tortugas, is in a serenely beautiful setting, accessible primarily by ferry and seaplane.

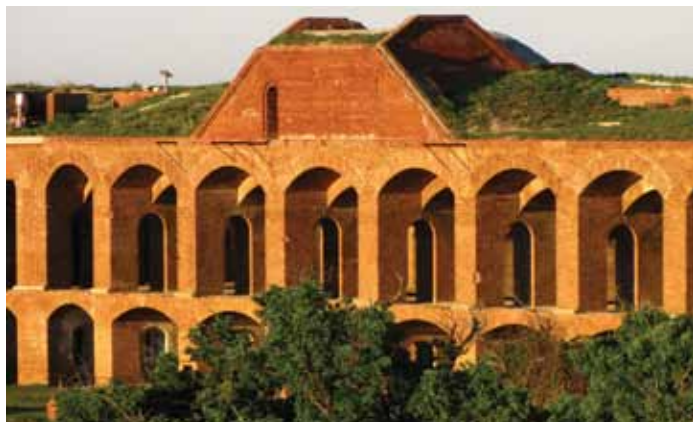
Figure 3: Arches and vaults composed of 16 million bricks surround inner cores of coral concrete.

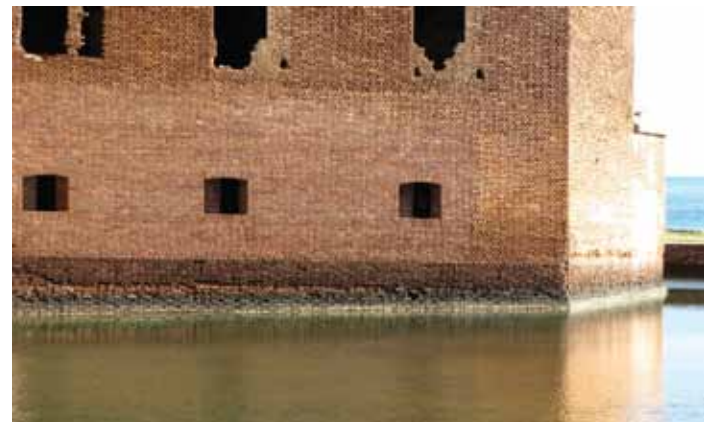
Figure 4: Settlements are as much as 24 inches per 200 feet. Here the water level in the moat makes settlement observation easy at Bastion 1.

Many of us see settlements in the neighborhood of an inch or two, and occasionally several inches, on existing structures. But between the middle of Front 2 and the tip of Bastion 1 at the fort, a distance of approximately 200 feet, the floor of the second level of the fort drops almost 24 inches, giving an average grade of one percent over that distance (Figure 4). The casemates show the movement with fracturing of the vaulting that makes modern structural analysis particularly challenging.

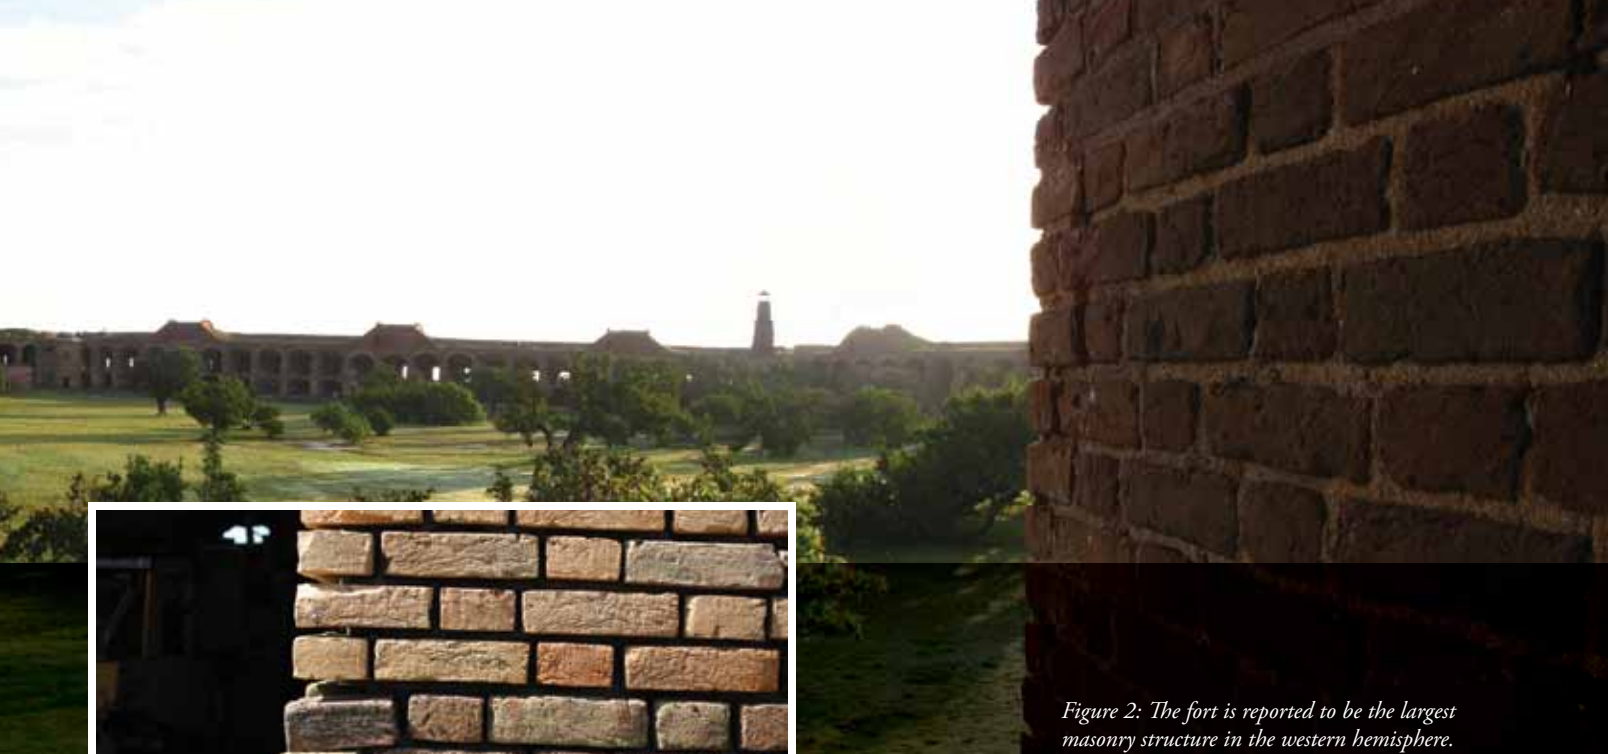
Figure 2: The fort is reported to be the largest masonry structure in the western hemisphere.

Fort Jefferson National Monument is located in the Dry Tortugas, a group of sand bars 70 miles west of Key West, Florida. This great pile of 16 million bricks surrounding coral concrete cores was originally intended to defend a harbor for ships of the US Navy, allowing the naval forces to control shipping through the Straits of Florida and, ultimately, to control trade through the Gulf of Mexico and into the Mississippi River. The fort occupies over seventy percent of Garden Key, one of the larger islands of what is now Dry Tortugas National Park (Figures 1, 2 and 3).

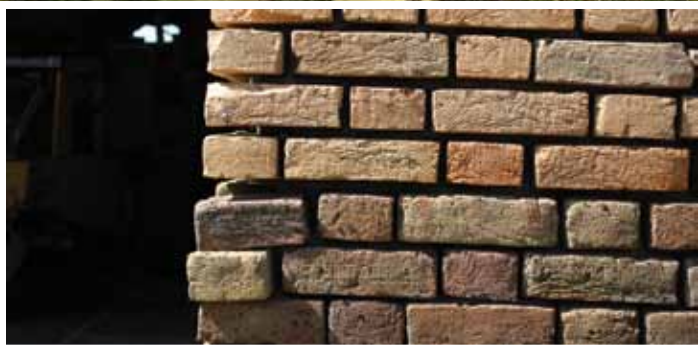
Figure 5: Mortar loss is severe in many areas.

common. Not here at Fort Jefferson, where 160 years of moisture migration through masonry has left mortar so deeply eroded that bricks falling and touching bricks below is far from uncommon (*Figure 5*).

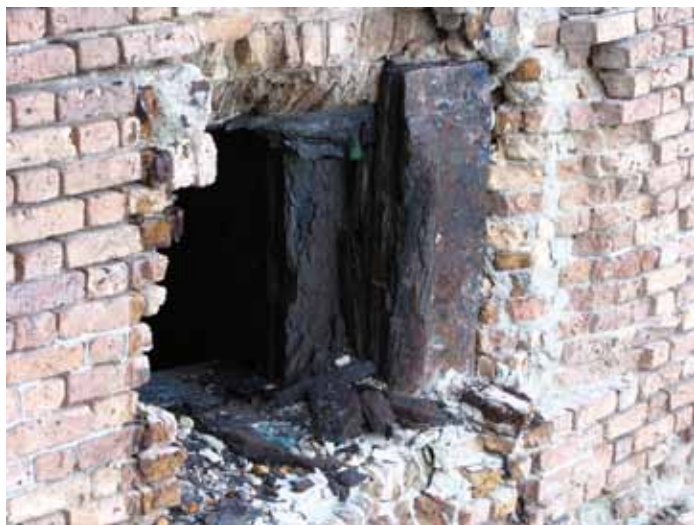
Figure 6: Corrosion of the embedded iron Totten shutters has severely damaged the masonry surrounding the embrasure openings.

Fort Jefferson's greatest challenge comes from embedded iron (*Figure 6*). The great military engineer, Joseph Totten, designed iron shutters to close and protect the embrasure openings from cannon fire. Unfortunately, the eight-inch thick, 1500-pound armor blocks were embedded between 18 and 24 inches into the masonry walls of Fort Jefferson. On Fronts 4 and 6, as well as on other portions of the fort, the damage to the scarp walls has been so severe that the iron has had to be removed and the walls rebuilt to a depth of as much as 24 inches (*Figure 7*). Reconstruction of these vaulted, loadbearing masonry walls was particularly challenging, as was any work at all 70 miles from the nearest building supply store.

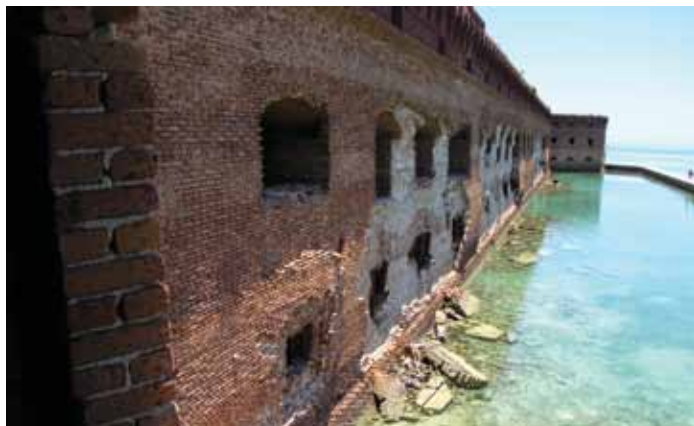
Figure 7: The damage to several fronts is severe but none as bad as that on Front 3.

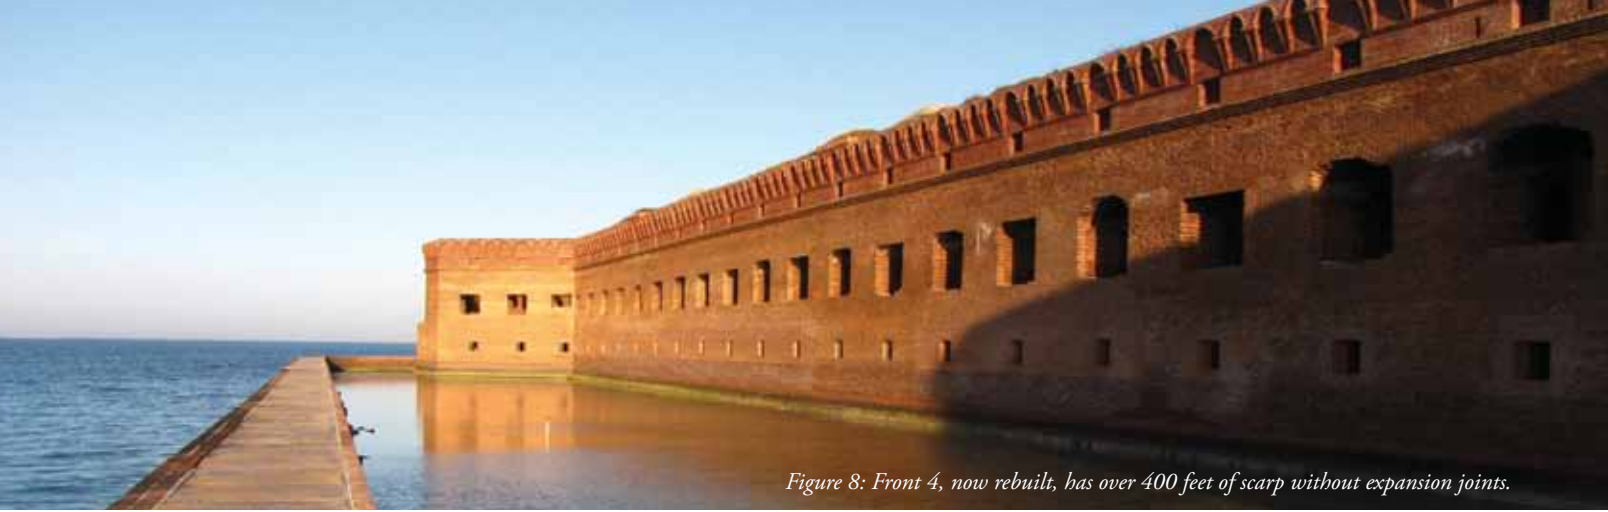
Figure 8: Front 4, now rebuilt, has over 400 feet of scarp without expansion joints.

In modern construction, it is common to leave regularly spaced expansion joints in brick masonry, roughly every 24 feet in the southeastern United States. But the reconstruction of Fronts 4 and 6 required that roughly 400 feet of brick walls (*Figure 8, page 32*) be rebuilt without jointing and be done on a relatively tight schedule, with a non-hurricane working window of only six months a year. Fortunately, experience with similar issues at Fort Washington, Maryland had taught the team that they were able to force early permanent growth into the masonry with extended submersion of the bricks. Careful measurement work on extended brick soaks by Mike Schuller's team at Atkinson-Noland of Boulder, Colorado had shown that seven to 28 day soaks could force enough growth in the bricks prior to

their installation to avoid pushing the bastions apart. Without the pre-wetting, up to four inches of wall movement was anticipated.

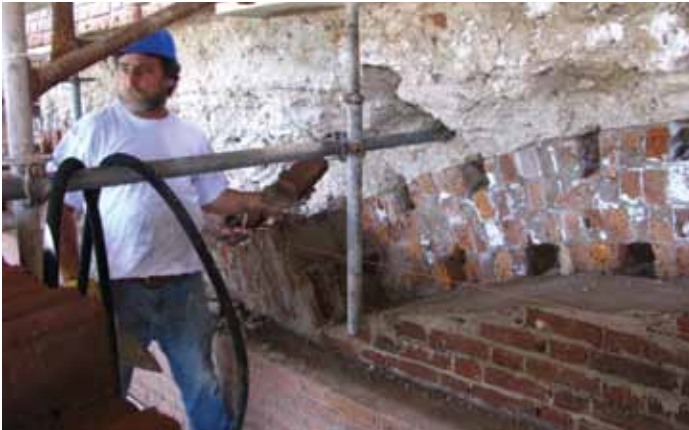
Figure 9: Tie bricks let into the undamaged vaulting tie the new vaulting into the old. The coral concrete is seen above.

Tying new vaulting on the face of the scarp walls back into the existing vaulting behind the scarp was interesting. The Florida State Historic Preservation Officer had asked the team not to use metals to make a tension tie of the new construction back to the existing, although Series 316 stainless steel and bronze both have reasonably good track records of holding up well in a marine environment. By

judiciously cutting in the existing vaults and laying in tie bricks (Figure 9) then carefully laying out the brick coursing around the ties (Figure 10), the team was able to achieve a continuity similar to the original.

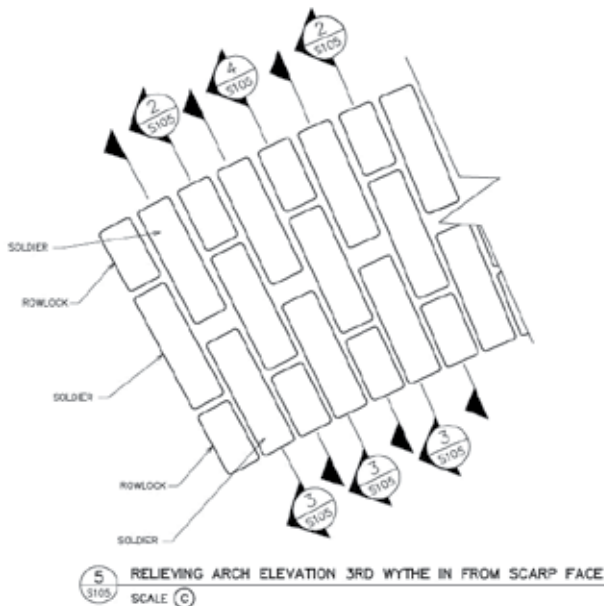
Figure 10: Layout of the vaulting incorporated the tie bricks.

be laid out, course by course and wythe by wythe, in order to match the tie bricks and achieve the final bond pattern.

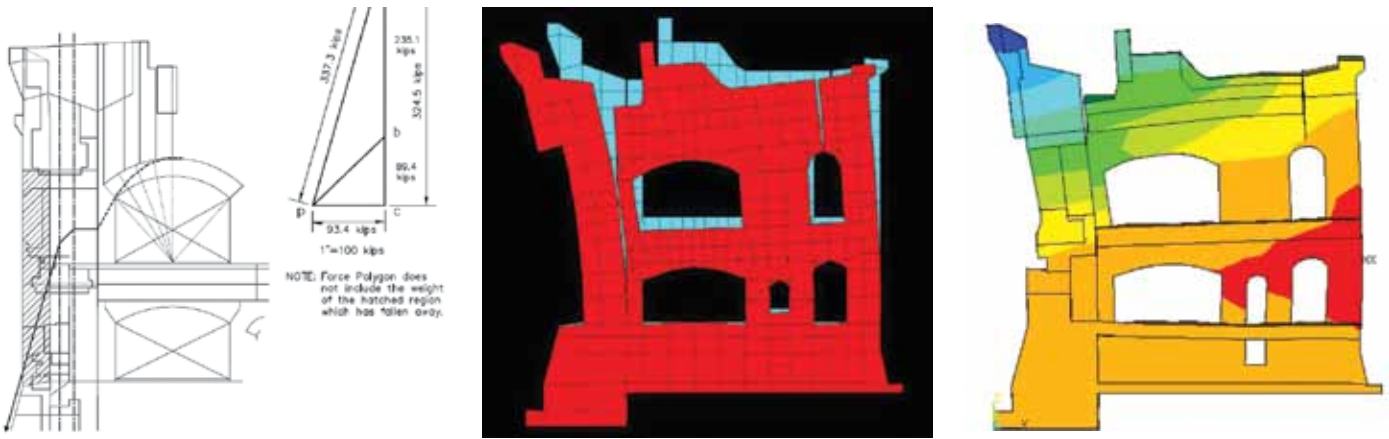
Figures 12, 13 and 14: Graphic statics calculations and two finite element models and confirmed that, without the scarp, the arch supporting the vaulting was on the edge of stability.

Finally, the greatest concern was the possibility that deep cuts in the scarp wall could destabilize the casemate vaulting behind the scarp. Three different analytical models (two finite element and one based on graphic statics) had shown that the arch supporting the vaulting was close enough to being unstable (Figures 12, 13 and 14) that the depth of the reconstruction had to be tightly limited and that certain columns had to be restrained during the disassembly and reconstruction.
