National Park Service
Cultural Landscapes Inventory
2011

Edison Laboratory Complex
Thomas Edison National Historical Park

Inventory Unit Summary & Site Plan

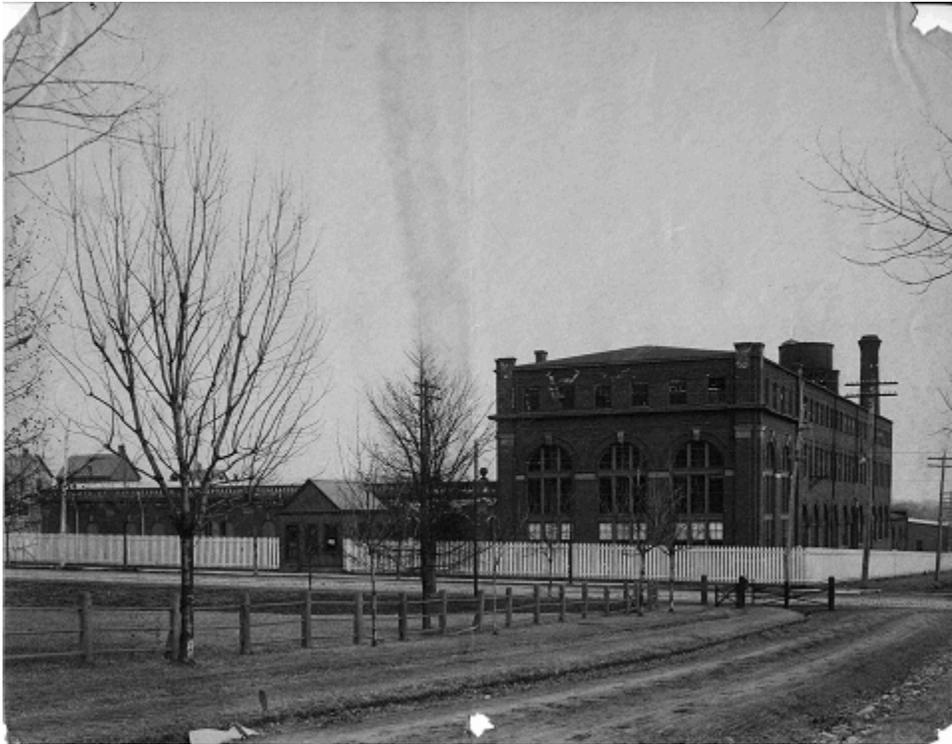
Figure 1. View looking east towards the Edison Laboratories, Main Laboratory, Power House, Gate House, Physics Laboratory, c.1900 (Album 64, EDIS Archives).

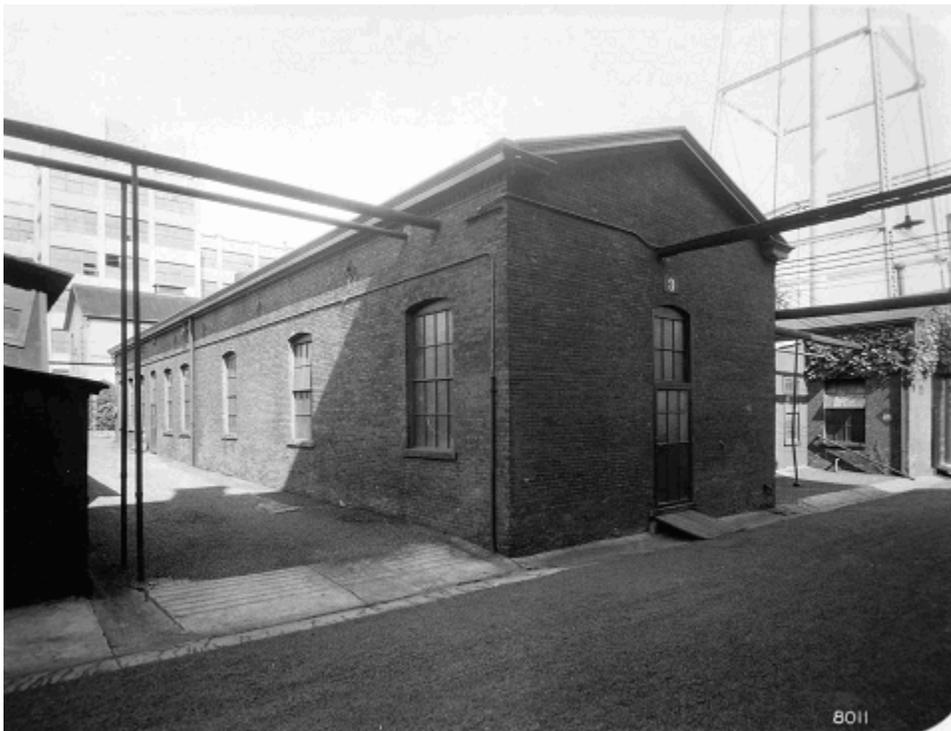
Figure 2. A 1939 image looking east showing the Chemical Storage and Pattern Shop, drainage gutter, and entry ramp (Album 43, Cat. 547, Neg. 8011, EDIS Archives).

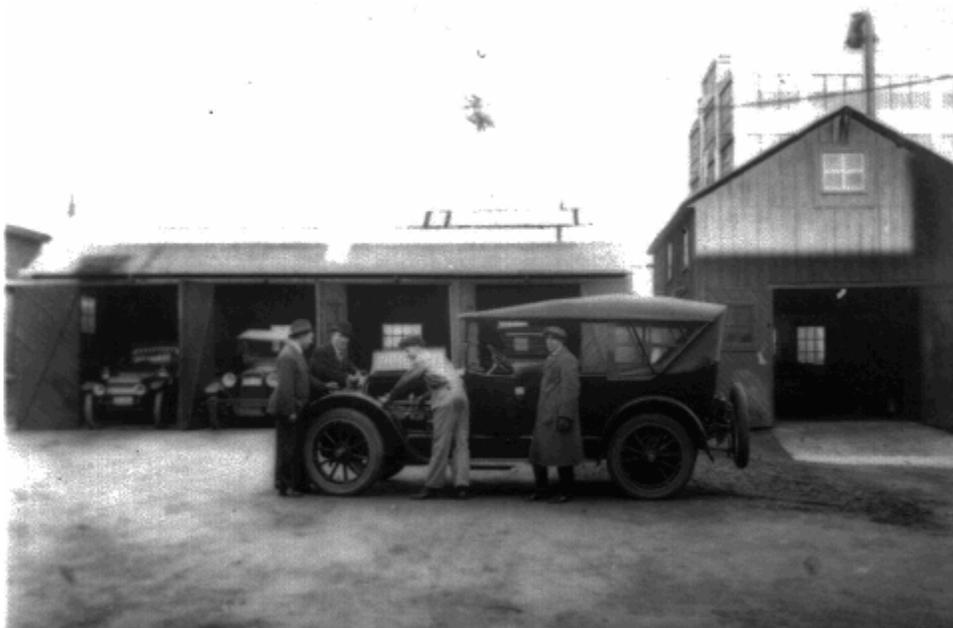
Figure 4. View looking northeast showing the Garage and Building 11 (No. 11), c.1917 (EDIS Archives).

While the West Orange Plant was experiencing tremendous growth, the Edison Laboratories site remained within its boundaries but did experience several changes. Several new buildings were added including the Blacksmith Shop (No. 7), Storage Vault (No. 8), Garage (No. 10), Building 11 (No. 11), Pattern Shop, Experimental Studio, Gold Plating Facility, Glass House, and several unidentified buildings. In addition, utilities were improved (Figure 4) (CLR, 1996: 26).

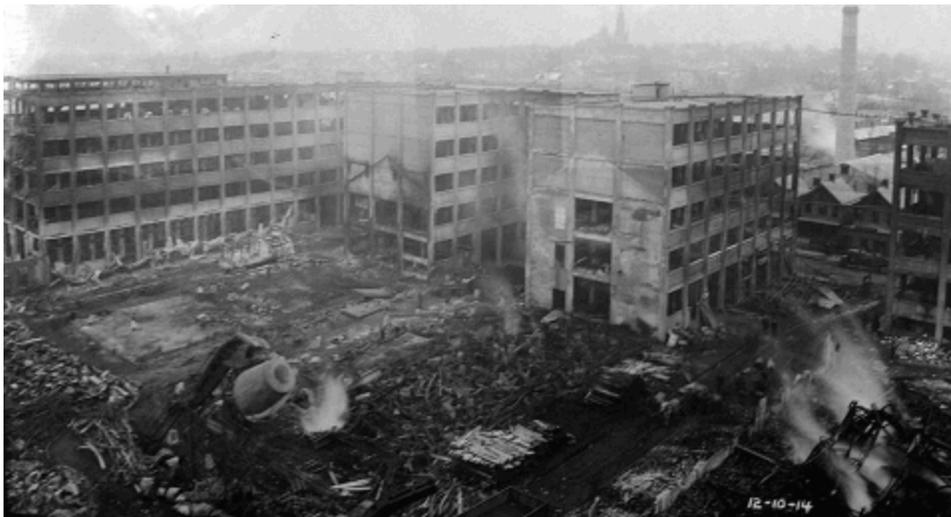
Figure 5. The West Orange Plant following the 1914 fire (Album 10, Cat. 5209, EDIS Archives).

The plant’s growth continued until December 1914 when a major fire occurred at the site (Figure 5). The fire, which started in the film inspection building (No. 41), destroyed many of the buildings at the West Orange Plant. By the next day, 15 of the 22 Edison Phonograph Works’ buildings were either severely damaged or completely destroyed. The fire had burned throughout the night and smoldered for weeks. The Laboratory and Company fire departments joined fire departments from nearby towns to battle the blaze and were credited with preserving the Edison Laboratories from fire damage. The storage battery building also was undamaged (CLR, 1996: 27-28).

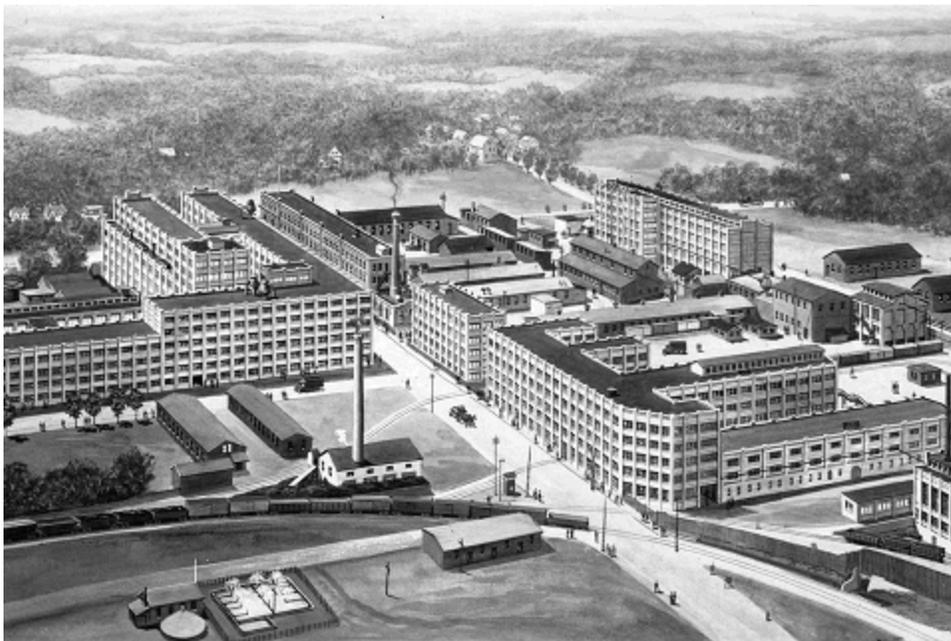
Figure 6. View of looking north of the West Orange Plant after reconstruction, c.1917 (10. 380/25 EDIS Archives).

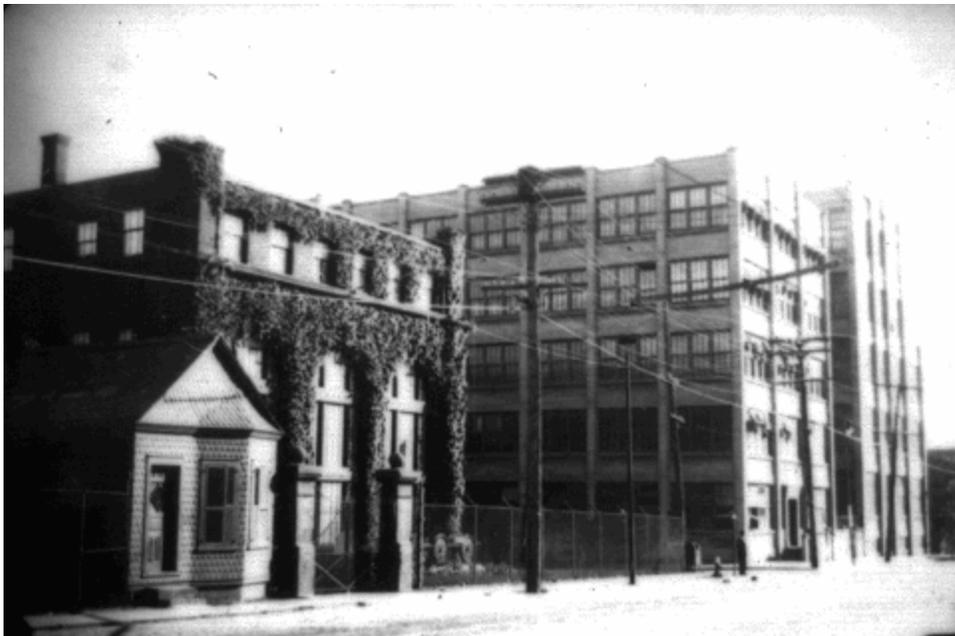
Figure 8. View looking south showing the Gate House (No. 9), wrought-iron gate, Main Laboratory (No. 5), and chain-link fence, c.1927 (EDIS Archives).

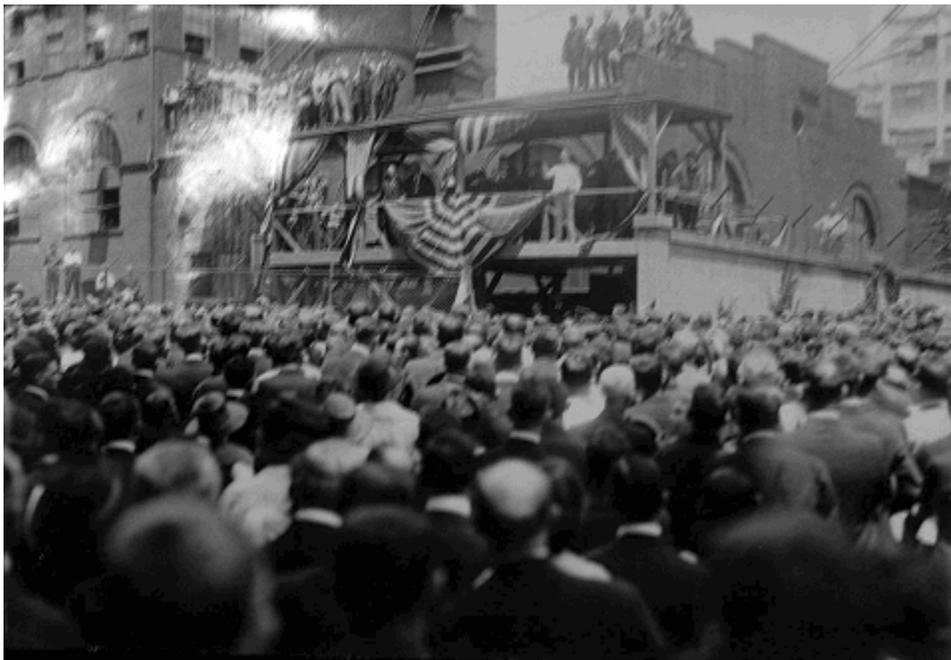
Figure 9. View looking north showing a temporary bandstand constructed on the southwest elevation of the Power House (No. 6), c.1918 (Album 15, Cat. 14, 257, EDIS Archives).

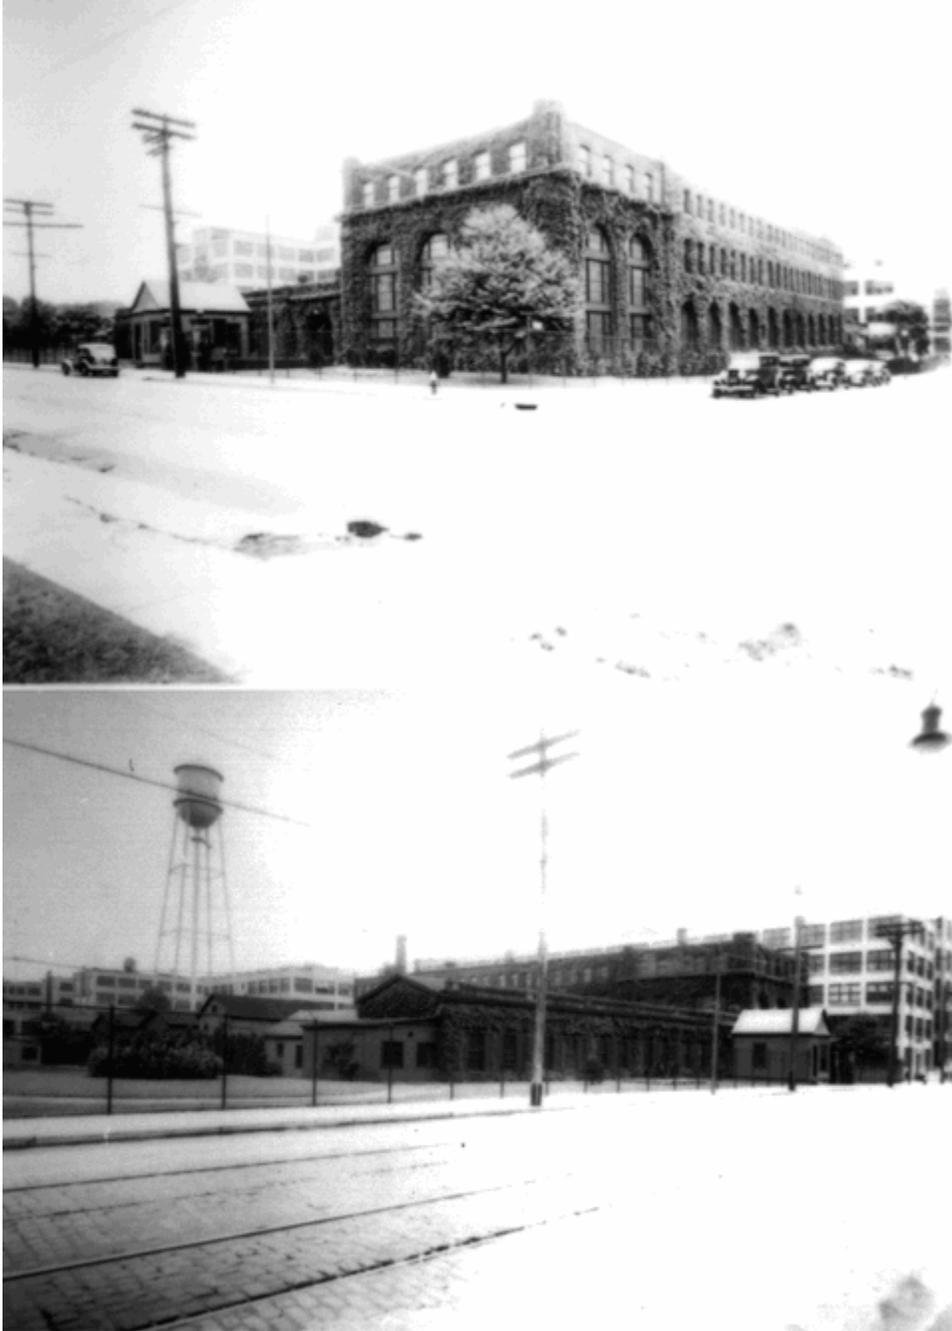
Figure 10. Images taken in 1939 of the Main Laboratory building and vegetation, including the Mazzard cherry (top), and row of spruce trees and canna (bottom) (EDIS Archives).

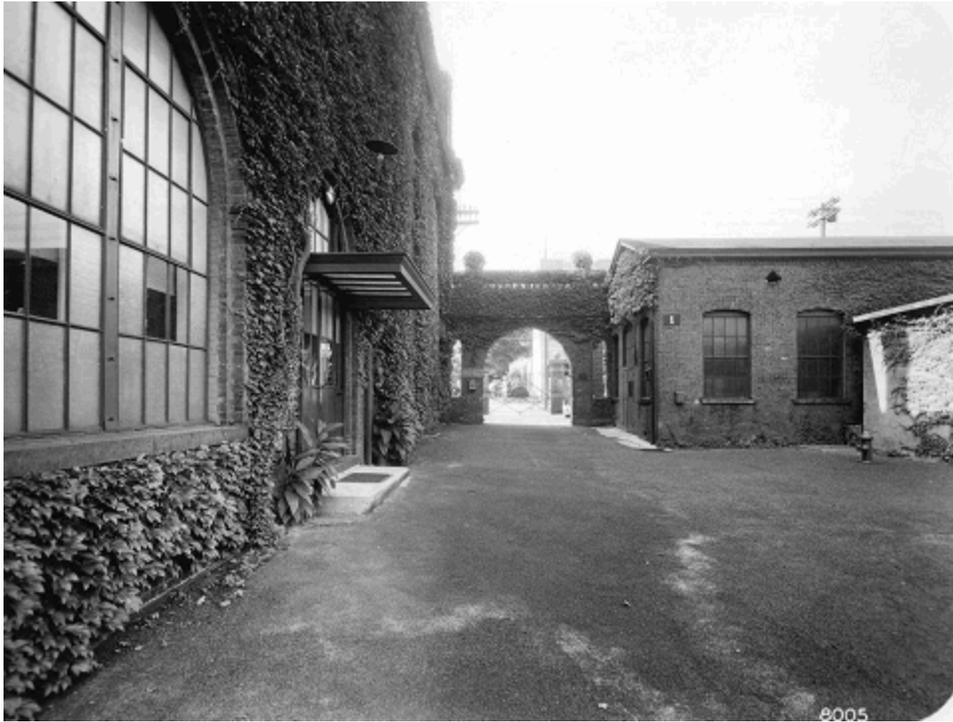
Figure 11. View looking northwest showing the main corridor, courtyard and main entry and vegetation within the Edison Laboratories, c.1939 (Album 43, 8005, EDIS Archives).

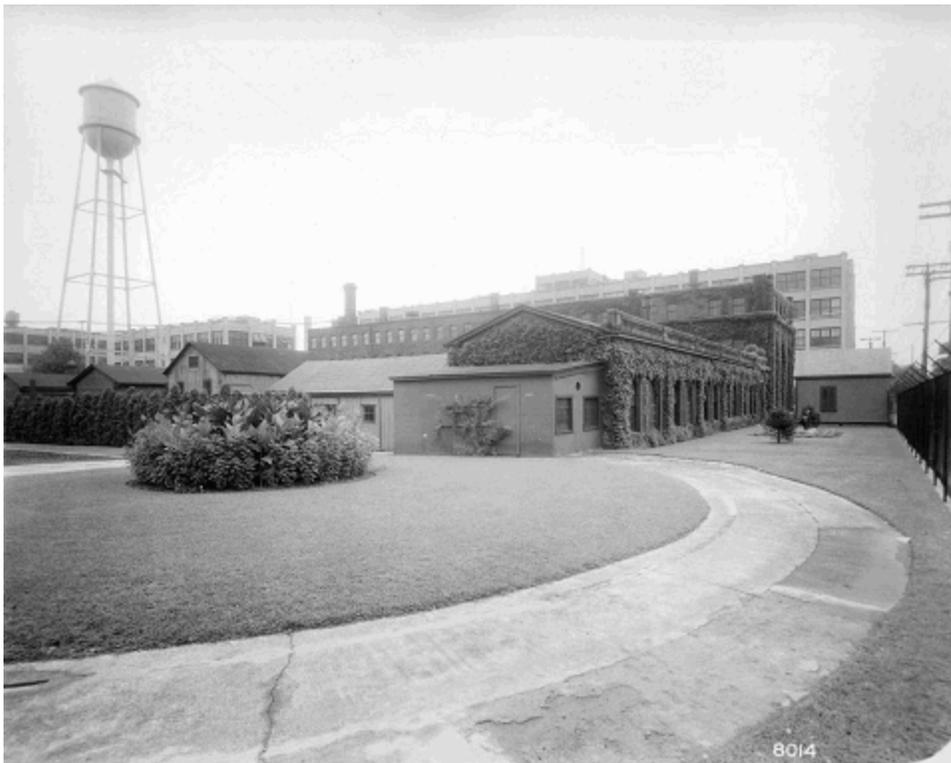
Figure 12. View looking southwest showing the vegetation and pavement test circle, c.1939 (Album 43, 8014, EDIS Archives).

Built	A pavement test circle is installed for testing stone, concrete, brick, metal, steel, and wood.
AD 1914 - 1919	Expanded	In response to World War I, the West Orange Plant manufactures new war products for the government. There is a rapid increase in the labor force. However, the work force decreased substantially following the war.
AD 1914 - 1915	Built	Blue Ambersol Vault (No. 33) and Disc Record Vault (No. 32) are constructed.
AD 1916	Built	Experimental Record Shed is constructed. Foundry is also constructed northeast of the Physics Laboratory.
AD 1916 - 1917	Built	Nickel Plating Building is constructed between the Foundry and the Copper Plating Building.

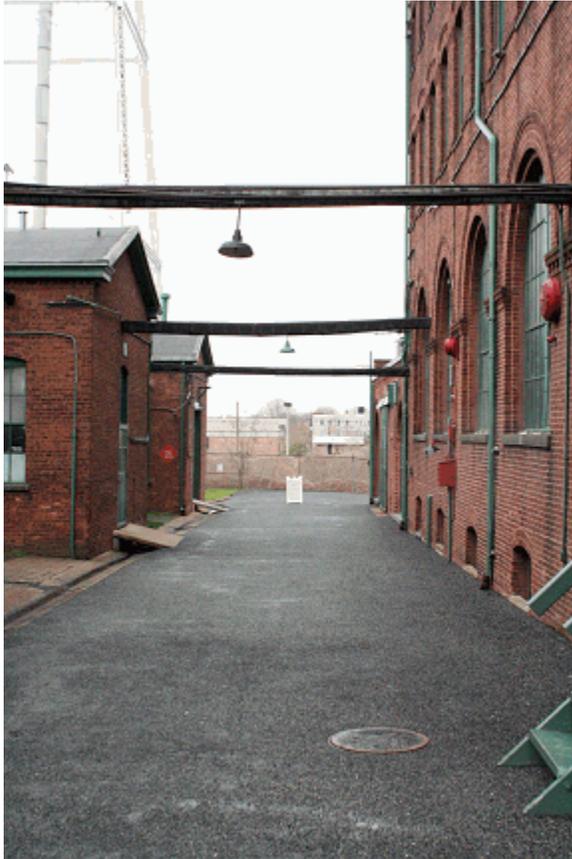
Figure 13. View looking southeast showing the satellite laboratories and main corridor within the Edison Laboratory Complex (OCLP, 2011).

Following the death of Thomas Edison, the spatial organization of the Edison Laboratories was slightly diminished with the removal of building 11 on the northeast side of the courtyard. The courtyard enclosure—a key outdoor feature of Edison's original plan—was subsequently lost. The addition of the Underground Storage Vault did little to restore the enclosure since only a three and one-half foot section of the building was above grade. Between 2002 and 2004, however, the spatial organization of the site was restored when the Building 11 (No. 11) was relocated close to its approximate original location on the northeast side of the courtyard (Figures 13-15).

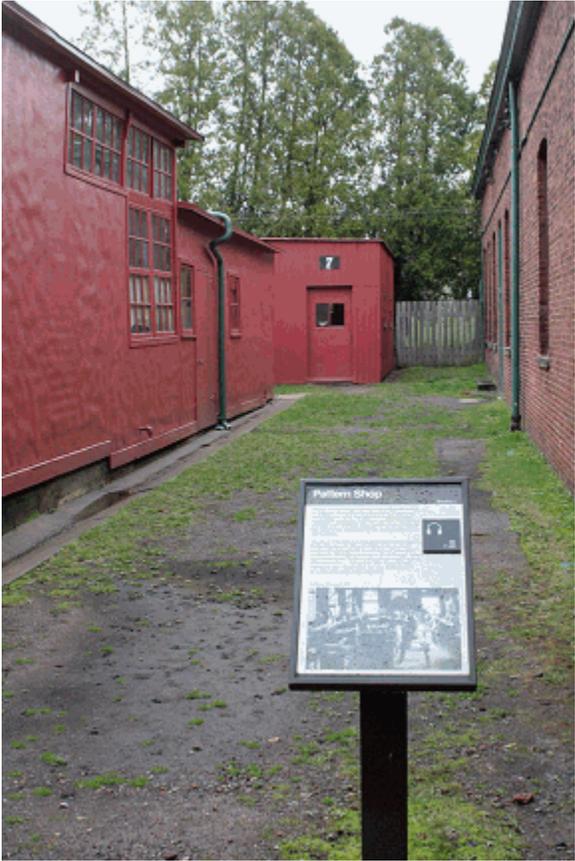
Figure 14. View looking northeast showing a secondary corridor between the Chemical Laboratory (No. 2) and the Chemical Storage and Pattern Shop (No. 3) (OCLP, 2011).

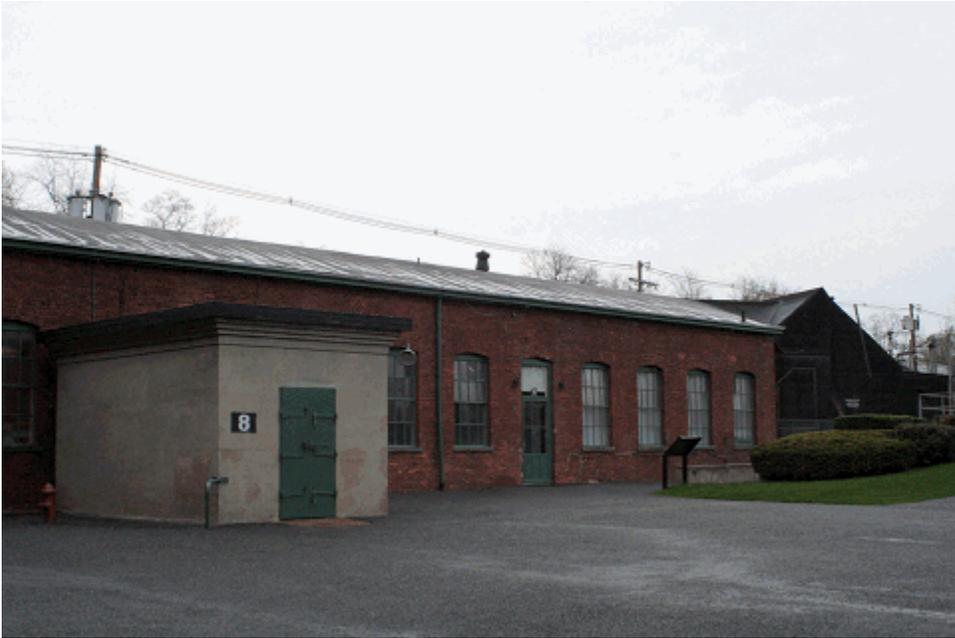
Figure 15. View looking north of the Physics Laboratory (No. 1), Small Storage Vault (No. 8), and courtyard within the Laboratory Complex (OCLP, 2011).

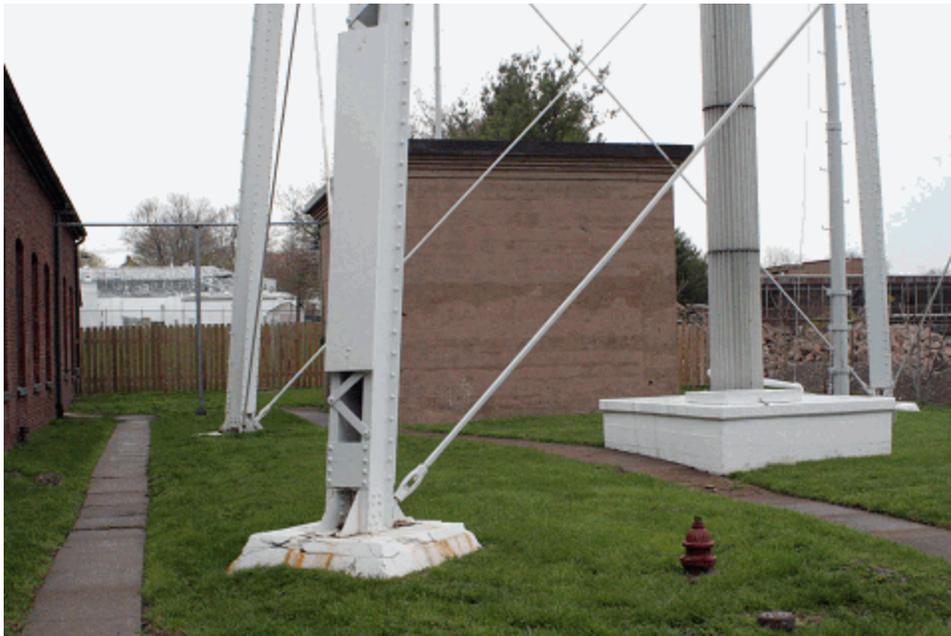
Figure 16. View looking east showing the concrete sidewalk remnants at the Edison Laboratory Complex. Note the Diamond Disc Vault (No. 32) in the background (OCLP, 2011).

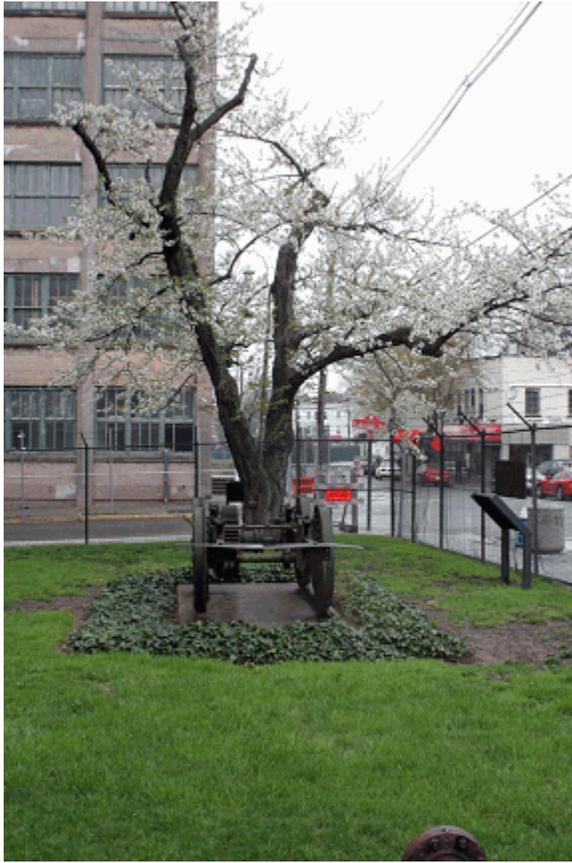
Figure 17. View looking northwest showing the Mazzard cherry (Prunus avium) (2-1-1), railroad truck and groundcover, fencing, and wayside (OCLP, 2011).

As part of the renovations completed to the Edison Laboratories between 2003 and 2009, the Norway spruce and other ornamental plantings were removed. Today, vegetation at the Edison Laboratories includes the open lawn areas, ground cover around railroad trucks, the Mazzard cherry, rows of arborvitae and globe-shaped privets, and foundation plantings around the Underground Storage Vault (No. 11) and Power House (No. 6). The maintenance area adjacent to the Edison Laboratories includes a wooded area and numerous flowering pear trees (Figures 17-22).

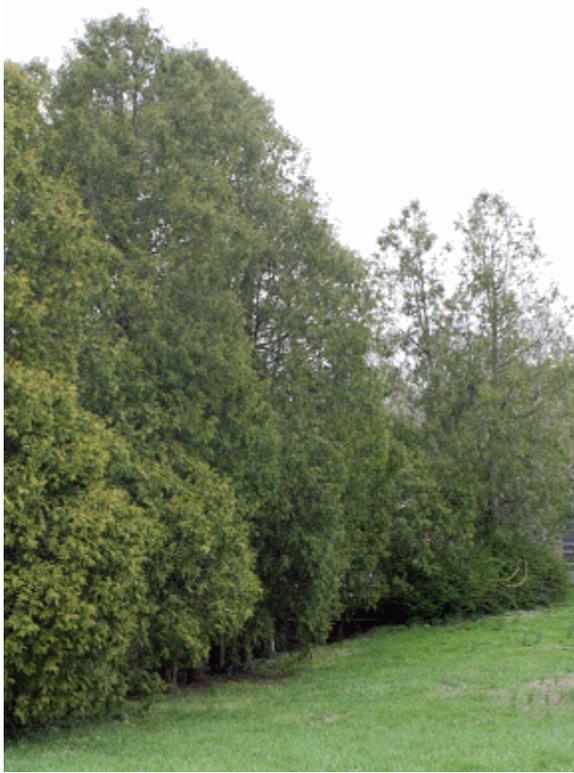
Figure 18. View looking west showing the row of arborvitae (2-1-7) within the Edison Laboratory Complex (OCLP, 2011).

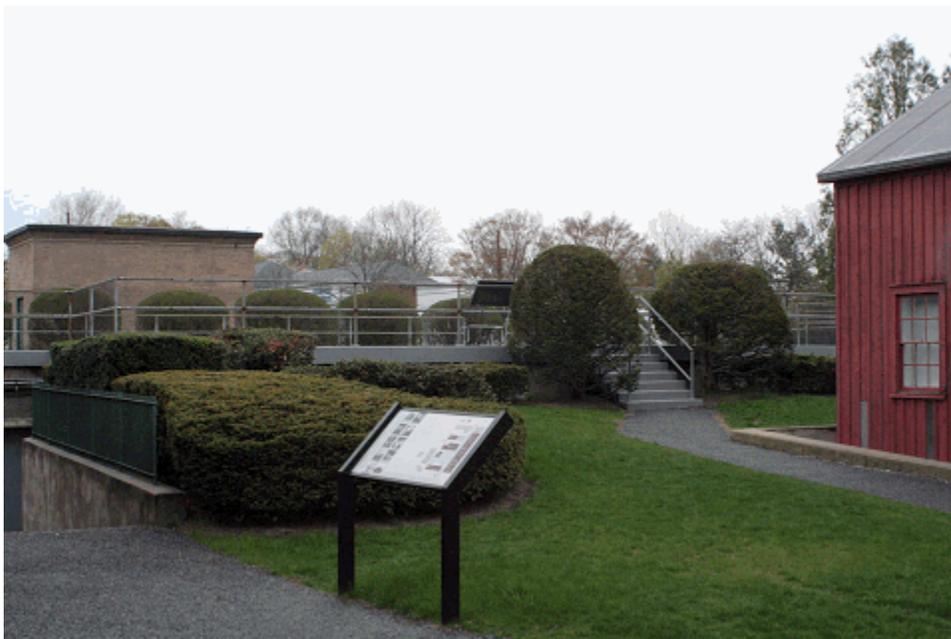
Figure 19. View looking east showing the Main Storage Vault (No. 12) and foundation plantings (2-2-19 through 2-22) (OCLP, 2011).

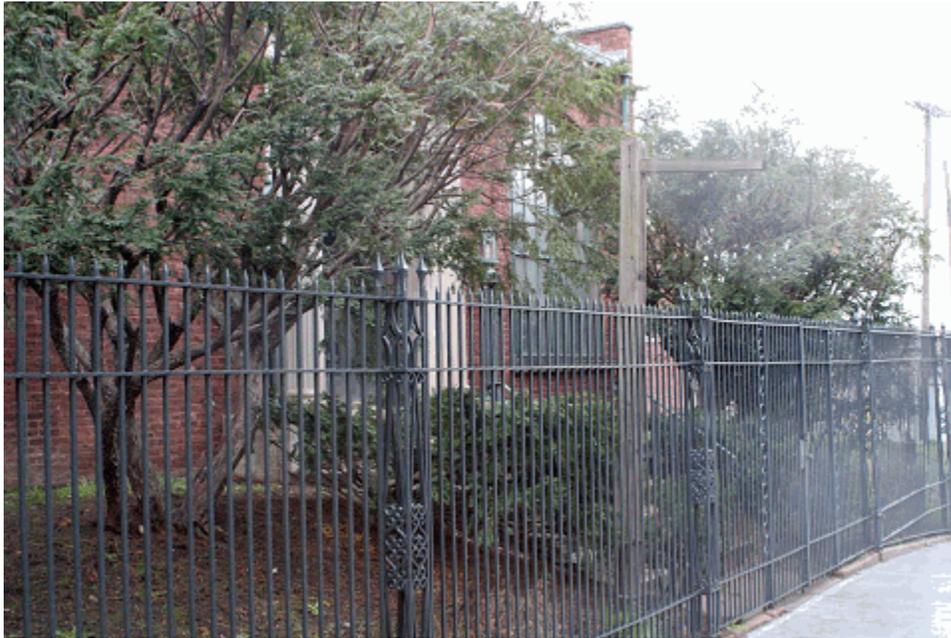
Figure 20. View looking east showing the entry foundation plantings (2-2-29 through 2-2-36) located along the south elevation of the Power House (No. 6), as well as the visitor's gate (OCLP, 2011).

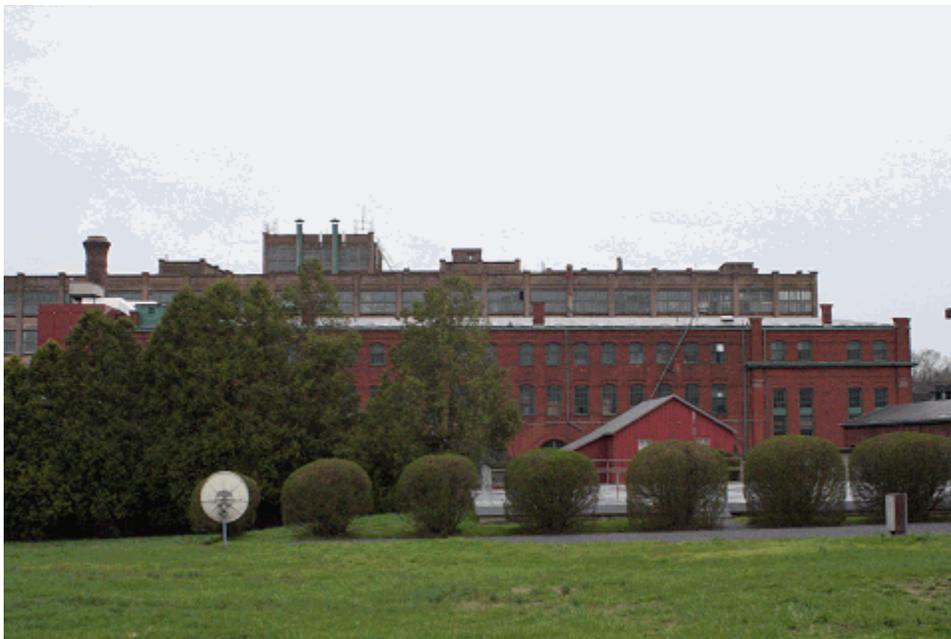
Figure 21. View looking southwest showing the Edison Laboratory Complex. Note the privet globe hedge and arborvitae in the foreground and the Main Laboratory (No. 5) in the background (OCLP, 2011).

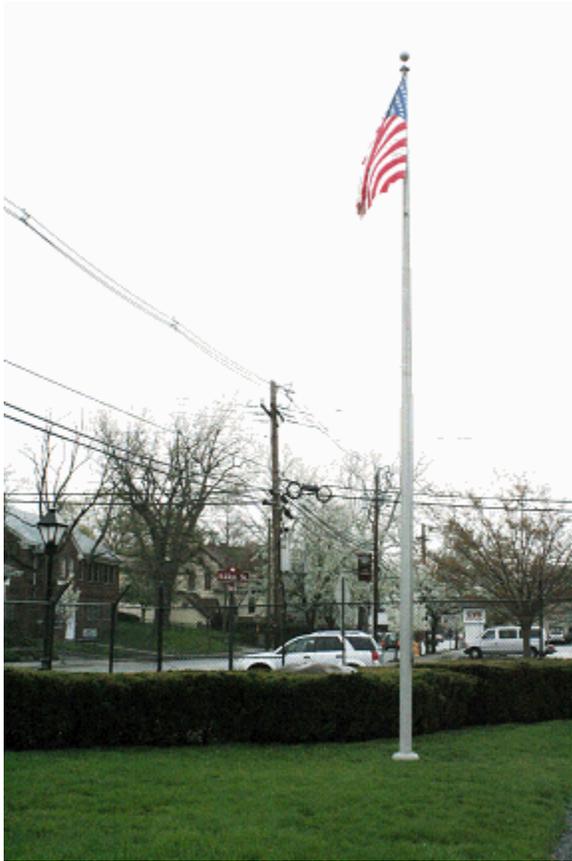
Figure 22. View looking north showing the war memorial juniper and yew planting, as well as flagpole within the Edison Laboratory Complex (OCLP, 2011).

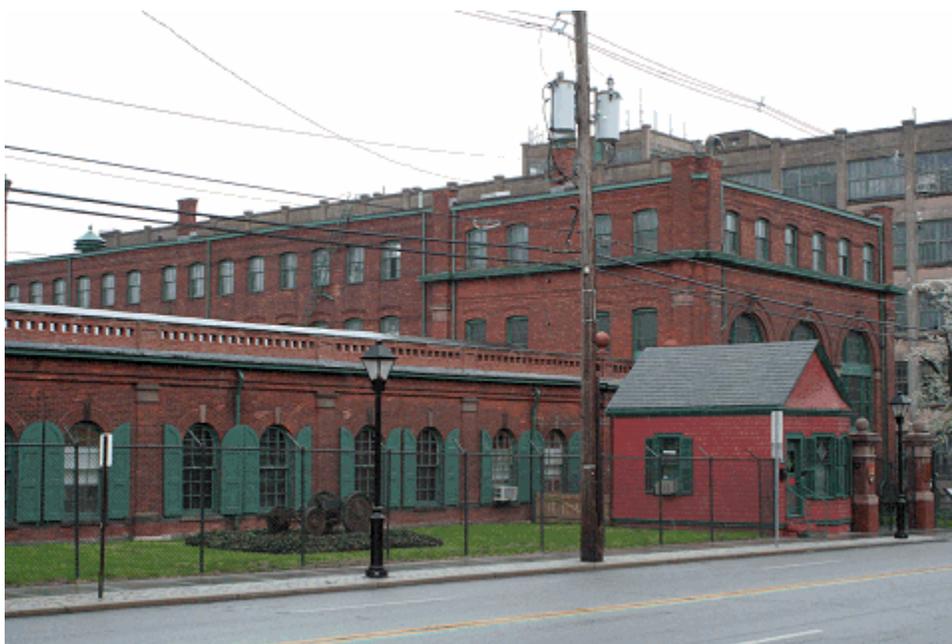
Figure 23. View looking south showing the Edison Laboratory Complex. Shown in the image are the Physics Laboratory (No. 1), Gate House (No. 9), and Main Laboratory (No. 5) (OCLP, 2011).

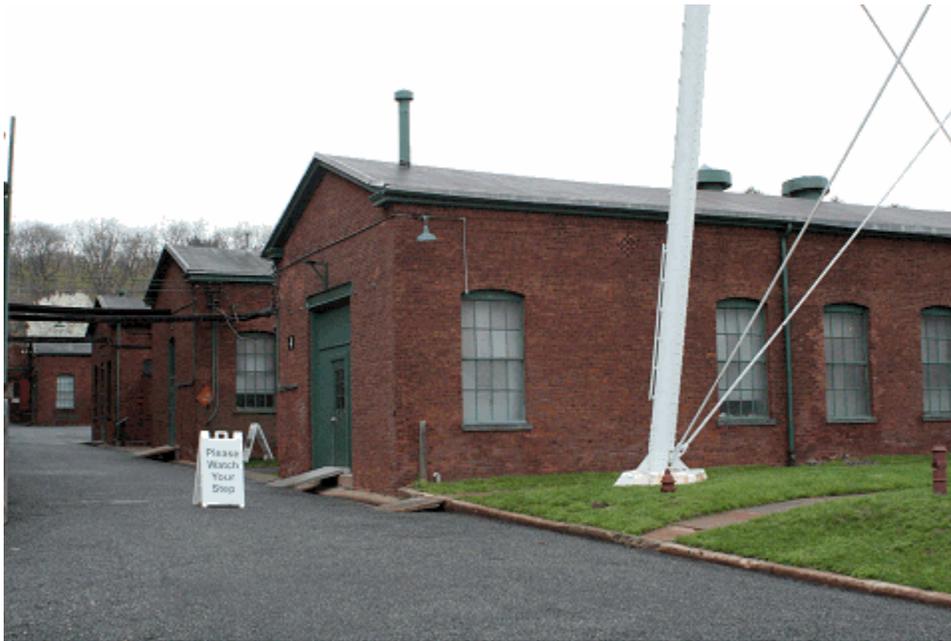
Figure 24. View looking north showing the satellite laboratories and main corridor within the Edison Laboratory Complex (OCLP, 2011).

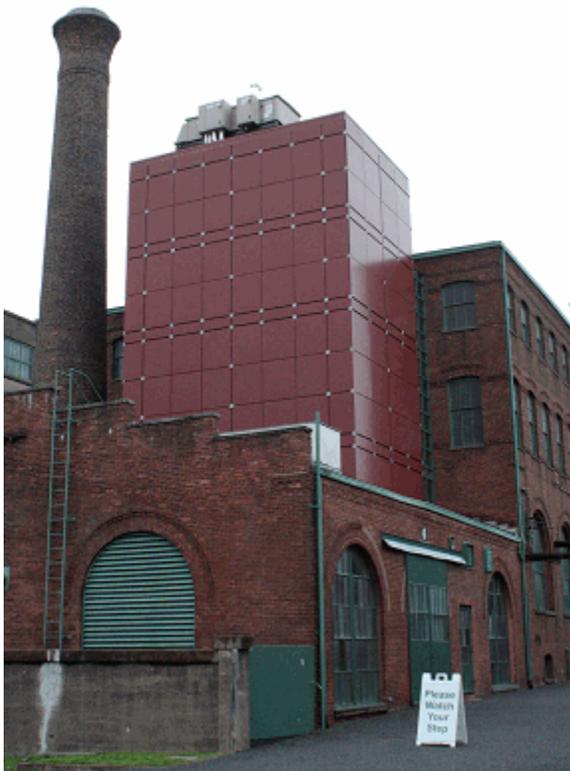
Figure 25. View looking west showing the Power House (No. 6) (OCLP, 2011).

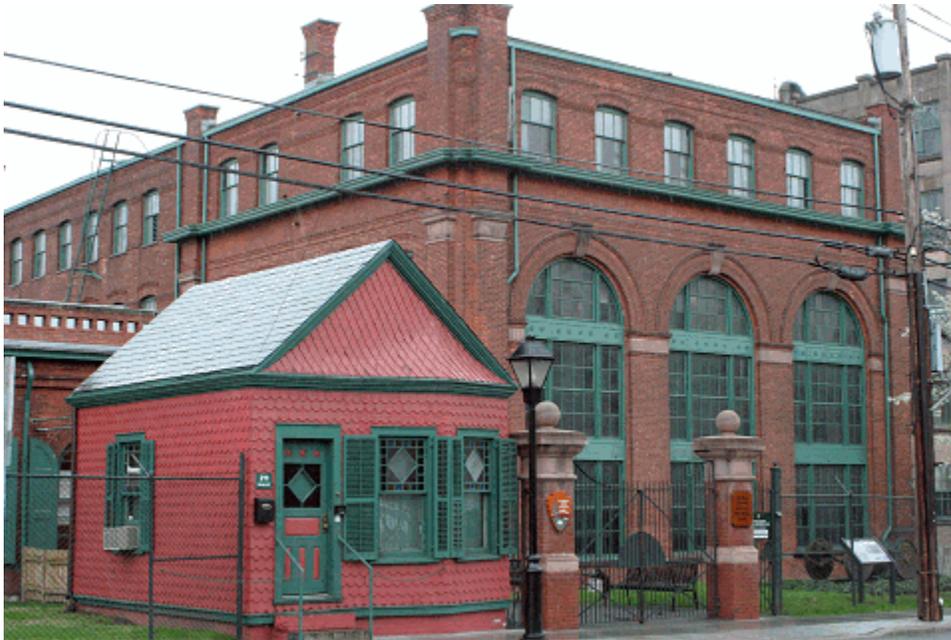
Figure 26. View looking south showing the Gate House (No. 9), Main Street wrought-iron gate, and Main Laboratory (No. 5) (OCLP, 2011).

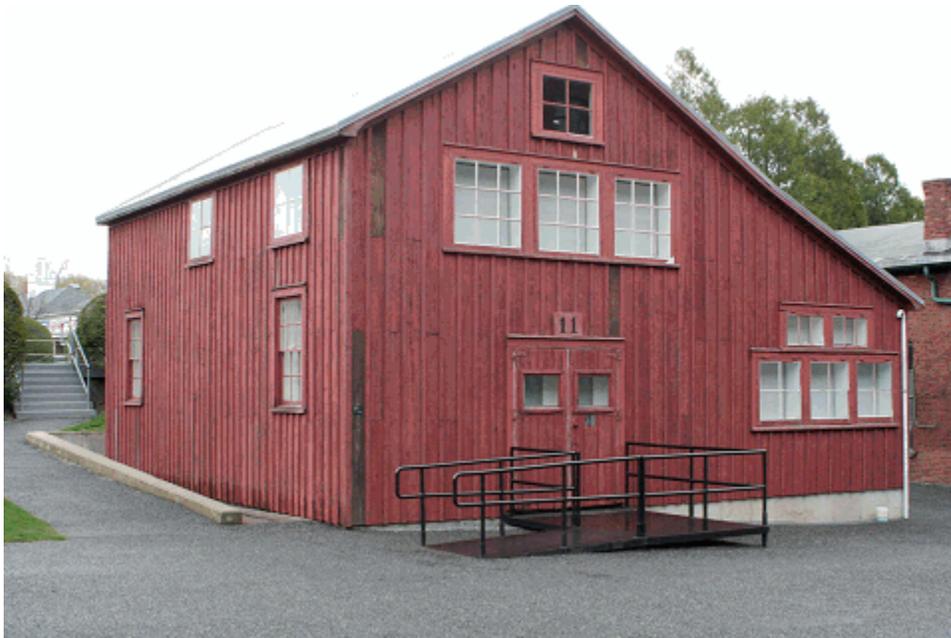
Figure 27. View looking east showing the Building 11 (No. 11). The building was moved to Greenfield Village between 1939 and 1940, but was relocated back to its approximate original location between 2002 and 2003 (OCLP, 2011).

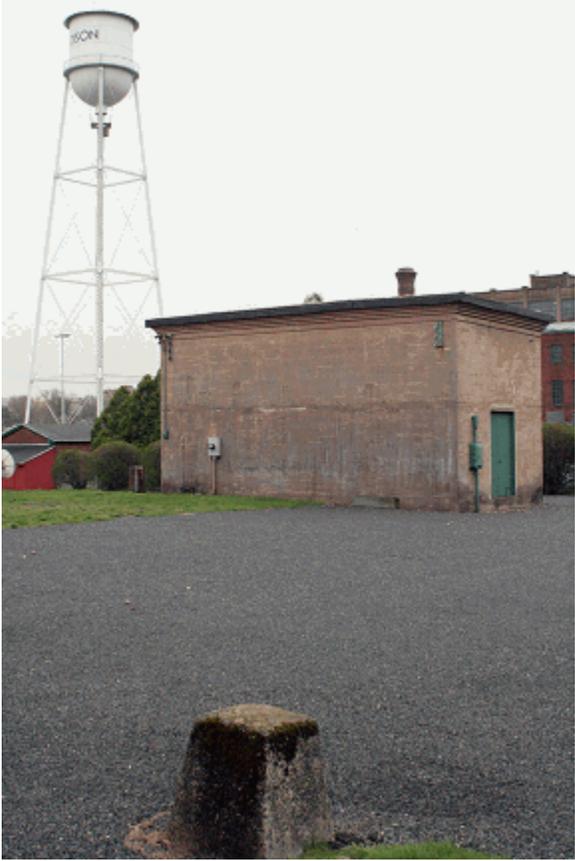
Figure 28. View looking south showing the Water Tower (No. 34) and Blue Amberol Vault (No. 33) (OCLP, 2011).

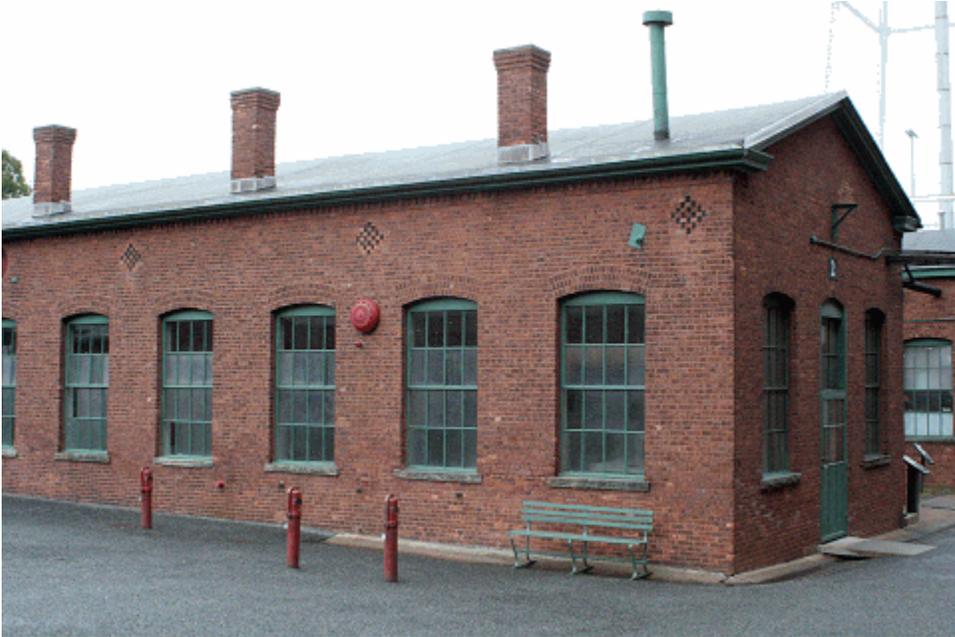
Figure 29. View looking east showing the Chemical Laboratory (No. 2), miscellaneous utility structures, and bench (OCLP, 2011).

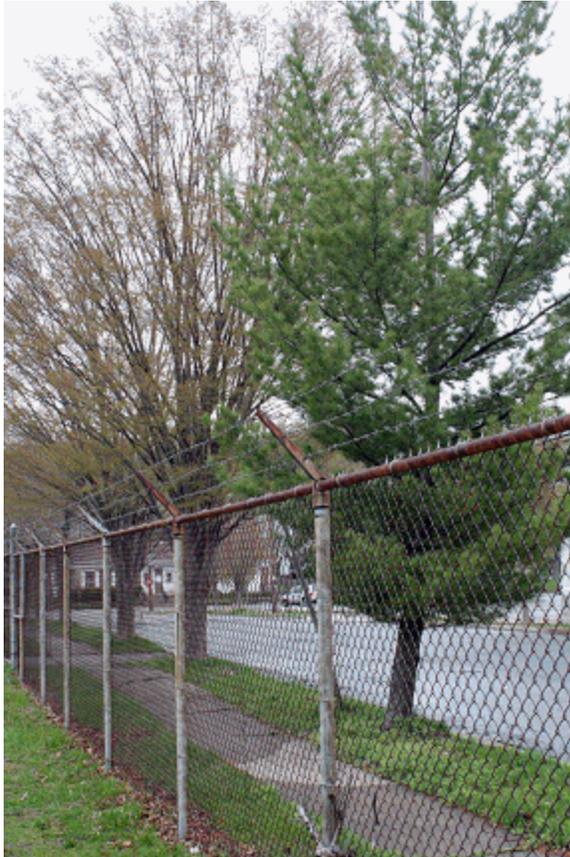
Figure 30. View of the chain-link fence located along the northern boundary of the Edison Laboratory Complex (OCLP, 2011).

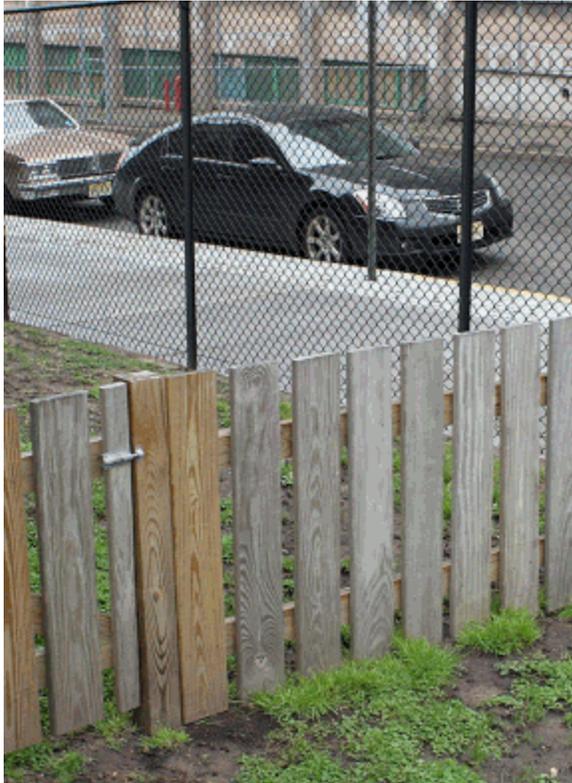
Figure 31. View of the wood fence and chain-link located along the southern boundary of the Edison Laboratory Complex (OCLP, 2011).

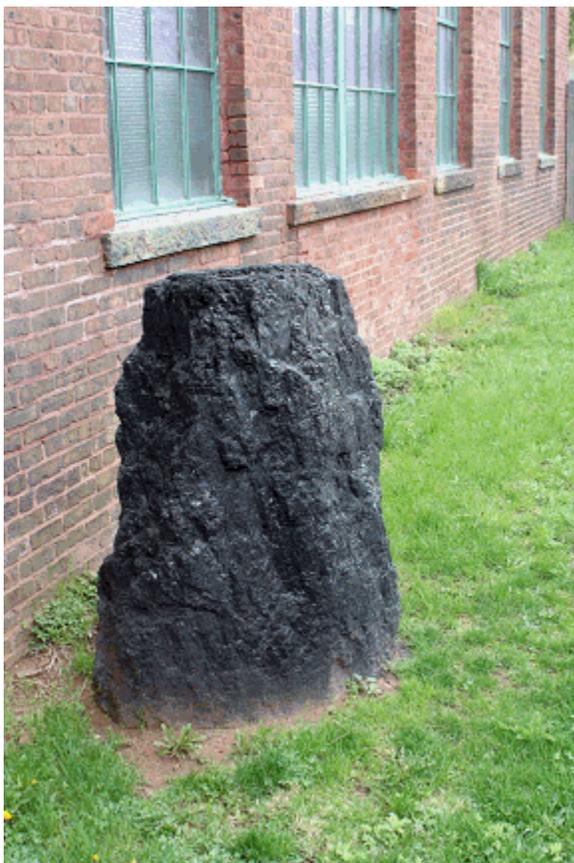
Figure 32. View of the coal remnant located along the southeast elevation of the Chemical Storage/Pattern Shop (No. 3) (OCLP, 2011).

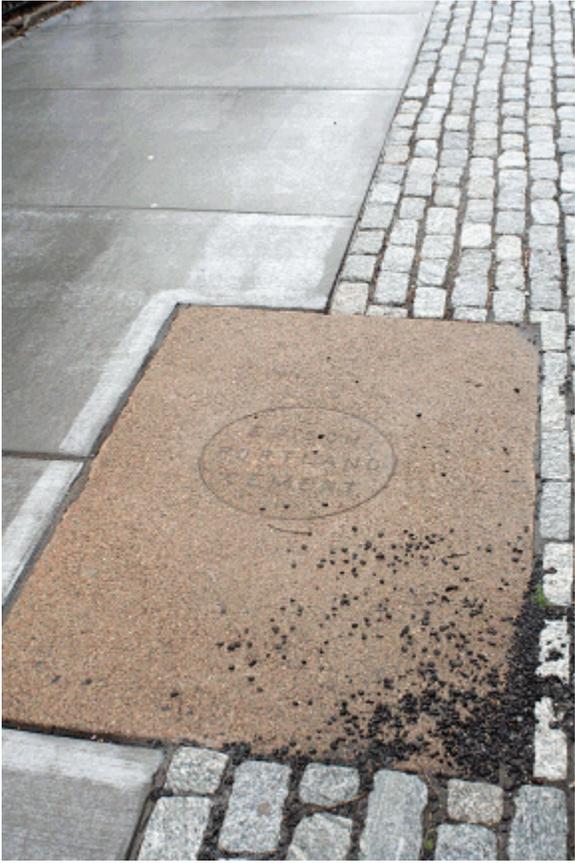
Figure 33. View of the Portland cement sidewalk plaque located near the Lakeside Avenue entry (OCLP, 2011).

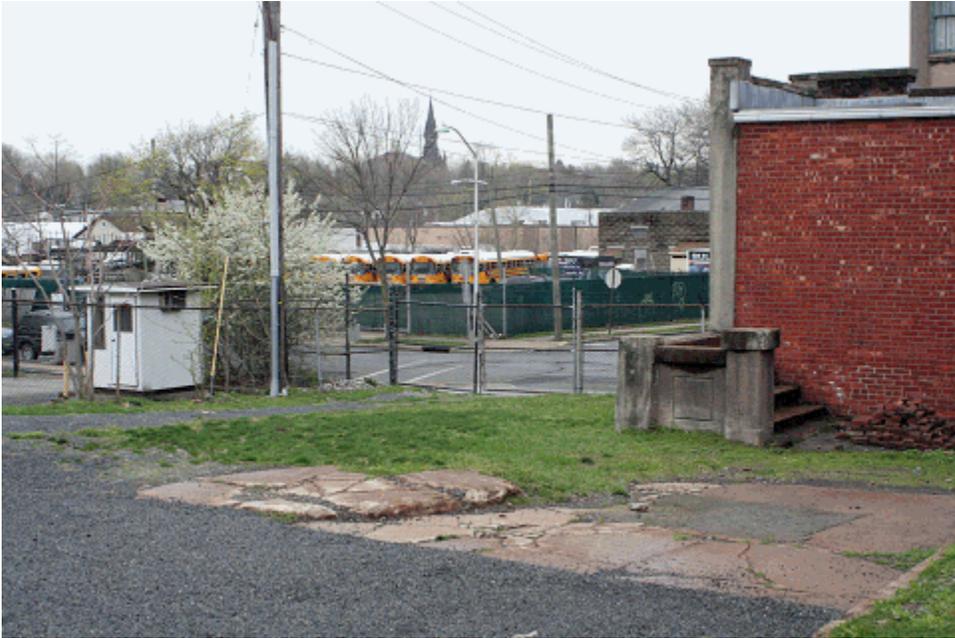
Figure 34. View looking south showing the Administration Building (No. 25) walkway and Lakeside Avenue gate (OCLP, 2011).

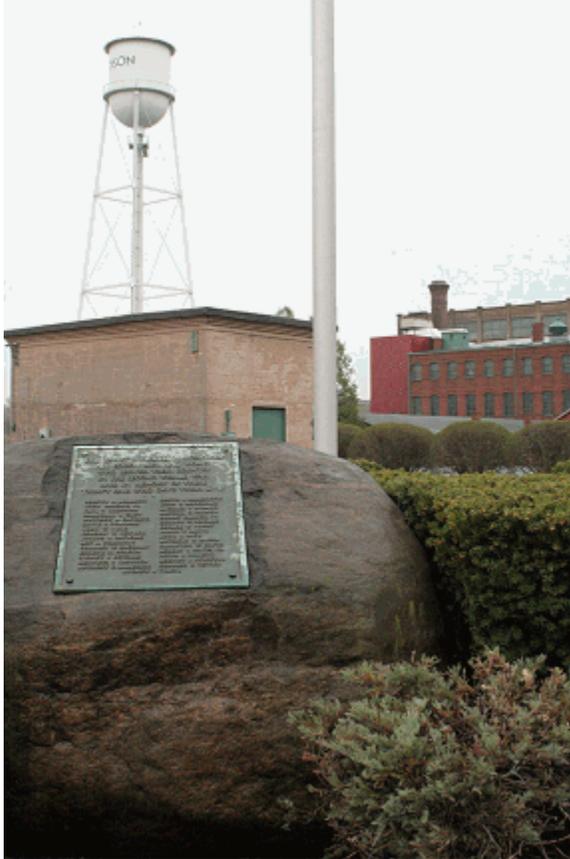
Figure 35. View looking south showing the World War II plaque within the Edison Laboratory Complex (OCLP, 2011).
