DEVELOPMENT CONCEPT/ENVIRONMENTAL ASSESSMENT

EDISON NATIONAL HISTORIC SITE

West Orange, New Jersey

January 1998

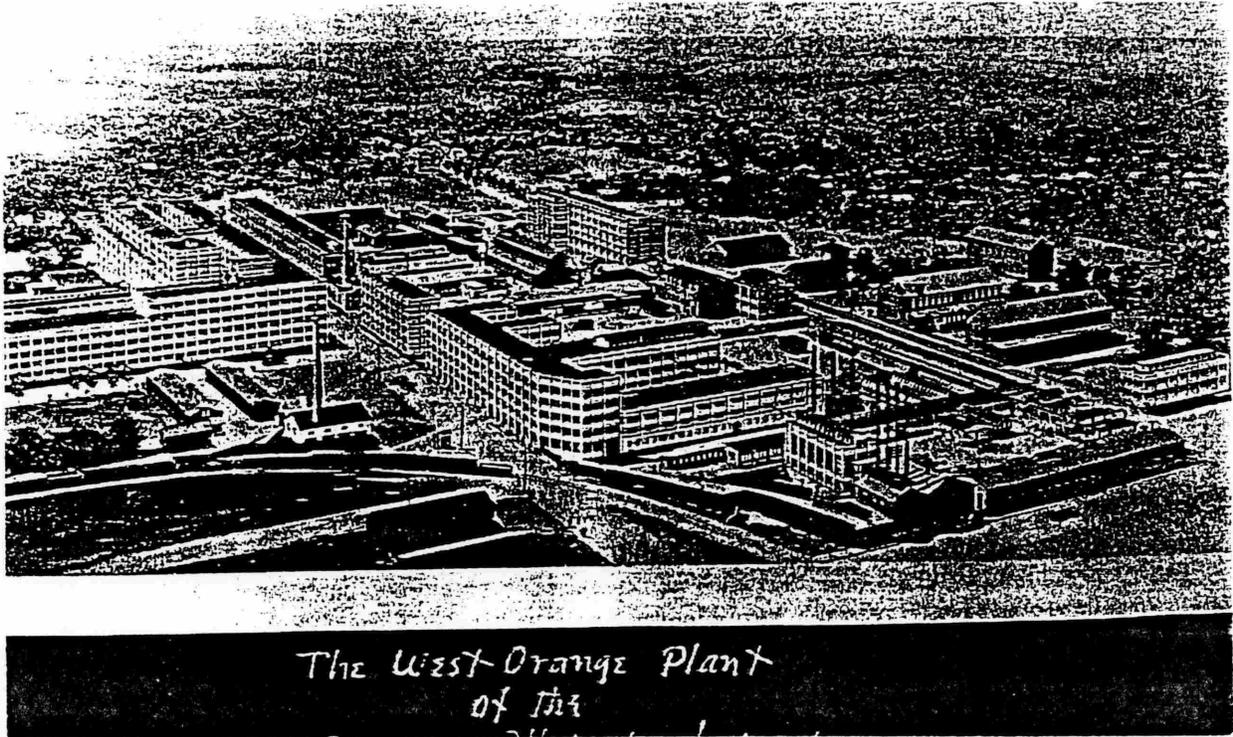
Figure 1
A rendering of the West Orange Plant, ca. 1917. This is how the plant looked after reconstruction due to the fire in 1916. (EDIS archives, photo 10.380/25)

The core of the Laboratory Unit of Edison NHS is composed of the remaining buildings and features of the "Edison Laboratories," the research and development arm of Edison's many industries. Substantially intact today, the Edison Laboratories were once surrounded by a busy industrial zone of about 22 acres of Edison manufacturing facilities, collectively known as the "West Orange Plant." These facilities were generally massive, multi-storied concrete structures, dwarfing and surrounding the smaller Laboratory facilities. (Figure 1)

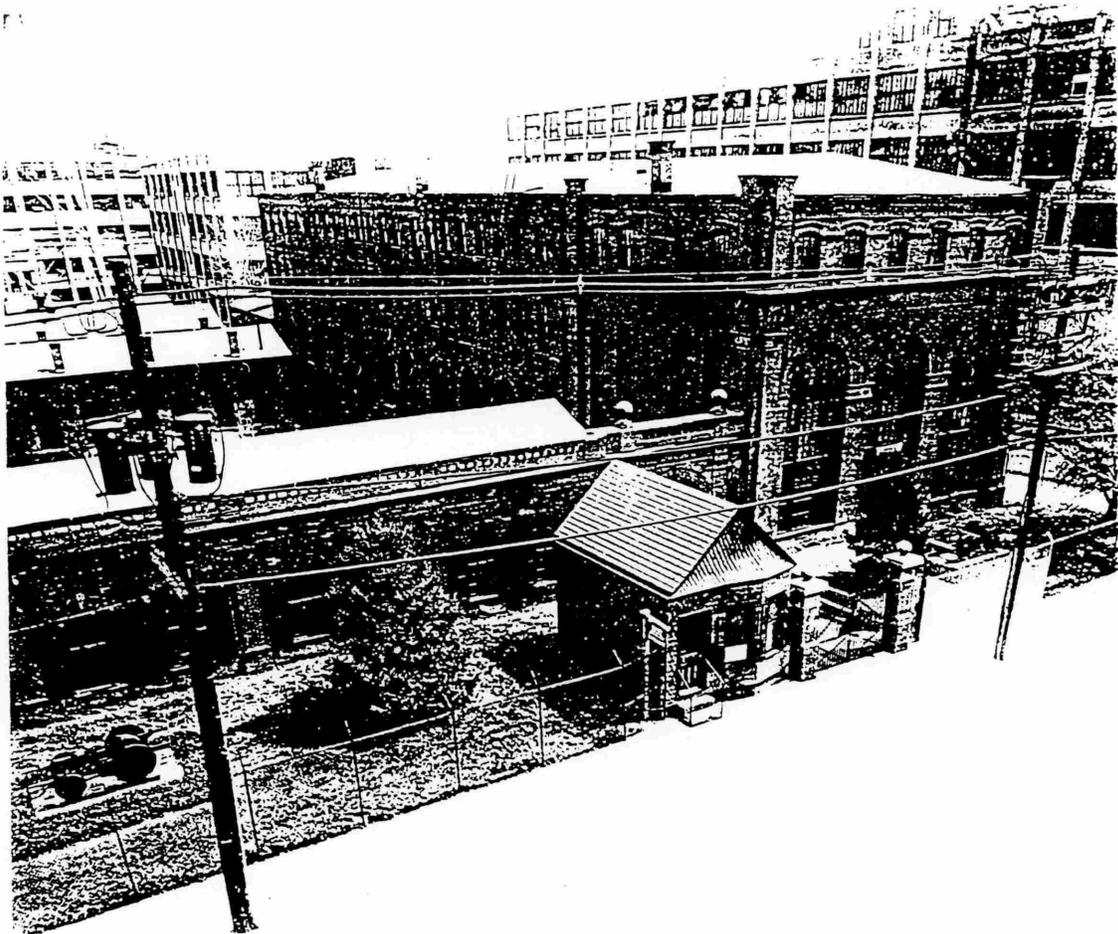
Figure 2

A view of buildings #1, #5 and the gatehouse from across Main Street showing the sense of enclosure once offered by the surrounding manufacturing buildings.

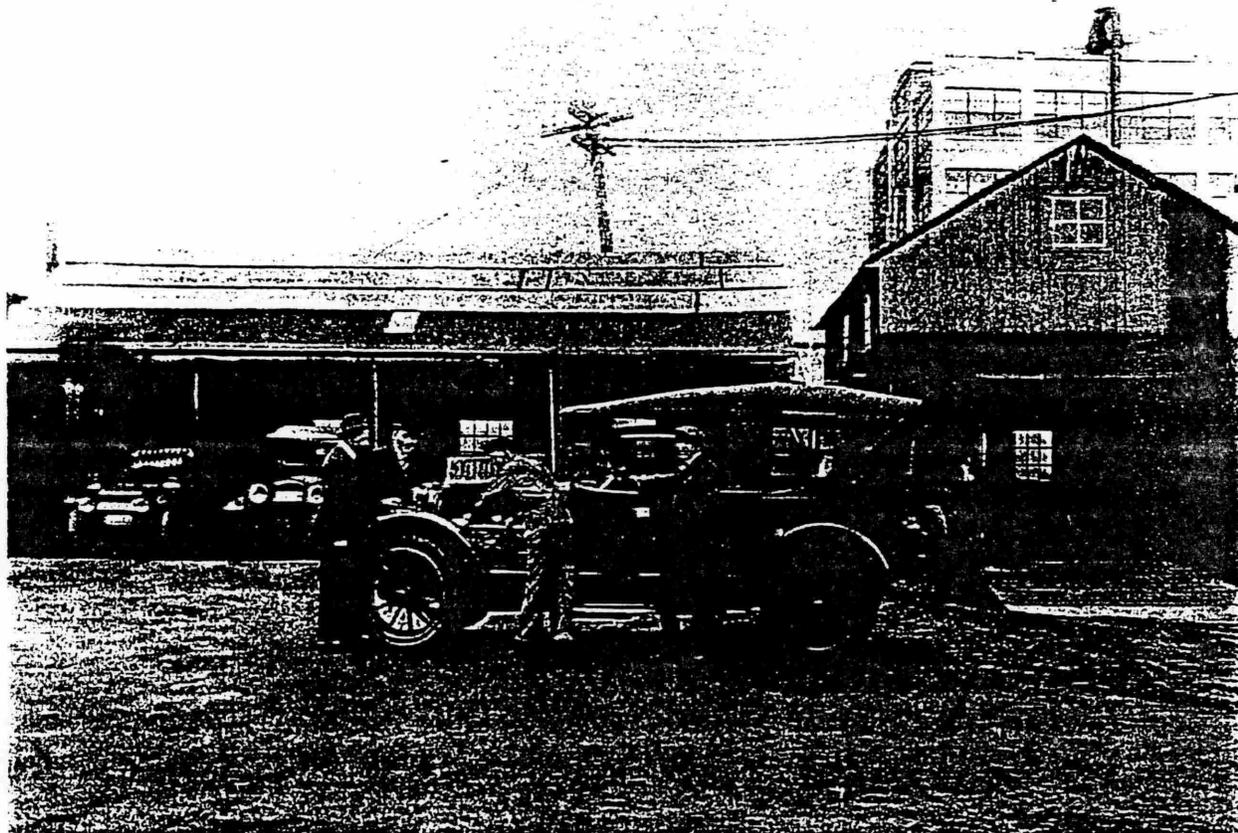
Figure 3

The north edge of the courtyard enclosed by building #10 (garage) and building #11 (garage/ experimental studio), 1917. Behind building #11 the upper floors of the phonograph works building are visible. (EDIS archives)

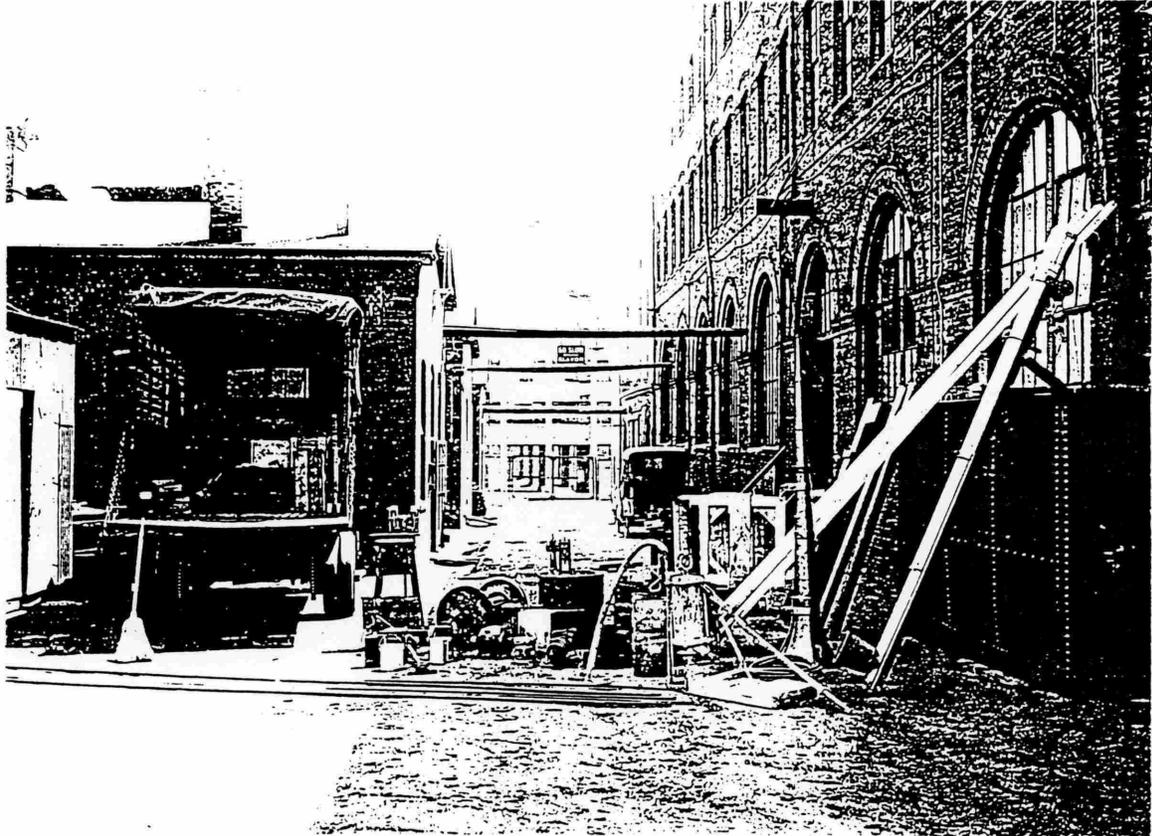
Figure 4
Equipment and trucks in the courtyard, August 19, 1917.
(EDIS archives, photo 10.380/27)

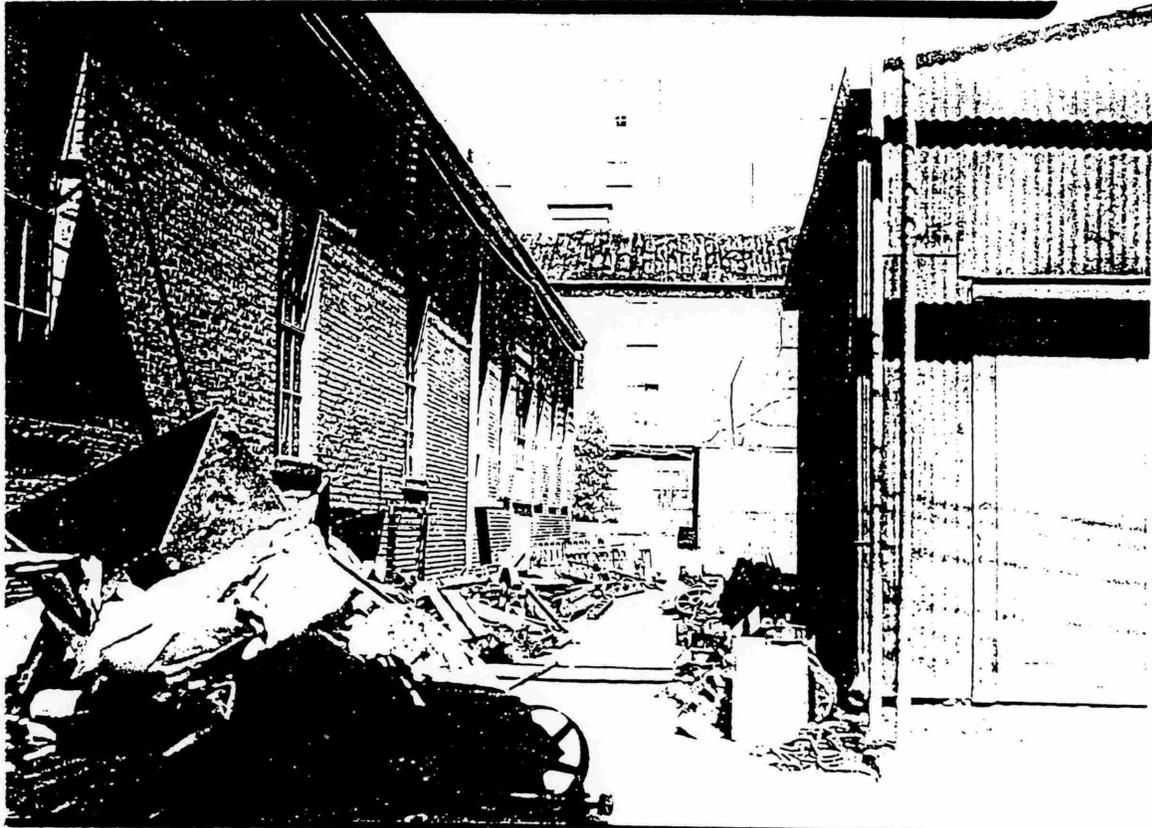
Figure 5

The alley adjacent to building #2 illustrating how the exterior spaces were utilized historically.

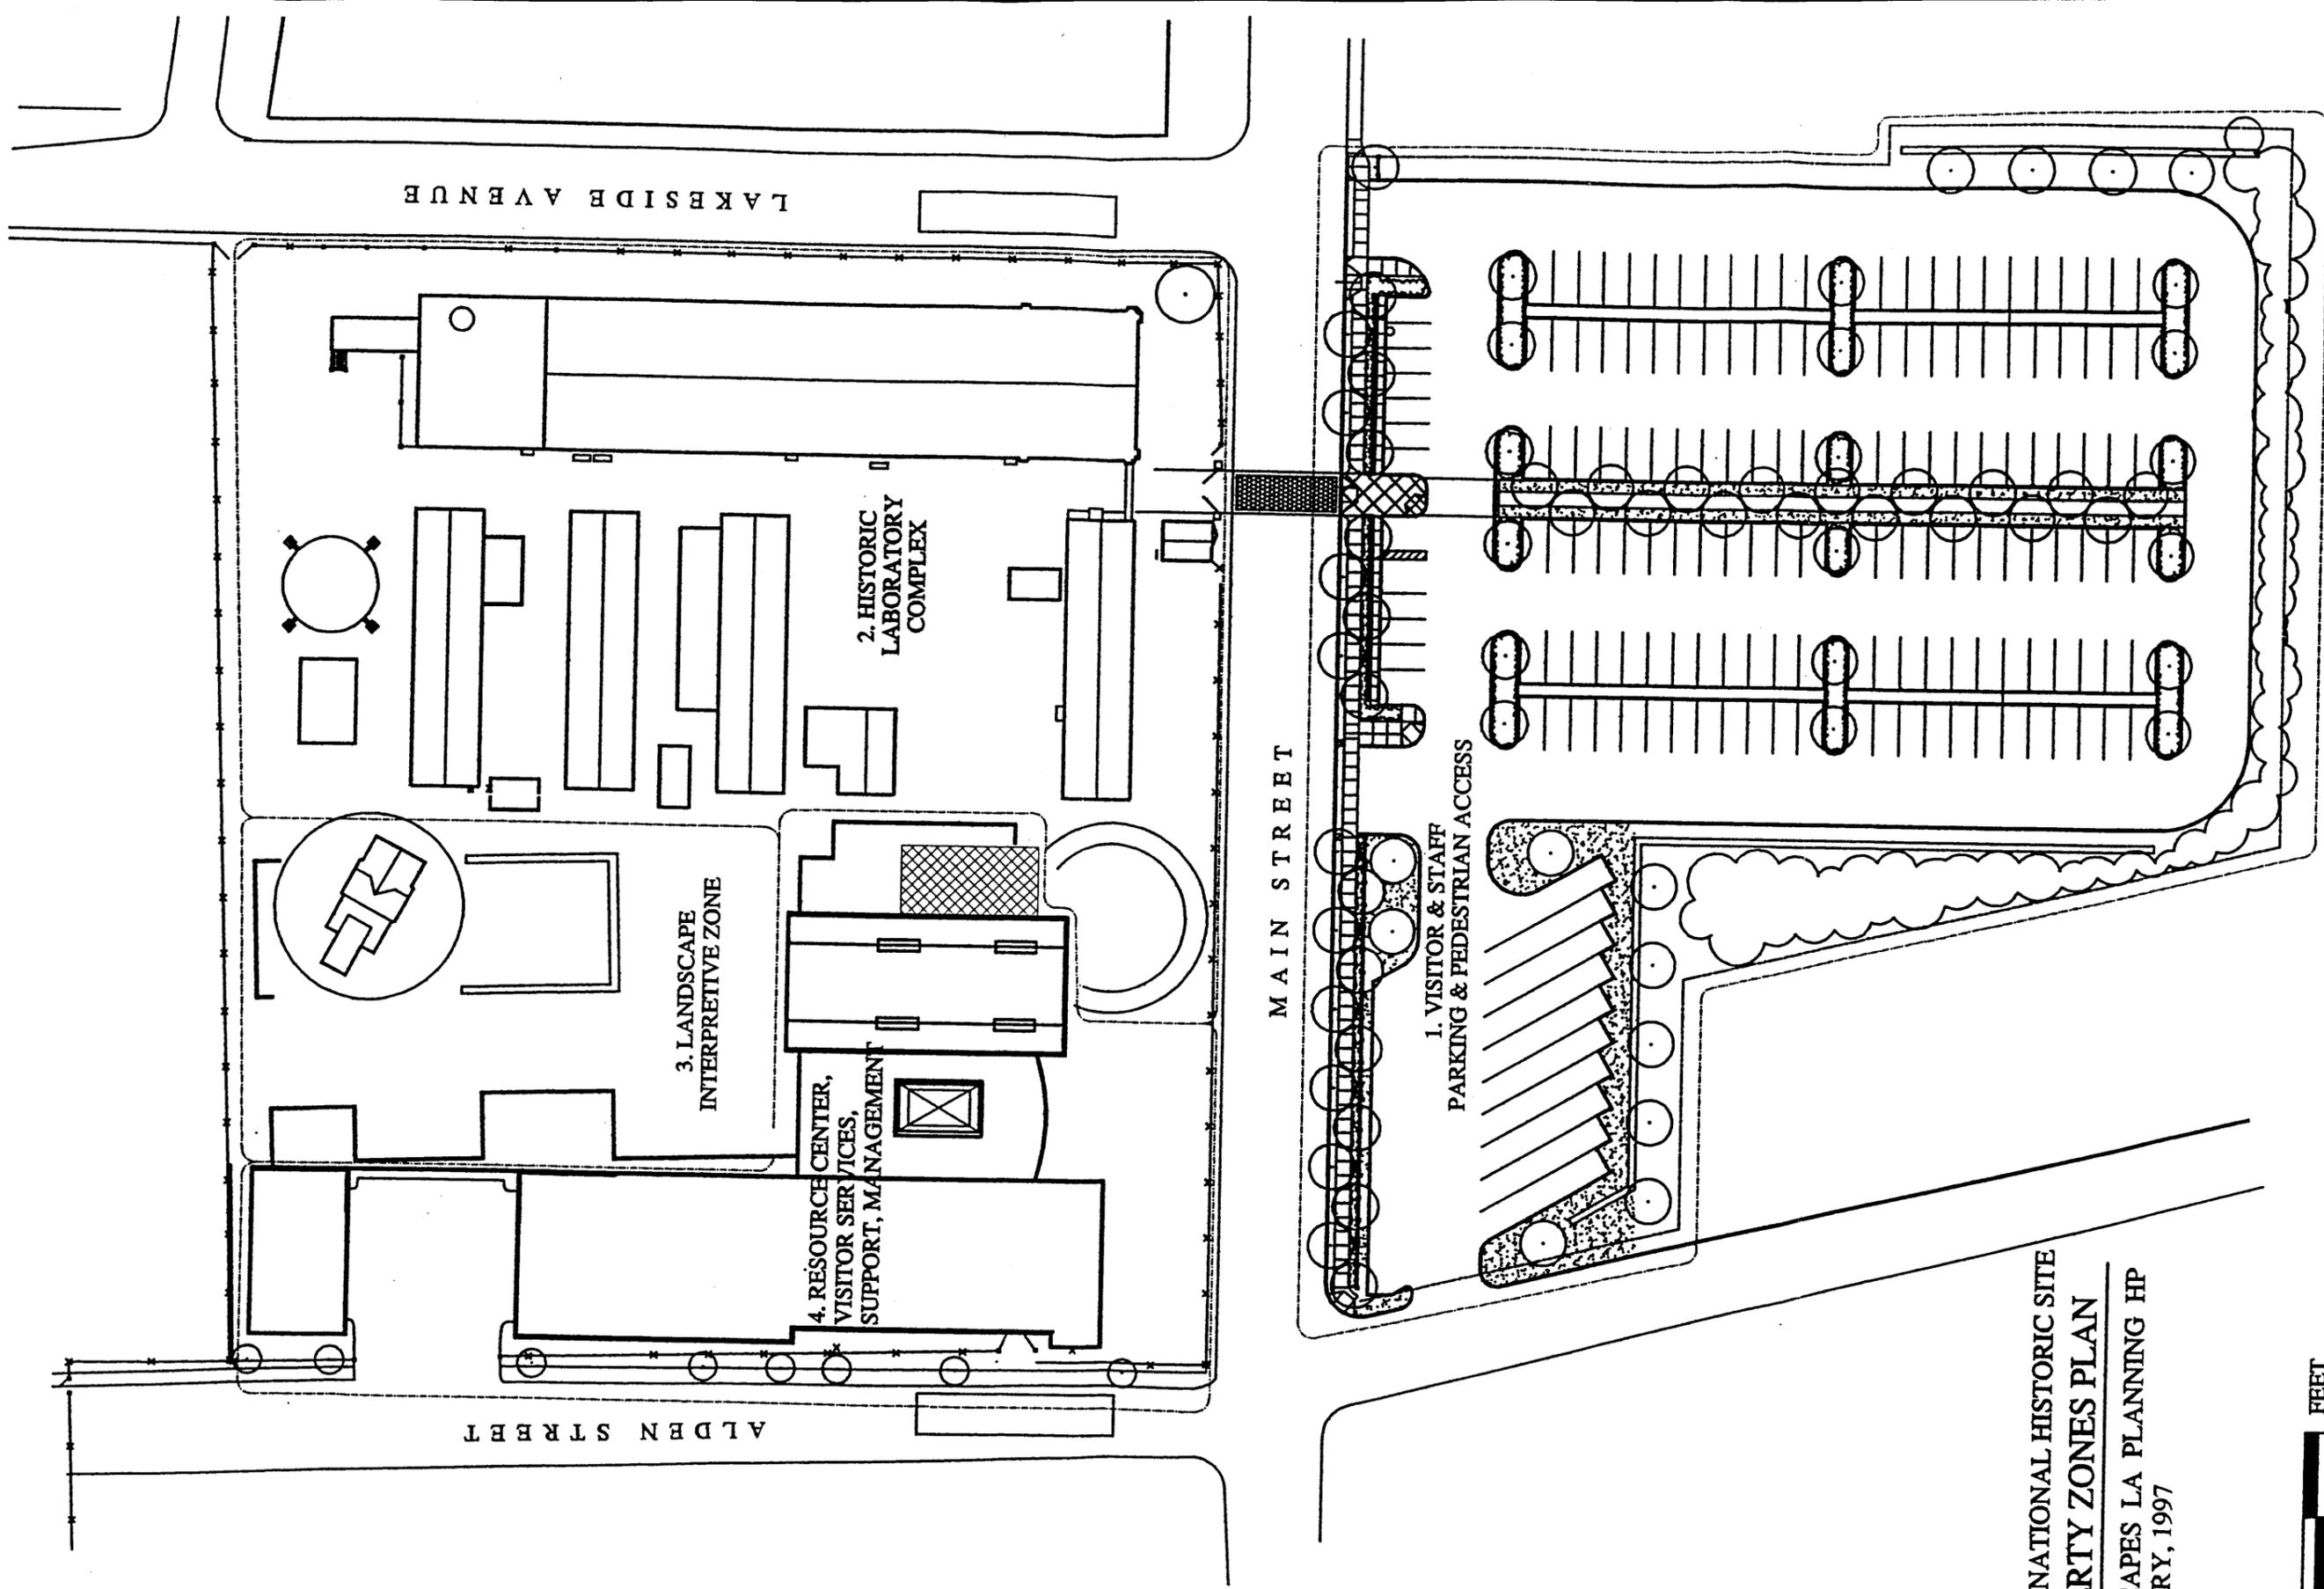
Figure 6
4-14

EDISON NATIONAL HISTORIC SITE
PROPERTY ZONES PLAN
LANDSCAPES LA PLANNING HP
FEBRUARY, 1997

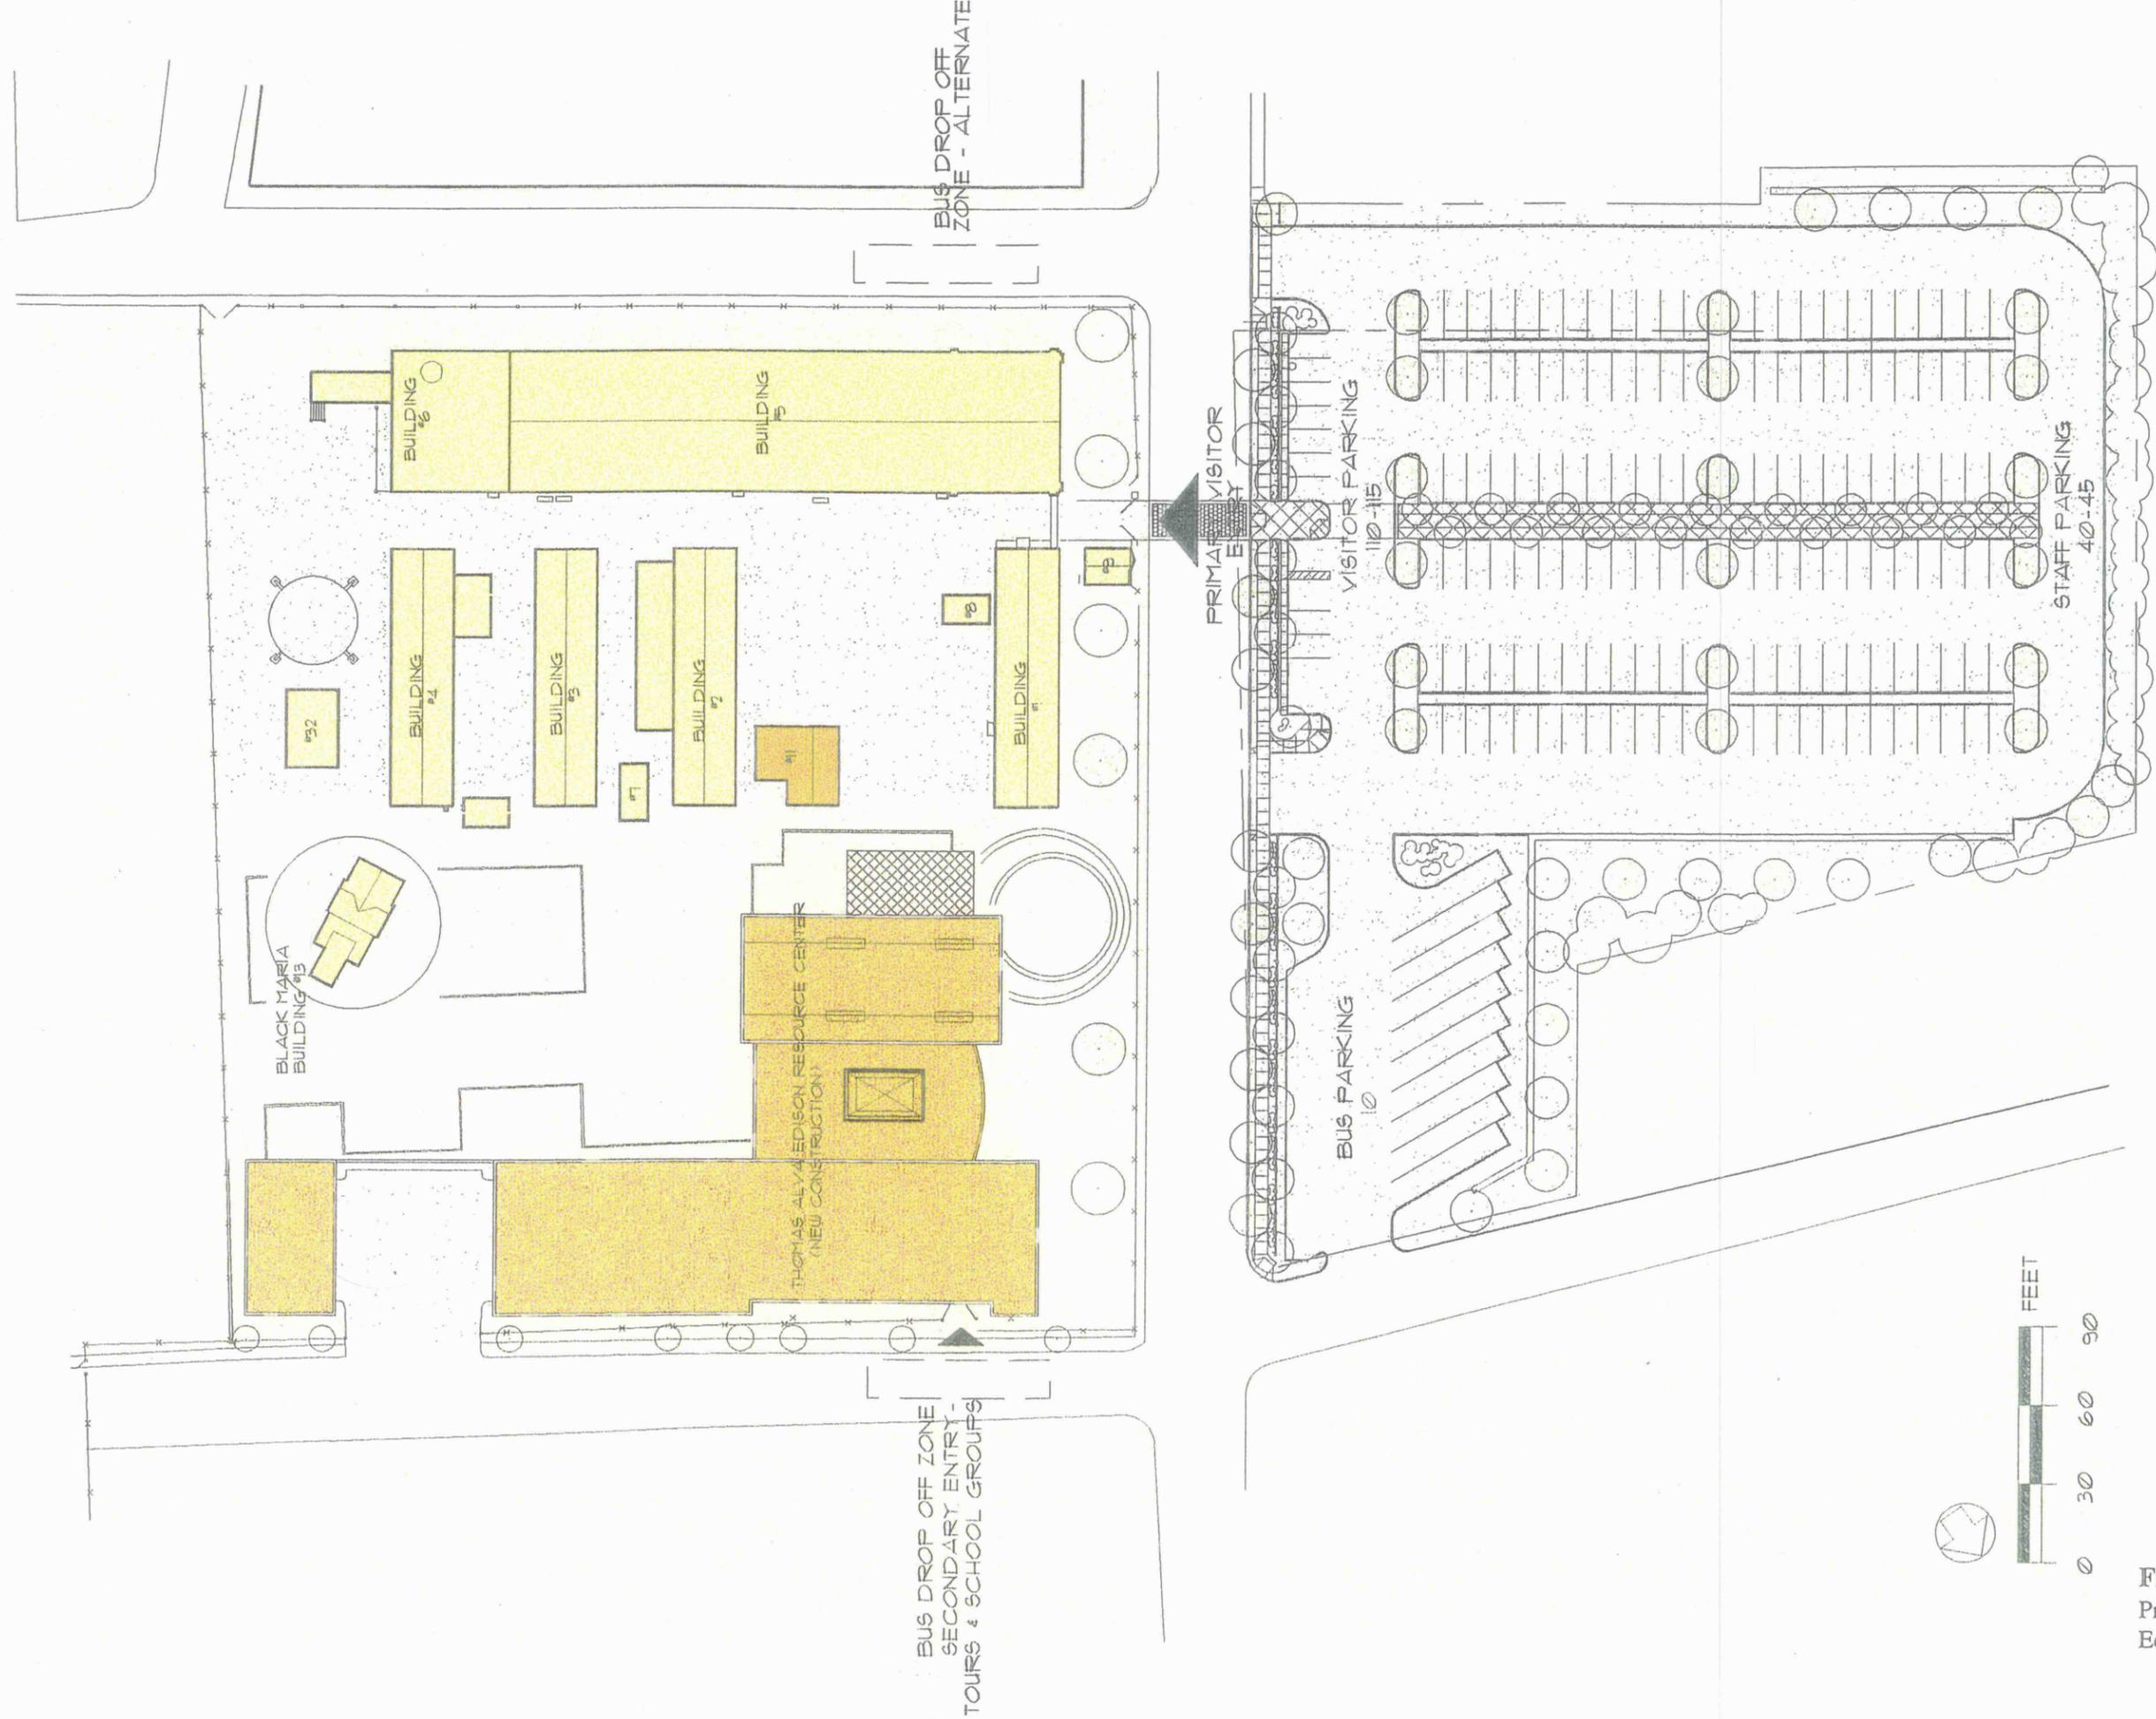
SITE DEVELOPMENT

Figure 9
Proposed Site Development
Edison NHS- Lab Unit

-The historic laboratory site can be divided into three zones. The southern portion of the site consists of the core laboratory buildings which date primarily from the initial period of construction at the site. The northern portion of the site, along Alden Street, which is now mainly open space should be utilized for new construction. Construction in this area will close off a view corridor from the historic core that is inappropriate. The third area is in the middle, between the northern and southern areas. This zone can be utilized as an area for interpretation, both indoors and outdoors.

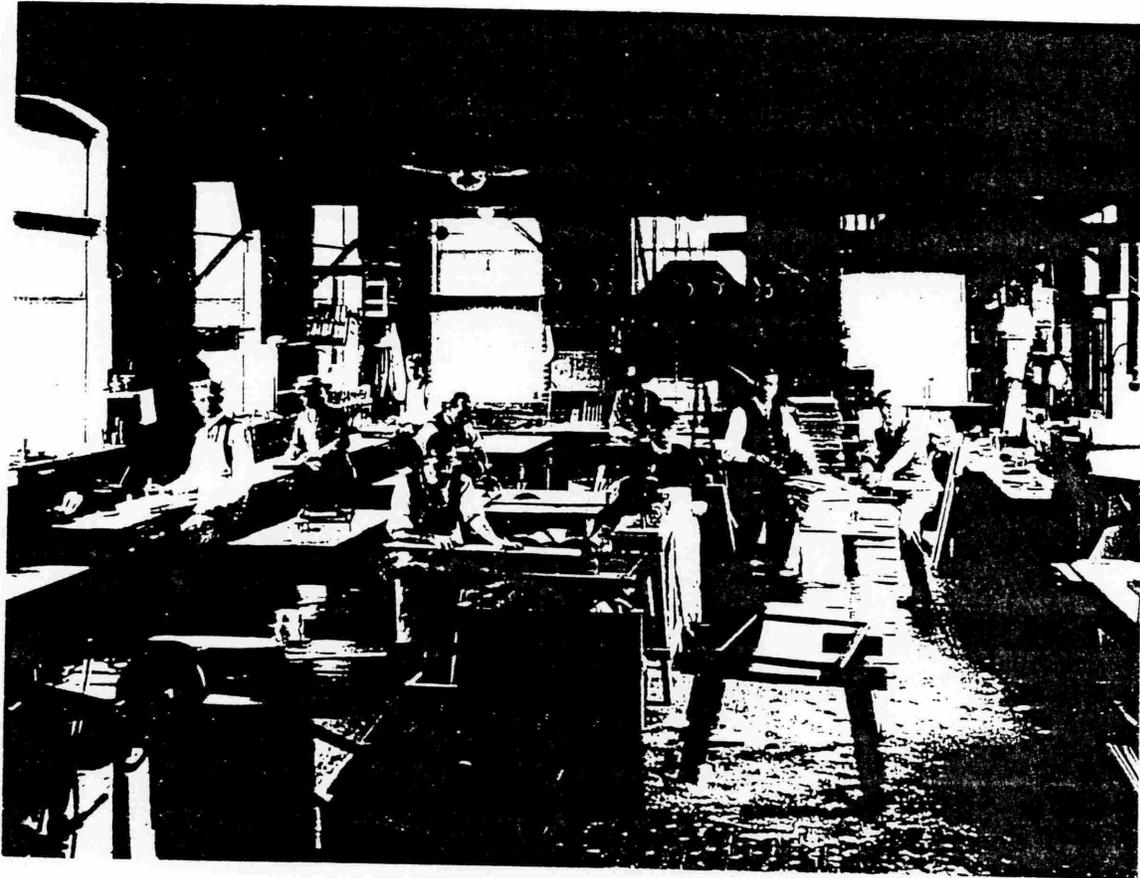
Figure 11
The pattern-making shop, building #3, January, 1917.
(EDIS archives, photo 10.382/3)

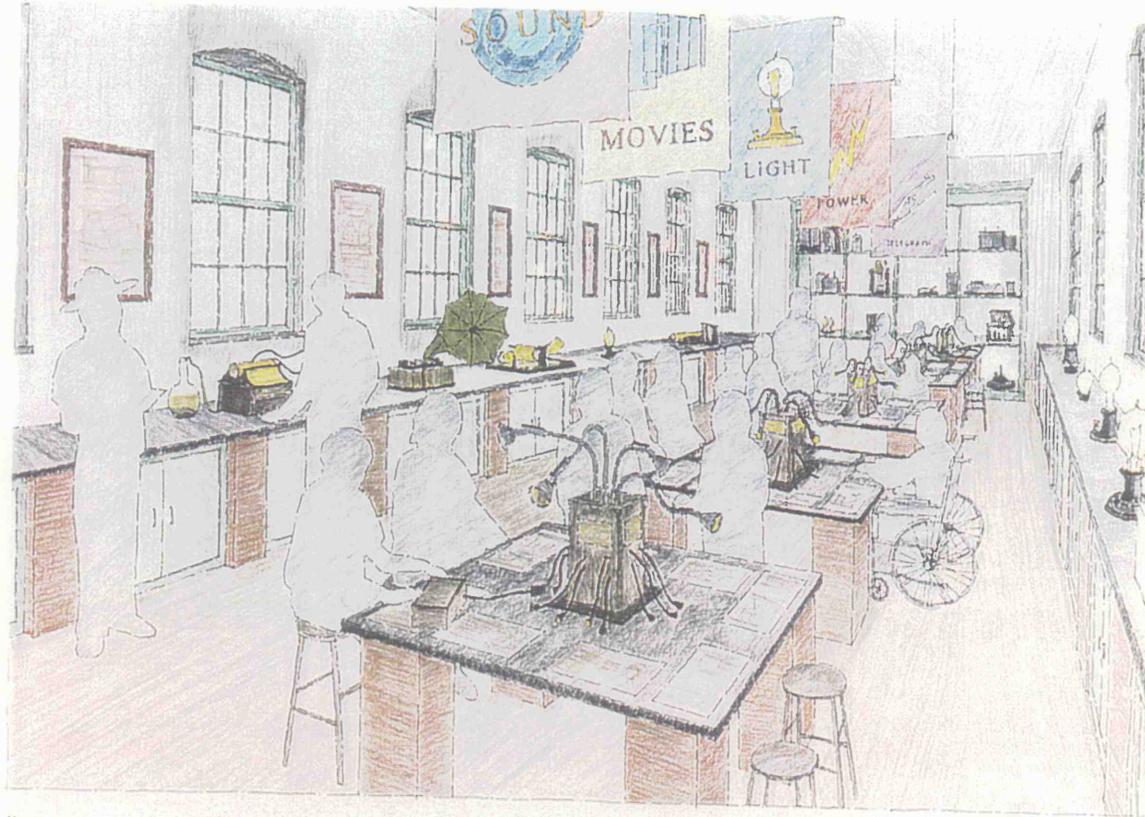
"EDISON'S WORKBENCH"

Figure 12
Rendering of the proposed interactive exhibit area,
"Edison's Workbench", to be located in building #3.

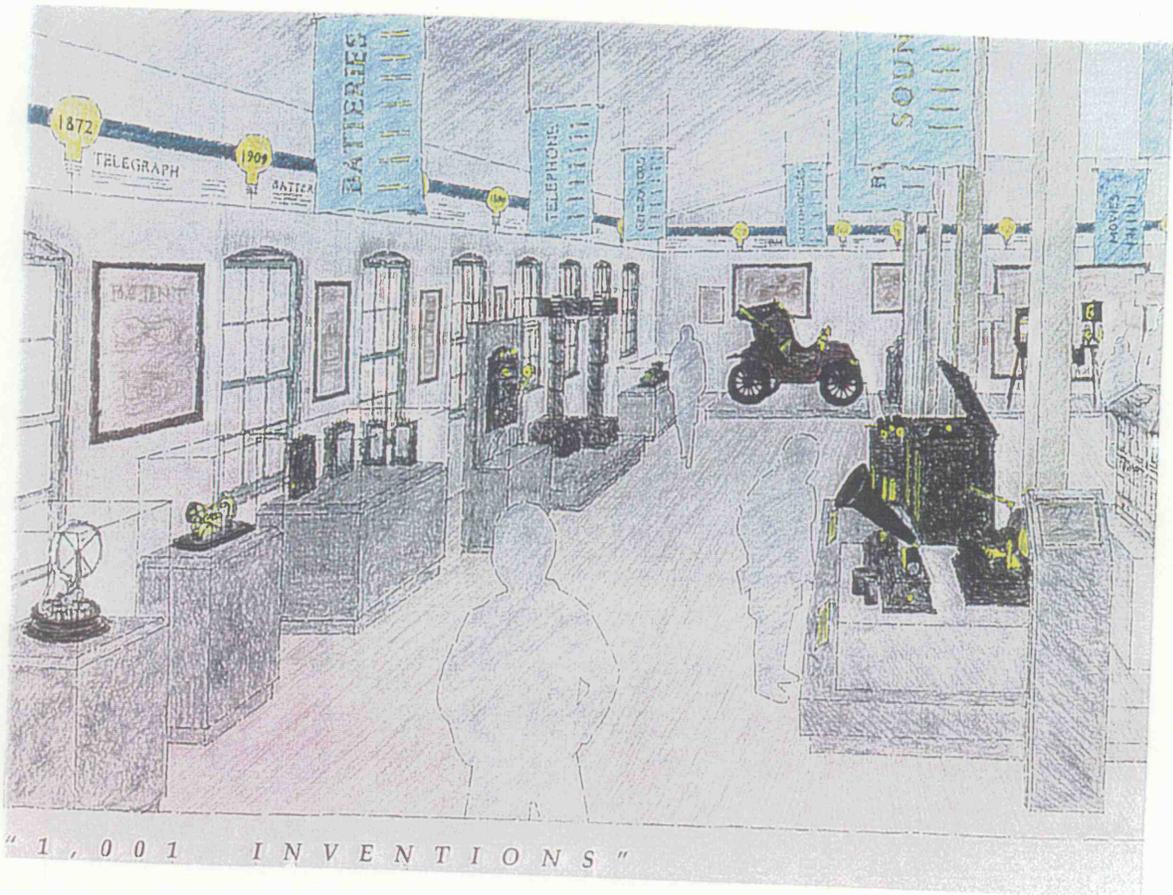
Figure 14
Rendering of the proposed exhibit to be located on the third floor of building #5, "The Edison Legacy or 1,001 Inventions".

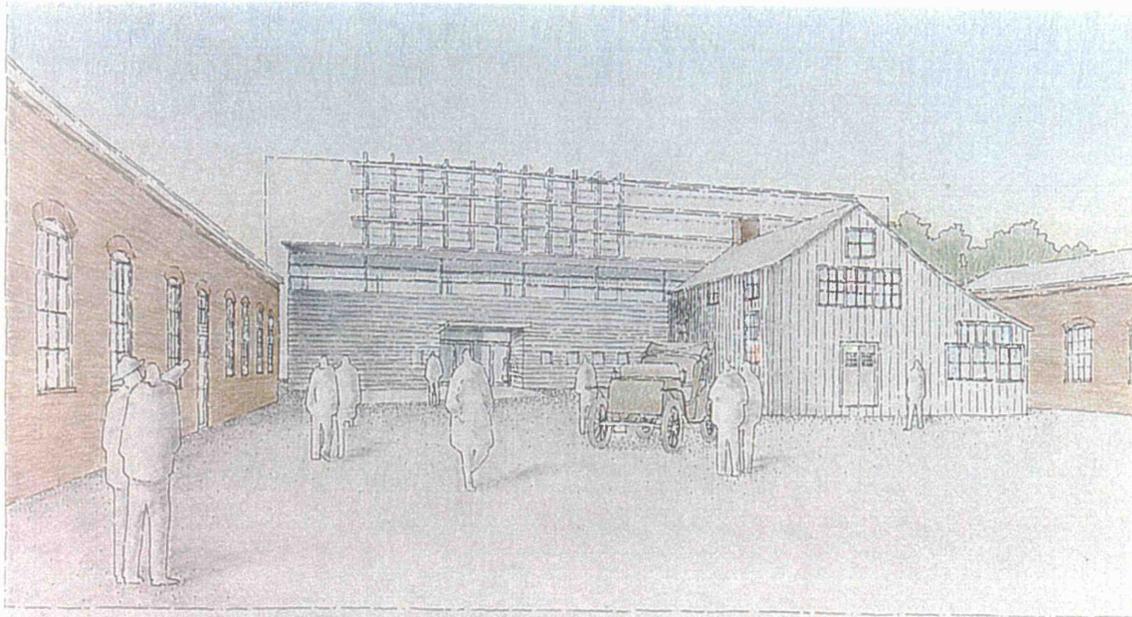
"VIEW FROM COURTYARD"

Figure 15
Rendering of the proposed Thomas Edison Resource Center
viewed from the courtyard.

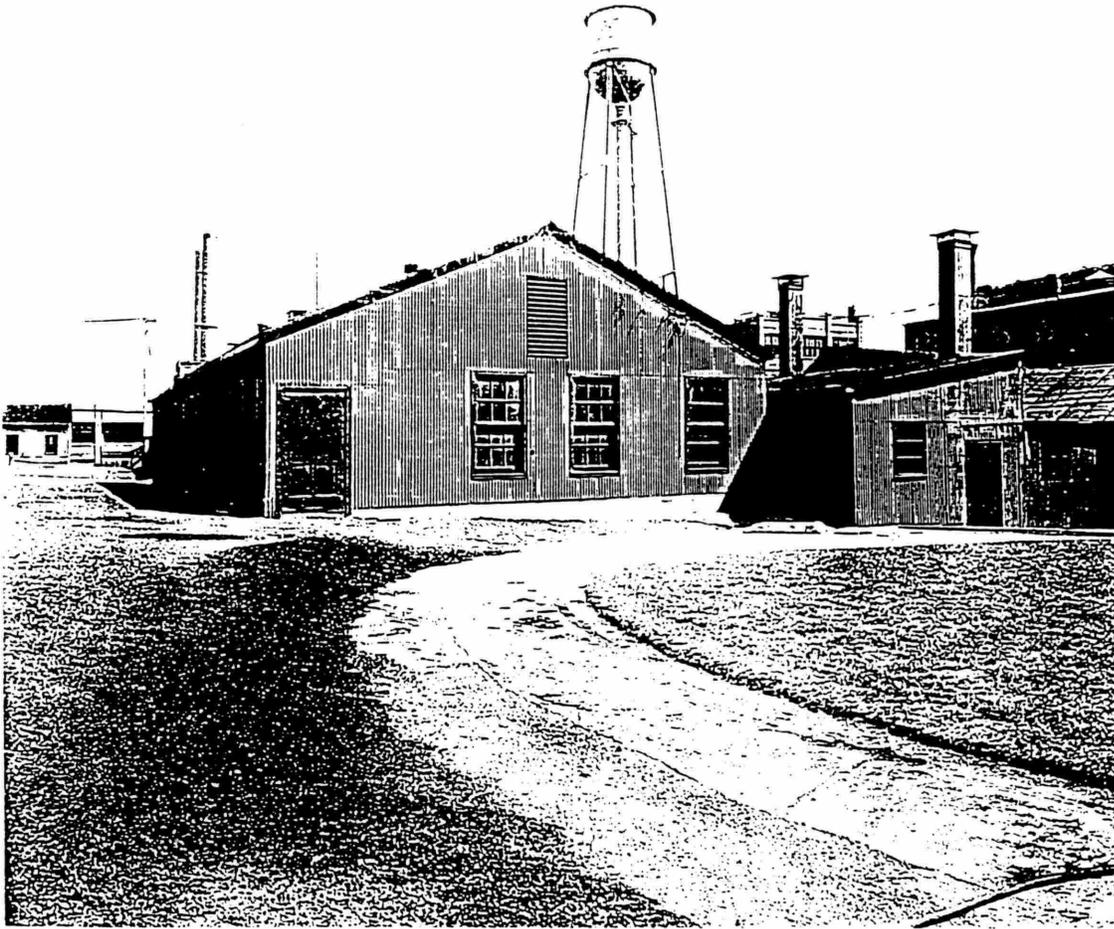
Figure 16

A photograph taken in 1936 of building #22b, which was located in the area just north of the main courtyard. The pavement test circle can be seen in the foreground (EDIS archives, photo 12.440/368)

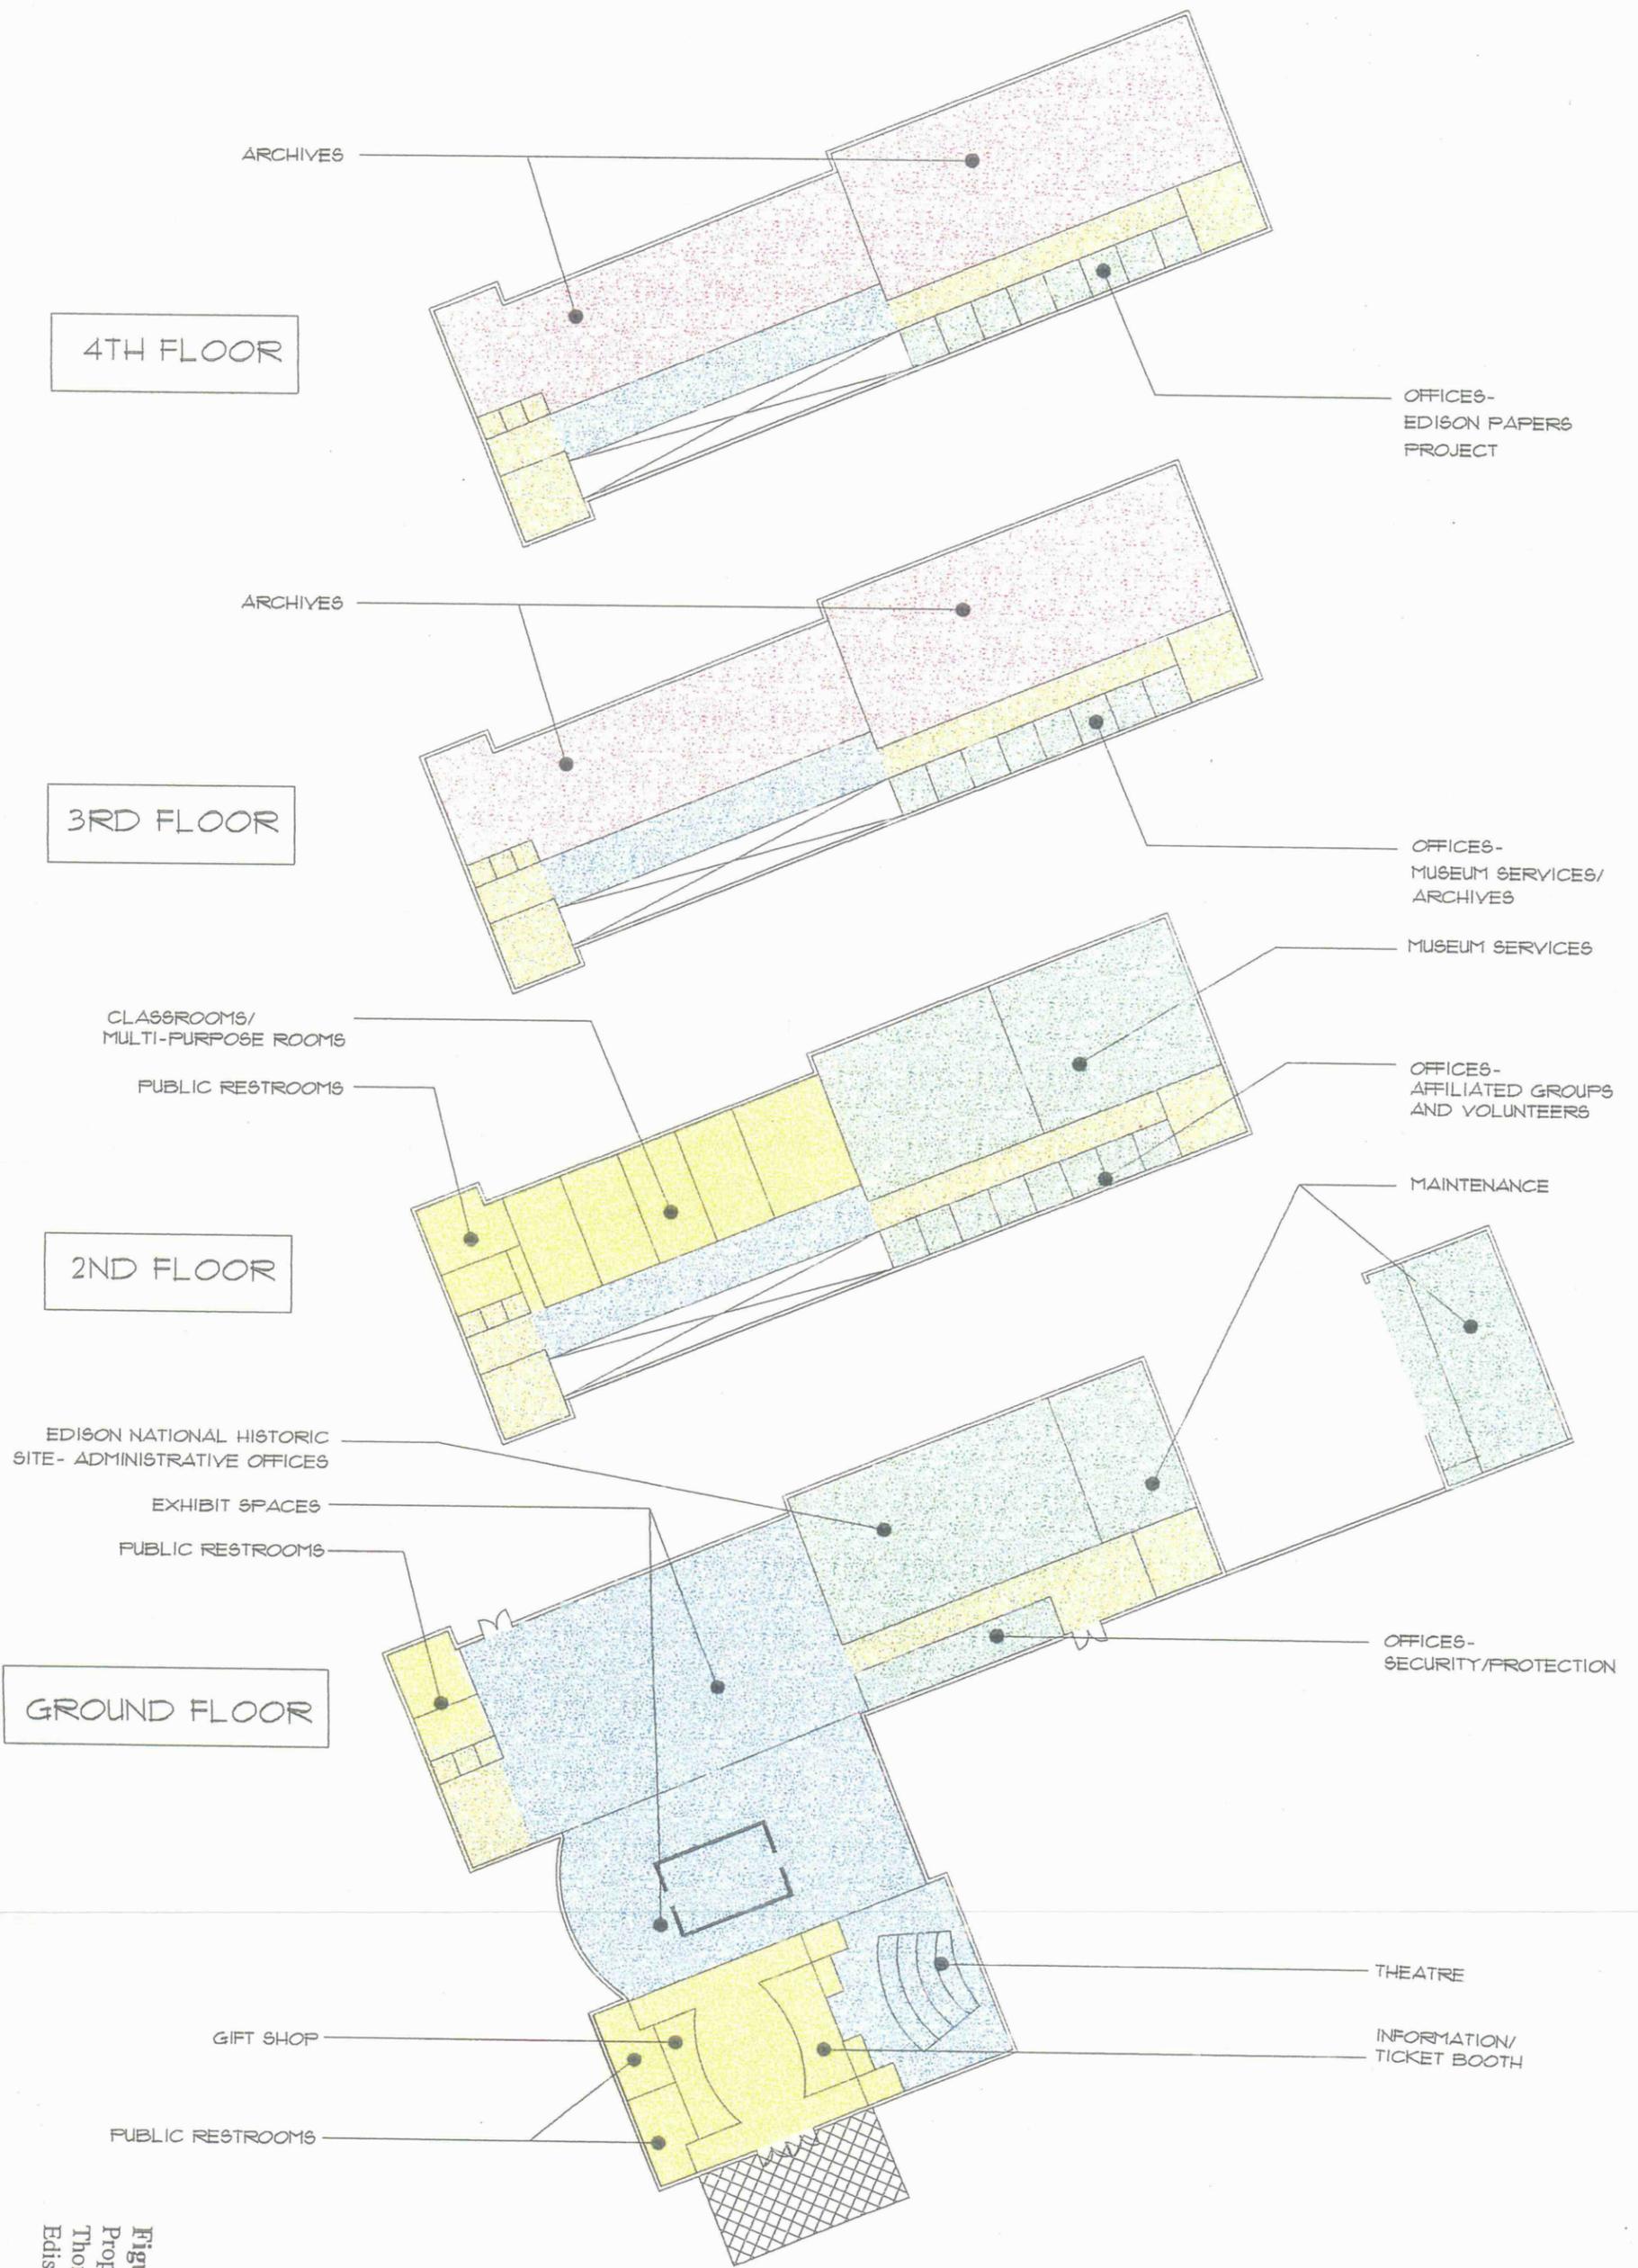
THOMAS ALVA EDISON RESOURCE CENTER

Figure 17
Proposed Space Use
Thomas Edison Resource Center
Edison NHS- Lab Unit

The first floor of the building will incorporate visitor services, administrative office space, and the maintenance shop. (Figure 17) Visitor services will be grouped in the one and one half story section, with a theater/lecture hall, information center, gift shop and restrooms grouped around a gathering space. Adjacent to this will be space which can be devoted to either permanent or changing exhibits. This space will surround Building #33, the Blue Amberol Vault, which can be incorporated into the exhibit. At the east end of the building is the maintenance shop, including an outdoor yard that is isolated from the site by a masonry wall. The remainder of the floor will serve as office space for the administrative and security staffs.
