DEVELOPMENT CONCEPT/ENVIRONMENTAL ASSESSMENT

EDISON NATIONAL HISTORIC SITE

West Orange, New Jersey

January 1998

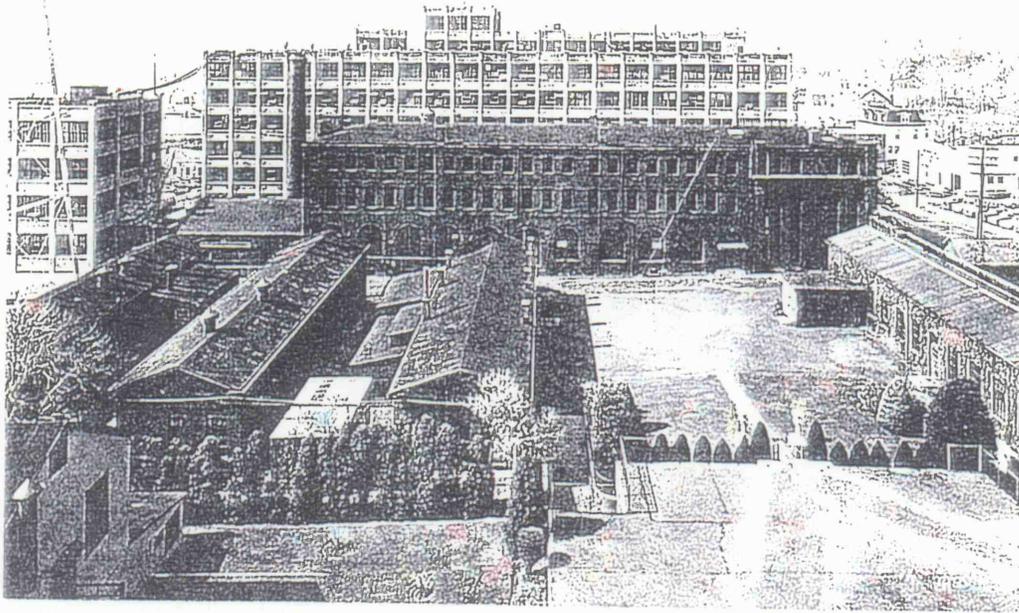
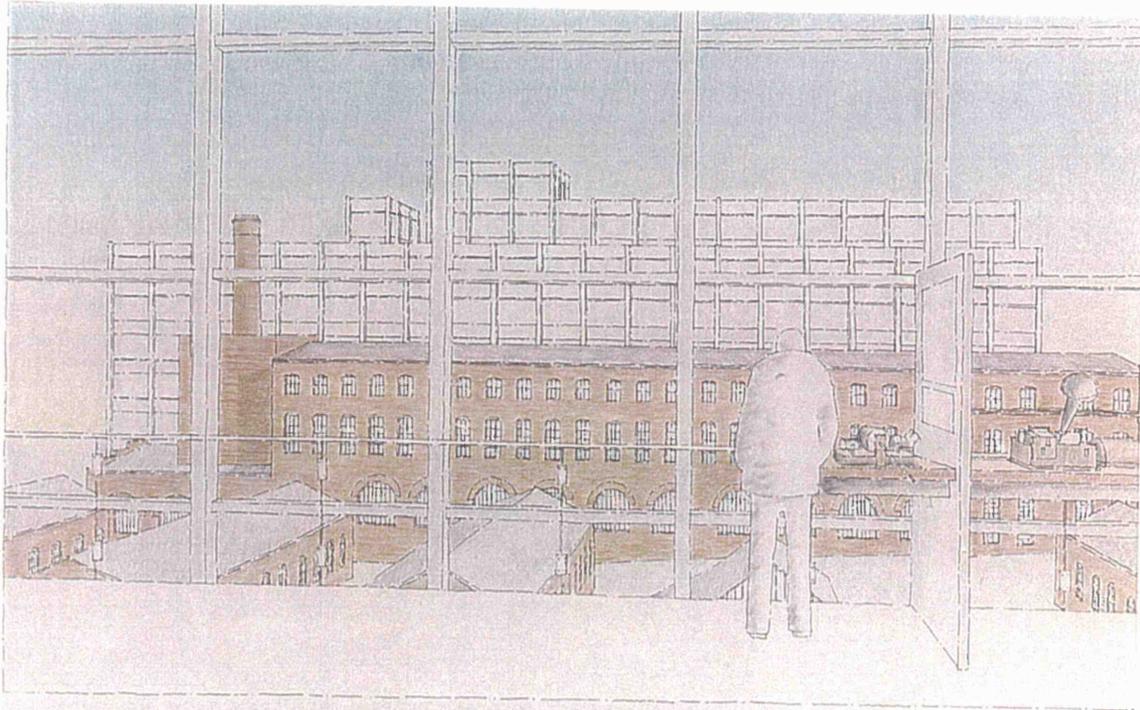
Figures 18 (top) and 19 (bottom)

"VIEW OF HISTORIC BUILDINGS"

The second floor includes classrooms and multi-purpose space as well as office space for the museum services and interpretive staff. The third and fourth floors are devoted primarily to archival storage and curatorial staff. Visitors will be offered the opportunity to visit these floors to view the collection through interior windows and to view the historic site from this raised vantage point. (Figures 18 and 19) In addition to the National Park
