Historic Structure Report

**THE HOUSE AT GLENMONT  
HISTORIC STRUCTURE REPORT**

**Edison National Historic Site  
West Orange, New Jersey**

**VOLUME II**

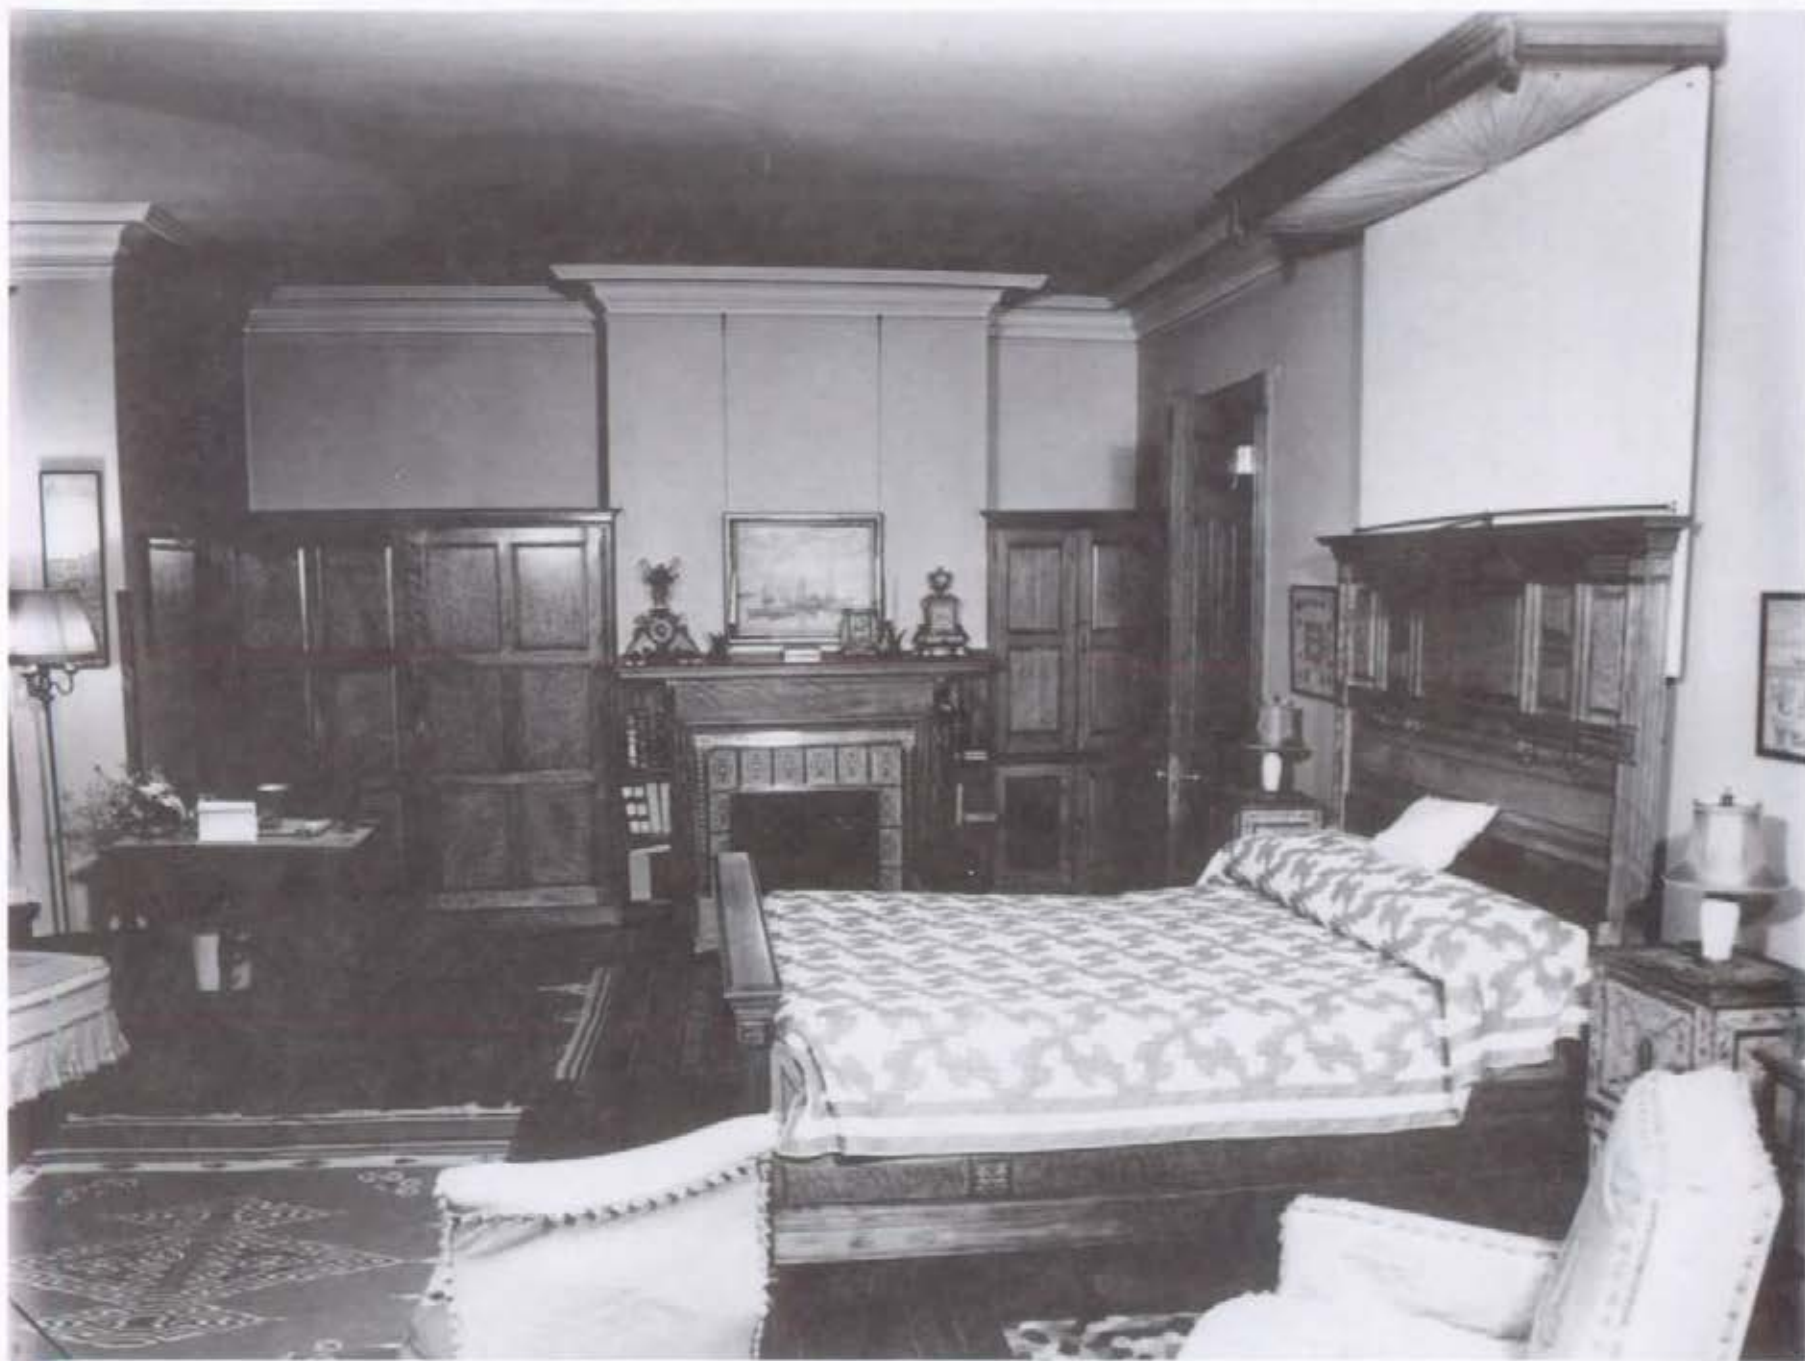
Figure 118. South Room (Room 200), looking north, 1947.

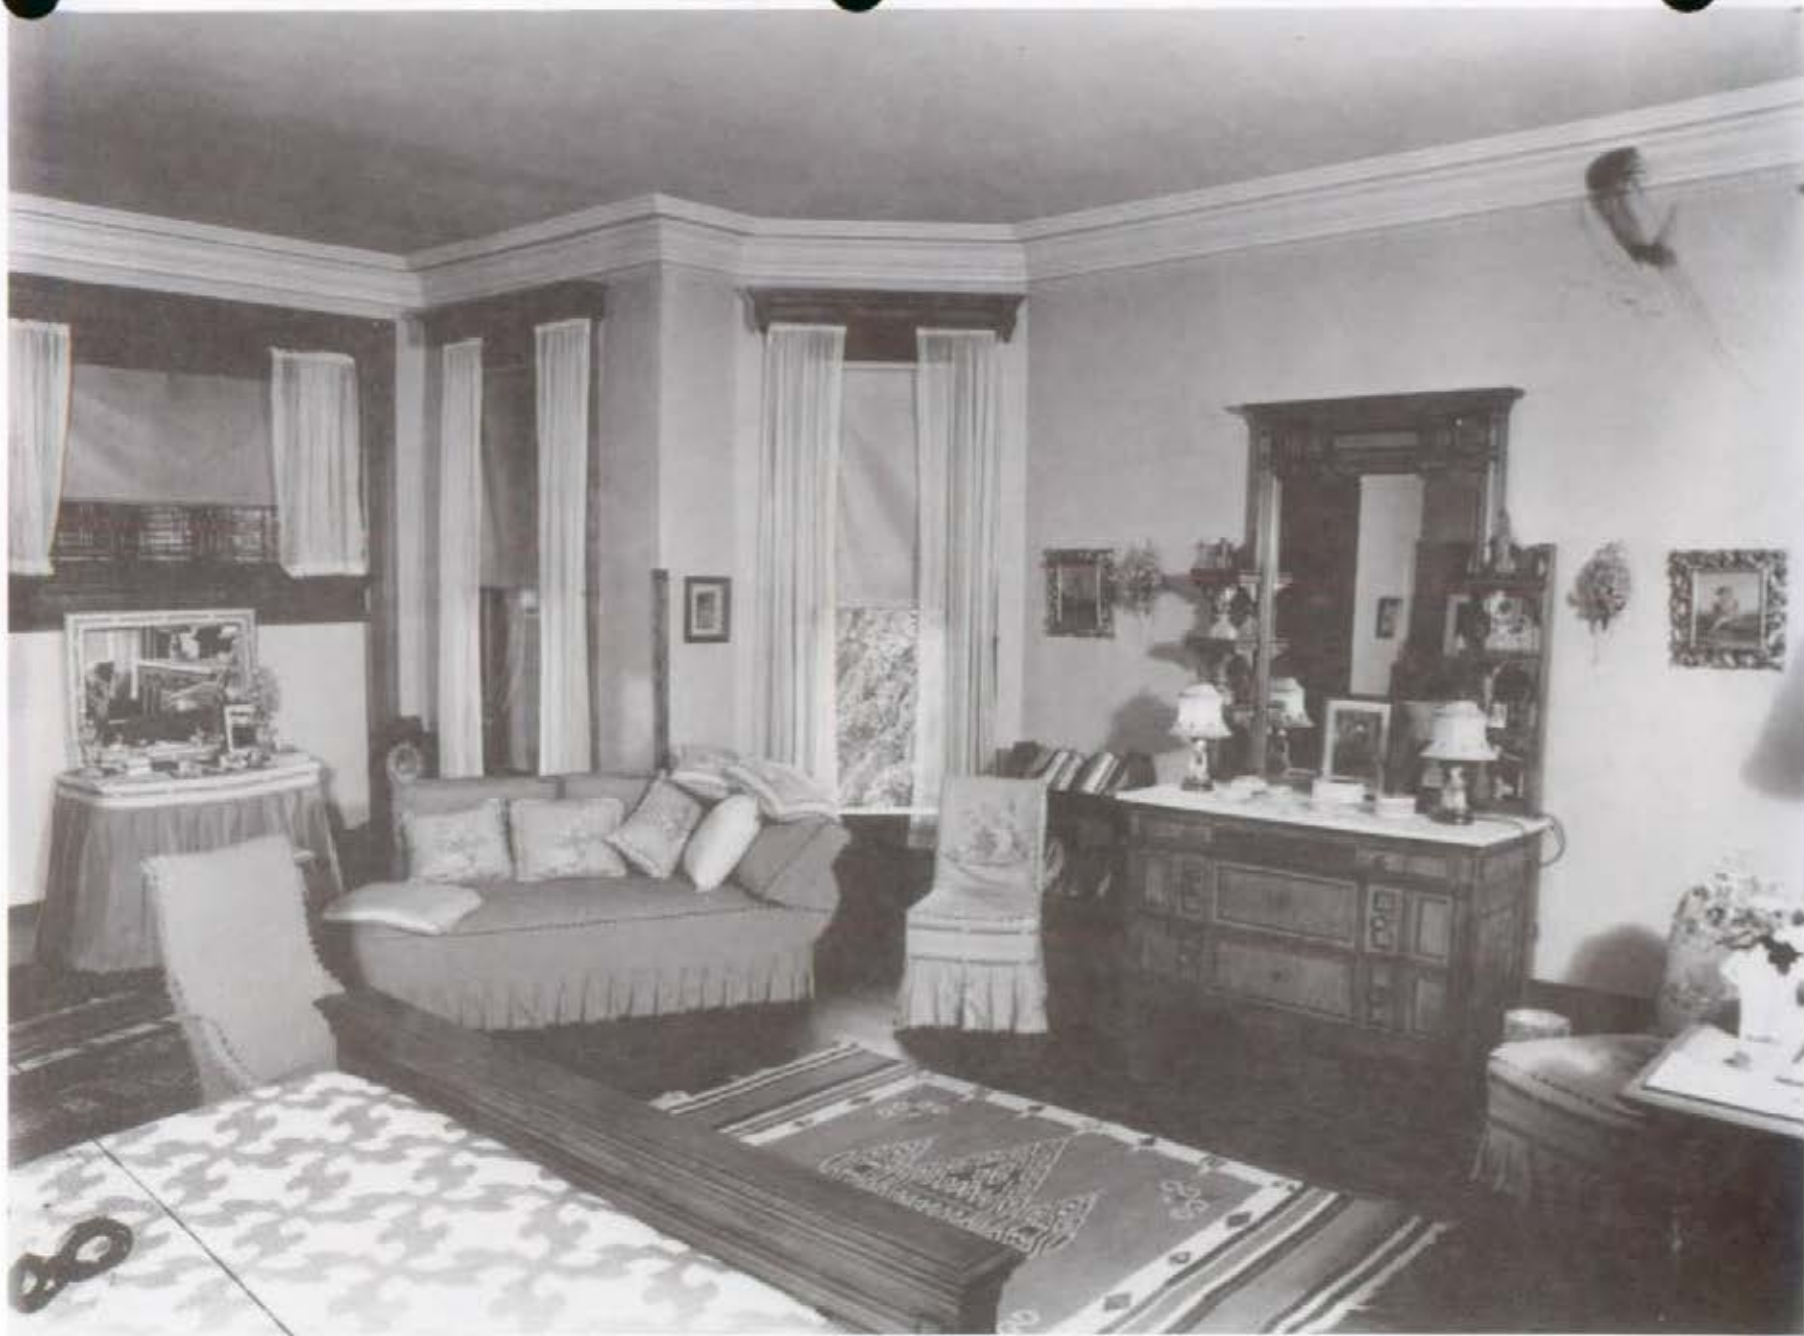
Figure 119. South Room (Room 200), looking southwest, 1947.

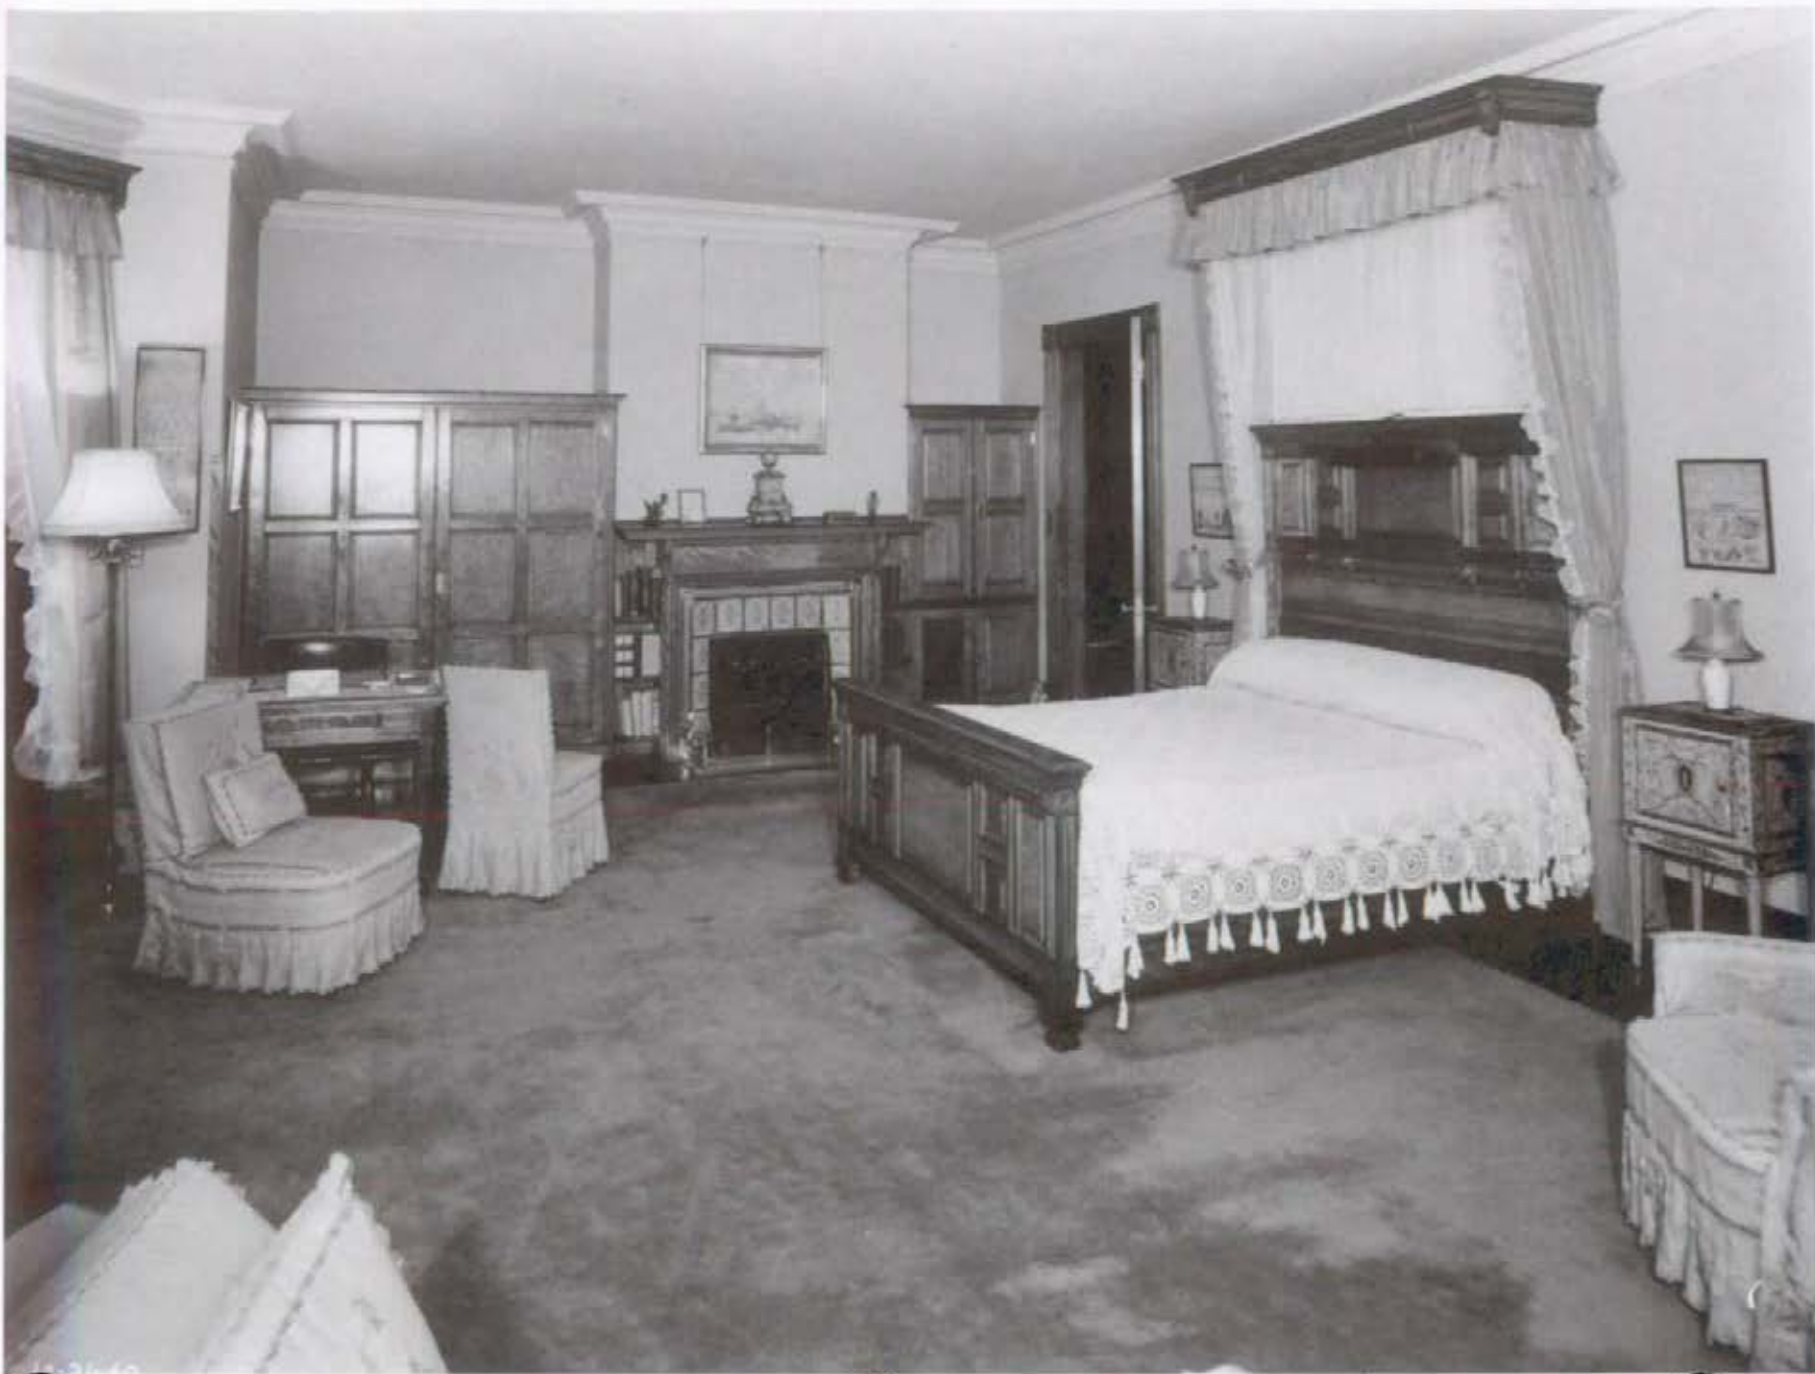
Figure 120. South Room (Room 200), looking northeast, 1960.

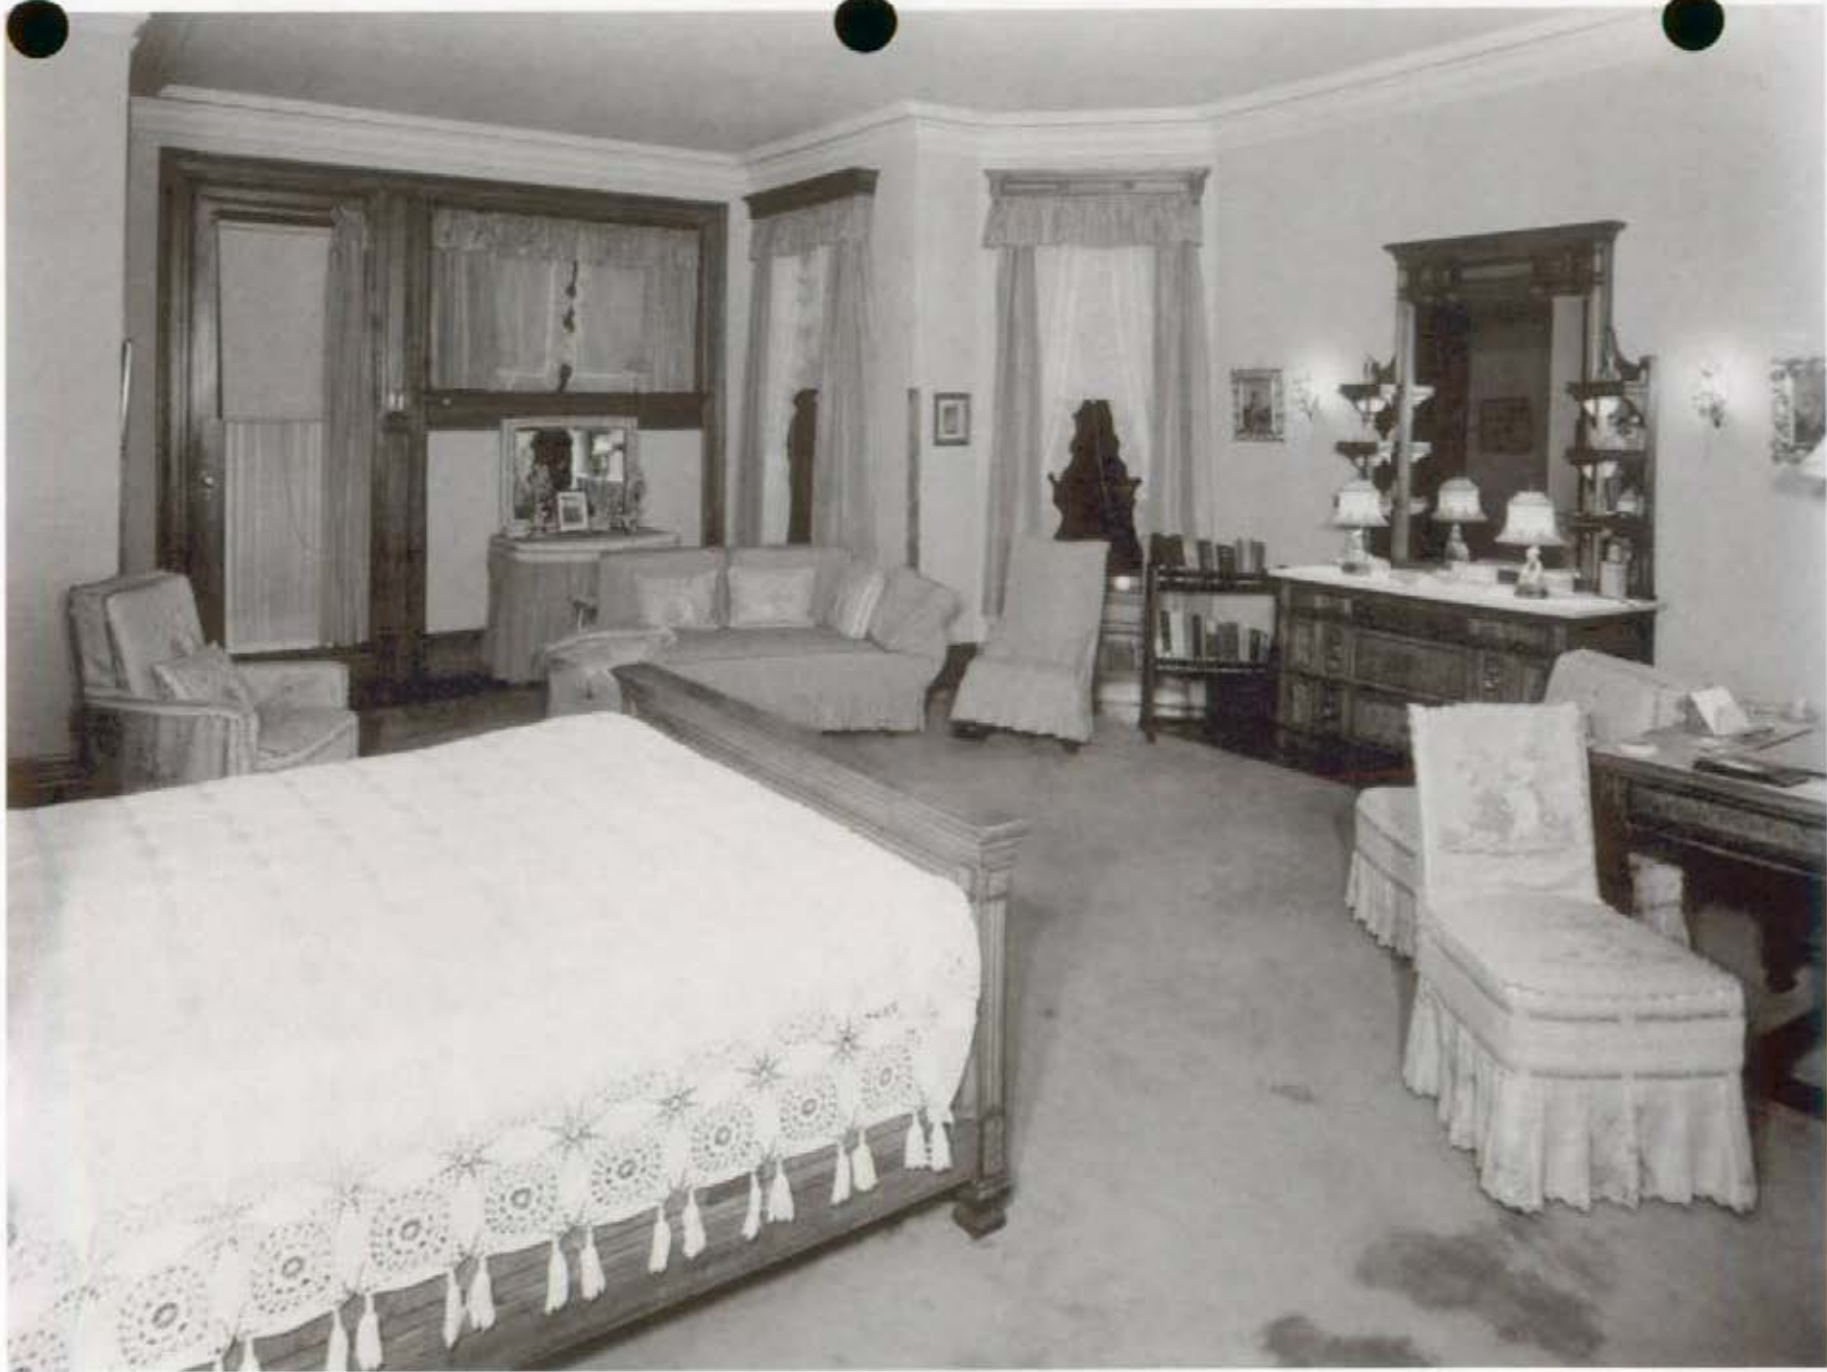
Figure 121. South Room (Room 200), looking southwest, 1960.

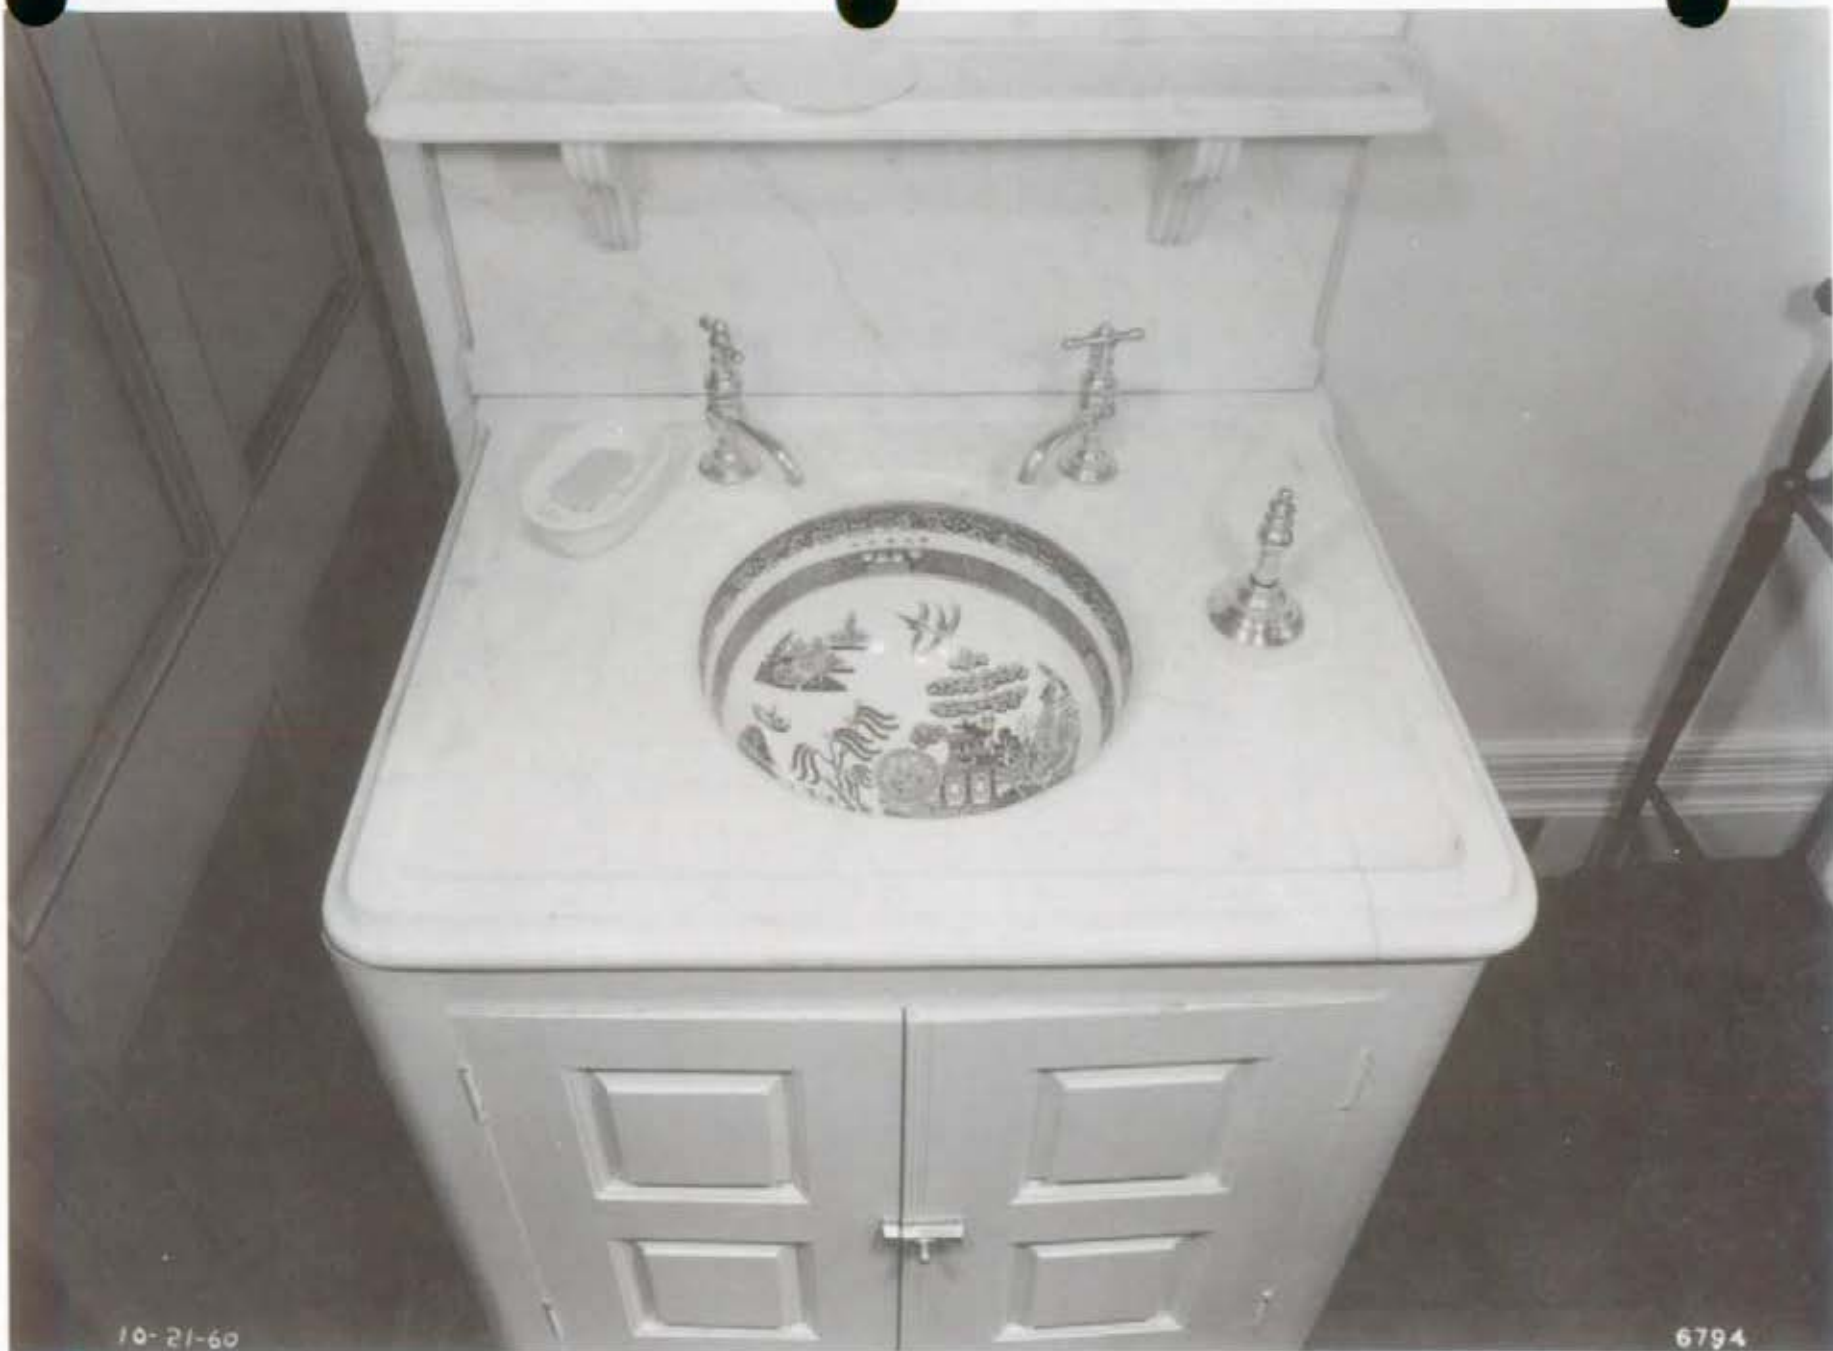
Figure 181. Sewing Room (Room 305), detail of marble-counter lavatory at the west wall, 1960.

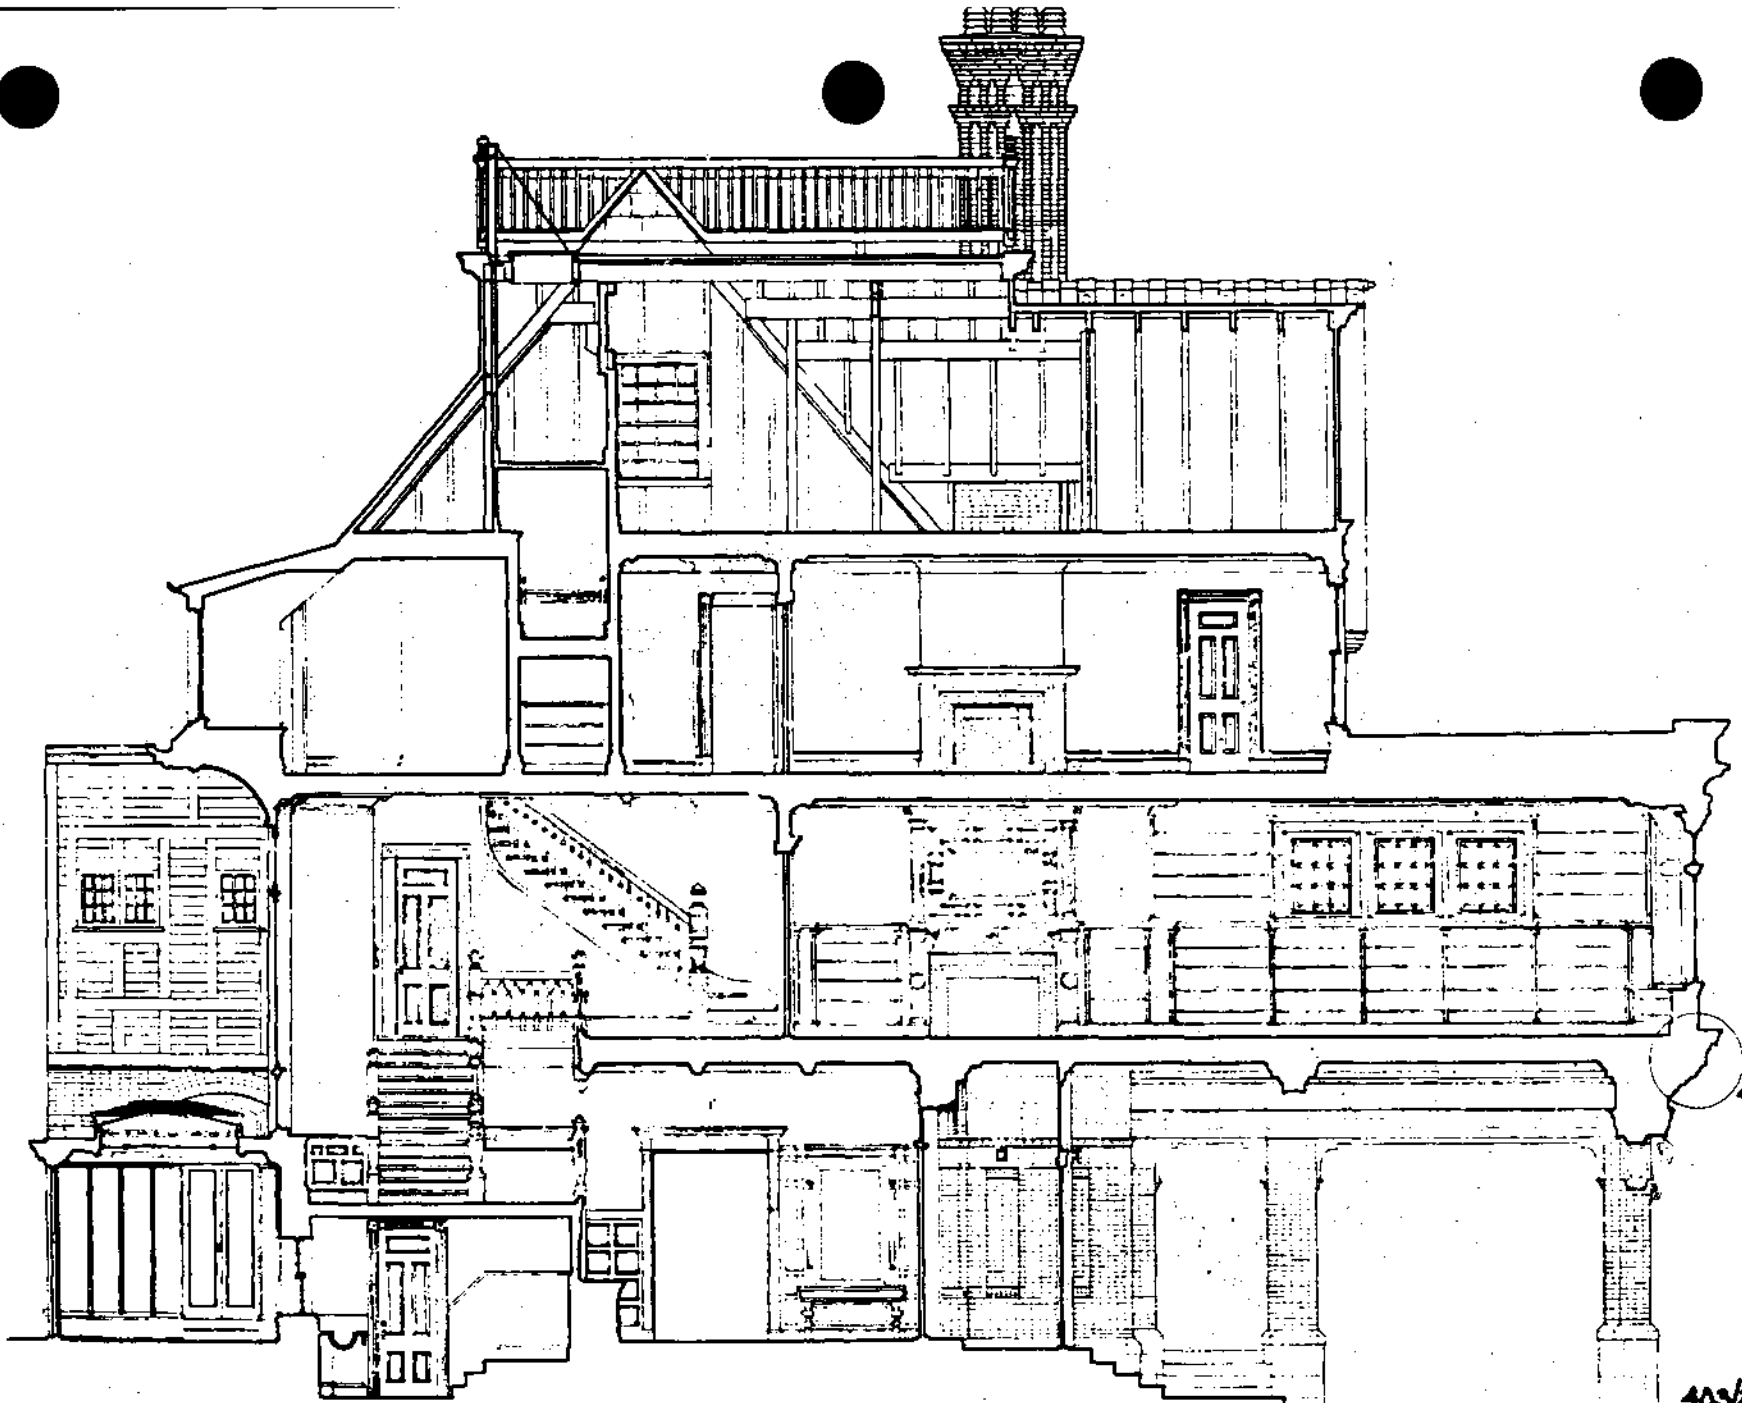
SECTION D-D

ADAPTED FROM NPS DRAWING NMS'ED1 3001 SHEET 9  
DRAWN BY JOHN SHAW & JOHN WHITE, 1962

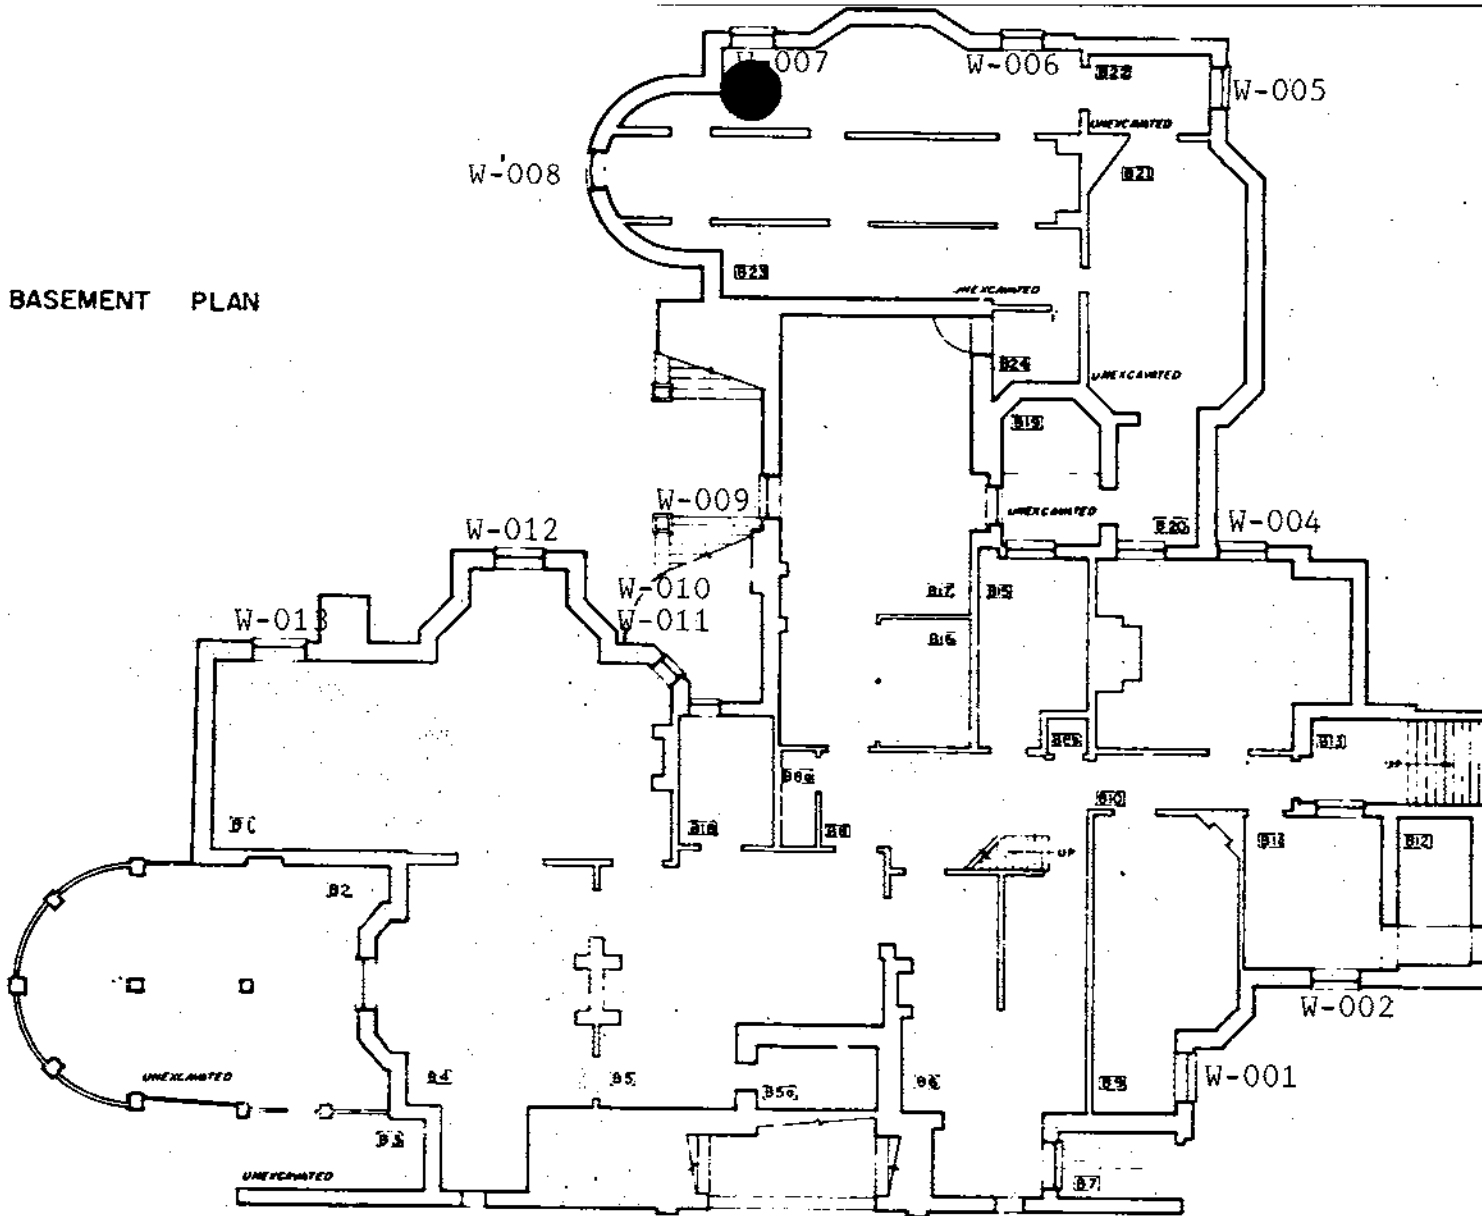
BASEMENT PLAN

Following the floor plans are window charts that describe each individual window. Descriptions of the windows' interior features can be found in the report within the discussions of individual rooms. Descriptions of the doorways can be found in the section entitled "Exterior Elements: Doorways."
