Monitoring and Preservation

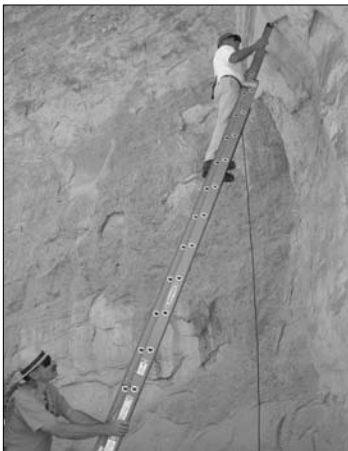
The large crack just beyond marker #12 is believed to be stable, but it is monitored for any movement. To measure the crack, four bolts must be accessed by ladder. The bolts have been placed on opposite sides of the joint to serve as reference points. Park staff periodically climb up the ladder and record the distances between the bolts.

Another method the park uses to monitor this joint is a tilt meter. It was installed to record changes in the inclination of the monolith by measuring degrees of

tilt. The instrument is located high on the cliff near marker #13. Rangers connect a recording device to the wire leading from the instrument to obtain the inclination in two directions.

Since Fall 2000 when the current measuring devices were installed, the data suggest that the rock does move a bit, particularly in winter and spring with the freezes and thaws, but only in the range of tenths of millimeters. Most of the movement is in and out, as opposed to an outward trending movement. The tilt meter indicates no more than $1/4^{\circ}$ of increased lean in the last 36 months. The monolith seems stable for now, but monitoring will continue.

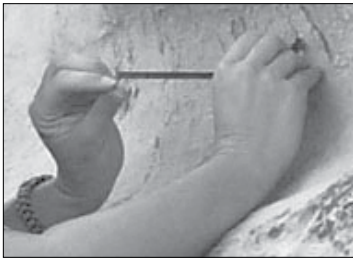
The inscriptions are carved into sandstone that is very weakly cemented—the sand particles are held together only by clay between the grains. The poor cementation of the rock made it easy to carve inscriptions, but it is also the reason the rock is deteriorating quickly.

Inscription Rock is eroded mechanically and chemically. Mechanical attack includes expansion by freeze/thaw and wet/dry cycles, growth of lichens, burrowing by animals and insects, and abrasion by wind and water. Chemical weathering includes the interaction of the rock with the chemicals in the ground water, which can lead to erosion.

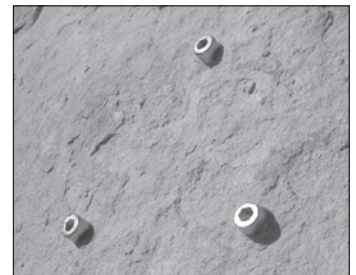
To monitor the progress of natural disintegration, the Park Service has photographic and sketched records of the appearance of the inscriptions. For quantitative measurements of erosion, small reference pins were installed in several places. The distance from the pins to the surface of the rock is measured. In the five years of measuring, the rock face has, in places, eroded about 1/32 inch (0.8 mm).
