PASO POR AQUI: A HISTORY OF SITE MANAGEMENT AT EL MORRO NATIONAL MONUMENT, NEW MEXICO, U.S.A.

Antoinette Padgett and Kaisa Barthuli

Abstract: The subject of this paper is past and present site management and conservation efforts at El Morro National Monument in New Mexico. Interpreting the three distinct cultures of the area has presented a challenge for management. In addition to this interpretation, present site management focuses upon preserving the area's cultural heritage, including engravings and inscriptions found on the sandstone bluff that dominates the landscape. Also emphasised is the importance of comprehensive site documentation and archival storage of materials.

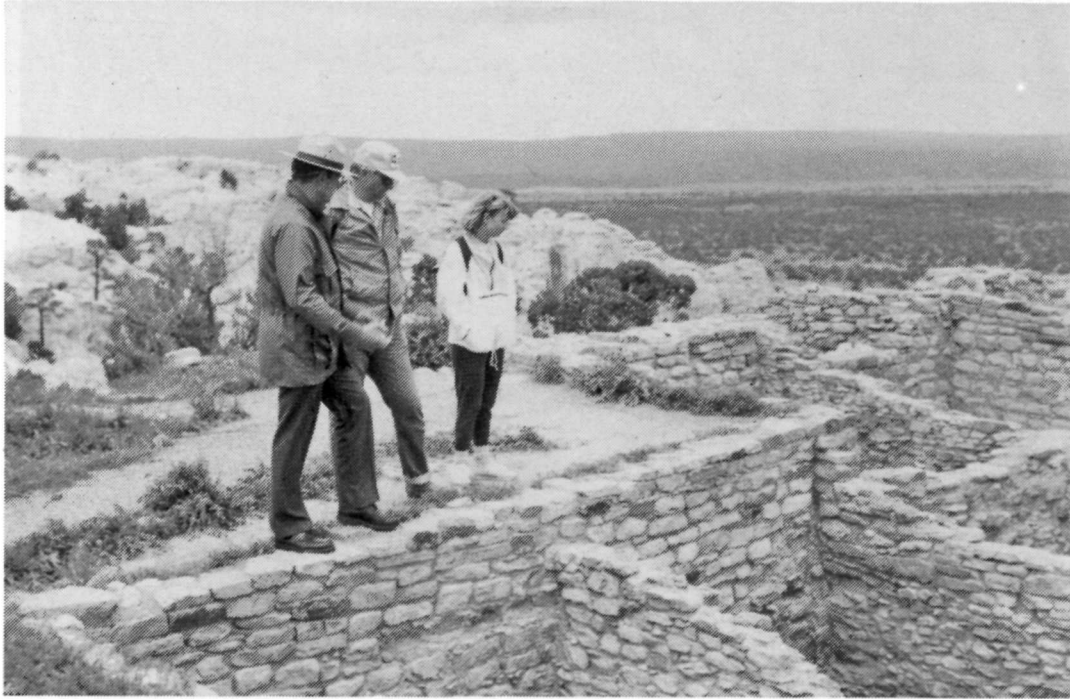
Plate 2. Superintendent Reed Detring of El Morro National Monument and geologists George Austin and Tanya Baker from the New Mexico Bureau of Mines and Mineral Resources examine the prehistoric pueblo village of Atsinna at the top of Inscription Rock.

According to the Statement for Management for El Morro (National Park Service 1992: 6), issues concerning present site management encompass the following: protection and preservation of the inscriptions and other cultural resources, including the prehistoric pueblo villages of Atsinna and North Ruin located at the top of the rock outcrop (Plate 2); management of the El Morro collections; repair of trails and preservation of the natural setting.

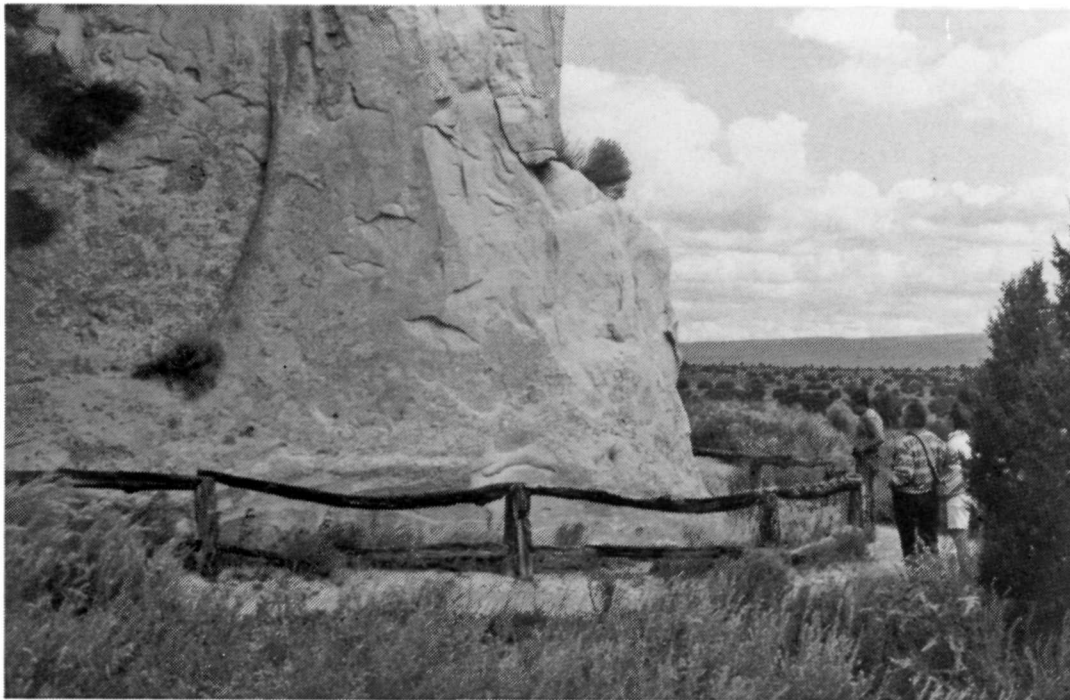
Plate 3. A wooden barrier fence separates visitors from the inscriptions.

Strategically-placed signs warn visitors against defacing the rock, and wooden fences serve as a barrier between the trail and the inscriptions (Plate 3). Although there are not enough rangers to patrol the whole trail system, relatively little vandalism occurs; graffiti is promptly removed to prevent further occurrence. The present practice of staff at El Morro, however, is to remove any new graffiti with a wire brush (Sievers 1970: 3; National Park Service 1992: 12). This method can be detrimental when used in close proximity to inscriptions or rock images, especially in areas where the rock surface is unstable. Other more appropriate methods, such as poulticing or disguising graffiti (Thorn 1991a: 74-5, 1991b: 57-61) were discussed with Monument staff.

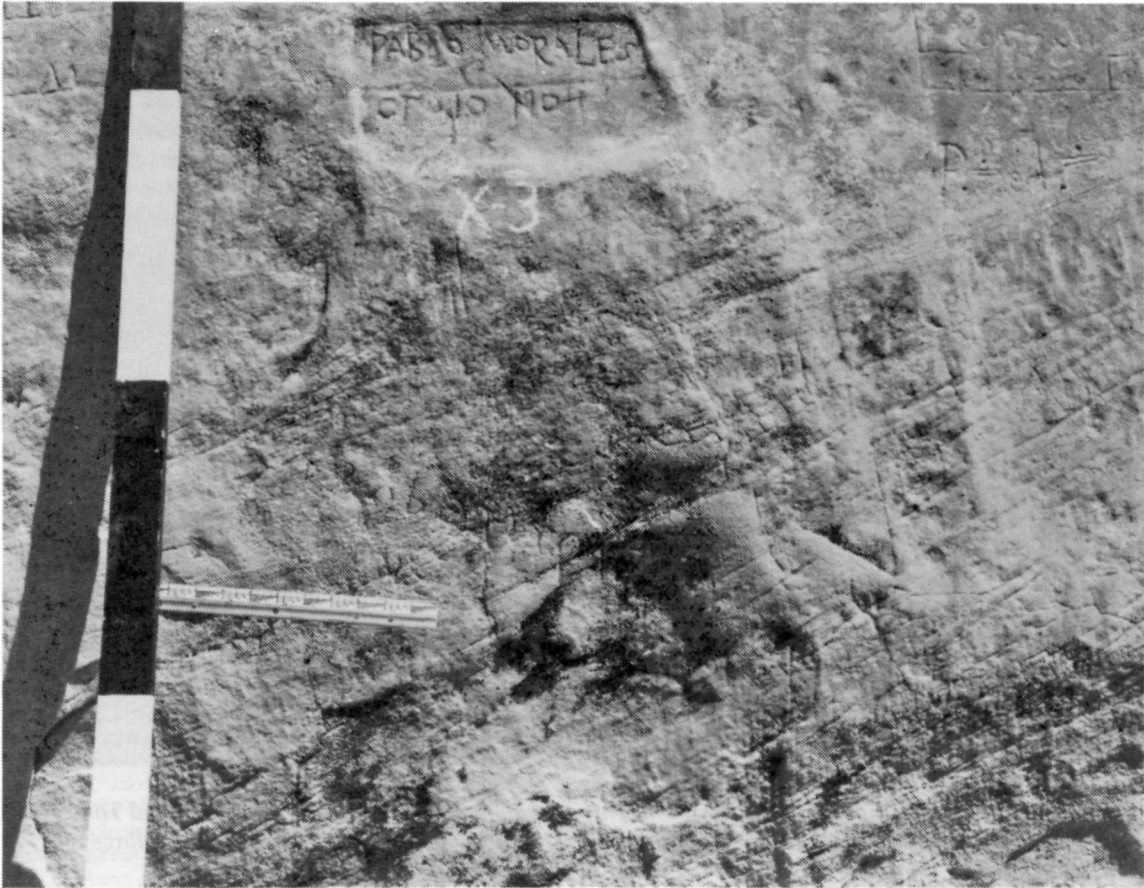
Plate 4. Inscription of Pablo Morales, photographed by Irving McNeil Jr in 1955 (photograph courtesy of El Morro National Monument).

The El Morro National Monument archives contain numerous boxes of photographs and negatives from the late 1880s to the present day; these were made by various photographers, including author Charles F. Lummis. While representing a large resource of information about the condition of particular inscriptions and painted and engraved panels in the past, they are neither catalogued nor stored archivally. Also included in this collection is a comprehensive report by Martin (1986) listing all known rock picture sites at El Morro on State of New Mexico site record forms. The most useful set of photographs in the collection was a survey of the inscriptions, compiled in 1955 by Irving McNeil Jr (then Superintendent of El Morro), with assistance from Channing Howell. This survey was the first systematic record of all the inscriptions known at that time. Inscriptions were photographed at intervals and lettered brass markers were driven into the base of the rock to denote sections. Each photograph was numbered and lettered correspondingly, and notes were transcribed onto index cards, numbering over one thousand. The brass markers are still in place and are used today for denoting specific inscriptions. This photographic survey was invaluable as baseline data for comparing the condition of the inscriptions between 1955 and 1992 (Plates 4 and 5).

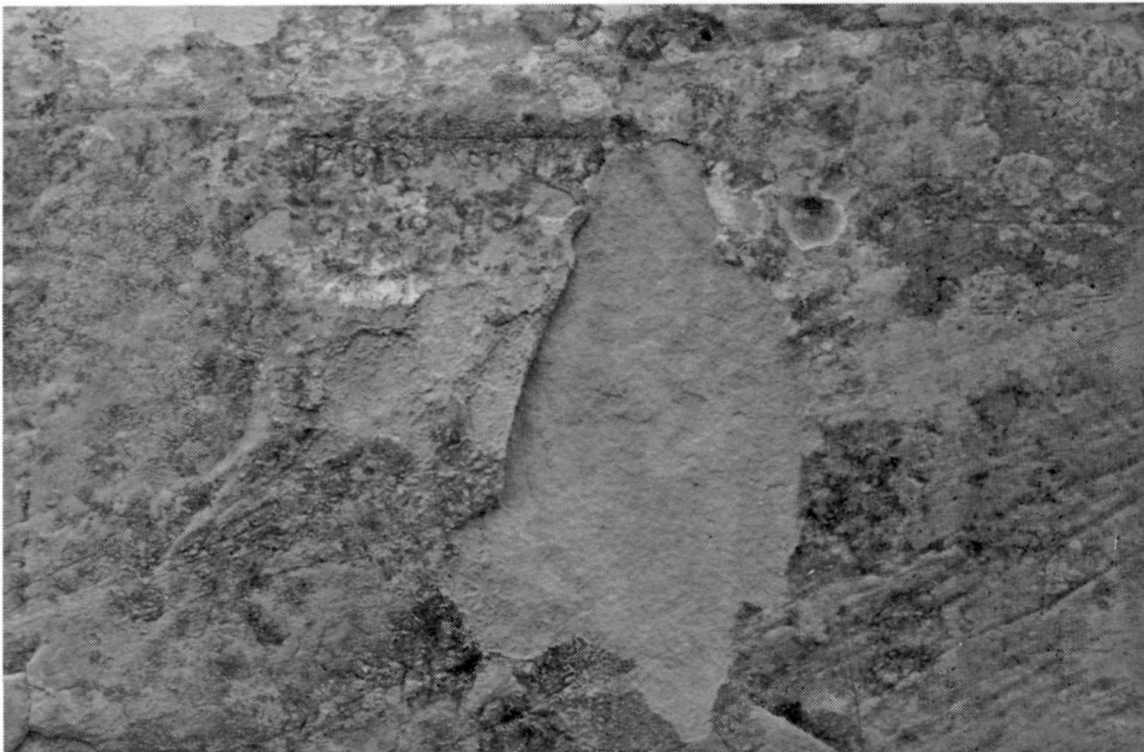
Plate 5. Inscription of Pablo Morales, photographed by Kaisa Barthuli in 1992. Note the degree of spalling of the rock surface.

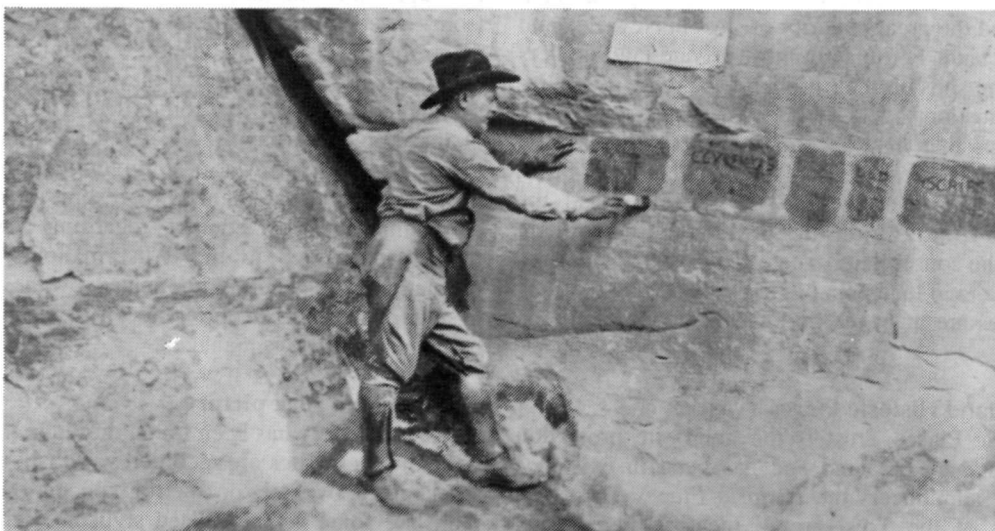
Plate 8. El Morro Custodian Evon Z. Vogt shown testing various consolidants in 1925 over the words, 'Colourless coverings save old inscriptions'. These carved words can still be seen today (photographer unknown, photograph courtesy of El Morro National Monument).

As early as 1925, various consolidants were tested and used on inscriptions at El Morro. A trial area was found during this project and the words carved by Custodian Evon Vogt, 'Colourless coverings save old inscriptions' can still be seen (Plate 8). Five products were brushed onto the rock surface, each covering one of the words. The products used were 'Gar Kem', 'Super Por Seal', 'Glidden's Compound', 'Driwall' and 'Transview'. They were described as equally colourless (El Palacio 1926). 'Driwall', a paraffin solution that was developed by the United States Bureau of Standards, was chosen and used for several years (Vogt 1925). The treatment was described by Vogt (1934):
