HISTORIC RESOURCE STUDY
FORT DAVIS NATIONAL HISTORIC SITE

By
Jerome A. Greene

November 1986

U.S. Department of the Interior / National Park Service

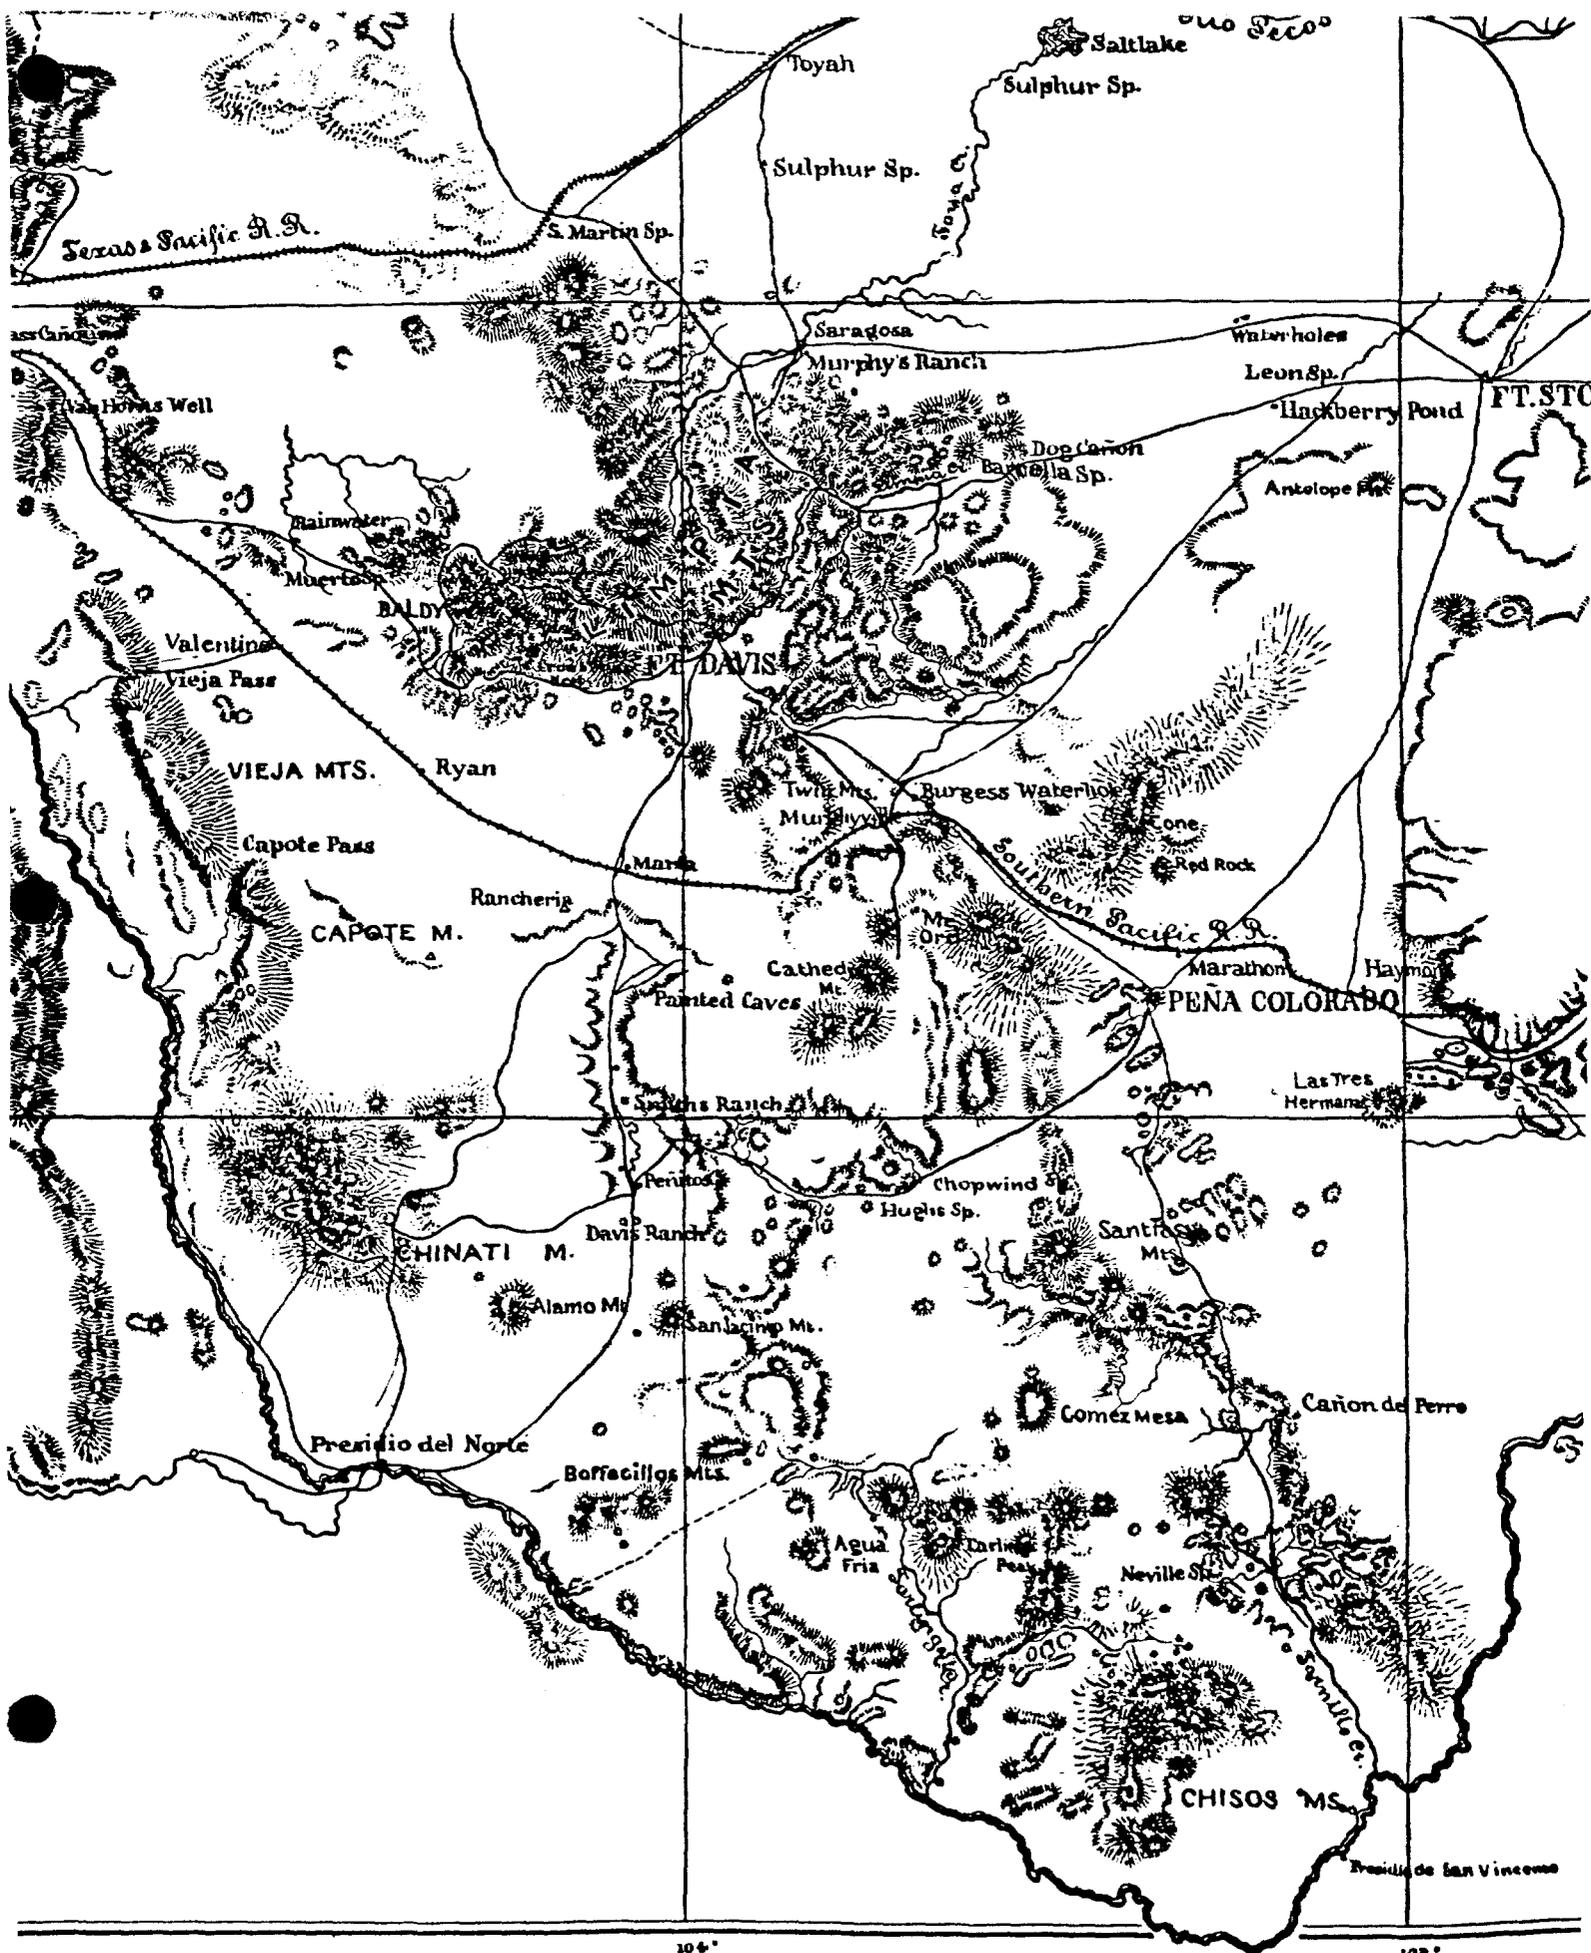
Illustration No. 10

Map of Fort Davis in 1856.

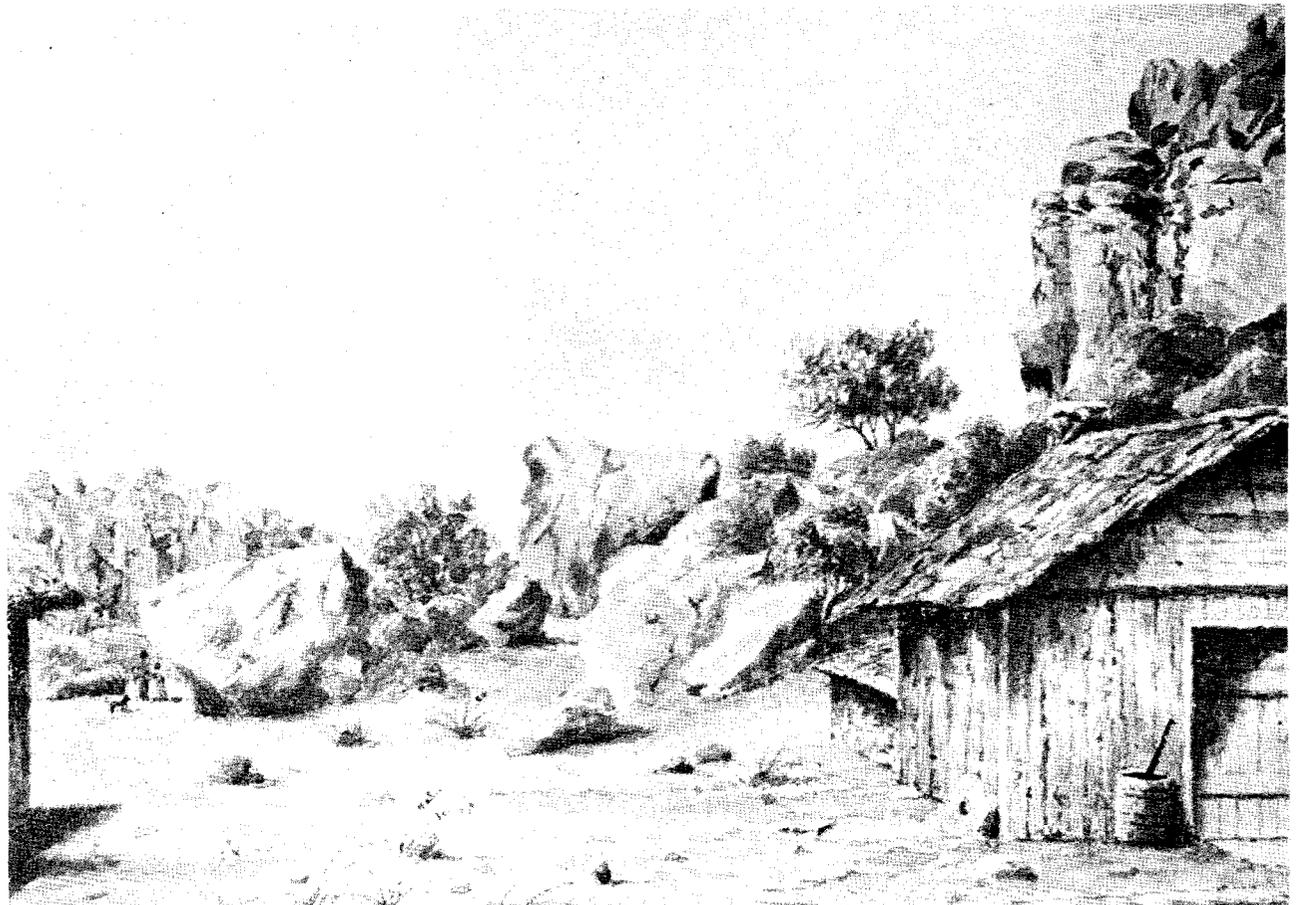
Illustration No. 15

View of the first Fort Davis, 1854-58, showing Barracks Unit No. 6 at left, the Guard House at left front, and the Sutler's Store at right. Note relative position of flagstaff.

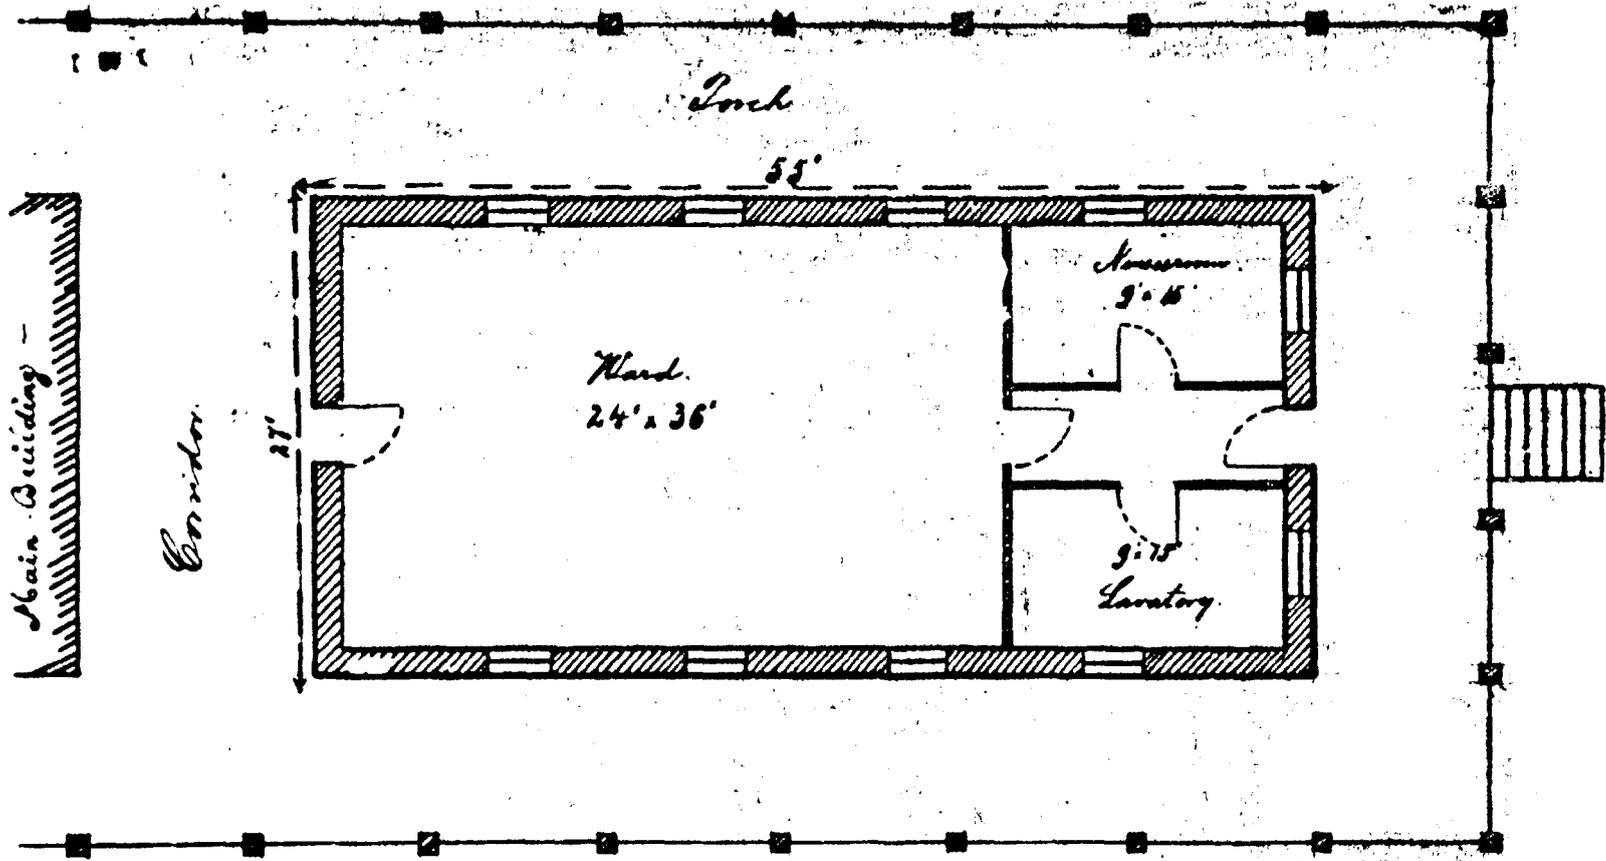
Scale: 1/4 inch = 1 Foot.

Ground Plan of additional Ward to Post-Hospital
Fort Davis, Texas.

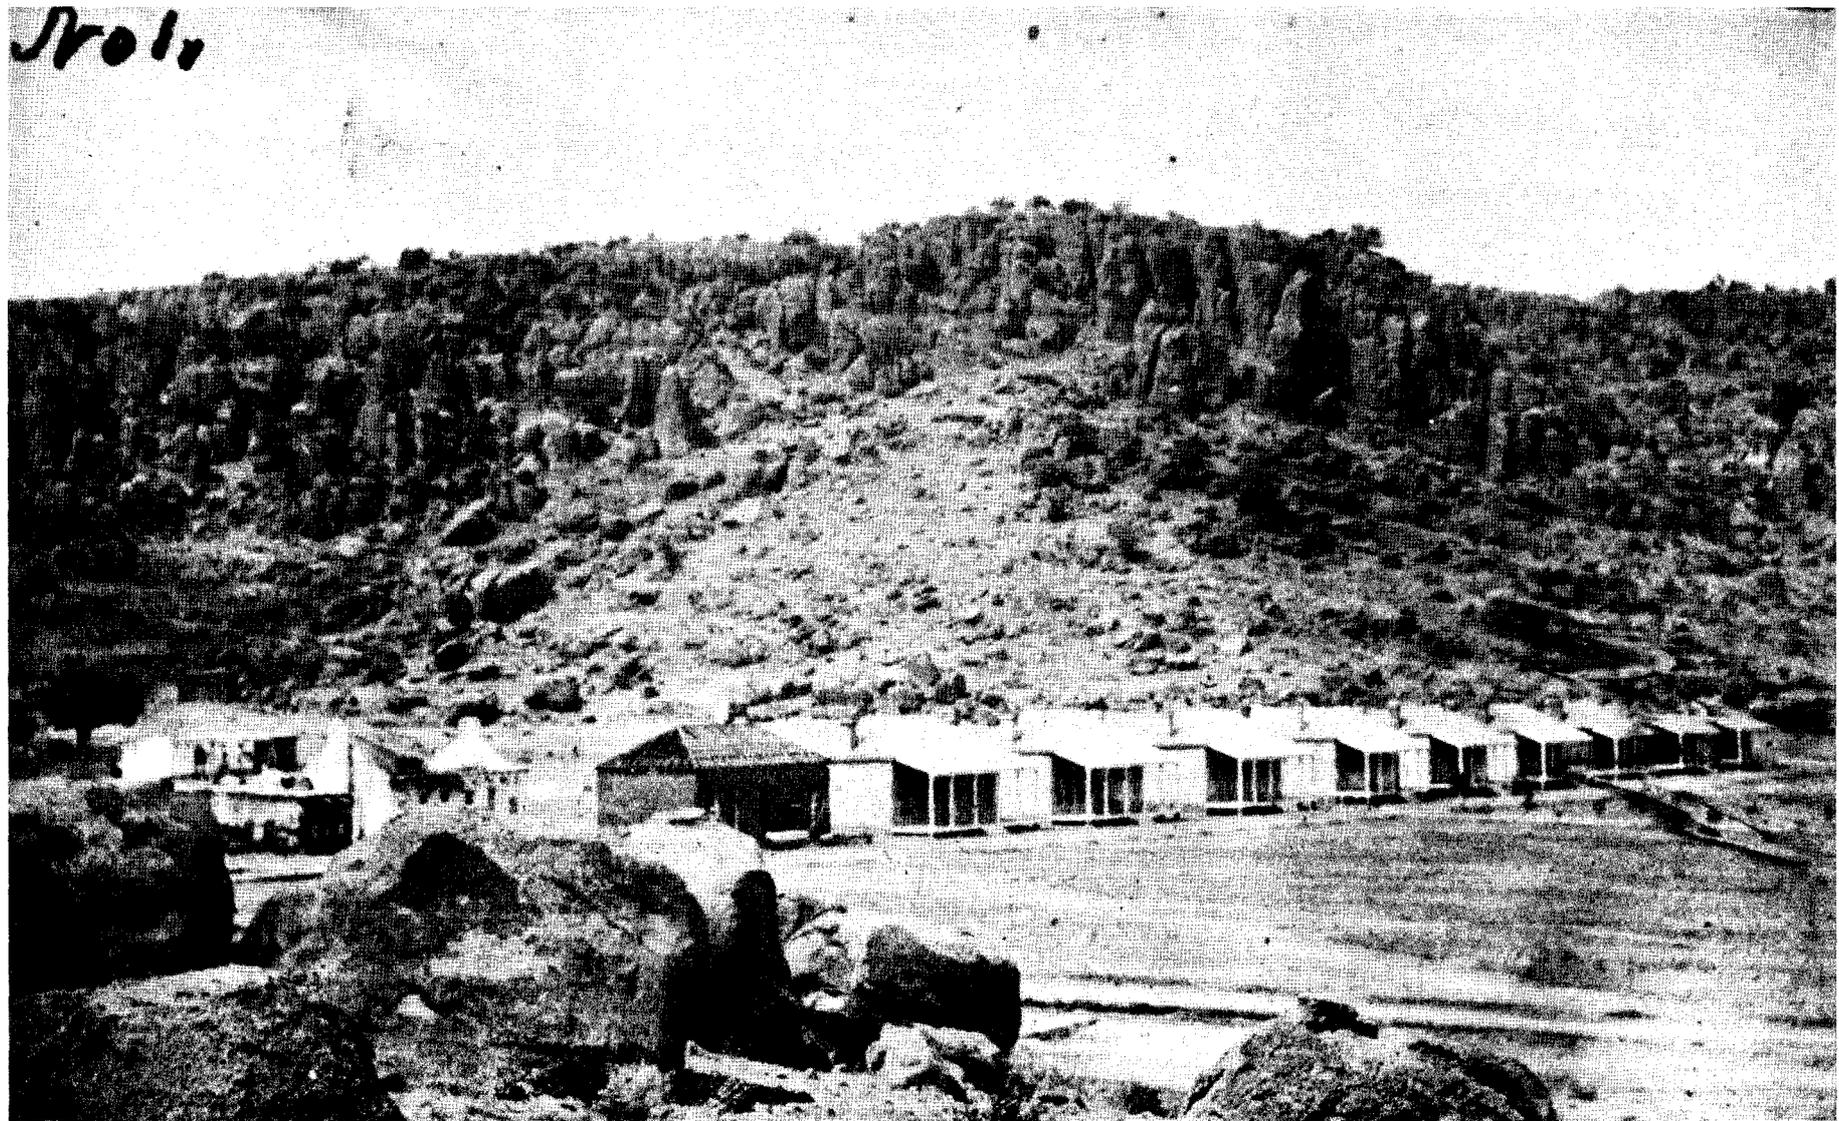
Illustration No. 40

Post of Fort Davis from the north in 1871. Building at left is Commanding Officer's and Adjutant's Office (HB-29). Foundation for hospital never completed is at right.

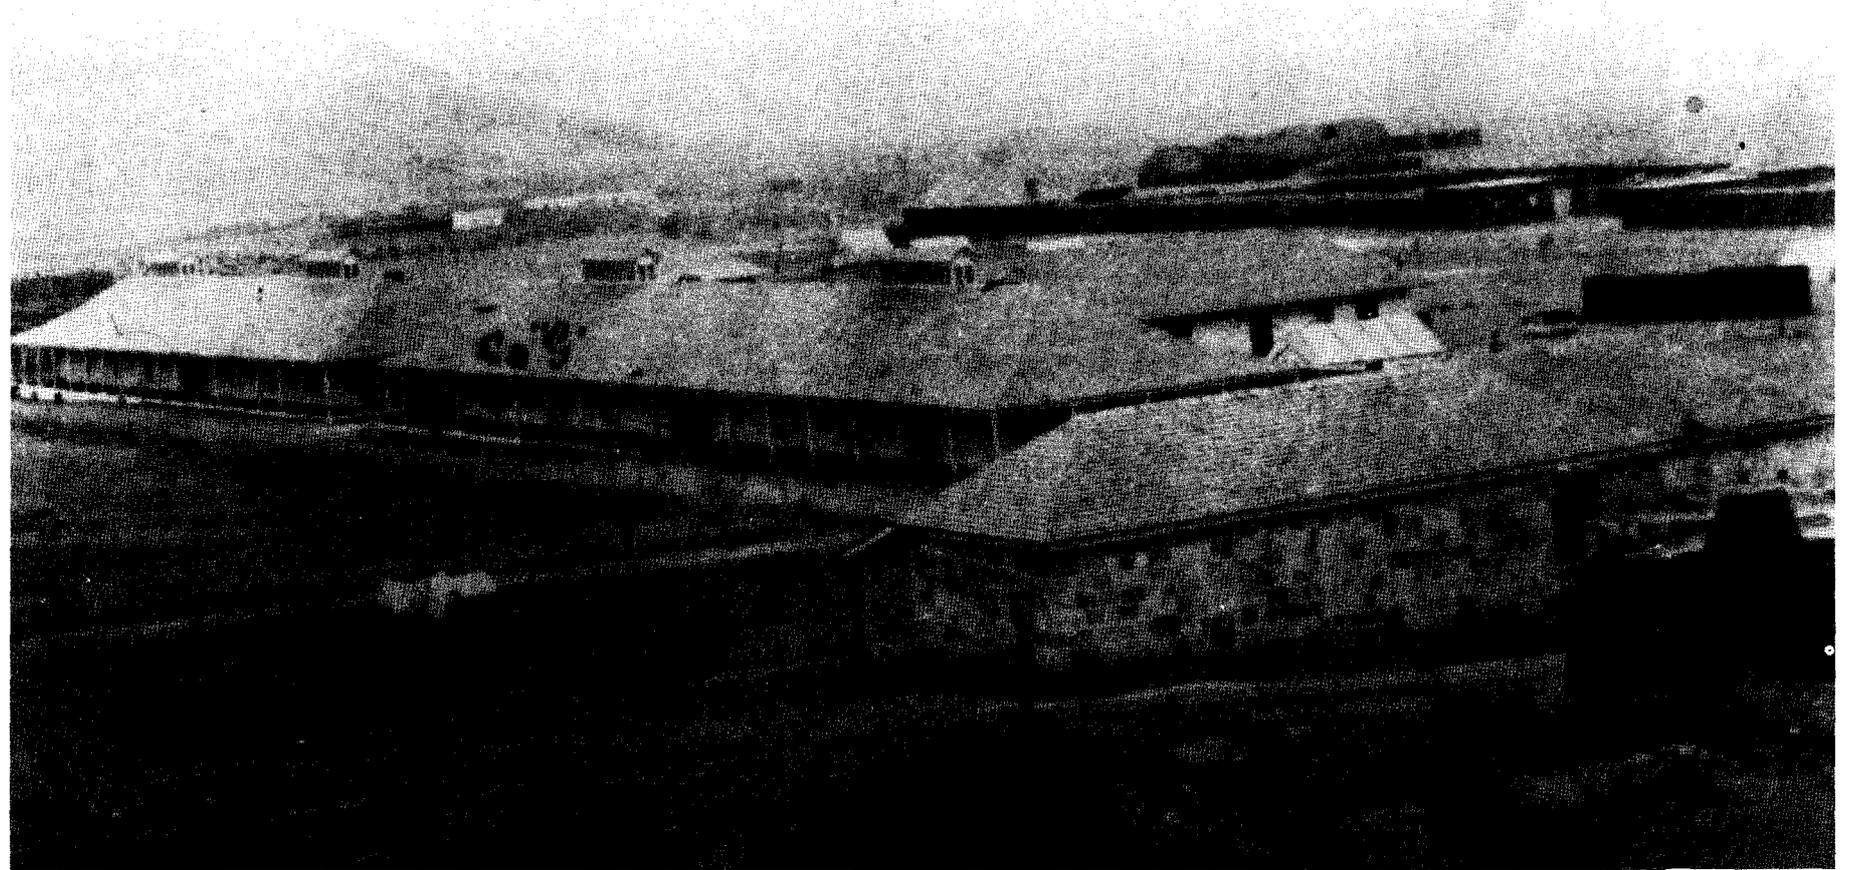
Illustration No. 44

Barracks HB-20 and HB-21, 1875. Unfinished Barracks HB-23 is at left, while the Quartermaster Corral (HB-40) and Cavalry Corral (HB-41) are in rear.

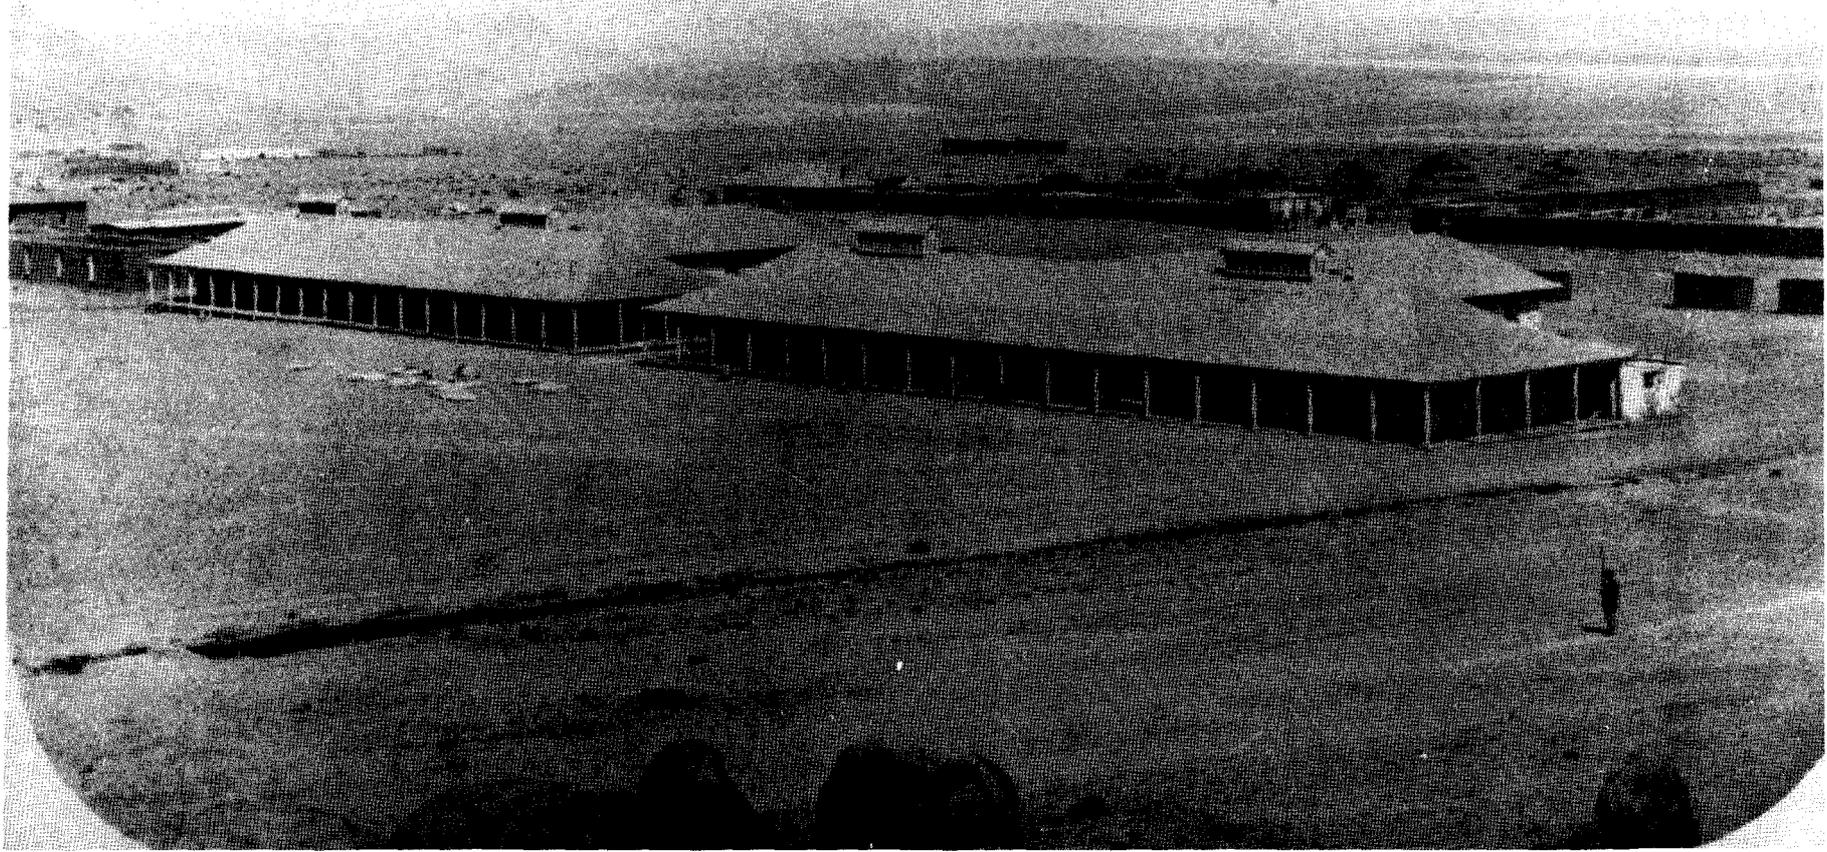
Illustration No. 45

View of post ca. 1875. Trader's Store (HB-49) is at right, behind first Guard House. Barracks HB-20 and HB-21 are at center. Unfinished barracks HB-22 and HB-23 appear at left.

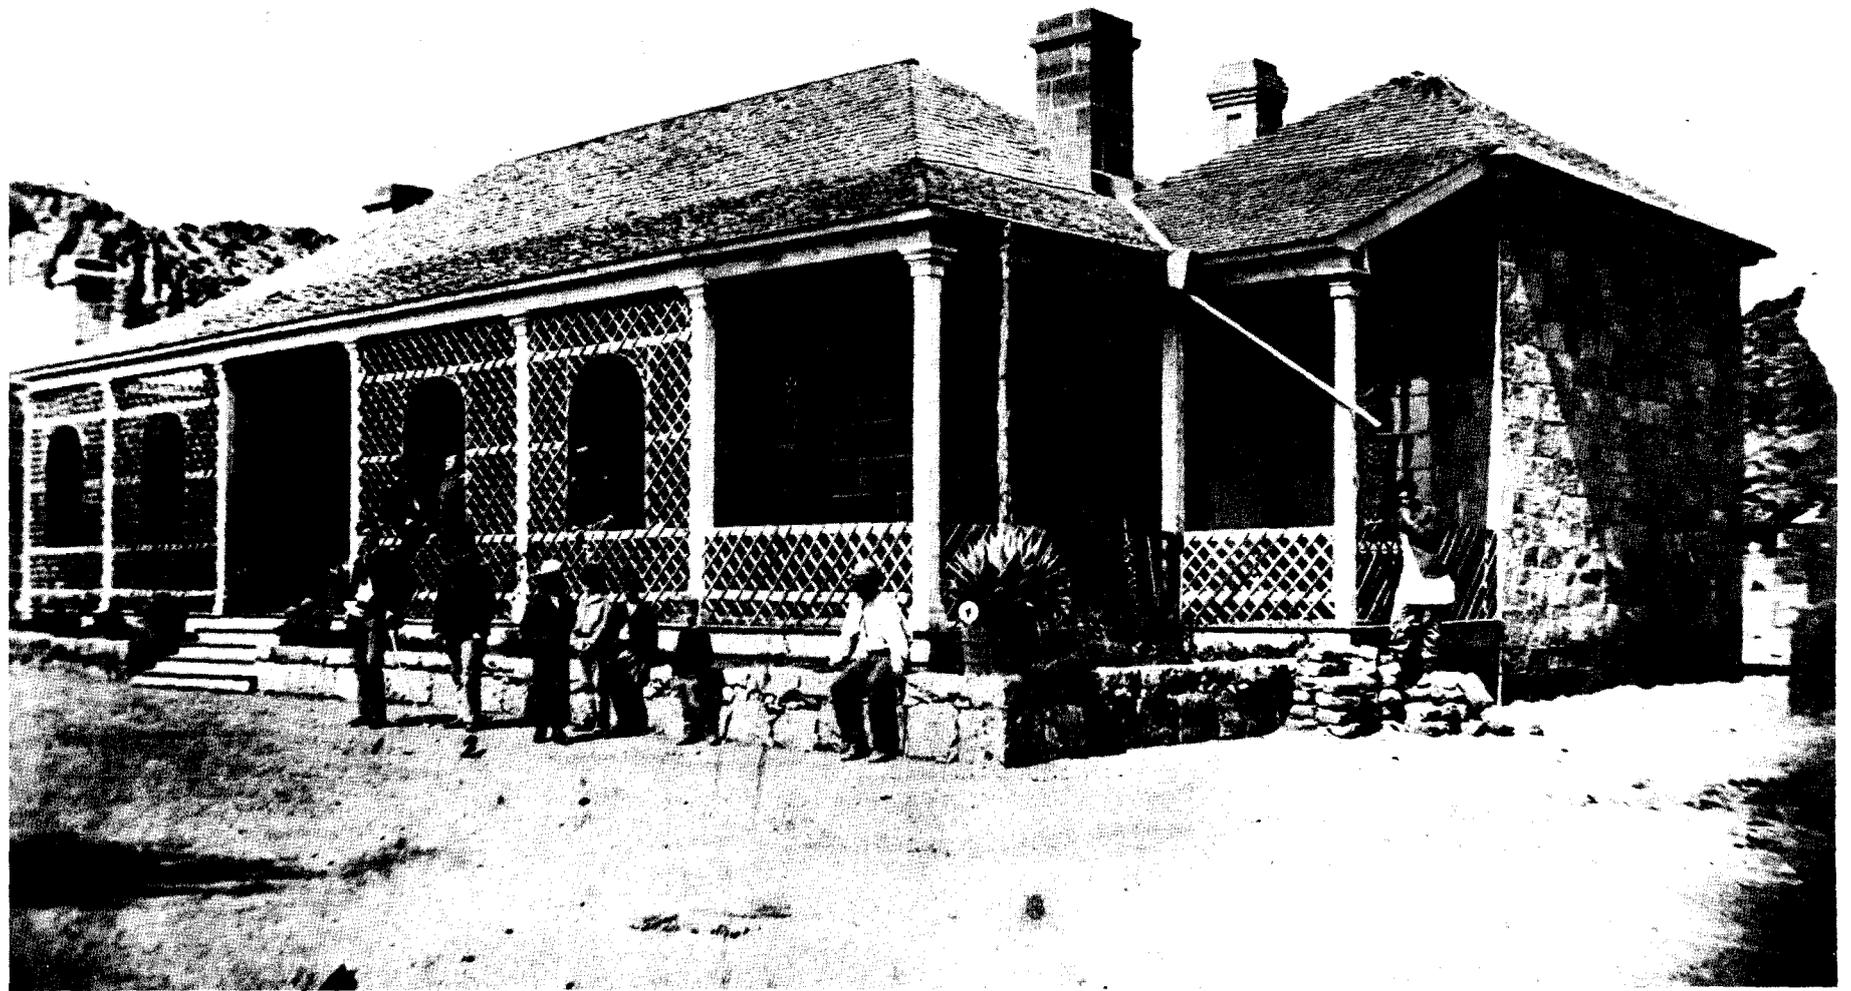
Illustration No. 48

Post Hospital (HB-46), ca. 1876-80, before south ward was added.

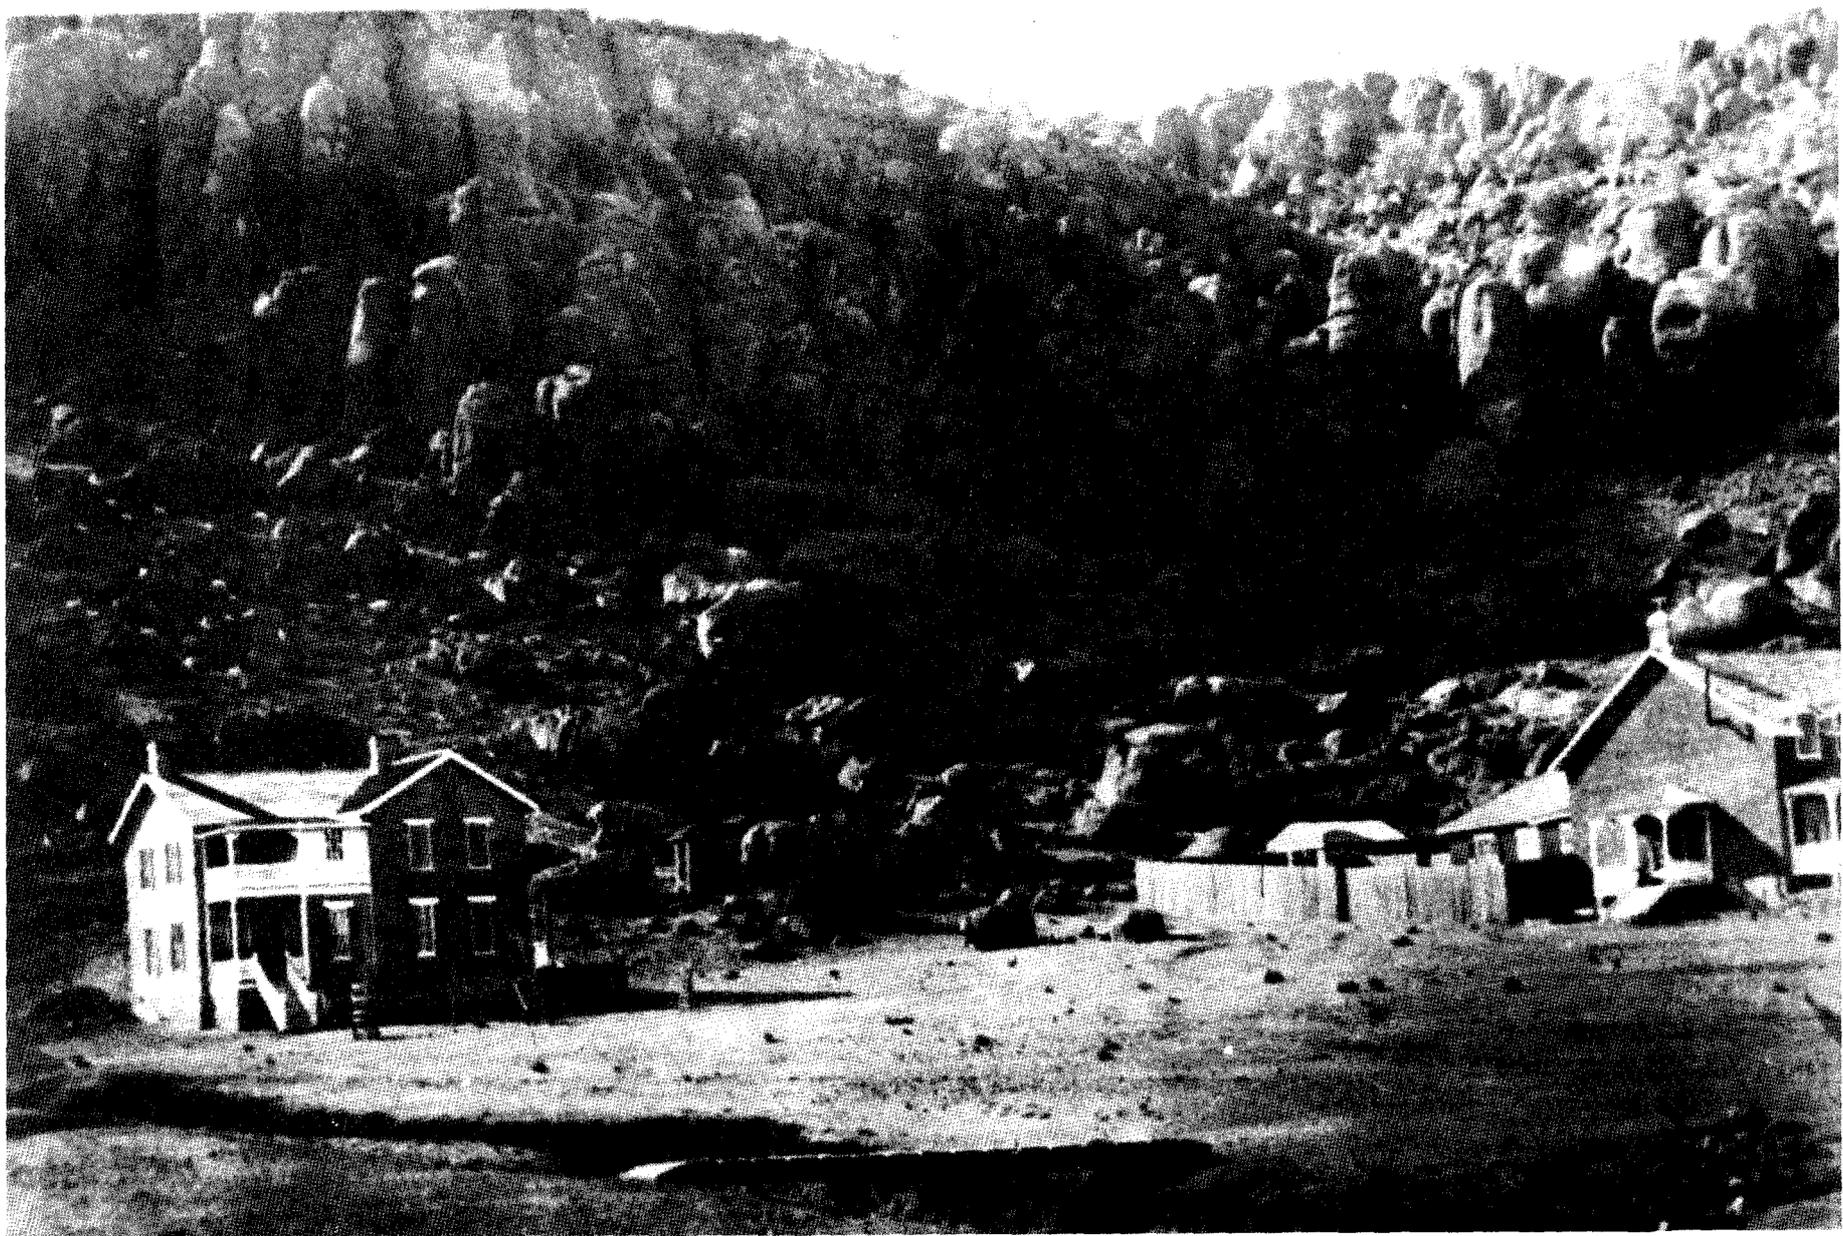
Illustration No. 51

Post Hospital complex (HB-46-50), ca. 1885-88. Magazine
(HB-49) is at base of cliff.

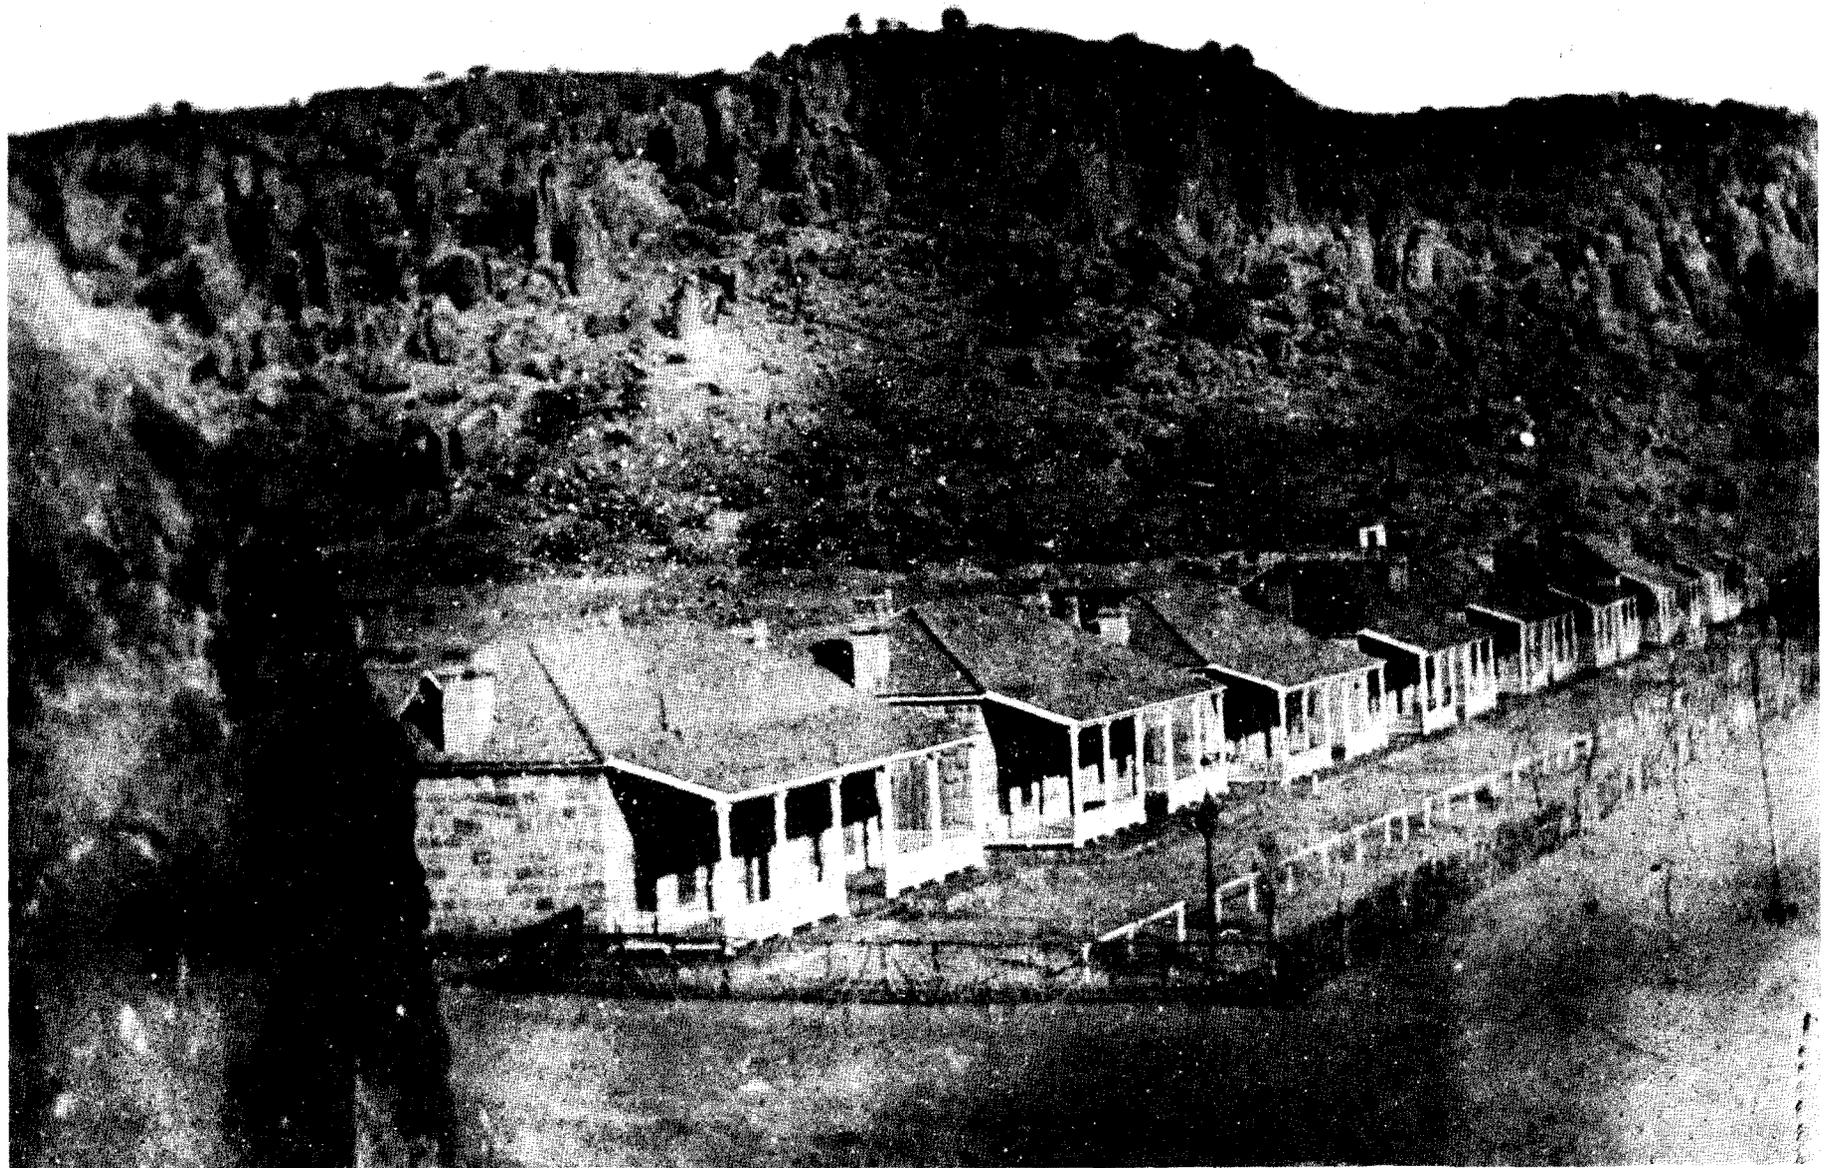
Illustration No. 60

Fort Davis from the west, ca. 1889. Note drainage ditch
in foreground and behind Officers' Row.

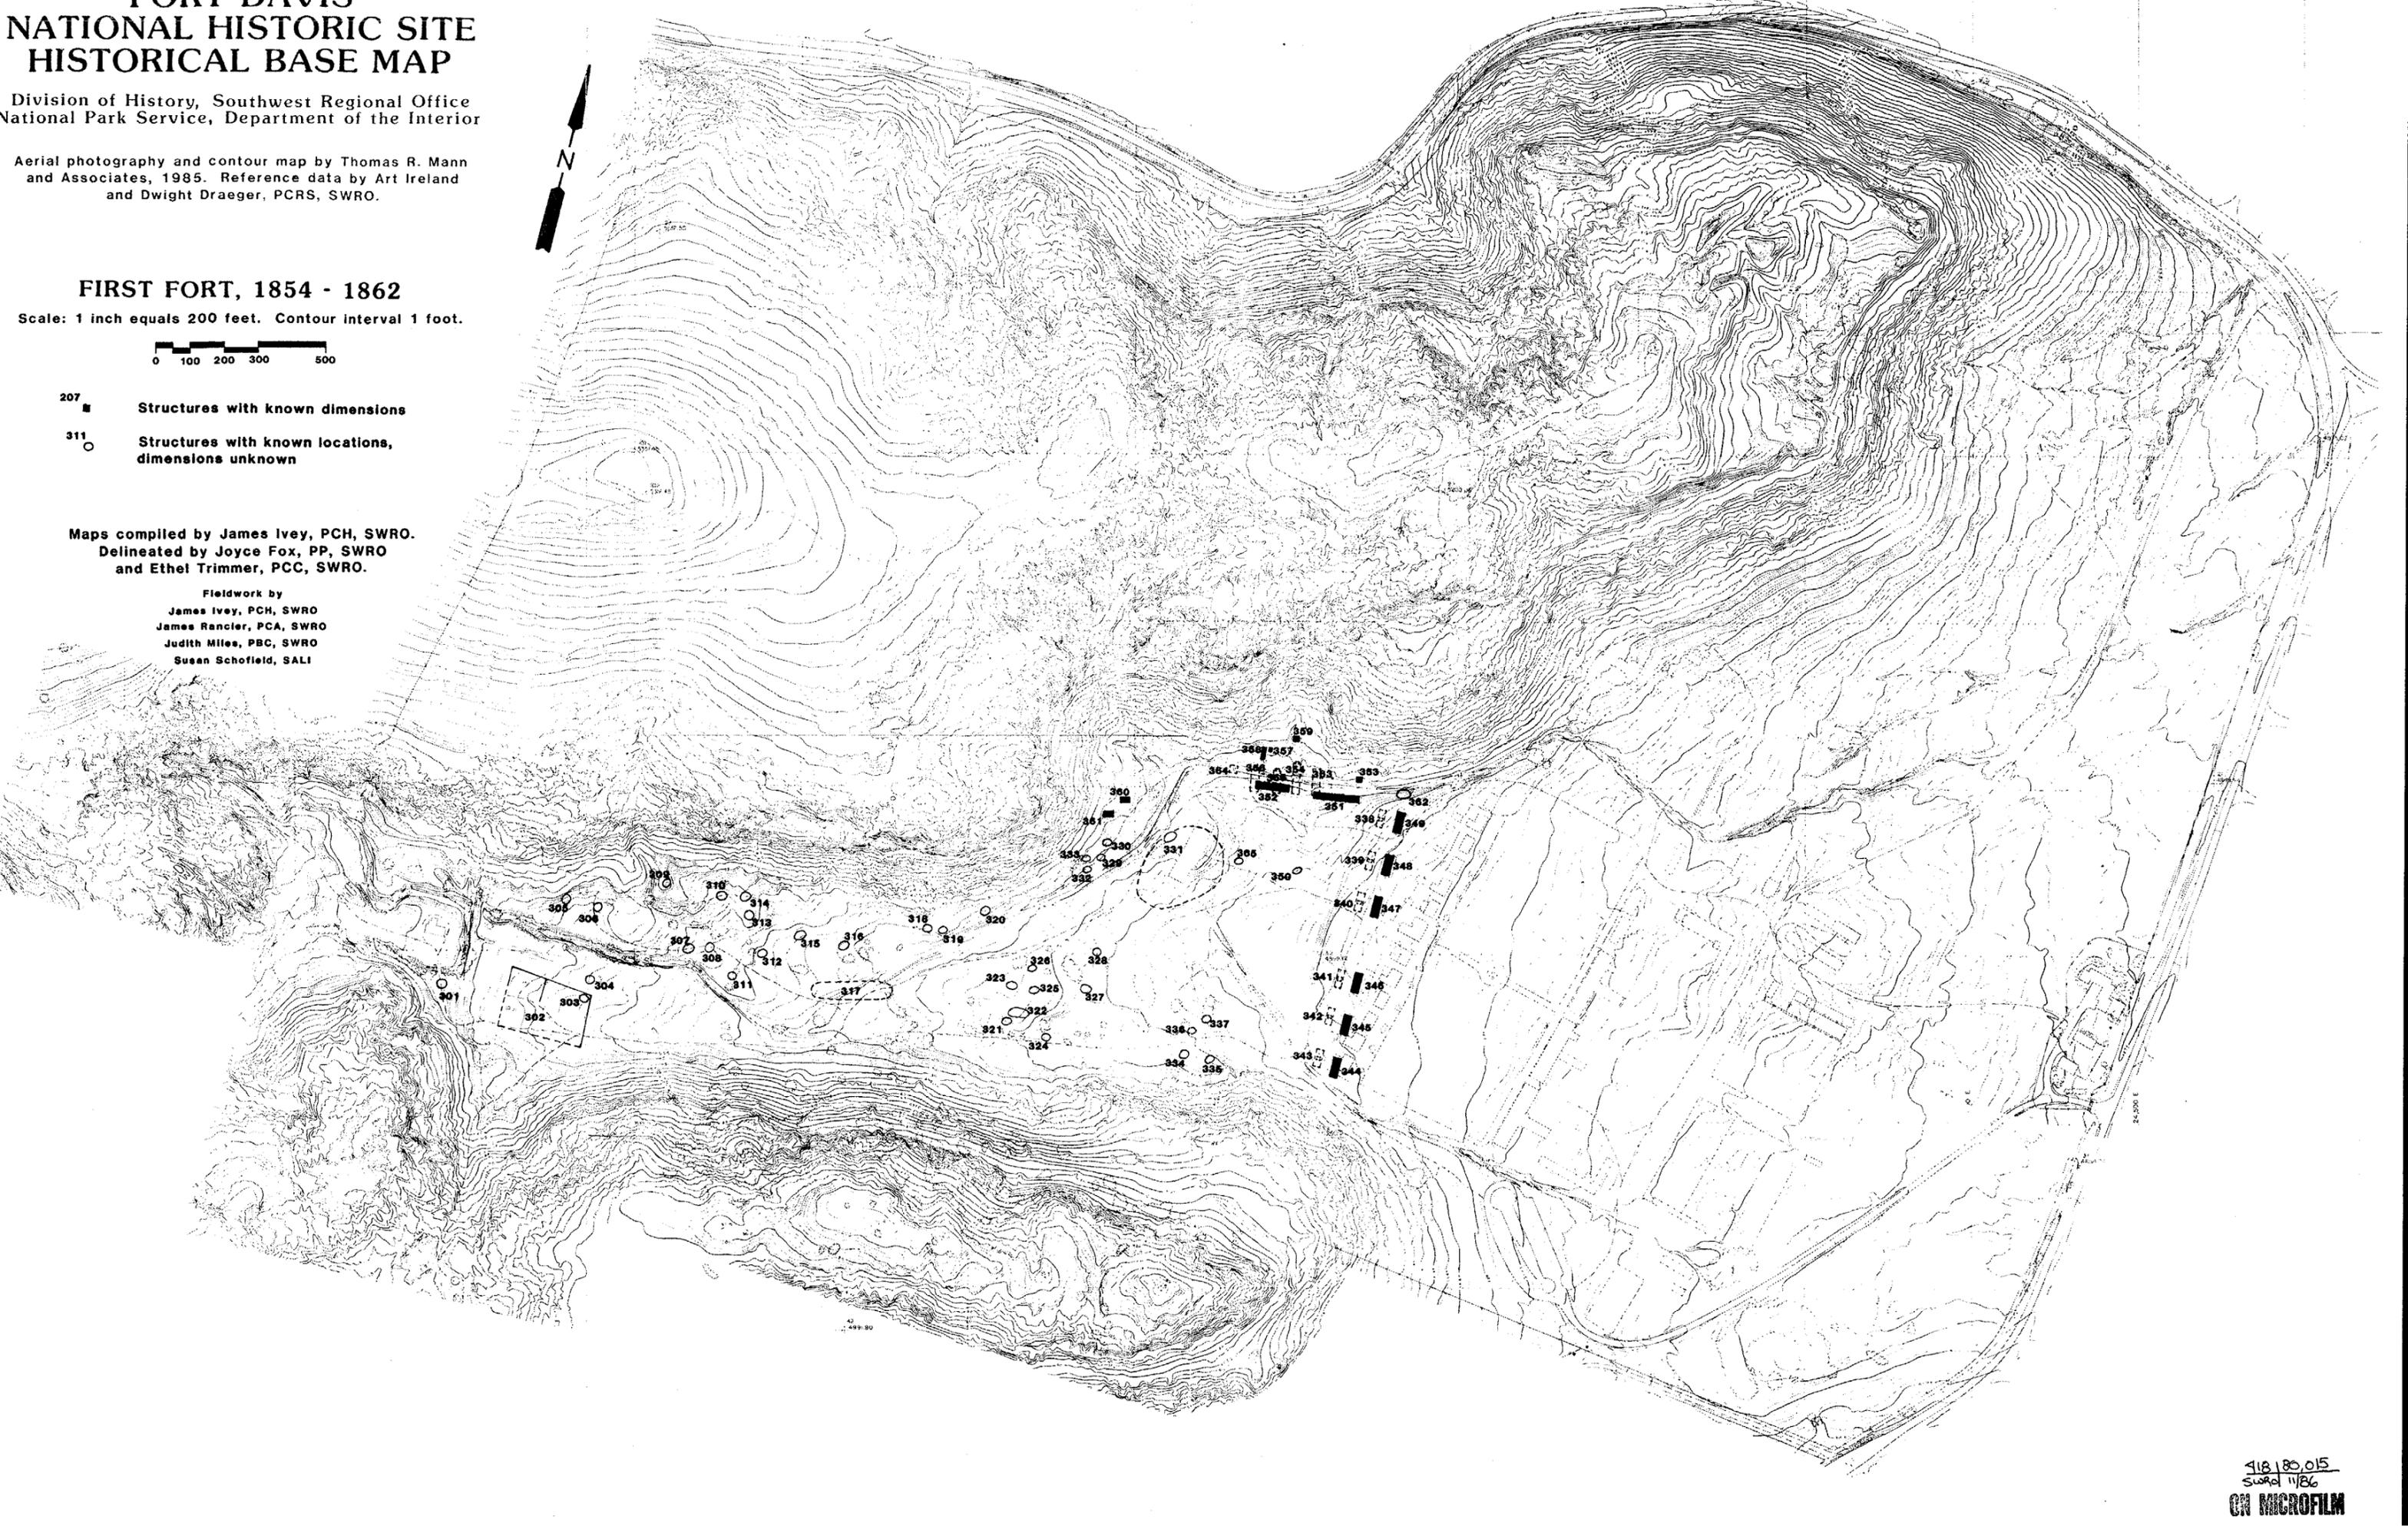
NATIONAL HISTORIC SITE HISTORICAL BASE MAP
