HISTORIC RESOURCE STUDY
FORT DAVIS NATIONAL HISTORIC SITE

By
Jerome A. Greene

November 1986

U.S. Department of the Interior / National Park Service

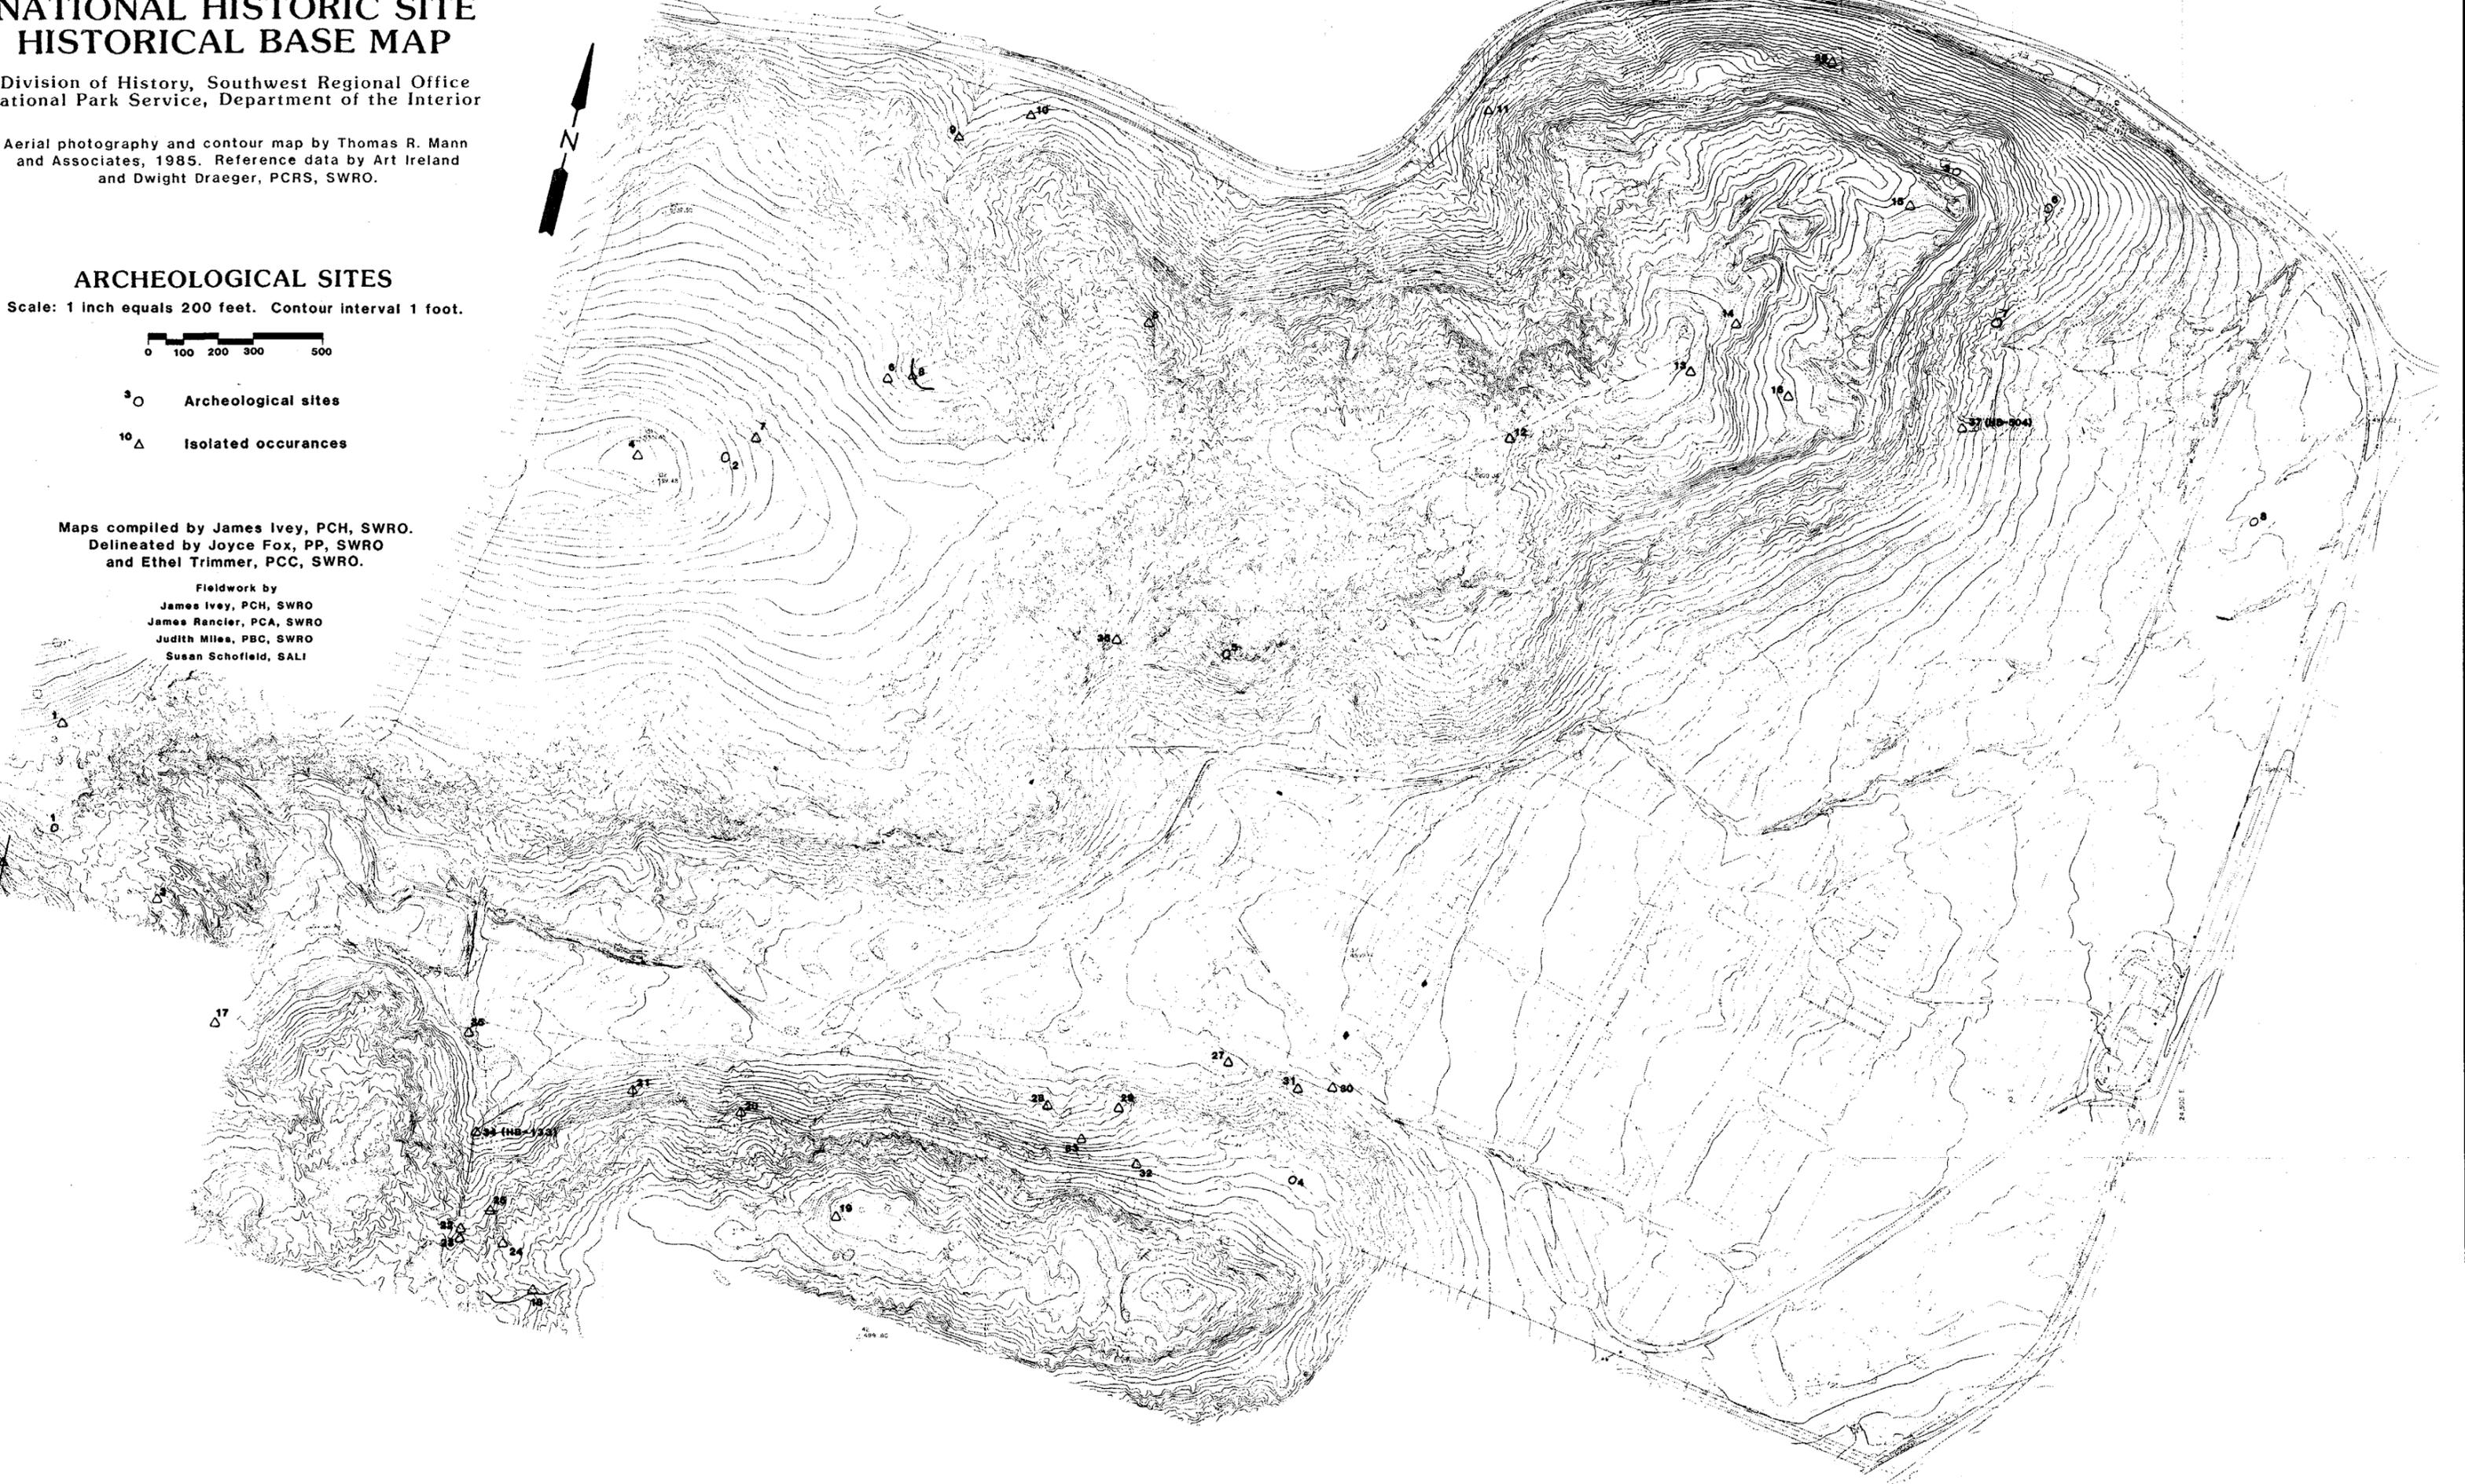
FORT DAVIS NATIONAL HISTORIC SITE HISTORICAL BASE MAP
