Fort Laramie National Historic Site

Cultural Landscape Report

National Park Service
Intermountain Region
Denver

2006

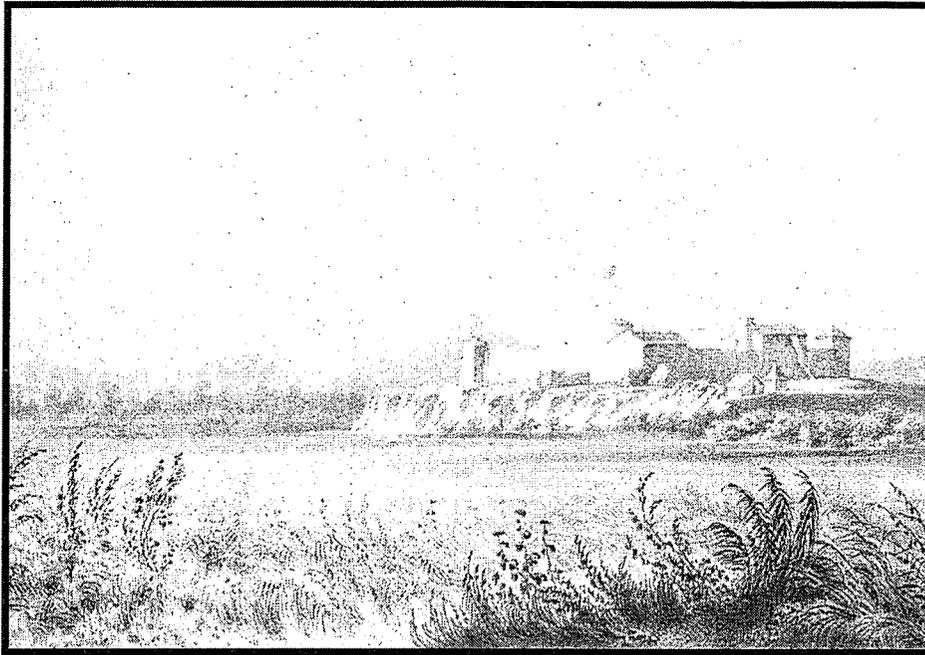
Figure 4. Fort John. Lithograph from Stansbury. Credit: U.S. Army Signal Corps.

In 1847, Brigham Young and several of his followers passed through the fort and made a set of measured drawings of both Fort John and Fort Platte. Fort John was the larger fort, about 122 feet by 167 feet, and consisted of 18 rooms inside the stockade, each with one door and one window opening onto the courtyard.

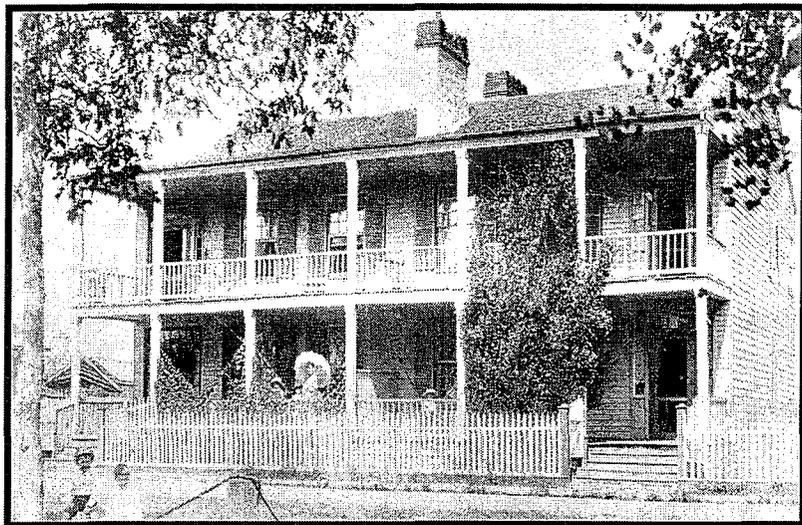
Figure 5. Old Bedlam, c. 1889. Credit: E.A. Brininstool

By winter of 1849, the construction of a two-story block of officers' quarters (later known as Old Bedlam), a barracks, a bakery, and two stables neared completion. The two-story barracks for enlisted men was built at the northeast end of the parade ground opposite Fort John. Stables were built along the southeastern edge, roughly parallel to the Laramie River. On the northwestern edge, Old Bedlam was constructed. Although much of the building at this time was temporary in nature, Old Bedlam remained a vital part of the activity of the military post throughout its entire history. This two-story frame building housed the officers' and the post commander's headquarters through the 1860s and early 1870s, and was the stage for military social life. Its sweeping two-story veranda gives it more the appearance of a southern United States mansion than a military structure (see figure 5).

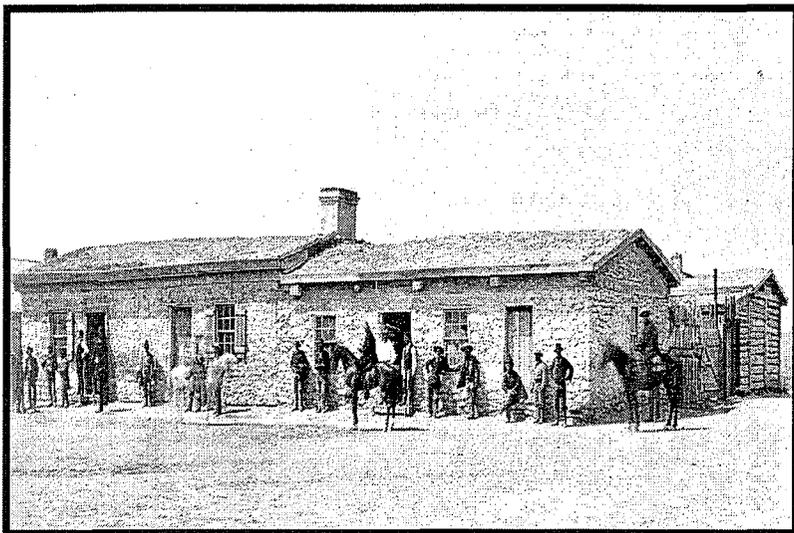
Figure 6. Sutler's Store, c. 1877. Credit: FOLA NHS.

Just outside the parade ground and approximately equidistant from both Old Bedlam and the soldiers' barracks is the Sutler's Store, originally built of sun-dried adobe. The post sutler held a contract with the military to trade on fort grounds. The sutler managed a steady business with emigrants, as well as with military personnel. Later additions of stone and lime grout were added to the original adobe structure (see figure 6). The Sutler's Store and Old Bedlam remain today as the oldest surviving structures of the military period.

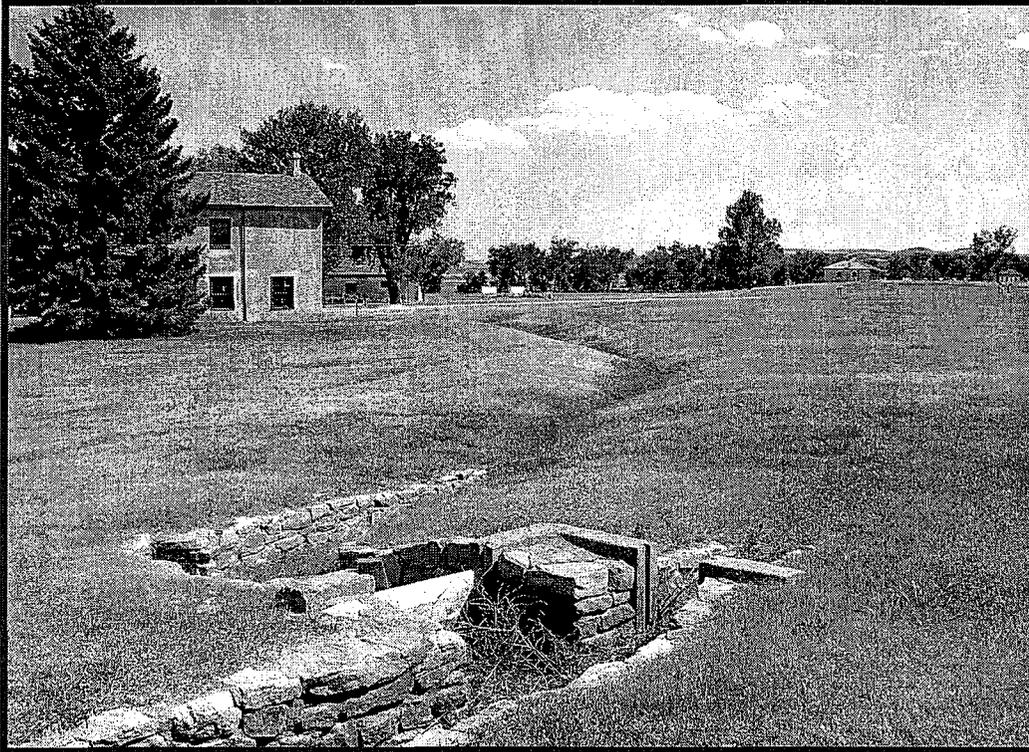
Figure 9. Fort Laramie Ditch. Credit: Olivia Salmon, July 2005.

preceded the Fort Laramie ditch (built in the 1890s) which crosses the northern portion of the site today (see figure 9). Many spurs of this ditch traverse the site, but their exact dates of construction cannot be determined.

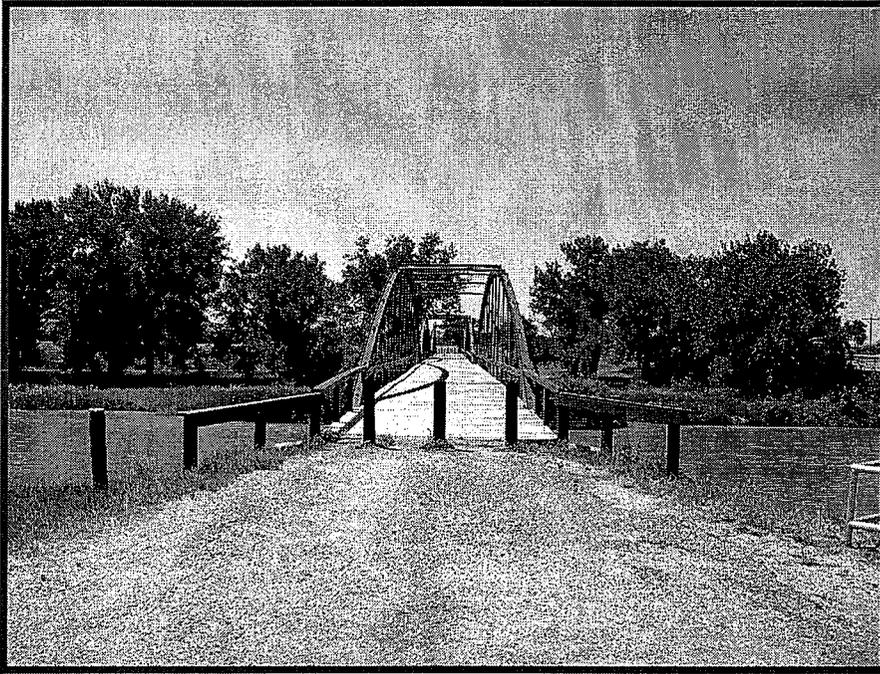
Figure 22. North Platte Bridge. Credit: Olivia Salmon, July 2005

Emigrant traffic from east to west continued until the completion of the transcontinental railroad. From the 1860s, a north-south route from Cheyenne to Deadwood, South Dakota, was heavily used. Circulation within the fort grounds was informal, with the exception of the parade ground, which, by the 1880s, had a well-worn circular path surrounding it. By the mid-1850s, bridges spanned the Laramie River at various points. In 1875, the iron army bridge was erected over the North Platte River (see figure 22).

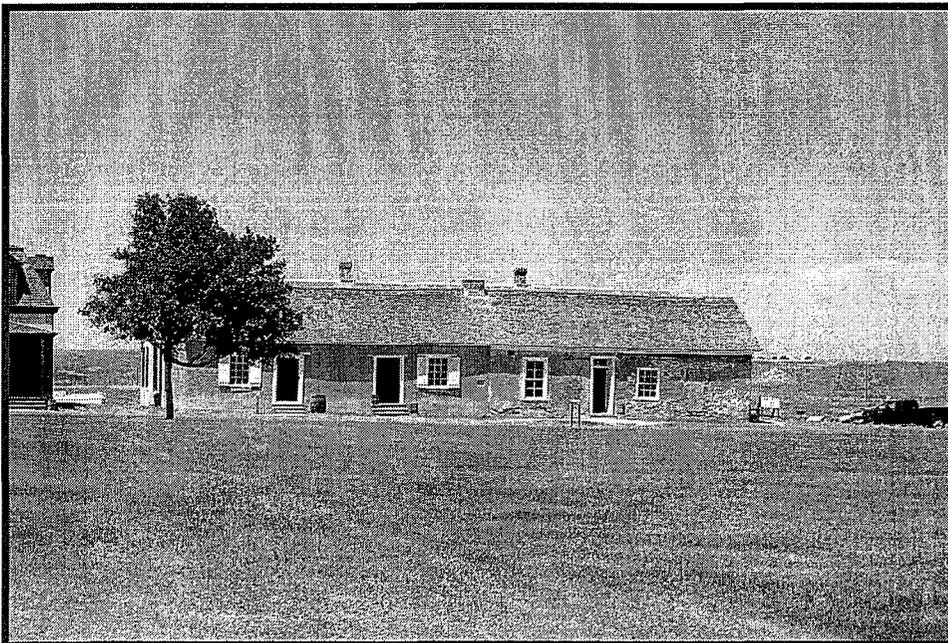
Figure 33. Sutler's Store. Credit: Olivia Salmon, July 2005

There are no obvious physical remains of either Fort William or Fort John. However, one of the earliest surviving buildings at Fort Laramie, the Sutler's Store, is an adobe structure (see figure 33). It reflects the continuation of a vernacular style that Fort John introduced at the site, and reflects some continuity between the fur trade and military periods.

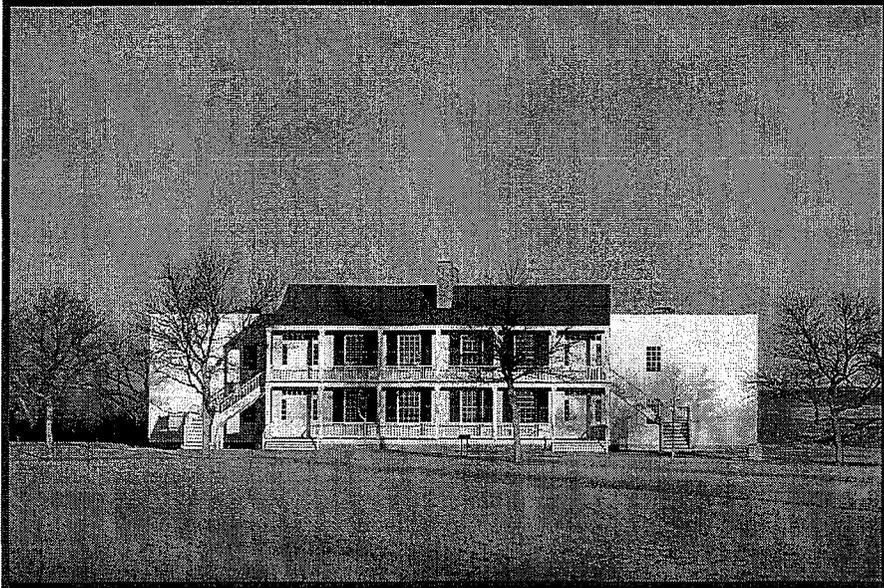
Figure 34. Old Bedlam. Credit: Kevin Haberman, January 2005.

STRUCTURES AND BUILDINGS <i>(these resources and their reference numbers are depicted in figures 51 and 52).</i>	S	C	BRIEF DESCRIPTION	In
1. Old Bedlam (roofed structure)	C	F	Restored. Built in 1849. Adobe and wood frame construction.	H

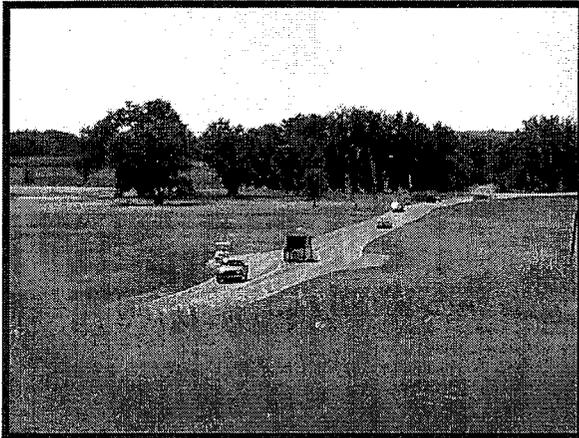
Figure 42. Fee Station, located alongside Entrance Road. Credit: Olivia Salmon, July 2005.

Several structures were built during this time to facilitate visitor experiences and to accommodate park activities. A fee station (see figure 42) is located at the entrance of the park, and maintenance facilities are found across the Laramie River. Toilets were also constructed for visitor use.

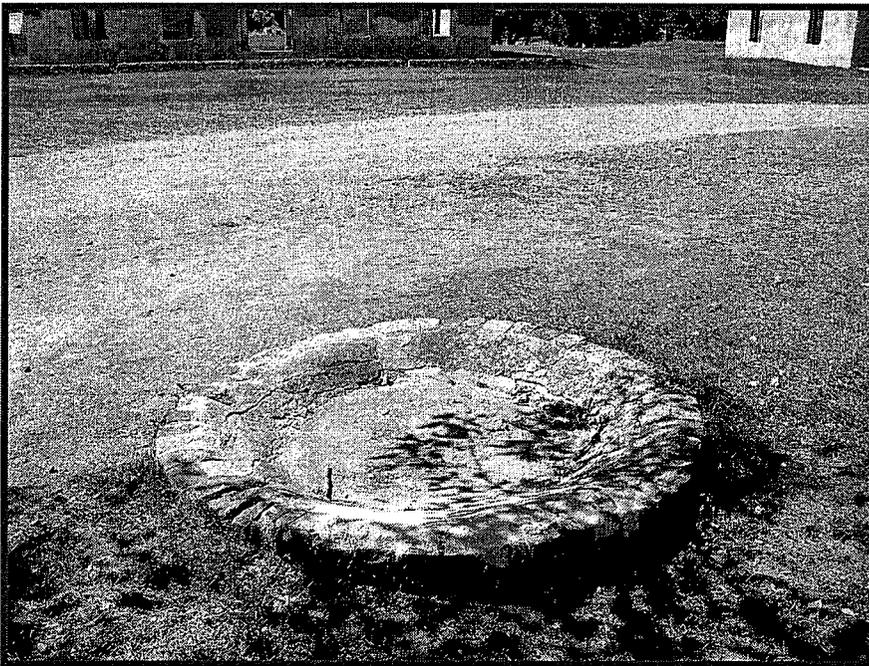
Figure 45. Birdbath. Credit: Olivia Salmon, July 2005.

A birdbath, constructed in 1880, is the only small-scale feature remaining from the military period (see figure 45).

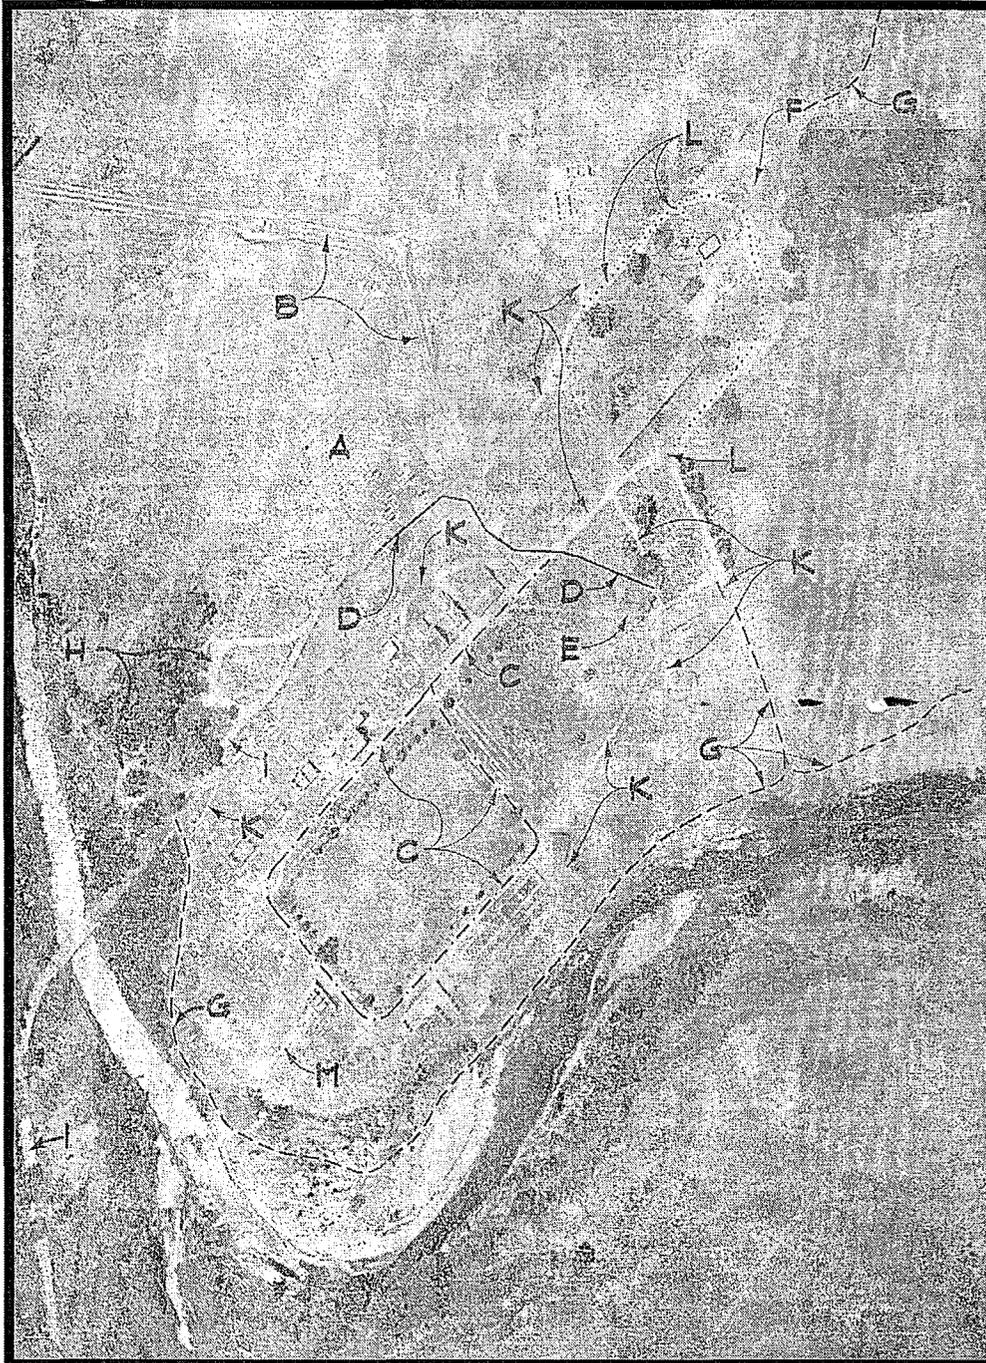
- A - PAVED PARKING (VISITORS)- **NC**
- B - PAVED ENTRANCE ROAD- **C**
- C - GRAVEL WALK AROUND PARADE GROUNDS- **C**
- D - CONCRETE WALK- **NC**
- E - UNPAVED, NO GRAVEL WALK- **NC**
- F - GRAVEL PARKING (MAINTENANCE)- **NC**
- G - UNPAVED, NO GRAVEL ROAD- **NC**
- H - GRAVEL ROAD & PARKING (PICNIC AREA)- **NC**
- I - PAVED ROAD- **NC**
- K - GRAVEL WALK- **NC**
- L - GRAVEL ROAD- **NC**
- M - GRAVEL WALK WITH WOODEN HANDRAILS- **NC**
- N - GRAVEL ROAD- **NC**, (LOCATED ON OVERALL PLAN WHICH FOLLOWS) **NC**
- O - PAVED COUNTY RD. 15 (LOCATED ON OVERALL PLAN WHICH FOLLOWS) **C**
- P - UNPAVED, NO GRAVEL ROAD, (LOCATED ON OVERALL PLAN WHICH FOLLOWS) **NC**

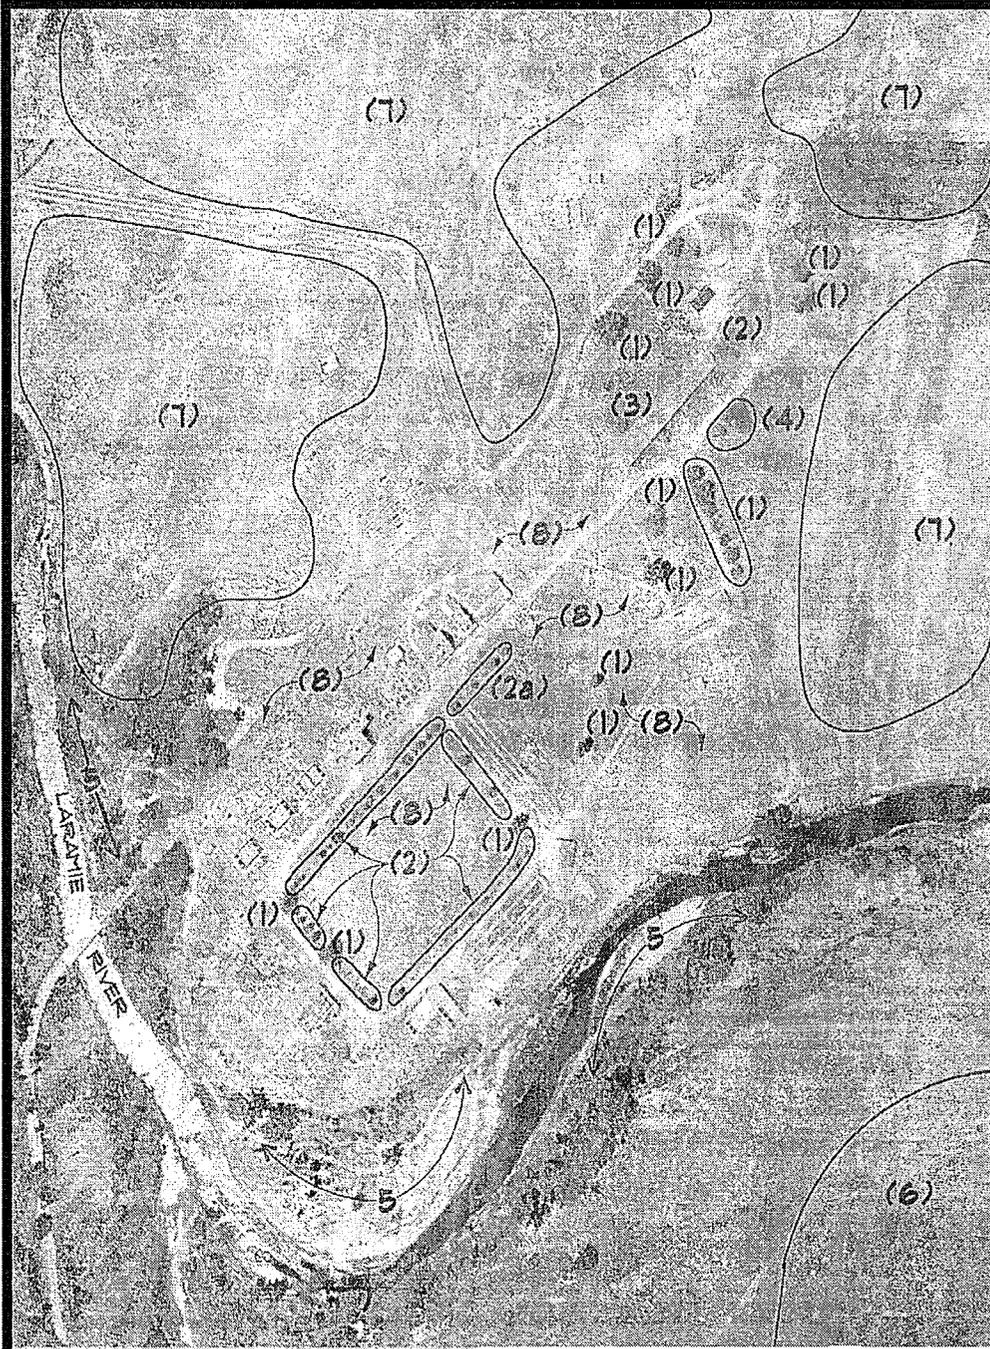
- (1) - COTTONWOOD SPECIES- **NC**, WITH EXCEPTION OF TREE GROUPING AROUND PARADE GROUND- **C**
- (2) - GREEN ASH- **C**
- (2a) - GREEN ASH- **NC**
- (3) - SPRUCE SPECIES- **NC**
- (4) - WILLOW SPECIES- **NC**
- (5) - RIPARIAN VEGETATION- **NC**
- (6) - NATIVE PERENNIAL GRASS- **C**
- (7) - ANNUAL/ PERENNIAL MIX- DISTURBED LAND- **NC**
- (8) - BLUE GRASS MIX- **NC**, WITH EXCEPTION OF PARADE GROUND AREA- **C**
- (9)- WETLAND VEGETATION- **C** (LOCATED ON FOLLOWING OVERALL PLAN)

VEGETATION <i>(these resources and their reference numbers are depicted in figures 55 and 56).</i>	S	C	BRIEF DESCRIPTION	In
1. Cottonwood species	NC	G	Naturalized along irrigation ditches. Were not present during period of significance.	NC
1a. Cottonwood species	C	G	Several cottonwoods exist as a part of the tree grouping that encircles the parade ground. These specific trees may be the remains of an early planting around the parade ground during the late military period.	H

- 1- Replace contributing plant material only. Non-contributing plant material in decline should not be replaced. Refer to Figure 55 for identification of contributing and non-contributing plant material.

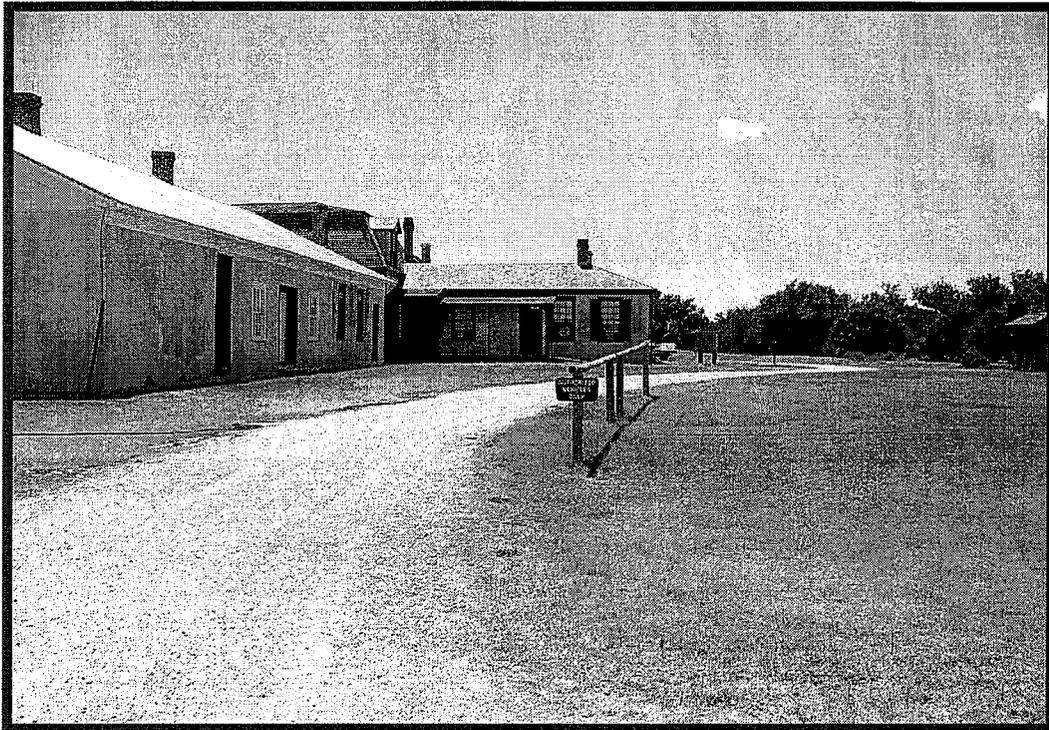
Figure 61. Road behind Sutler's Store. Credit: Olivia Salmon, July 2005.

This road currently has no specific use and is contributing to the deterioration of nearby resources (see figure 61). However, it may be a historic resource. It is recommended that further study be conducted to determine the historic transportation corridors through and around the fort – specifically, this road's significance and relationship to the history of Fort Laramie. If the road is found to be a historic resource, preservation measures should be undertaken.

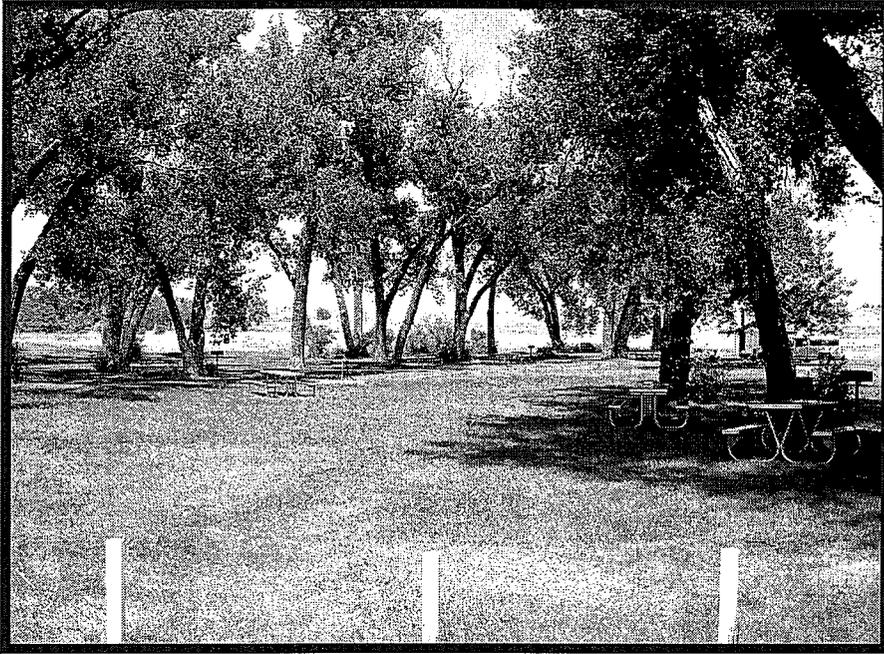
Figure 62. Picnic Area. Credit: Olivia Salmon, July 2005

Research is needed to examine the option of relocating the existing 1979-era picnic area and rehabilitating the site (see figure 62). A location that is farther away from the historic core would address the GMP concerns regarding the preservation of the historic scene. It would also help to address erosion. The current picnic area should be rehabilitated to its natural vegetative state. Relocation of the picnic area would be undertaken after the completion of additional location studies

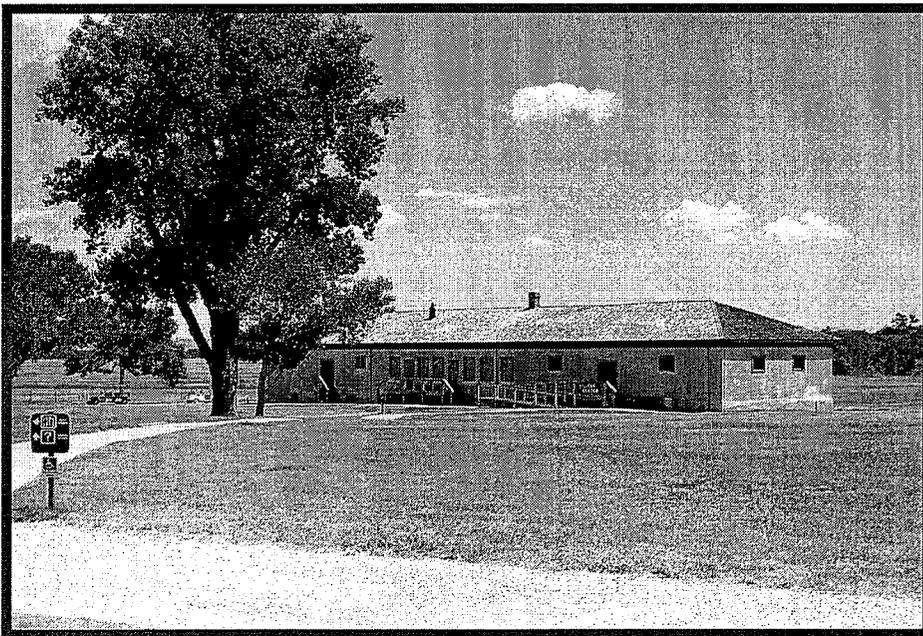
Figure 64. Commissary Storehouse/Visitor Center. Credit: Olivia Salmon, July 2005.

The park offices and library were established in the cavalry barracks, and the visitor center, museum, and administrative offices were established in the old commissary storehouse (see figure 40 in Treatment). The Sandercrock residence across the Laramie River from the fort grounds was dismantled, and maintenance facilities were located there.

With reference to the GMP, it is suggested that alternative locations for the visitor center be considered (see figure 64). One suggested alternative location for the visitor center is the hospital site. This location is a high point in the landscape and would be excellent for visitor orientation and interpretation of the entire site. However, more analysis is required before the move could take place. As mentioned above, it is recommended that all views be considered when site alternatives are analyzed.

Once the visitor center is moved, it is recommended that the exterior of the commissary storehouse be restored to its military-period condition and that the non-contributing features be removed.
