FT. LARNED

HISTORIC STRUCTURES REPORT

Fort Larned National Historic Site, Kansas

Historic Structures Report
Part I

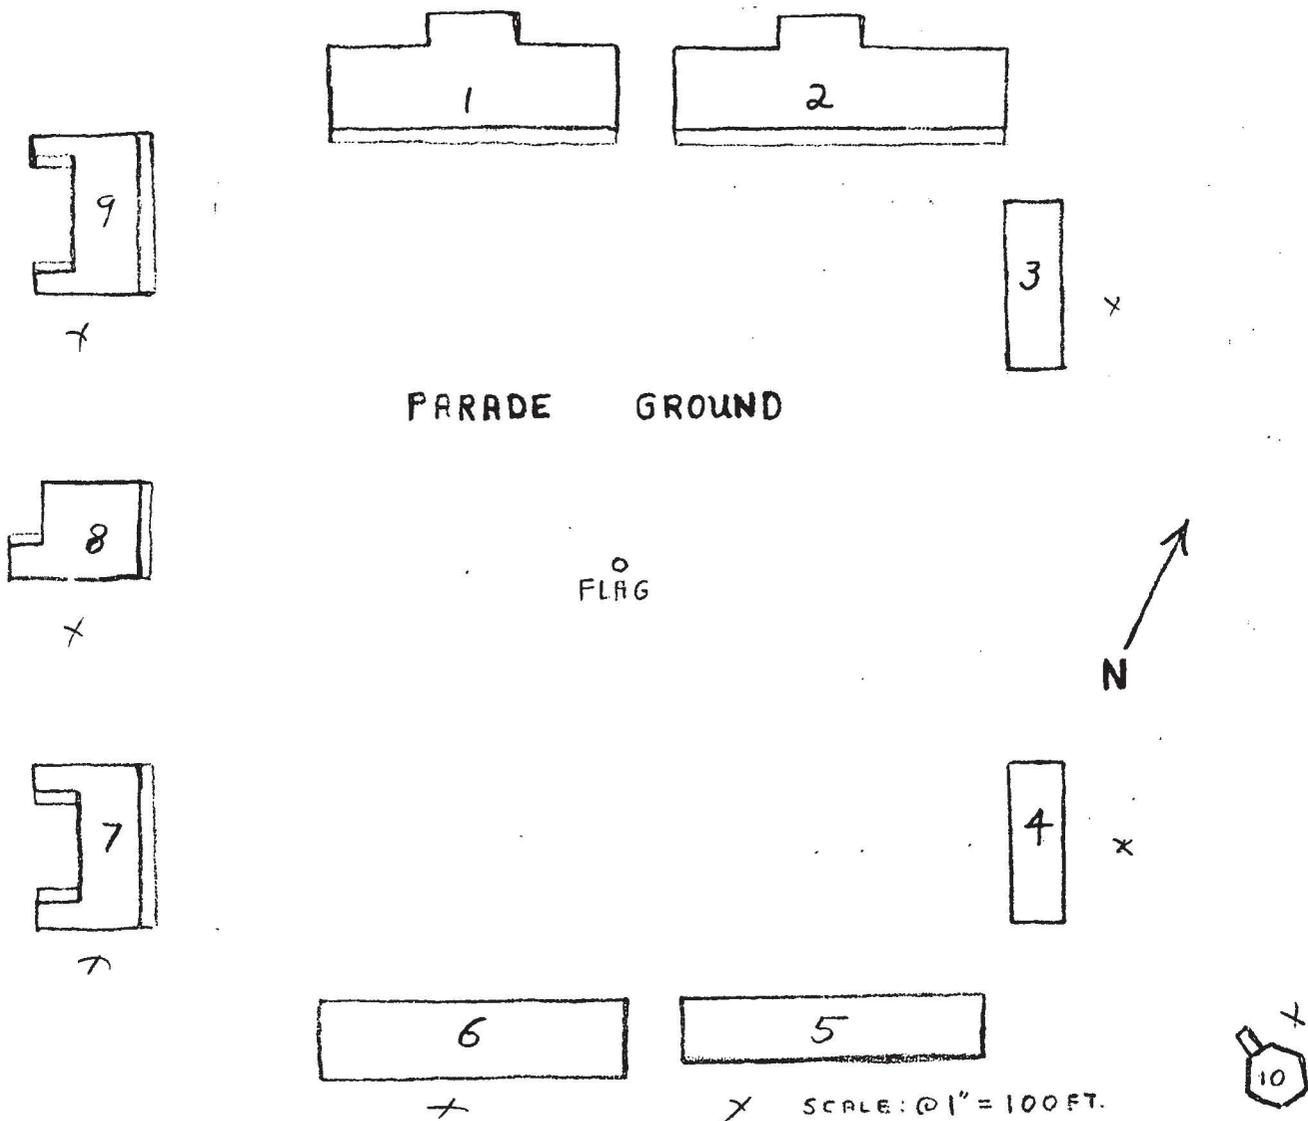
BUILDINGS LAYOUT DIAGRAM

| 1. BARRACKS | 6. QUARTERMASTER |
| 2. BARRACKS | 7. OFFICER QUARTERS |
| 3. SHOPS & BAKERY | 8. COMMANDING OFFICER'S QTRS. |
| 4. COMMISSARY (1868) | 9. OFFICER QUARTERS |
| 5. COMMISSARY (1866) | 10. BLOCKHOUSE |

114. ICE HOUSE

(ALL BUT NO. 10 STILL IN PLACE)

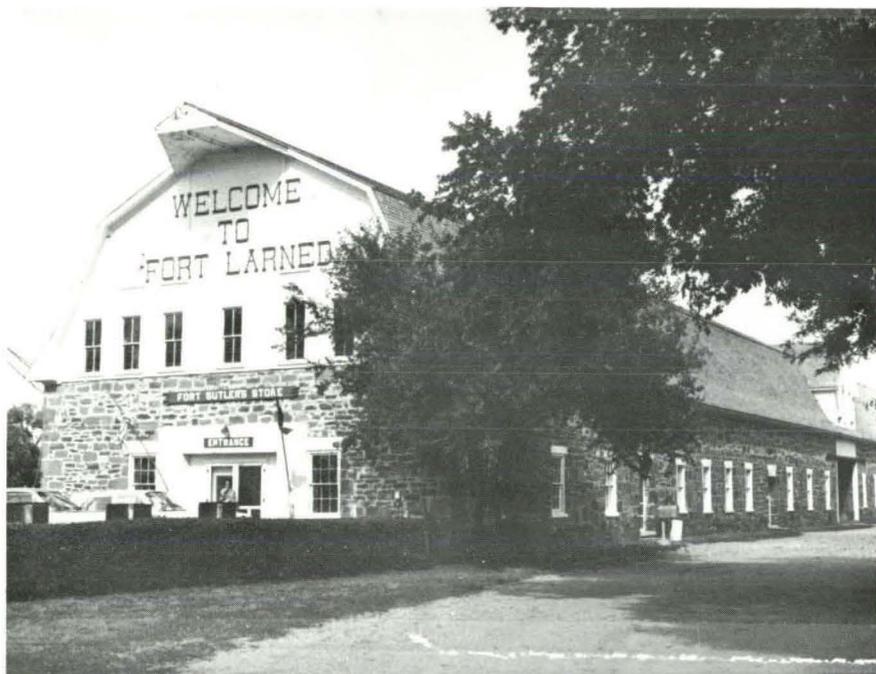
Building 1, Enlisted Men's Barrack, 1867.

Walls heightened and barn roof added after 1902. Roof structure connects this building with no. 2, the east barrack, at the far right of the picture. View is of the west end of the structure.

Built during the last half of 1867, the kitchen wing on the north side was added before July 9, 1868. A roof extension originally covered a 10 1/2 foot porch on the south side, supported by 16 wooden posts. This structure was designed to house two companies of soldiers, including dual kitchens,

Soon after transfer to civilian ownership in 1884, the porches were removed, and, between 1902 and 1917, the hay barn roof was added, the walls were heightened about 5 feet, and the structure was connected with building No. 2. When built, this barracks had four chimneys and measured 150 feet long by 43 feet wide and was about 12 feet high at the eaves. A double-kitchen wing, 34 feet by 36 feet, extended to the rear at the center of the building.

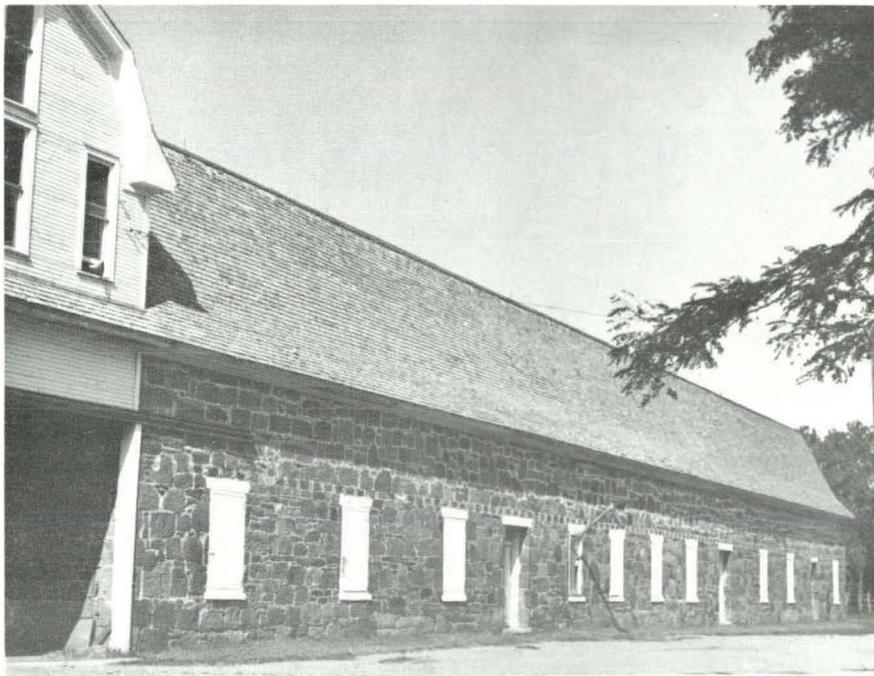
Building 2, Enlisted Men's Barrack, 1867.

Picture shows the south side of the building.

This structure was almost a duplicate of No. 1, built nearly simultaneously with it, as quarters for two companies. The major difference is at the east end of the building, where the barracks room was 22 feet longer, resulting in the overall dimensions being 172 feet by 43 feet, and 12 feet high at the eaves. The added length required 18 porch roof posts rather than the 16 used in No. 1. A double-kitchen wing, 34 feet by 36 feet, extended to the rear near the center of the building.

section before 1875. Like No. 1, the walls were raised about 5 feet after 1902, and the barn roof added to cover a hayloft.

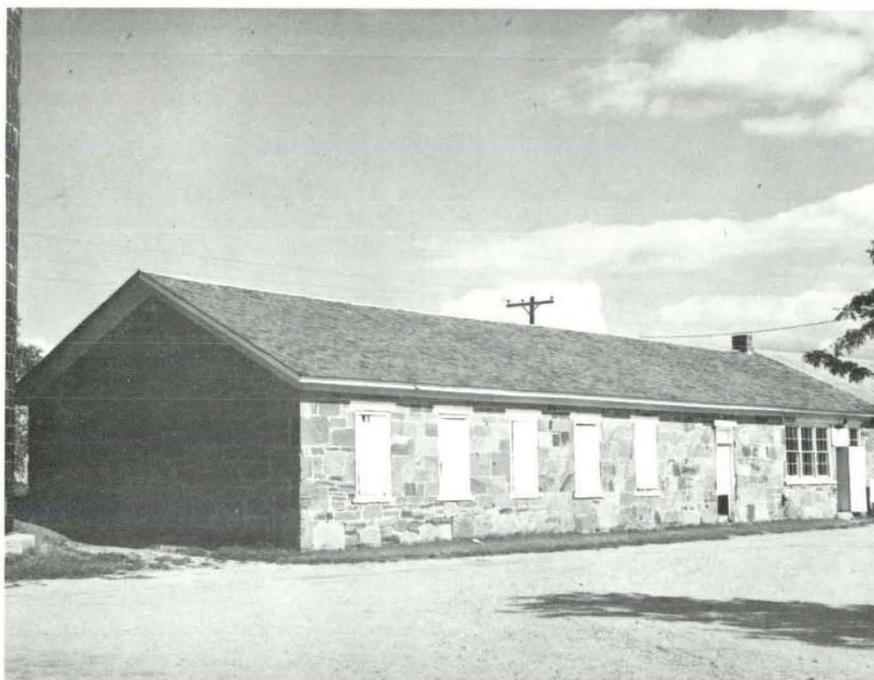
Building 3, Shop Building and Bakery, 1867.

Originally housed, blacksmith, wheelwright, painter, and saddler shop, plus the post bakery. Seen from the west.

Begun late in 1867, this building was completed in 1868, with dimensions of 84 feet long by 30 wide, and about 12 feet high at the eaves. The bakery was probably at the north end of the building, in a space about 26 feet by 28 feet. Other rooms were partitioned off for use as carpenter, wheelwright, painter, and blacksmith shops. The structure underwent no known major alterations prior to abandonment by the Army, but since 1902 it has been connected to No. 4 by a long shed.

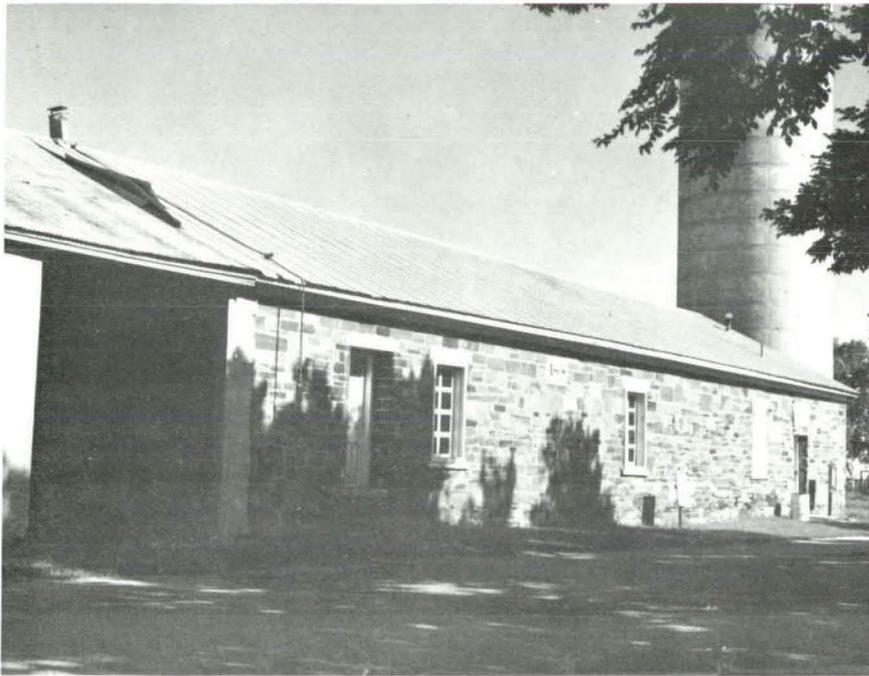
Building 4, New Commissary, 1868.

Original use was as a warehouse. View from the west side.

Built in 1868, this structure measured 84 by 30 feet, with a height at the eaves of about 12 feet. During the summer of 1868 a partition may have been added to the original plan, to provide a guardroom in addition to the building's primary purpose and use as a storehouse. Local tradition has erroneously designated this building as a messhall and bakery, which it was not, and local Boy Scouts built a completely non-historic "tunnel" from its cellar to the ox-bow pond bank after 1957.

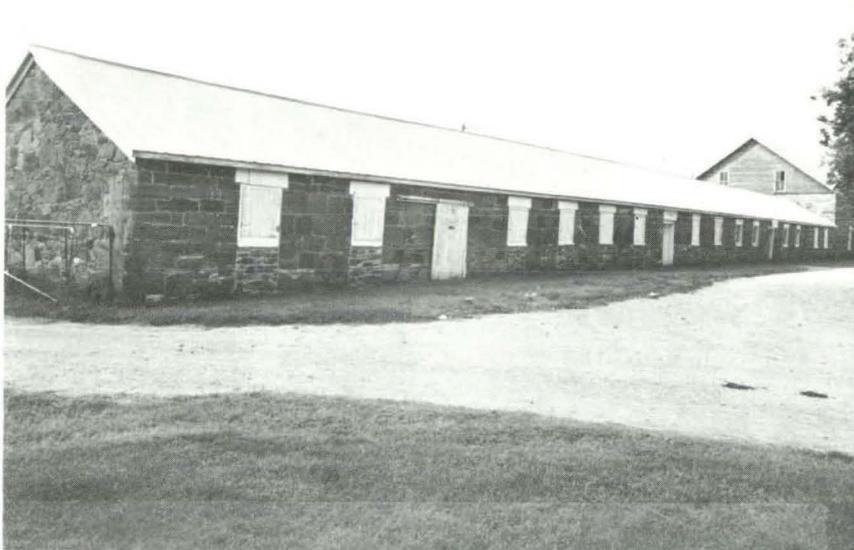
Building 5, Old Commissary, 1866.

Used as a storehouse and a defense strong point, by loop-holing the outer walls with gun ports. Picture shows the north side of the building.

Fort Larned, and the second stone building put up there. As built, it measured 155 feet long by 27 feet wide and about 12 feet high at the eaves. Designed primarily as a storehouse for commissary supplies, it was also intended to serve an auxiliary purpose in defense of the post; rifle ports being spaced waist-high through all but the interior or north walls. During the last half of 1867, a small office space was partitioned off, flooring was installed, and a cellar was dug underneath part of it. A stone wall connecting this building to No. 6 was added after 1902.

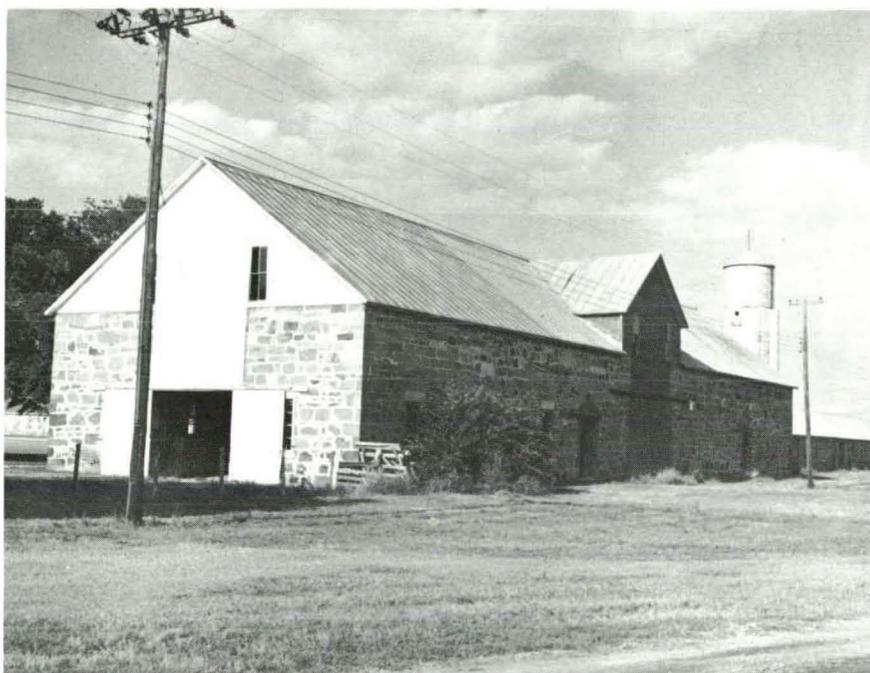
Building 6, Quartermaster Storehouse, 1868.

Walls heightened and barn roof added after 1902. Outer (south) wall seen here is loop-holed for rifle fire. Seen from the southwest.

Completed by January 31, 1868, this structure had been commenced early in August 1867. Like No. 5, its south wall was pierced with a row of rifle ports for defense of the post's vulnerable south side. By 1869, an office area had been partitioned off and ceiled. Its original roof was torn off in a windstorm in 1880. Originally a little higher at the roof eaves than No. 5, its walls were raised about 5 feet and a hayloft and barn installed after 1902. Outside dimensions originally were about 157 feet long by 40 feet wide.

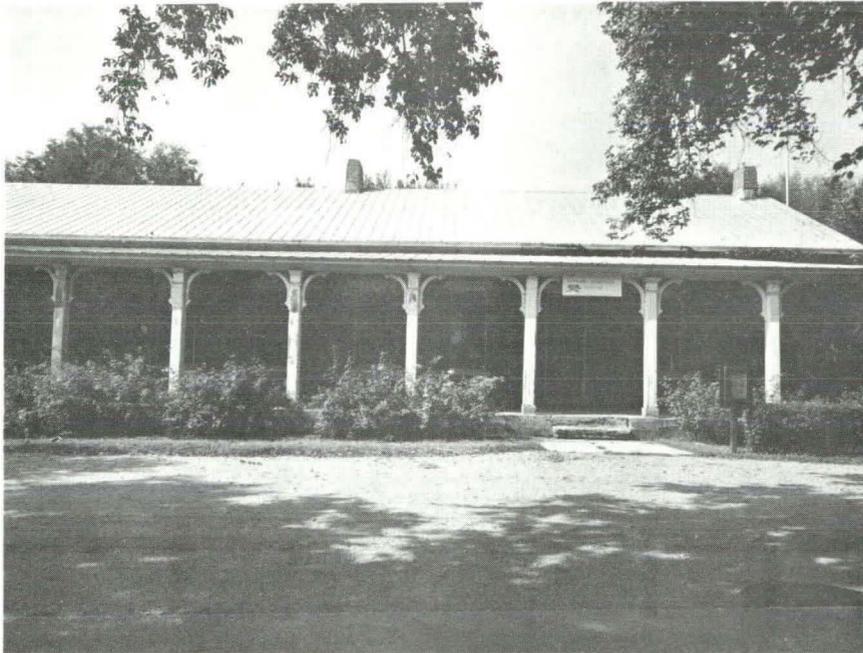
Building 7, Officer Quarters, 1868.

Currently used for display of furniture and other historic artifacts, by the Fort Larned Historical Society. View from the east.

in 1867, it was completed in the spring of 1868, including a wooden porch across the front and a small porch in the rear next to the kitchen. A cellar was dug under each kitchen. A separate frame kitchen and dining room structure was built in the rear, occupying the open end of the building's "U," late in 1869 and early 1870. Outside measurements of no. 7 were 84 feet by 33 with the 20 feet by 20 feet kitchen "L's" extending to the rear at each end. A sink, or latrine, was in the backyard which, like the 1869-70 kitchen building, has vanished long ago. A concrete porch base was added sometime after 1902.

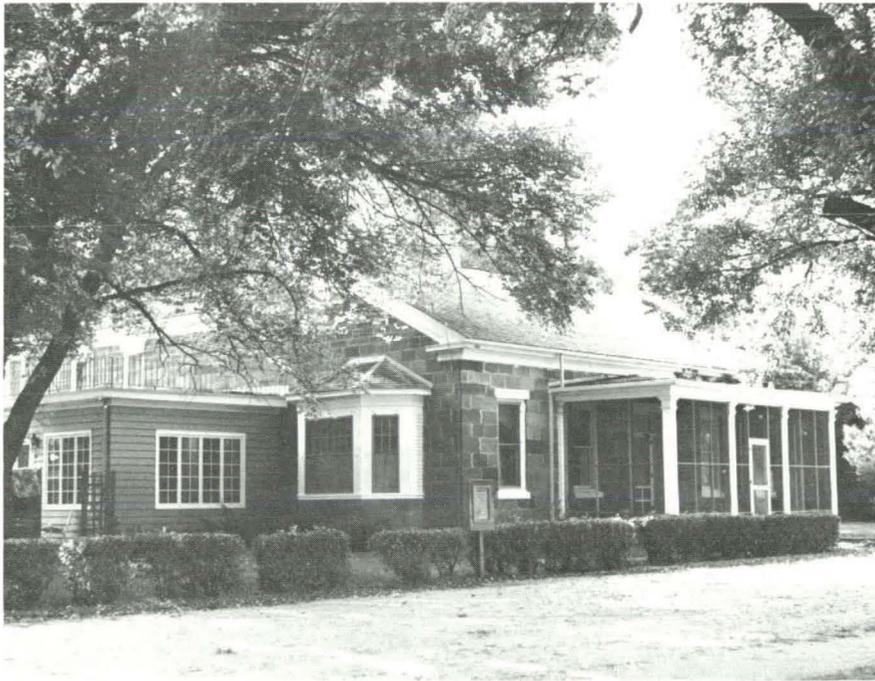
Building 8, Commanding Officer's Quarters, 1868.

Extensively added to since 1902. Residence of R. R. Frizell. Photograph shows the eastside of the house.

This structure was begun and completed in 1867, including a cellar under the kitchen "L". Like the other officer quarters, this one had a latrine in the backyard. Having been used as the owner's residence since 1902, this building has undergone several alterations and had additions made to it. Original dimensions were: 36 feet by 47 feet with the 18 feet by 20 feet kitchen extending to the rear at the south end.

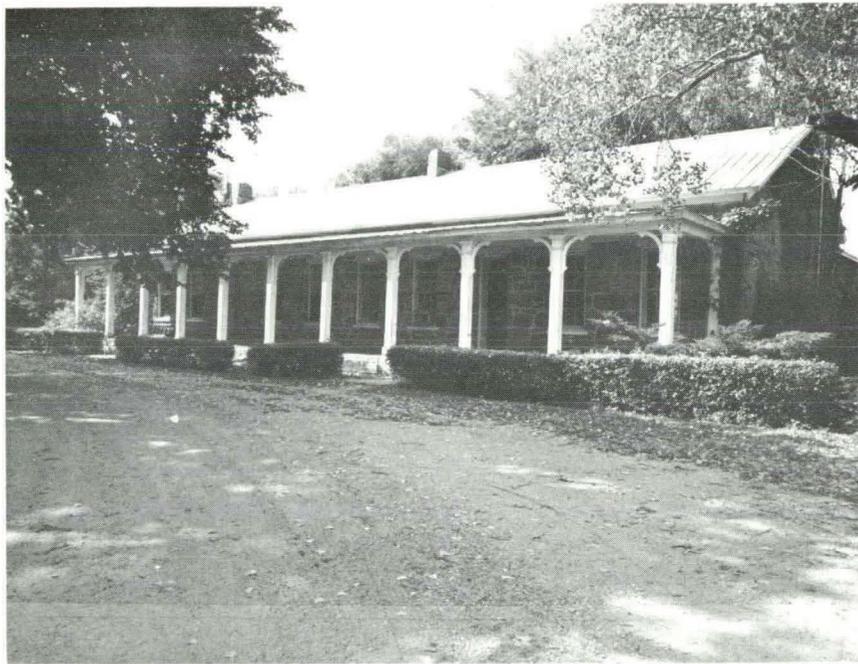
Building 9, Officers' Quarters, 1868.

As seen from the east.

Same construction history as no. 7.

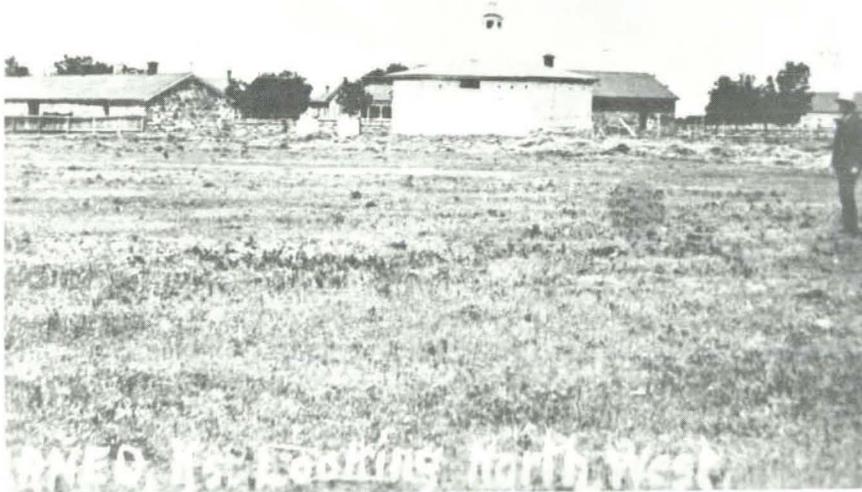
Building 10, Blockhouse, 1865.

As seen from the southeast corner of the fort in 1886. Structure was dismantled before 1900.

Unfortunately, it was dismantled shortly after 1886. Descriptions of it are vague as to its exact shape: being variously described as 6, 7, and 8-sided, and sometimes designated as the "roundhouse". As originally built, the roof was of poles, hay, brush and earth.

Captain Rockwell repaired and altered the blockhouse during his tenure as post construction supervisor in 1867-68. A shingle roof was added, as was a small wooden watch tower. As of 1868, it was used as the guardhouse, with a rough lumber room added as an extension from the door area for the use of the guard. Two rows of rifle ports pierced the walls on all sides; one near the ground and the other up close to the eaves. The building is mentioned as having had a cellar (where some post prisoners may have been lodged), with an interesting tunnel feature, or "covered way", extending about 14 feet from it to a well, making water available in the event of a siege or extended attack. Archeological research will be required to determine the location, ground plan, and other data about this interesting structure. As built, the walls were 11 1/2 feet high and about 22 feet on a side. Height of the original roof peak was 16 feet; increased to 20 1/2 feet by the watch tower addition.
