“On the shore dimly seen...”: an Archeological Overview  
Fort McHenry National Monument and Historic Shrine  
Baltimore, Maryland

John Milner Associates, Inc.  
5250 Cherokee Avenue, 4th Floor  
Alexandria, Virginia 22312

2000

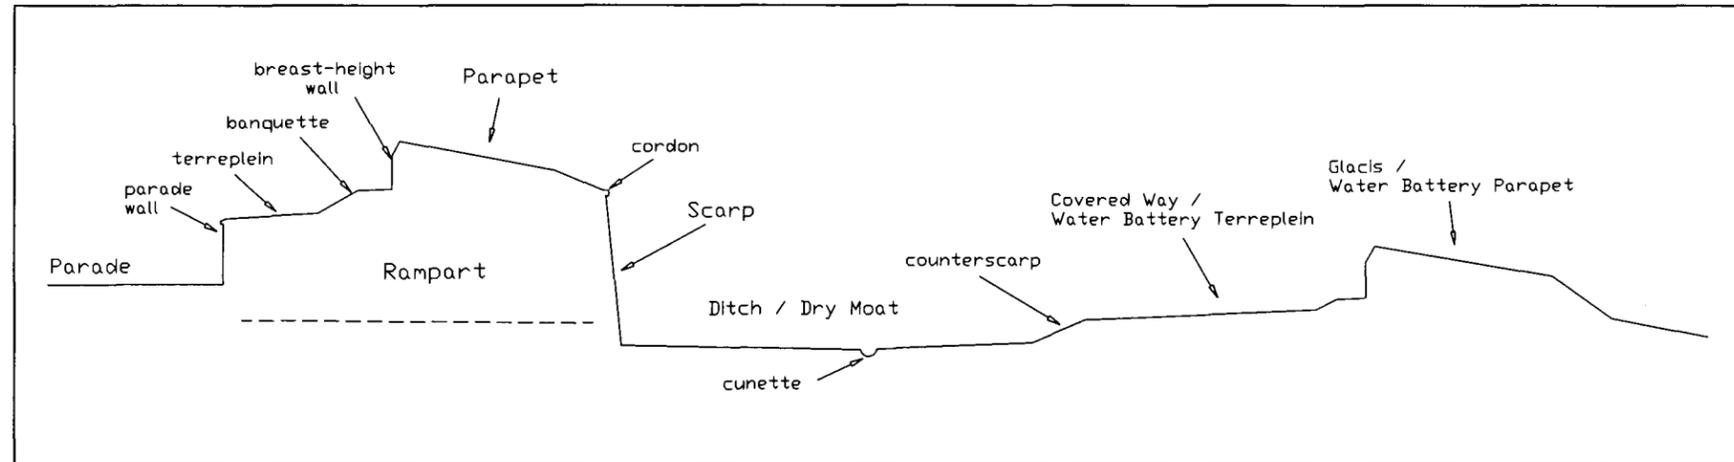
Figure 3. Schematic cross-section of a fort.

**banquette** A continuous step or ledge at the base of the parapet, sufficiently high to enable the defenders standing upon it to fire over the crest of the parapet.

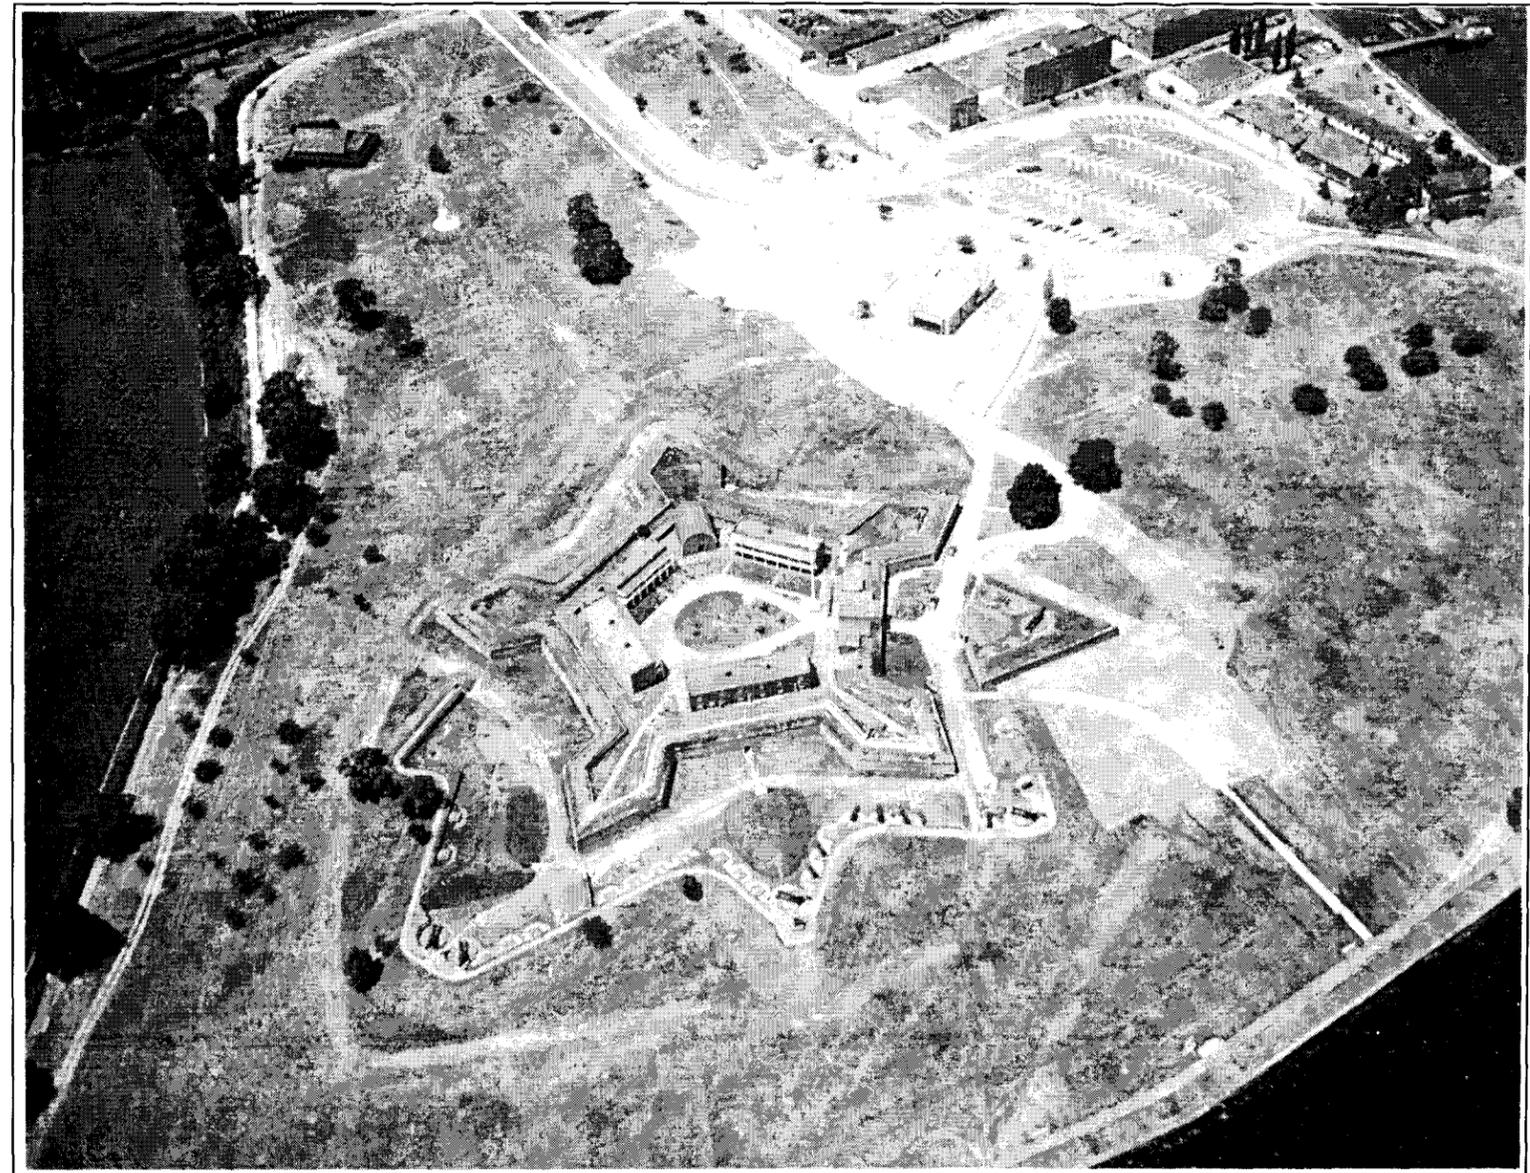
Figure 15. An aerial view of Fort McHenry National Monument and Historic Shrine from the southeast, ca. 1964.

Beginning in 1956, as part of its Mission 66 program, the NPS began planning for substantial improvements in the physical facilities of the park, the condition of historic structures, and the quality of interpretation.<sup>88</sup> Among the initial efforts was the Historical and Archeological Research Project (HARP) of 1957-58, which resulted in the establishment of the collection of copies of primary documentation concerning the fort noted above, as well as concise interpretive reports concerning the fort's development and historical context. The HARP effort served as the foundation for Nelson's 1961 Historic American Buildings Survey report and for the 1974 Historic Structure Report by Thompson and Newcomb, as well as for all future interpretive plans. The new facilities, built in 1964, included a new visitor's center and a new and substantially larger parking lot; the visually intrusive lot adjacent to the ravelin was removed. New maintenance facilities and staff housing were also constructed, in the northwestern corner of the park, and various alterations and improvements were made in the park's landscape (Figure 15). The archeology performed at Fort McHenry during the 1950s and 1960s is discussed below.

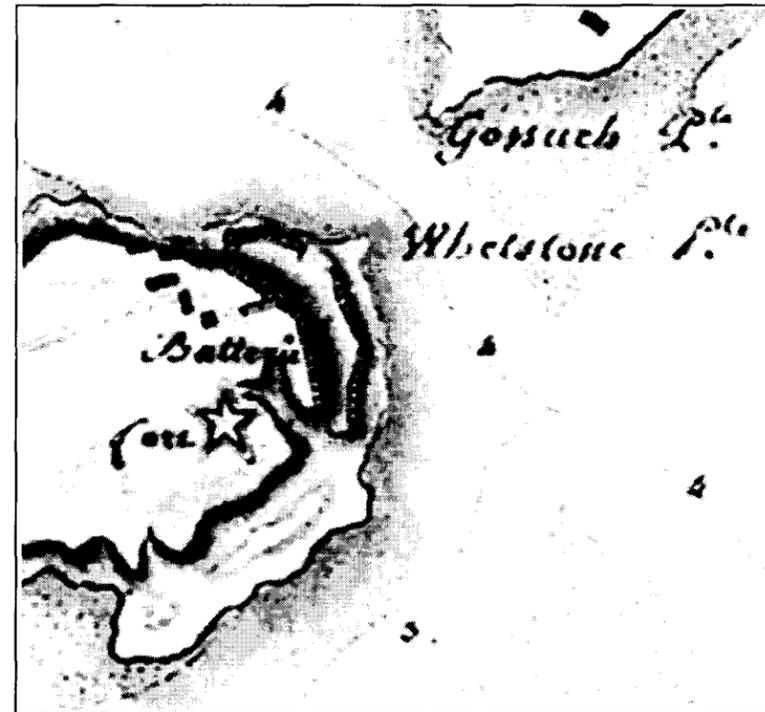
Figure 17. Detail of Berthier's *Port et Rade de Baltimore*, 1782.

The 1782 Rochambeau collection map (Berthier 1782) shows Fort Whetstone, the original earthen redoubt at the site, configured as a 'true' heraldic star, situated on the southeast edge of a plateau at the east end of Whetstone Point (Figure 17). Surrounding this plateau there appears to have been a somewhat less-elevated terrace or bench, on the northeastern part of which the fort's upper water battery had been constructed. Grade was lower still, of course, toward the shoreline of the point, where the lower water battery was located. Intruding into the terrace at the south end of the upper water battery, east of the star fort, is what looks like a small ravine. This ravine-like feature is likely to have been created in establishing a roadway to facilitate communication among the three elements of the fortifications: the redoubt on the plateau, the upper battery on the terrace, and the lower battery along the shoreline. Rivardi's 1794 letters to the Secretary of War and the Governor of Maryland imply this,<sup>6</sup> but they also suggest that exposure of iron ore deposits in the area had encouraged additional excavation, between 1781 and 1794, to exploit the ore. Along the shoreline south and southwest of the fort there were small hillocks, most likely remnants of the once larger terrace, isolated as a result of erosion or earlier mining activity. Rivardi remarked, in his letter to the Governor, that the easternmost of these hillocks functioned as an epaulement for the right flank of the lower battery. The 1819 and 1834 plans of Fort McHenry indicate that remnants of a hillock to the fort's south served as the site of the fort's original cemetery, prior to its ca. 1836-37 removal.

the fort's existence. As discussed above, Berthier's map (Figure 17) indicates the notable original topographic features at the site: the high-ground plateau at the southeast end of Whetstone Point, with elevations of about 30-35 ft. amsl; an uneven, presumably sloping terrace or bench at the margins of the plateau, with elevations of 15-30 ft. amsl; and a low-lying shoreline area, with elevations of 5-15 ft. amsl. Also depicted, in addition to the fortifications themselves, are hillocks within the area of low ground south and southeast of the redoubt, and what is likely to have been an artificial cut into the terrace, made for the purpose of communication among the fortification components. The low ground, as a distinct element of the landscape, had very likely been at least partially produced by earlier mining activity, accompanied by erosion.

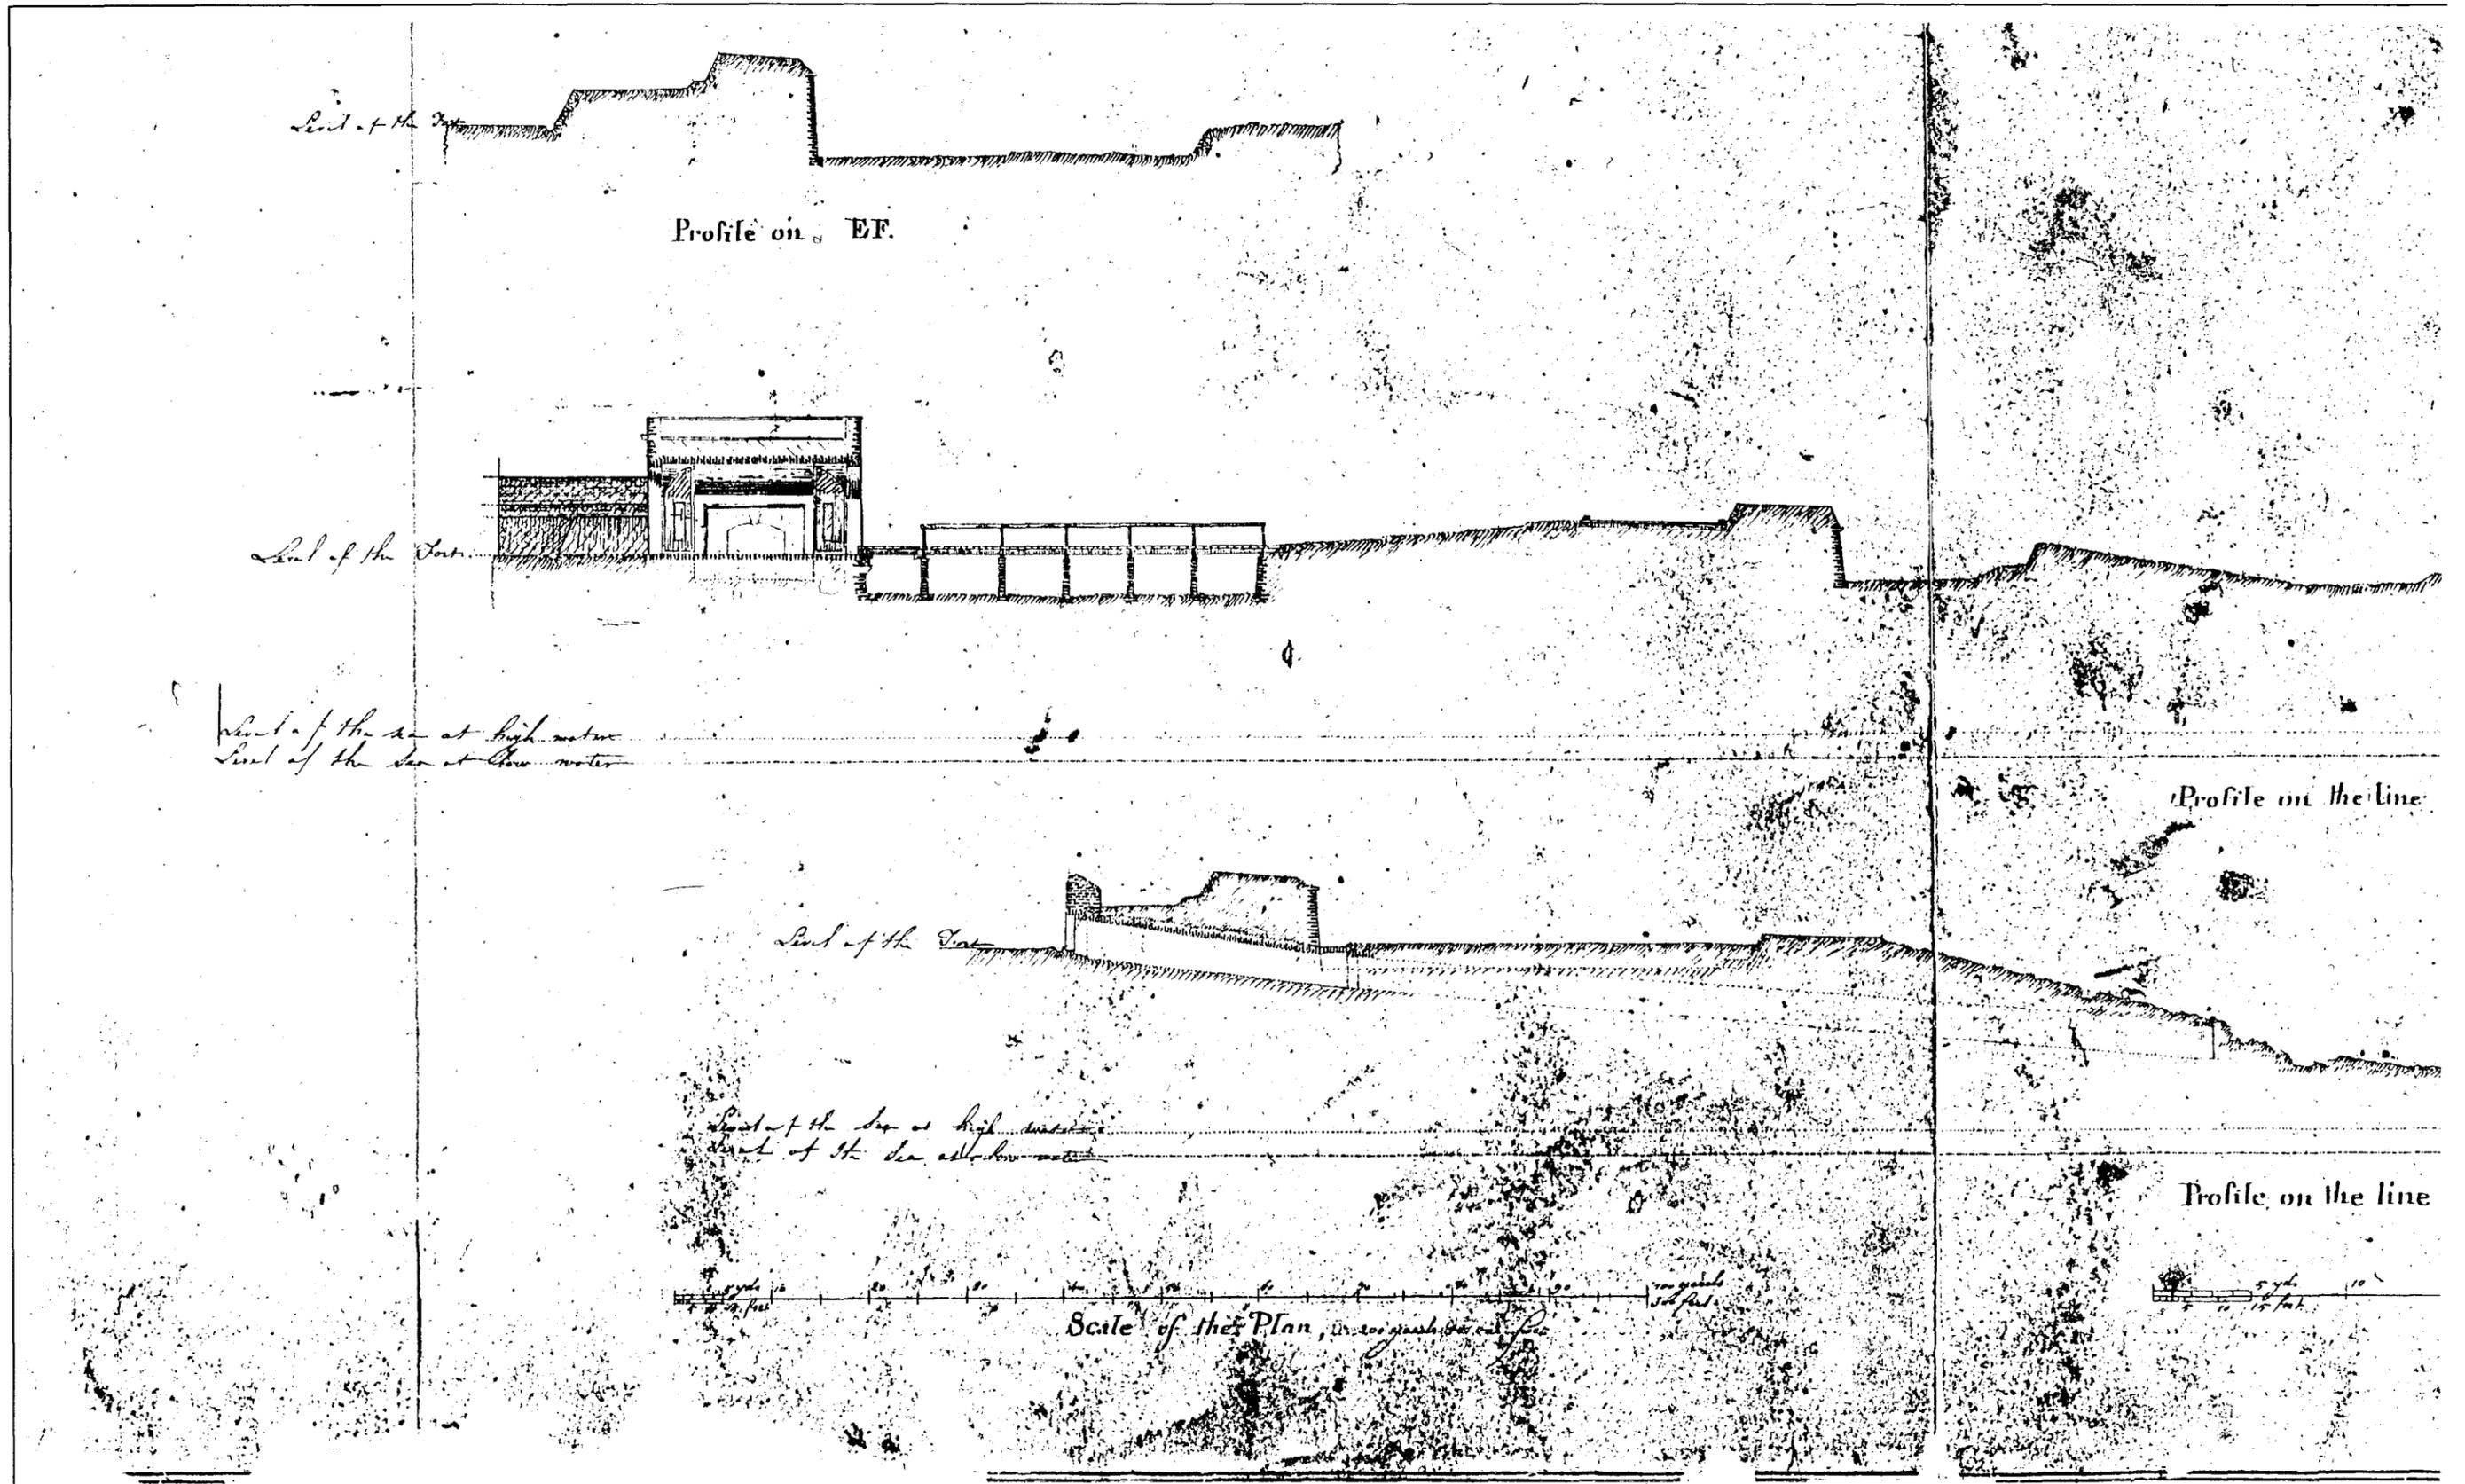
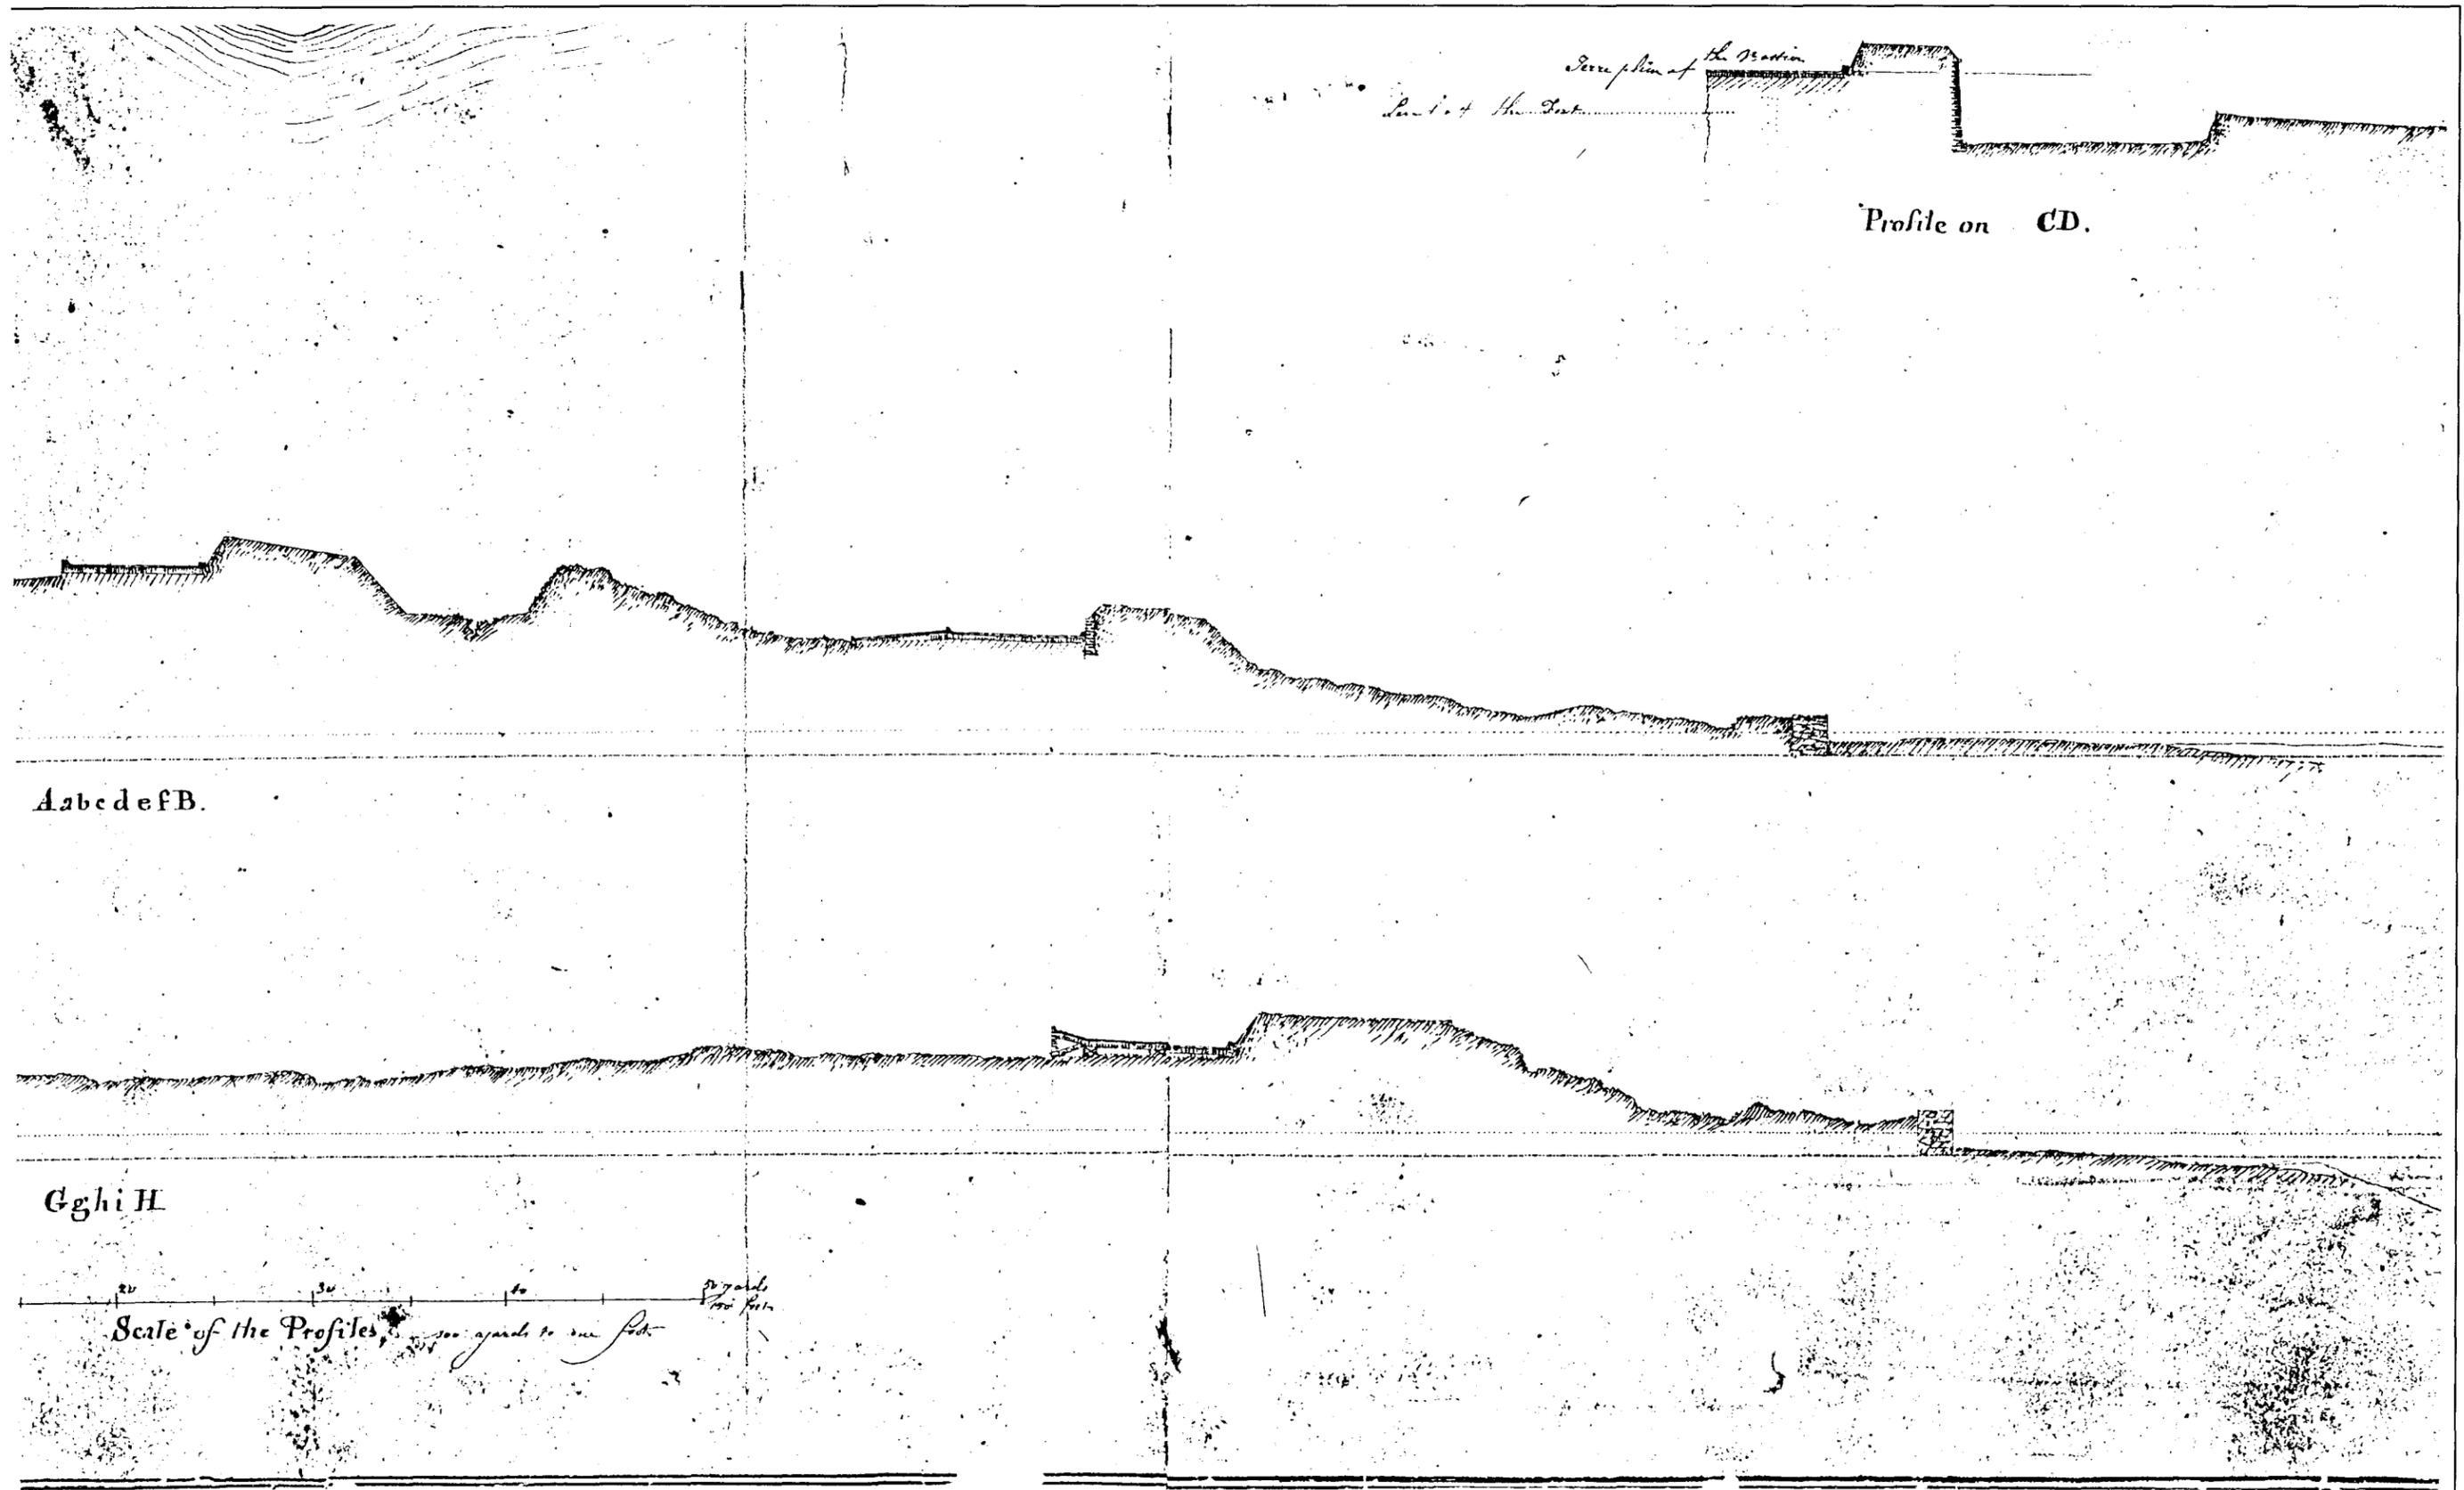
Figure 18. Detail of Capt. William Tell Poussin's *Plan and Profiles of Fort McHenry*, 1819, showing profiles: Aa...fB through sally port, gorge,

ravelin, and water batteries; CD through left face of bastion 1; EF through bastion 2-3 curtain; Gg...iH through postern, moat (caponniere), glacis, and lower water battery.

In any case, one of the 1819 profiles, keyed E-F and located at the center of the curtain between bastions 2 and 3, depicts a 20 ft. wide terreplein (although the accompanying plan indicates an 18 ft. width), 5.5 ft. above the higher, northwestern part of the parade, and 2.25 ft. below the level of the scarp wall cordon. Another 1819 profiles, keyed GghiH, and located at the center of the curtain between bastions 4 and 5, has the terreplein, about 17.5 ft. wide, situated 6.5 ft. above a lower part of the parade (where drainage from the parade emptied into the postern), and 2.8-3 ft. below the

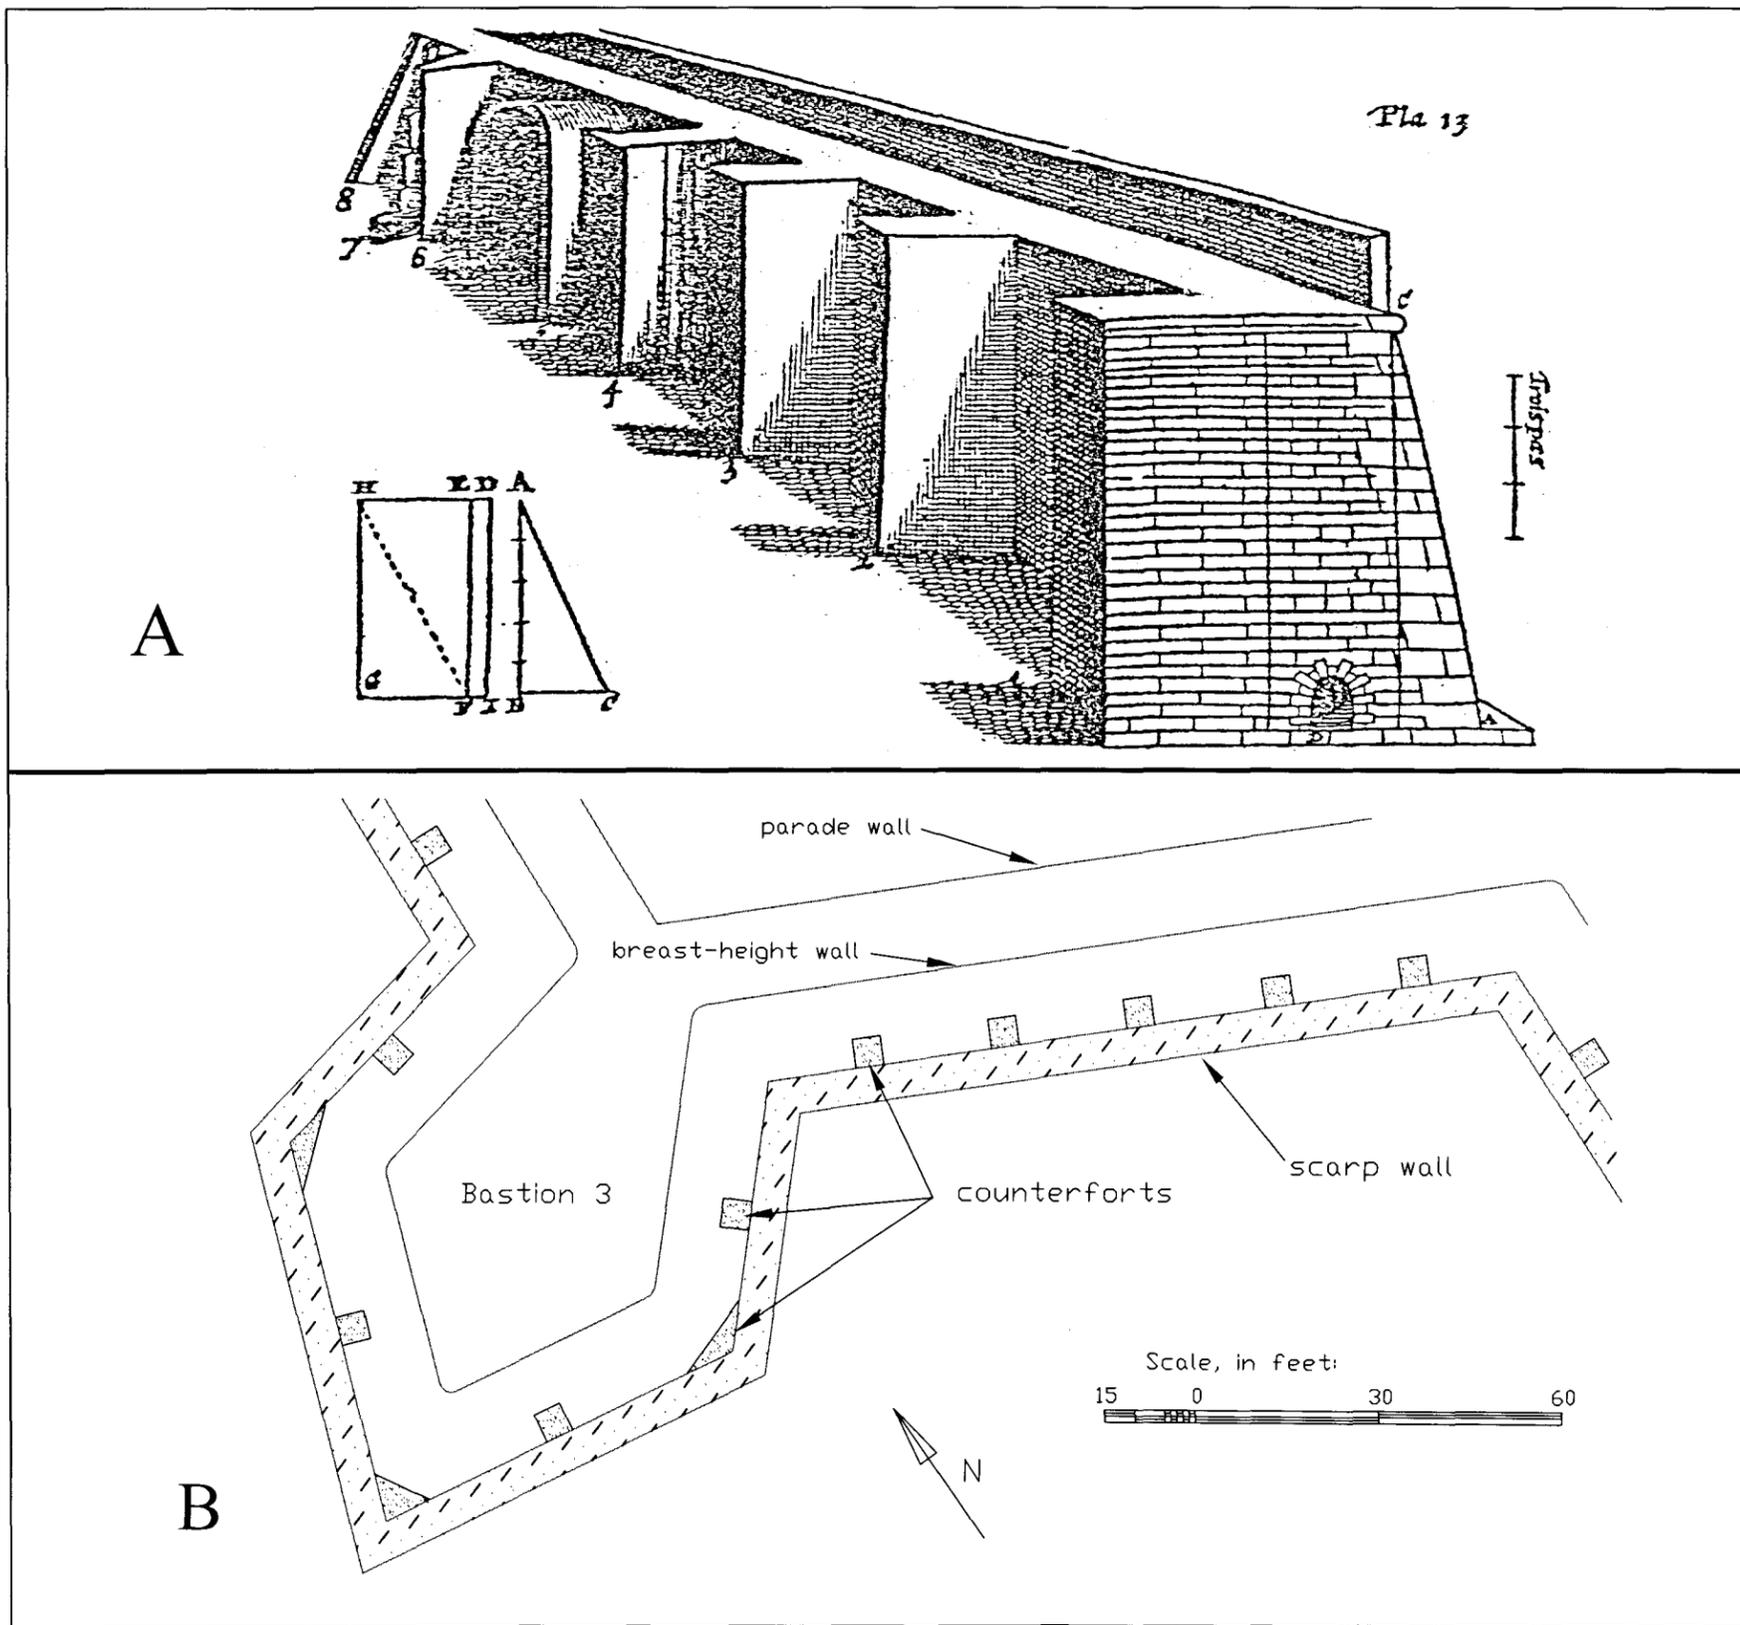
Figure 20. A - DeVille's drawing, 1629, showing counterforts (Duffy 1975:42); B - Configuration of Fort McHenry's counterforts (based on Joseph and Cheek 1985: Figure 18).

Counterforts, which function as stone buttresses, have been documented beneath Fort McHenry's parapet, adjoining the interior side of the inner wall.<sup>34</sup> The counterforts and the earth fill of the rampart between them were intended to help prevent the collapse of the scarp wall under bombardment. In contrast to the foundations, Fort McHenry's counterforts were constructed of dressed stone, and laid up without chinking stones.<sup>35</sup> The counterforts are commonly rectangular in plan, about 4.65 ft. wide by 5 ft. front-to-back, perpendicular to the scarp wall. There are triangular counterforts, however, interior to the salient angles and shoulders of the bastions. Each bastion face and flank wall has one rectangular counterfort behind it, while each of the curtain walls has four or five rectangular counterforts, one centrally located (except at the sally port, and presumably 3

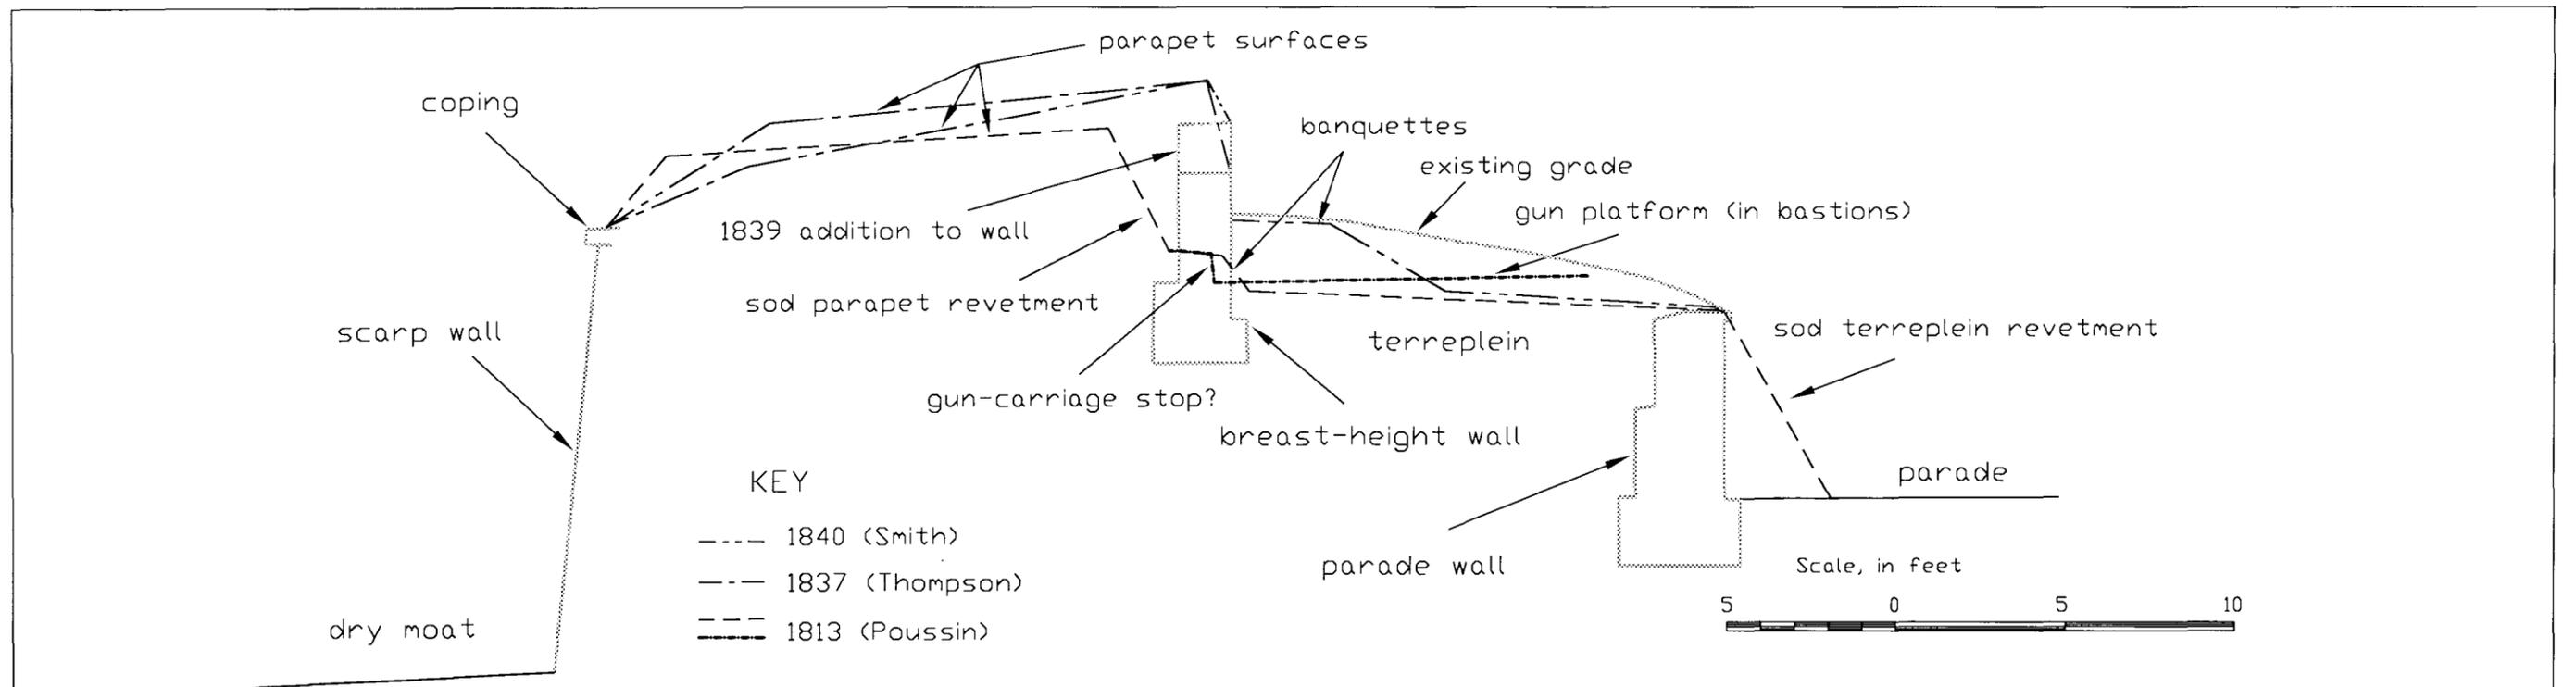
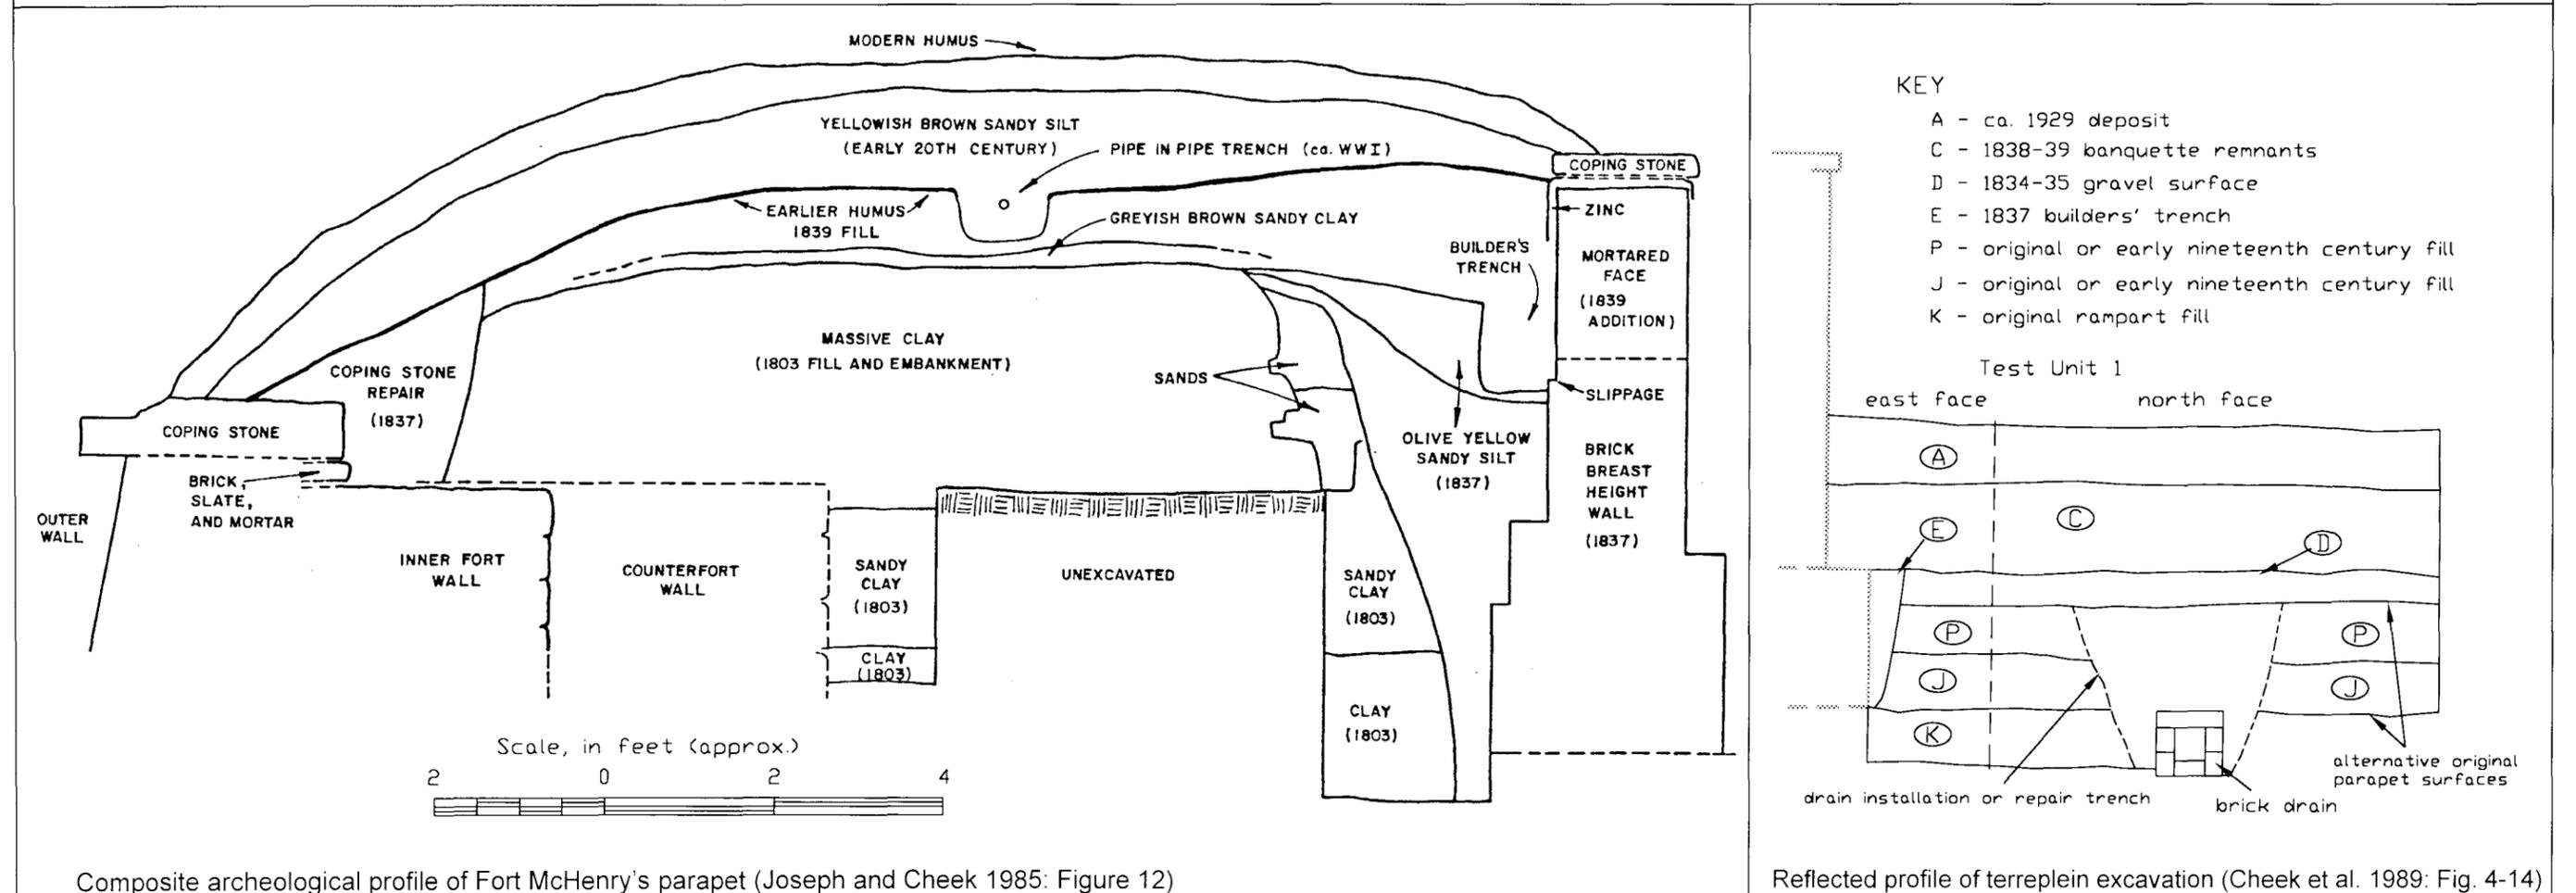
Comparative overlay of historical cross-sections of Fort McHenry's parapet and terreplein, 1819-1840.

Composite archeological profile of Fort McHenry's parapet (Joseph and Cheek 1985: Figure 12)

Figure 21. Comparative overlay of historical cross-sections and archeological profiles of Fort McHenry's parapet and terreplein.

The interior slope of the original parapet was for the most part destroyed when the breast-height wall was built, beginning in 1837, along the same alignments. Remnants of what must have been the upper part of the slope have been identified, however, in some parapet excavations. A more complete section of the sod-revetted interior slope was documented in 1994, as discussed below, interior to the angle between the right flank of bastion 1 and the northwest end of the northeast (sally port) curtain wall. The original parapet, as shown on the 1803 and 1834 plans, had larger-radius

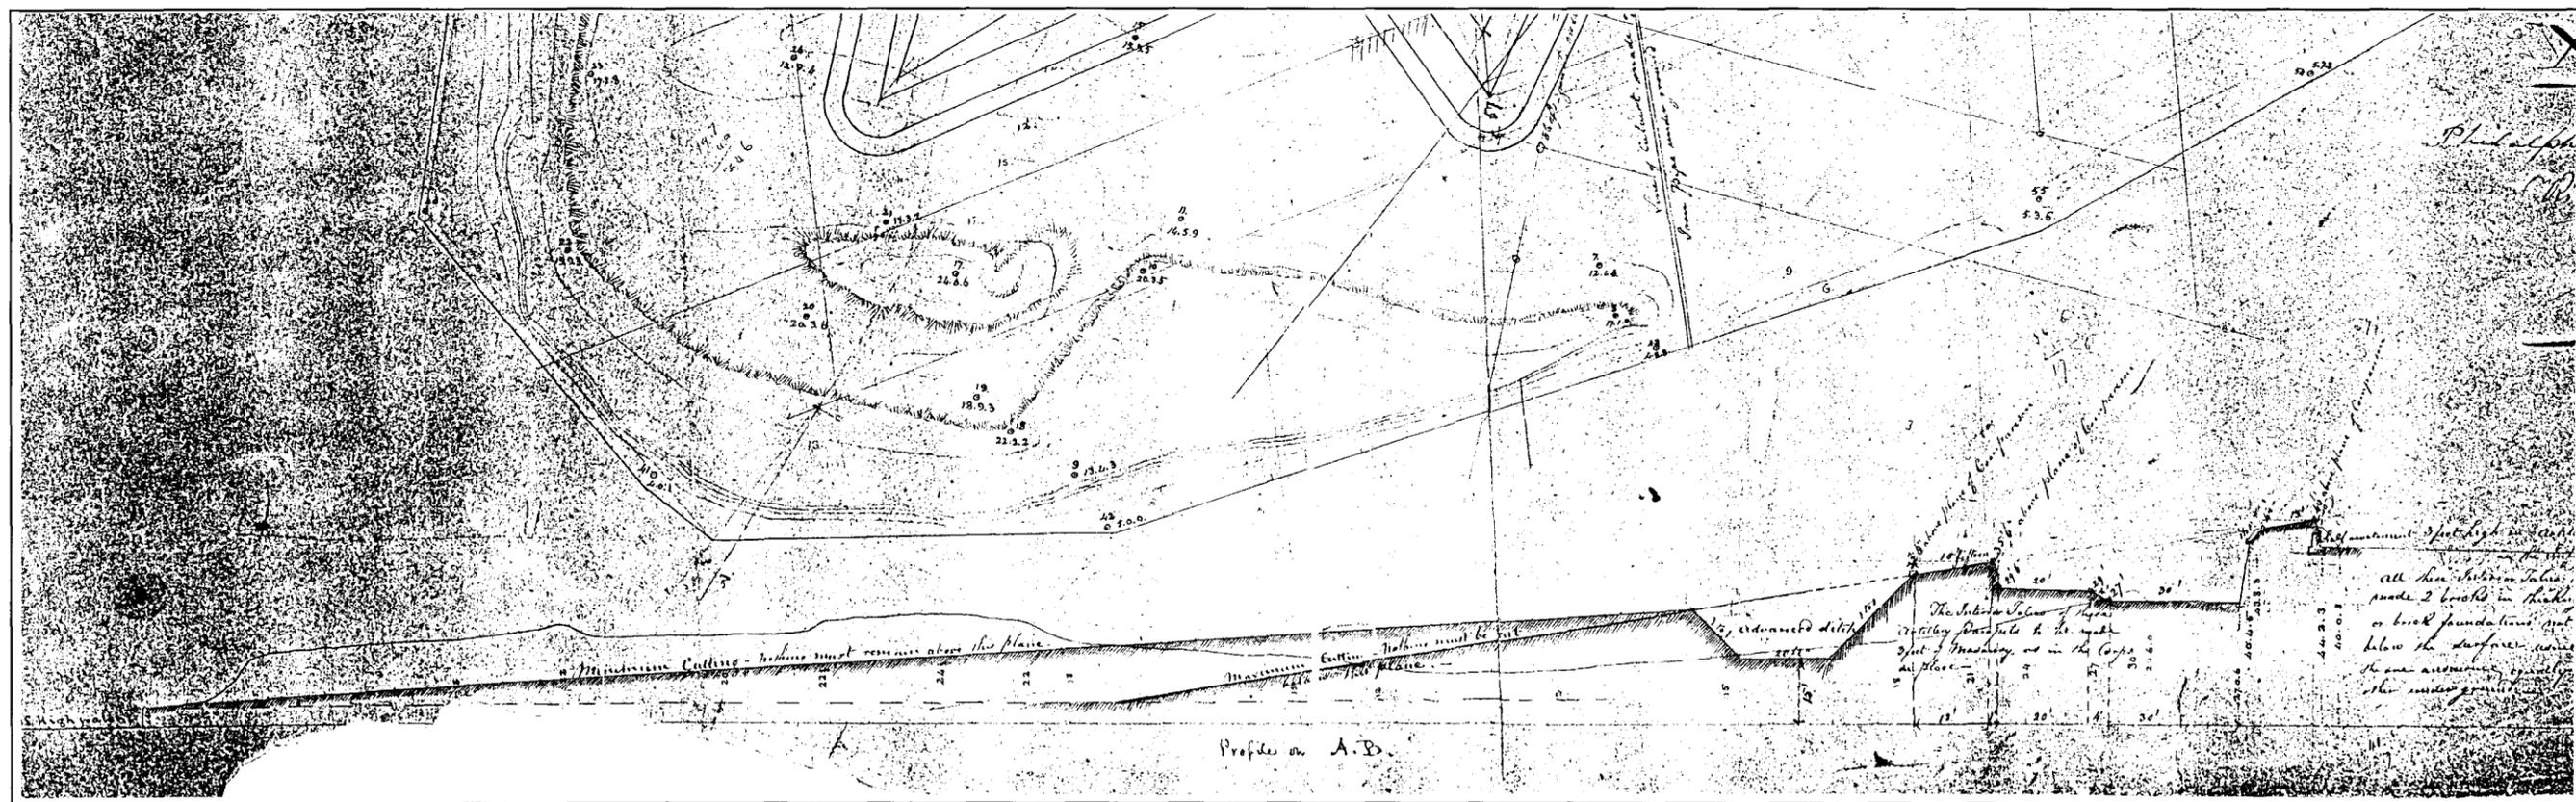
Figure 22. Detail of Capt. Richard Delafield's Project for an exterior battery to Fort McHenry, 1836, showing the profile of the fort and battery.
