“On the shore dimly seen...”: an Archeological Overview  
Fort McHenry National Monument and Historic Shrine  
Baltimore, Maryland

John Milner Associates, Inc.  
5250 Cherokee Avenue, 4th Floor  
Alexandria, Virginia 22312

2000

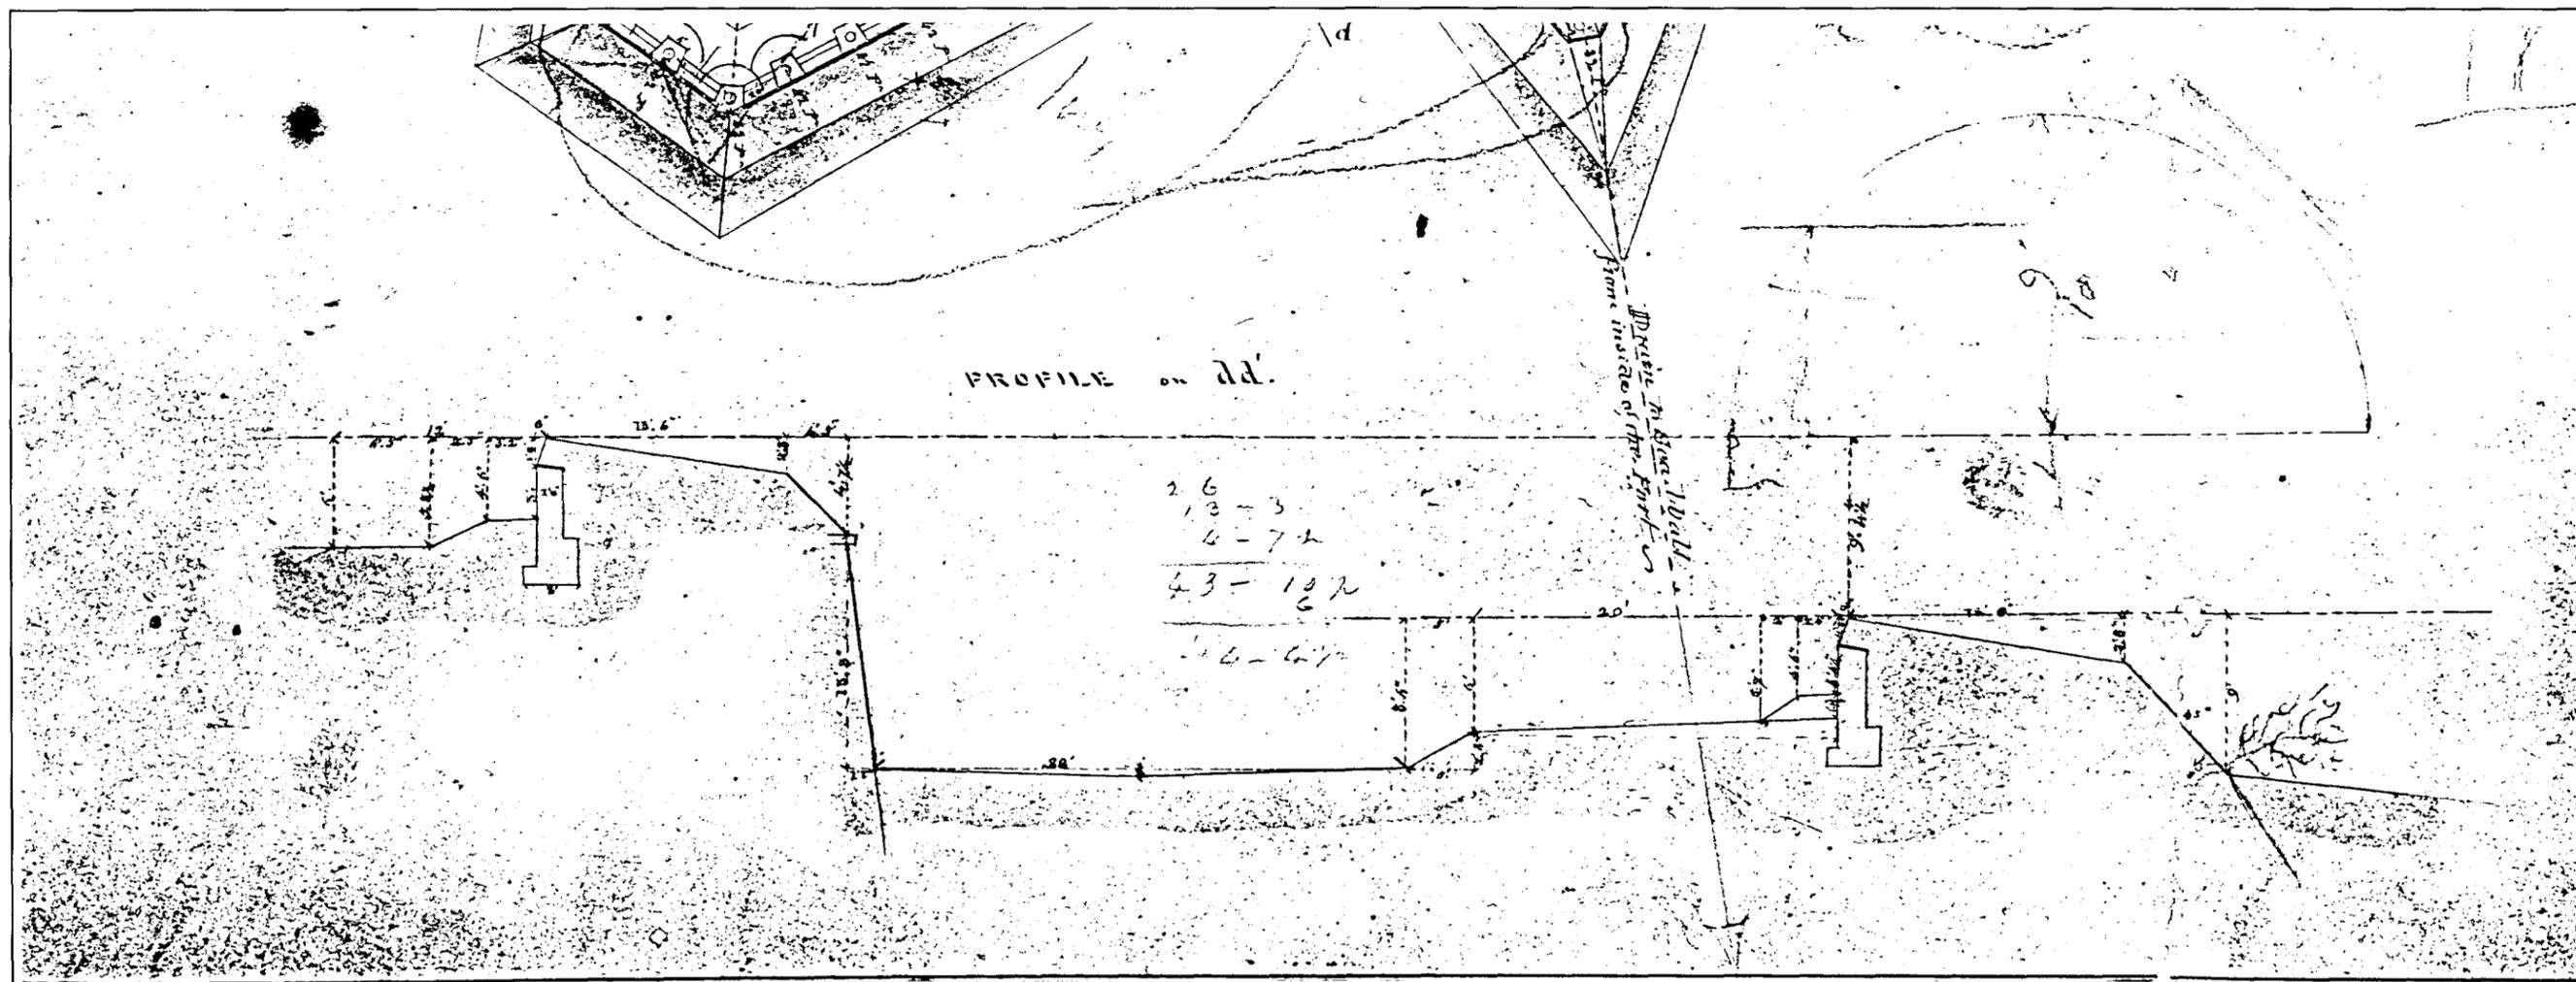
Figure 23. Detail of Capt. Fred A. Smith's *Fort McHenry*, 1840, showing the profile d-d', through left face of bastion 4 and the water battery. The abatis depicted exterior to the outer battery's parapet is a Civil War era feature, added, along with certain other details, during the war, when the drawing was evidently at the fort in the possession of Col. Henry Brewerton.

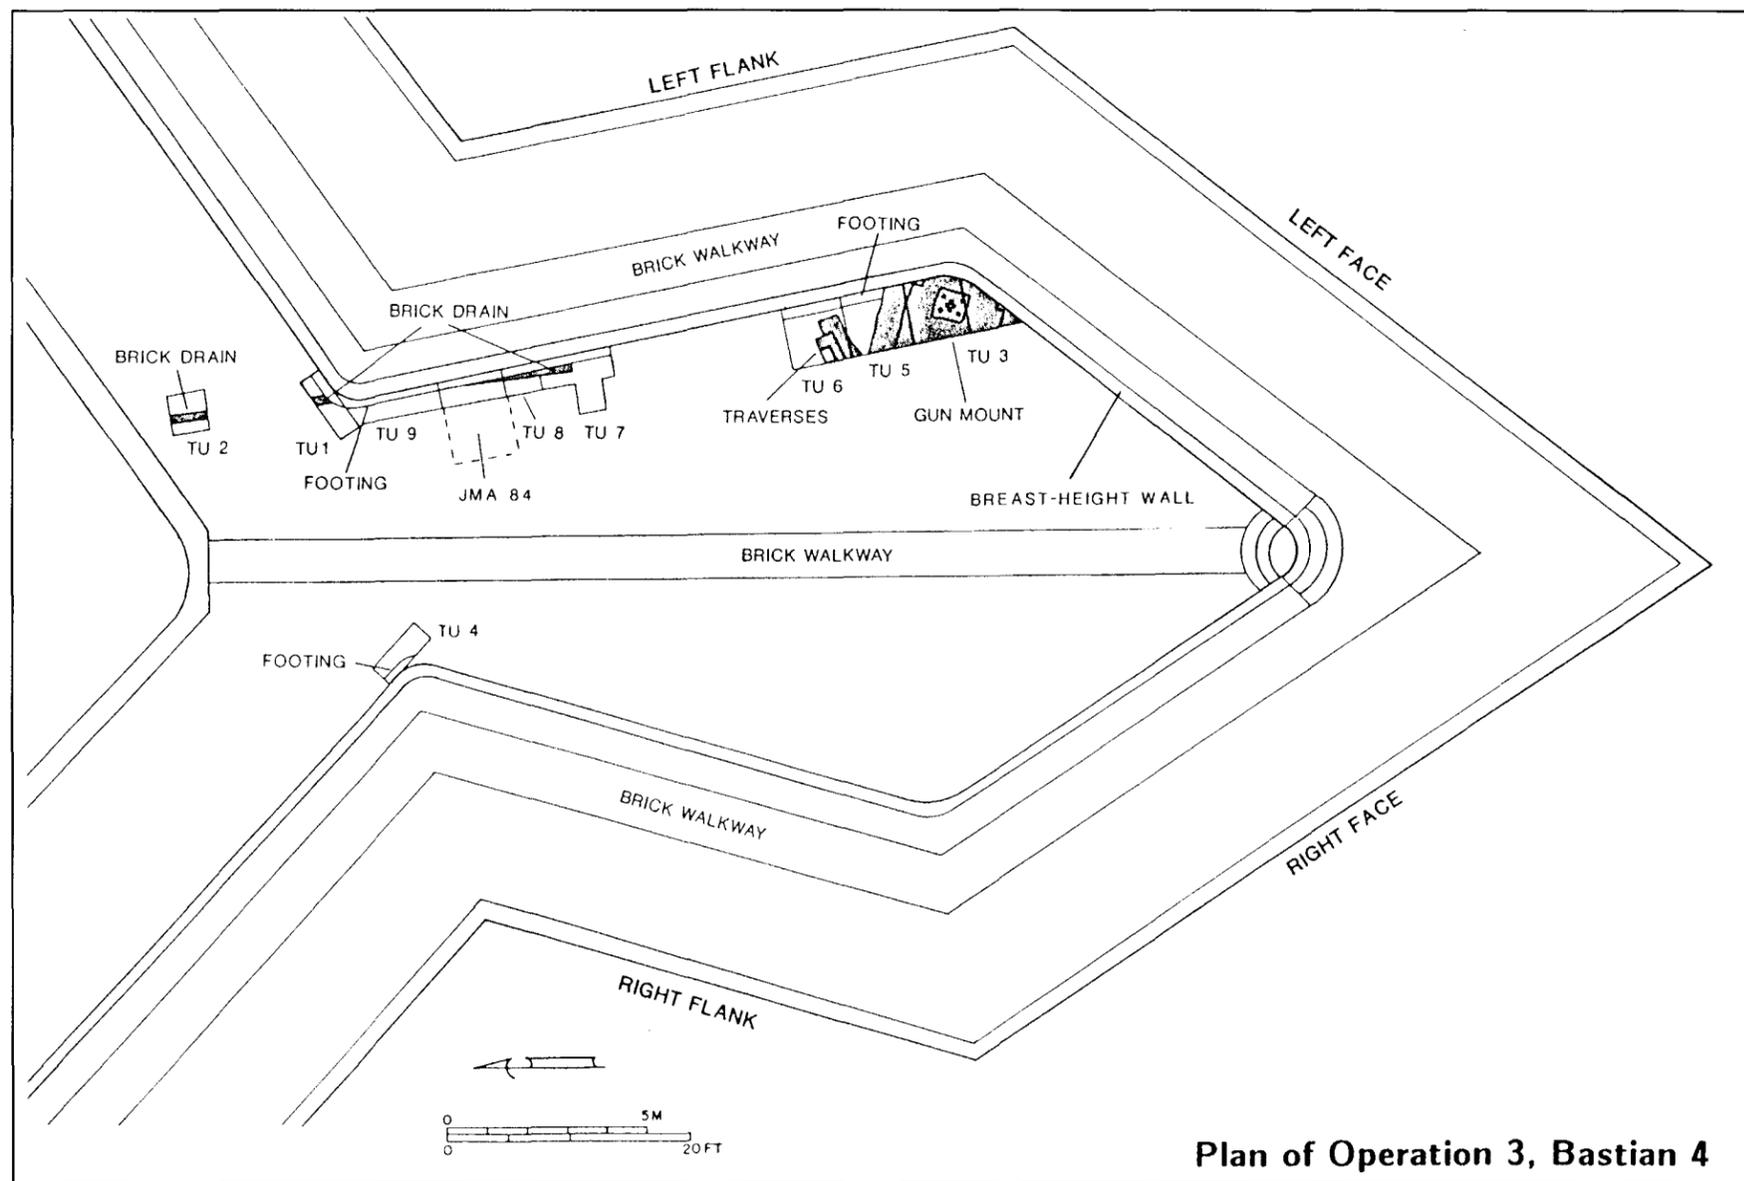
Figure 24. Plan of excavation in bastion 4, showing the ca. 1814-15 (?) brick drain and 1837-39 gun emplacement (Cheek et al. 1989:Figure 4-9).

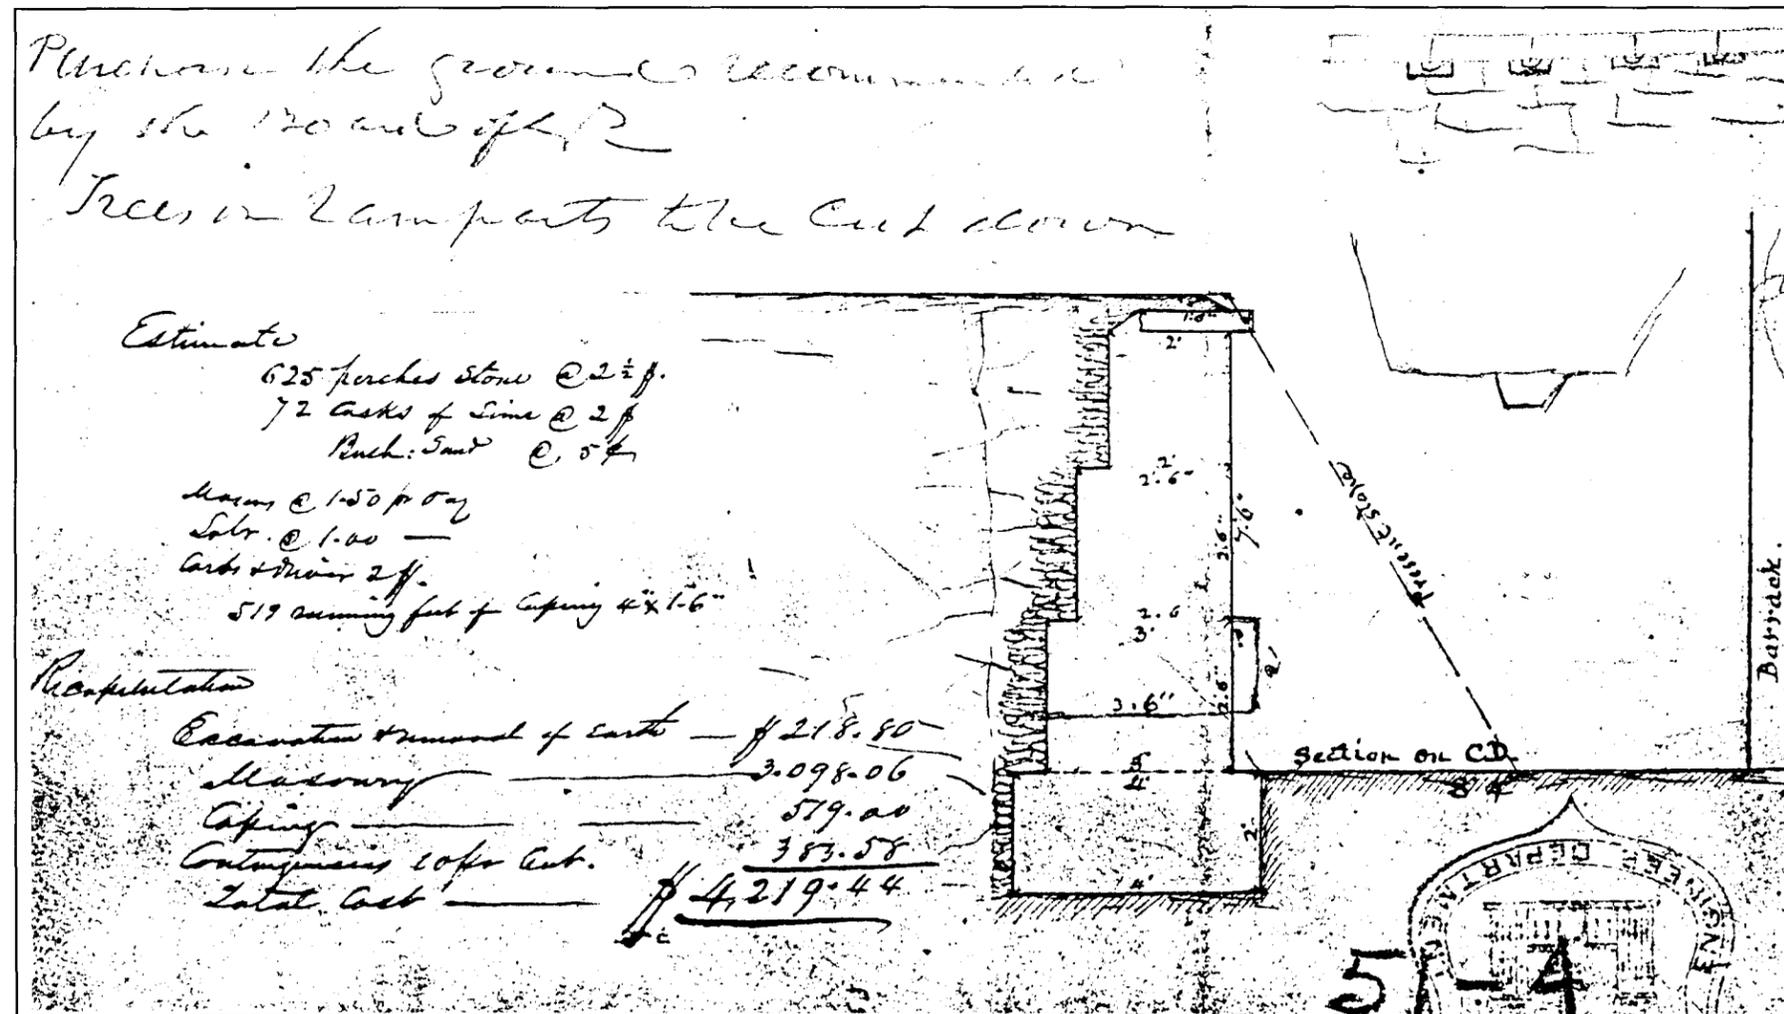
Figure 29. Detail of Fort McHenry, Md., ca. 1833, showing cross-section of parade wall behind enlisted men's barracks no. 2.

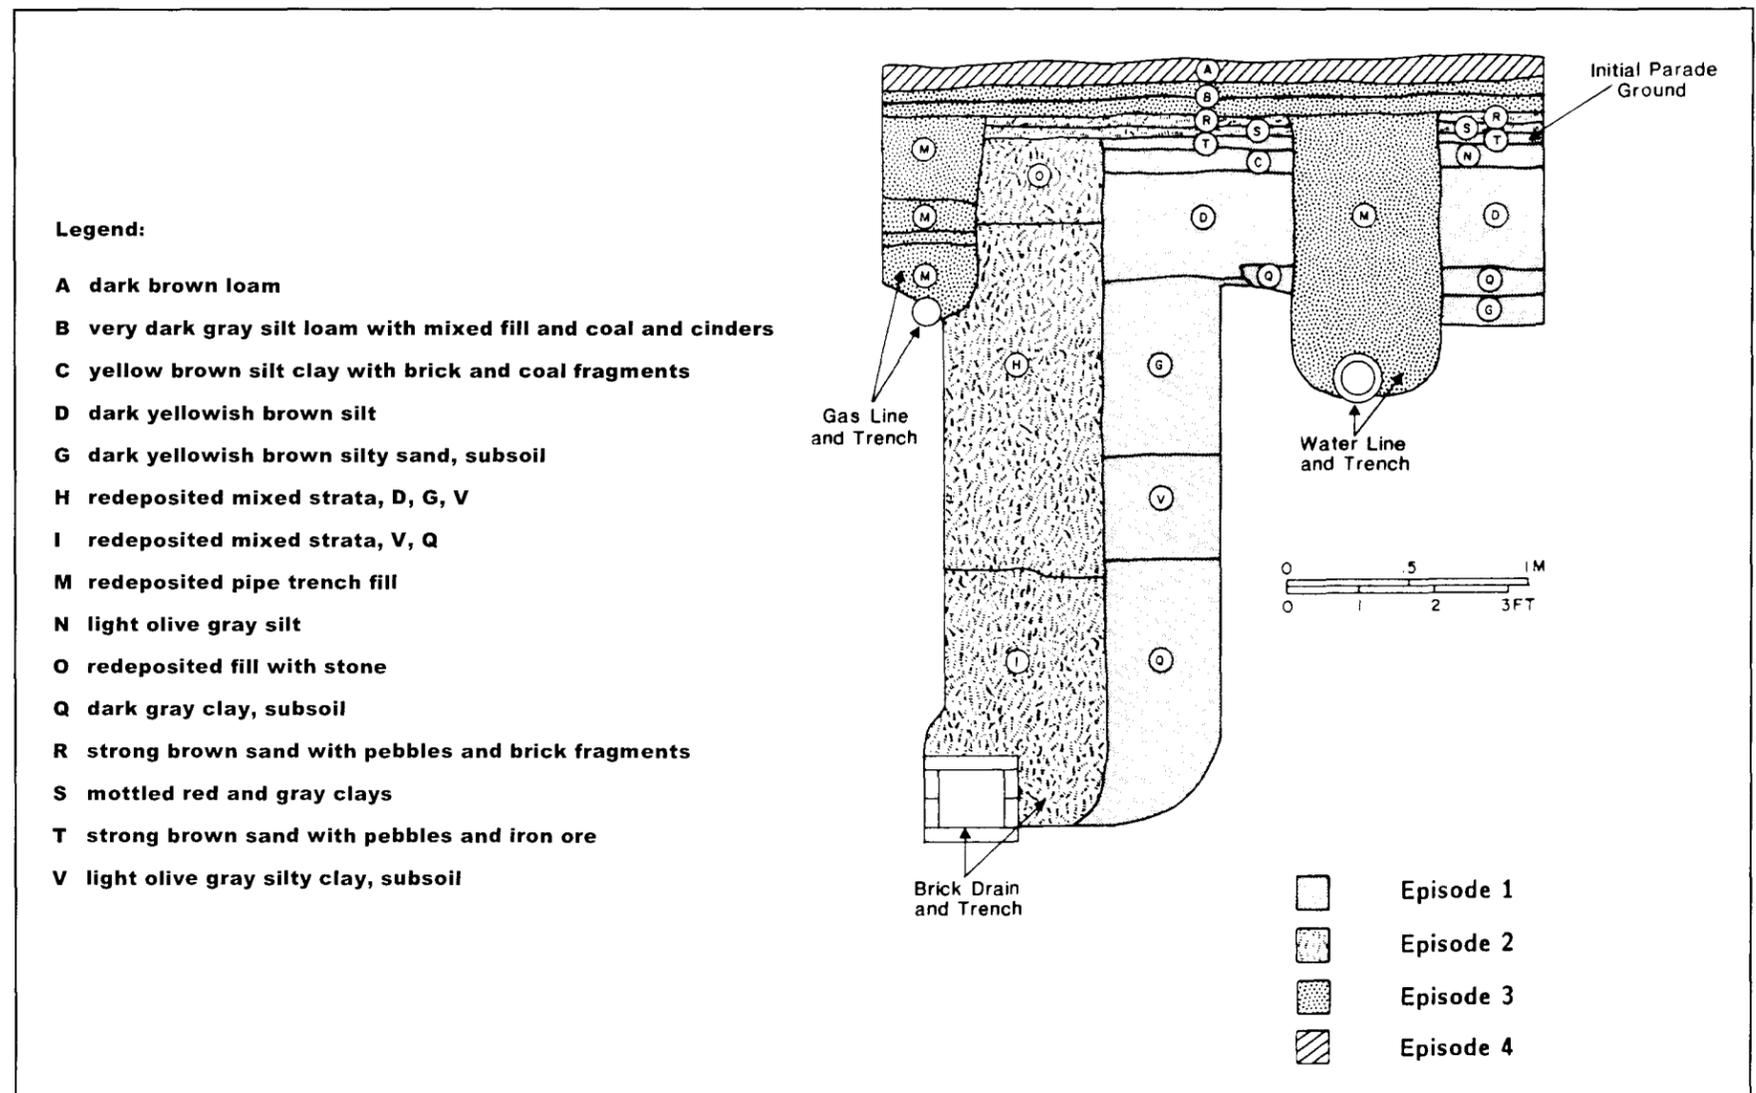
Figure 31. Profile of JMA's test unit 1, north face, 1988, showing the stratigraphy of the parade and the early drain (Cheek et al. 1989:Figure 4-19).

The natural sequence is capped by the probable initial cultural stratum, a clay layer (Figure 31, strata C and N) that may have been placed as a sealing cap to aid surface runoff, or as the base for the parade surface. Resting directly on this clay, at a depth of 1-1.2 ft. below the present surface, is a layer of pebbles and iron ore fragments in a strong brown sand (stratum T).<sup>104</sup> This most likely was the ca. 1800-1830 surface of the parade, but may have been just a construction era surface, ca. 1799-1800. Above this layer was another strong brown sand with pebbles and brick fragments (stratum R), in some areas separated from the underlying, ore-laden layer by a mottled clay layer (stratum S). The stratum R surface is likely to correspond with one or more of the episodes of development that began with the 1829 construction of second stories on the quarters and barracks, continued with 1833-34 construction of the parade wall and new surface drains, and concluded with the 1835-40 construction of gun

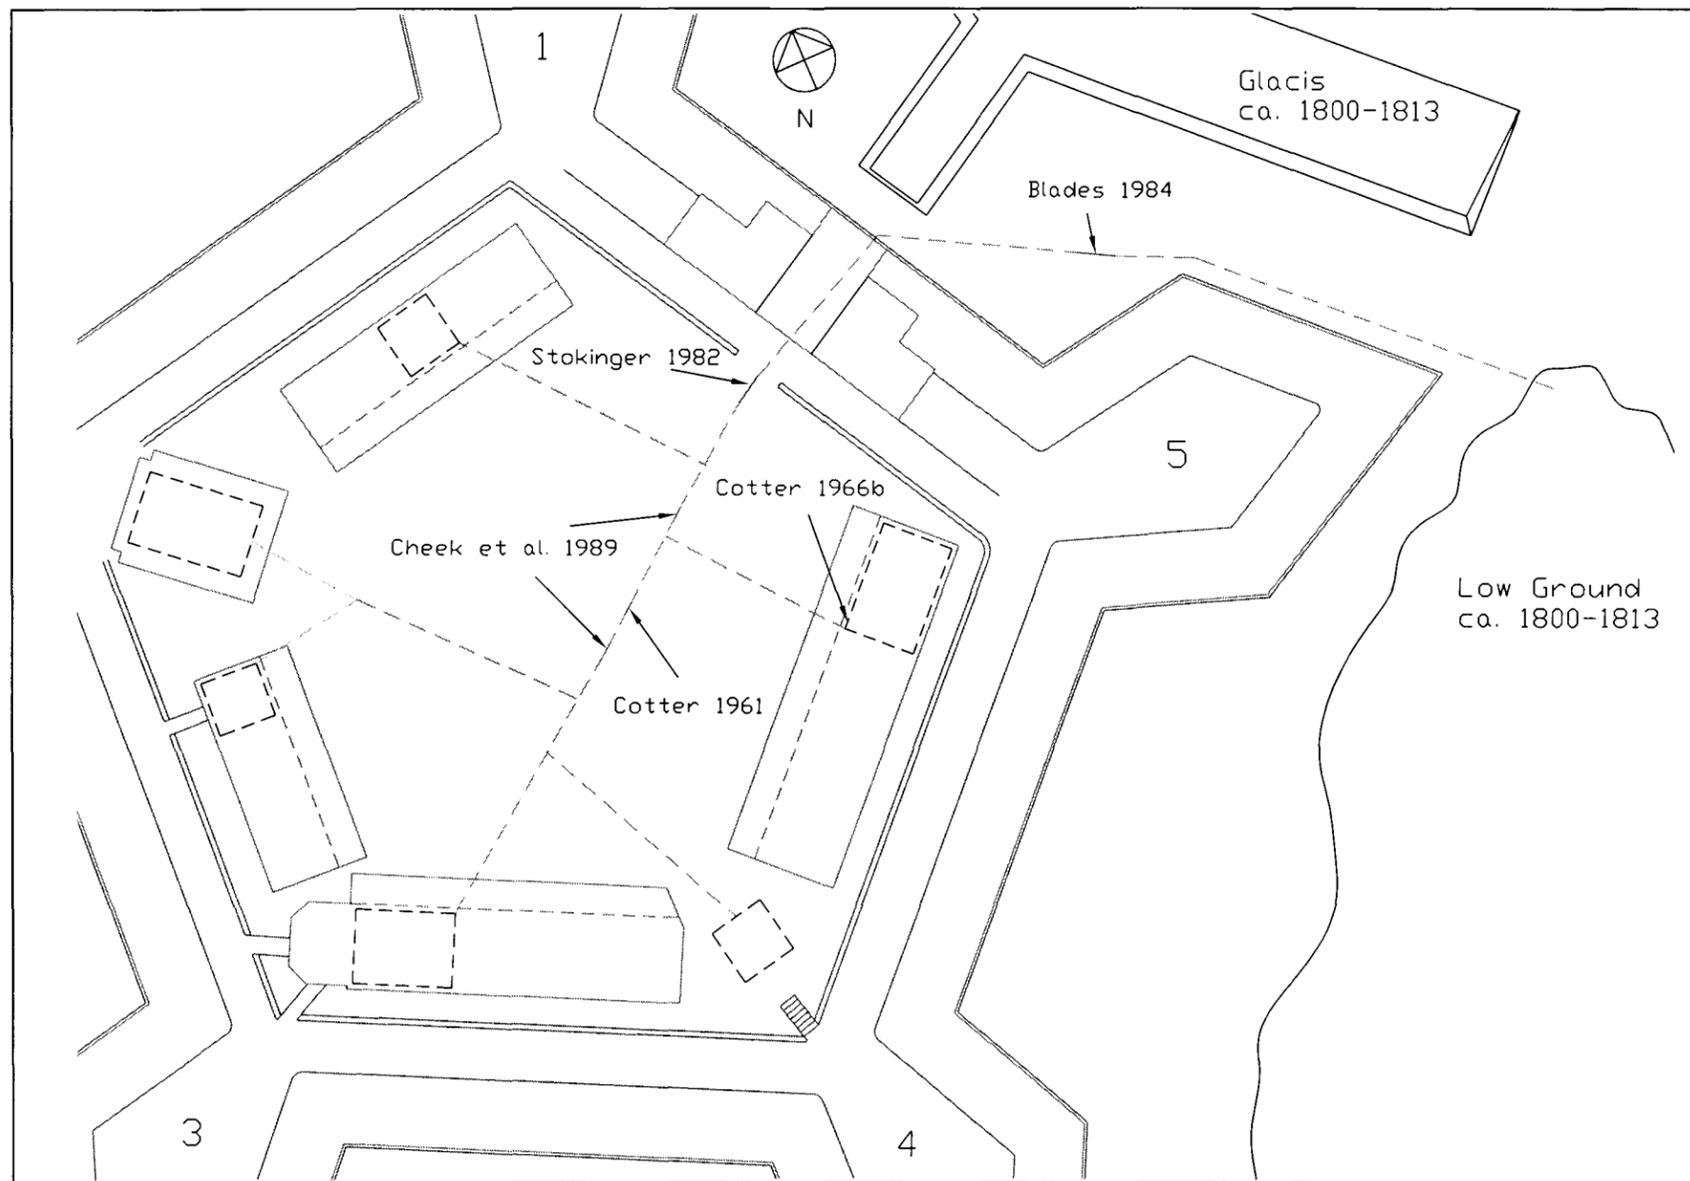
Figure 32. Conjectural plan of Fort McHenry's original subsurface drainage system. Arrows mark where the drain or its trench have been found.

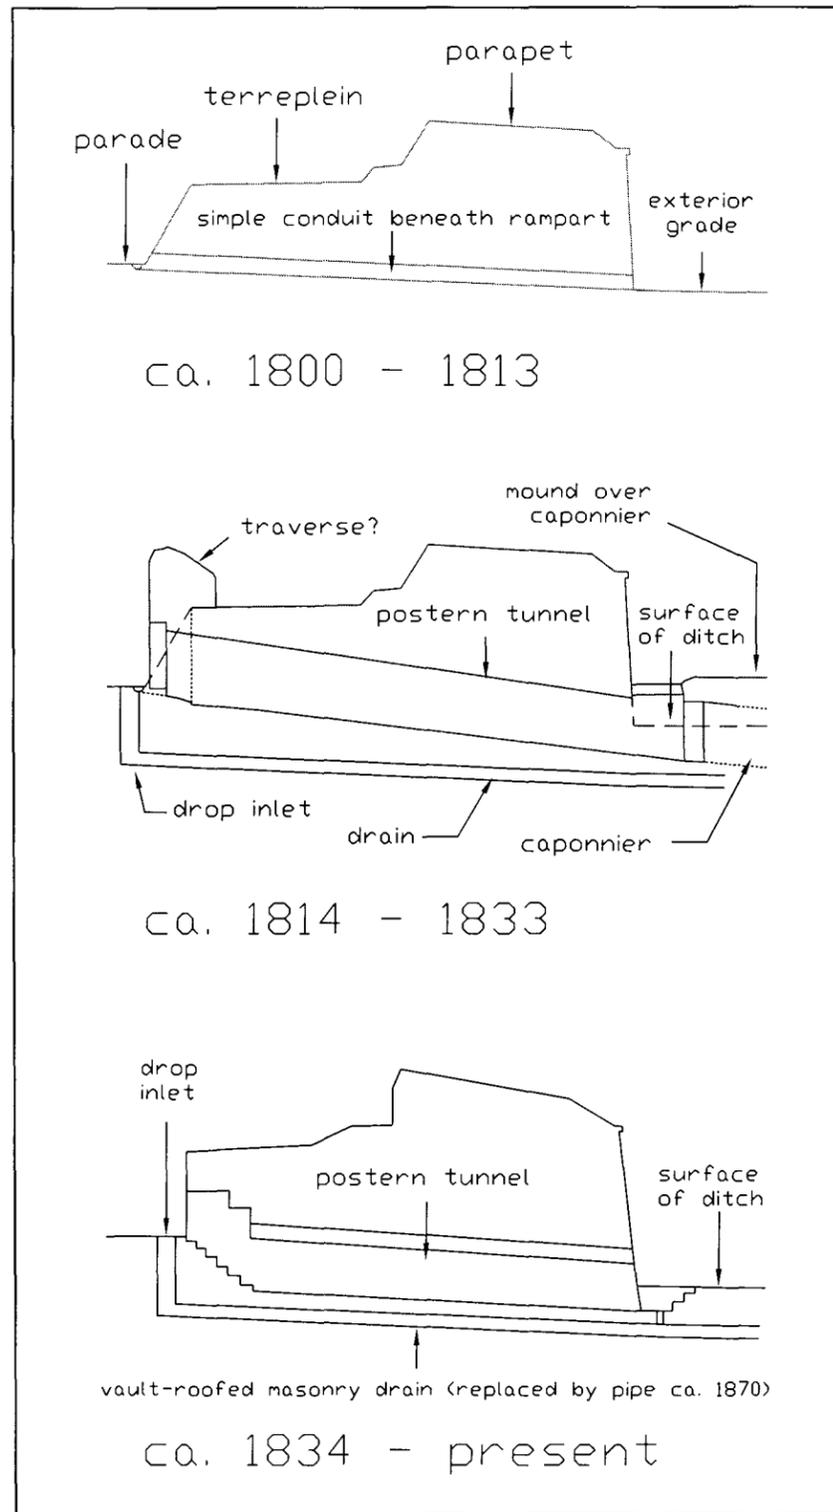
Figure 33. Sequence of development of postern tunnel; the ca. 1800-1813 configuration and the 1814-1833 drain are hypothetical.

During the partial reconstruction of the parade wall in 1975, one side of an alteration or repair trench over the postern tunnel was exposed; if

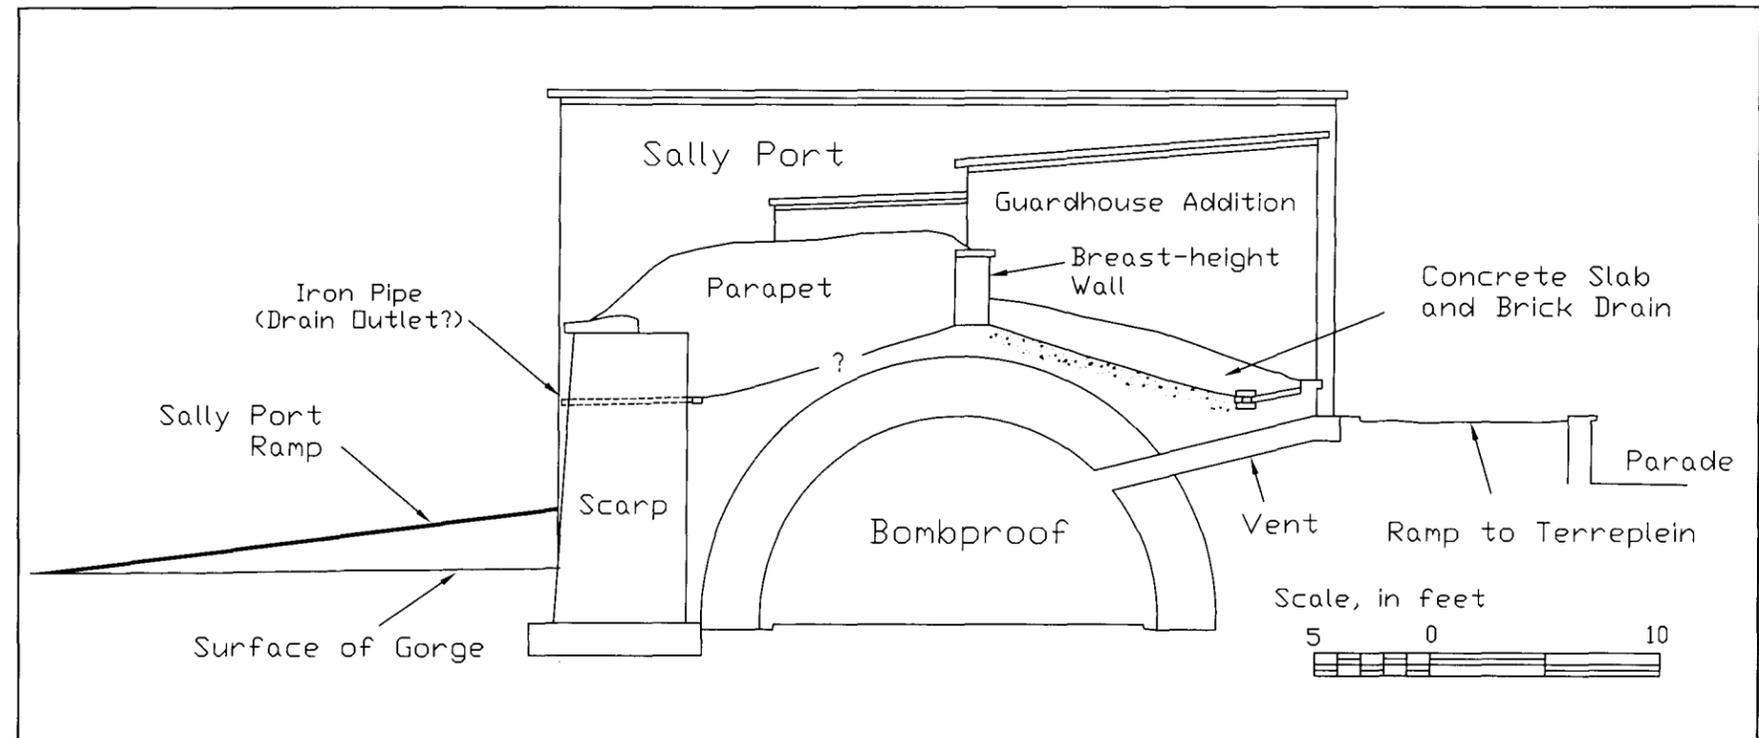
Figure 35. Cross-section through the rampart northwest of the sally port.

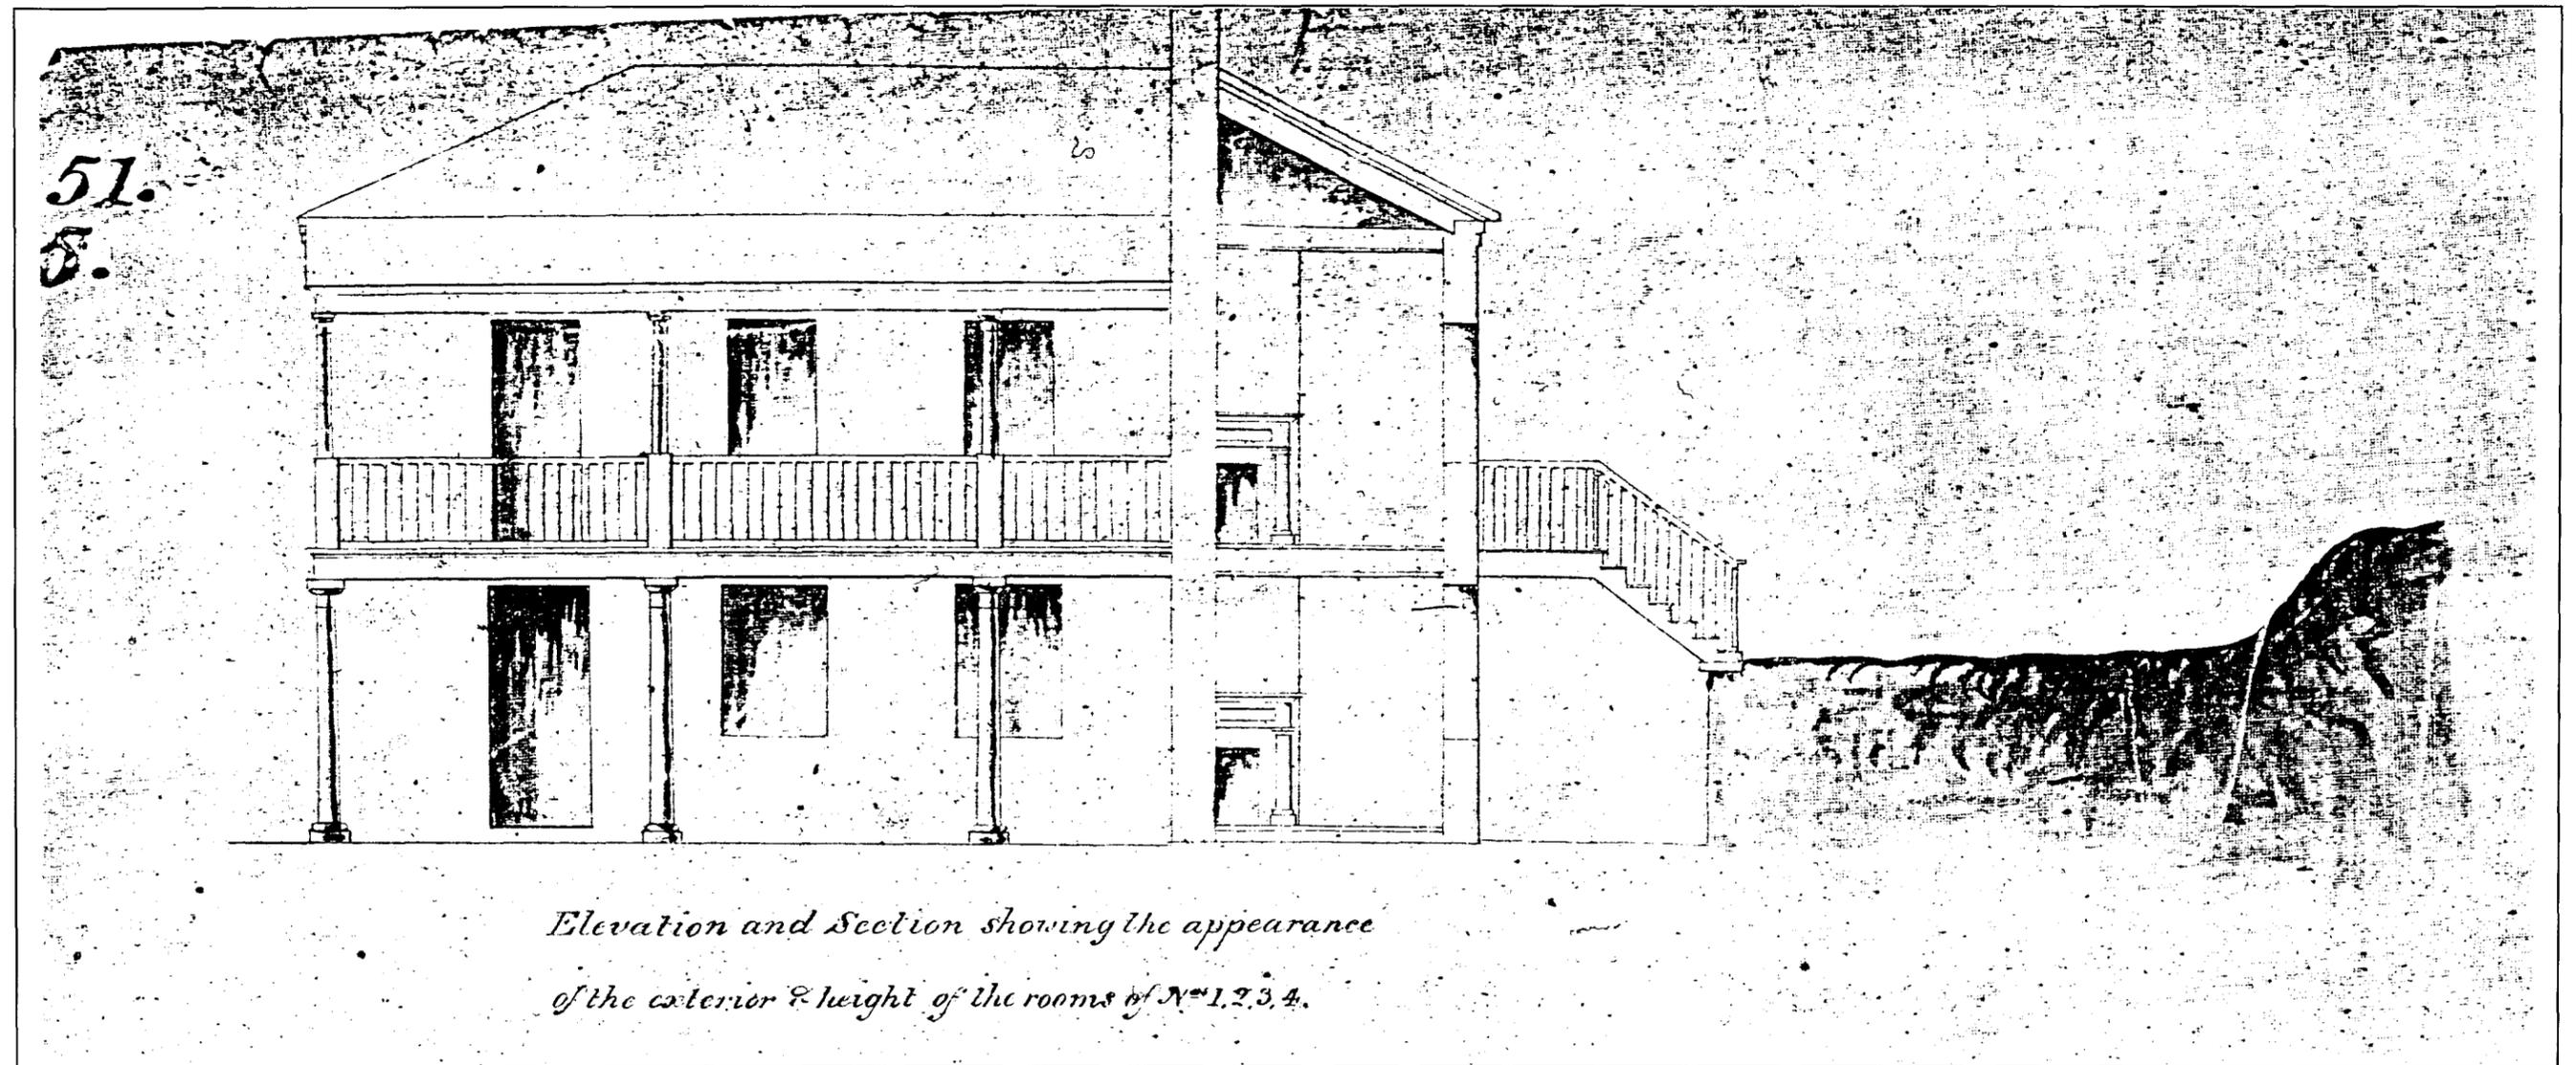
Figure 38. Detail of Lt. Thomas I. Lee's *Fort McHenry*, 1834, showing elevation and cross-section of typical quarters within fort.

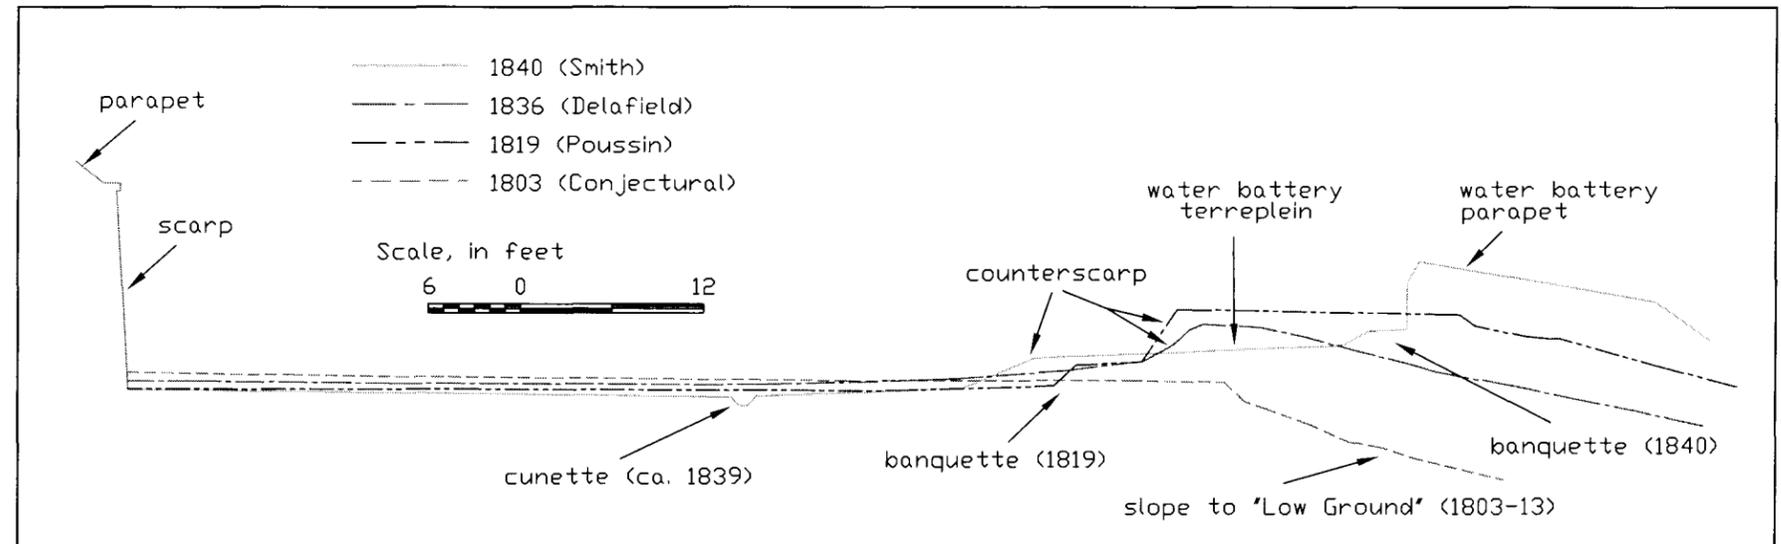
Figure 39. Grade changes along the southeast front of Fort McHenry, 1803-1840.

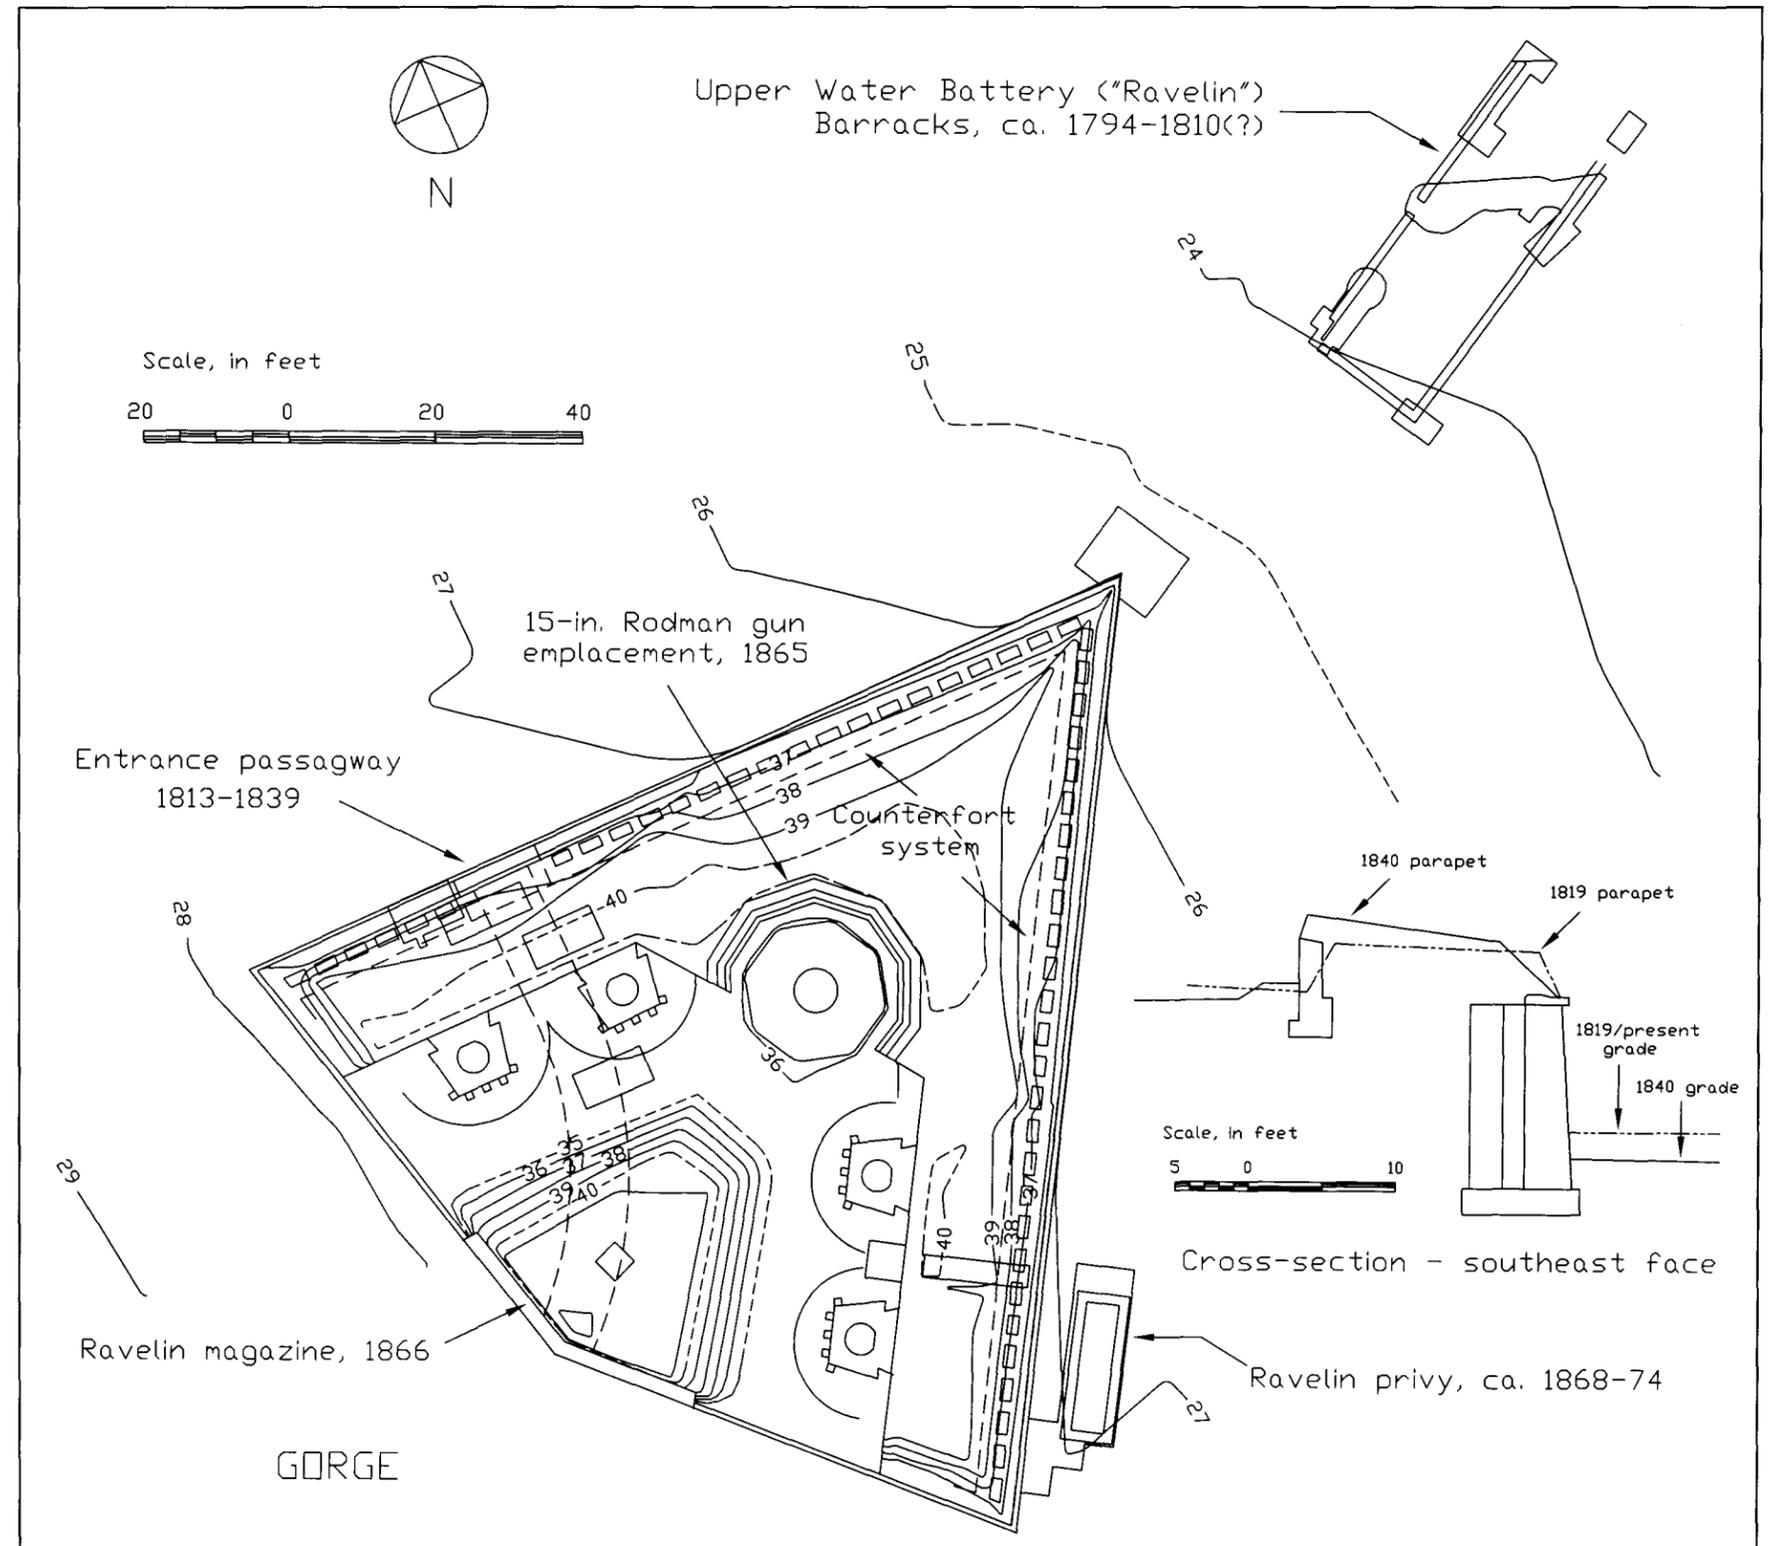
Figure 40. The ravelin at Fort McHenry, showing its counterfort system and the former entrance passageway.
