“On the shore dimly seen...”: an Archeological Overview  
Fort McHenry National Monument and Historic Shrine  
Baltimore, Maryland

John Milner Associates, Inc.  
5250 Cherokee Avenue, 4th Floor  
Alexandria, Virginia 22312

2000

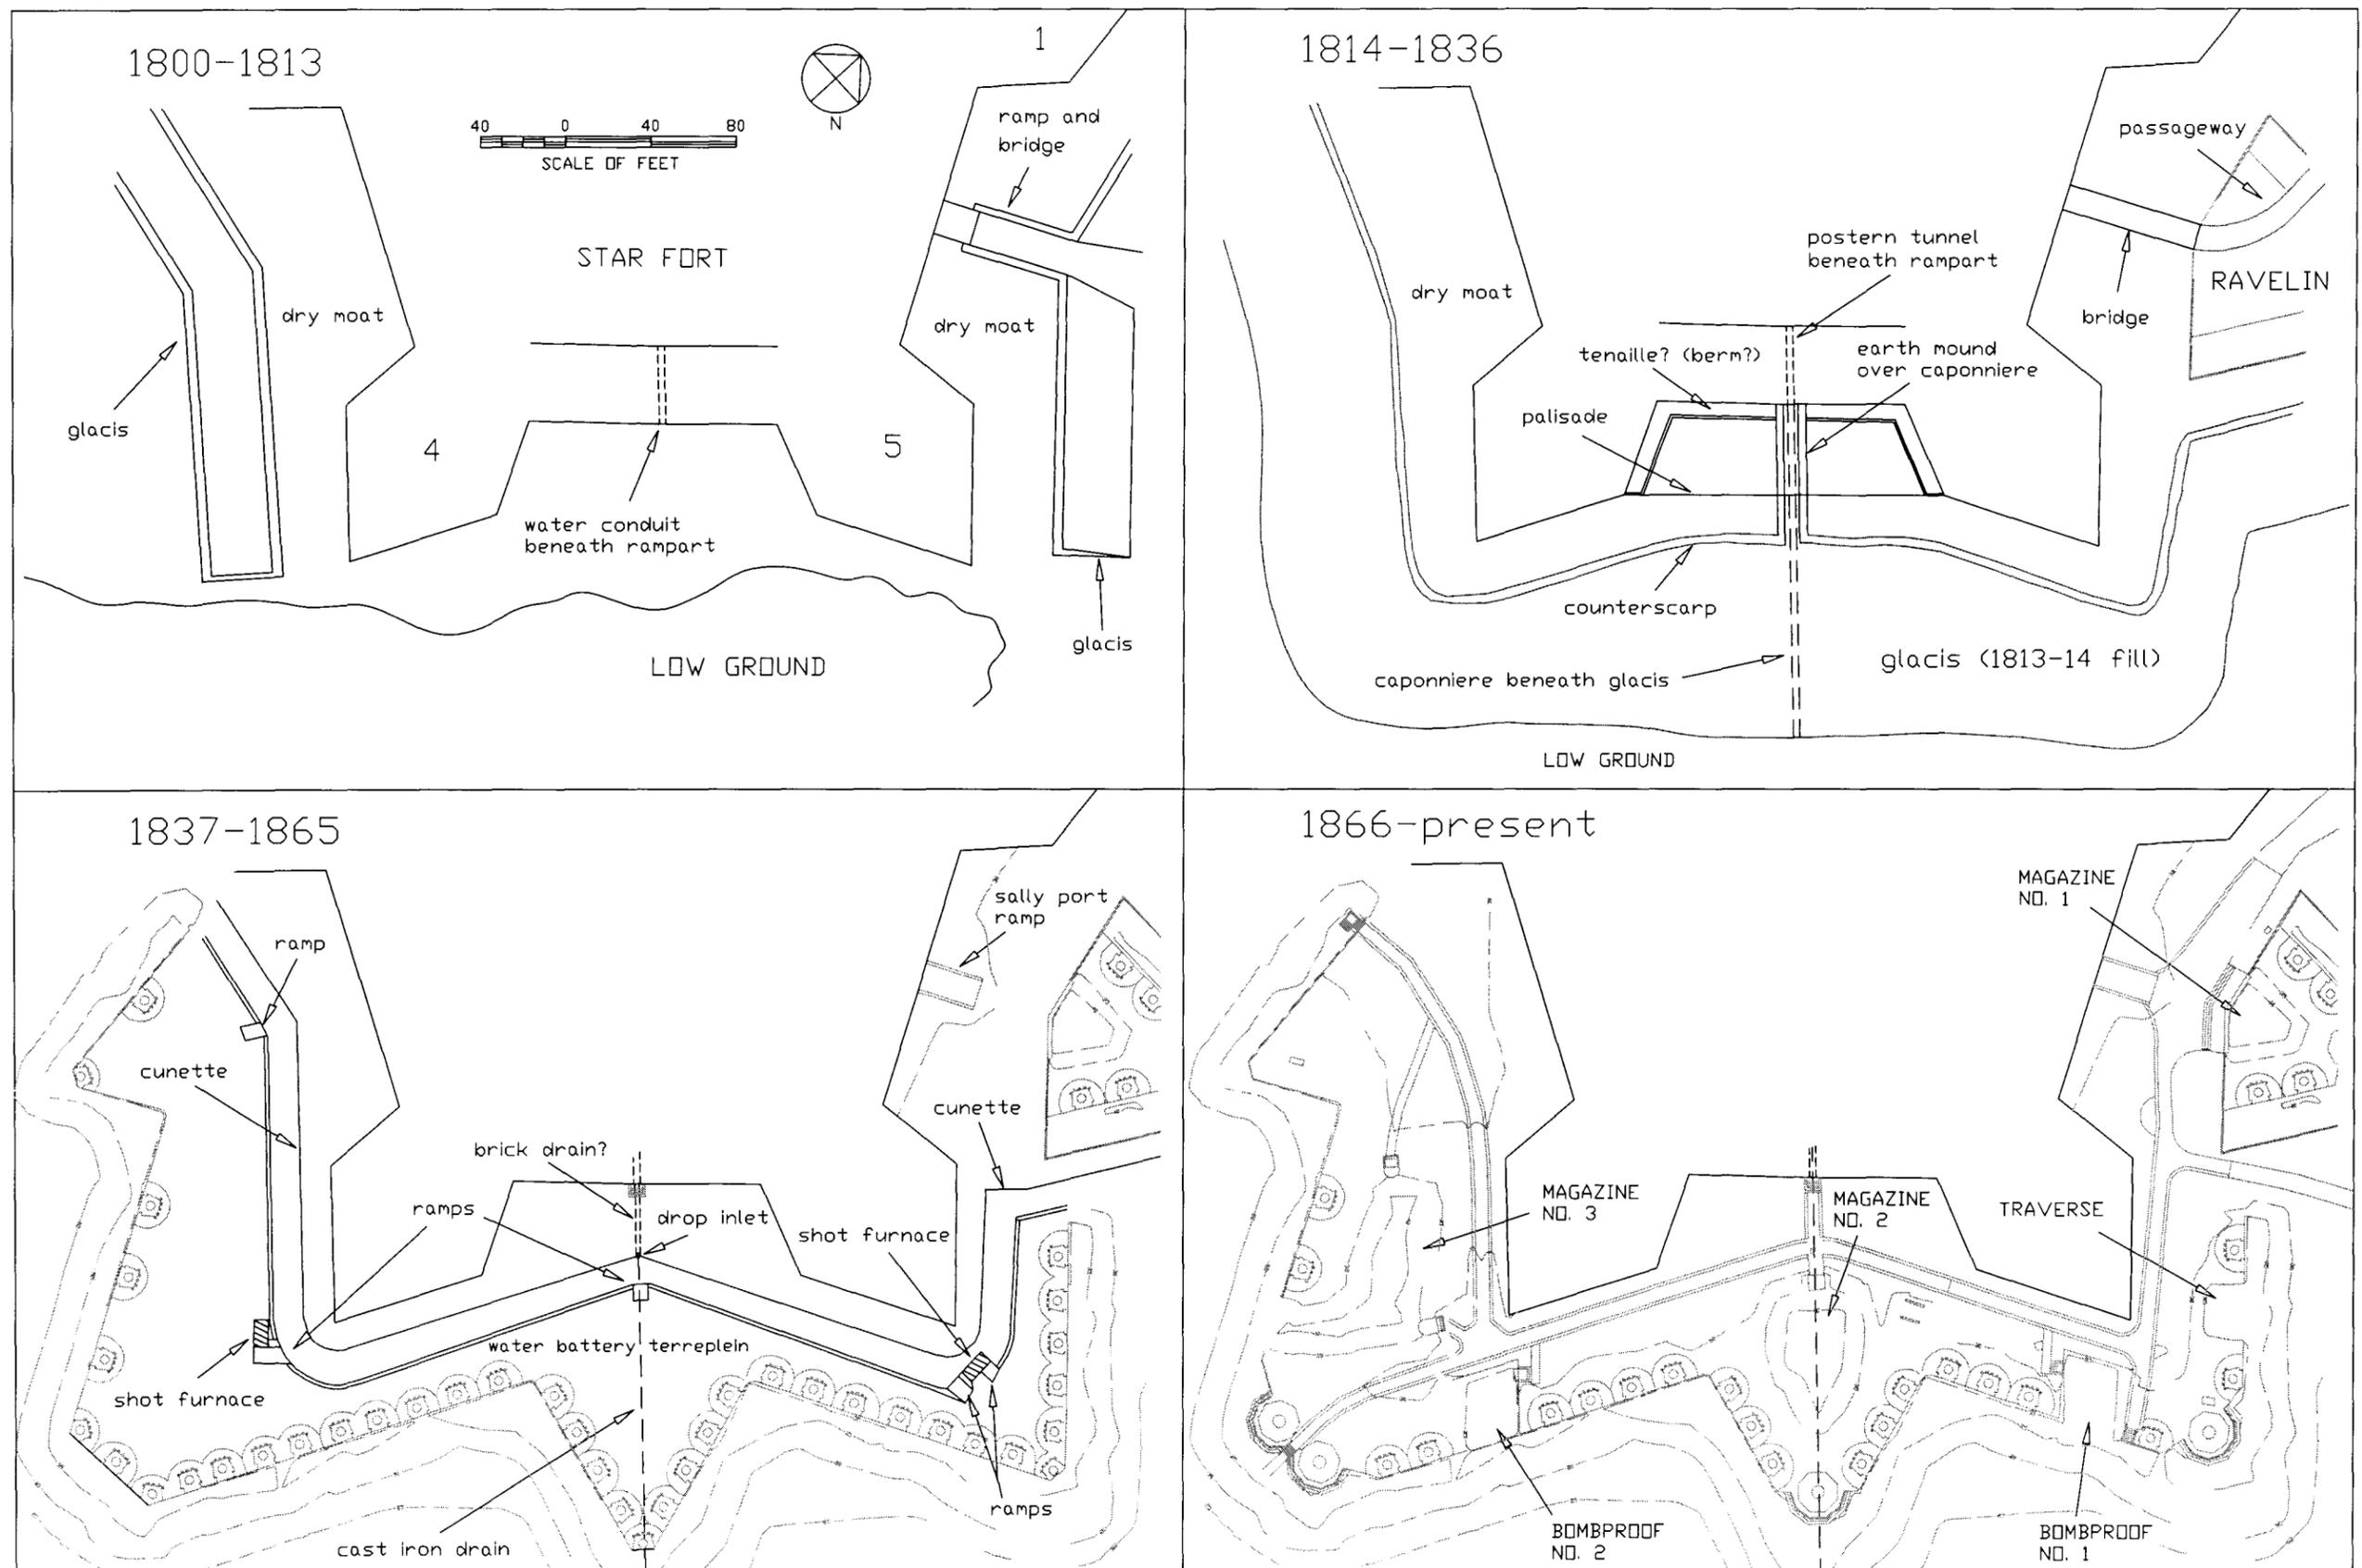
Figure 41. Stages of development of the water battery vicinity, ca. 1800 - present.

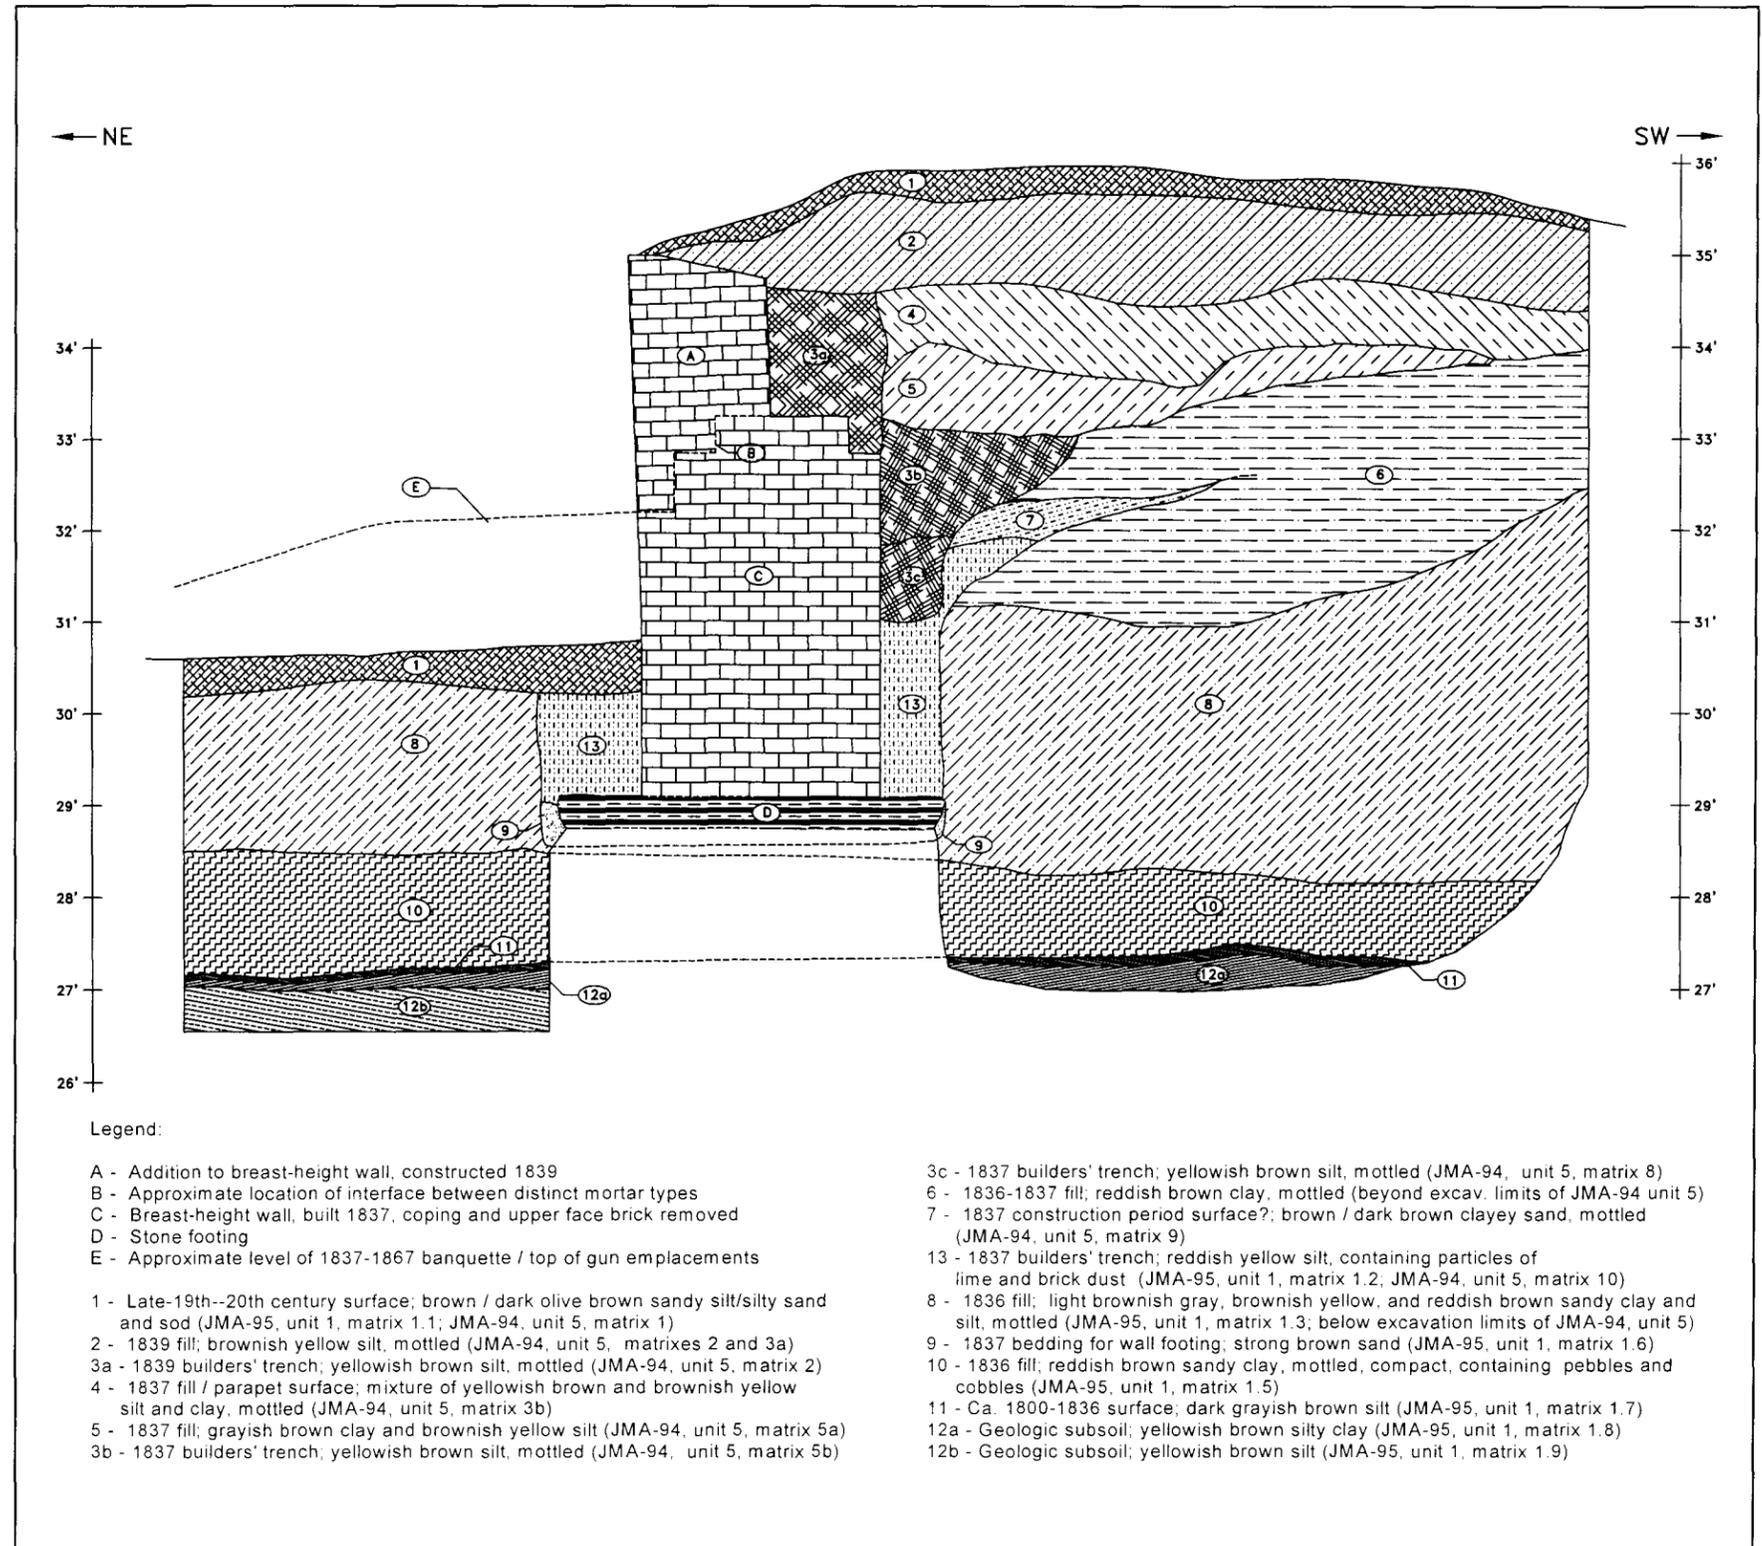
Figure 43. Profiles of archeological excavations at the water battery's revetment wall, providing a partial cross-section of parapet, wall, and terreplein.

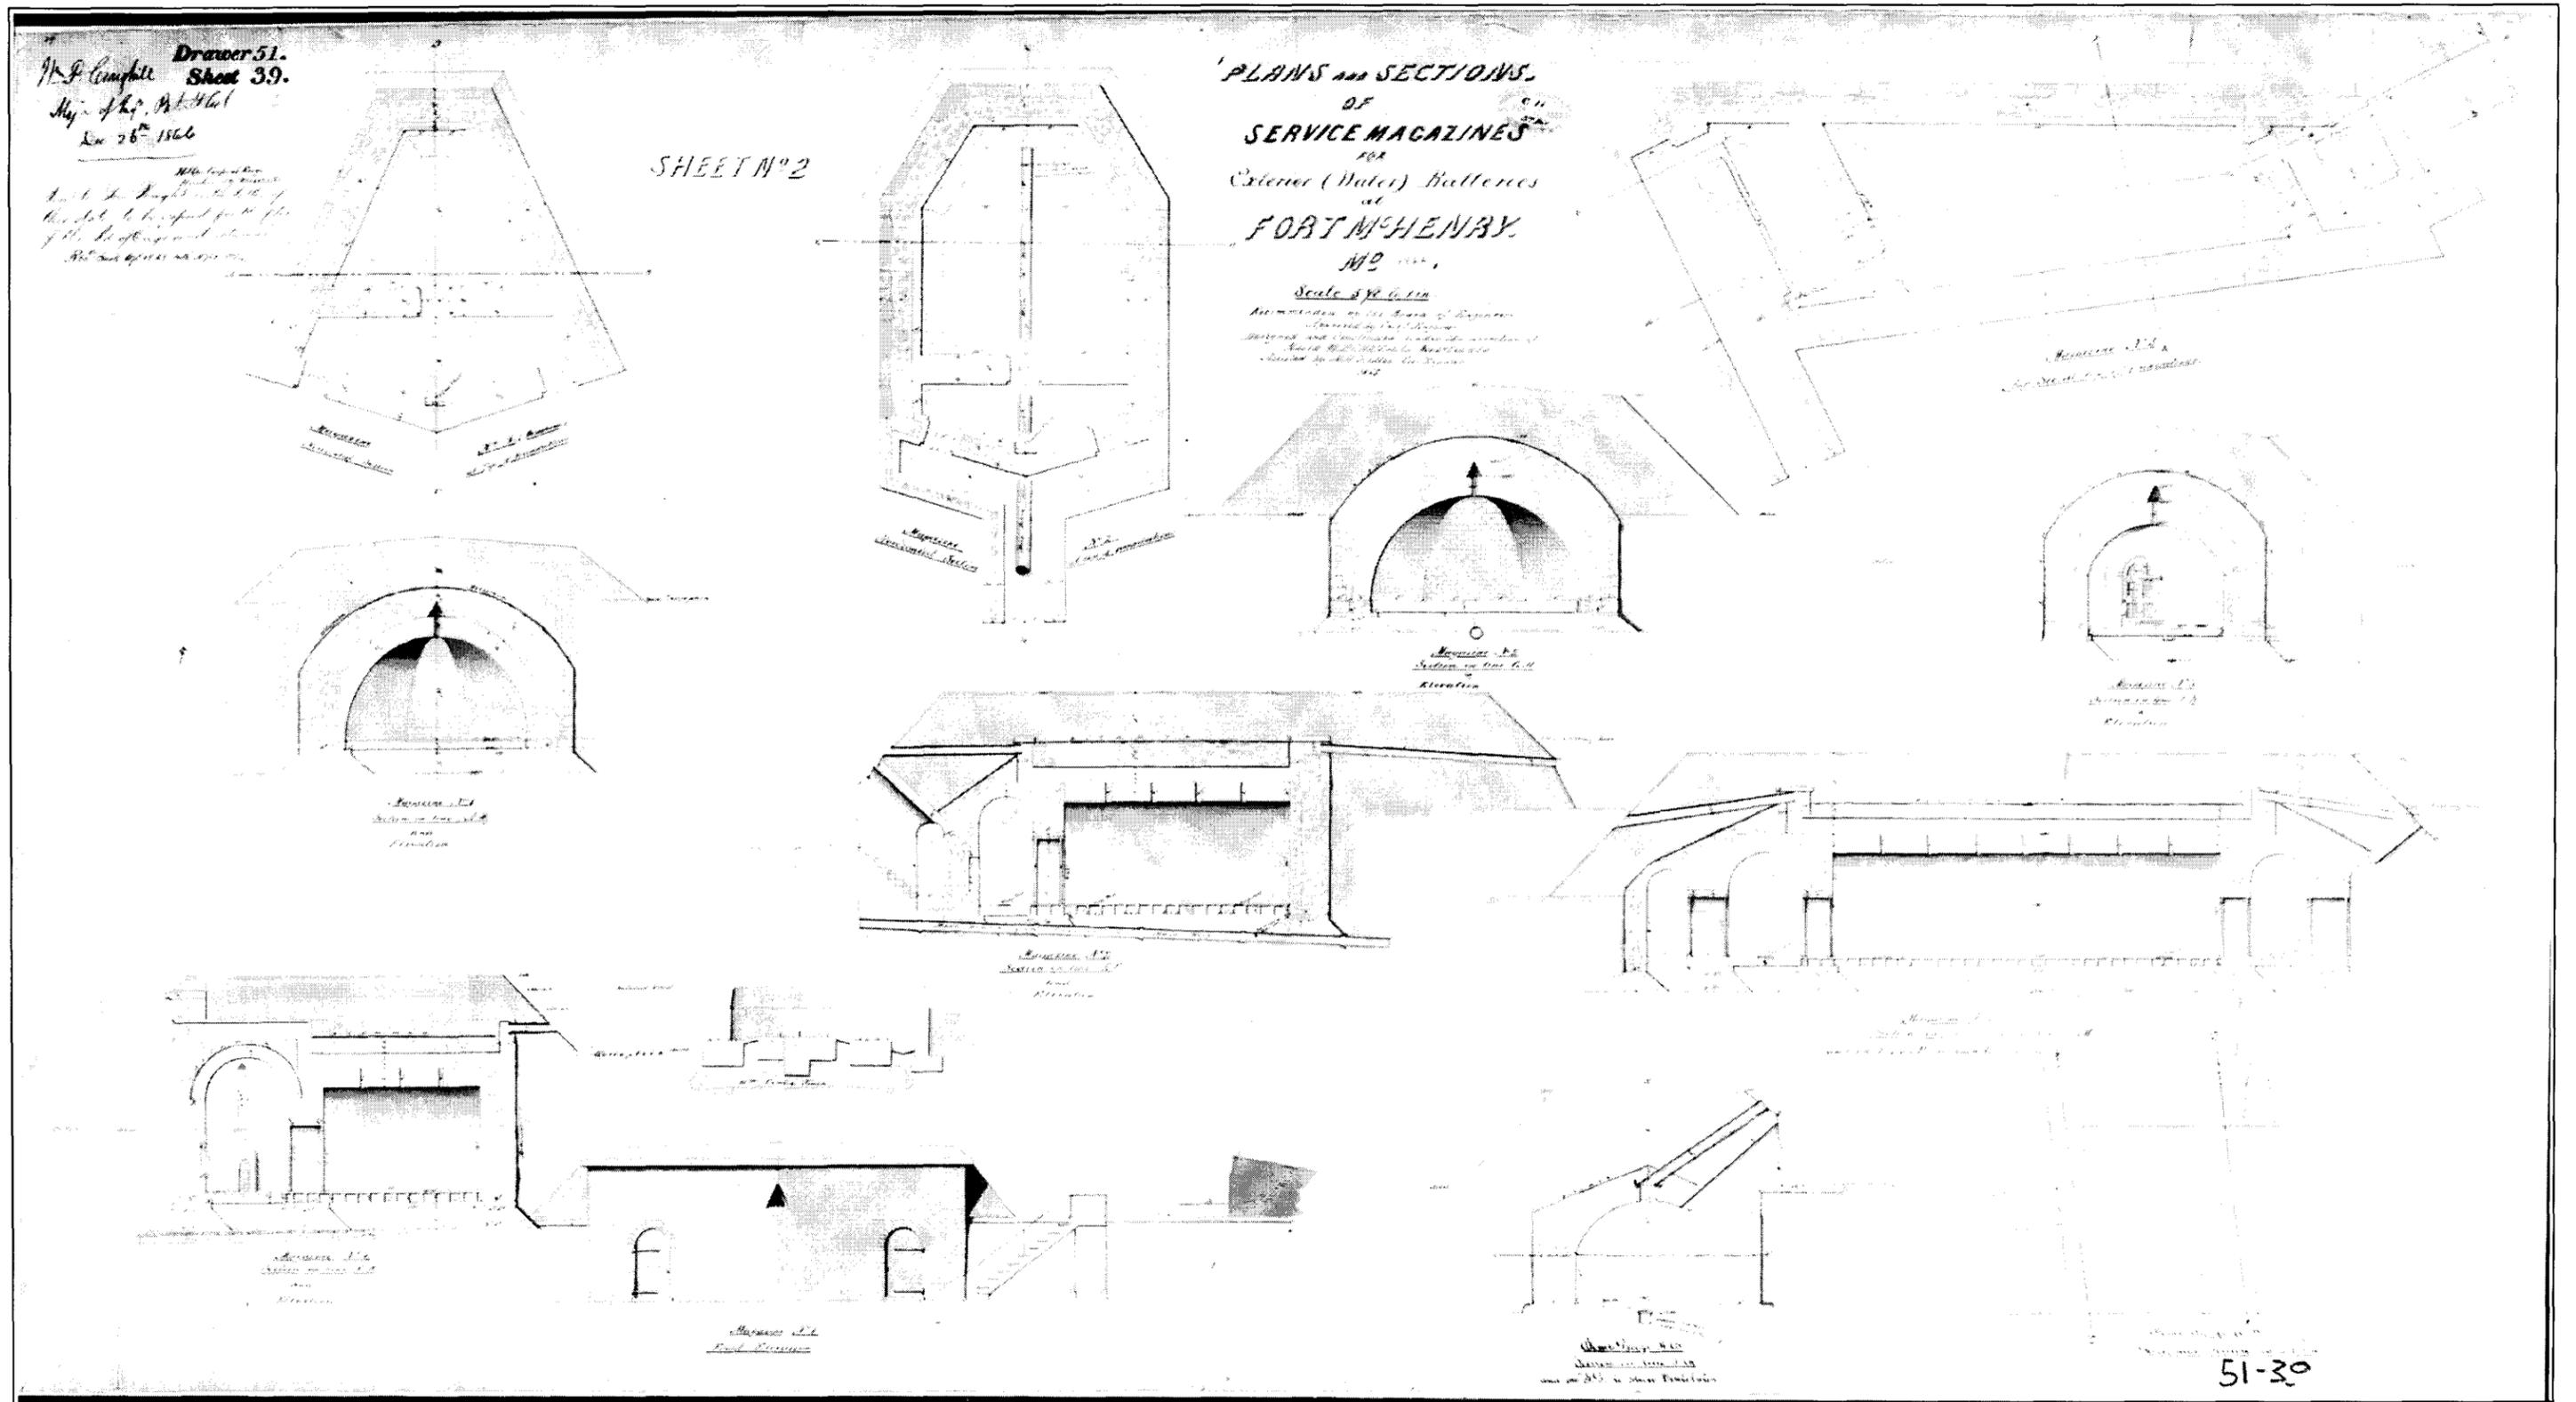
Figure 44. Major William D. Craighill's Plans and Sections of the Service Magazines for Exterior (Water) Batteries at Fort McHenry, 1866.

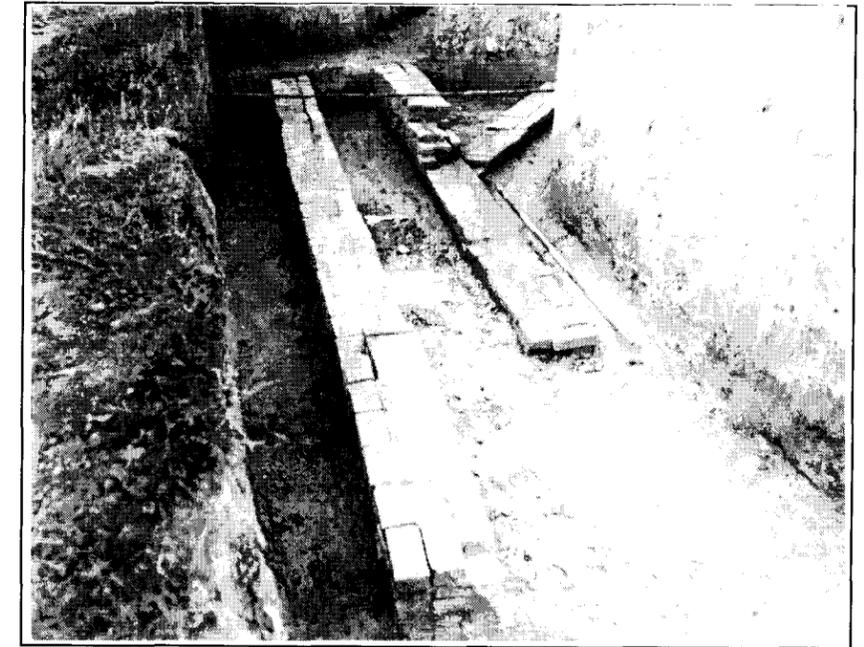
Figure 47. Possible ramp footings, 1776 lower water battery, viewed from the east, 1958.

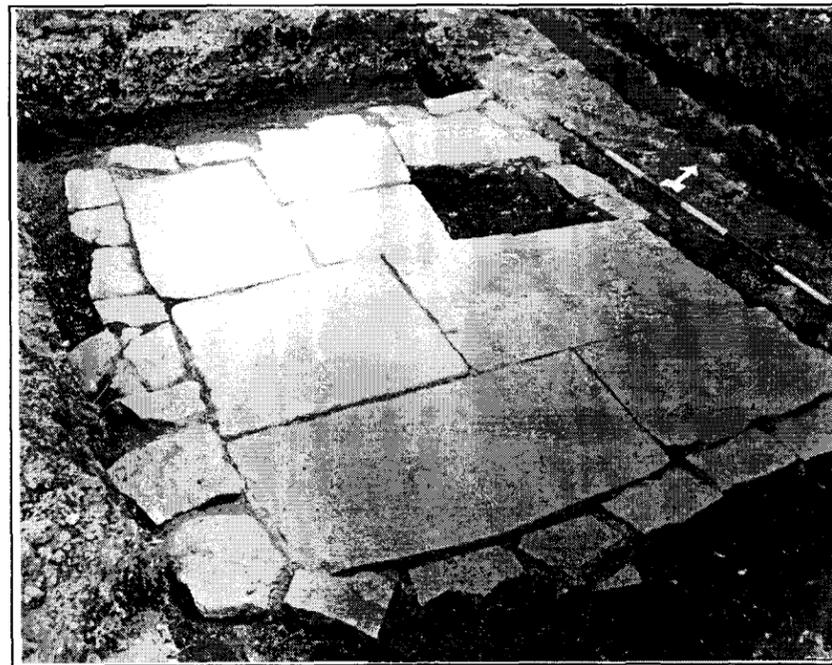
Figure 51. Remnants of possible ca. 1795-98 magazine or bombproof, viewed from the southeast, 1958.
