Water Quality and Nuisance Species Management in the Fort Pulaski National Monument Moat

Natural Resource Report NPS/SECN/NRR—2009/134

July 2009

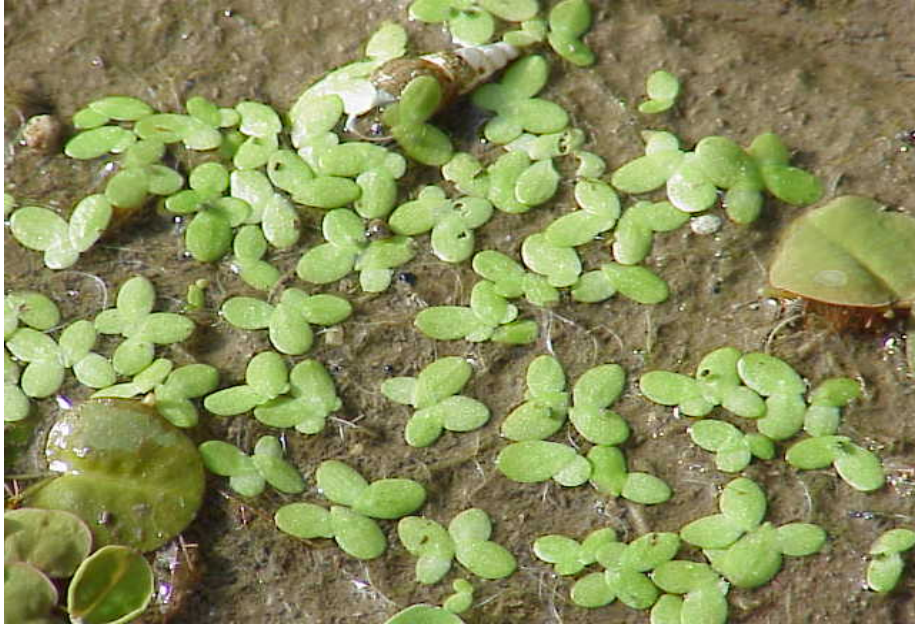
Figure 1. Duckweed.

In 2008, duckweed was a big concern for FOPU management. This small brightly colored plant can quickly grow into thick mats. It grows well in slightly acidic fresh to mildly brackish water of a moderate temperature (Table 1). Duckweed prefers high nutrient waters and given adequate growing conditions, can double in mass in less than two days (Hodgson, 1970).

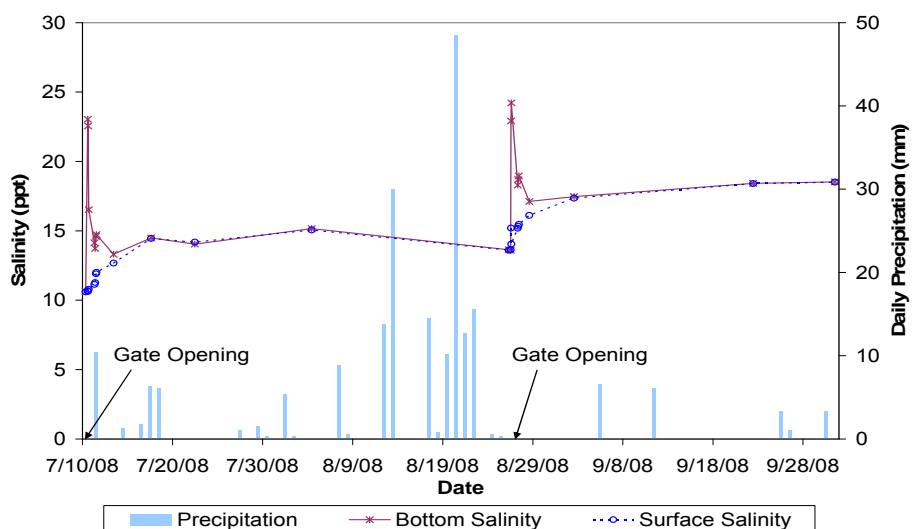
Figure 5. Recorded levels of salinity at sample site 1 on the surface and bottom. Note the formation of a salt-wedge after each partial water change. Salinity equilibrium reached one week after each partial water change. Rainfall associated with tropical storm Fay reduced salinity (8/20-8/24). Weather courtesy of www.NOAA.gov.

Each partial water change (6/18/09, 7/10/09, and 8/26/09), including the unmonitored, increased overall salinity in the moat, while heavy rains associated with tropical storm Fay (8/20/09-8/24/09) decreased overall salinity (Figure 5). Following each partial water change, a salt-wedge formed, with the relatively dense high-salinity water from the Savannah River settling to the bottom, while the lower-salinity moat water remained at the surface. The salt wedge increased bottom salinity up to 9.98 ppt over just a few hours. Saline water was first detected near the bottom at the sites 1 and 2 (nearest the gate), and slowly spread out to the remaining sites within fifteen hours after gate opening (Figure 6). The wedge persisted for several days after each water-change, and took about a week to disappear (Table 5, Figure 5). After salinity equilibrium was reached, each partial water change increased overall salinity by 3.98 – 5.48 ppt.

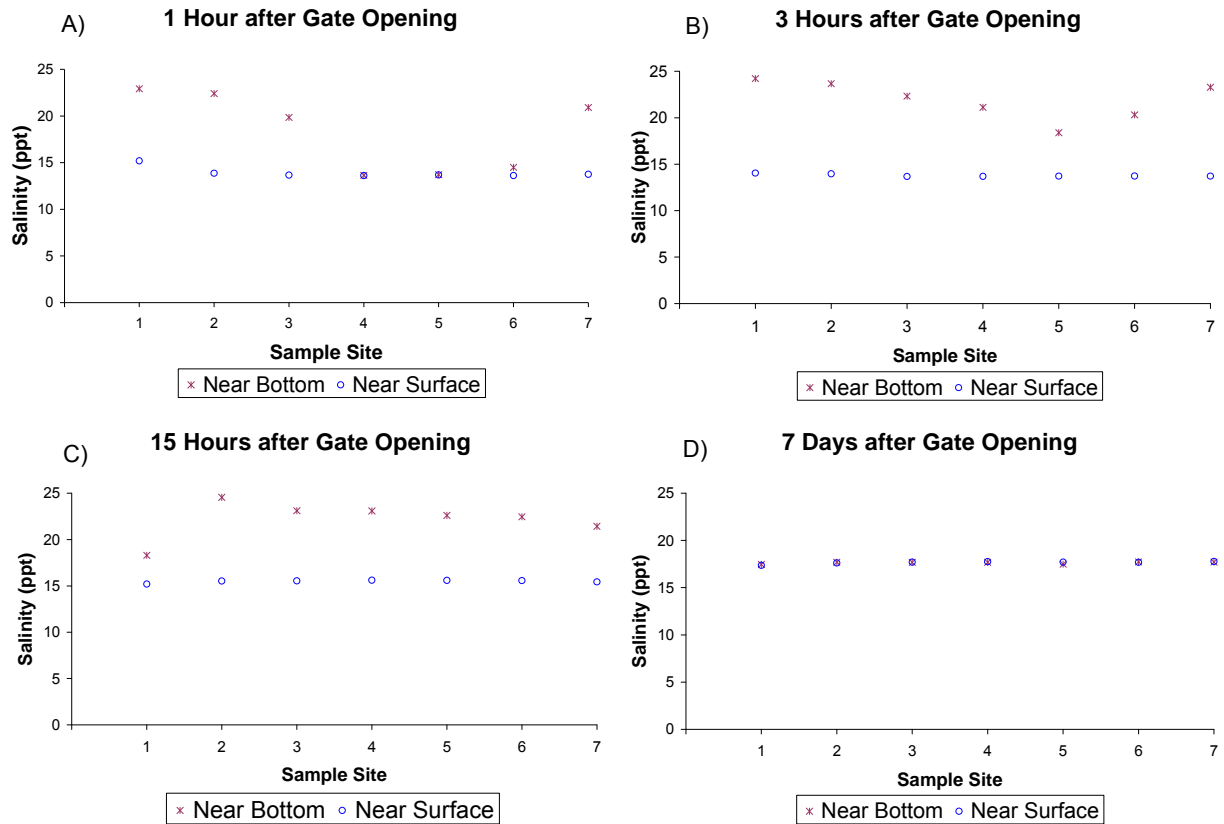
Figure 6. Salinity changes over a one-week timeframe at the seven sites following the 8/26/08 gate opening. Higher saline water first appeared in the sites nearest the gate (sites 1 and 2), and appeared last in sites furthest from the gate (sites 4 and 5). After 15 hours (C), a salt wedge had formed with fairly constant bottom salinity across most sites. Site 1 had reduced bottom salinity while the wedge was present, possibly due to it being about 0.5 m shallower than the other sites. All sites had uniform surface and bottom salinity seven days after gate opening.

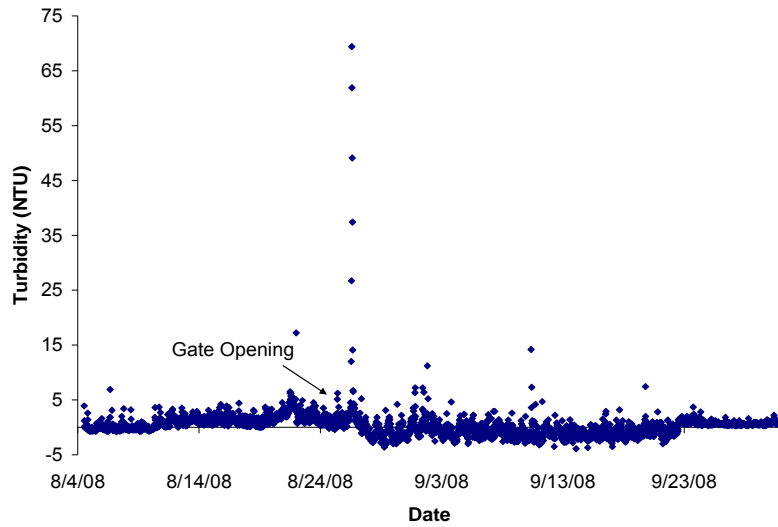
Figure 7. Turbidity readings remained low throughout the study, but increased for a short period of time following the partial water changes. Turbidity spiked during gate opening events as water flow stirred up sediments.

The high chlorophyll *a* reading on August 4th was not accompanied by an increase in turbidity. Turbidity remained low and was less than 5 ntu 98.9% of the time. Increases in turbidity were observed for several hours after the gates were opened (Figure 7).

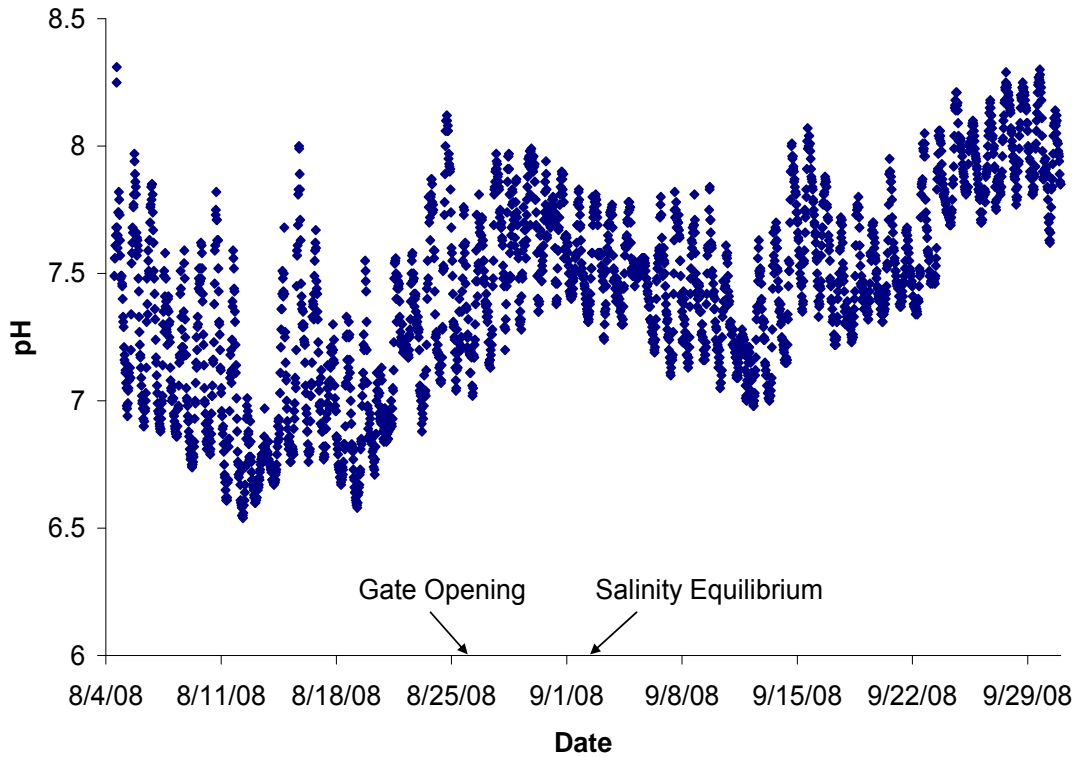
Figure 8. pH increased following third gate opening.

The pH increased following partial water changes (Table 5, Figure 8). Surface pH was higher than bottom pH 96.9% of the time, with an average surface pH of 7.68 and an average bottom pH of 7.35 (Table 5). Even after salinity equilibrium was reached, pH remained unequal with regard to depth (Figure 9).

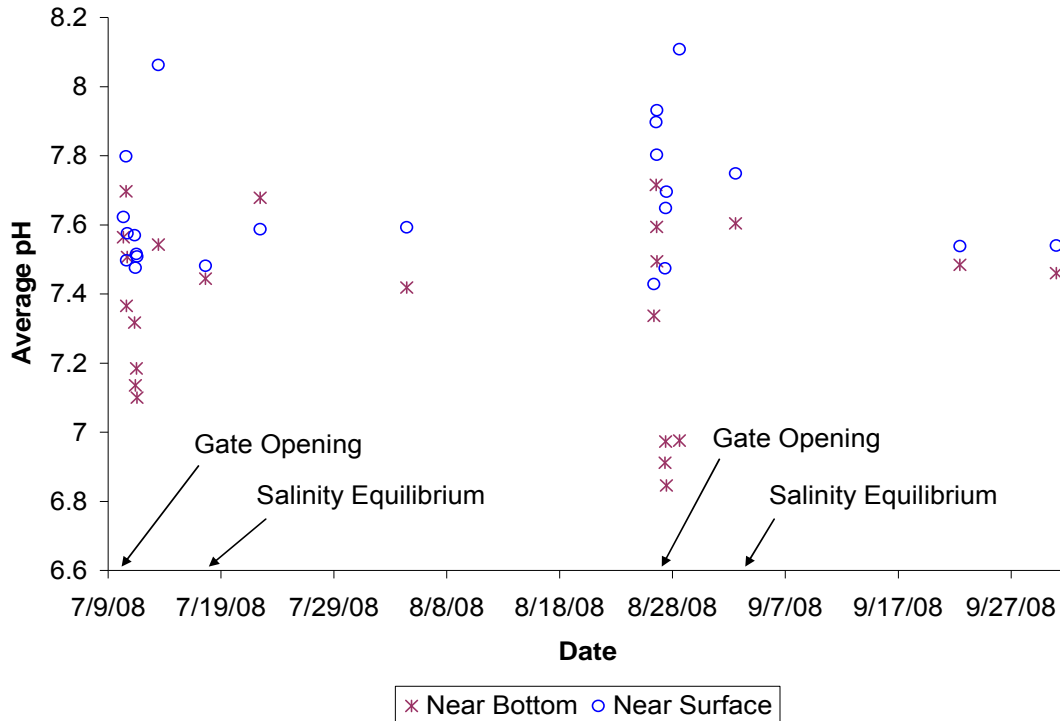
Figure 9. Average pH readings (sites 1-7) at the surface and near the bottom. pH was consistently higher near the surface than near the bottom, even after salinity equilibrium was reached.

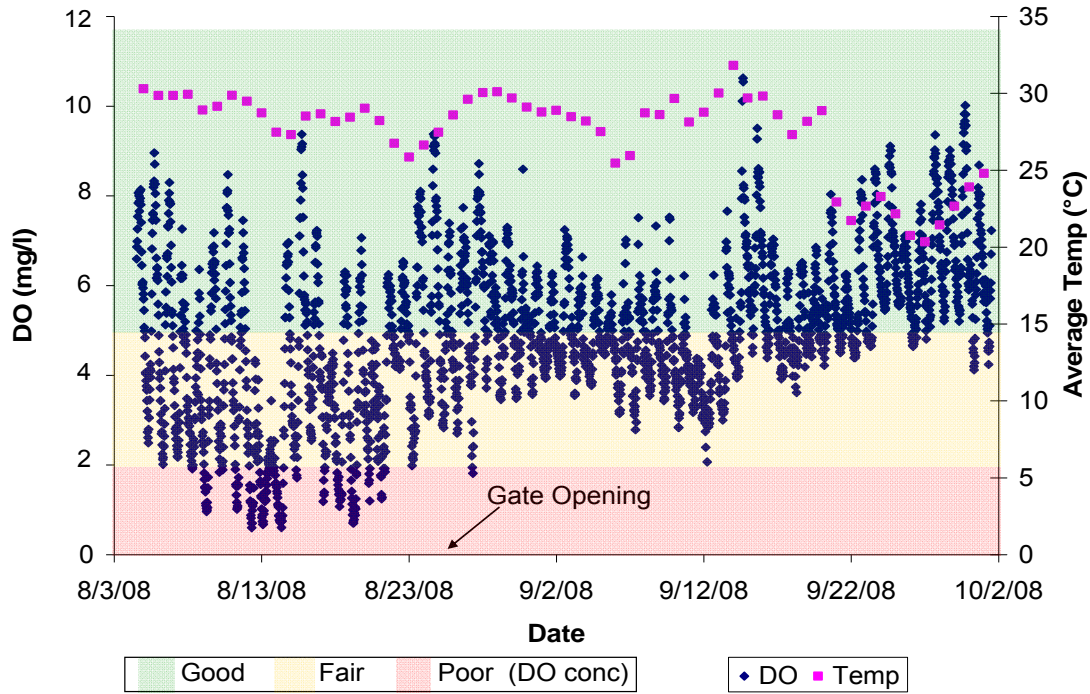
Figure 10. DO changes over time at fixed-site. DO increased after partial water change and increased further when temperatures started dropping around 9/21/08. Good, fair, and poor indicate assessment criteria according to U.S. EPA 2001.

Dissolved oxygen at the fixed site (8/4/2008 – 10/1/2008) had an overall range of 0.64-11.15 mg/l with an average of 4.34 mg/l, therefore ranging between poor and good values according to the National Coastal Condition Report (U.S. EPA 2001, Table 7). Dissolved oxygen increased following the second monitored gate opening and increased further when water temperatures started dropping (Figure 10). Dissolved oxygen was always higher at the surface than near the bottom, and the surface readings (Range 4.04-13.31 mg/l) were all within the good range (Table 7, Figure 11). Near-bottom readings ranged from good to poor (Range 0.23-8.36 mg/l), and were often within the poor range during the nighttime and early-morning hours (Figure 11). On the morning of 7/10/08 when dissolved oxygen concentrations were within the poor range, crabs were observed swimming near the middle of the water column.

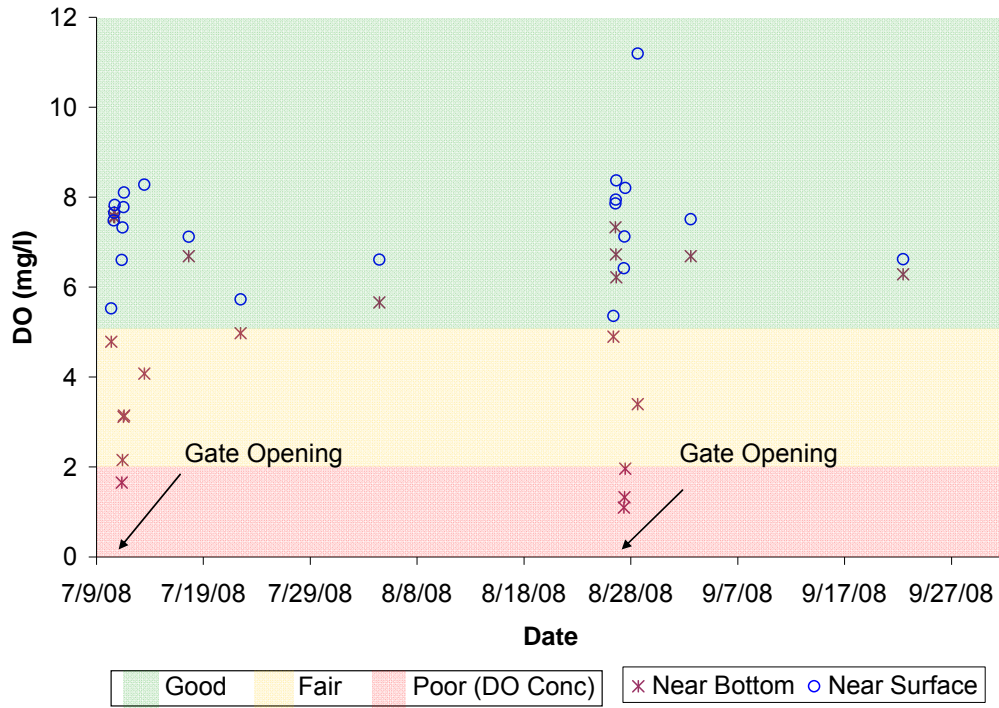
Figure 11. Average DO readings (sites 1-7) at the surface and near the bottom. Good, fair, and poor indicate assessment criteria (U.S. EPA 2001). All near-surface readings were within the good DO range, however near bottom readings were often within the fair to poor range.

Dissolved oxygen remained high enough over the summer of 2008 to prevent a fish kill, despite frequently dropping into the “poor” range along the bottom at night. Dissolved oxygen was increased after the partial water changes and increased further once temperatures started to cool as summer ended. Higher dissolved oxygen levels at the surface perhaps served as a refuge for animals during low nighttime oxygen conditions.

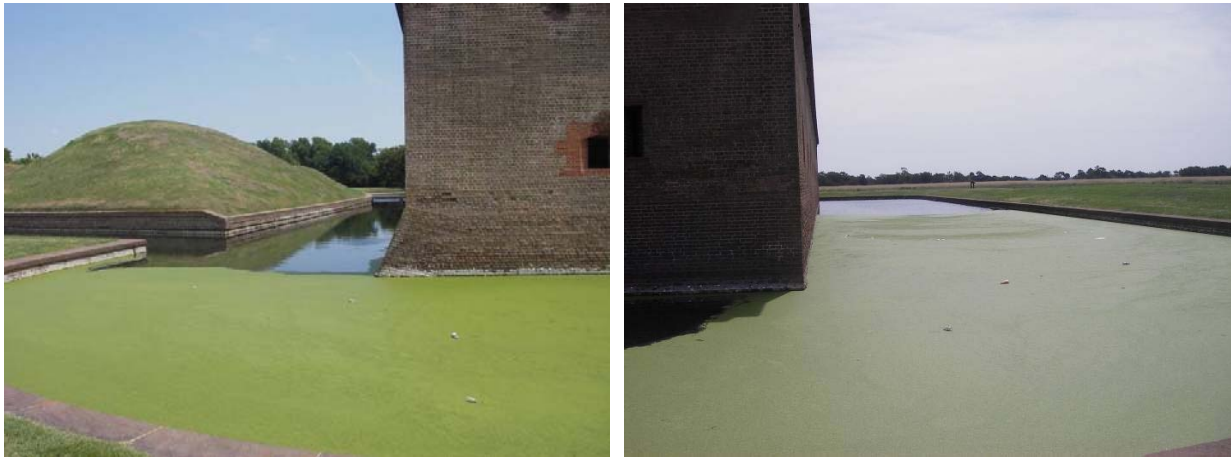
Figure A.1. July 1, 2008 (nine days before project began). Calm day. Duckweed mostly in a single layer.

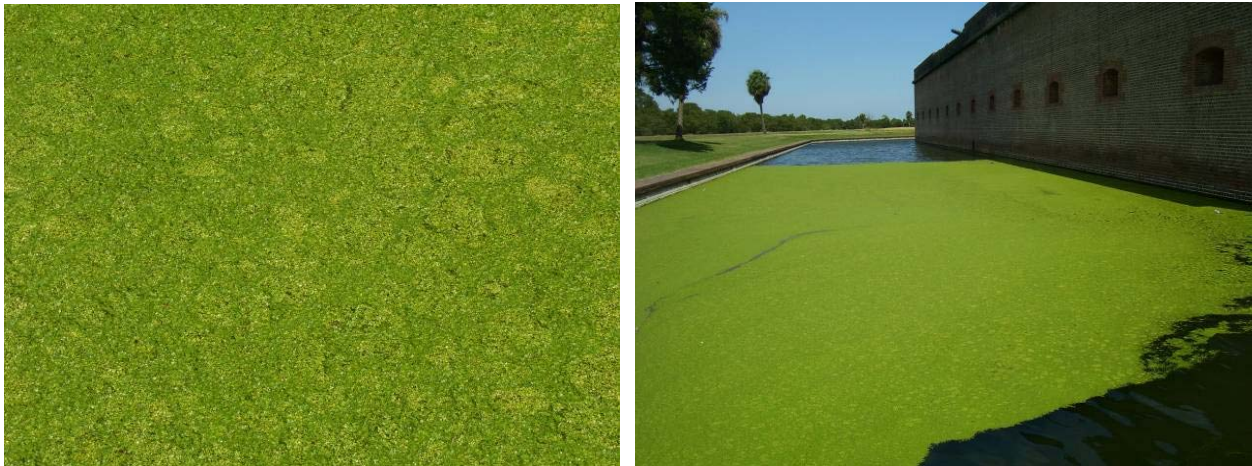
Figure A.2. July 11, 2008 (Day after first monitored gate opening). Windy day. Duckweed pushed all together and in “thick layer”. On the 10th, the duckweed was spread sparsely all the way along the moat – not stuck together. Surface salinity is about 10.6

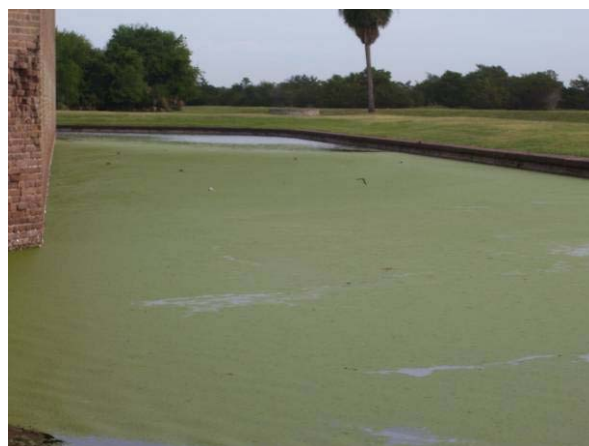
Figure A.3. July 13, 2008 (two days after gate opening). Duckweed looks less bright. Still clumped together in a “thick” layer. Surface salinity is 12.8.

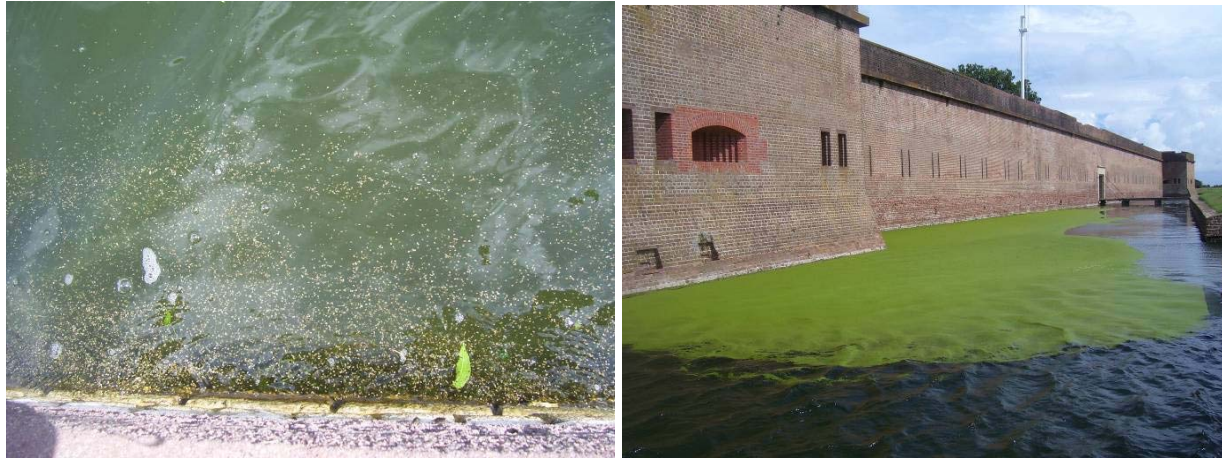
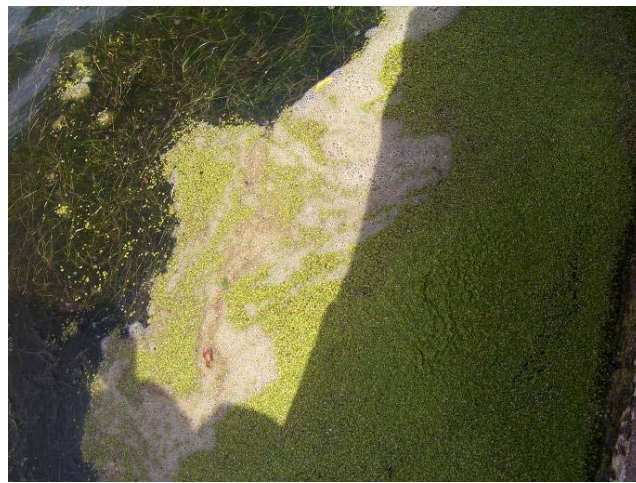
Figure A.4. July 17, 2008 (four days after opening). Duckweed visibly dying. Decaying pieces floating in the water column. Duckweed looks unhealthy. Salinity is 14.5. However, last week, the widgeon grass was abundant, but not thriving. Now it has tons of new green growth. Additionally, at sample site 7, there is this surface algal film that was not present previously.

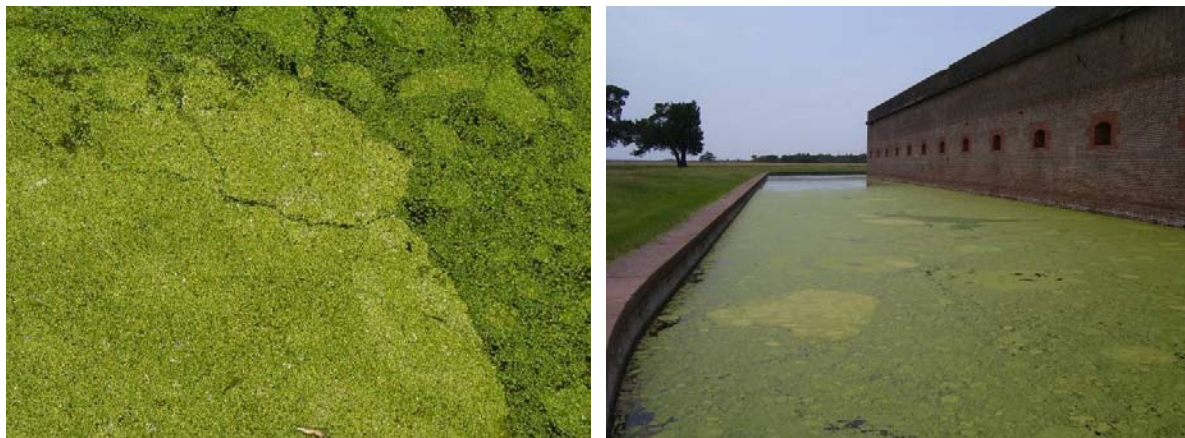
Figure A.5. August 4, 2008 (three weeks after opening). Surface salinity is about 15.2. Duckweed yellower than previously, especially that present in thick clumps. Appears to be about half the duckweed as was there initially.

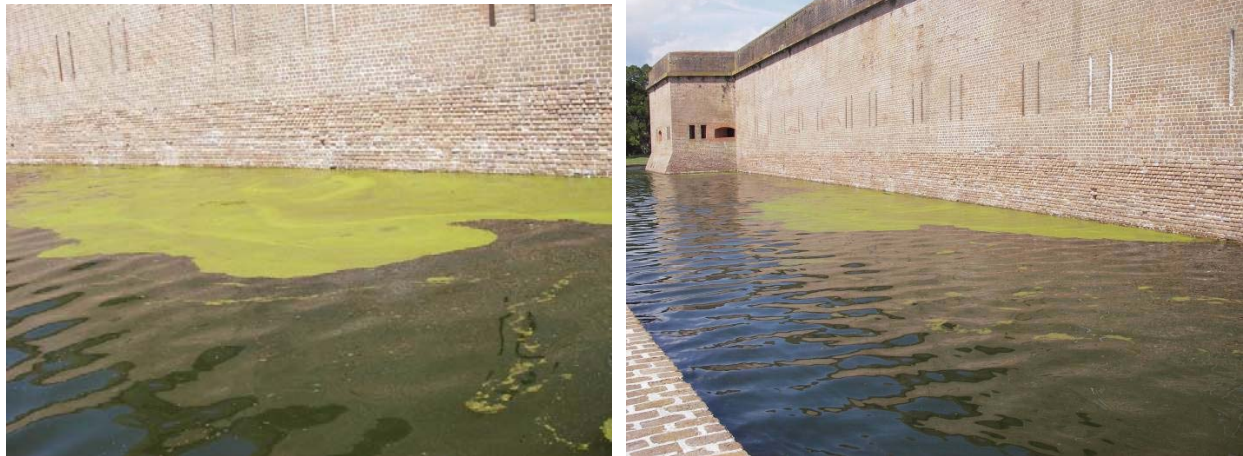
Figure A.6. August 26, 2008 (day of 2nd opening; six weeks after first opening). Salinity about 13.5. much less duckweed. Only two patches on either side of the drawbridge between the demilune and the fort. The widgeon grass is less green than last time. Site 7 has lots of widgeon grass though (lower DO?)

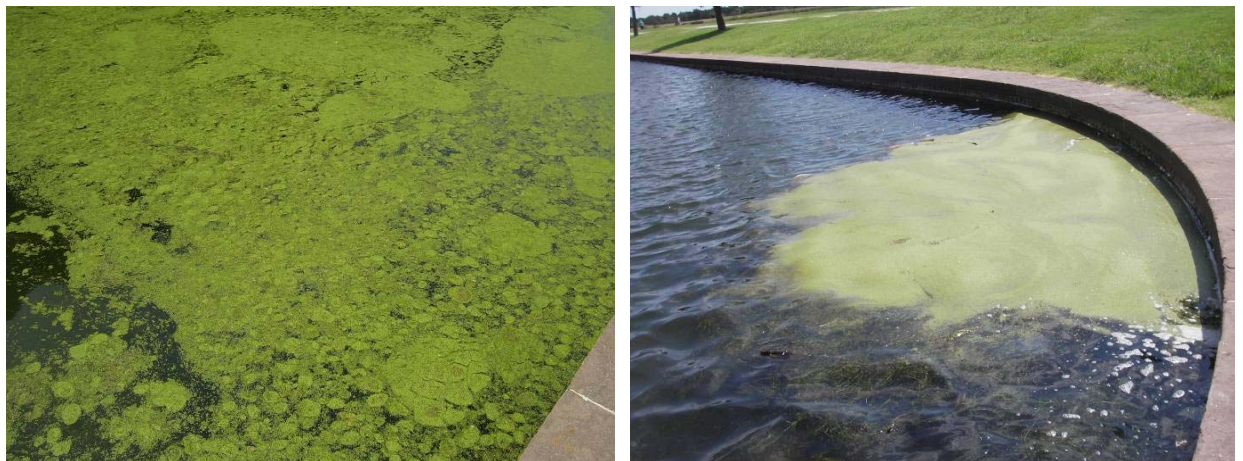
Figure A.7. September 2, 2008 (one week after 2nd opening). Much less duckweed. Salinity is about 17.7 on the surface. Widgeon grass still relatively abundant, but not thriving. Dead duckweed in water column.

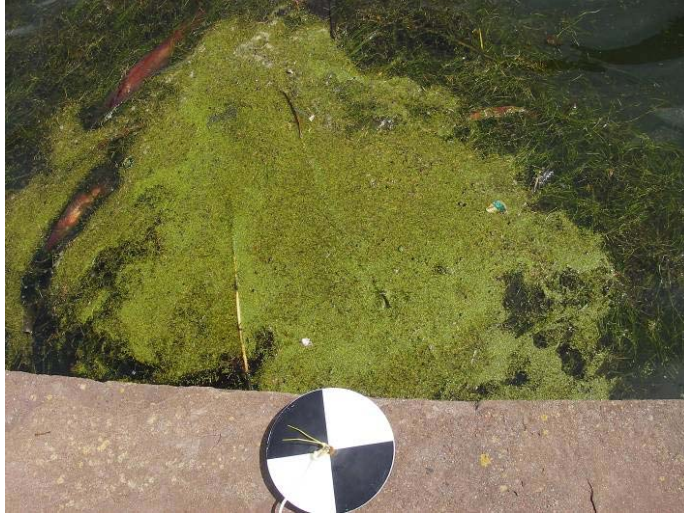
Figure A.8. September 22 (a little over 3 weeks after 2nd moat opening). Surface salinity about 18.4. Almost no duckweed or widgeon grass. Cooler temps as well. Different fish community than original one. The pictures show almost all of the widgeon grass (there was one other plant left at site 7, but it appeared almost dead with only a little bit of green on it). Pictures show about half the duckweed (the rest was sprinkled along the wall).
