GEOLOGICAL ANALYSIS OF ROCK DETERIORATION  
AT SELECTED NATIONAL PARK SERVICE  
ARCHEOLOGICAL SITES

GEOLOGICAL DETERIORATION OF STONE MASONRY

By: Bruce G. Wachter, Ph.D.

April 1979

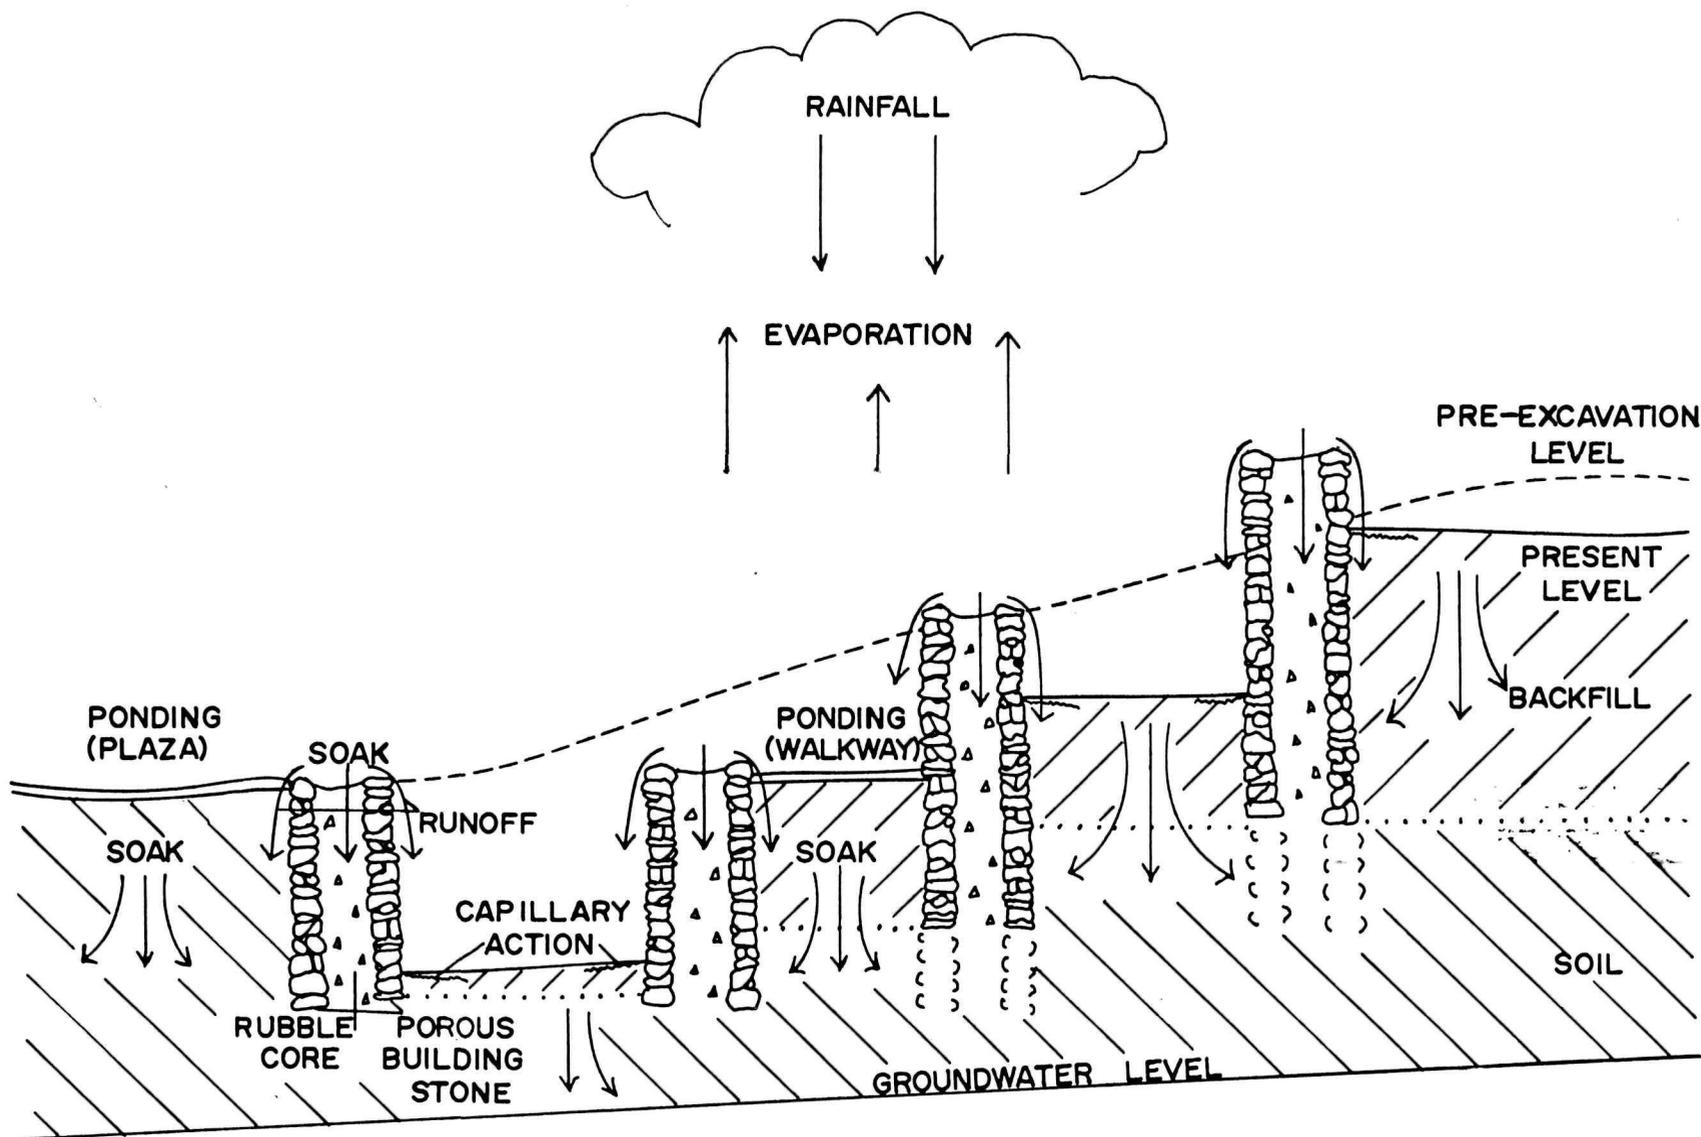
NOTE: SOME WALLS HAVE NO CAPS OR ARE PERMEABLE TO WATER

Figure 1: The Water Cycle, Chaco-Mesa Verde Type Sites

Observed field conditions tie in with the likely water-salt interactions shown in Figures 1 and 2.

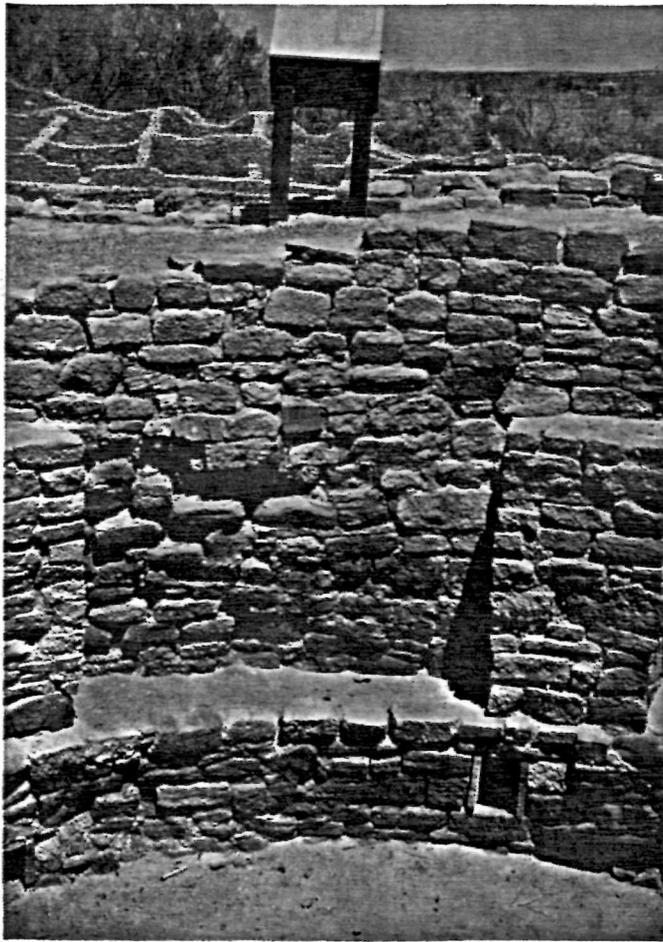
Figure 3. Aztec. General deterioration accompanied by moderate oxidation on wall of Kiva "N". Water ponds somewhat on walkway above. Rubble core wall may absorb some surface water directly.

Random deterioration exists within enclosed rooms at the base of rubble-core walls. High salt concentrations (mainly nitrates) exist in such areas though salt bloom is not always visible (Figures 3 through 6).

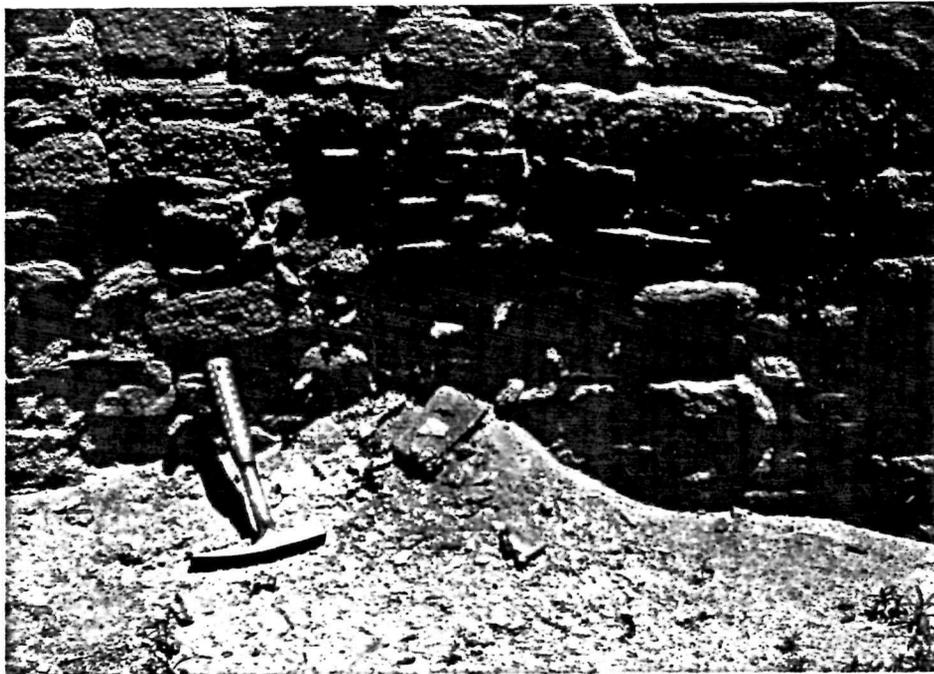
Figure 4. Aztec. Localized intense deterioration culminating in partial failure shows intense oxidation within the wall. Some such zones carry very high nitrate contents and the normally stable green impermeable rocks there deteriorate more rapidly than the generally susceptible sandstones. Kiva "V".

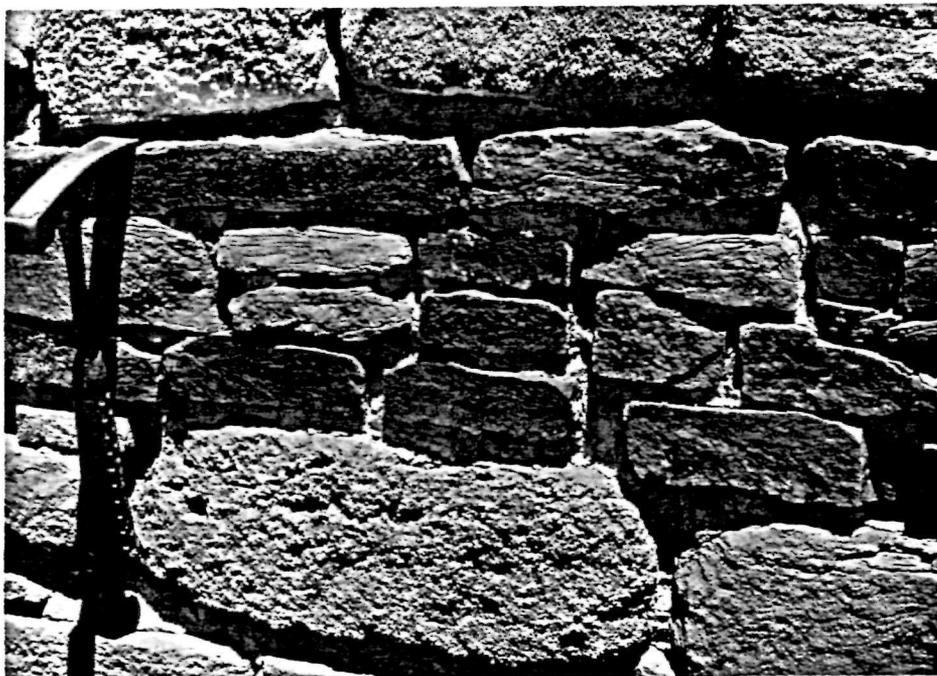
Figure 5. Aztec. Dense green siltstone generally does not deteriorate (see Figure 4). Here on the west wall, it shows beginning deterioration but much less than the permeable sandstones. This zone is in a drain water-course.

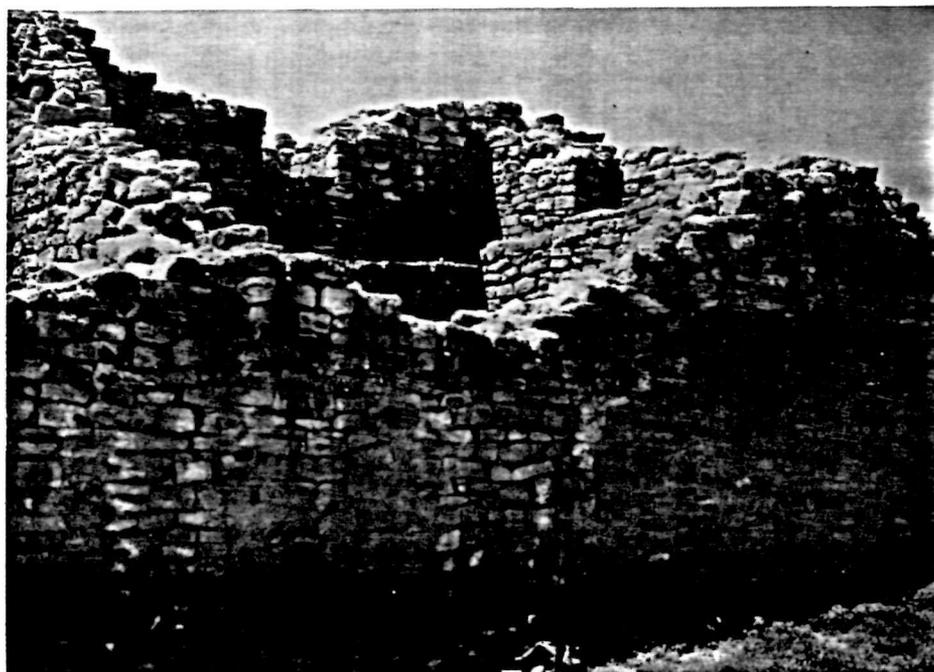
Figure 6. Drain water-courses are moist and bordered by salts following snow melt. White surface salts parallel the wall-top also. Sources are: (a) water, soil, and cement added as soil-cement caps; (b) more likely, airborne particulate salts. In any regard, deterioration is minor.

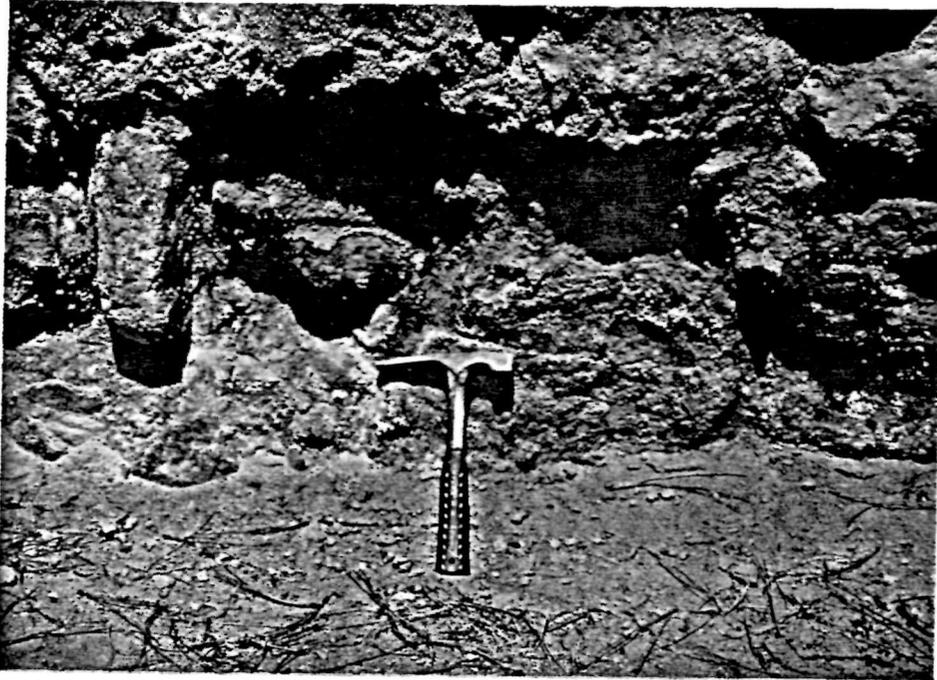
Figure 7. Bandelier. General deterioration at and below ground affecting tuff masonry, Longhouse. Though the volcanic glass fragments are geologically-chemically unstable, salt-moisture effects are physical dissociation of grains and minor oxidation rather than gross devitrification of the glass itself as might be expected.

- B. Bandelier. The rock used in masonry at Bandelier is tuff; composed of geologically unstable volcanic glass particles partially welded together by originally contained heat. Glass instability does not appear to play a role in deterioration of the masonry stones. Minor oxidation and dissociation of the particles are the only processes generally evident. The effects are focused at and below ground level. Visible surface salts and non-visible salts within the rock mass were detected in such zones at Longhouse and Frijolito. Intense oxidation and deterioration of tuff-masonry is evident in the masonry of Rainbow House kiva walls (Figures 7 and 8).

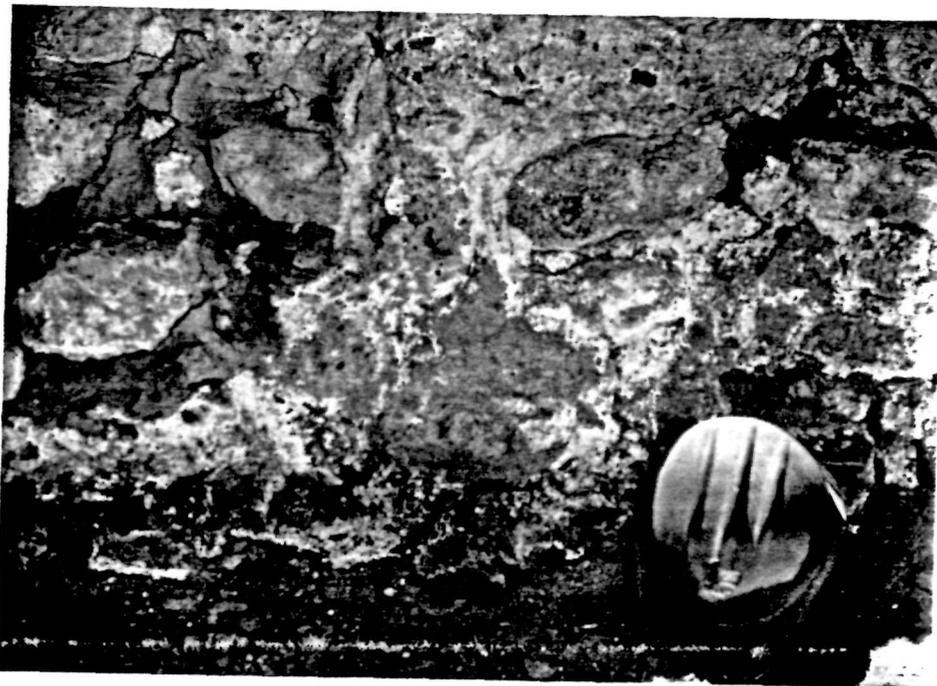
Figure 8. Rainbow House Kiva. Intense oxidation accompanies severe deterioration and obvious surface salt bloom in moist zones. Here some devitrification of the glass may be promoted. The glass fragments themselves are still sound, however, and intergrain dissociation is the deteriorating effect.

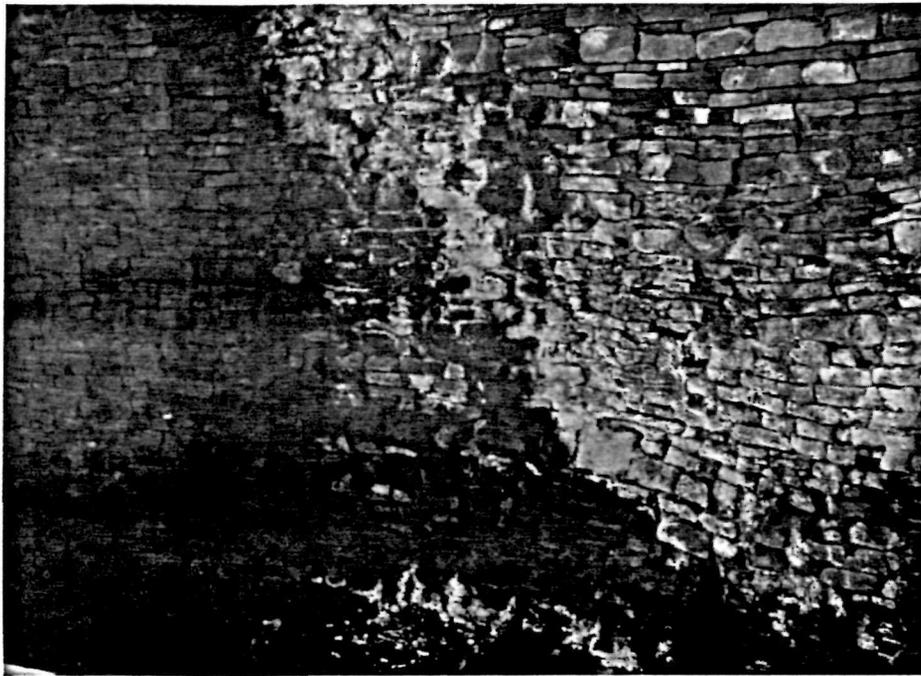
Figure 9. Chaco Canyon. Extreme chronic moist zone showing intense oxidation and surface salt bloom in kiva wall, Pueblo del Arroyo. The rock has been softened and is deteriorating physically.

- C. Chaco Canyon. The most severe deterioration noted during this study exists in the kiva at Pueblo del Arroyo. Oxidation, salt crusting and physical disintegration of sandstone masonry is carried to a visible extreme. Slump failure of the kiva wall has taken place on occasion, revealing deterioration within the rubble core as well. Groundwater may have risen to ruin level periodically since habitation, though ponding and soaking by surface water is probably a sufficient moisture source for initial deterioration. Processes are accelerated by continued chronic moistening and exposure of the wall face.

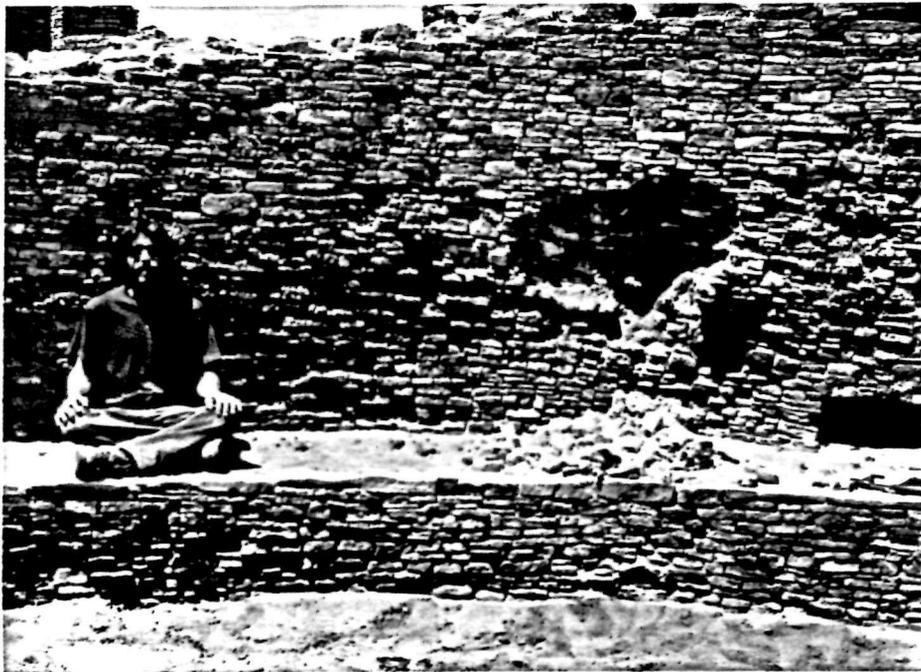
Figure 10. South wall, opposite view of Figure 9. Similar deterioration resultant in slump of wall materials. The apparently loose slump debris has dried and solidified due to its salt content, though surface salt bloom is minor here.

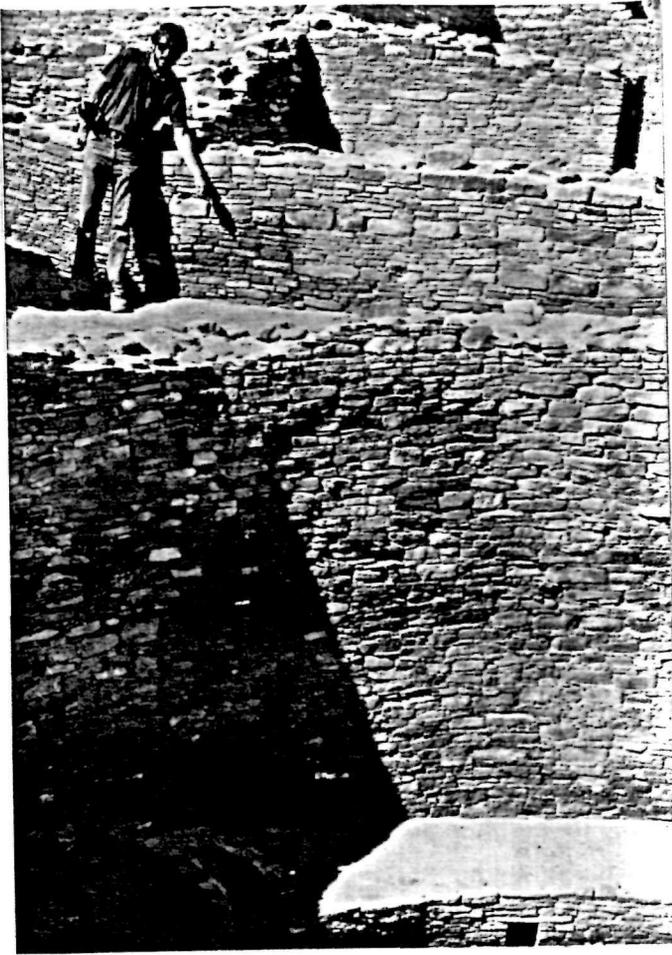
Figure 11. Pueblo Bonito. General deterioration of moderate to severe nature seen in several kivas. Ponding in the area pointed out by Jay and in the room behind contribute to chronic moistness.

Similar but less severe conditions exist in many Pueblo Bonito kivas. Unusually thick rubble core walls accept rainwater, and some ponding on nearby plazas and walkways was evident. Random deterioration occurs throughout the Chaco Canyon ruins where backfill levels vary from room to room (Figures 9 through 12).

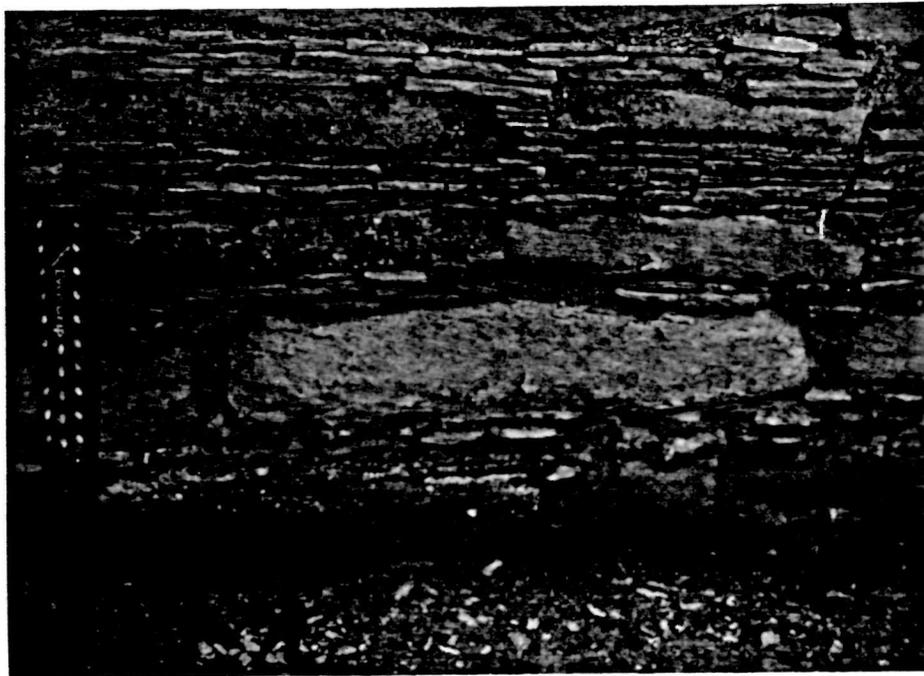
Figure 12. Pueblo Bonito. Random deterioration of susceptible stones near ground level. Rooms behind this wall, rear, are back-filled to a level higher than outside grade.

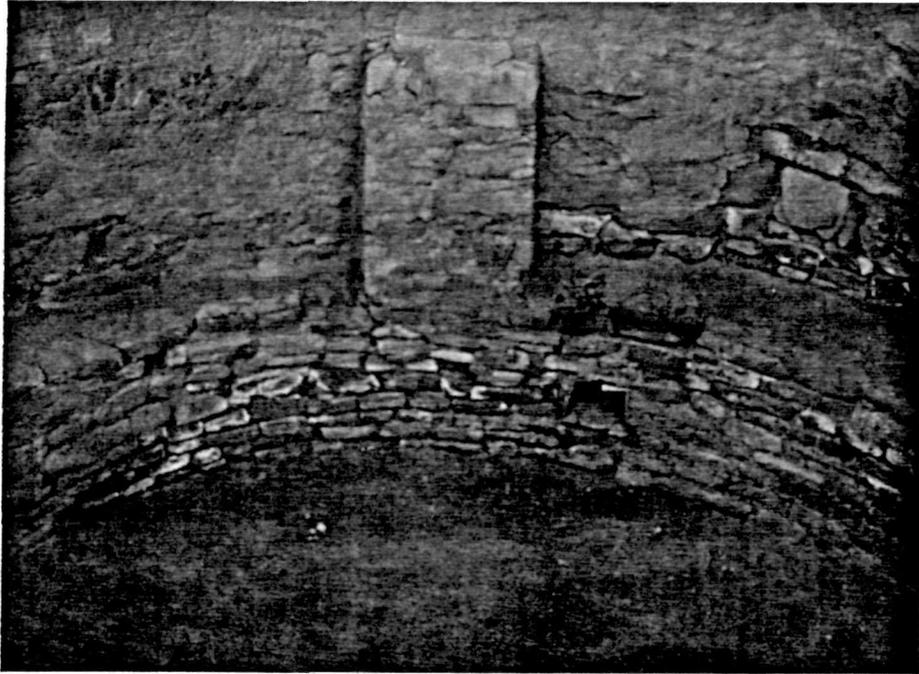
Figure 13. Mesa Verde. Noticeable salt bloom not accompanied by advanced deterioration. Kiva "C," Cliff Palace.

- D. Mesa Verde. Deterioration tends to be minor within cliff ruins visited at Mesa Verde (Spruce Tree, Balcony House, Cliff Palace), though at Cliff Palace some moderate deterioration is evident. Moisture has left notable salt bloom on some kiva walls, though it is not necessarily accompanied by significant deterioration.

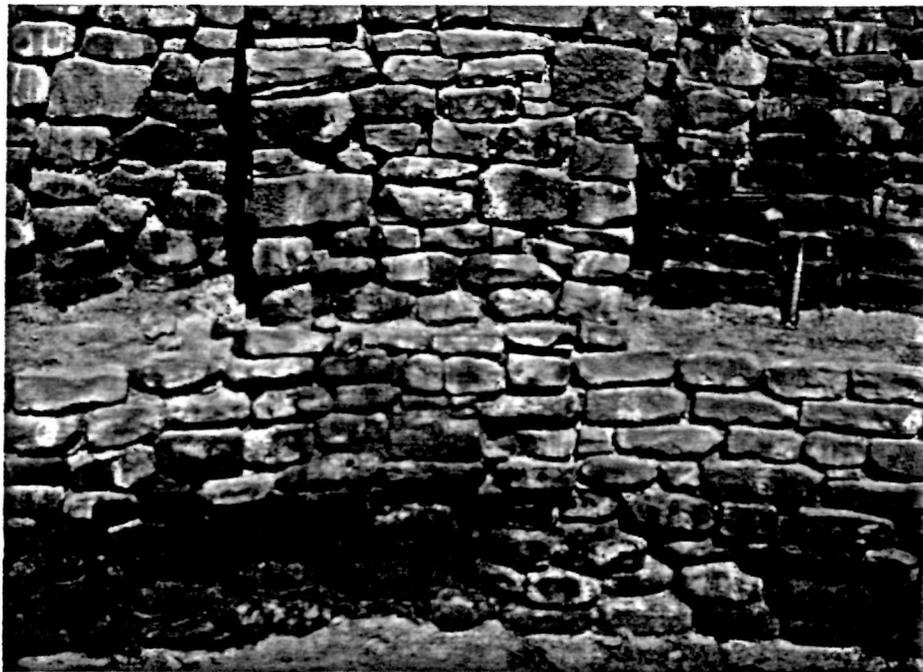
Figure 14. Mesa Verde. General deterioration typical of that seen in kivas of poorly drained mesa-top ruins at Mesa Verde. East wall, central kiva, Farview.

The mesa-top sites, particularly Far View and Site 820, show intense general deterioration rivalling that of Pueblo del Arroyo at Chaco Canyon. Even recently excavated kivas (Site 820) show advance oxidation and deterioration due to long-term underground wetness. Chronic moisture conditions prevail after excavation as shown by mosses growing along kiva wall bases. Surface salt bloom is minor to moderate.

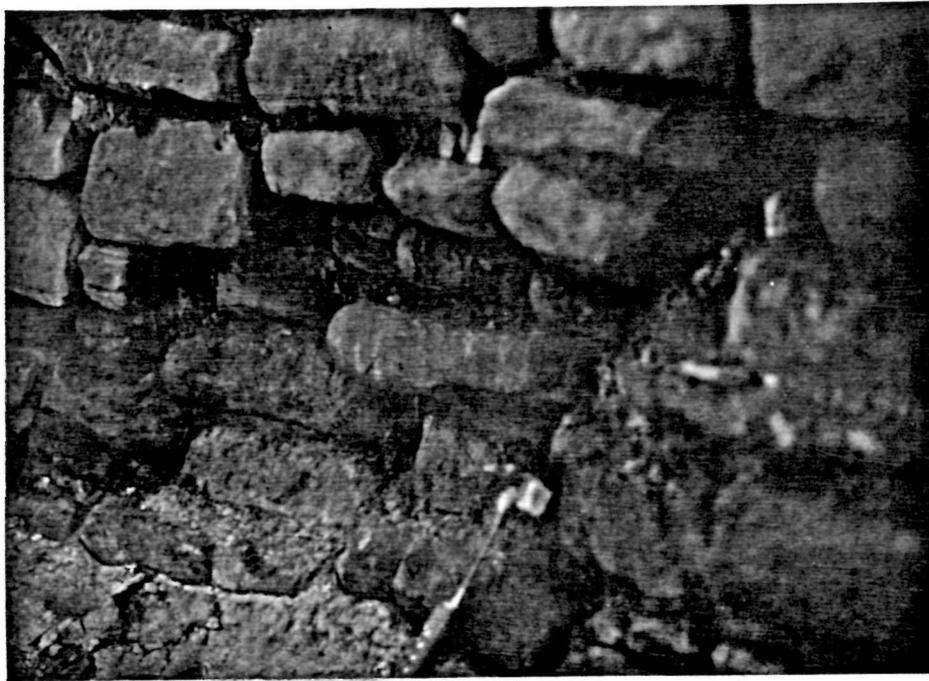
Figure 15. Mesa Verde. Extreme case, oxidation and physical deterioration. South wall, central kiva, Farview.

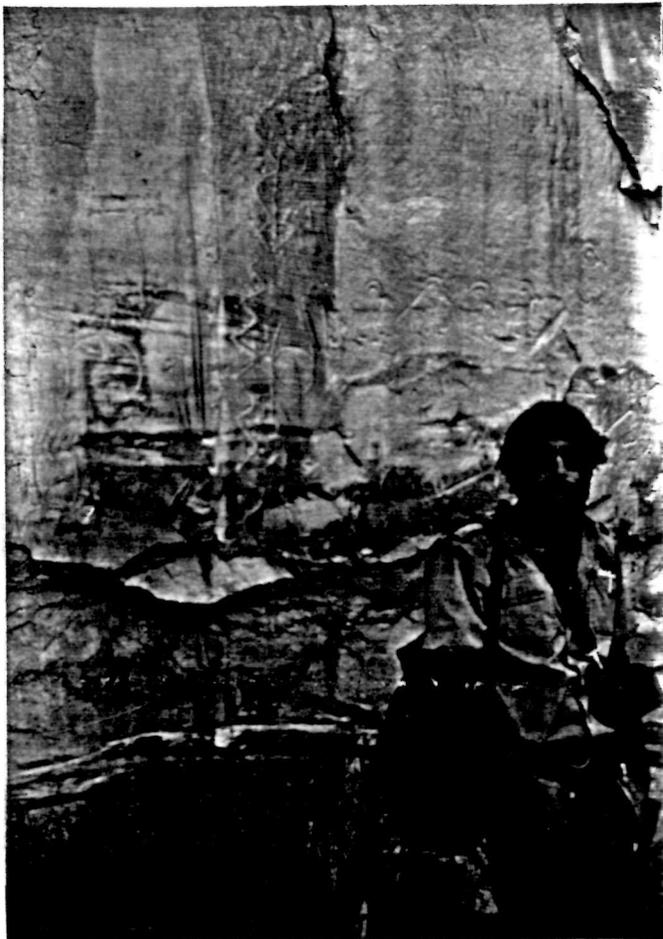
Figure 16. El Morro. The general condition for deterioration is base-caving at and above soil line in susceptible soft sandstone, due to long-term, low-level moisture activity. Upward slabbing threatens historic inscriptions and prehistoric petroglyphs.

Rock deterioration due to lichen growth is obvious at El Morro and freeze-thaw damage is likely to be important in the few chronic moist zones (Figures 16 through 20).

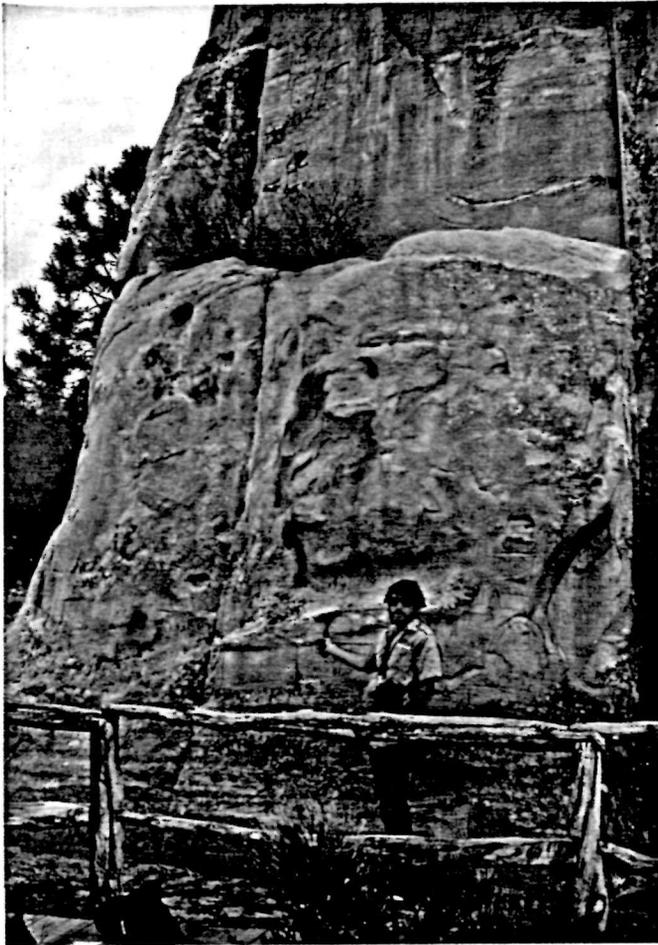
Figure 17. El Morro. More intense local deterioration in the chronic moist zone above the hammer. Rapid erosion of this face is evidenced by rivulet tracks and piles of eroded sand. The moisture reservoir could be eliminated by sealing the obvious crack where shrubs grow. Northeast point of Inscription Rock.

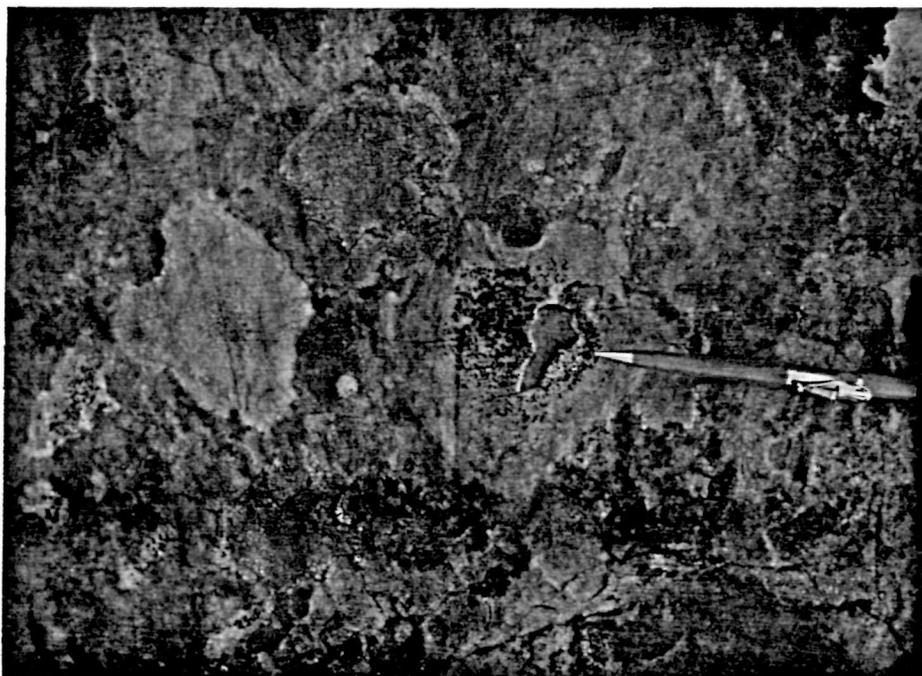
Figure 19. El Morro. Blistering and flaking of rock associated with lichen growth, north face, Inscription Rock. Deterioration rates in lichen-covered areas are at least double that for simple weathering-erosion of a "clean" exposed face.

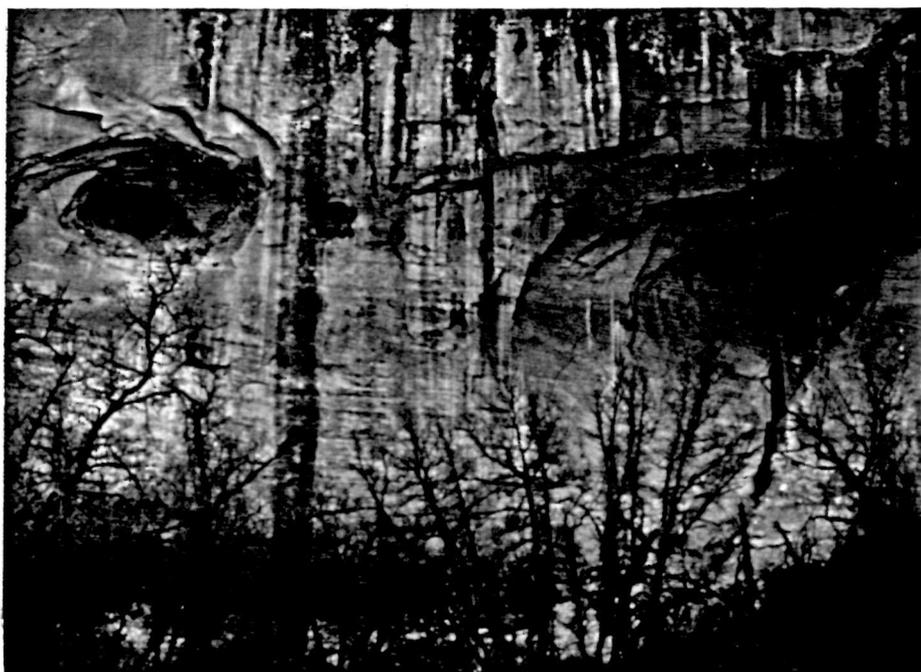
Figure 20. El Morro. Chronic moisture evident in concentric slabbing zones; freeze-thaw is a likely contributing agent of deterioration in this case of "incipient alcove formation." North face, Inscription Rock.

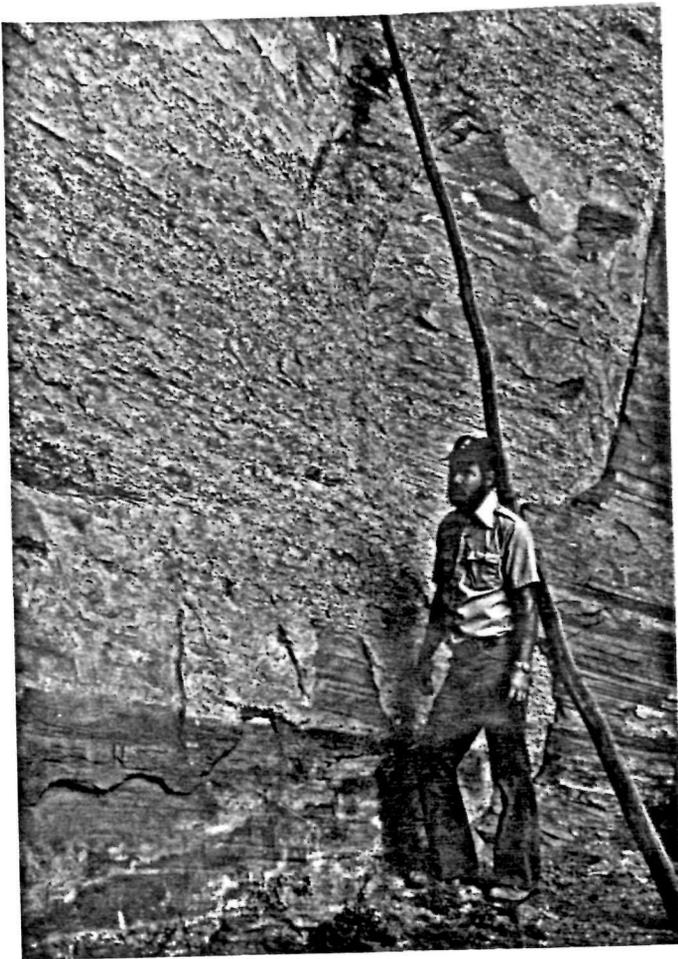
Figure 21. Navajo. Long-term effects of salt action shown as flaking of salt-impregnated chips from the face of Betatakin Alcove.

- G. Navajo. Deterioration of masonry is quite minor. A photo of the Betatakin alcove wall is included to document the potential of advanced salt action relative to the deterioration of sandstone (Figure 21).

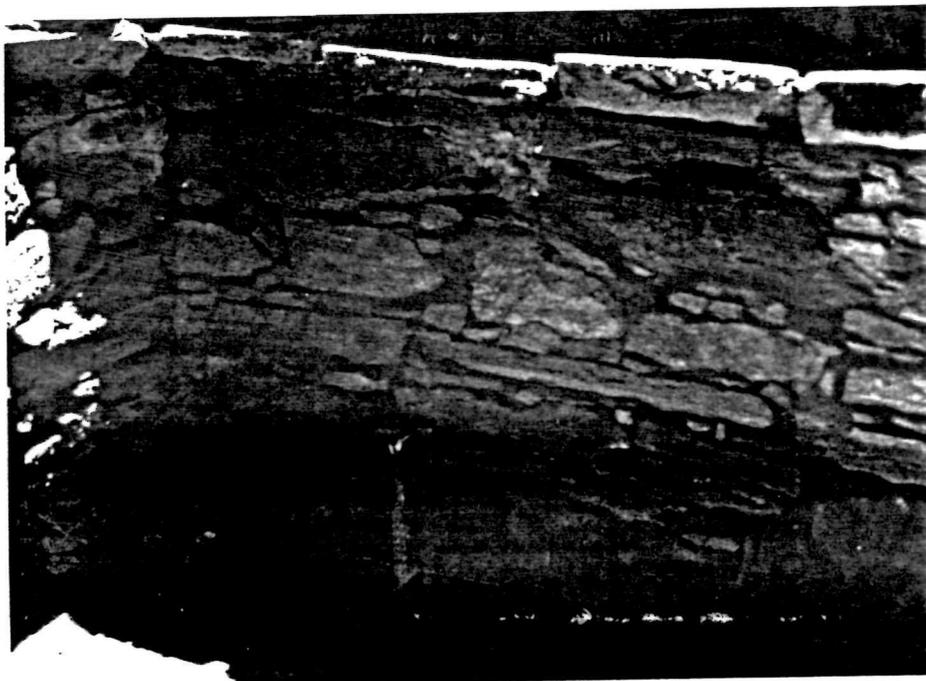
Figure 22. Canyon de Chelly. Oxidation and chemical deterioration is exposed by recent excavation in Antelope House. Physical deterioration continues rapidly due to moisture concentration near the back-fill surface.

- H. Canyon de Chelly. Locally intense deterioration exists in small room remnants below moist fill in Sliding Rock Ruin. At Antelope House excavated rooms and kivas show intense effects of pre-excavation deterioration. Though partially backfilled, physical deterioration is rapid near new grade levels (Figure 22).
