Popular Beach Disappears Underwater in Huge Coastal Landslide—Sleeping Bear Dunes, Michigan

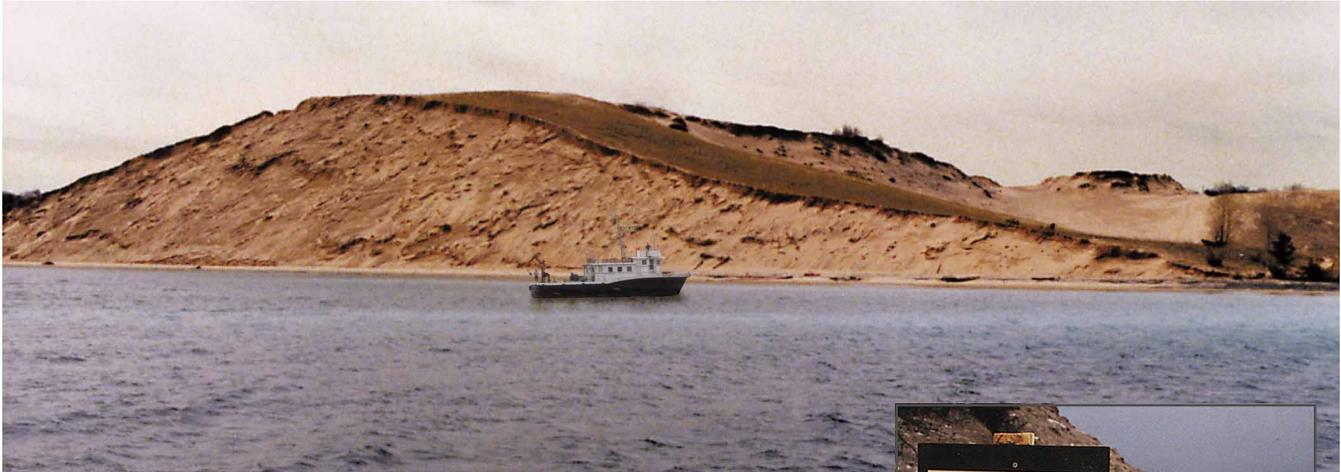
Three times this century, most recently in 1995, large parts of this bluff and the beach beneath it in Sleeping Bear Dunes National Lakeshore, Michigan, suddenly disappeared beneath the waters of Lake Michigan in huge landslides. To determine the causes of these slides, U.S. Geological Survey (USGS) scientists in 1997 studied the underwater part of the 1995 slide from this 70-foot-long ship. The results of this and other ongoing studies will help USGS and National Park Service (NPS) scientists identify times when slide danger is high and public access to this popular area should be restricted. Inset photo shows a warning sign put up by NPS rangers immediately after the 1995 slide. (Ship photo courtesy of Keith Vandervort, Traverse City Record Eagle.)

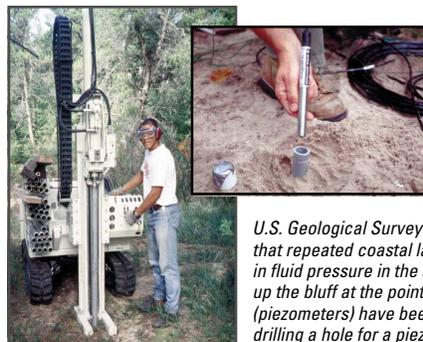
U.S. Geological Survey (USGS) and National Park Service (NPS) scientists believe that repeated coastal landsliding at Sleeping Bear Point may be related to increases in fluid pressure in the spaces between the grains of sand (pore pressure) that make up the bluff at the point. To test this idea, instruments to measure the pore pressure (piezometers) have been installed within the bluff. Photo shows a USGS scientist drilling a hole for a piezometer (inset).

To gather the data required to test this and other ideas about how landslides are caused at Sleeping Bear Point, USGS scientists have installed instruments that monitor pore pressure within the bluff and are also using information from Global Positioning System (GPS) satellites to detect any movement that might indicate instability. In 1997, USGS scientists conducted a variety of studies of the underwater part of the 1995 slide from a small ship. Near the shore they found a deep hole where there had been a gently sloping lake bottom. They also found that a thick blanket of debris from the slide extended more than 2 miles offshore into water depths greater than 250 feet, much farther and deeper than expected. Underwater video of the deeper part of the slide showed trees protruding from the sand.

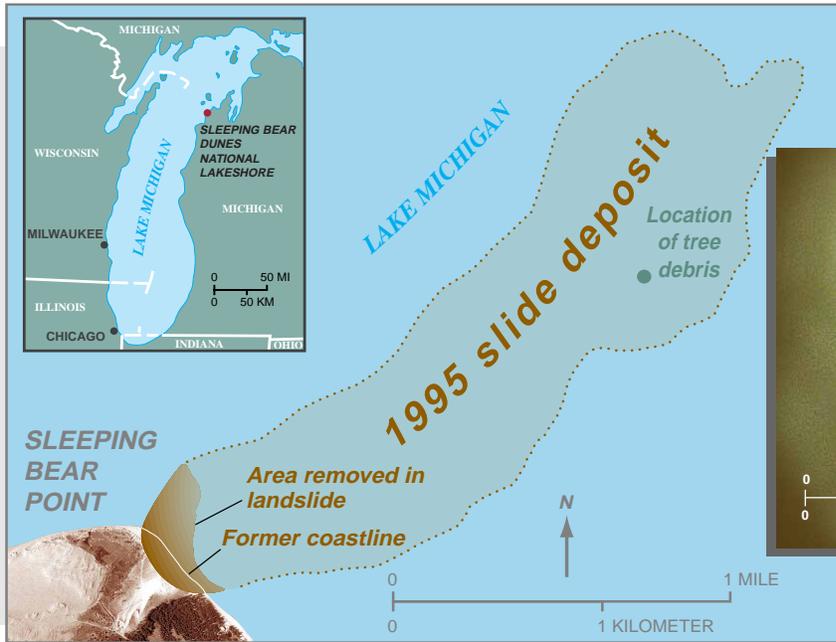
More than 35 million cubic feet of sand disappeared beneath the waters of Lake Michigan in a huge coastal landslide at Sleeping Bear Point in 1995. This composite image shows both the onshore and offshore areas removed from the point in that slide. In 1997, U.S. Geological Survey scientists found a thick blanket of debris from the slide extending more than 2 miles offshore, much farther than expected. Underwater video of the deeper part of the slide showed trees protruding from the sand (inset photo). These trees had been growing on the bluff at Sleeping Bear Point and were swept into deep water with the slide.

beach and just offshore. By comparing the bottom topography with that charted in 1971 by NOAA, the scientists were able to show that sand was gradually filling the underwater hole from the 1971 landslide at a rate of more than 1.5 million cubic feet per year. Because Sleeping Bear Point is an area where sand is being steadily deposited, the scientists concluded that the coastal landsliding is not the result of erosional undercutting of the offshore slope by water currents.

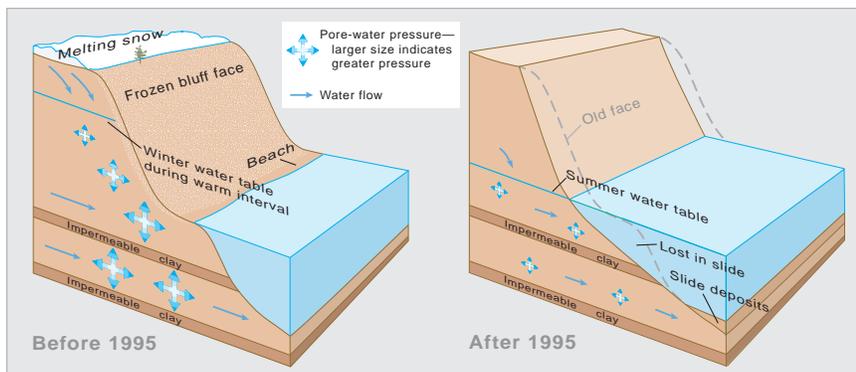
Coastal landsliding at Sleeping Bear Point may be related to increases in fluid pressure in the spaces between grains of sand (pore pressure). High pore pressure lessens the forces holding sand grains together, which may weaken the bluff at Sleeping Bear Point enough to trigger a slide. Pore pressure may be increased by water from snowmelt in winter being trapped behind the frozen bluff face or within sand layers confined by impermeable clay beneath the bluff. This idea is supported by the fact that all three known slides at Sleeping Bear Point (1914, 1971, 1995) happened in unseasonably warm weather during winter months.

USGS and NPS scientists now believe that the sliding at Sleeping Bear Point is related to increases in fluid pressure in the spaces between the grains of sand (pore pressure) within the bluff. High pore pressure lessens the forces holding the sand grains together, which may weaken the bluff enough to trigger a slide. The pore pressure may be increased by water from snowmelt in winter being trapped behind the frozen bluff face or within confined sand layers

beneath the bluff. This idea is supported by the fact that all three known slides at Sleeping Bear Point happened in unseasonably warm weather during winter months.
