THE BRIEN FARM AND FAMILY

Marcella Sherfy  
Resources Management Division  
Gettysburg National Military Park  
June 1972

BRIEN FARMYARD FENCING AND LAYOUT PLAN

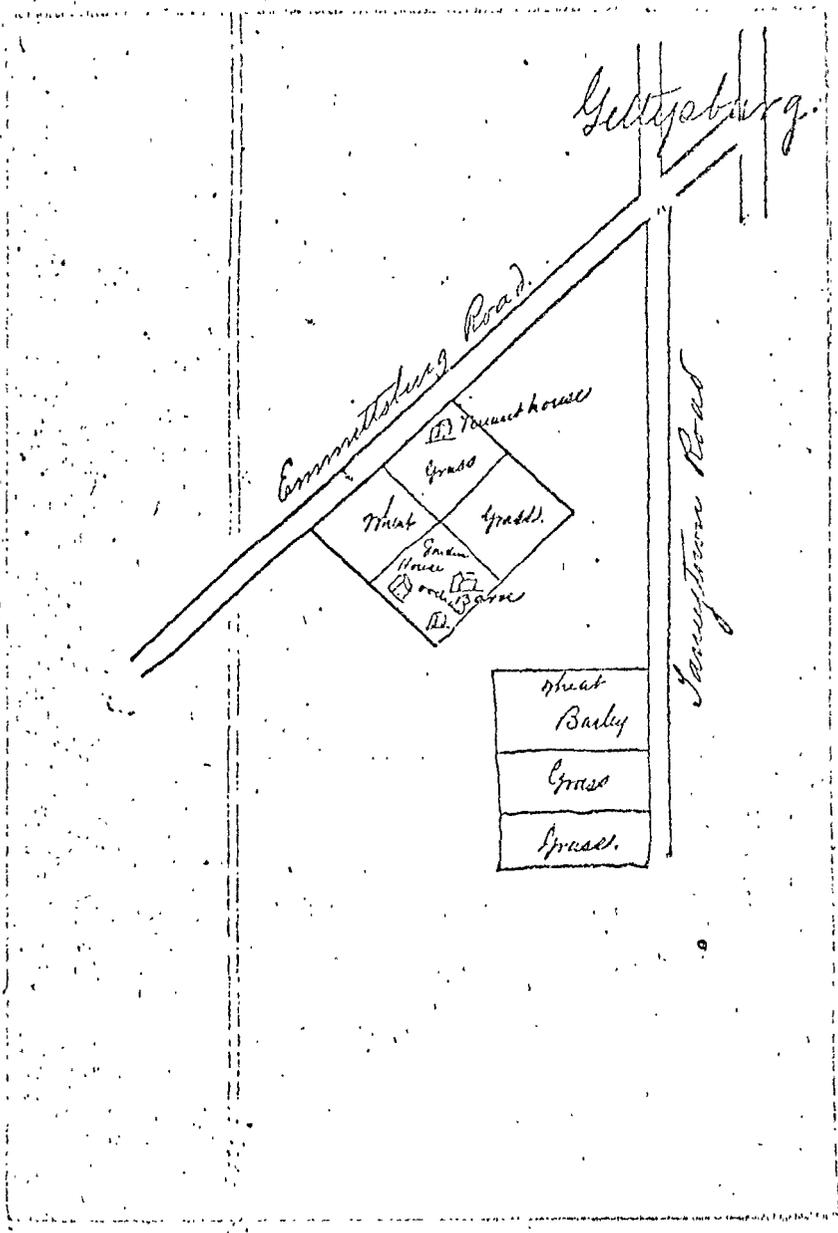
Map accompanying Abraham Brien's damage claims.

The most interesting portion of Brien's claim is its accompanying map, drawn either by Brien or at his direction. It provides the

only firsthand information available on the farm's Civil War period boundaries. Yet, the position of Brien's house and barn are reversed from that described in regimental histories, shown on the G. K. Warren Map of 1869, and indicated in W. H. Tipton photographs of the late 1800's. And there, as in his prose statement, he claims 20 acres of land instead of the 12 indicated by tax collectors. The map is shown below.

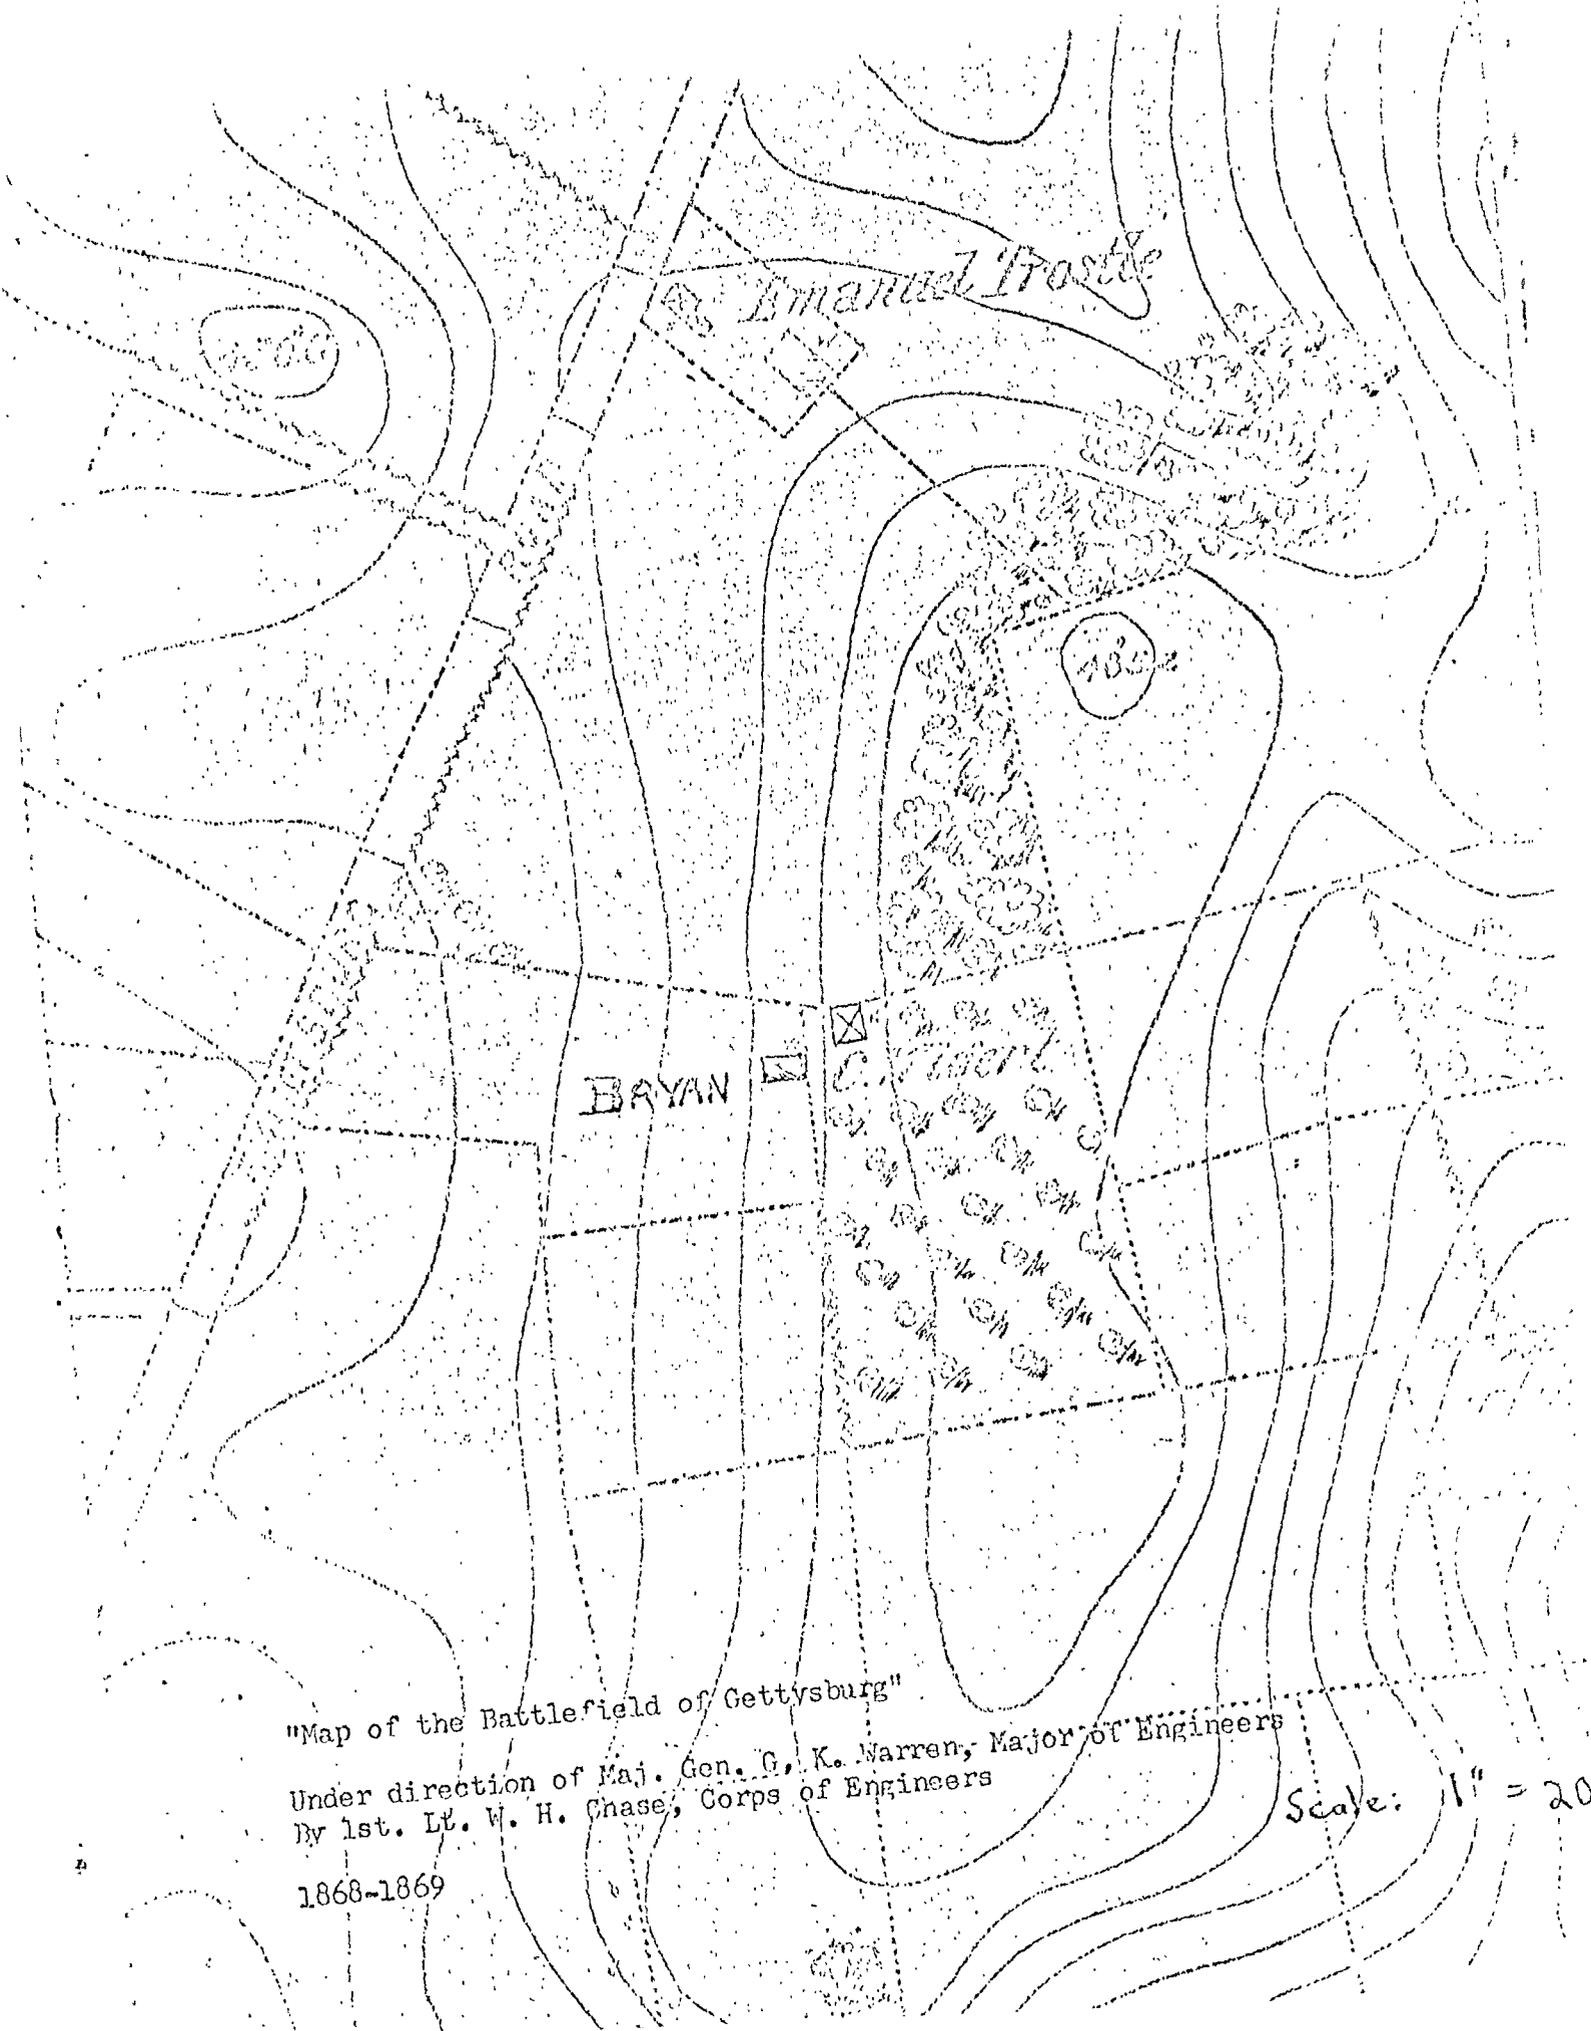
"Map of the Battlefield of Gettysburg"

Under direction of Maj. Gen. G. K. Warren, Major of Engineers  
By 1st. Lt. W. H. Chase, Corps of Engineers

1868-1869

Scale: 1" = 20

Historic fences on Brien land are noted in two of the four maps. They are identified in both Warren's map and the 1896 Cope map, but not in Brien's damage claim map. Differences between the Warren and Cope maps include a Virginia worm fence along the Emmitsburg Road on the Warren map and a post and rail in the same place on the Cope map. Warren also shows a post and rail fence on the north side of the Brien buildings while Cope indicates a stone fence that begins west of the barn; and Warren has a Virginia worm fence along a field south of the Brien house while Cope continued with the stone wall. No positive method exists to correctly resolve these differences, but Brien's damage claims indicate a preponderance of wooden fencing on his property. (194 panels of fence--part post and rail and part worm - worth \$174; stone fence destroyed worth \$5.00).

Fencelines on both the Warren and Cope maps are virtually identical, despite differences in fencing materials. These fence lines, however, do not follow the boundary lines shown on Brien's damage claims or those on the tract map of property purchased from the heirs of Jacob Benner in 1895. Again, with no deed description or other reliable source, no way exists to positively identify Brien farm boundaries. Acknowledging the questions that must be raised about the accuracy of Brien's damage claims and the accompanying map, it does show the existence of two separate tracts of land, located on the two roads. No other map indicates this. Nor, then, did the Park purchase all of the Brien land in 1895 from the Benners. The Taneytown Road tract was evidently sold separately between 1868 and 1895. Lack of adjacent fence lines in the western area of Brien's property on the Warren map encourage the belief that Brien's boundaries conform to the fences. This is, however, a judgment.

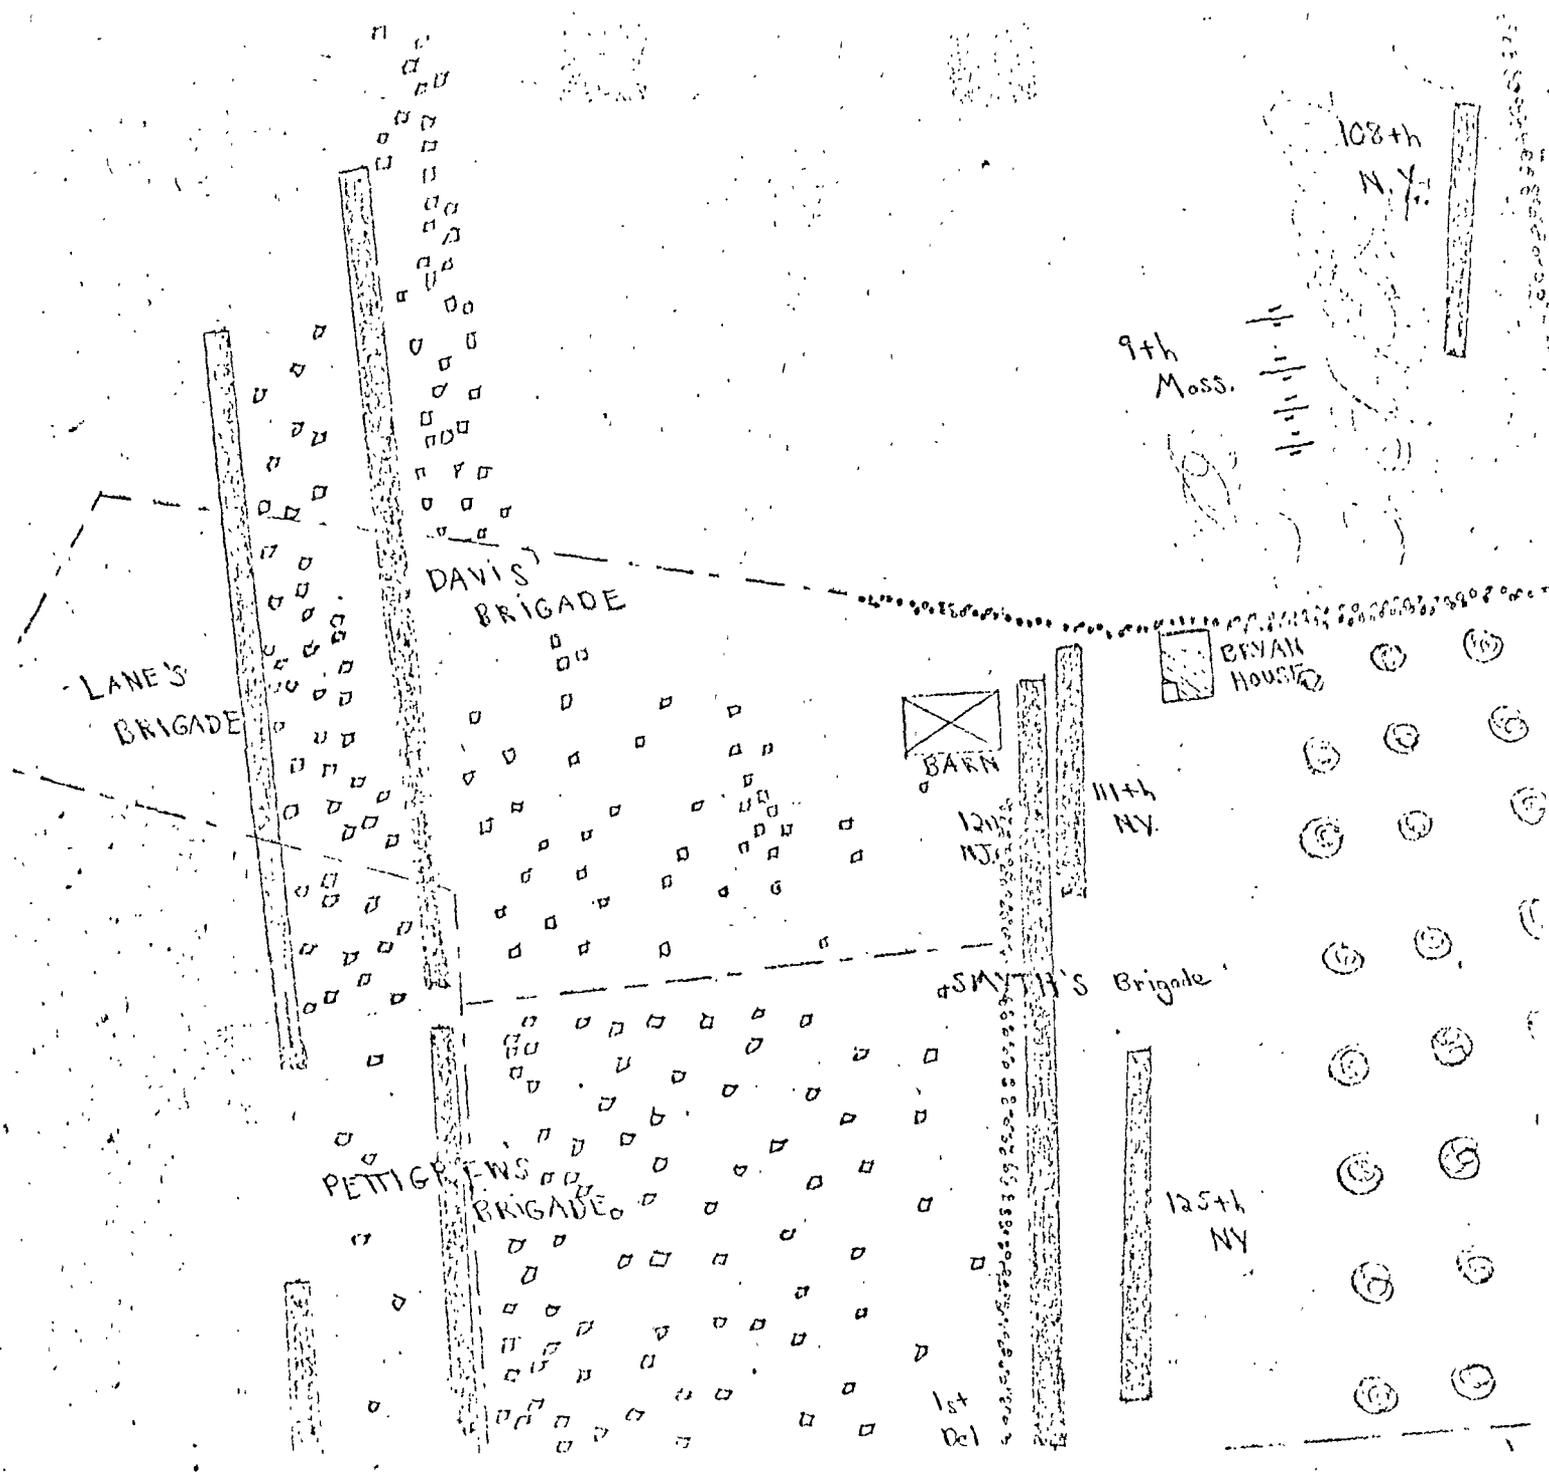
" Map showing the scene of Longstreet's final Assault on the Union Lines at Gettysburg. July 3, 1863, and the positions of the respective bodies of Troops therein of both armies."

Prepared by the Gettysburg National Park Commission and based upon the evidence carefully gathered from all sources and collated by said commission.

1896 Report  
 Lt. Col. F. B. Cope, engineer  
 S. A. Hammond, ass't engineer

Scale: 1" = 100'

Brien owned a small story and a half structure on the Emmitsburg Road, but its exact location has never been established. Brien's damage claim map and the Warren map indicate that this structure was north of Brien's own house. The Cope map and the Brady photograph, however, appear to show that house directly west of Brien's own. Consequently, Cope's map shows that the Emmitsburg

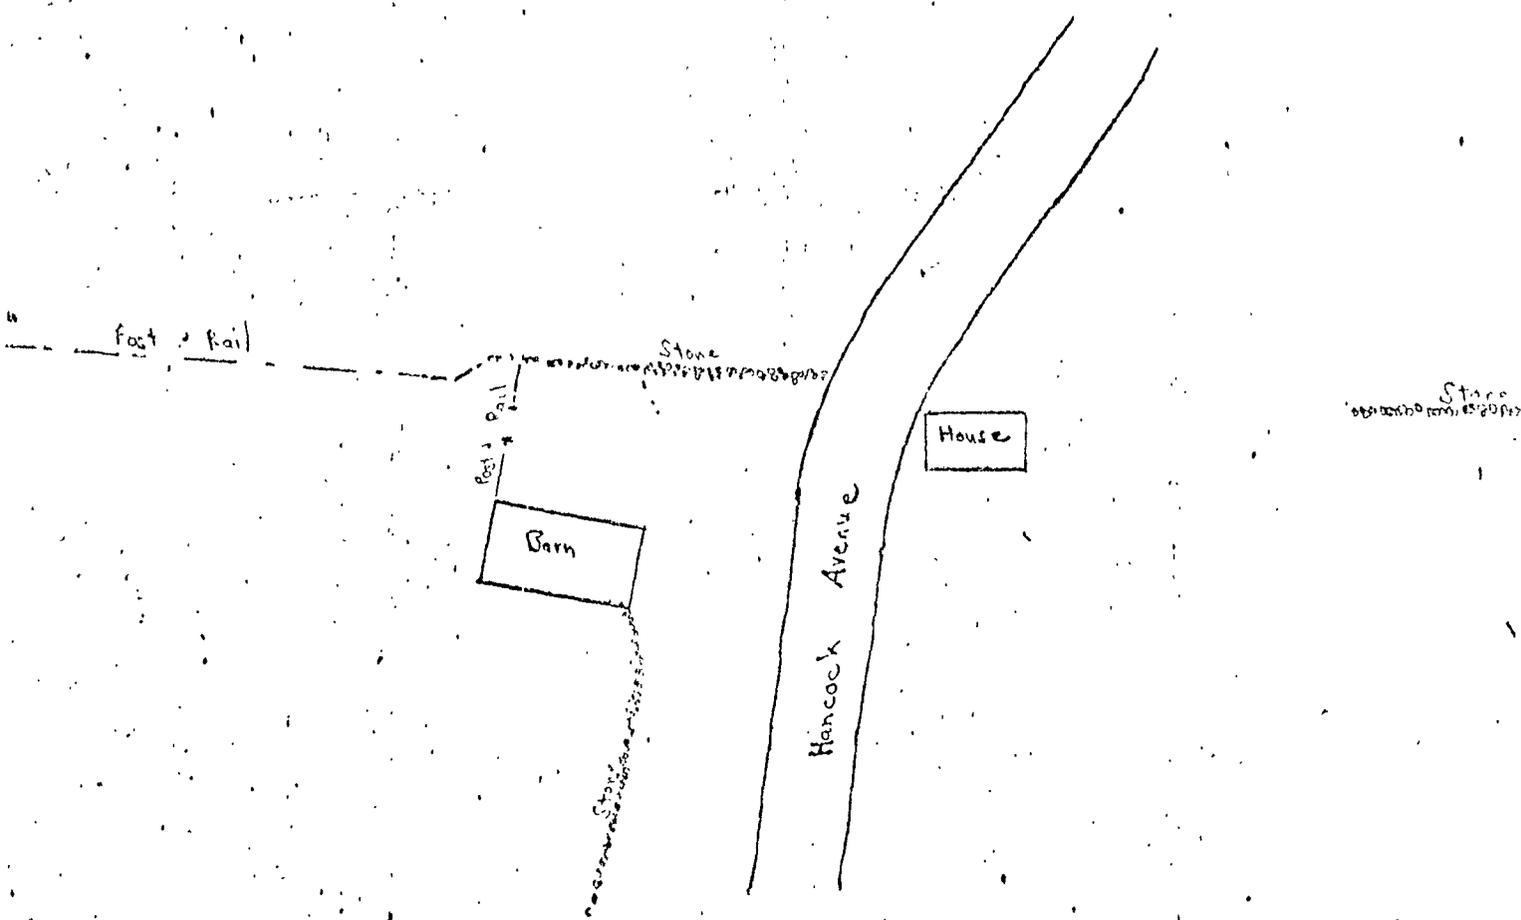
Fencing + Layout Plan

Recommendations for a current fencing and farmyard layout plan are based on the Brady photograph, the 1869 Warren map, and judgments that seem logical based on their information.

The first step necessary to recreate the historic layout of the area must be the removal and subsequent replacement of the stone fence which runs beside the concrete sidewalk on the north and east side of the Brien house. The Warren map shows a post and rail in its place, while the Brady photograph clearly shows a post and plank fence. The fence begins at and is attached to the northeast corner of the house and should then run in an easterly direction at the same angle as the house wall. The planks do not appear to be painted. The historic angle of the fence may have been slightly more northerly. The present sidewalk, however, prevents placing it that way.

The second project undertaken should be the removal of the stone fence which runs from the south below the Brien barn and which curves in toward the southeast corner of the barn. Only the curved portion of the fence needs to be removed. The stone work

should then continue in a northerly direction at the same angle as the previous line of fence, but should stop short of the present east-west stone fencing by a farm vehicle's width. The Warren map and Dr. Tilberg's research on field defense work confirm the presence of this stone wall slightly to the east of the barn. Although neither indicate the presence of a farm lane along the post and rail fence to the Emmitsburg Road, regimental accounts do describe the land and locate it in the Brien farmyard by a large tree. As mentioned earlier, the tree appears to sit west of the northwest corner of the house--and thus at the head of the farm lane.

Third, a section of stone wall running in an east-west direction and becoming a post and rail fence several feet beyond Hancock Avenue should be removed. According to the Warren Map, this should be a continuous post and rail fence. The angle of this fence also needs changing entirely. It should run in a more northerly direction, instead of directly west and should intersect the Emmitsburg Road opposite Long Lane.

The section of post and rail fence running north from the barn to the east-west post and rail fence should be removed entirely.

The addition of two further structures will place the Brien House in a more accurate historic context. These are the bake oven, documented in shape and location by the Brady photograph, and an outhouse. The outhouse does not appear in the photograph and has never been located historically. Its suggested location is based on determining from the photograph where it did not stand-- and on probably locations in respect to nearness to the house and prevailing wind directions.

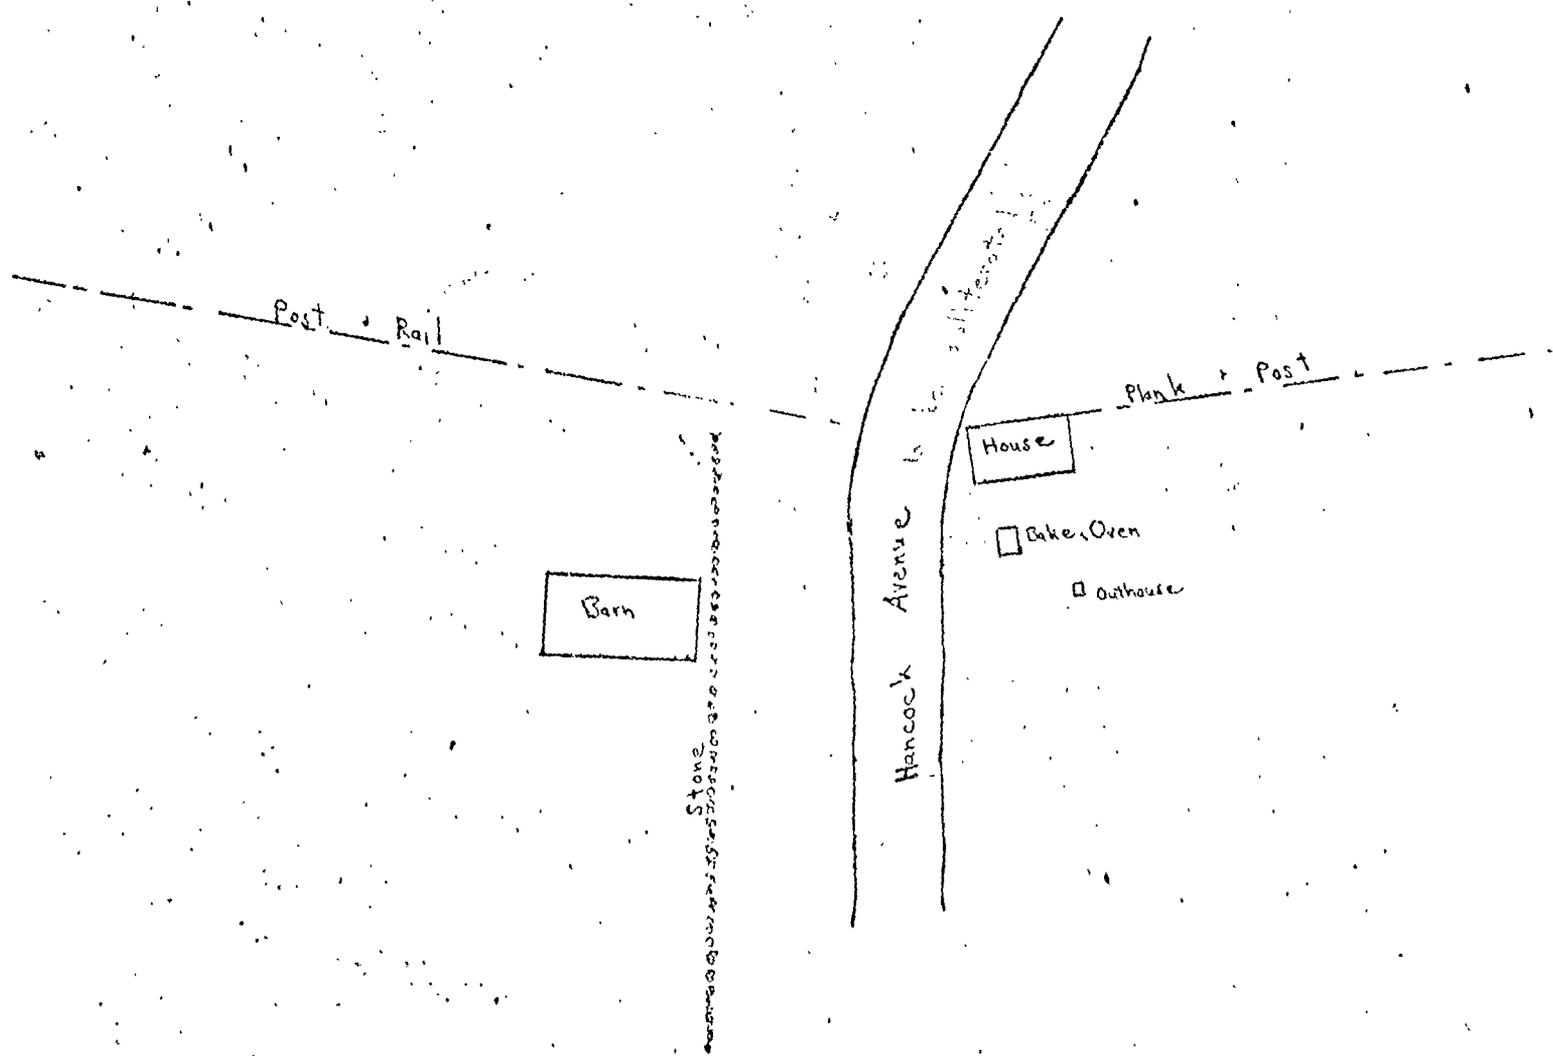
Yan' Farmyard  
Fencing • Layout Plan  
1972

Proposed - Summer 1972

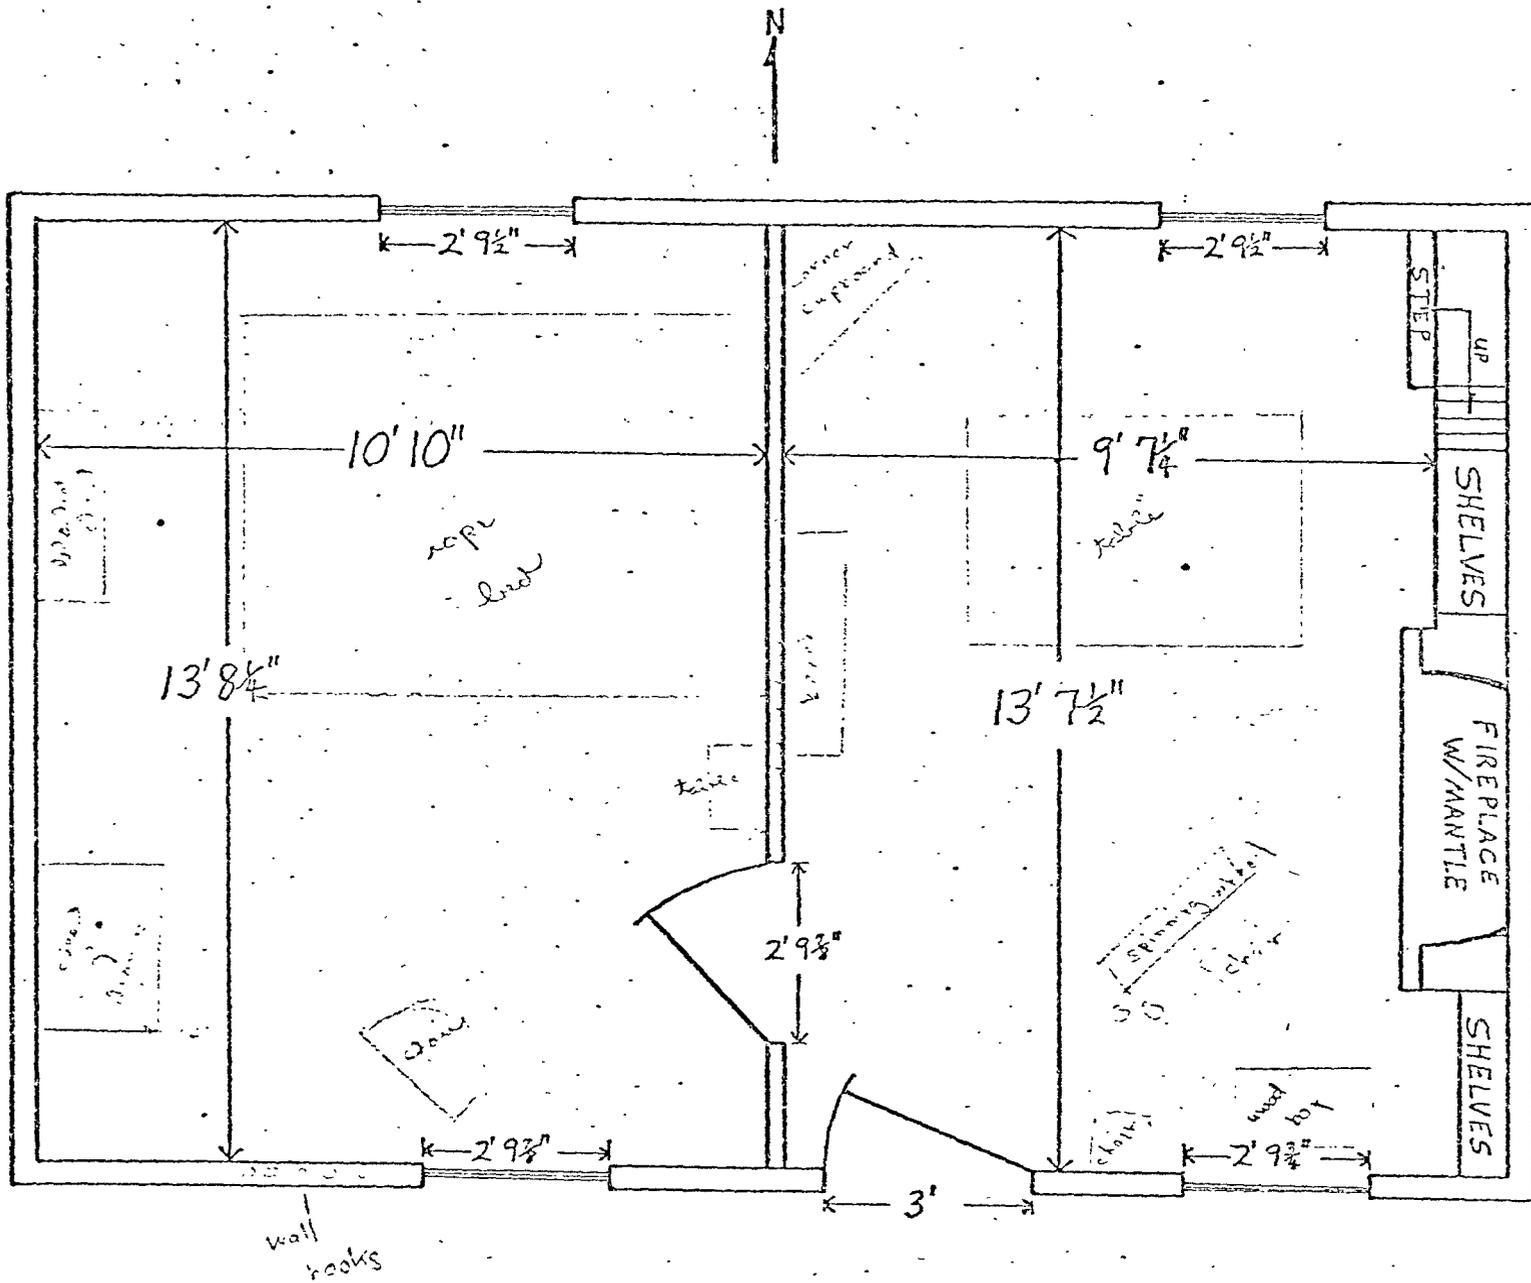
FLOOR PLAN  
BRYAN HOUSE

GETTYSBURG NATIONAL  
MILITARY PARK

W.F. Hubbard  
22 Oct, 1968

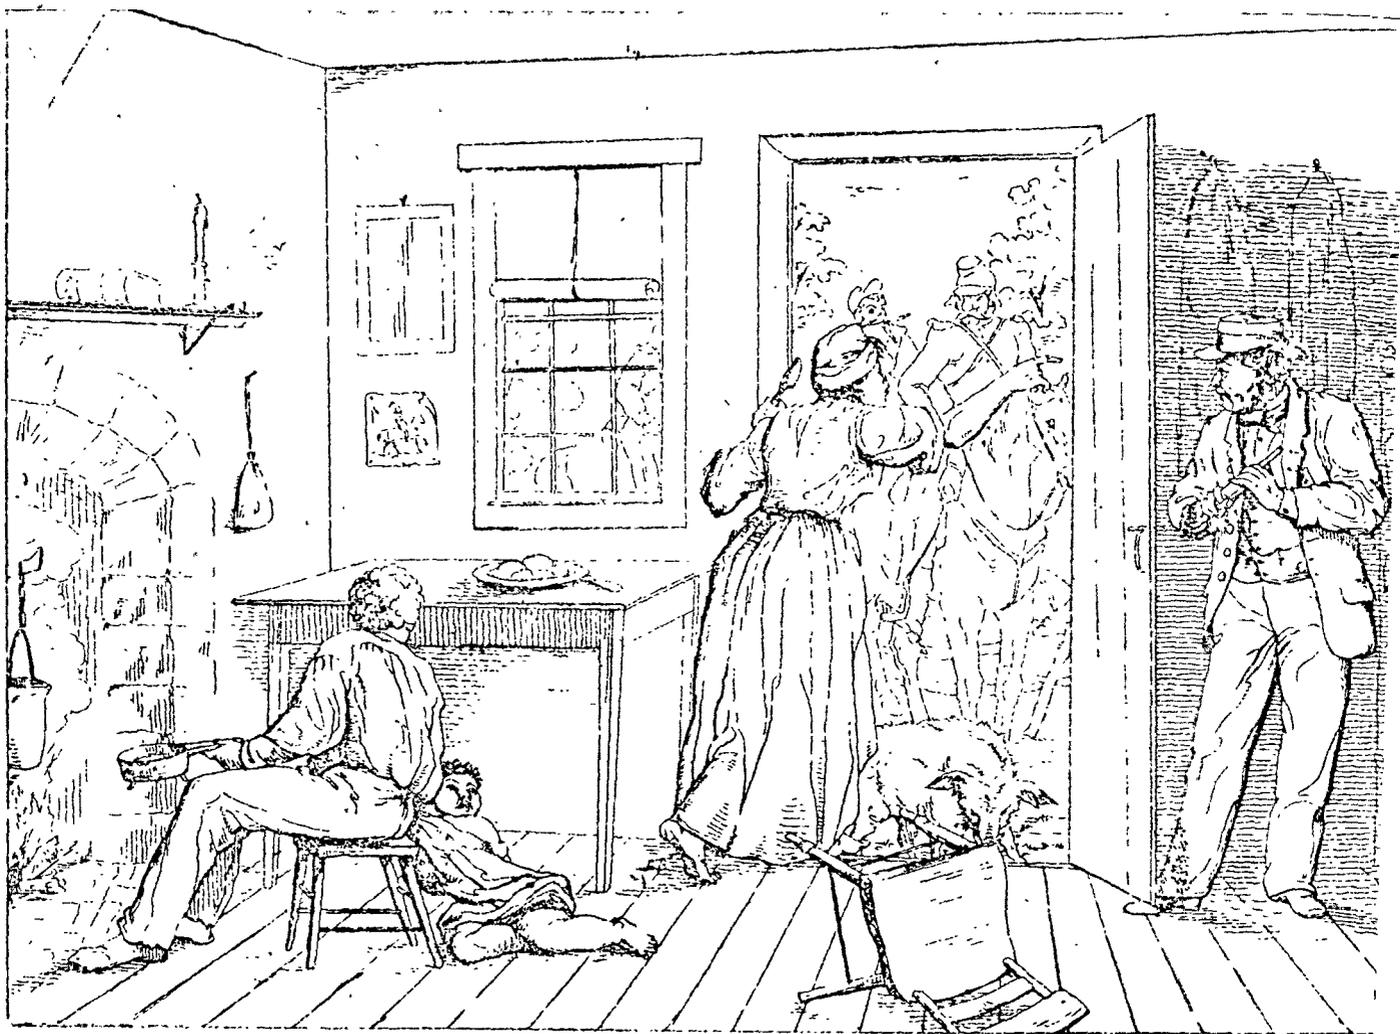
Plate 108. *Slaves Concealing their Master from a Search Party from Confederate War* Etchings by Adalbert J. Volck, 1862. Library of Congress.

As a Southern sympathizer, Volck naturally portrayed the living conditions of the slaves and their relationship to their master in the best possible light. Here the faithful servants are shown in a simple but comfortable room, very similar to those lived in by working class whites and farmers (See plate 111). The brick hearth of the cooking fireplace is completely free from clutter as it would have been in any working kitchen. This was an all-purpose room for living, cooking, eating and sleeping. The bed may be seen at the right with clothing hanging from nails or pegs on the wall behind the slave owner. The walls would appear to be plastered, and the window shade which rolls up like a porch blind is an interesting detail.
