CULTURAL LANDSCAPE REPORT

GEORGE WASHINGTON BIRTHPLACE  
NATIONAL MONUMENT

Westmoreland County, Virginia

VOLUME ONE: HISTORICAL AND EXISTING CONDITIONS DOCUMENTATION

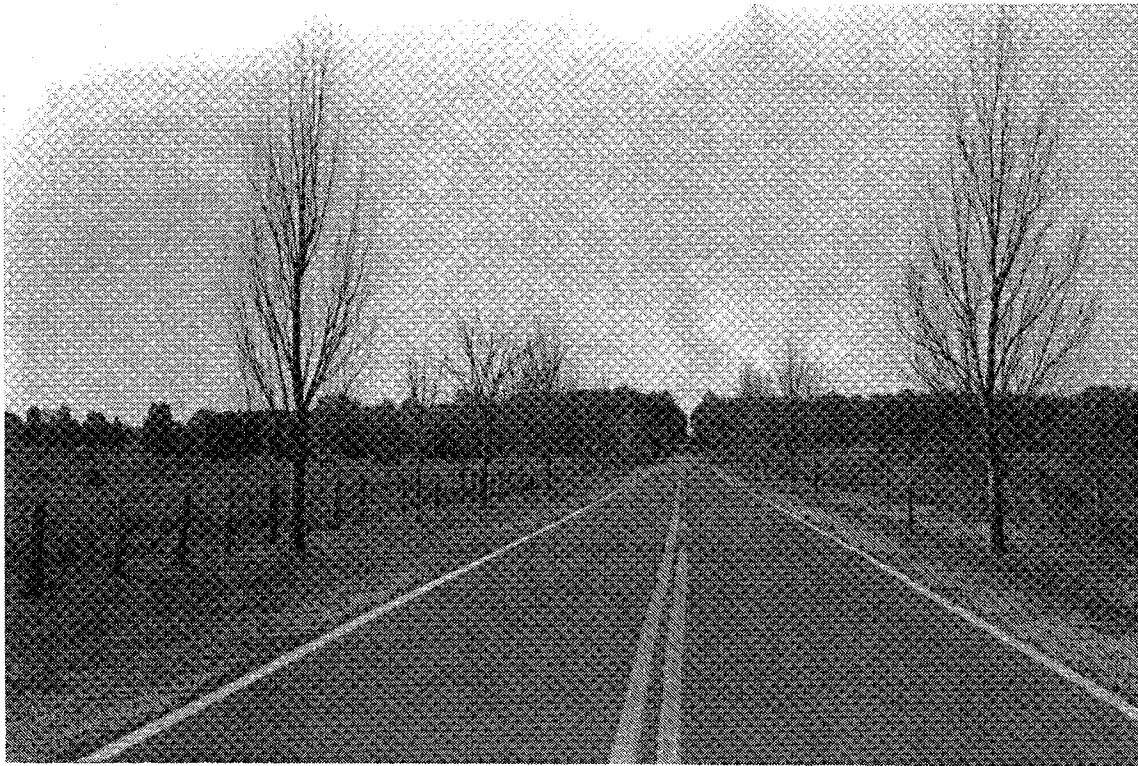
25. View southwest along State Route 204, the approach road to the park, which is edged by fenced agricultural fields and an allée of red maples.  
(See photo 1 in chapter 2 for a comparative view of historic conditions)

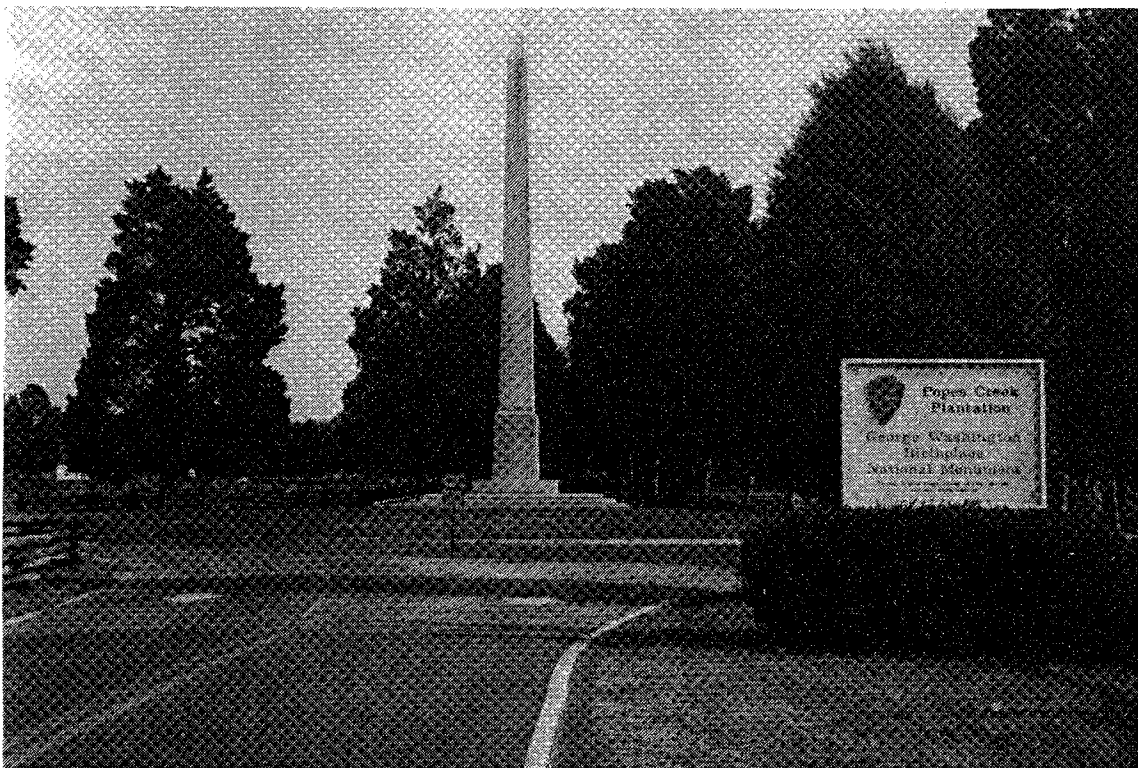
26. View northeast toward the park entrance sign and the granite Memorial Shaft. This obelisk, a one-tenth replica of the Washington Monument, was constructed in 1896 to commemorate the site of George Washington's birth.

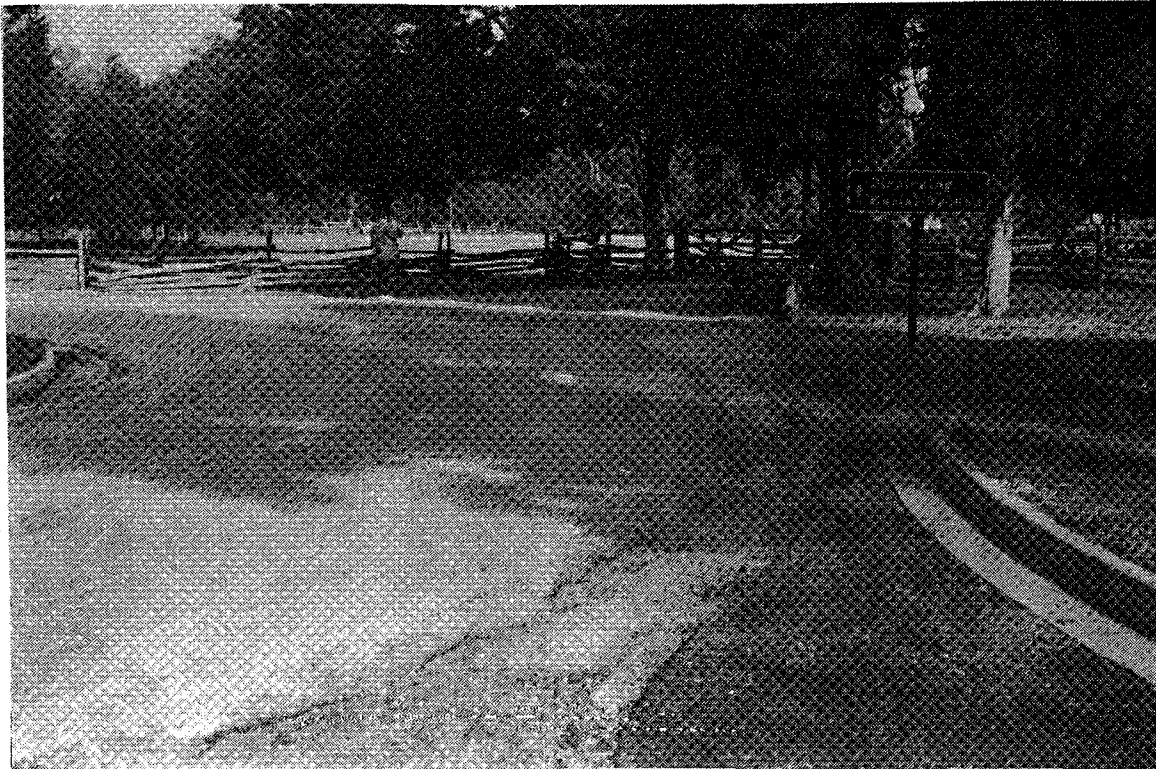
27. The traffic circle east of the monument.  
(See photo 11 in chapter 2 for a comparative view of historic conditions)

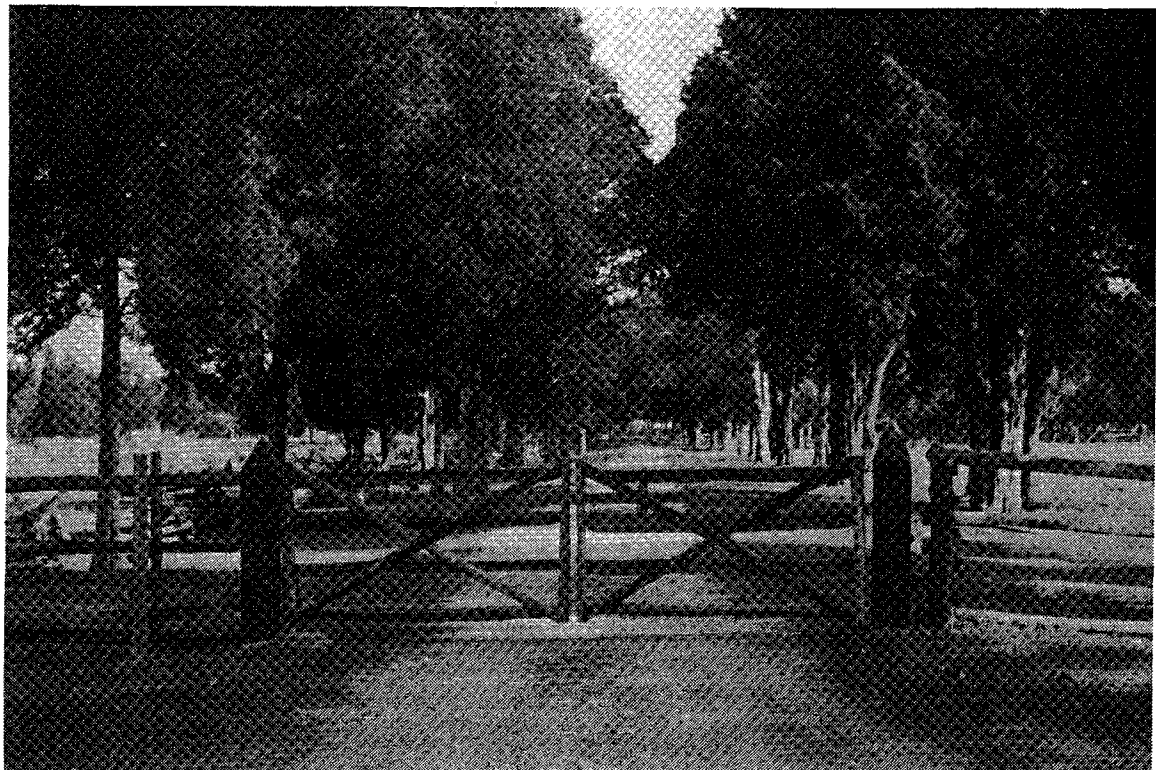
28. View northeast to the gated gravel road leading from the traffic circle toward the historic core. This was once the main entrance into the park. An allée of Eastern red cedar trees lines the road.  
(See photo 24 in chapter 2 for a comparative view of historic conditions)

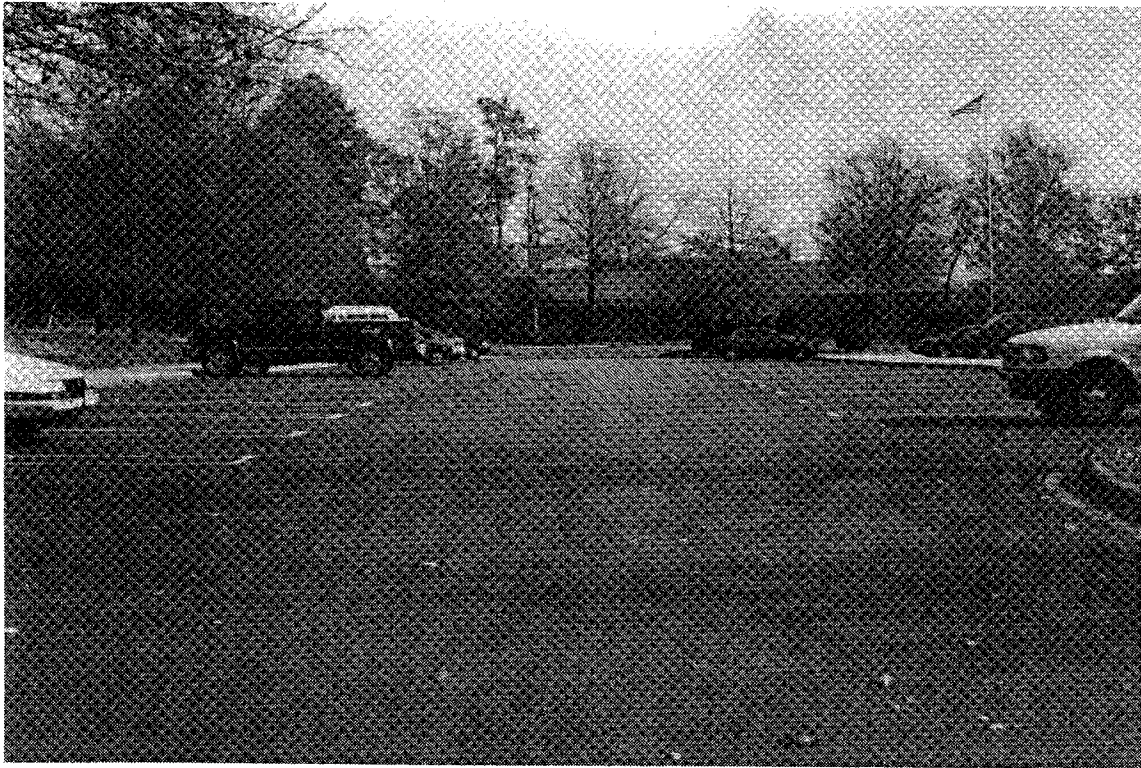
29. View northeast of the main parking area and the Visitor Center beyond.

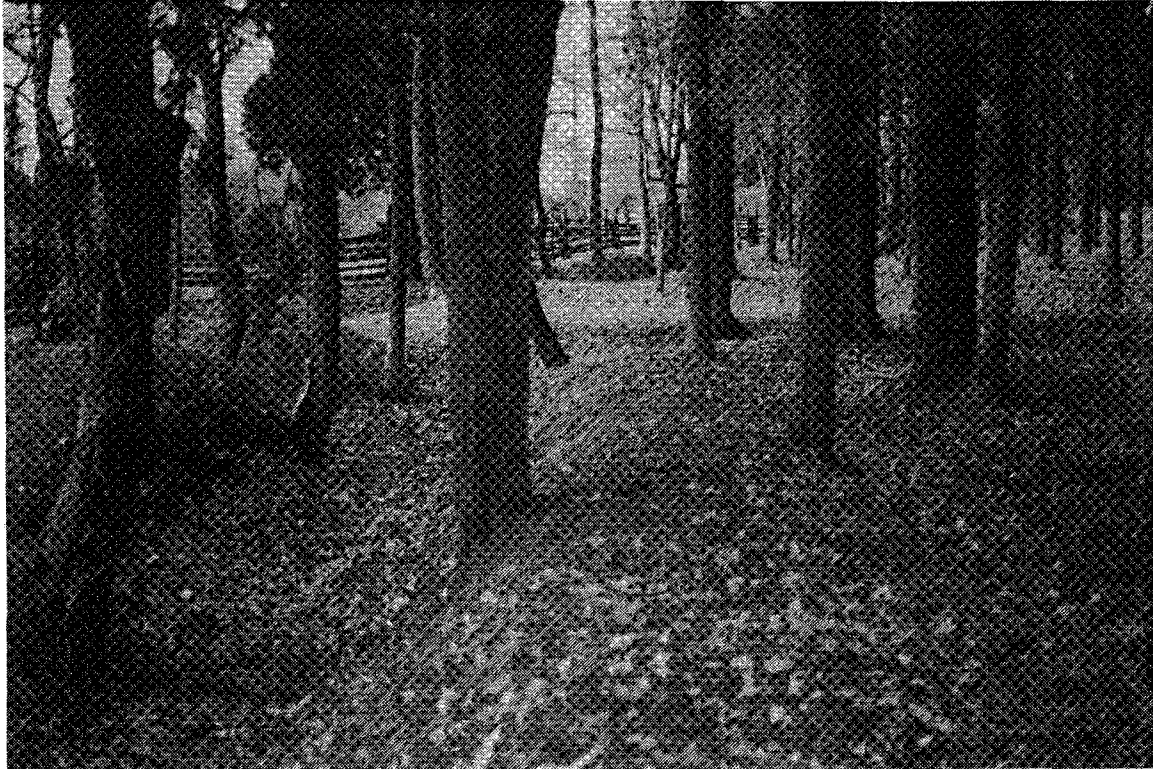
31. View southeast of the ditch system which lines the main park road to the west. These ditches appear throughout the park and are associated with agricultural fields, including those currently in use and those that have been abandoned and have reverted to woodland.

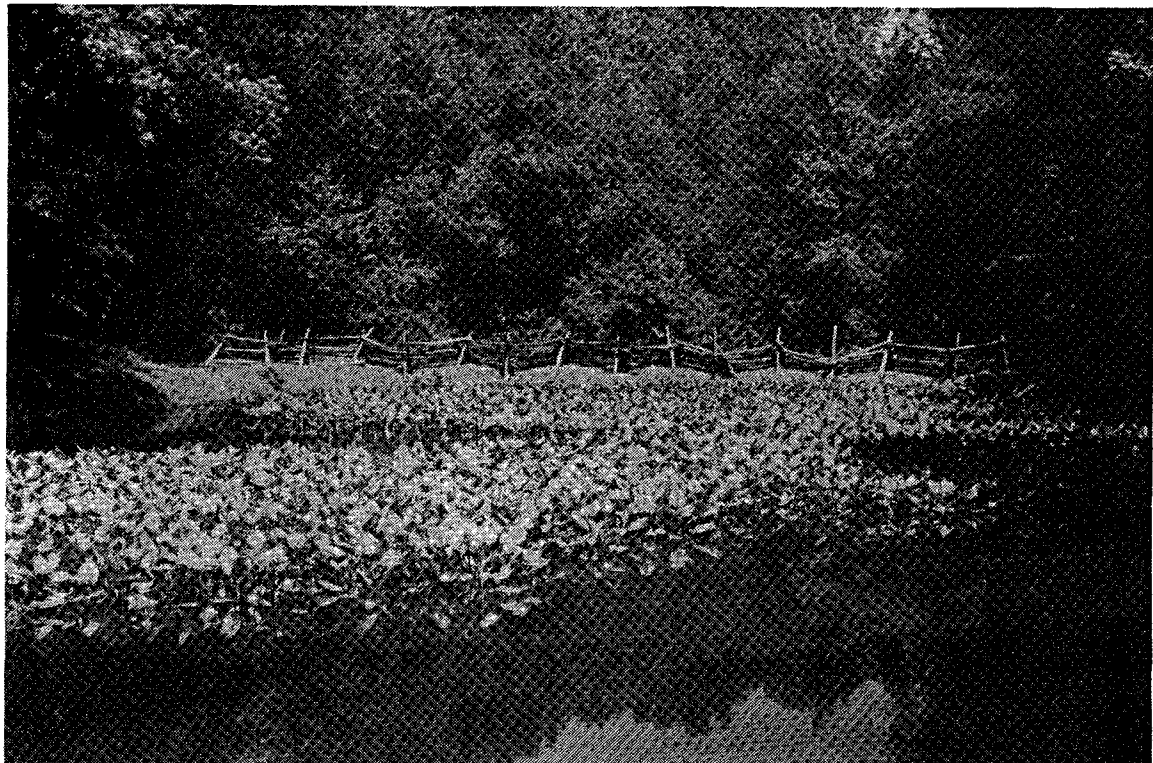
32. View northeast across the Ice Pond located east of the main park road near the traffic circle. It is one of two man-made ponds identified within the park boundaries.

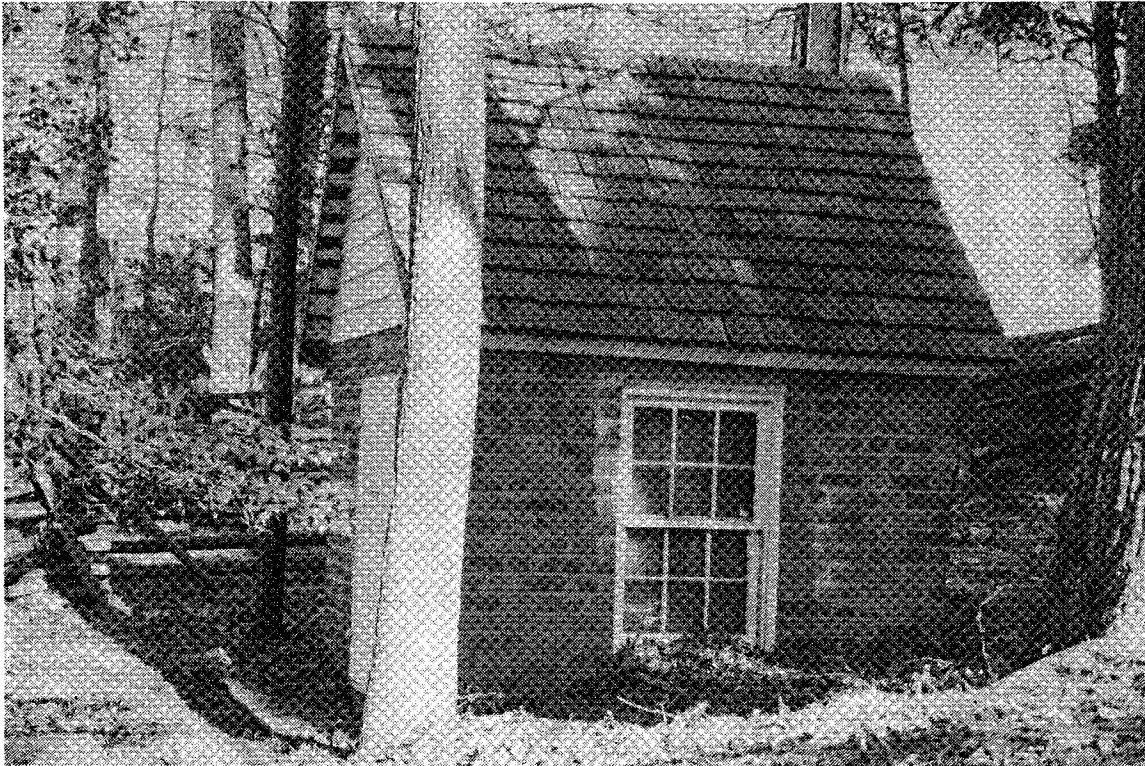
33. A brick pump house is located east of the Ice Pond and provides water to the historic core area.

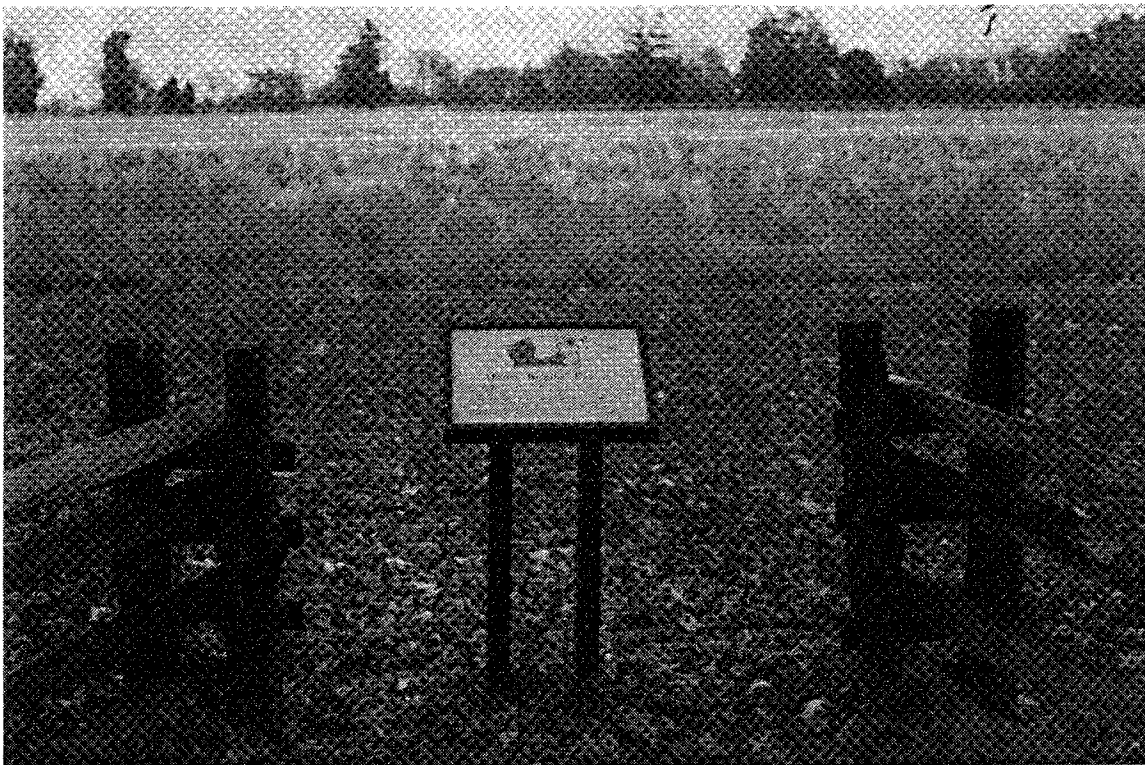
34. View northeast to an interpretive wayside identifying the location of "Henry Brooks Patent." This wayside, which includes an illustrative locator map of the land patent, is sited adjacent to the Burial Ground parking area.

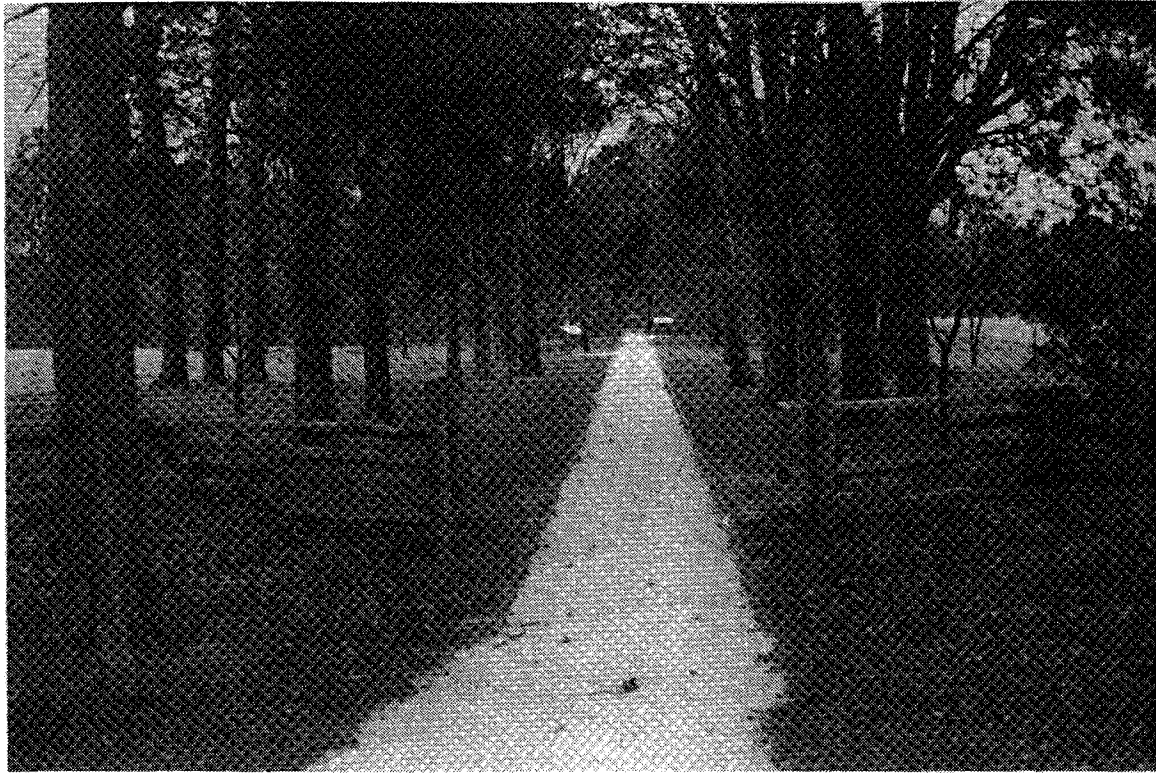
35. Walk leading to the Washington family Burial Ground.  
*(See photos 13 and 14 in chapter 2 for comparative views of historic conditions)*

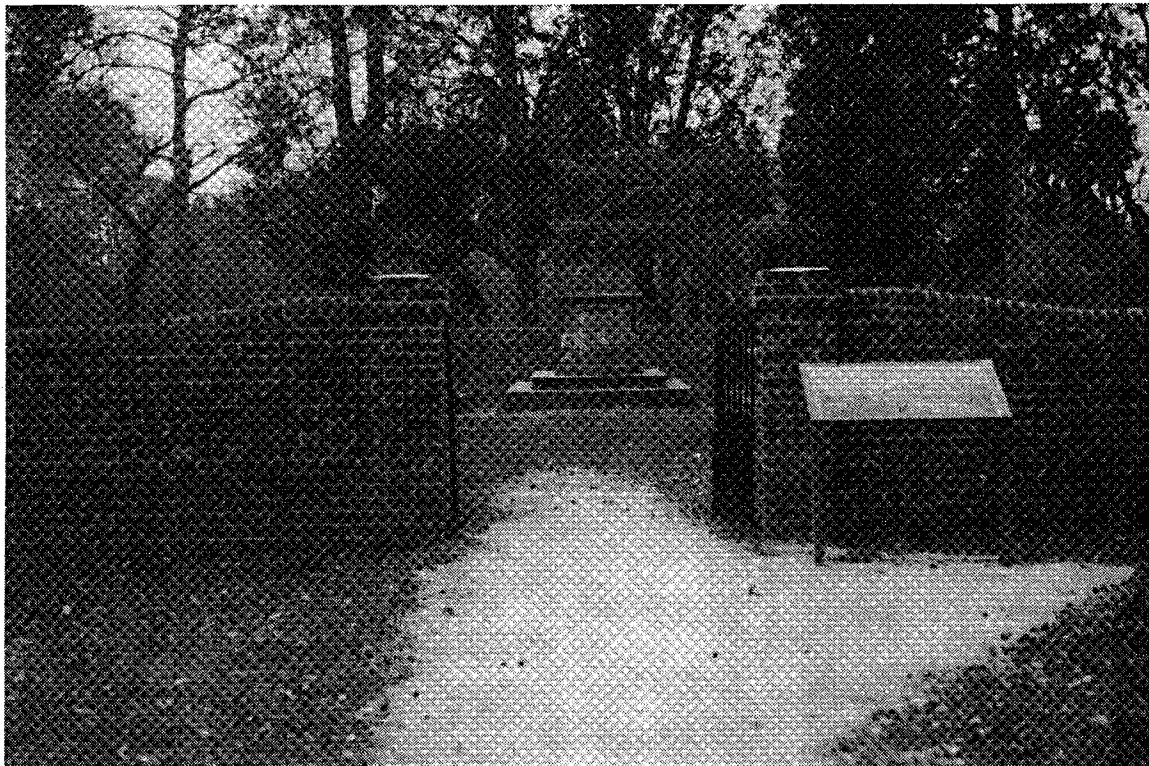
36. View southwest of the Burial Ground. John Washington, George's great-grandfather, first established a family burial ground here near his home in the late seventeenth century. Replica gravestones and commemorative tablets are interpreted on the site today.

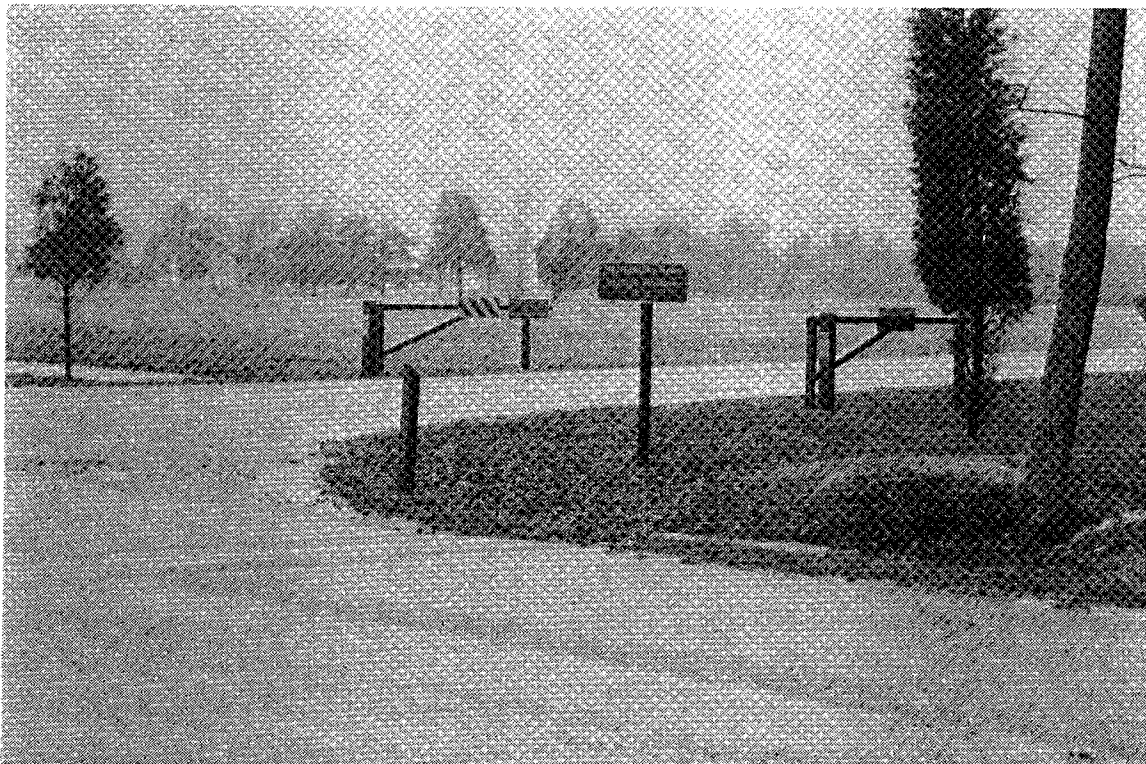
46. The access road to the maintenance area.

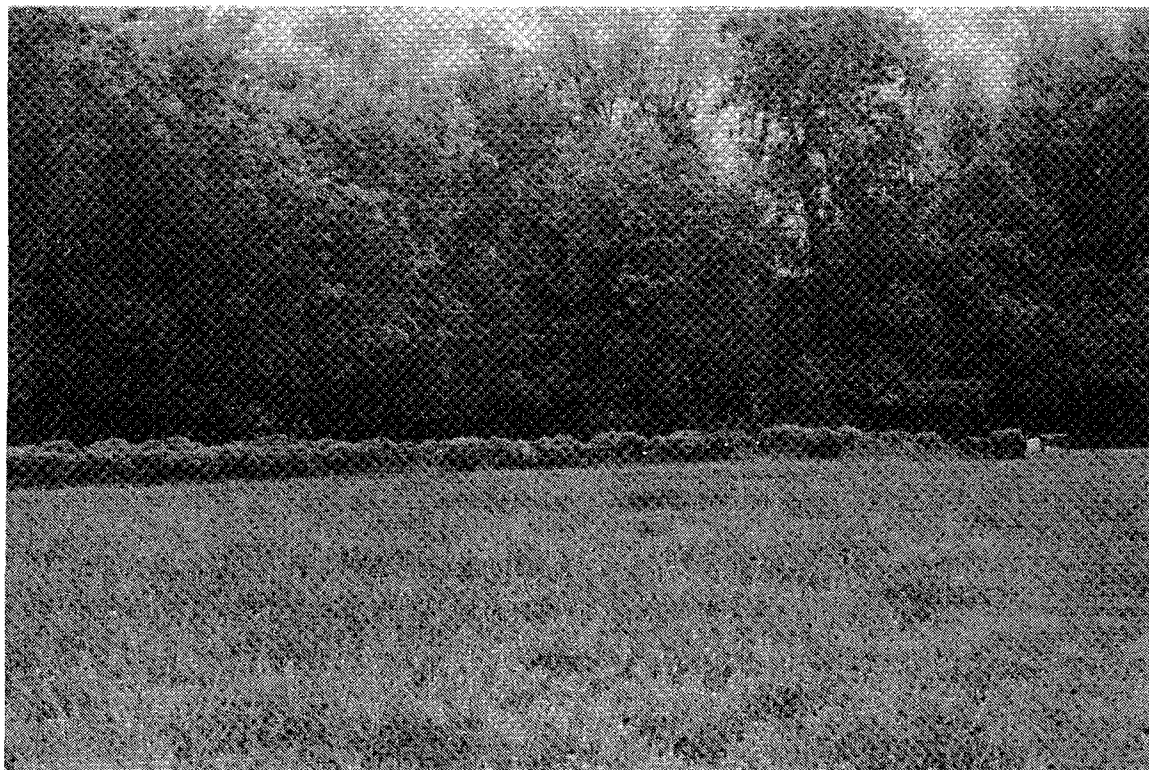
48. A boxwood nursery was observed in the maintenance area.

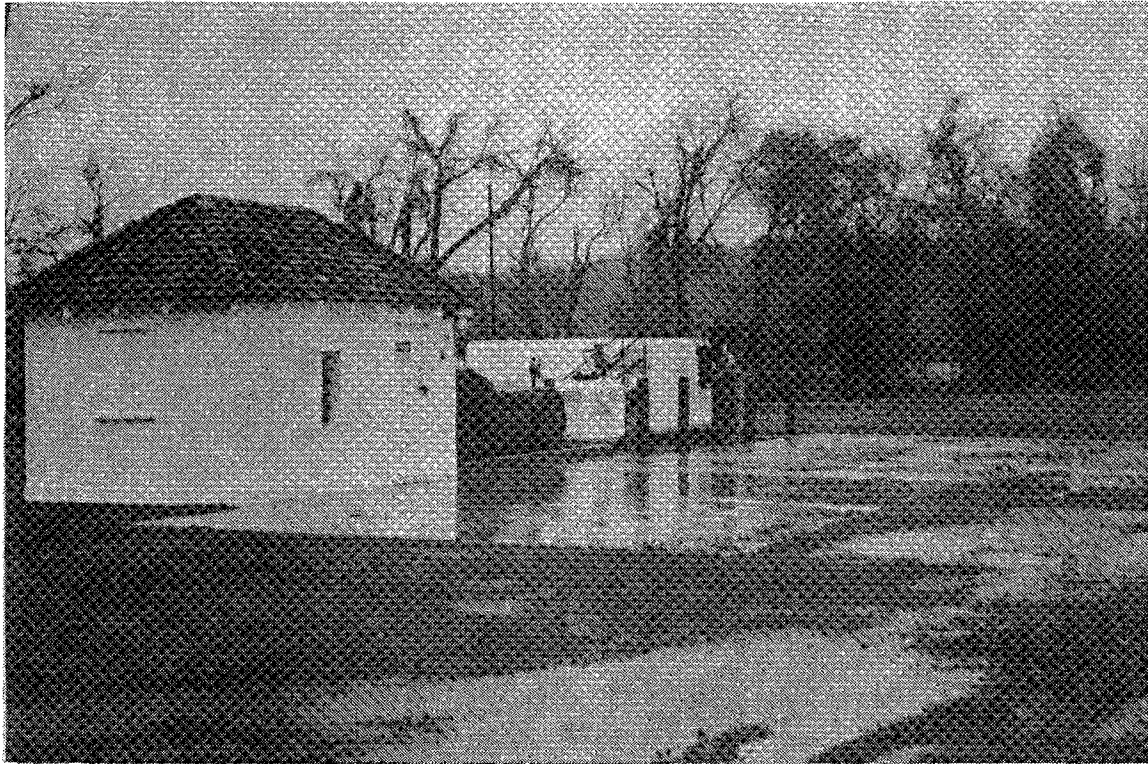
49. A cluster of utility structures are located in the maintenance area. The gas house provides fuel for maintenance vehicles.

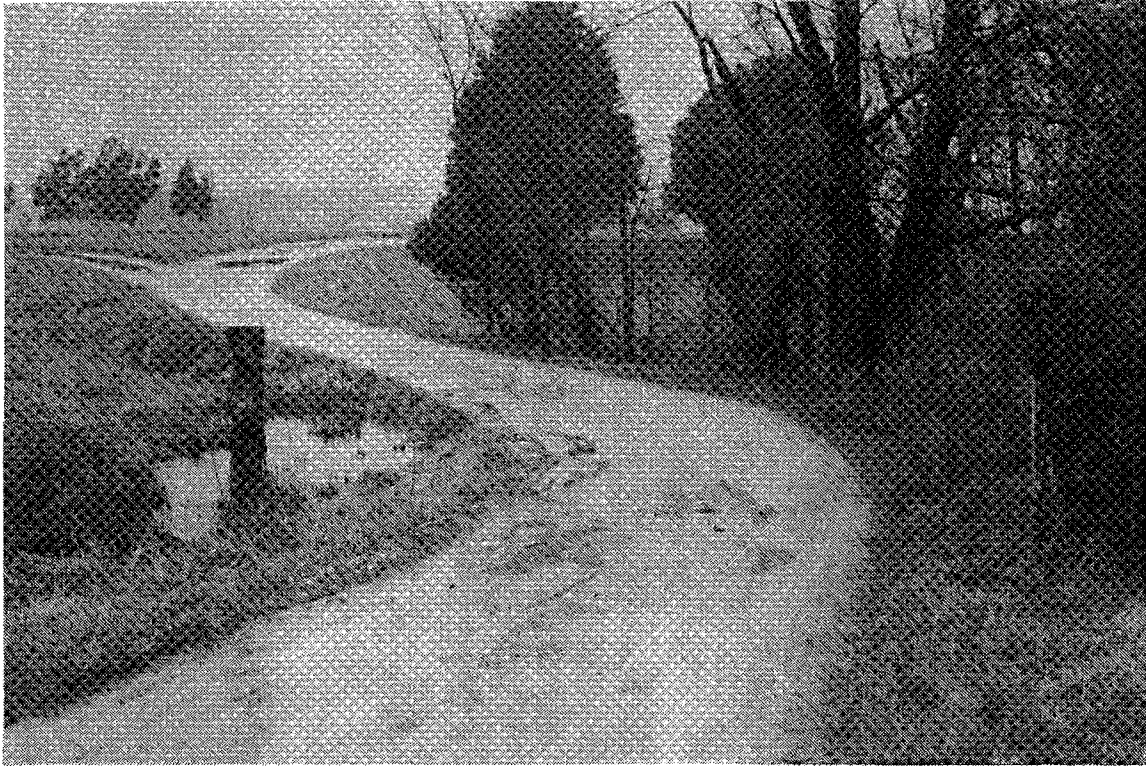
53. An access road to the adjacent agricultural fields from the maintenance area.

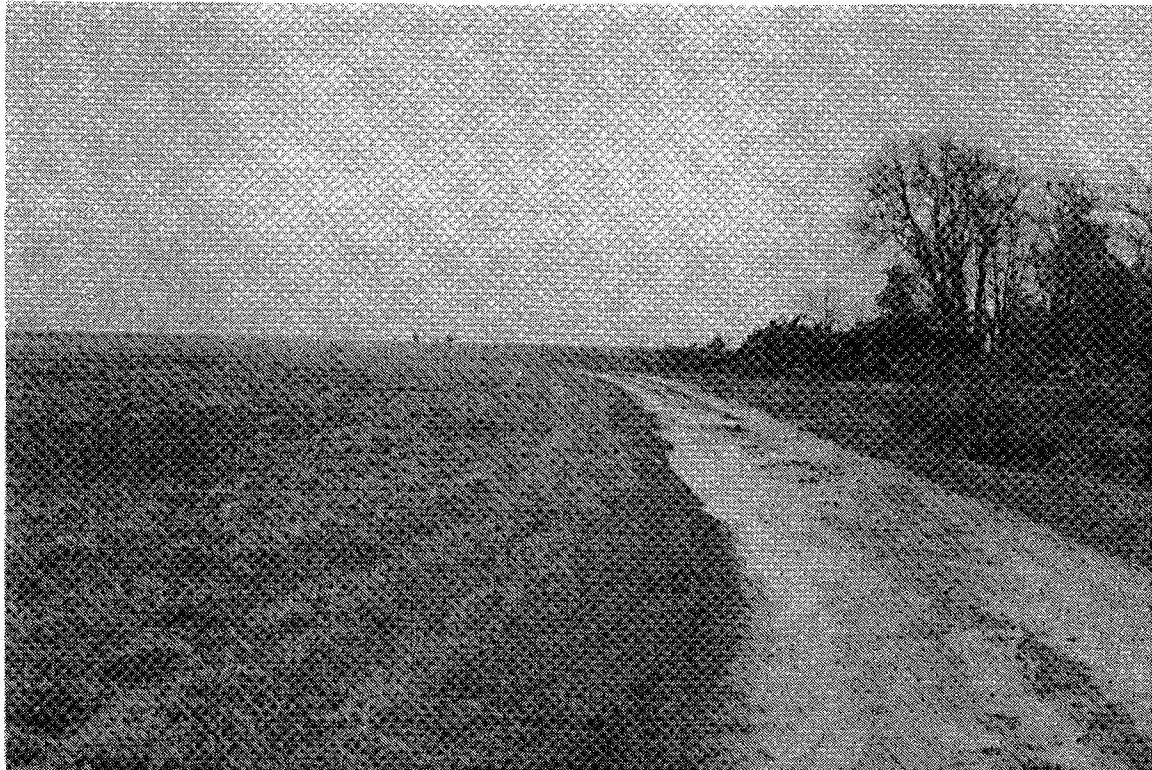
54. An access road to the adjacent agricultural fields; a debris pile is located on the right in the photograph.

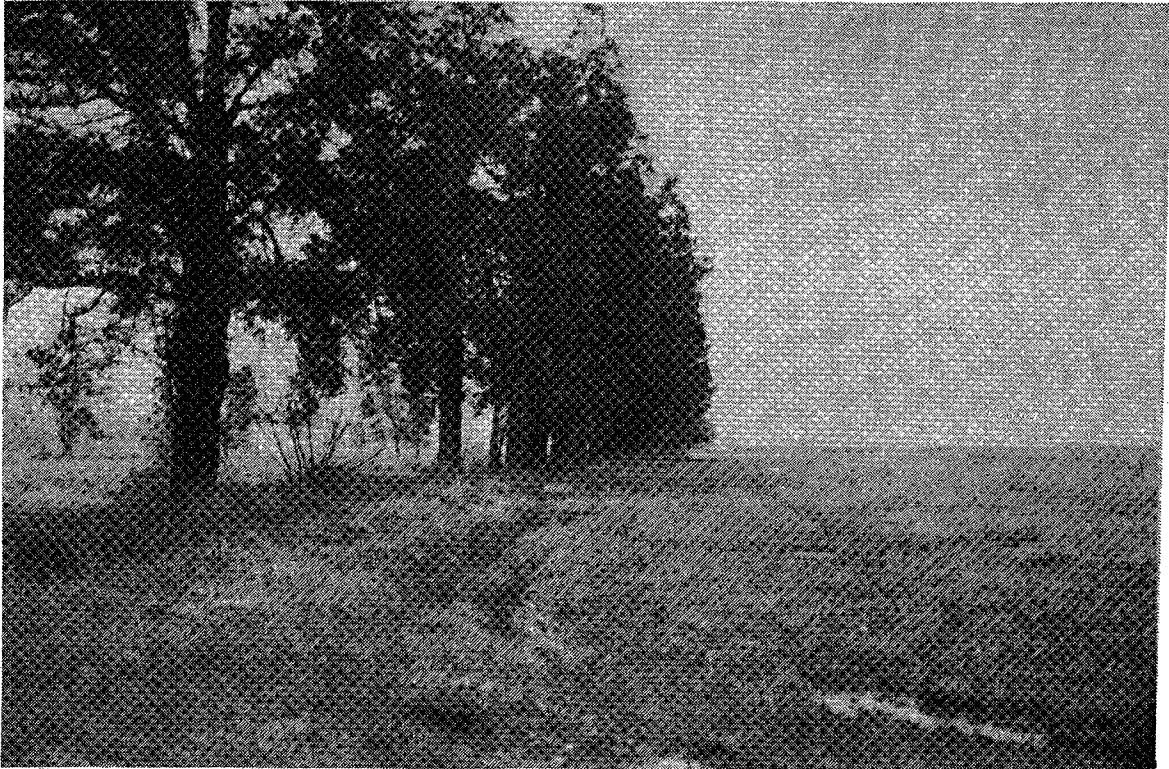
55. A hedgerow and parallel drainage ditch edging the agricultural fields southwest of maintenance area.

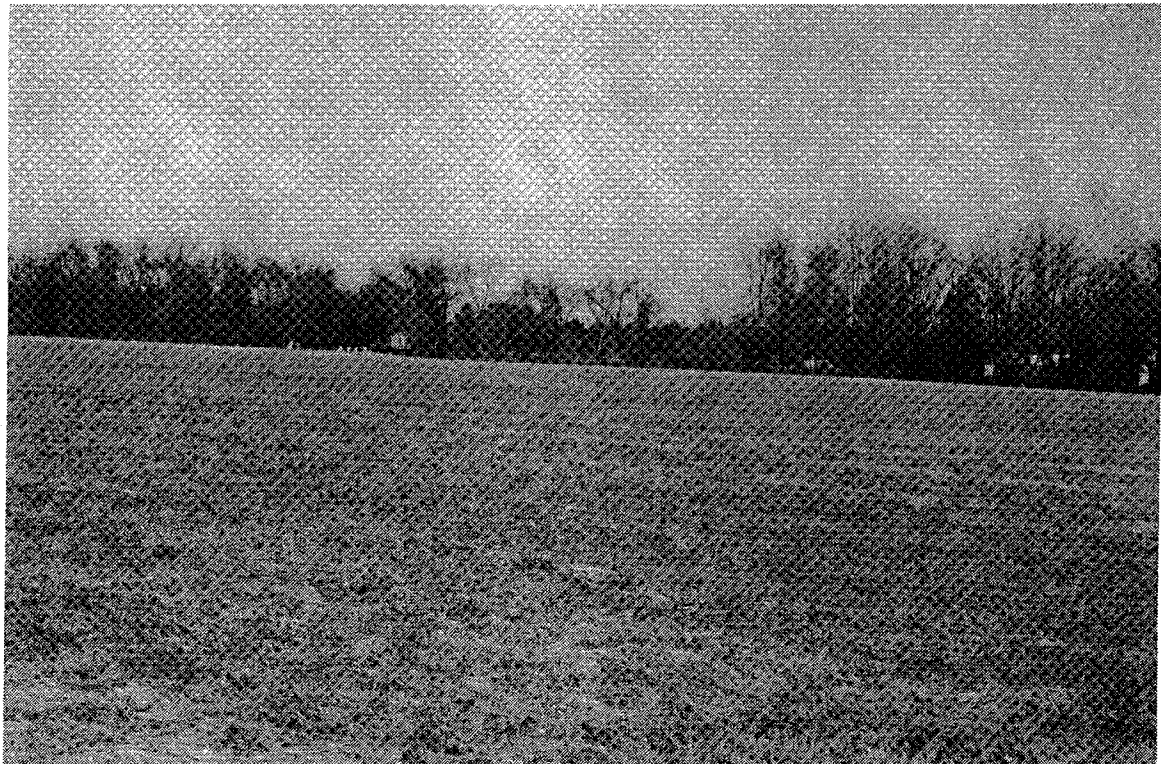
56. View west of an agricultural field located east of the main park road and adjacent to property owned by the Muse family. The park maintenance complex is located in the background of the photo behind the tree line.

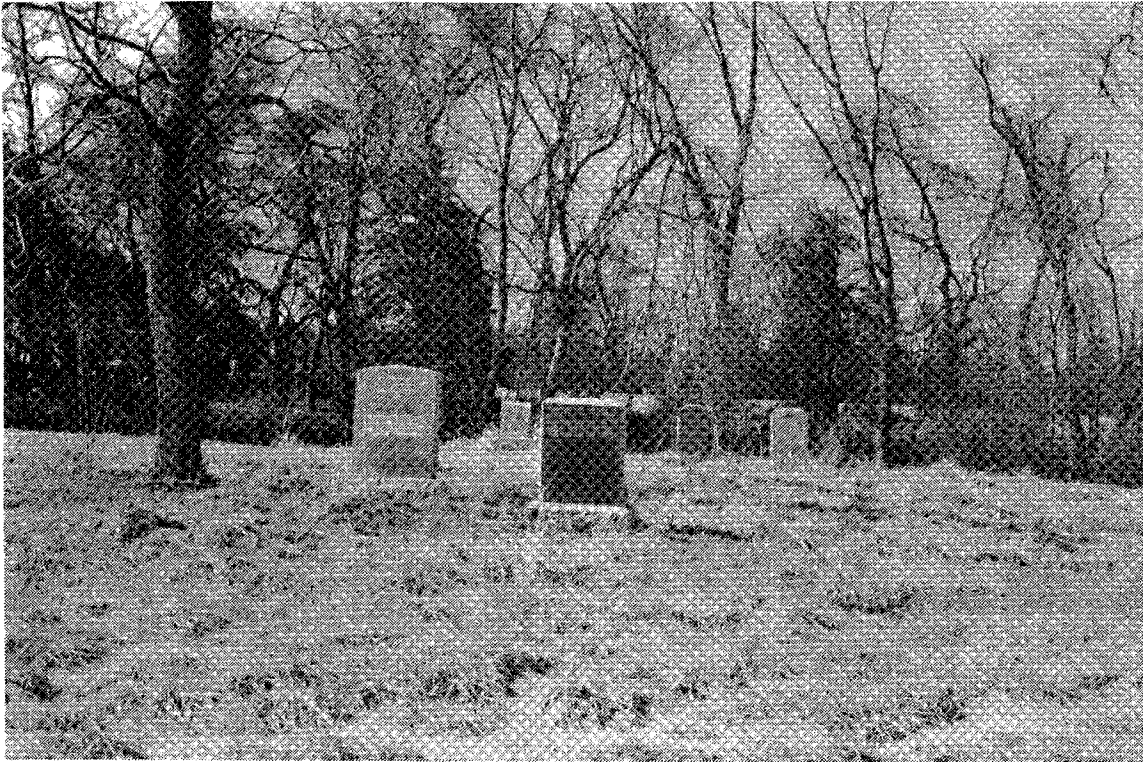
57. View west of the Muse family cemetery located along the edge of the agricultural field pictured above. Six gravestones and a black walnut tree mark the burial ground.

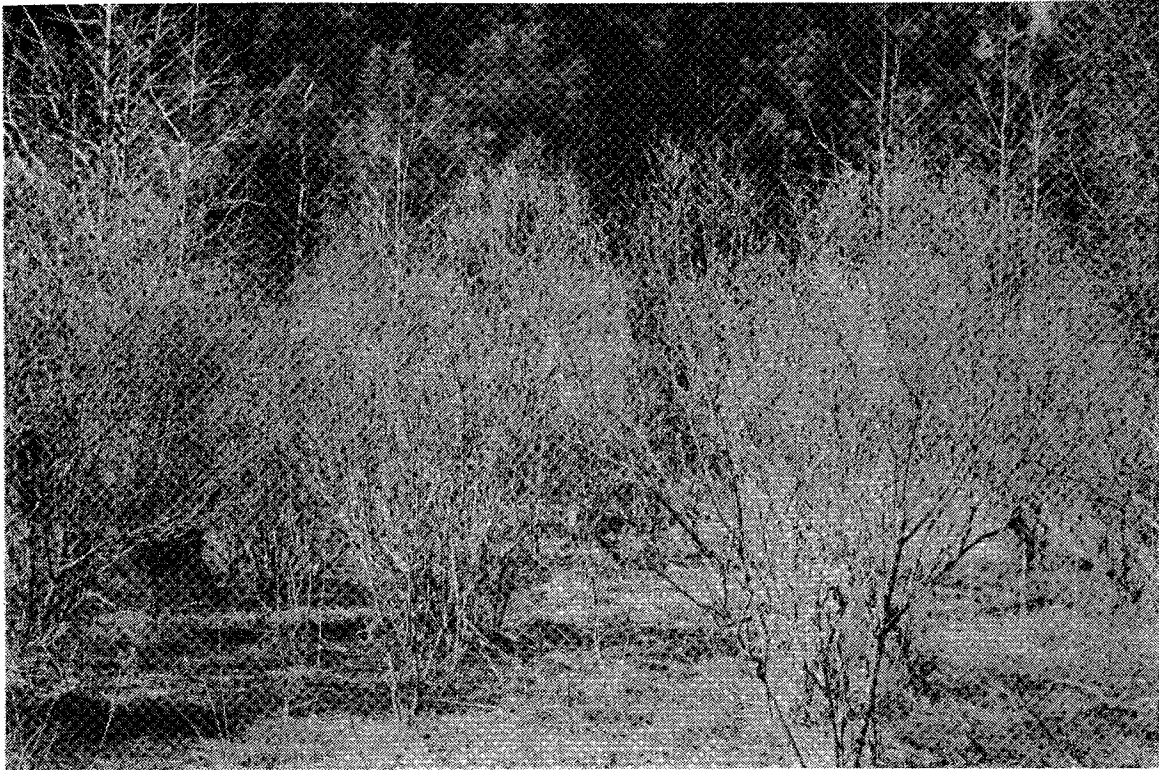
59. The interior of the pine plantation has been planted with autumn olive to provide food for wildlife.

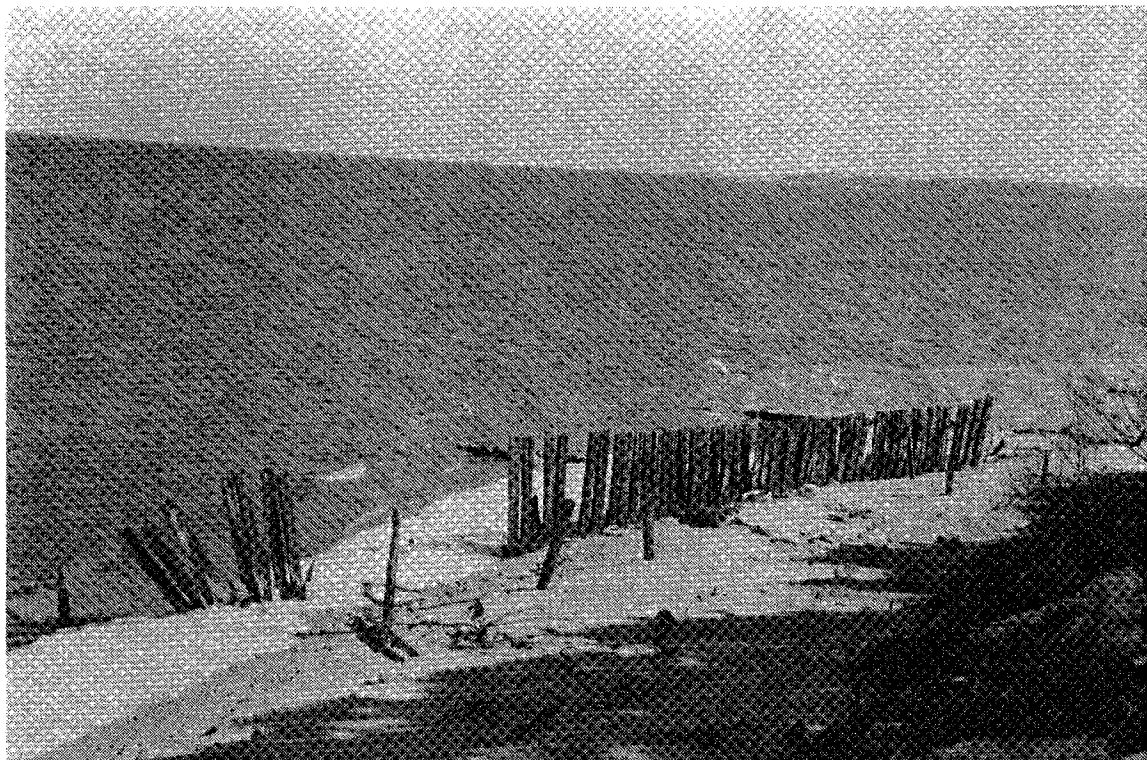
62. View east of a remnant pier system located along the Potomac within the parcel acquired by the park in 1978.

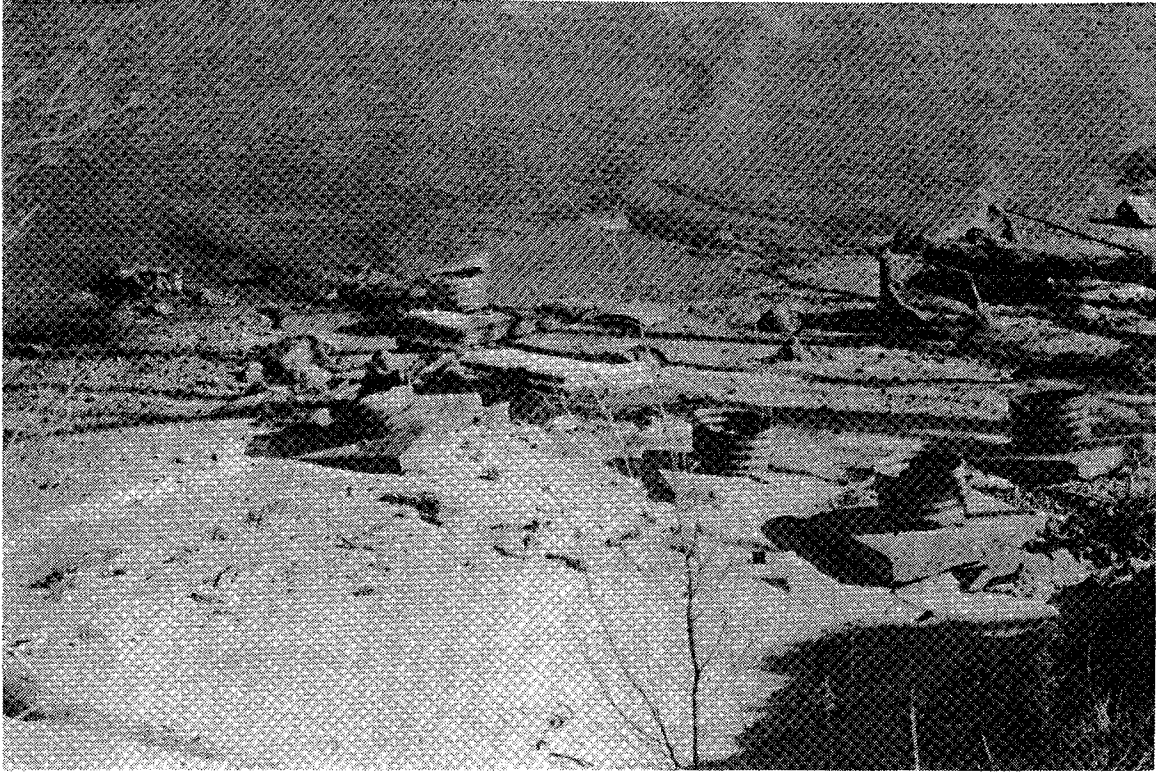
63. View north of remnant structures observed along the Potomac north of Longwood Swamp. These structures and a remnant road leading to the beach seen in this photograph suggest that a boat landing once occupied this site.

63. *Remnant structures observed along the Potomac.*
64. *Longwood Swamp wetlands.*
65. *The pond located northwest of Longwood Swamp.*
66. *A remnant spring house in severely deteriorated condition.*

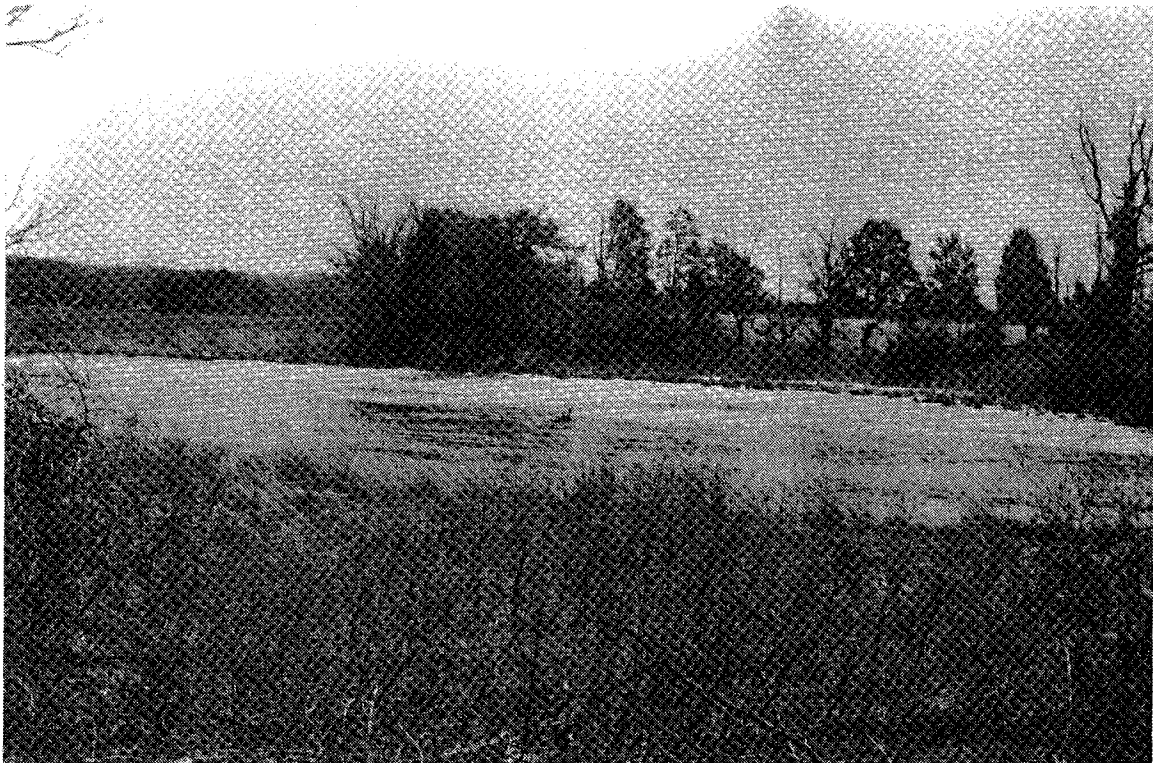
64. Longwood Swamp is comprised of various open water and marshland wetland types, with shrubs and trees dominating the higher ground. Phragmites, an invasive alien species, was observed.

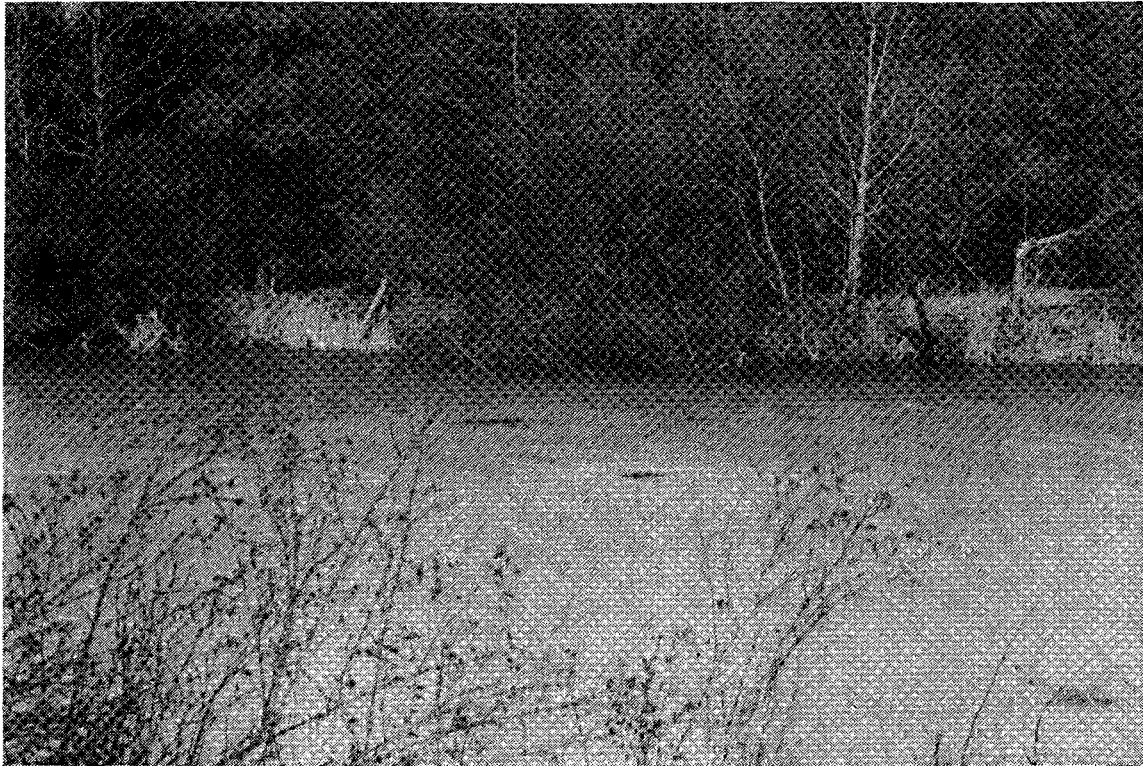
65. View west of the other man-made pond identified at the park and located northwest of Longwood Swamp. The pond's earthen dam is used as part of the road in this area.

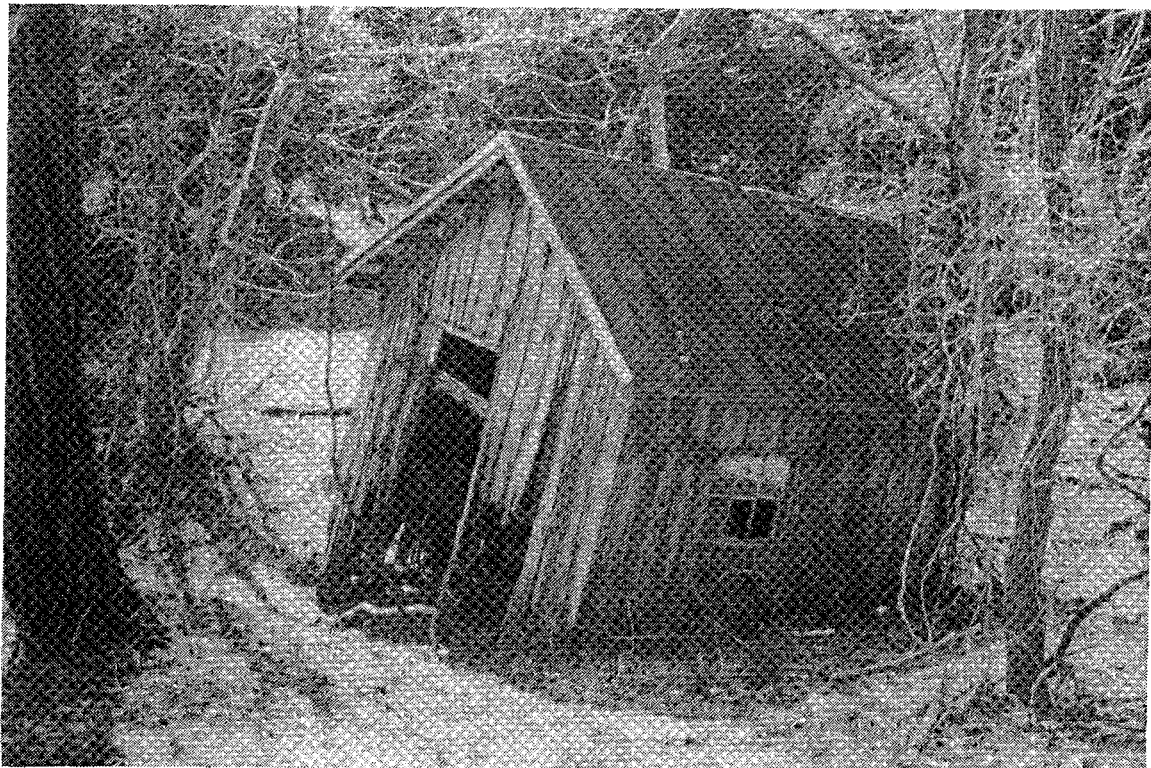
66. A remnant spring house, in severely deteriorated condition, was observed west of the pond illustrated above and southeast of the remnant house site shown below.
