CULTURAL LANDSCAPE REPORT

GEORGE WASHINGTON BIRTHPLACE  
NATIONAL MONUMENT

Westmoreland County, Virginia

VOLUME ONE: HISTORICAL AND EXISTING CONDITIONS DOCUMENTATION

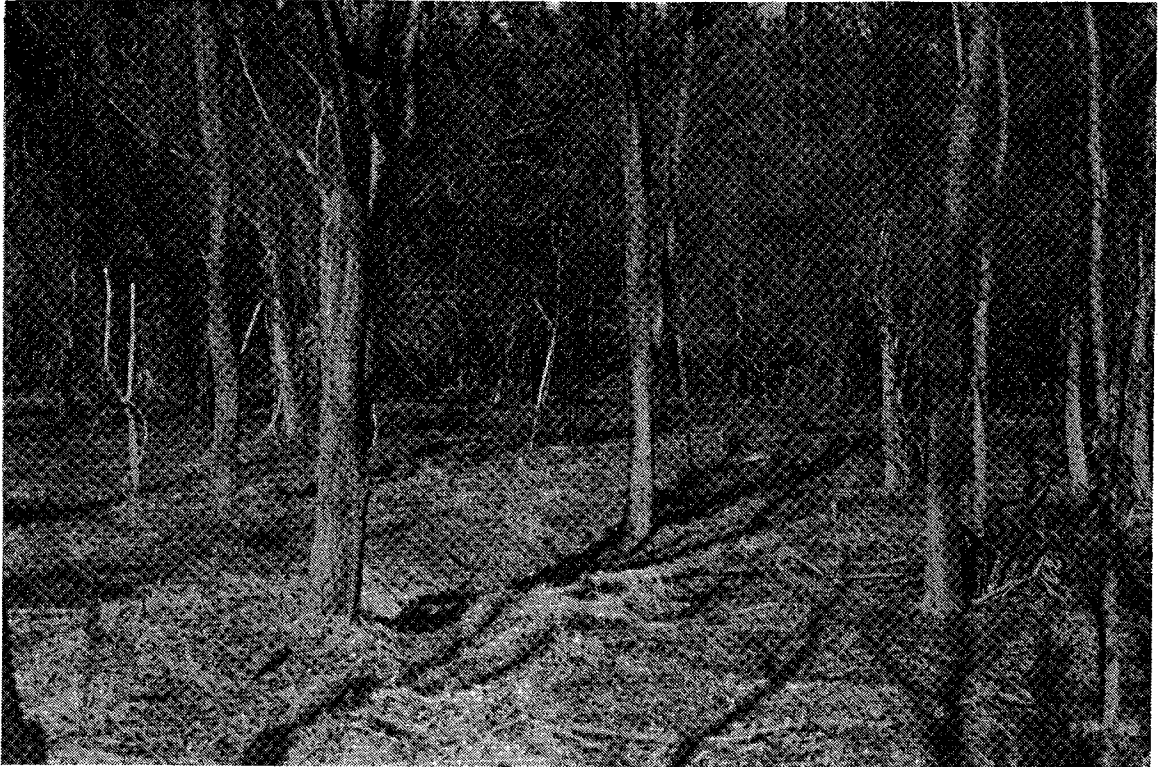
67. View north of an area thought to represent an abandoned house site. Features observed in this area include yucca plantings, a possible road trace, building footprint, and construction debris such as bricks and concrete.

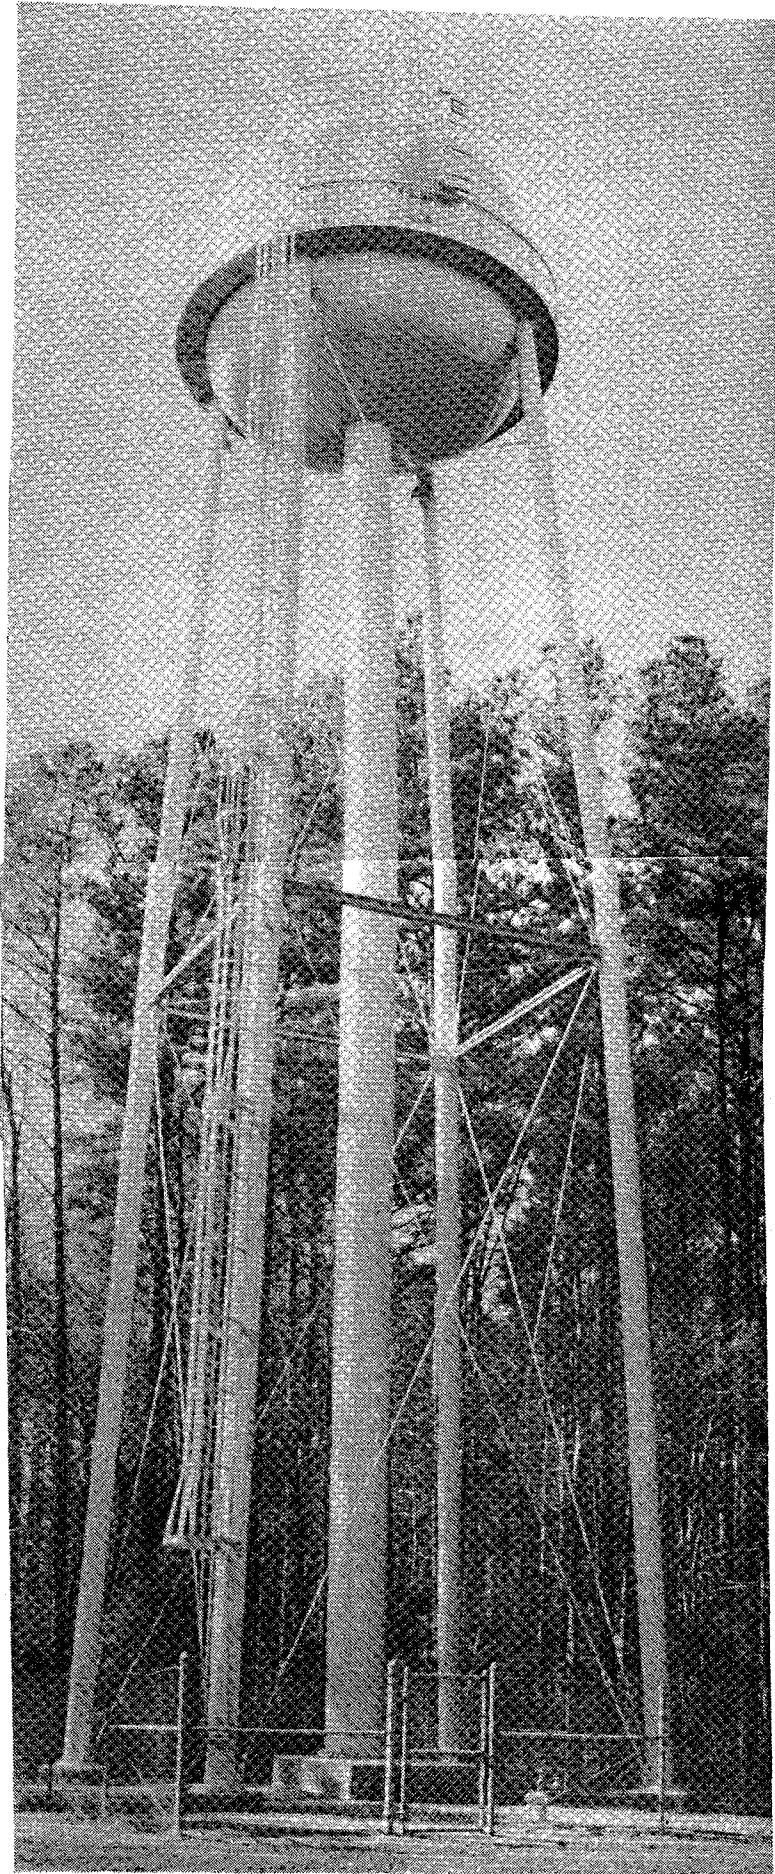
68. A 50,000 gallon elevated water tank and associated water treatment structure are located south of the access road to the Muse family farm. The water tower is generally screened from view by a successional woodland.

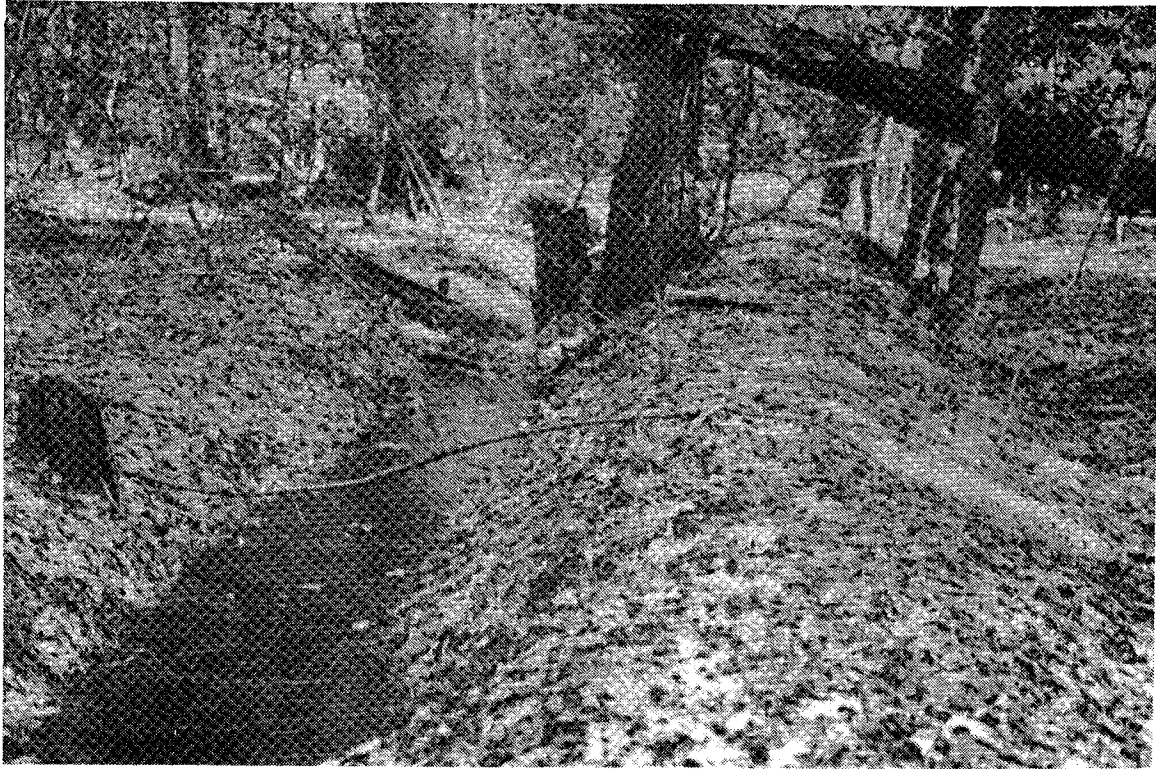
69. A Nature Trail, located in the successional woodland east of the main park road, crosses a series of remnant drainage ditches that most likely edged agricultural fields long since abandoned.

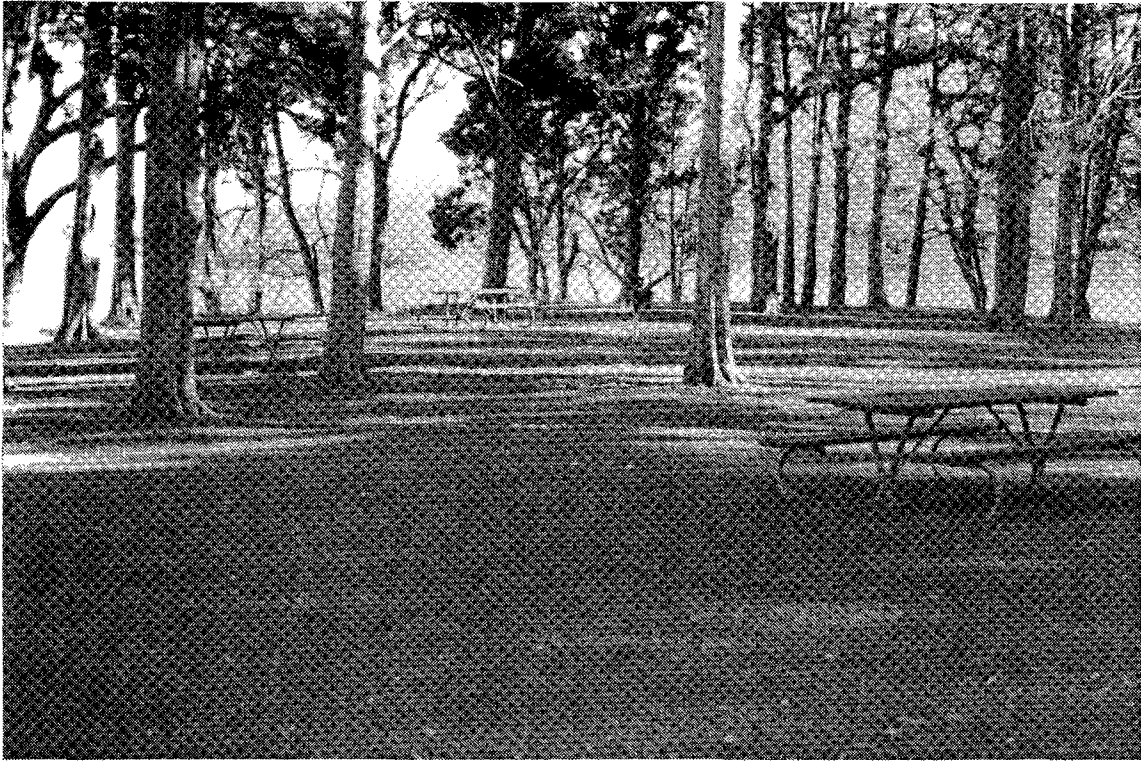
71. View southeast of the picnic area, including the numerous picnic tables located under the canopy of cedar trees.

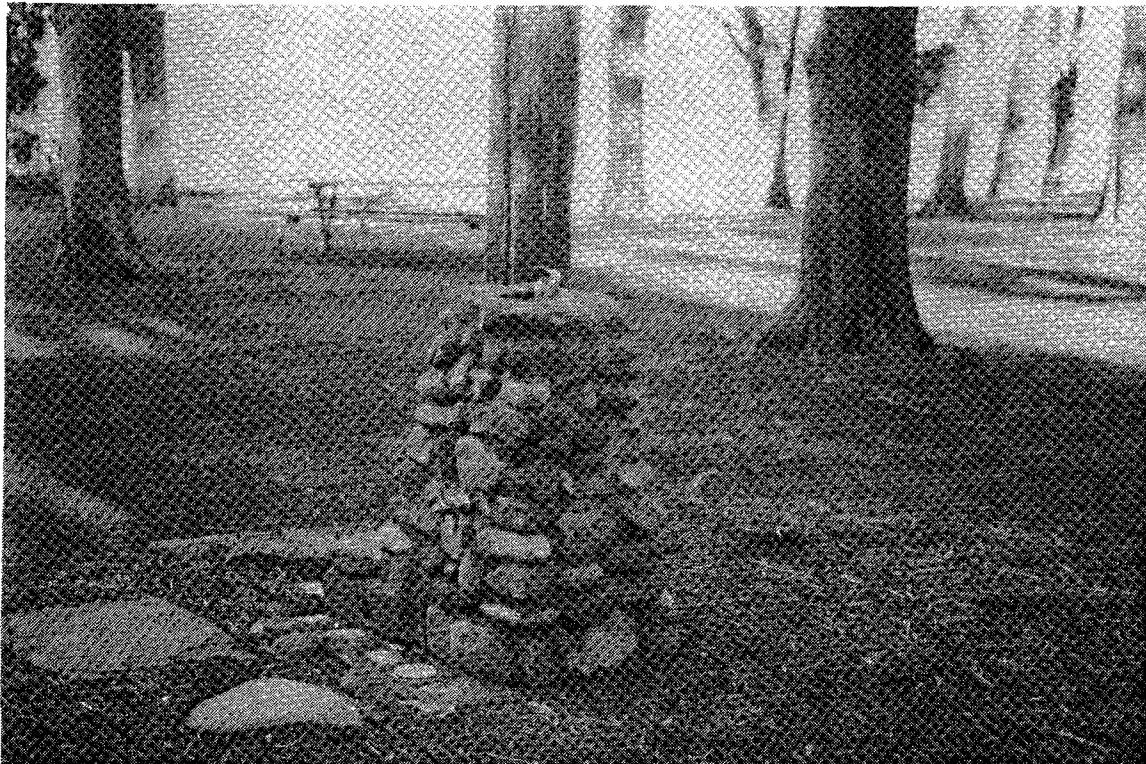
72. A stone drinking fountain is located near the picnic shelter at the picnic area.

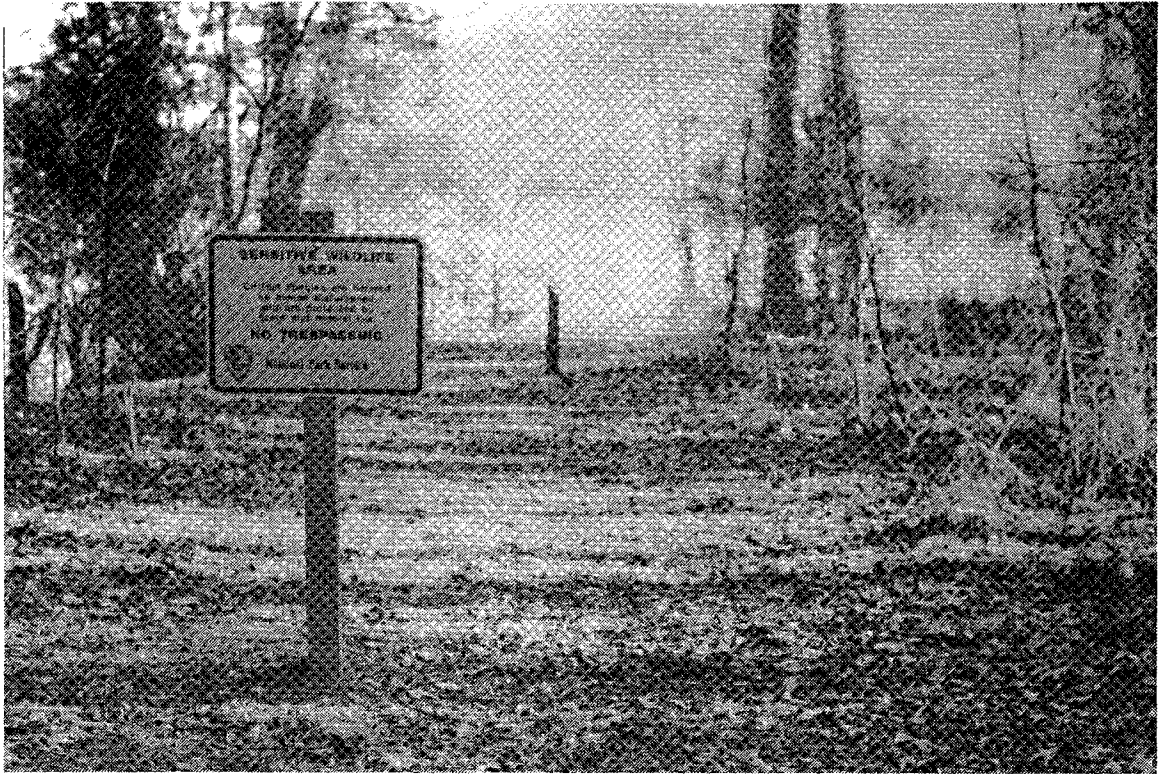
73. The Nature Trail continues south of the picnic area and runs along Dancing Marsh. During late winter and early spring, however, visitors are requested not to access this part of the trail during nesting season.

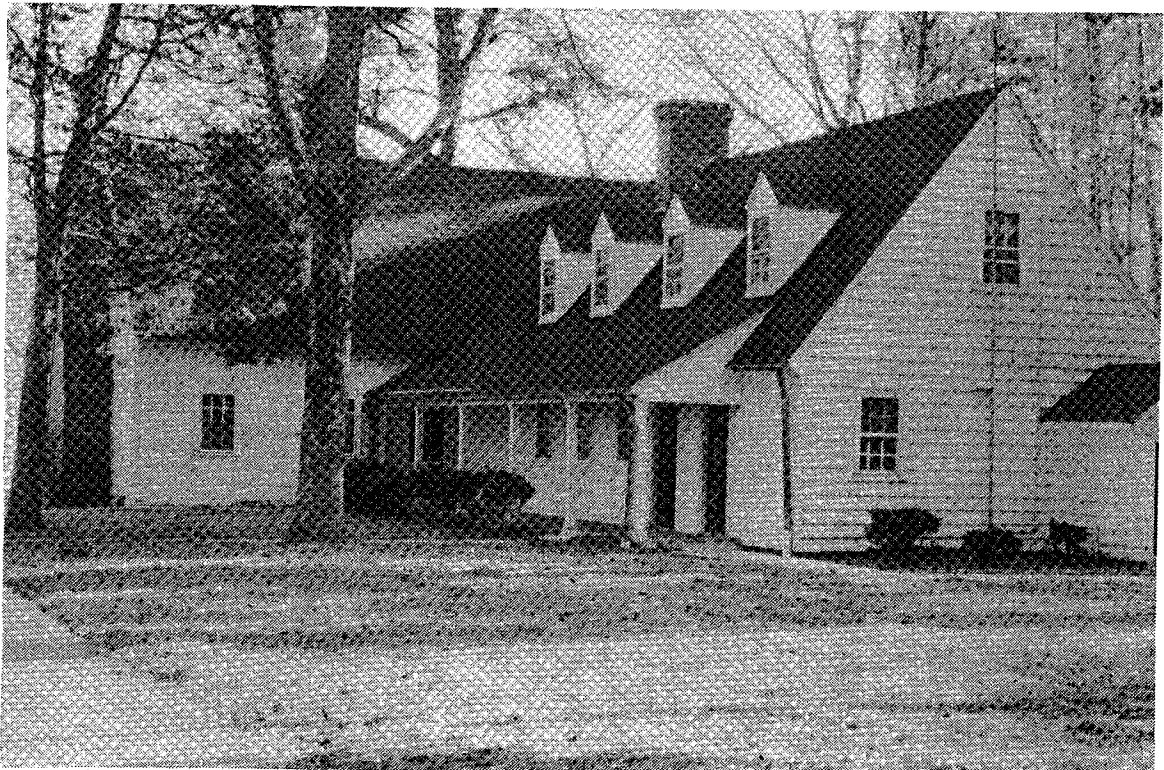
74. View south of the Log House located across Dancing Marsh from the historic core. This building is used by overnight guests and for park meetings.

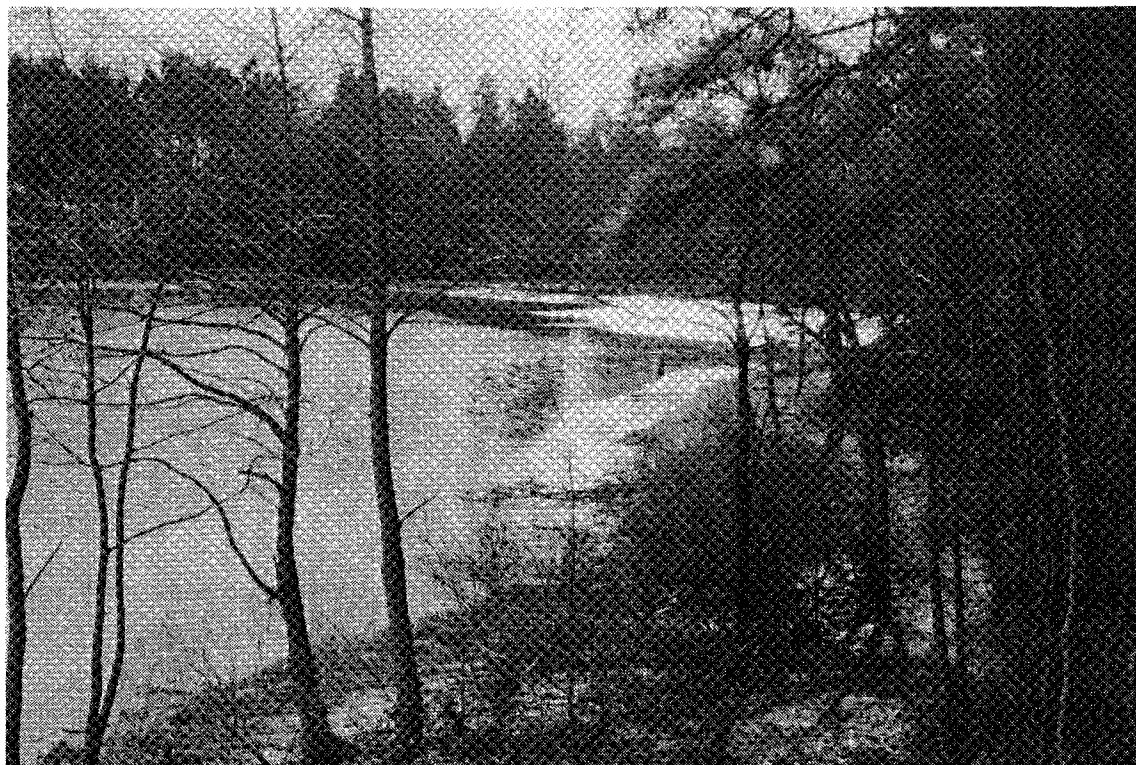
76. View south across Dancing Marsh toward the historic core from the Log House. Historically, a bridge connected the Log House area with the historic core. Plans are currently underway to restore this connection.

76. *The view of the historic core from the Log House.*
77. *Location of bridge, now missing, that once connected the Log House and historic core area.*

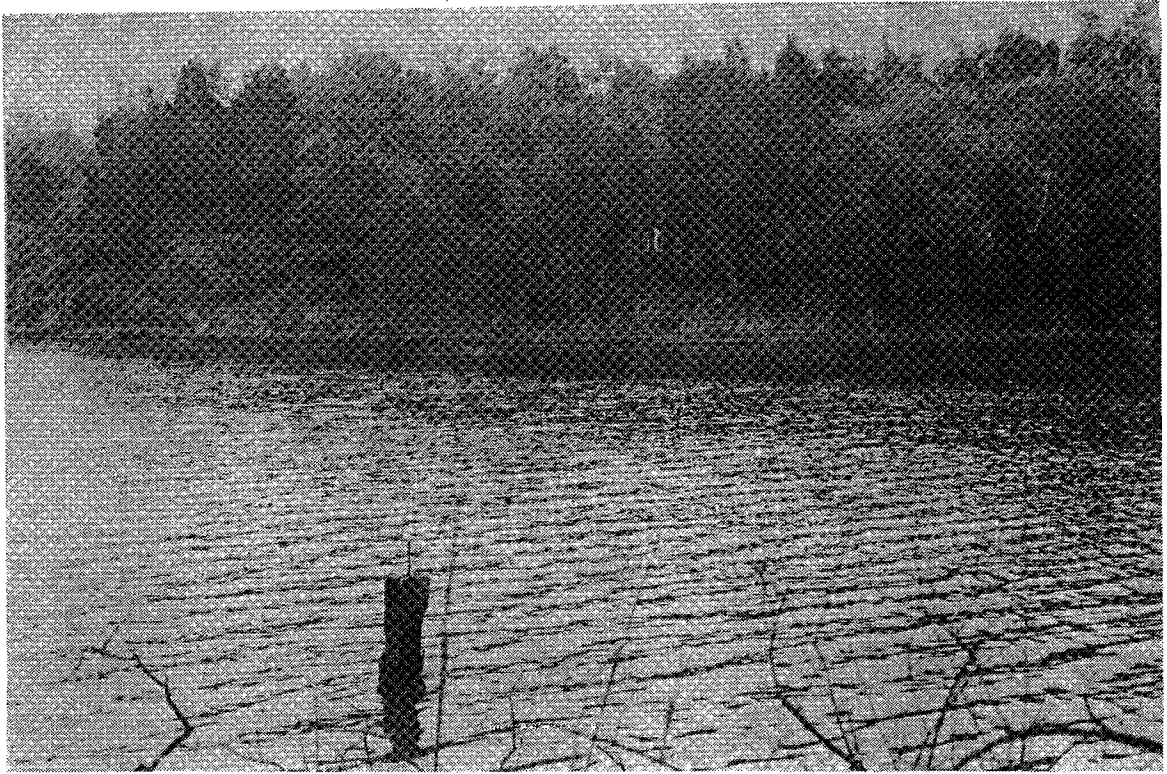
77. Location of bridge, now missing, that once connected the Log House and the historic core area.

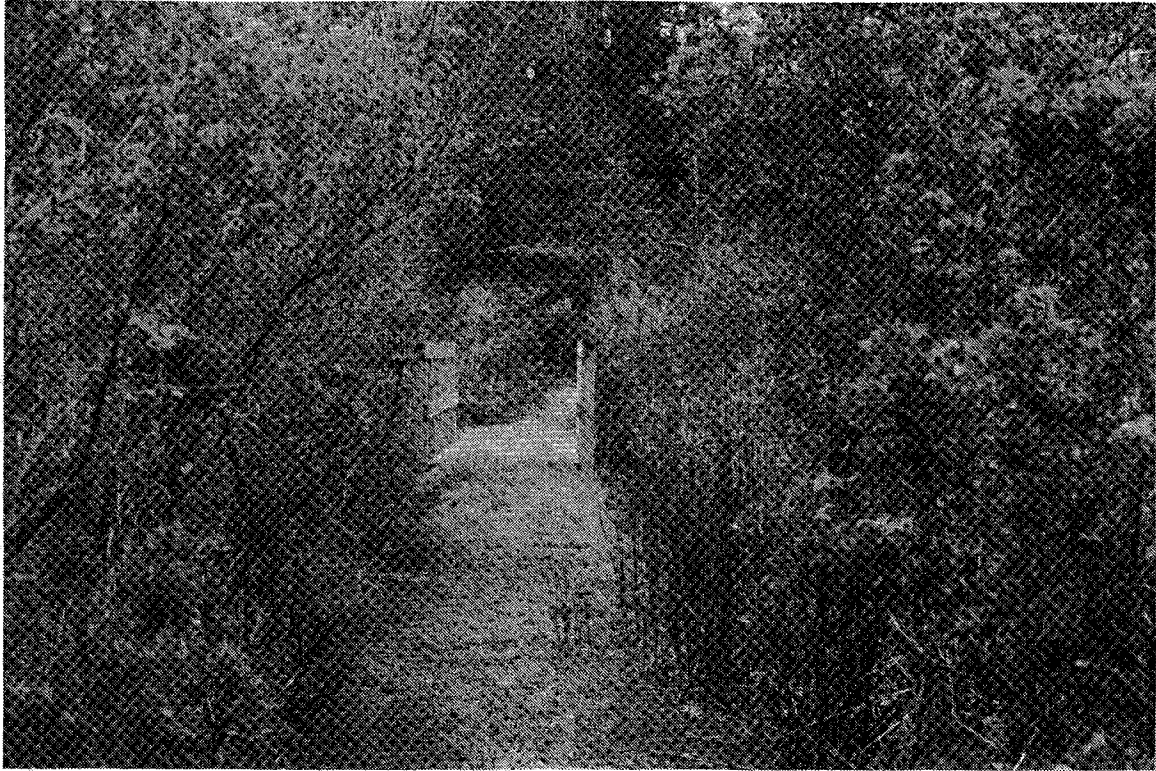
81. The footbridge leading towards the historic core from the residential area.

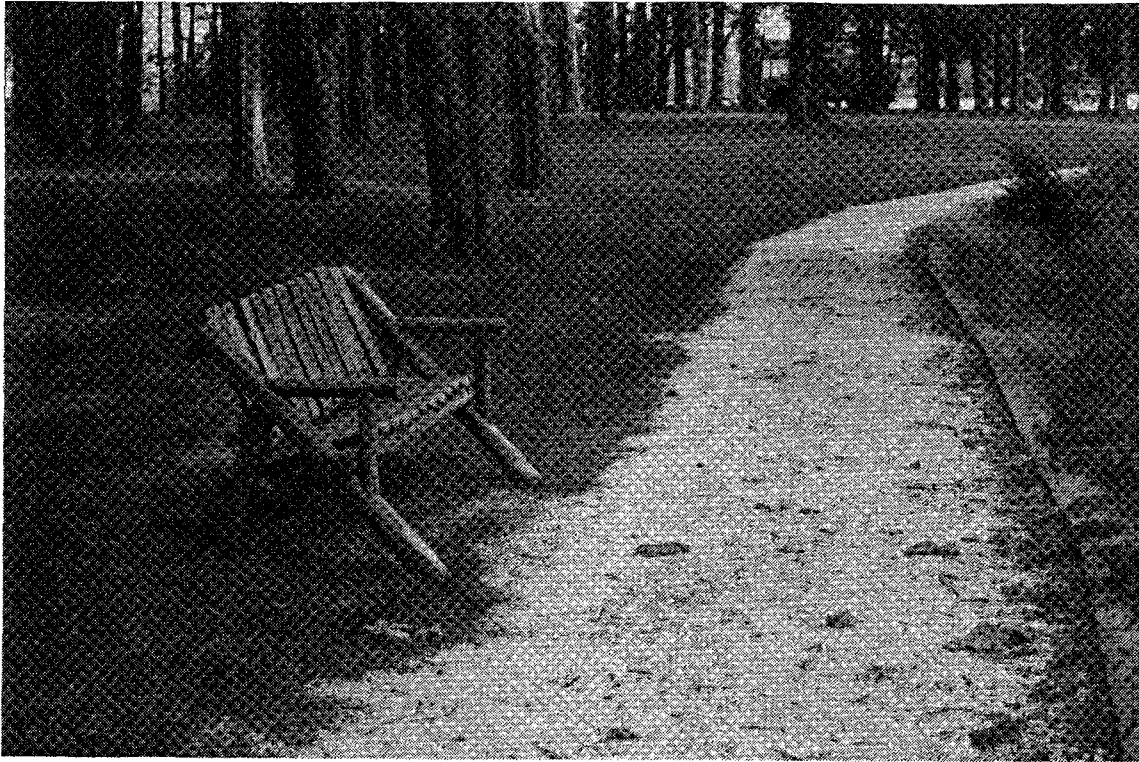
83. View north of the crushed oyster shell path located along Popes Creek south of the historic core. A grove of cedar trees edges the path to one side and Popes Creek the other.

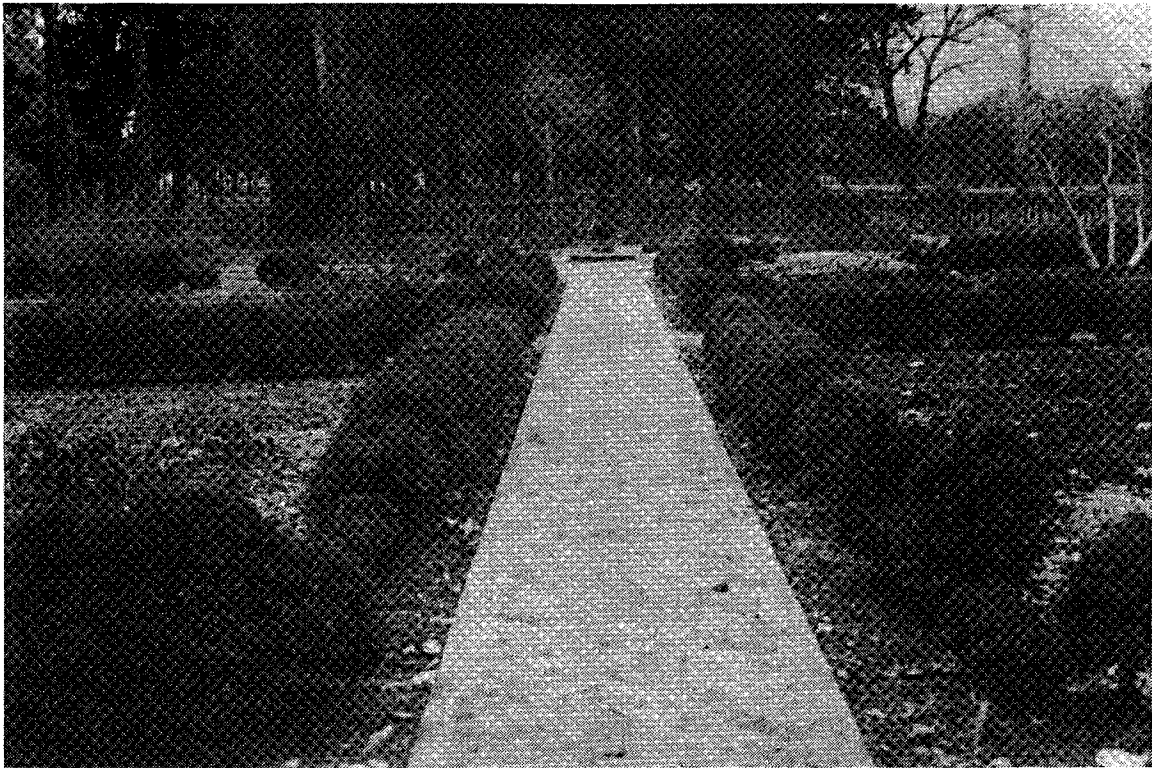
85. View southwest of the Colonial Herb and Flower Garden, constructed in the 1930s. The garden displays plants commonly found on eighteenth century plantations. A brick pedestrian walk leads through the garden which is edged by a wooded picket fence.

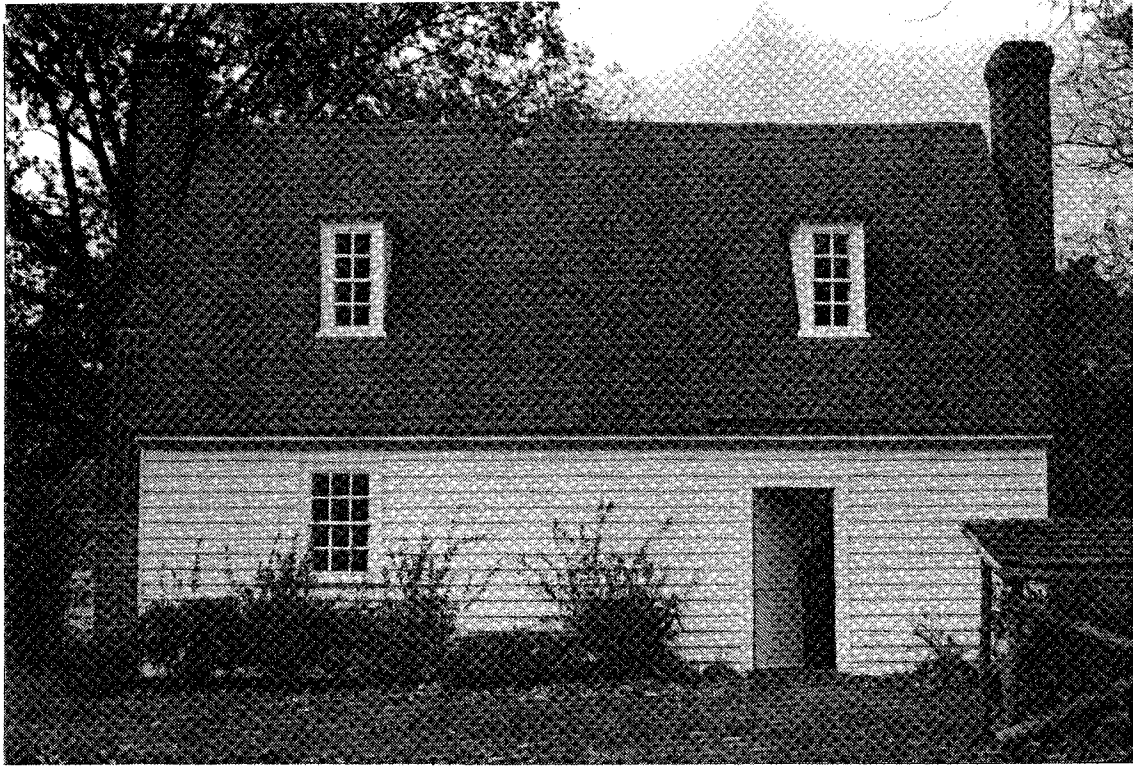
87. View northwest of the Kitchen House, also constructed in the 1930s. It is located 80 feet from the Memorial House. Costumed interpreters stationed here and elsewhere around the historic core provide visitors with information about eighteenth century life on the property.

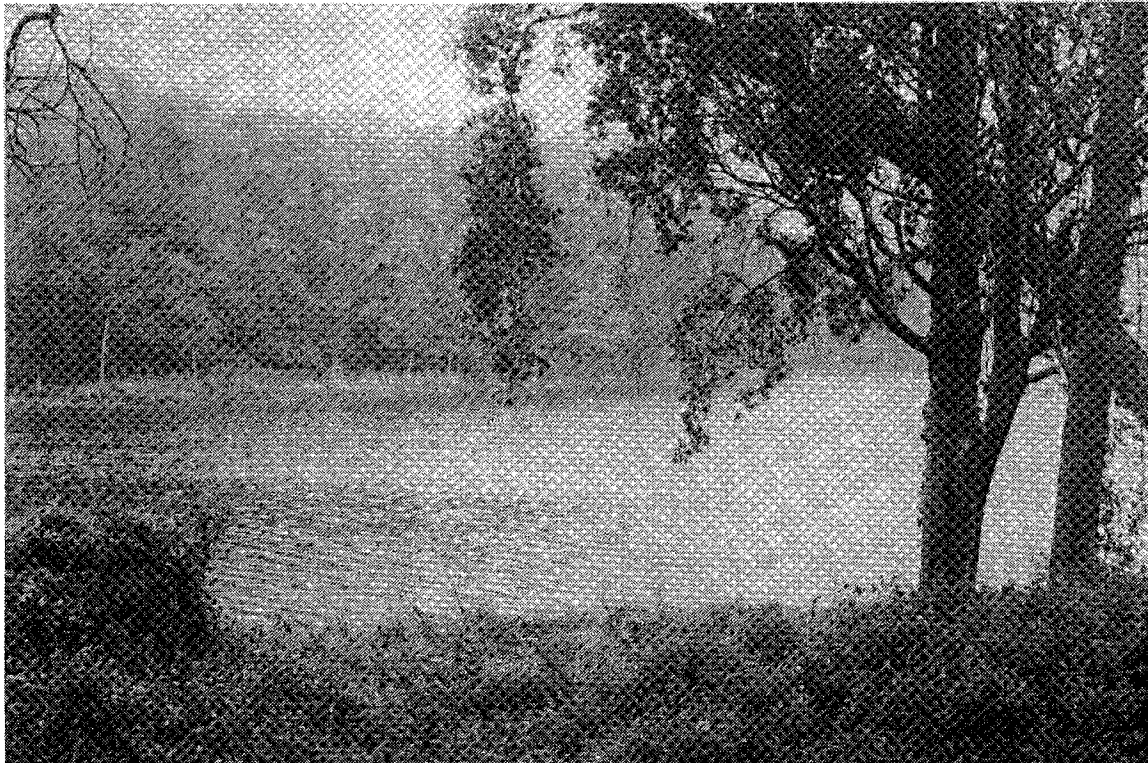
88. Site of bridge that once connected the historic core area and trails near the Log House.  
(See photo 16 in chapter 2 for a comparative view of historic conditions)

The day after the Saville project began, construction was initiated on another NPS designed landscape feature: a 400-foot footbridge across Dancing Marsh linking the “Mansion Grounds with the Log Lodge.” It was completed in June [Photo 16].<sup>216</sup> A trail system was built between the residential area and the birthplace house, complete with another twelve-foot bridge crossing part of the Dancing Marsh above the Ice Pond. Another reference to “Mr. Peterson’s plan” is found here, stating that “the trail approaching the Dancing Marsh footbridge from the Mansion grounds has been relocated and constructed under Mr. Peterson’s plan. The old trail was subject to washing out and was too steep, both of which difficulties are now removed.”<sup>217</sup>

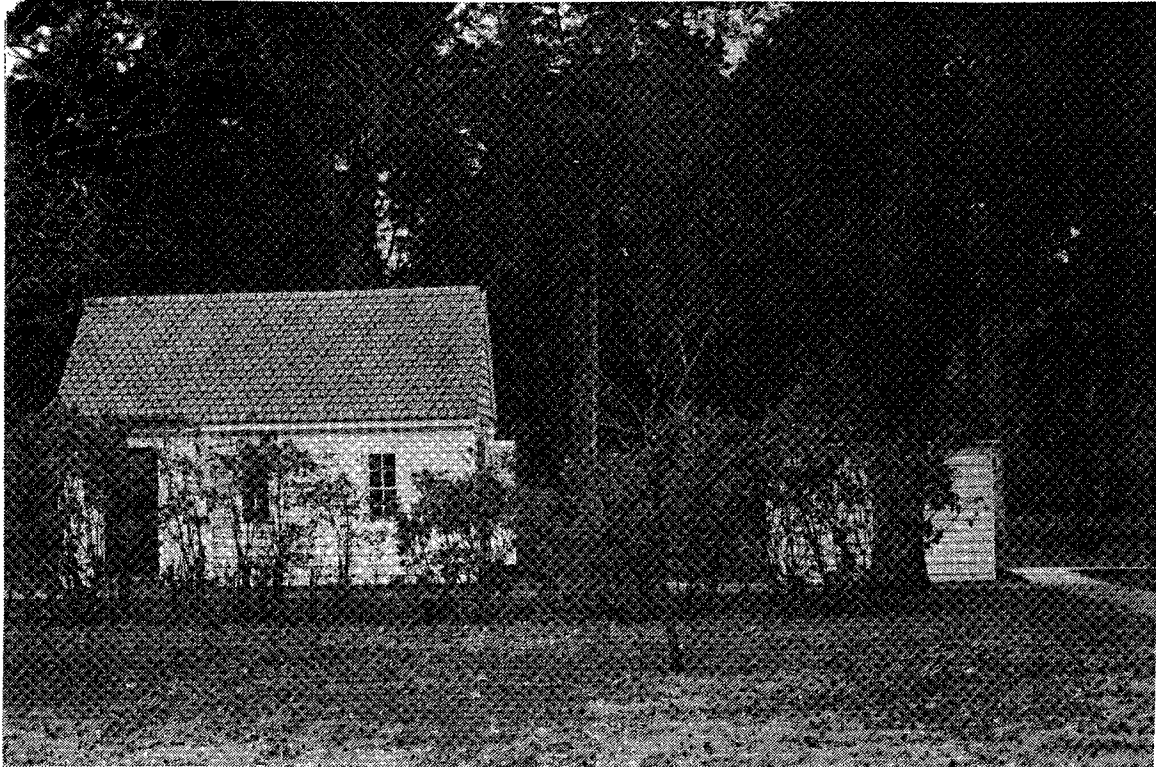
89. View northwest of two outbuildings located in the historic core. The Weaving Room, interpreting eighteenth century craft techniques is located on the left, and a shed to the right.

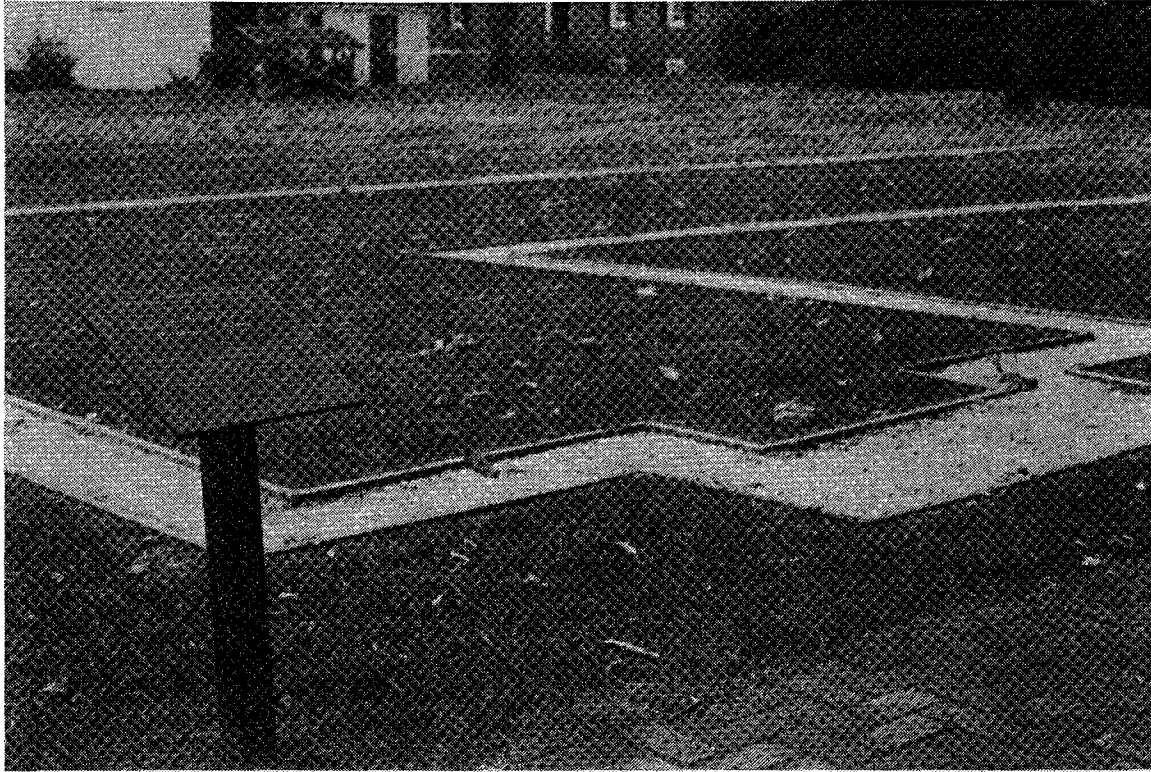
93. Oyster shells outline the archeological remains of the Washington birthplace foundation.

90. *The Farm Workshop and a storage structure.*
91. *The barn at the western edge of the historic core complex.*
92. *A demonstration plot of tobacco.*
93. *Oyster shells outline the archeological remains of the Washington birthplace foundation.*
