**Landmark in the Sky:  
The History and Preservation of Glacier's Going-to-the-Sun Road**

**Preserving the Historic Road in America Conference  
April 22-25, 2004  
Portland, Oregon**

**Jack L. Gordon  
Landscape Architect**

**Glacier National Park**

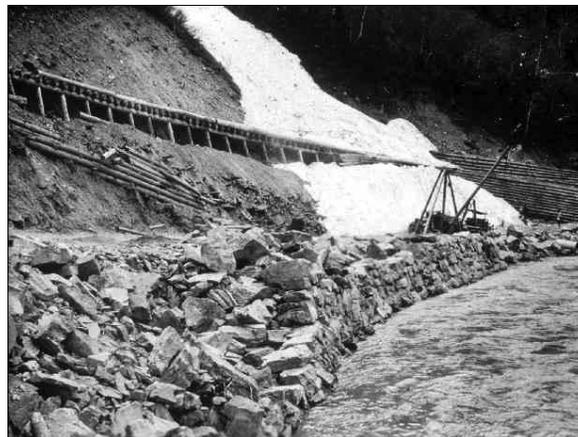
**Construction along Red Rock Point, Steven's Brothers Contract to Logan Cr.**

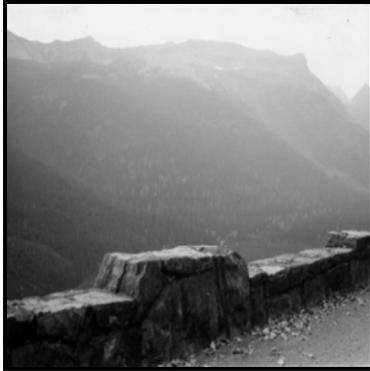
**Random Rubble Guardwall**

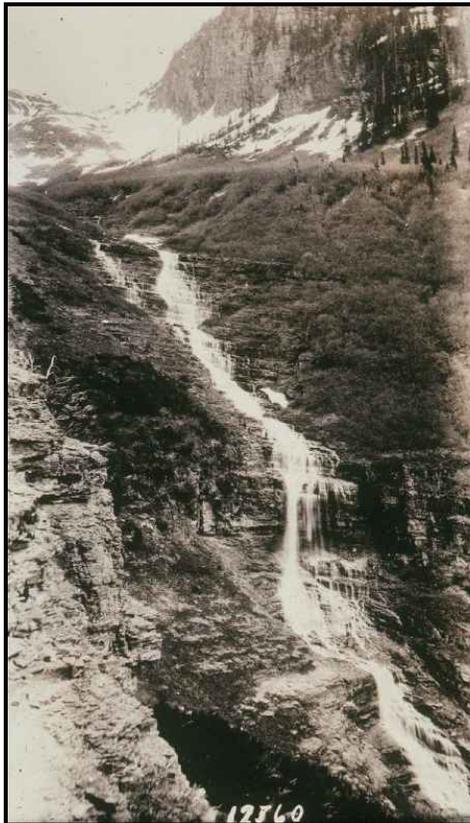
**Haystack Creek Arch, before**

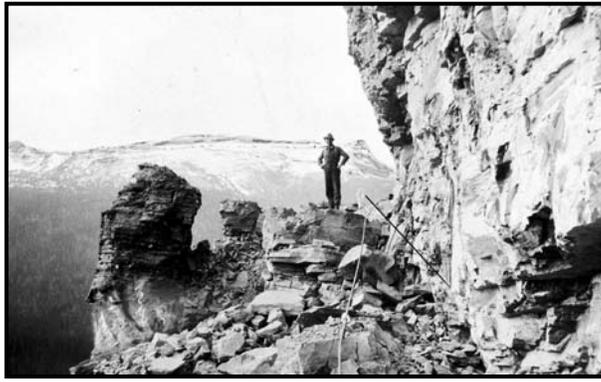
**An early “pioneer” cut**
