Cut Bank Ranger Station
Historic District
Property Name

NATIONAL REGISTER OF HISTORIC PLACES
REGISTRATION FORM

historic name: Cut Bank Ranger Station Historic District

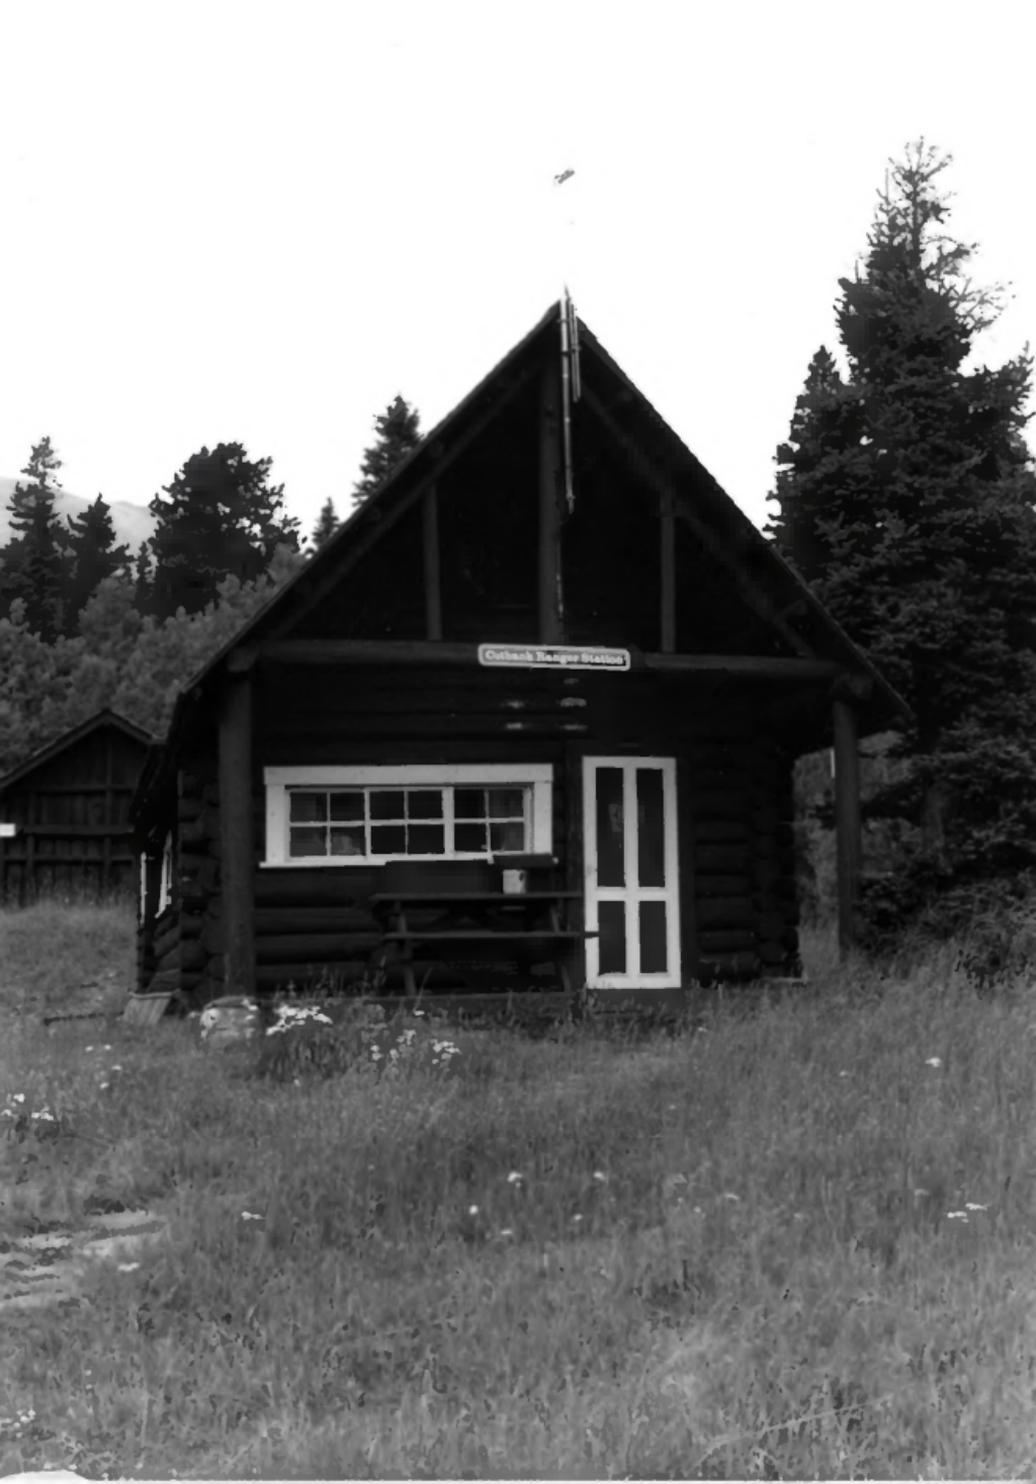
Photo #1

Ranger Station Hs 148

View to NW

The Cut Bank Ranger Station (office and dwelling) is a single-story rectangular building constructed of reverse saddle-notched logs with cement chinking and square-cut ends. The building rests on a series of stone piers. Unpainted wood shingles cover the steeply-pitched, log-framed gable roof. The roofline extends to shelter a log-framed open front porch with a wooden floor; the gable end is open, exposing the log-truss. Roof features include a brick chimney located high within the northeast gable slope and exposed log purlins and eight-inch rafters.

A wood-frame shed-roofed addition on the rear elevation of the building is covered with lapped horizontal wood siding. Rolled roofing covers the roof. Two wood-framed four-light by four-light sliding-sash windows are symmetrically placed within both side elevations of the original component. The front elevation, protected by the roof extension, contains an offset 4/4/4 sliding-sash window flanked to the northeast by a door constructed of vertical planks and paired with a wood screen door. Both gable ends contain a small four-light window. Features within the rear-elevation addition include a six-light by six-light sliding-sash window within the northwest elevation and a six-light awning window, flanked to the south by a vertical plank door, within the northeast elevation. Rear elevation features are limited to a small particle-board box used to store propane tanks. All windows are wood-frame with four-inch surrounds. The building is painted dark brown with white trim and is in good condition.

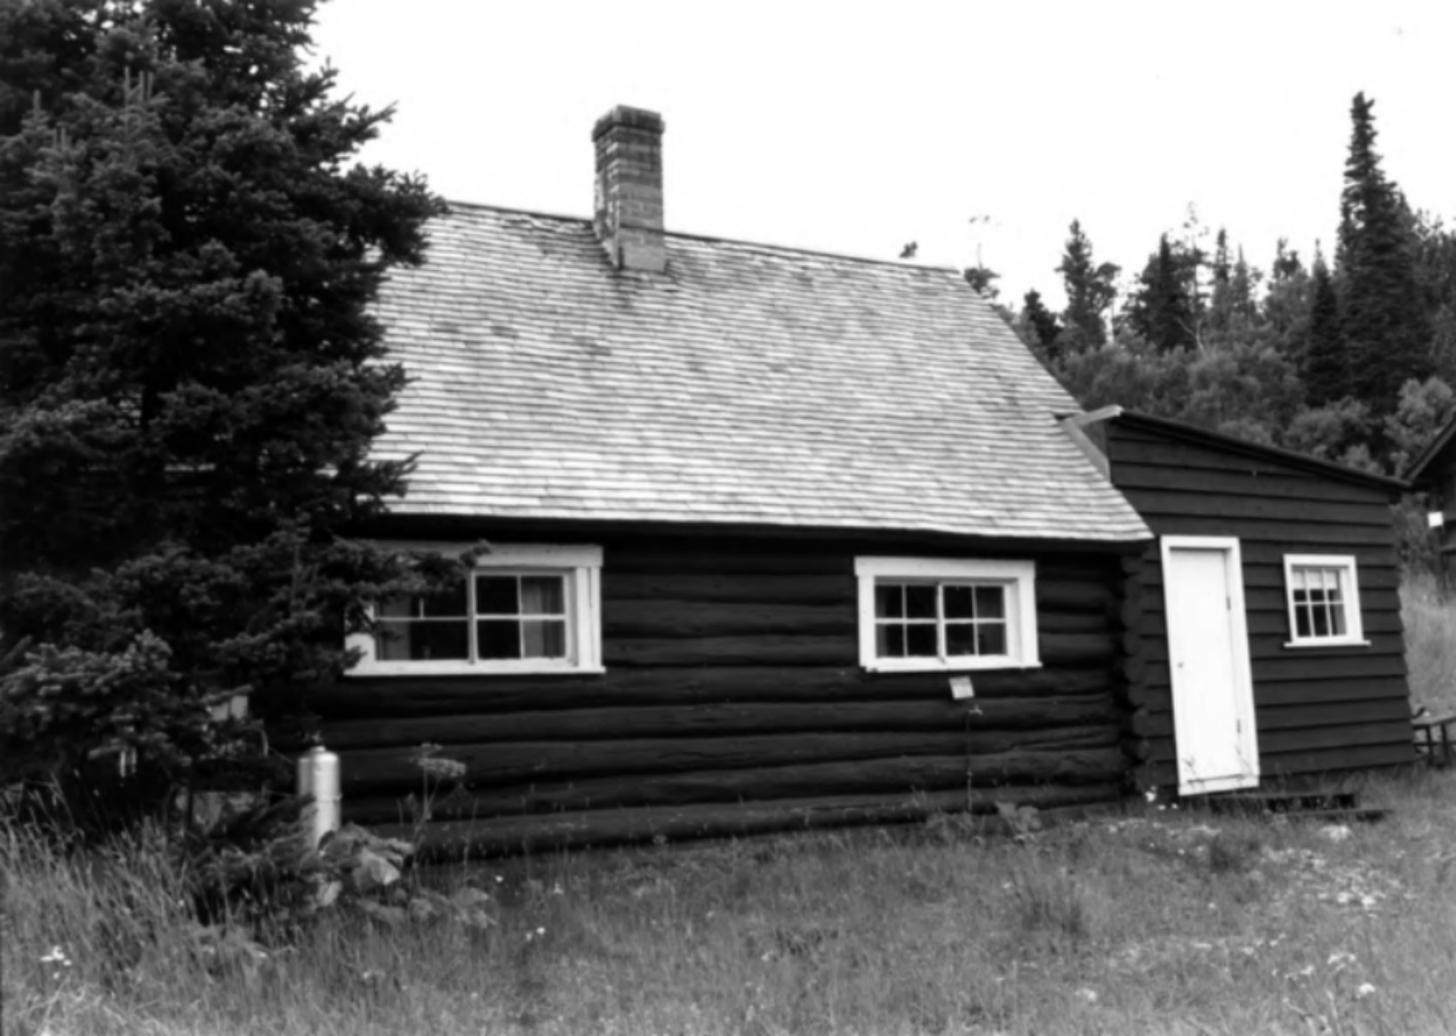
Photo #2

Ranger Station Its 148

view to SW

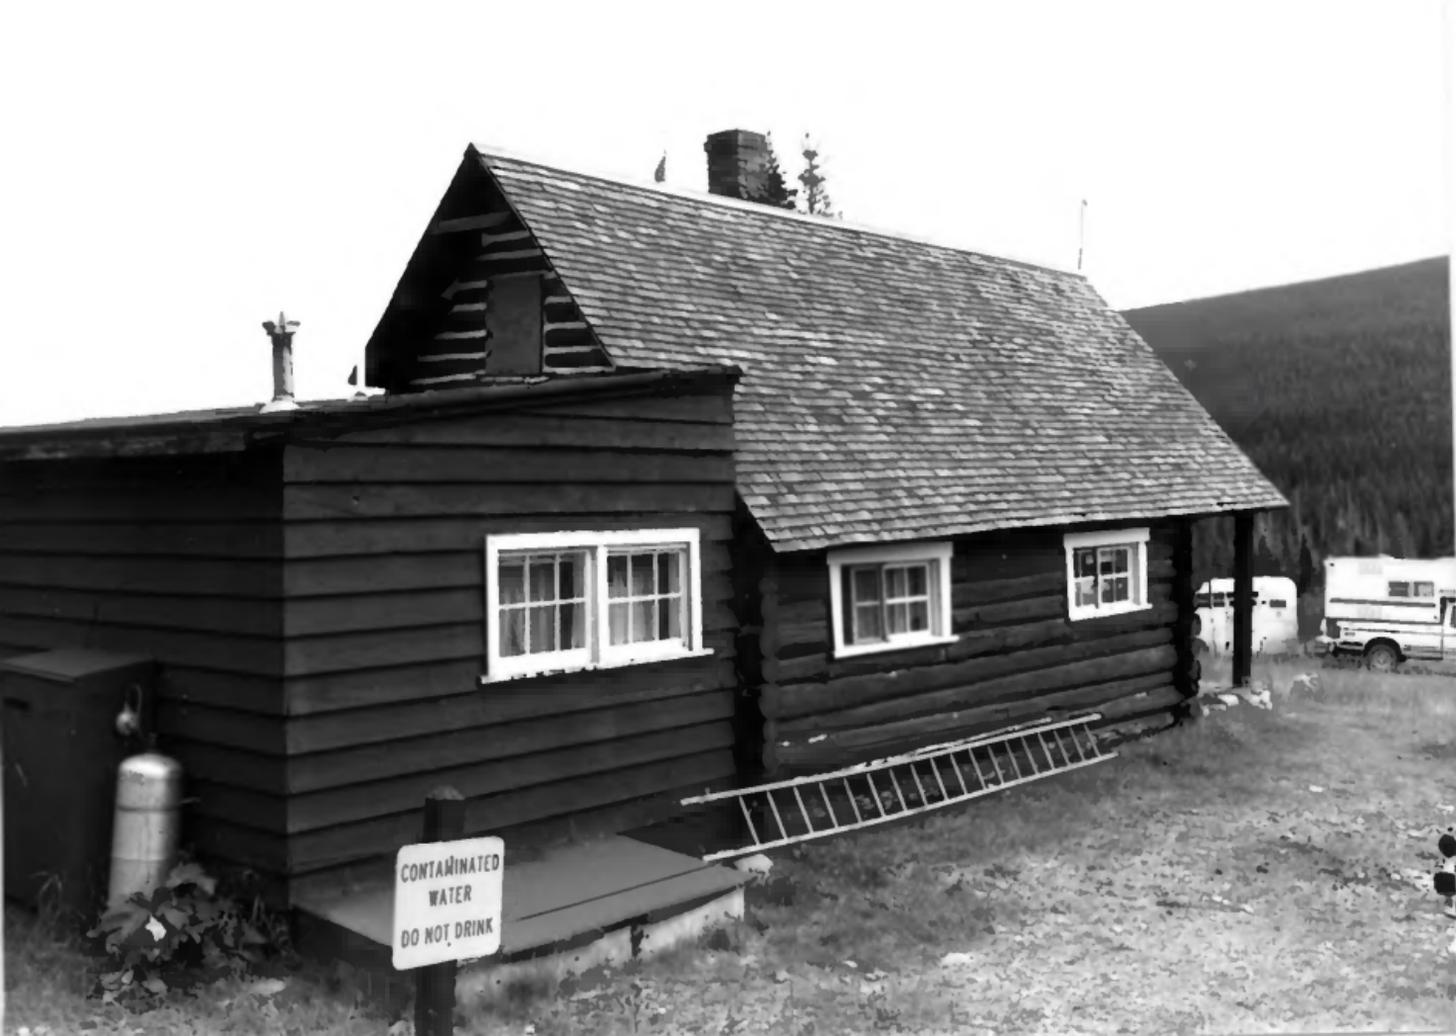
Photo #3

Ranger Station HS 148

View to SE

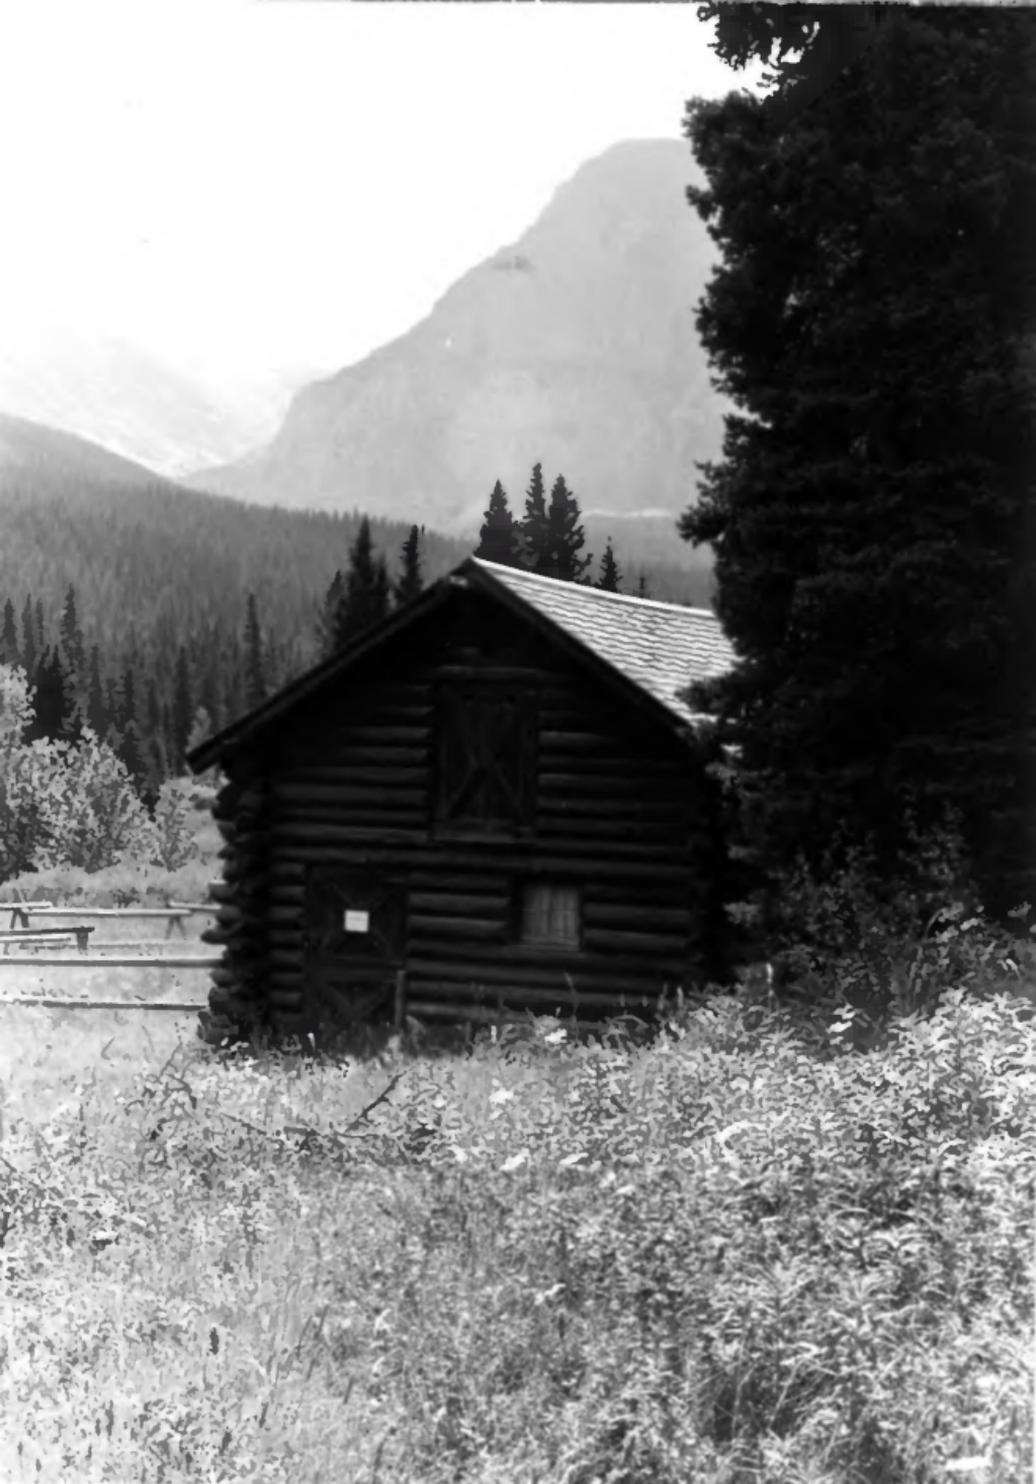
Photo #4

Barn HS 419

View to SW

The Cut Bank barn is a one-and-one-half story rectangular building constructed of saddle-notched logs with chopper-cut ends. The building rests on a concrete foundation. Wood shingles cover the front-gable roof. Roof features include exposed log rafter and purlin ends and an extended ridge pole that may once have supported a winch system.

The front (east) elevation contains an offset Dutch door constructed of vertical planks secured with diagonal cross braces, a four-light window, and a hayloft door -- also constructed of vertical planks secured with diagonal braces -- centered within the upper level. The south (side) elevation contains a centrally-placed dutch door flanked to either side by a six-light window. There are no features on the rear (west) or north elevation. The building is painted brown and is in generally good condition, with some deterioration evident in the log ends.

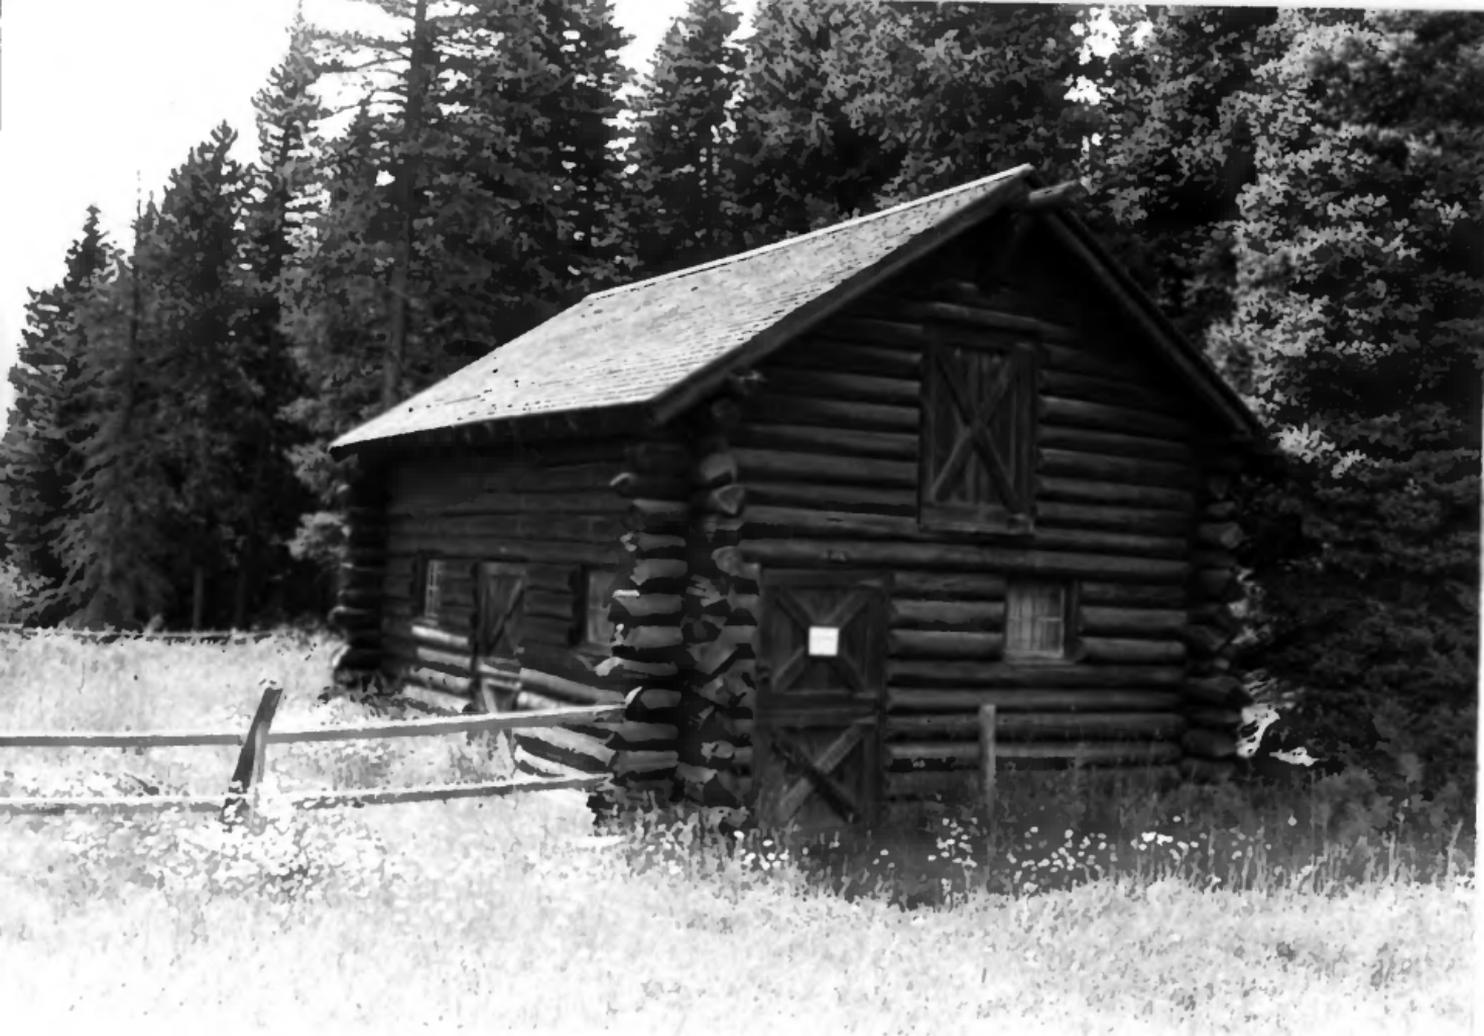
Photo #5

Barn HS 419

View to NW

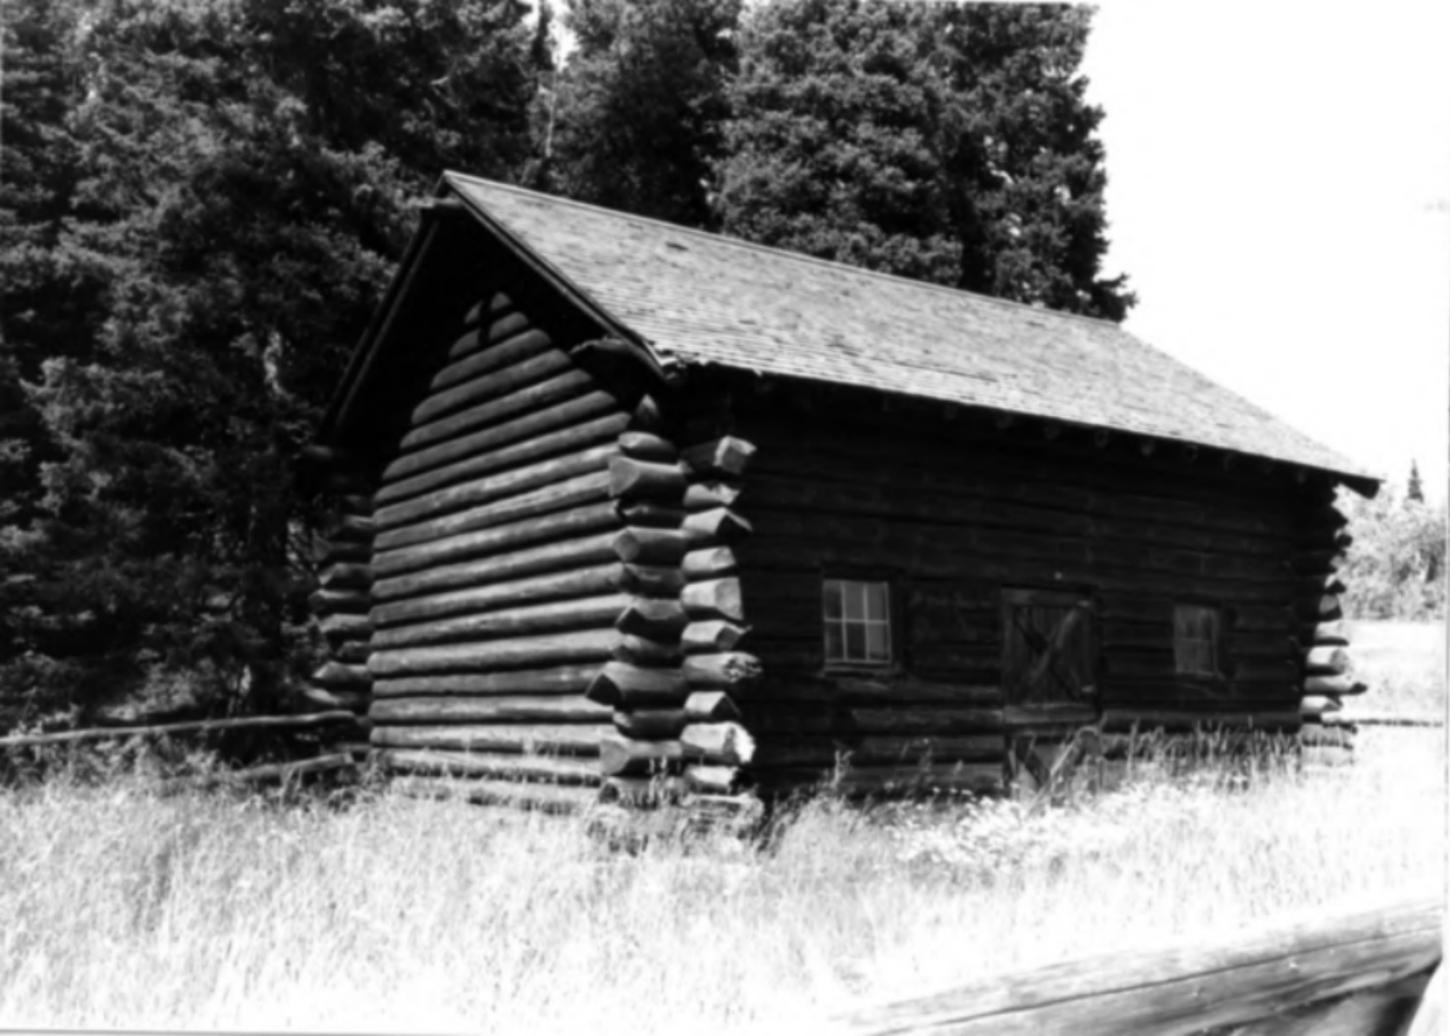
Photo # 6

Barn HS 419

View to NE

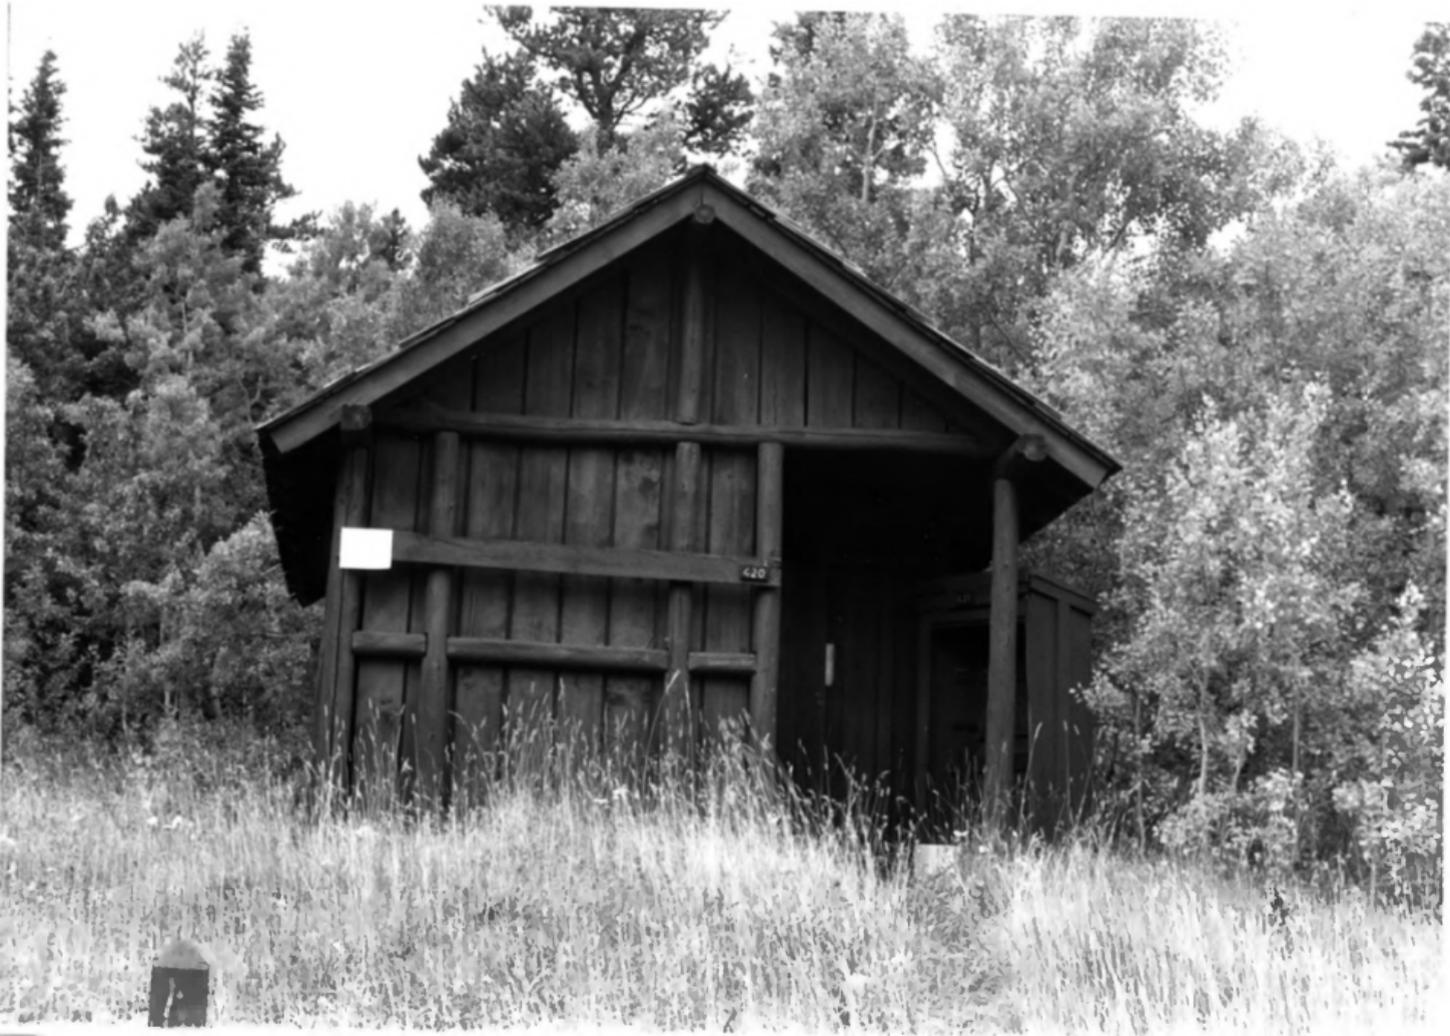
Photo #7

Woodshed HS 420

View to NW

The Cut Bank woodshed, located approximately 25' northwest of the ranger station, is a single-story building constructed of exposed log framing, with walls of vertical wood members. The building rests on a stone-pier foundation. Wood shingles, bearing remnants of the original green paint, cover the front-gable roof. Roof features include exposed frame rafter ends and log purlin ends. An inset entry area, protected by the primary roof, is offset within the front (southeast) elevation, breaking the simple square footprint.

Features are limited to a boarded-over four-light window within the southwest elevation and a six-inch vertical board door located within the "ell" created by the inset entry. A small storage cupboard, approximately 2'x3'x9' is located just off the southeast corner of the porch, under the protective cover of the eave. The building is painted brown with white trim.

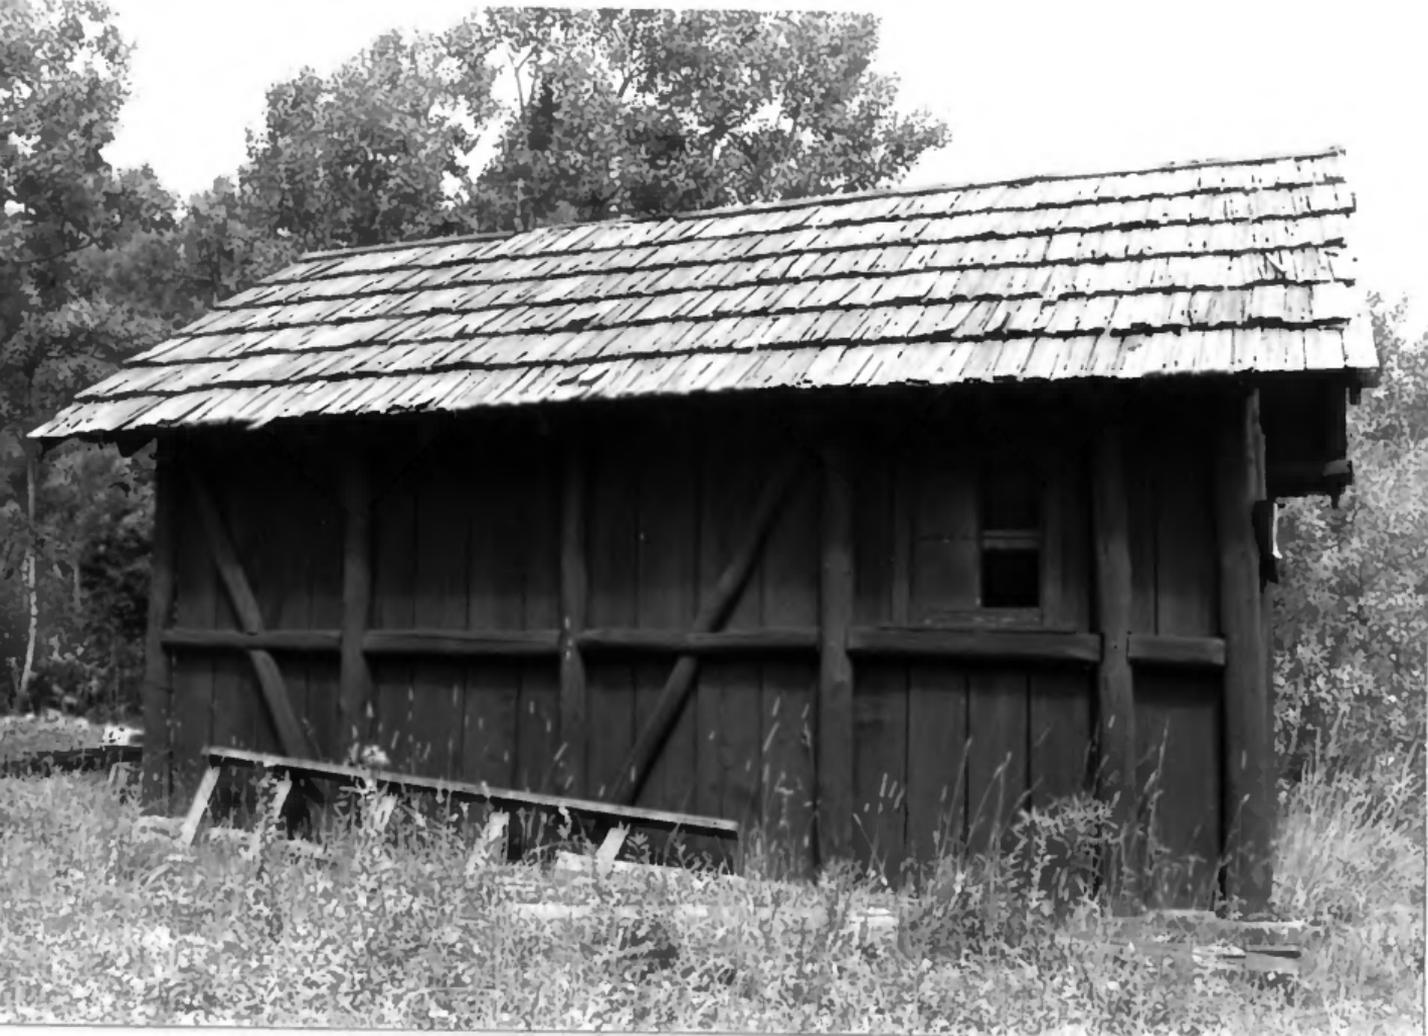
Cut Bank
Photo #8

Woodshed H/S 420

View to NE

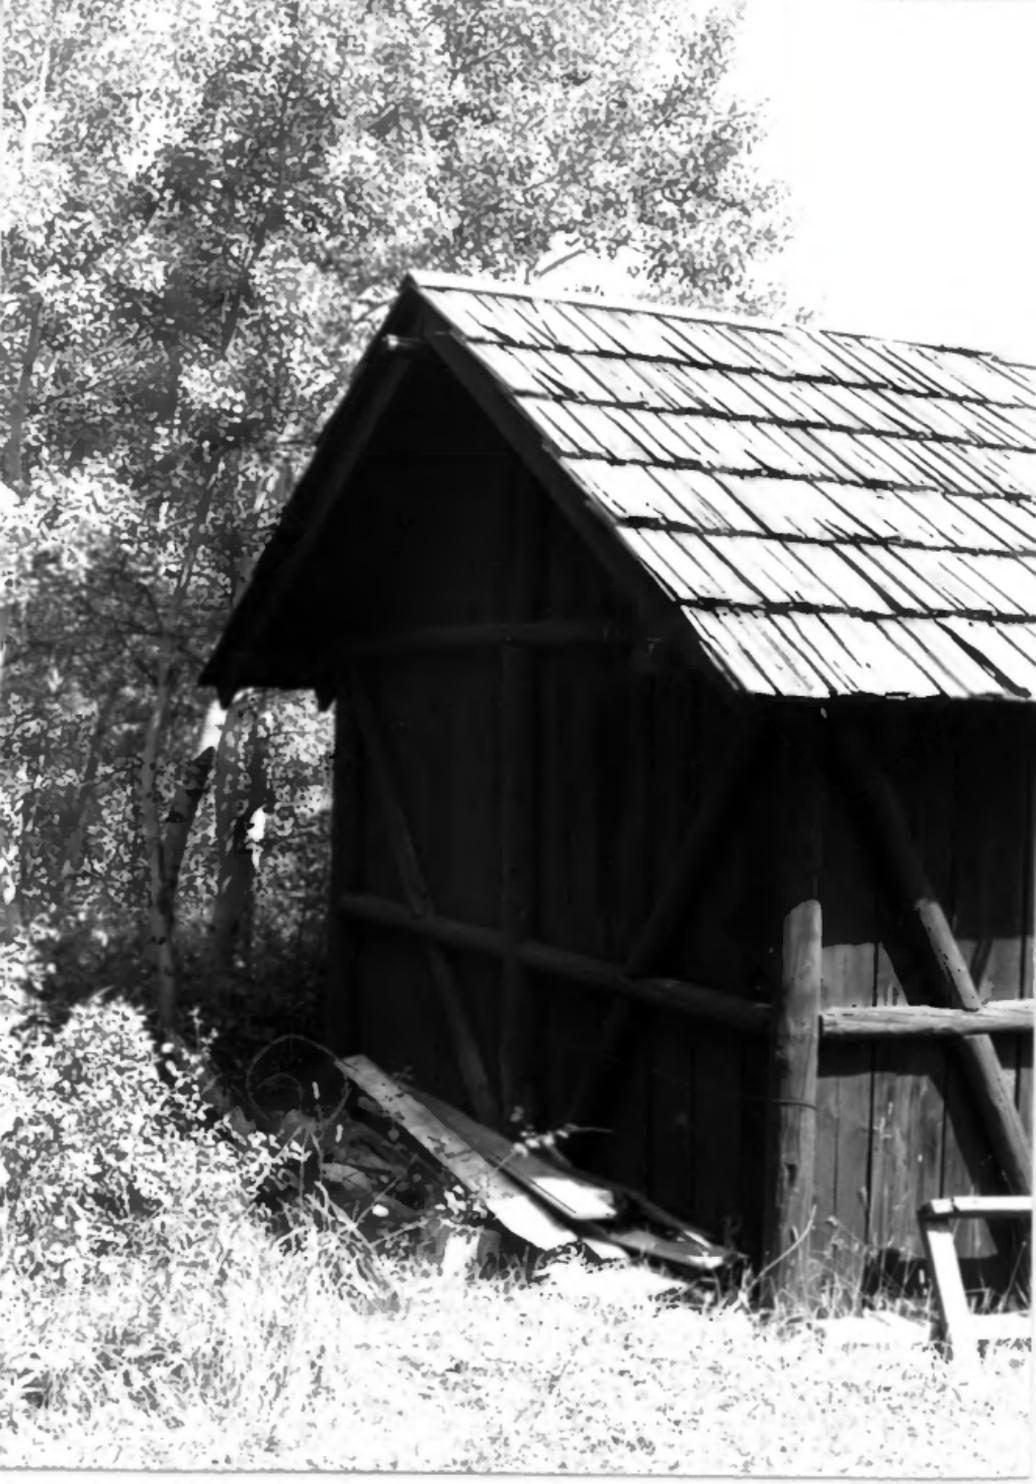
Photo #9

Woodshed LHS 420

View to SE

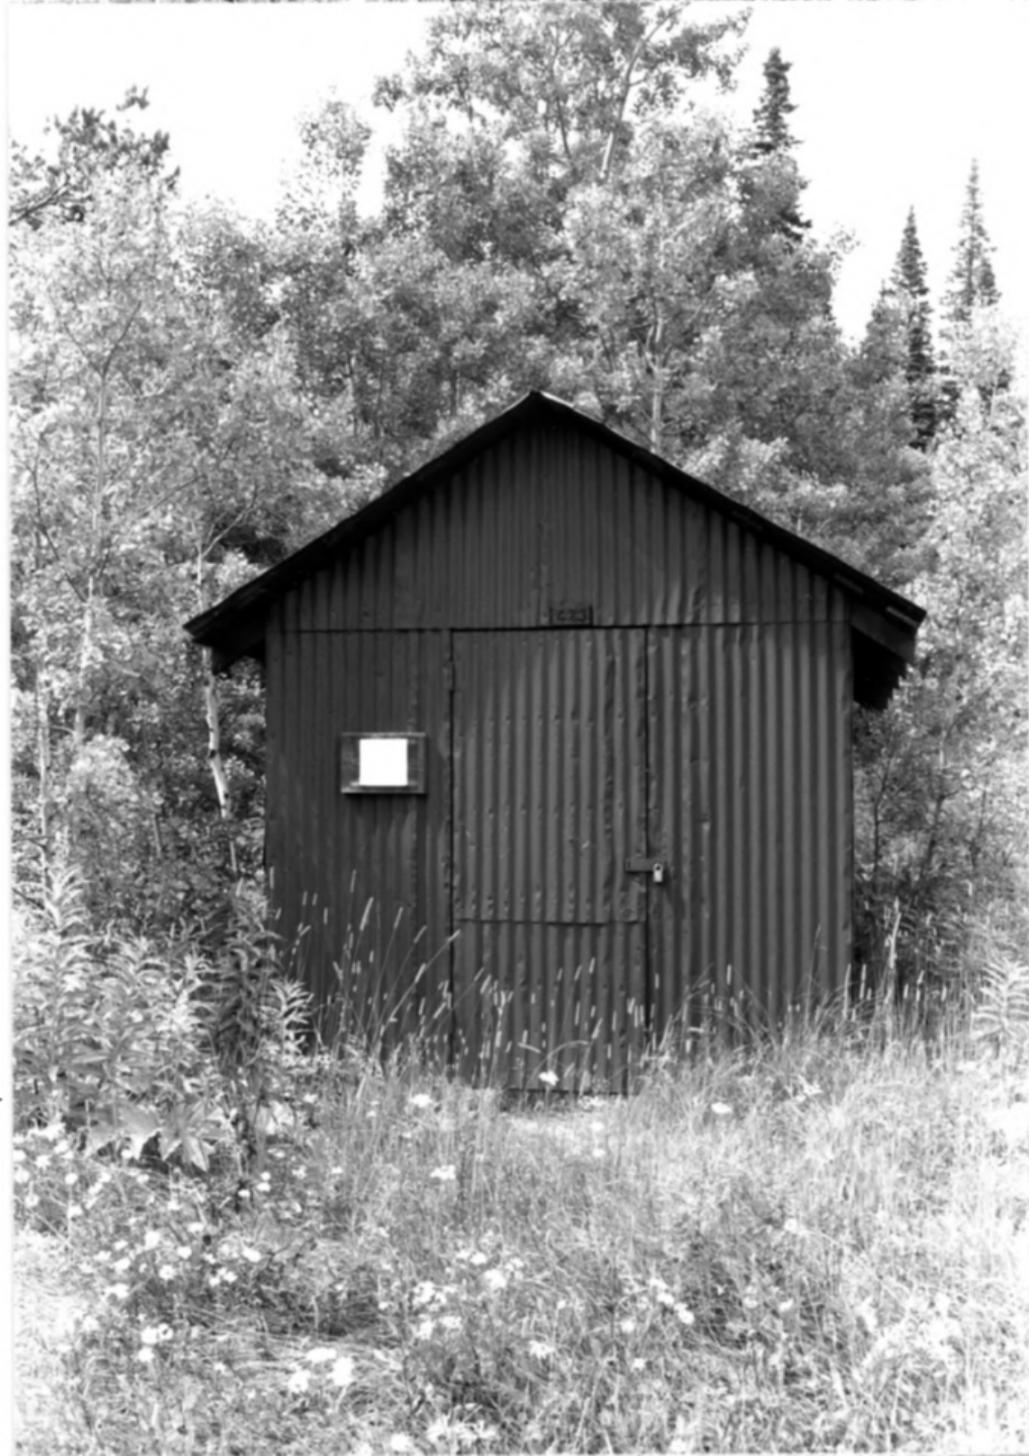
Photo #12

Oil Storage Shed H5 423

View to NW

This is a single-story wood-frame building with a square footprint. There is no apparent foundation. Corrugated metal covers the front gable roof, all exterior elevations, and the pedestrian door centered within the front (southeast) elevation. Metal also covers a window opening offset within the northeast elevation. Rafter ends are exposed. The roof is painted green and walls are painted brown. The building is in good condition.

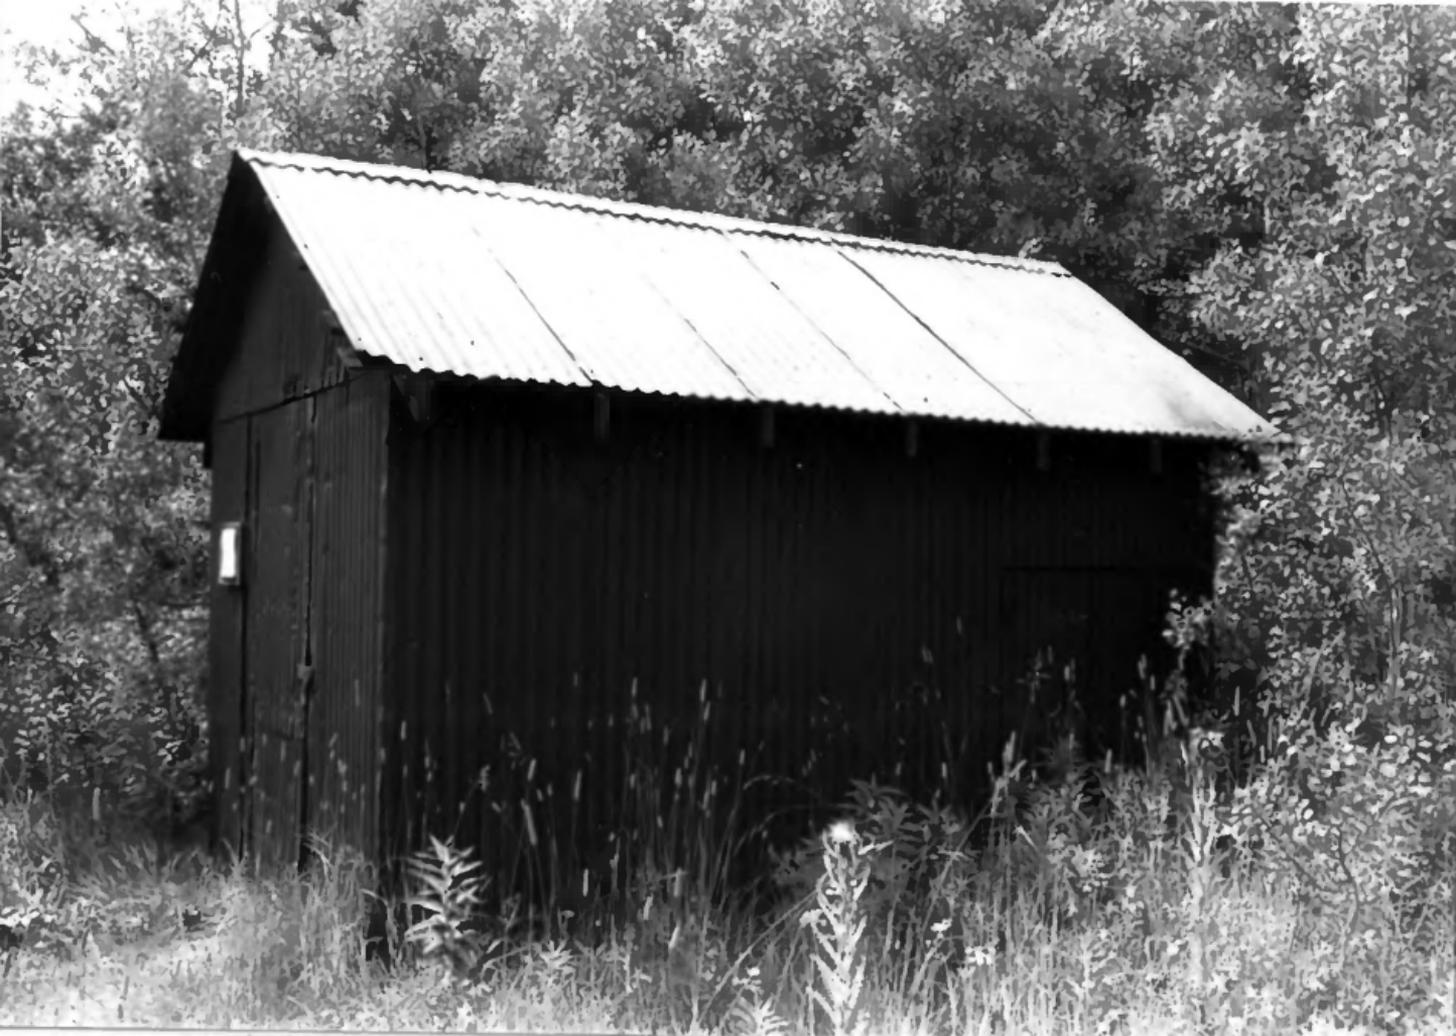
Cut Bank
Photo #13

Oil Storage Shed ITS 423

View to W

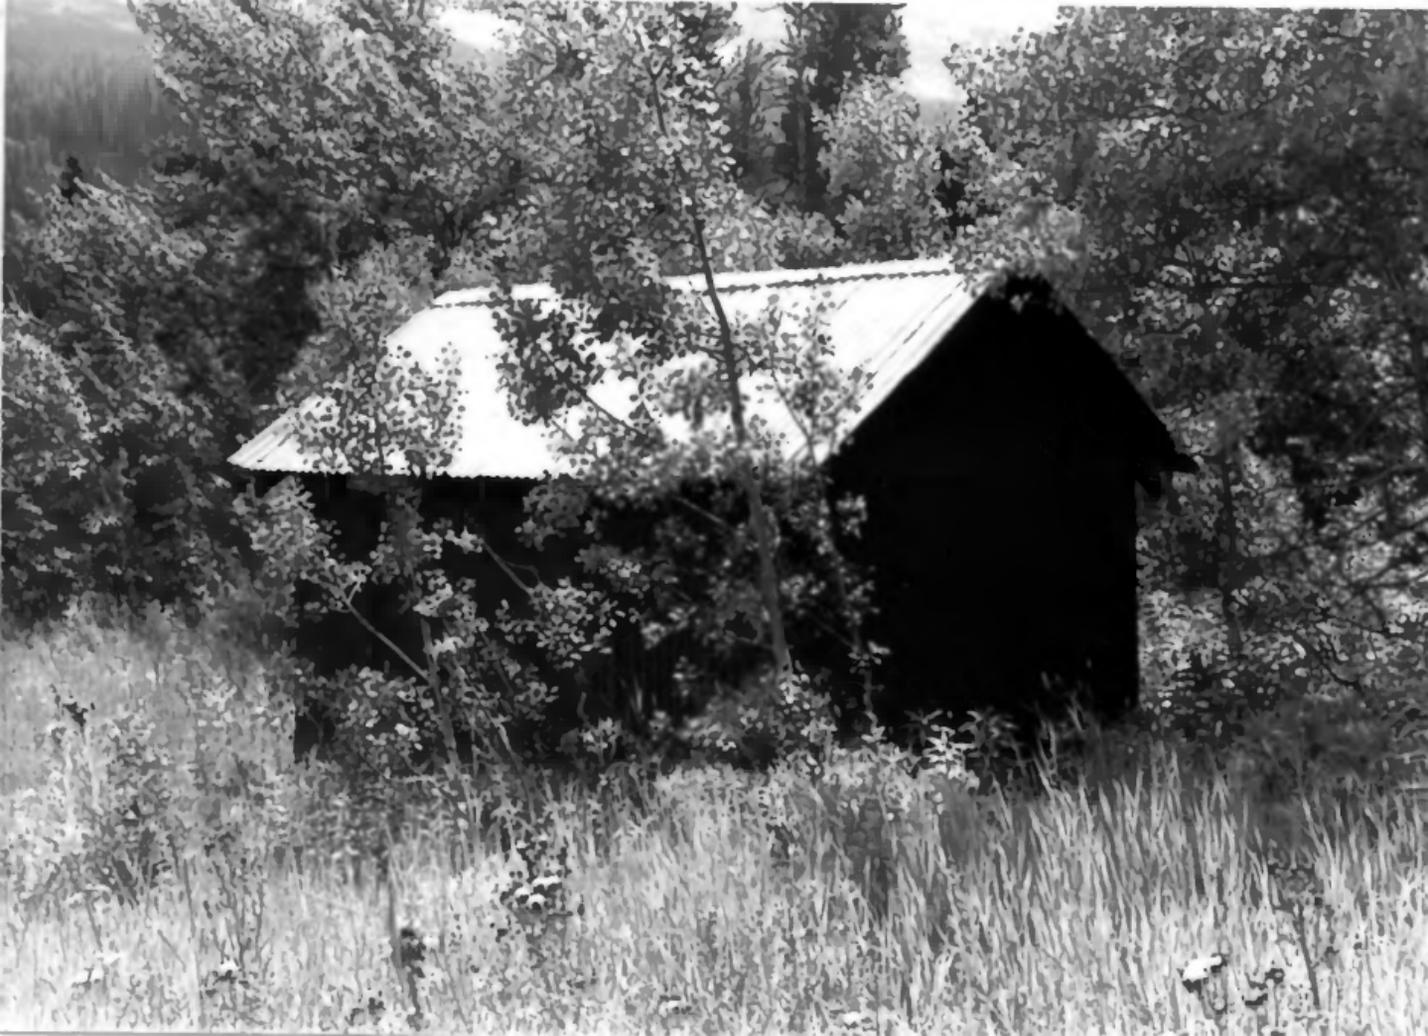
Cut Bank
Photo #14

Oil Storage Shed H/S 423

View to SW
