Fielding Patrol Cabin (addendum), Glacier Co., MT.

Section number 7 Page 2 Fielding Patrol Cabin (addendum), Glacier Co., MT.

Fielding Patrol Cabin (#389), 1936

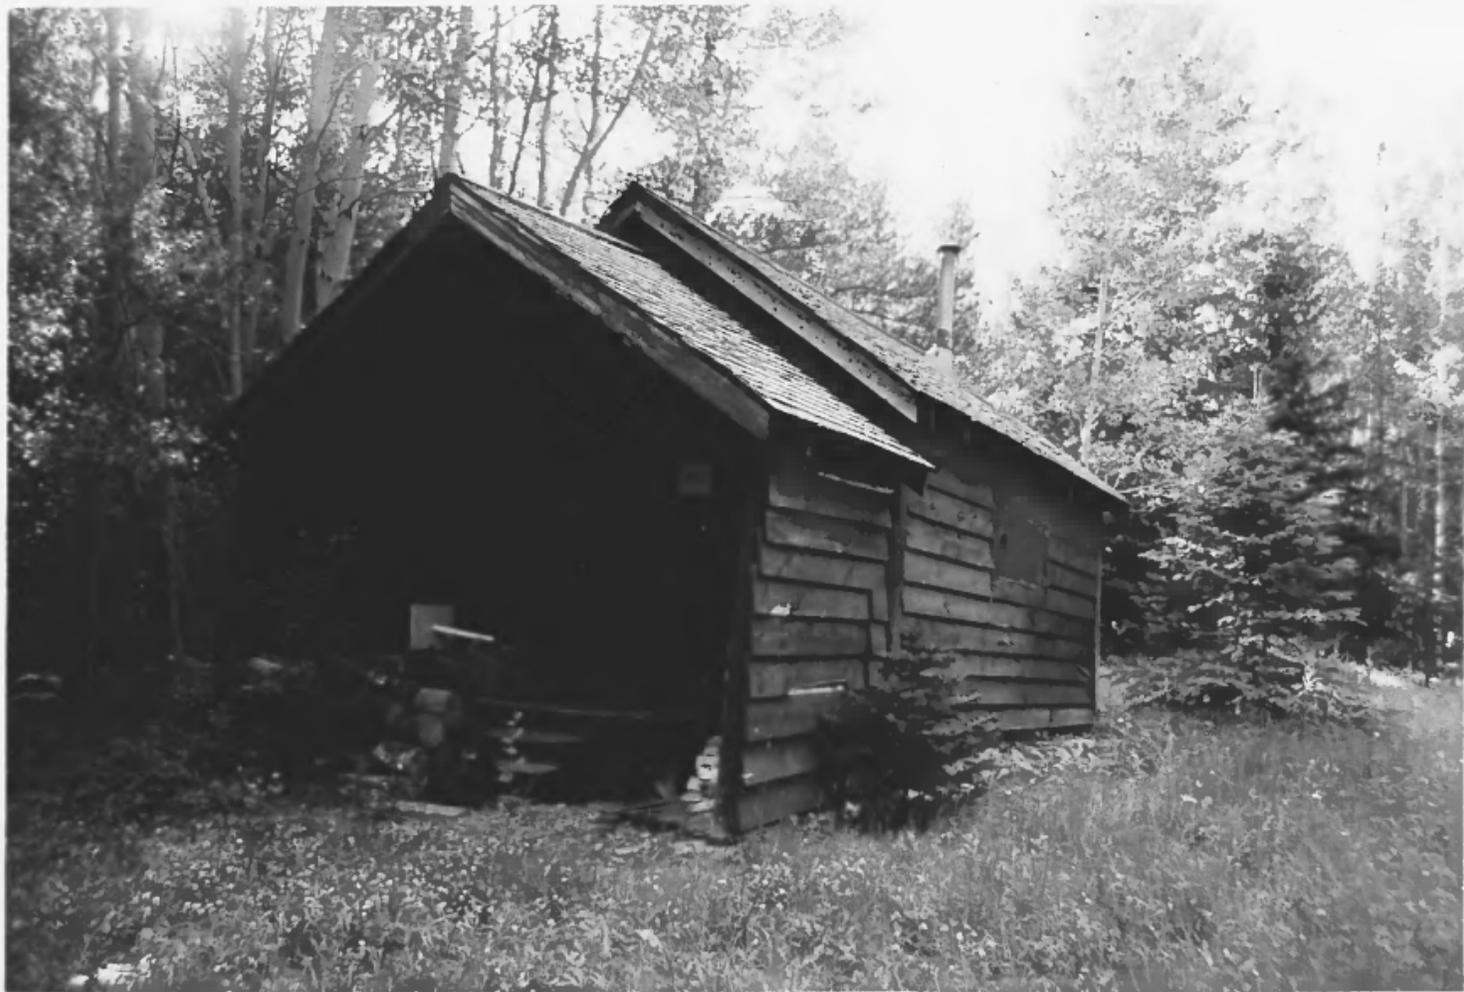
Figure 1

Fielding Snowshoe Patrol Cabin
(HS 389)

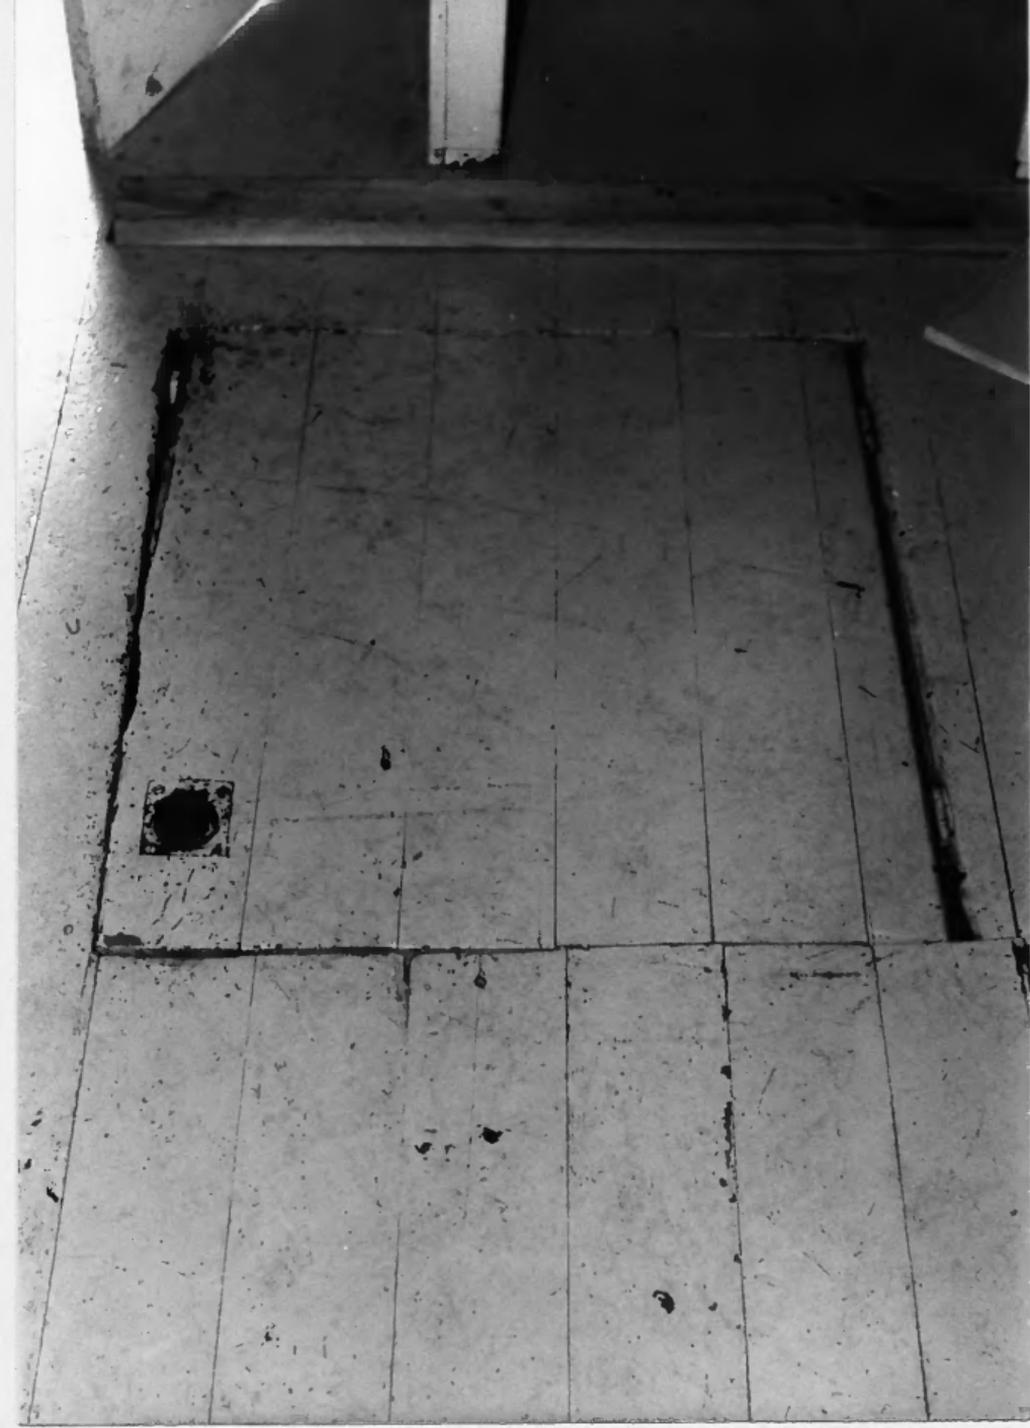
Figure 2

Fielding Snow Shoe Patrol Cabin
(HS 389)
