NATIONAL REGISTER OF HISTORIC PLACES NOMINATION, GLACIER NATIONAL PARK

STRUCTURE NAME: Huckleberry Fire Lookout **STRUCTURE NUMBER:** 587

Huckleberry Lookout (addendum), Flathead County, MT.

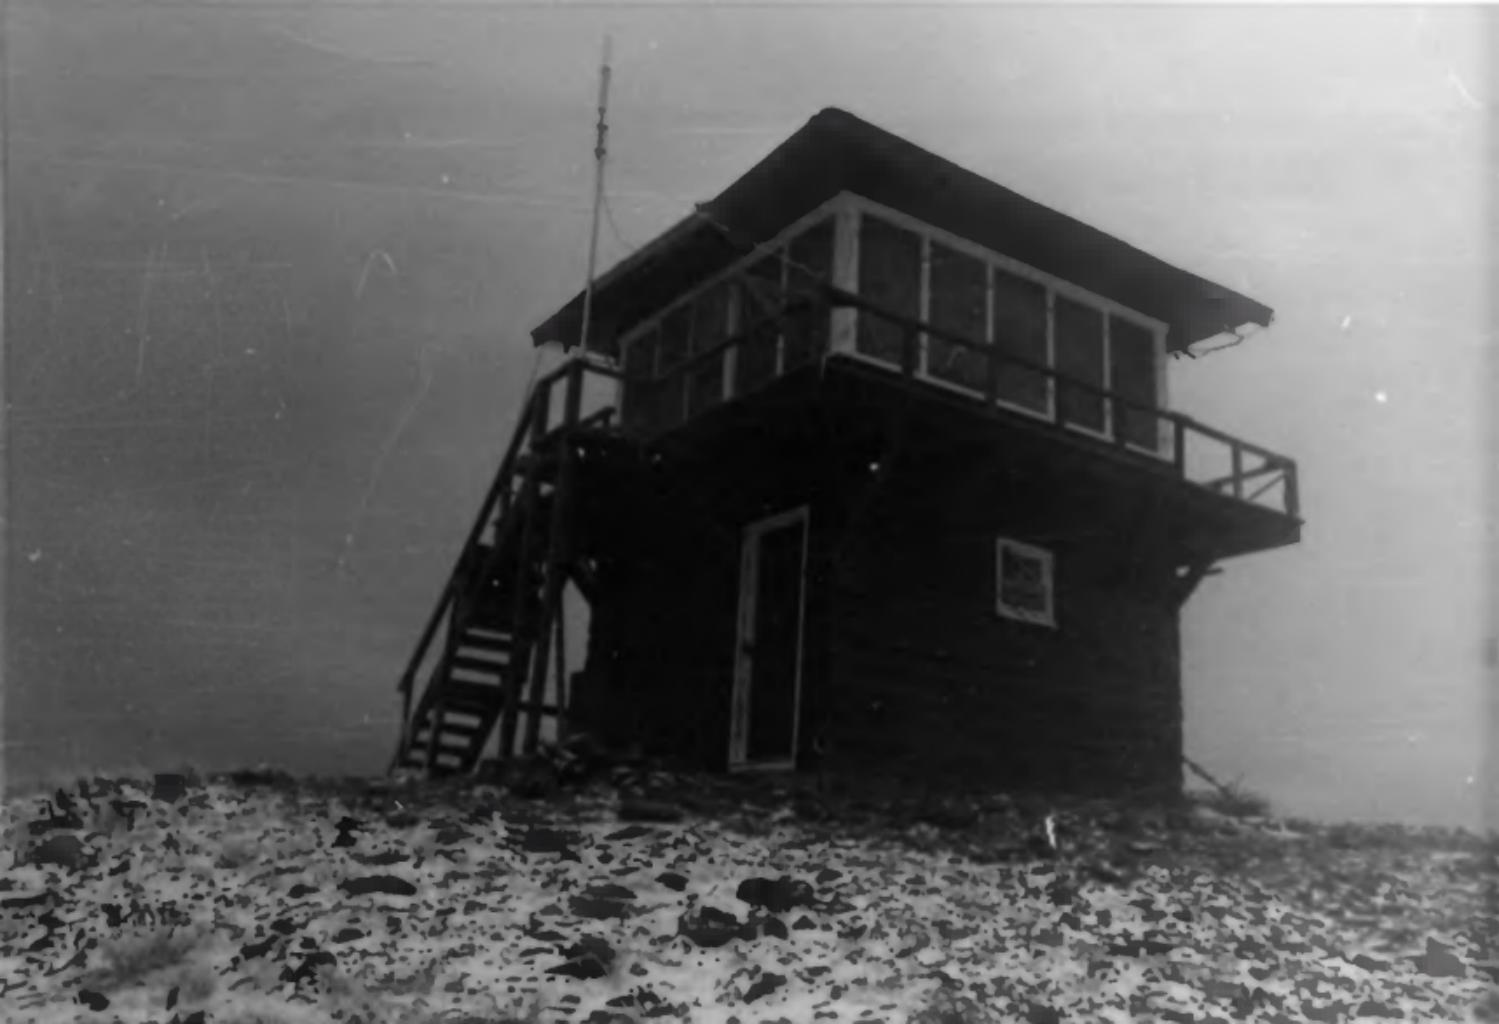
PHOTO NUMBER: 1

The Huckleberry fire lookout is a two-story, square (14x14 ft.), frame building with 1"x10" lapboard siding and a pyramidal hip roof covered with rolled asphalt. The structure is set on a rubblestone and concrete pad foundation. The lower level is solid with a single board-and-batten entry. The upper level is reached by a 2x8" plank stairway. Double pane windows and a catwalk wrap around four sides of the upper level. The structure is in good condition. This lookout is a standard, wood frame, 14x14-ft. house set on a 10-ft. tower with catwalk. The basic plan, originally designed by the United States Forest Service, was often modified and revised by both Forest and Park Service engineers. The Huckleberry lookout has good integrity of materials, design, and workmanship and is significant in the architectural history of Glacier National Park.

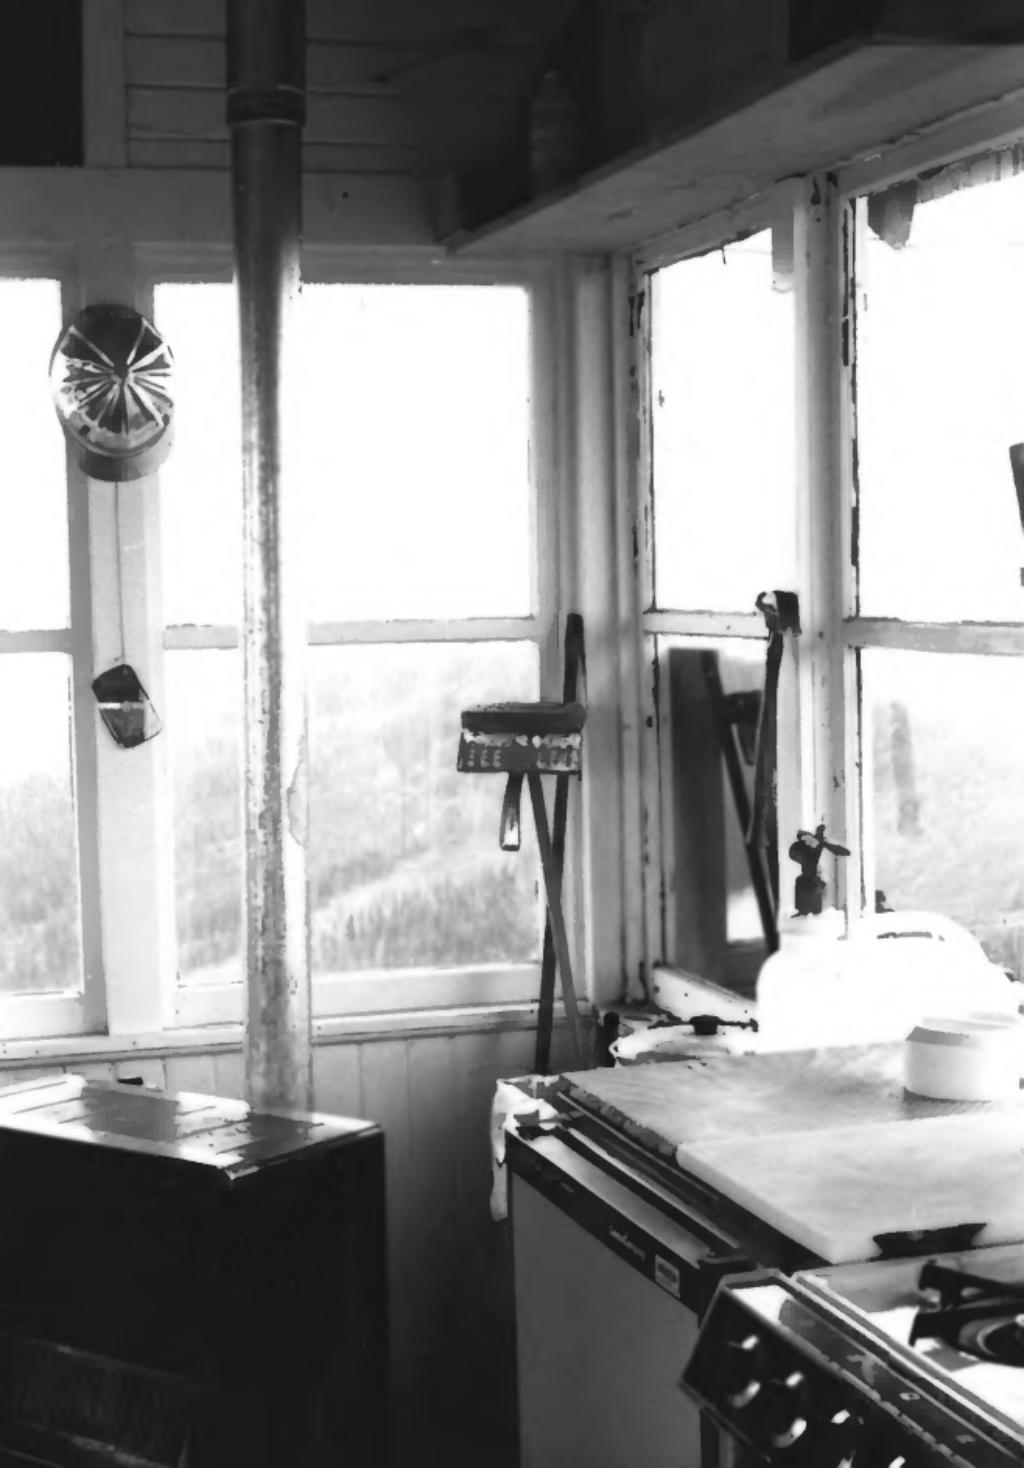
#1

As befits its function, pairs of large two-light windows dominate the interior of this small building. Two-inch floorboards, painted grey and paired with 3" baseboards (painted white), cover the floors. The same 3" planks (either shiplap or tongue-and-groove) cover the walls and ceiling; these boards are laid vertically below the windows and horizontally above. Walls are painted white and the ceiling is painted grey. A trap door, also constructed of 3" planks, provides access to the attic storage space. Two-inch boards frame all windows and the five-panel exterior door.

Furnishings include a gas range and refrigerator; free-standing cupboard units constructed of 3" planks (all countertops are currently covered with blue floral contact paper); a table; two crude handmade wooden chairs; the centrally located fire finder. Shelves have been constructed above the windows and hold a variety of household goods.

Interior - to SE
