NATIONAL REGISTER OF HISTORIC PLACES NOMINATION, GLACIER NATIONAL PARK

STRUCTURE NAME: Lower Logging Lake Snowshoe Cabin STRUCTURE NUMBER: 593

STRUCTURE NAME: Lower Logging Lake Boathouse STRUCTURE NUMBER: 545

Lower Logging Lake Snowshoe Cabin (addendum),
Flathead County, MT.

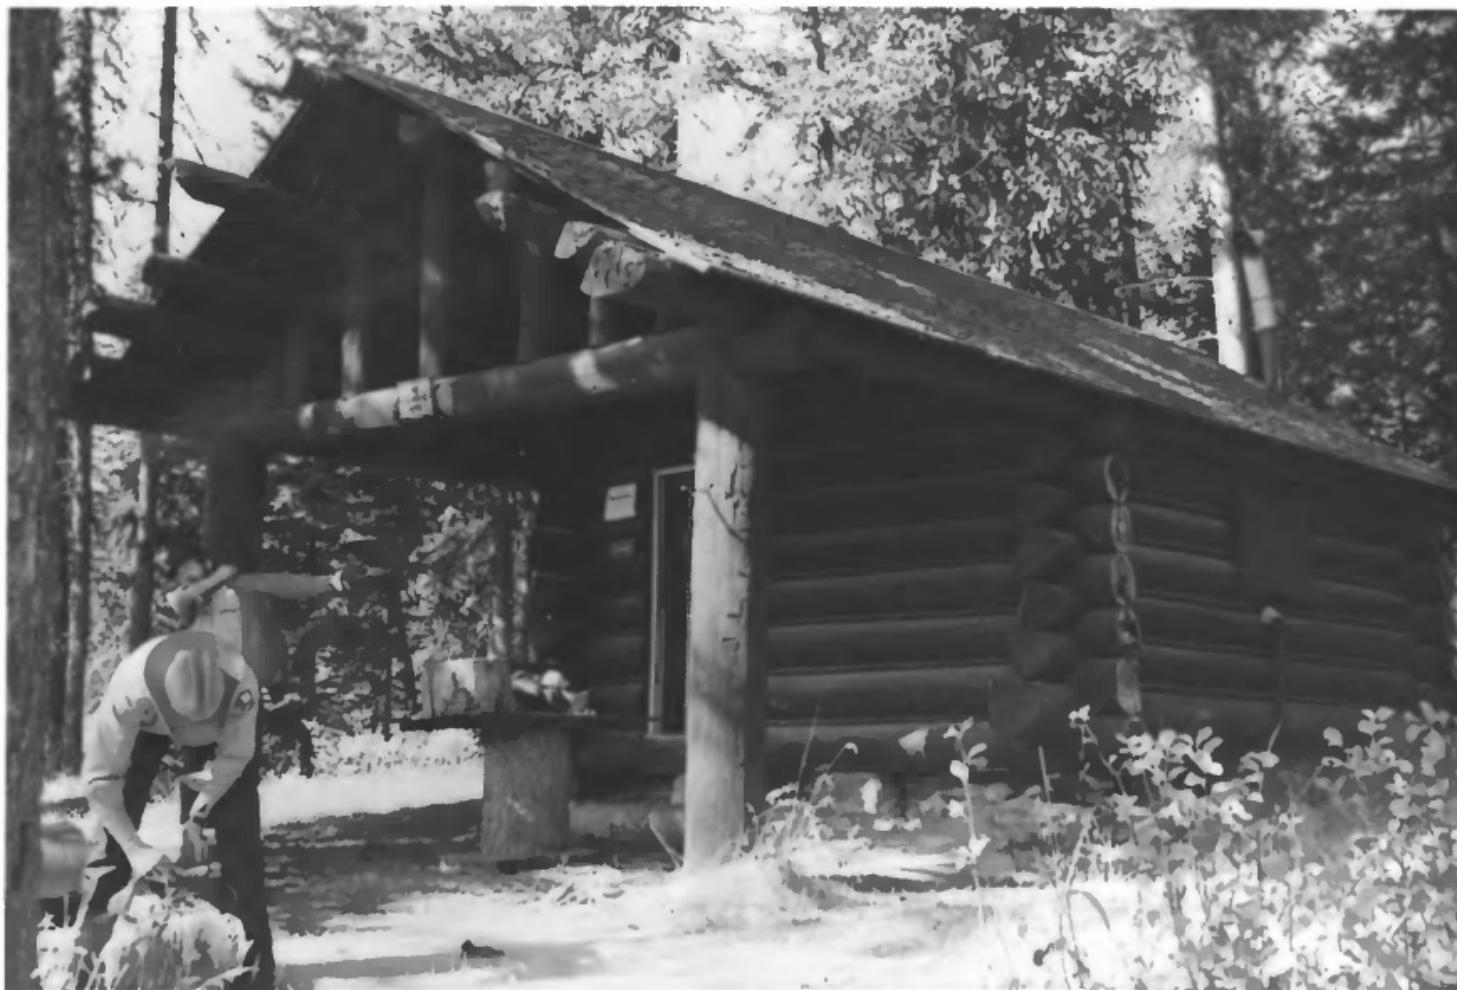
PHOTO NUMBER: 1

NAME: Lower Logging Snowshoe Cabin (593)

The Lower Logging Lake snowshoe cabin measures 26x12' and has a wood-shingled gable roof extended to form a full porch with 11 purlins and 7 vertical supports beneath the purlins on a tie beam and vertical posts. The square-cut purlin crowns extend beyond the gable end. The cabin logs are saddle notched with sapling chinking and rest on a concrete pad foundation. The structure has three six-light windows and is in good condition. The sill logs were replaced in 1978. The Lower Logging Lake snowshoe cabin was constructed in 1933 by area contractors Austin Weikert, Ace Powell, and Asa Peck from standard Park Service plan G-931. Landscape Architect Charles E. Peterson designed the 24x12-ft. building.¹ The cabin retains good integrity and still displays some of the extended, rough-cut crown ends specified in the original drawings. The Lower Logging Lake snowshoe cabin is a significant example of rustic architecture and log craftsmanship in Glacier National Park.

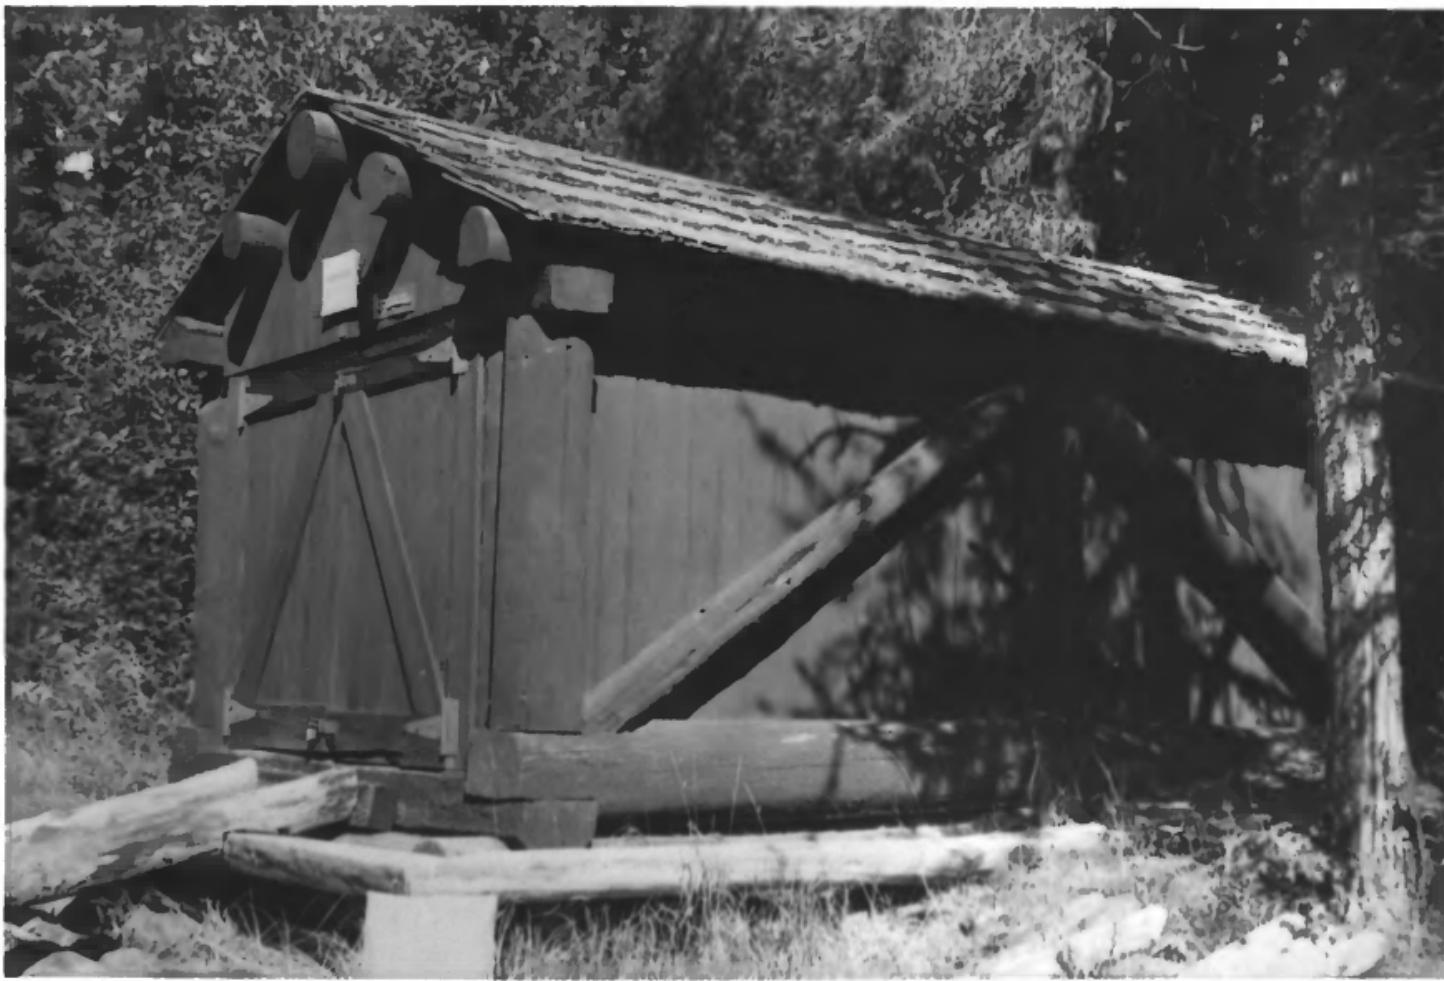
PHOTO NUMBER: 2

NAME: Lower Logging Lake Boathouse (545)

The Logging Lake boathouse is a one-story structure with timber frame and vertical wood walls and five log purlins. Square-cut crowns extend slightly beyond the eave of the shingled gable roof. The building rests on a log foundation and has Z-braced double wood doors. Log skids lead to the lake. The structure is in good condition. The Logging Lake boathouse, adjacent to the Lower Logging Lake snowshoe cabin, is characteristic of Park Service design and materials. The integrity is good and the building enhances the significance of the nearby cabin.

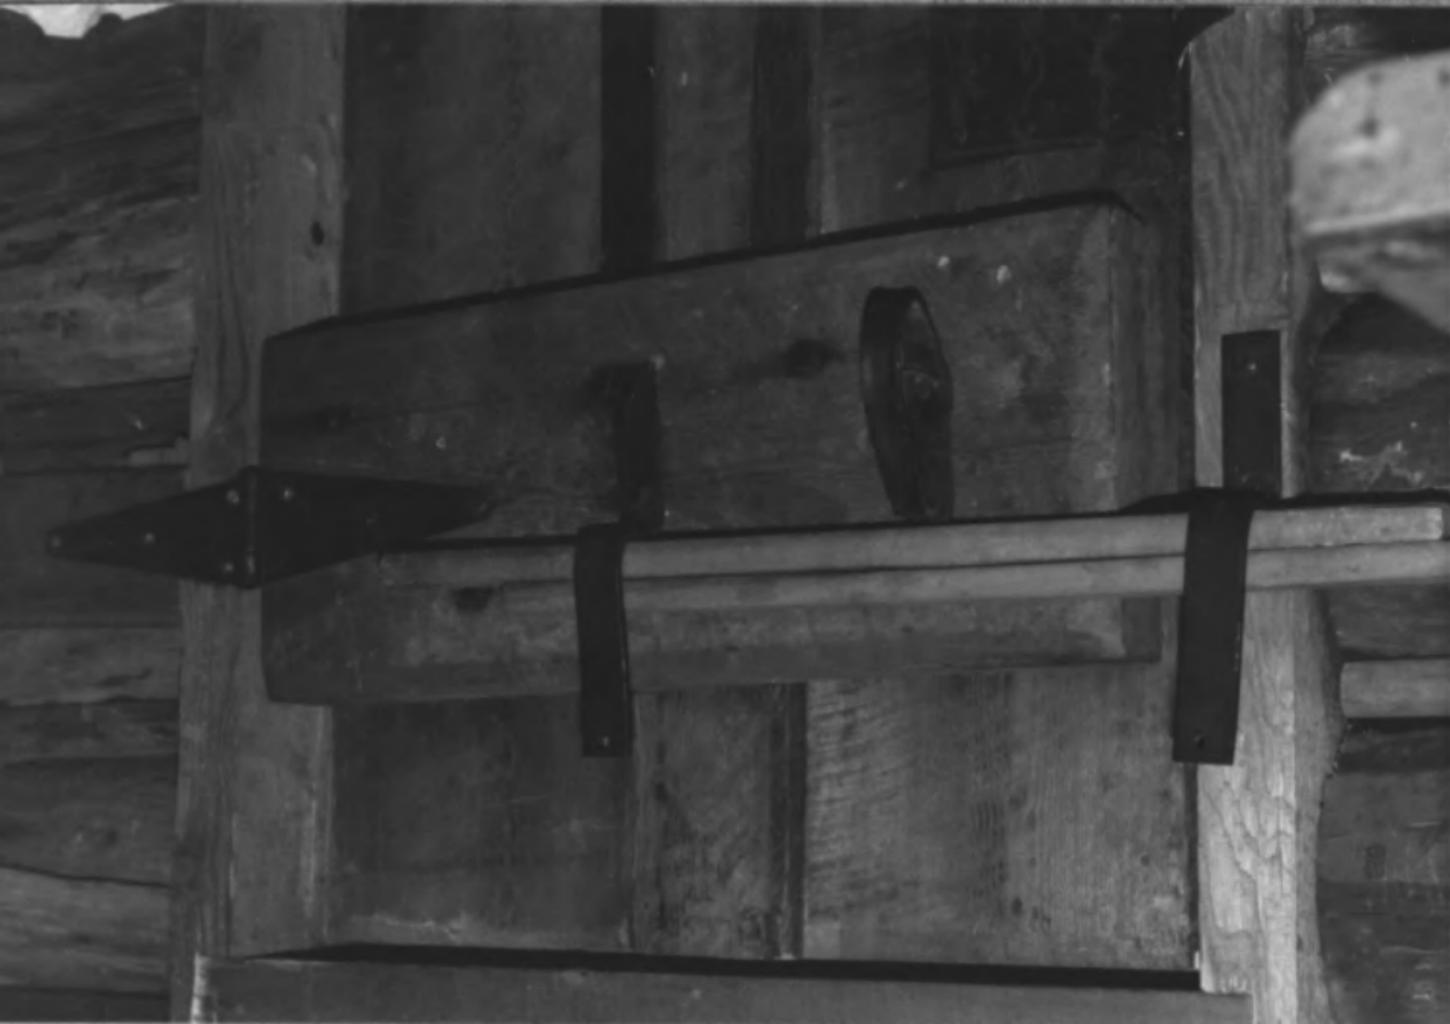
Figure 1

Interior

Door

~~upper~~ ^{lower} Logging Lake Snowshoe Cabin
Flathead Co., MT, Glacier NP

Although constructed eight years after construction of the Upper Logging Lake Snowshoe Cabin, this building is remarkably similar in materials and design to its upper lake neighbor. Heavy 10" x 3" planks secured with bolted 10" horizontal braces, form the front entry. Hardware appears to be historic and includes large metal hinges (approx. 28" x 5"; see photo #2), a metal latch, and a strip of leather nailed to the inside of the

door for a handle. Metal guards run across the opening and allow for the placement of a board to prevent entry from the outside. Five-inch tongue-and-groove planks (in contrast to the more common shiplap), painted grey, cover the floor. The trap door, also constructed of 5" planks, opens to reveal a concrete-lined pit accessed by a short ladder. Whole logs, chinked with sapling, form the interior walls; metal flashing runs along the north and south walls, at the floor juncture. The ceiling is open to the roof, exposing the purlins and 12" roof boards.

PHOTO NUMBER	STRUCTURE NAME AND NUMBER	LOCATION/DIRECTION OF VIEW
1	Lower Logging Lake Snowshoe Cabin (#593)	Interior - detail of door/latch
2	Lower Logging Lake Snowshoe Cabin (#593)	Interior - note fold-down table and suspended bed

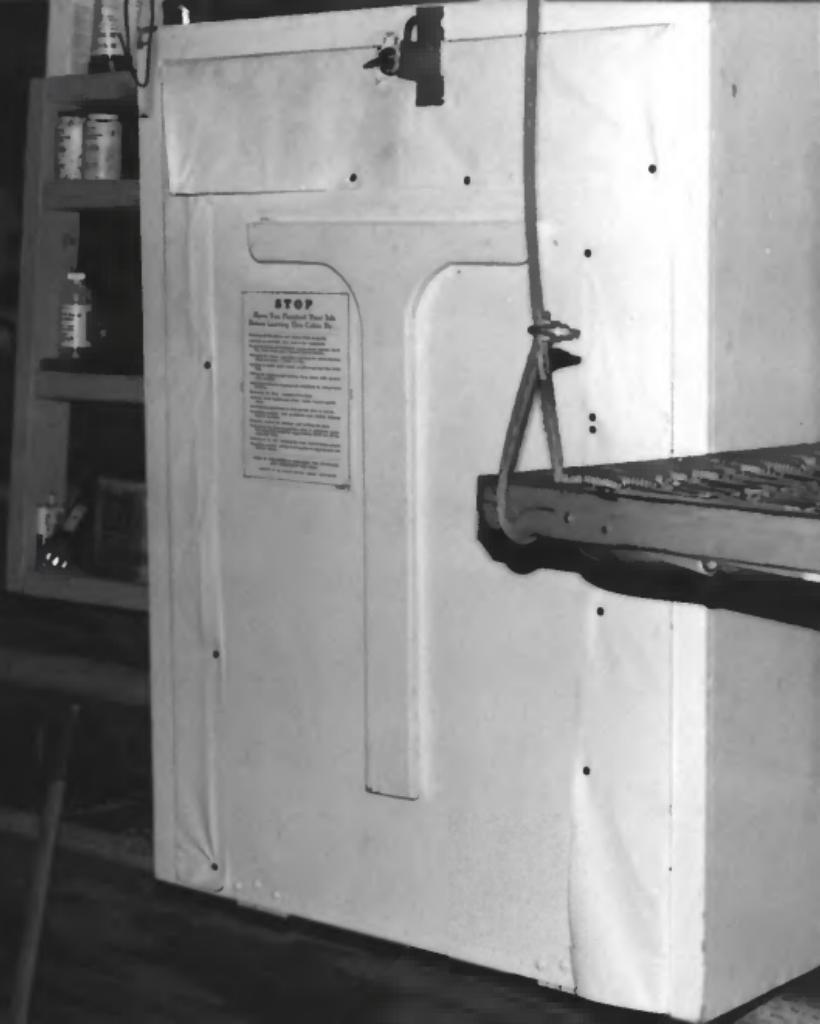
Figure 2

Interior

Logging Lake Snowshoe Cabin

Furnishings are standard backcountry issue: food cupboard with hinged table/door, two wooden chairs, rodent-proof bedding storage boxes (constructed of shiplap planks and featuring a heavy top and side vents), and ceiling hooks for Coleman lanterns. Suspended bunkbeds are located along the east and west walls: the upper bunk is suspended by cables secured to two heavy metal hooks set in the nearest purlin. A wood slat bracket, bolted to the wall, provides additional support. The lower bunks are supported by fold-down legs. The cookstove is located in the northeast corner and is surrounded by the usual collection of pots and pans, placed on open shelving units or hung from nails pounded in the wall logs.

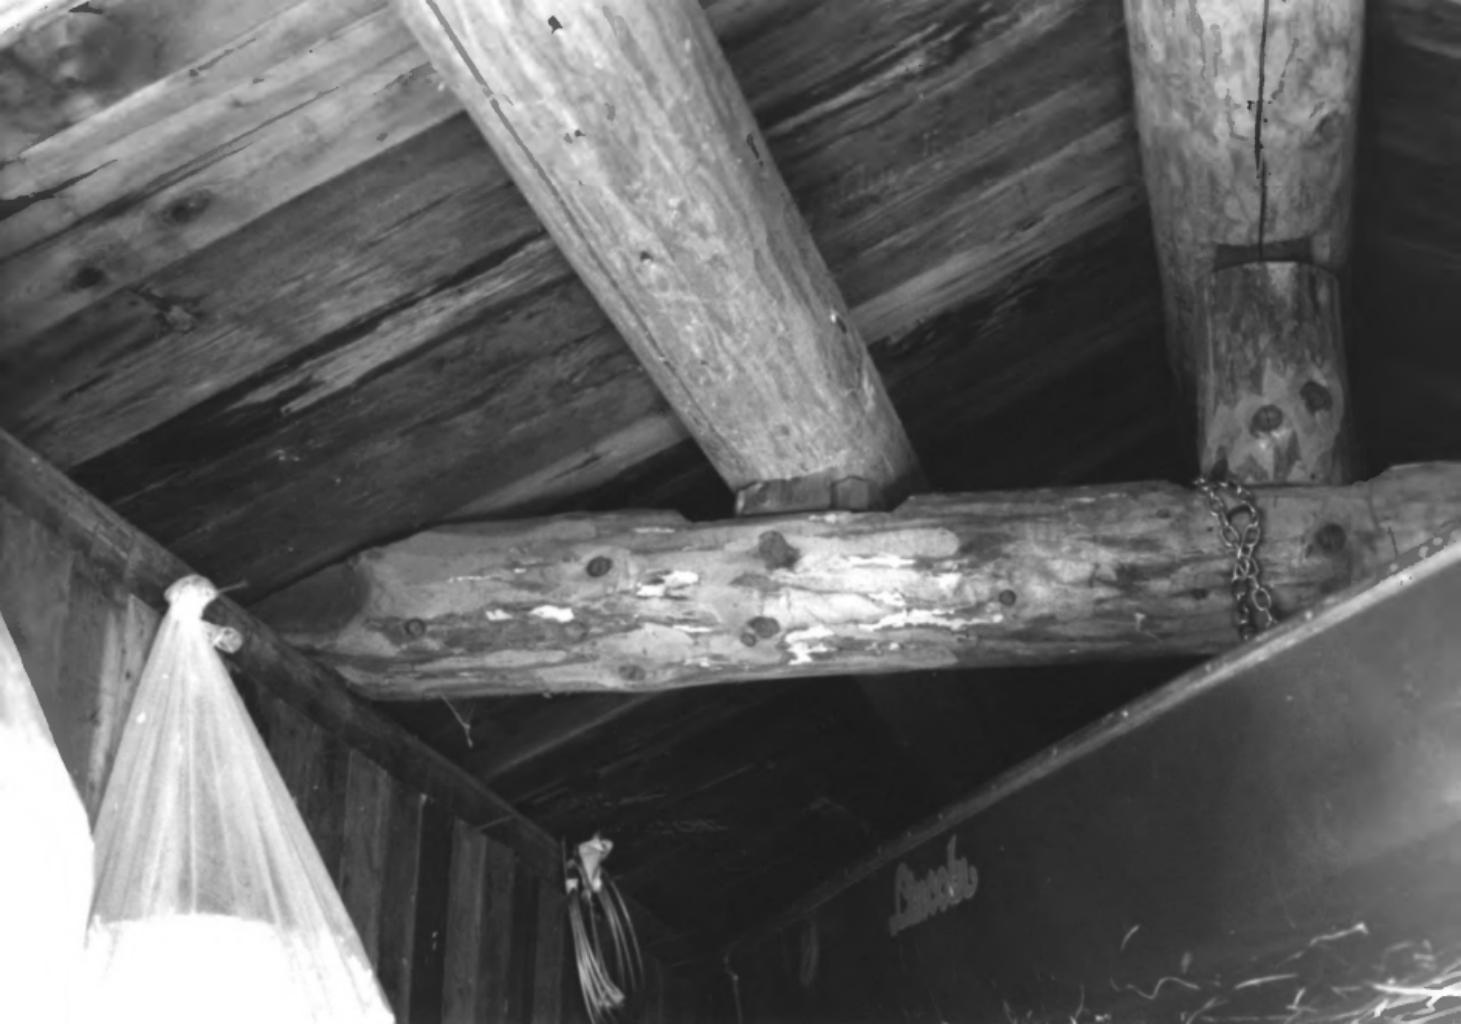
Figure 1

Interior

Ceiling

Logging Lake Boathouse

The Logging Lake Boathouse is located near the Lower Logging Lake Snowshoe Cabin and stores the canoes used by park rangers on their patrols of the lake and their journeys between the upper-lake and lower-lake patrol cabins. The log framing system is exposed, leaving interior walls formed by the 5" vertical shiplap (or tongue-and-groove) siding. The ceiling is open to the roof, exposing the log purlins and log rafter. The large double doors that dominate the lakeside elevation are constructed of a double layer of 5" tongue-and-groove, secured with large metal hinges. Open shelves located high on the back wall, hold a variety of trail maintenance and fire tools. A canoe is strapped to the log rafter.

PHOTO NUMBER	STRUCTURE NAME AND NUMBER	LOCATION/DIRECTION OF VIEW
1	Logging Lake Boathouse (#545)	Interior-ceiling detail
2	Logging Lake Boathouse (#545)	Interior-walls and floor

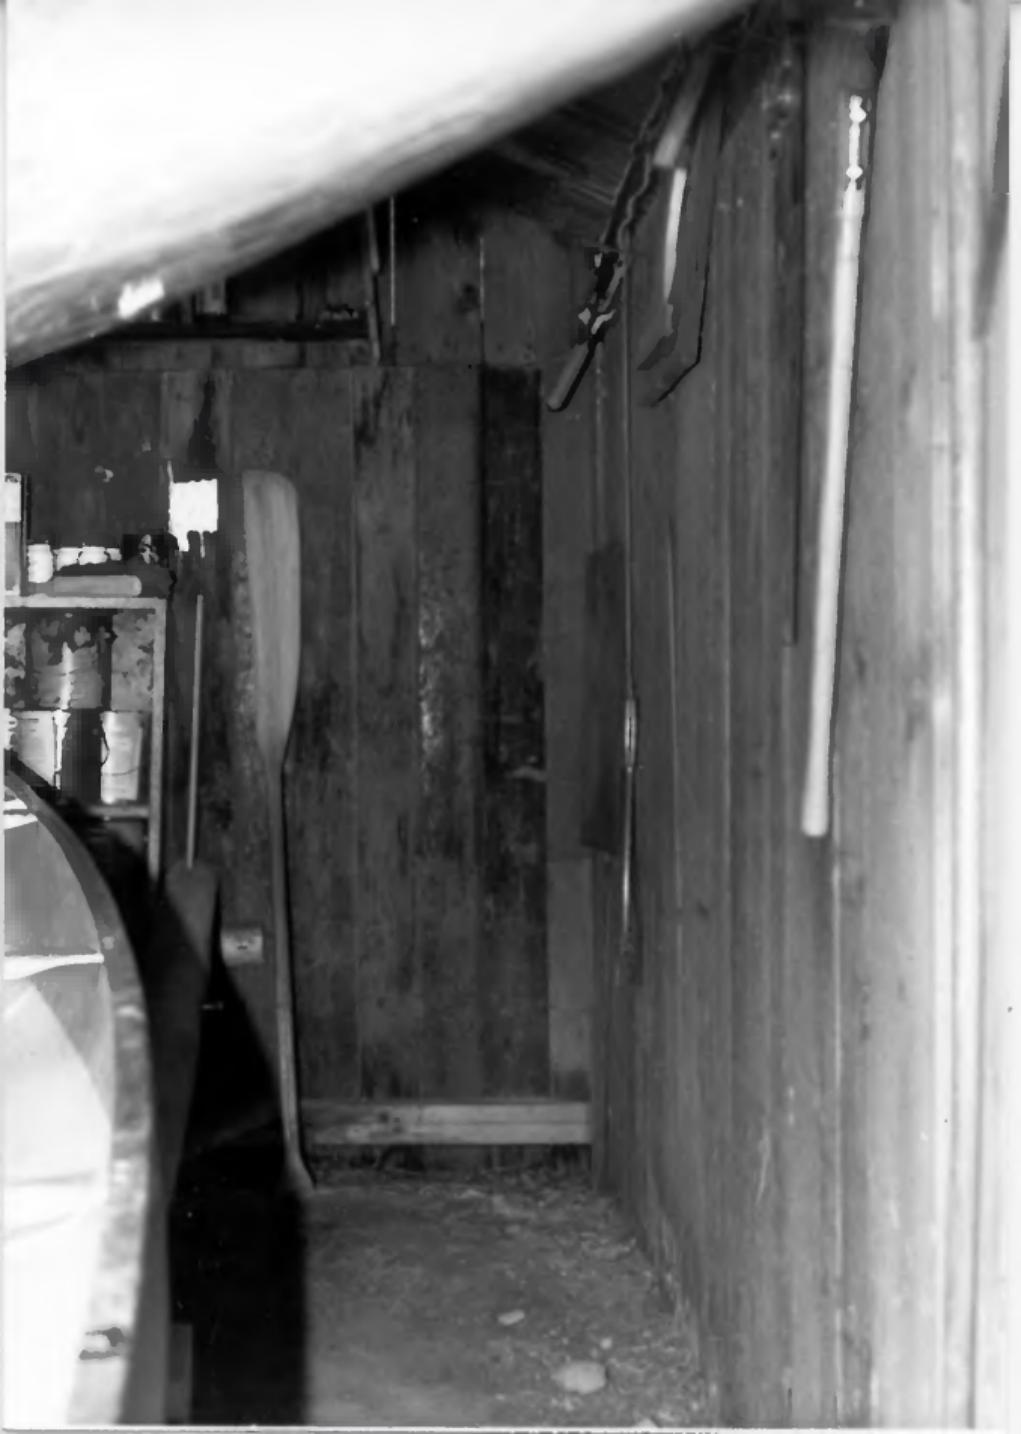
Figure 2

Interior

Logging Lake Boathouse
