NATIONAL REGISTER OF HISTORIC PLACES NOMINATION, GLACIER NATIONAL PARK

STRUCTURE NAME: Numa Ridge Fire Lookout STRUCTURE NUMBER: 611

Numa Ridge Lookout (addendum), Flathead County, MT.

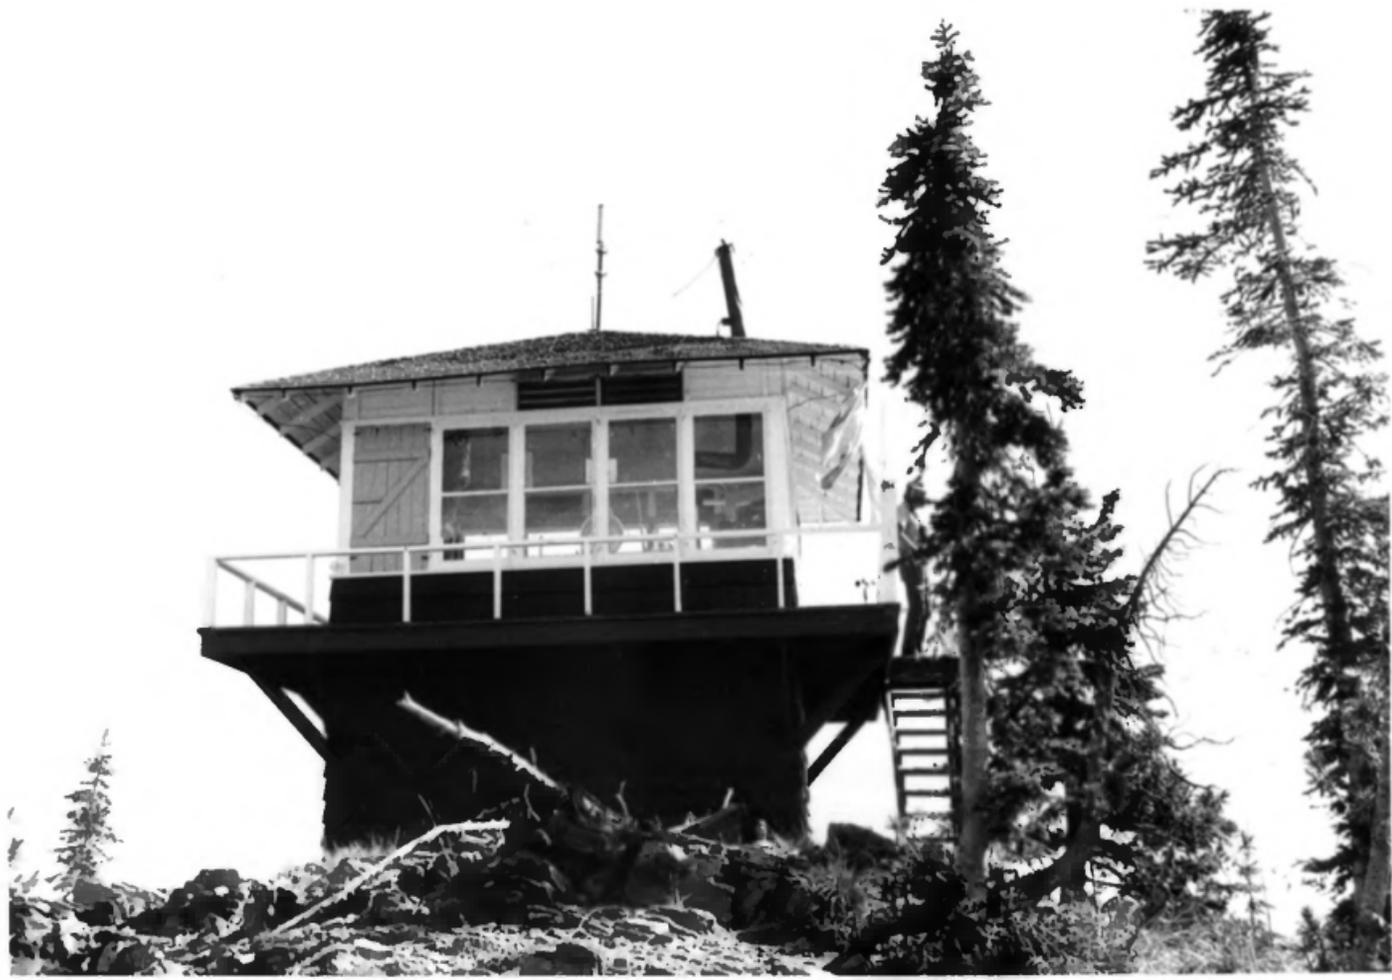
PHOTO NUMBER: 1

The Numa Ridge fire lookout is a two-story, square (14x14'), log-framed interior building with a cedar-shingled pyramidal hip roof. The structure has 1'x10" lapboard siding and is set on a rubblestone and concrete pad foundation. The lower level is solid with a single board-and-batten entry. The upper level is reached by a 2x8" plank stairway. Double pane windows and a catwalk wrap around four sides of the upper level. The structure is in good condition. This lookout is a standard, wood frame, 14x14-ft. house set on a 10-ft. tower with catwalk. The basic plan, originally designed by the United Forest Service, was often modified and revised by both Forest and Park Service engineers. The lookout has good integrity of materials, design, and workmanship and is significant in the architectural history of Glacier Park.

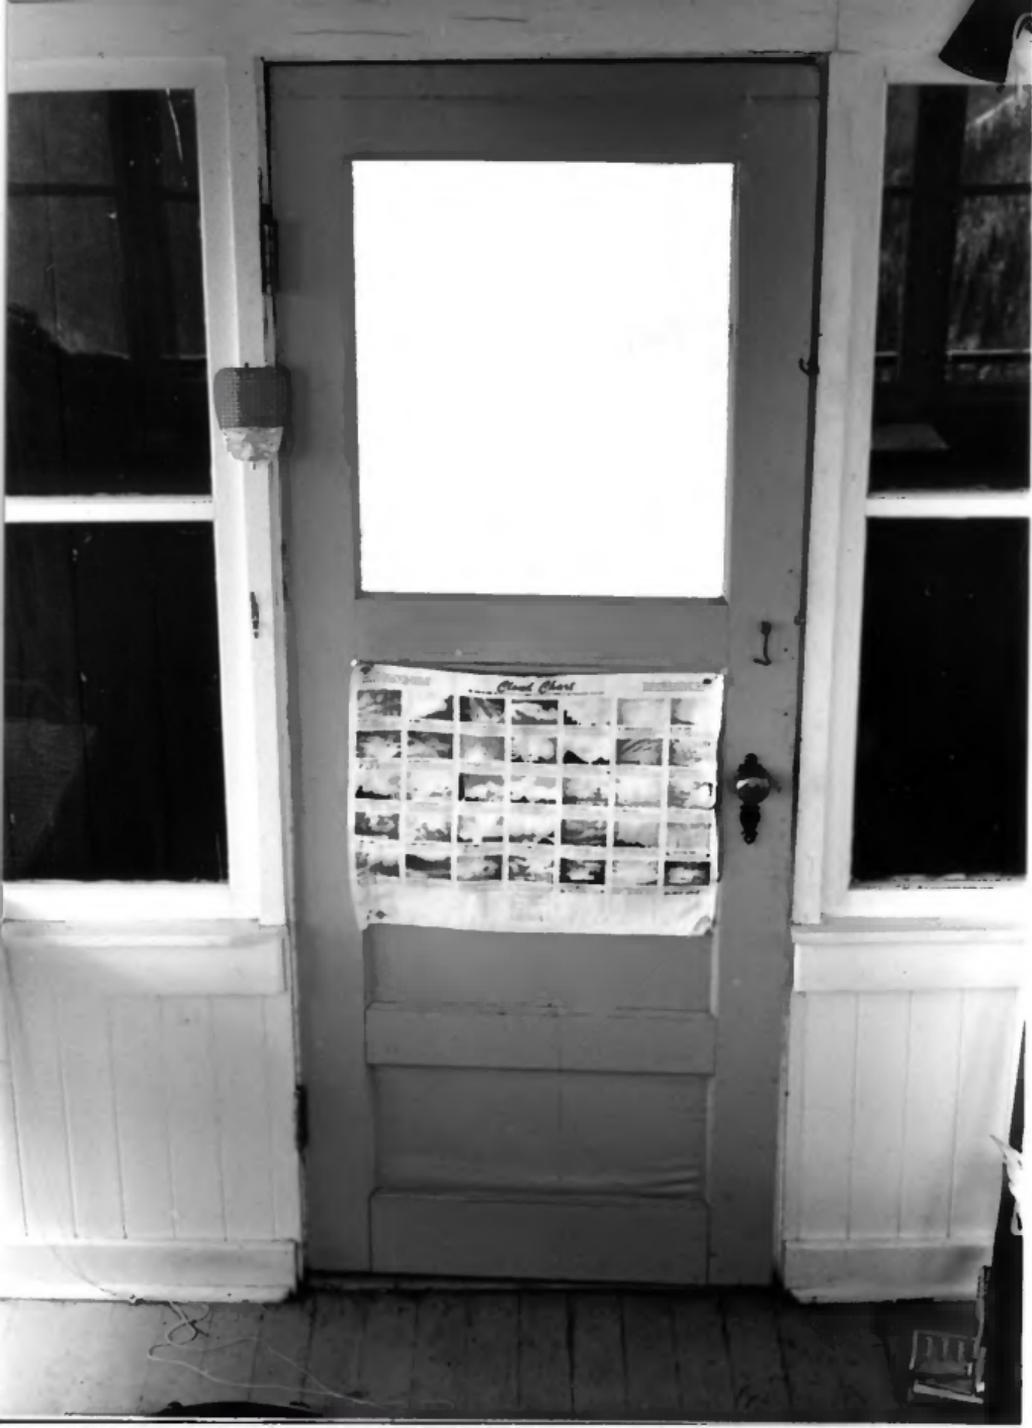
#1

Interior - door

As befits its function, walls of windows dominate the interior of this small building. Three-inch floorboards, painted grey and paired with 4" baseboards, cover the floors. The same 3" planks (either shiplap or tongue-and-groove) cover the walls and ceiling; this siding is laid vertically below the window and horizontally above. A trap door, also constructed of 3" planks, provides access to the attic storage space. Two-inch boards frame all windows and the three-panel/one-light door. Door hardware, including heavy metal hinges, a metal doorknob, and an incongruous decorative latch plate, appears to be historic.

PHOTO NUMBER	BUILDING NAME AND NUMBER	DESCRIPTION
1	Numa Ridge Lookout (#611)	Interior-detail of door, facing west
2	Numa Ridge Lookout (#611)	Interior-cupboard units

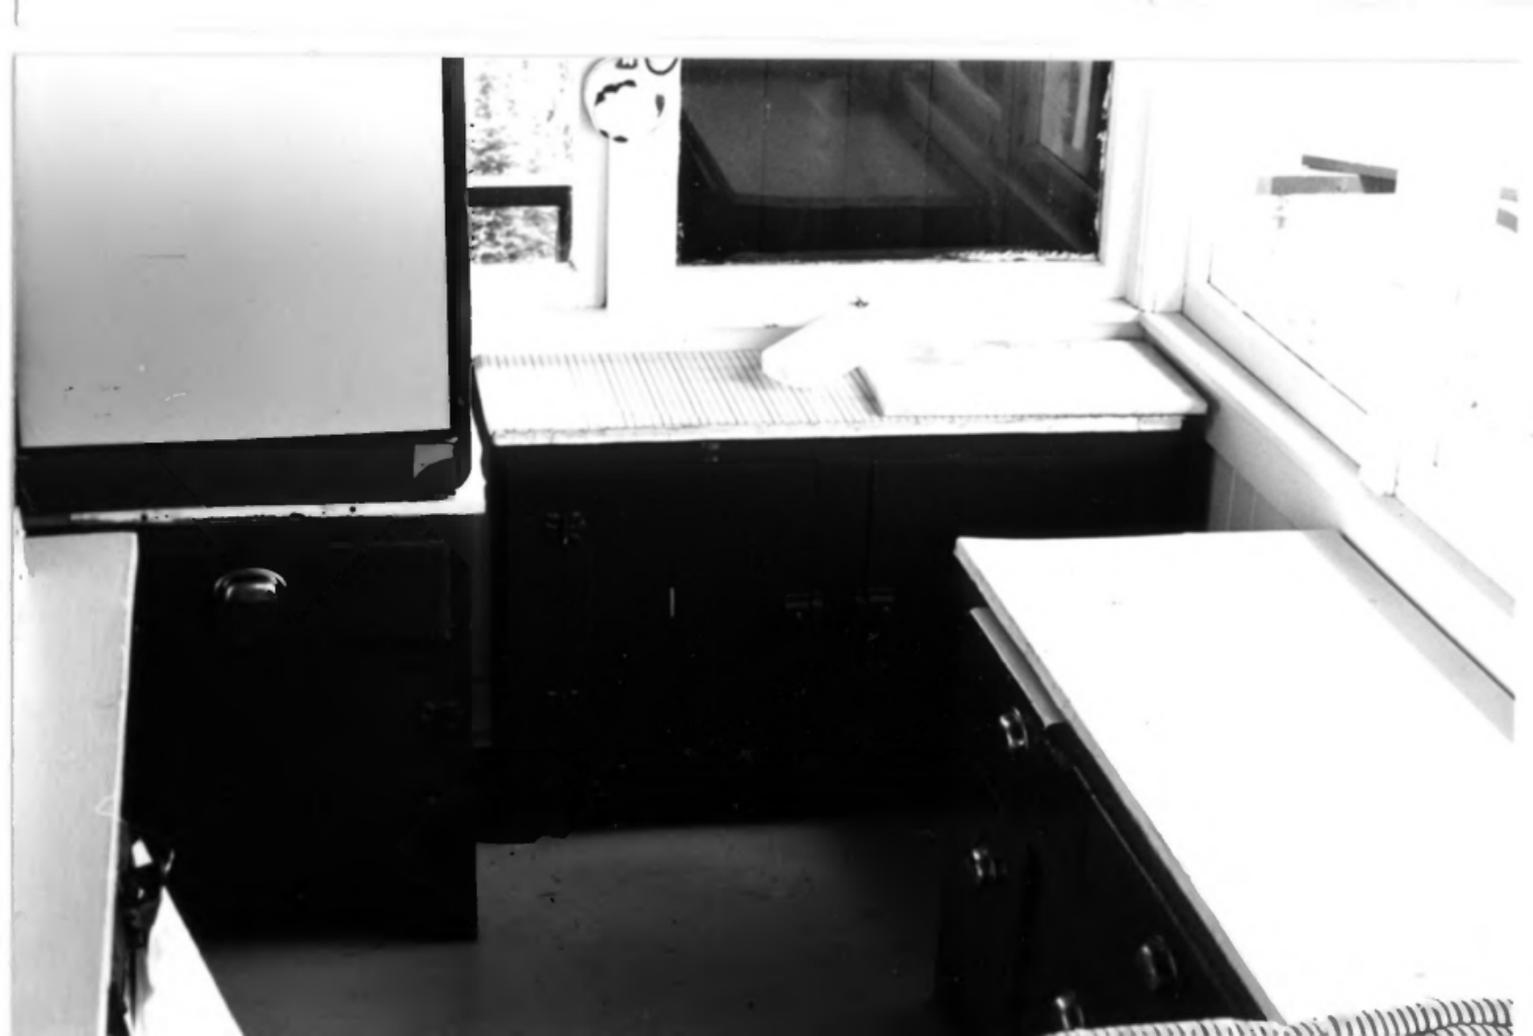
#2

Interior - cupboards

Fixed furnishings include two free-standing cupboard/drawer units, a table (one side supported by the window ledge), a wood chair, a metal bedframe, a crank phone (see the Polebridge to Numa Ridge Phoneline; listed in the NRHP), and the centrally located aledaide or "fire finder," mounted on a wood stand.
