NATIONAL REGISTER OF HISTORIC PLACES
REGISTRATION FORM

historic name: Glacier National Park Pit Toilets

Section number 7 Page 1 Glacier National Park Pit Toilets, Flathead Co., MT.

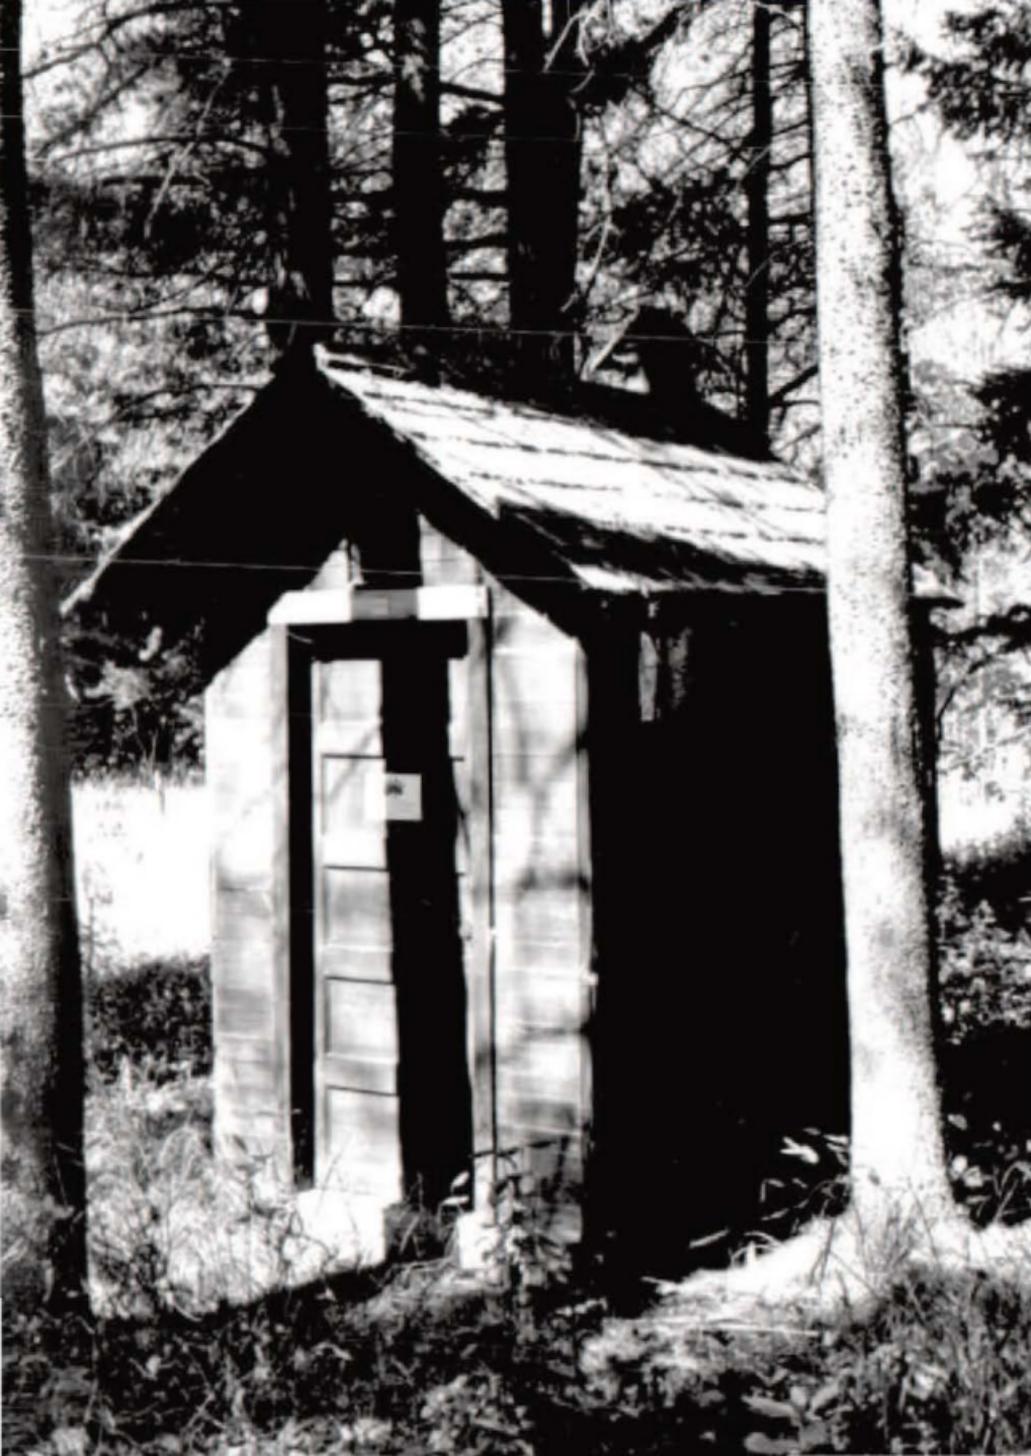
Det Toilet ~~to~~ 301

Maintenance files from the 1950s describe the Belly River outhouse as sided with vertical board and batten. The outhouse currently on site, located approximately 75' north northeast of the ranger station, is sided with horizontal shiplap siding on two elevations and vertical board and batten on two elevations. In contrast to most park outhouses, it features a relatively large multi-light double-hung window in the rear elevation. The door is constructed of vertical boards and features vintage hinges and a branch "latch." The outhouse may date to 1942, the construction date of record. It is located just outside the boundaries of the Belly River Ranger Station Historic District.

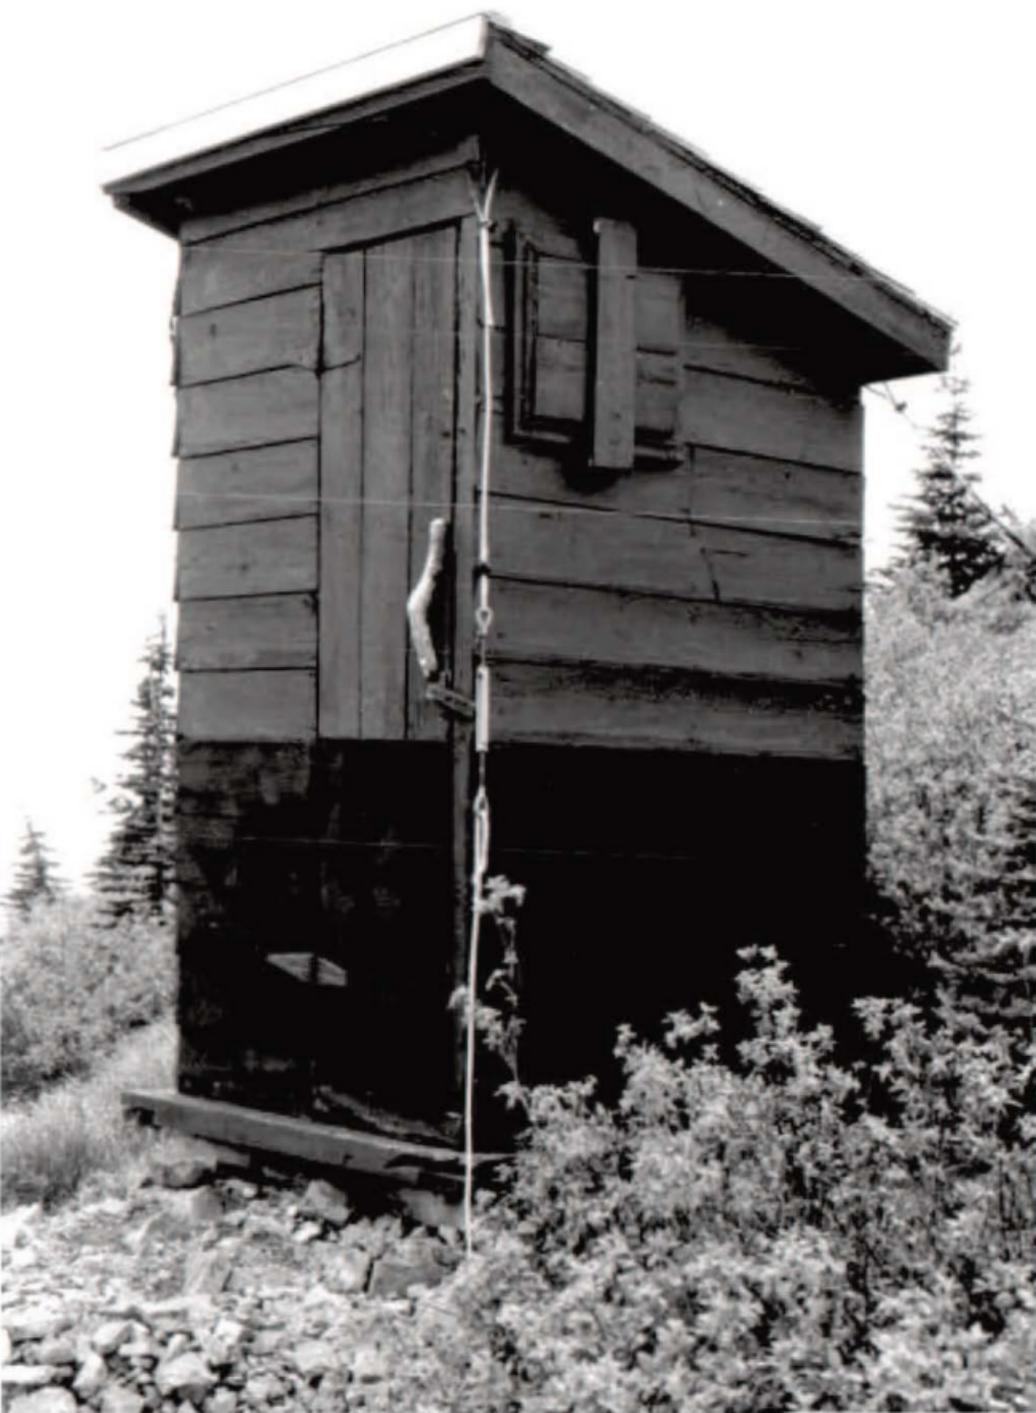
T. Let # 1088

This small wood frame outhouse is located approximately 60' downslope (north northwest) of the lookout, where it commands an outstanding view. Seven-inch shiplap planks, laid horizontally, cover the exterior walls and wood shingles cover the shed roof. The roof features wide eaves, finished with fascia but no soffit. The door, offset within the front (northwest) elevation, is constructed of vertical 7" planks and features a branch handle and wide exposed hinges. Vents located high in the side elevations are boarded over. This outhouse is constructed of the same materials as the adjacent lookout and may date to the 1930s, the construction date of record for Huckleberry Lookout pit toilet #588.

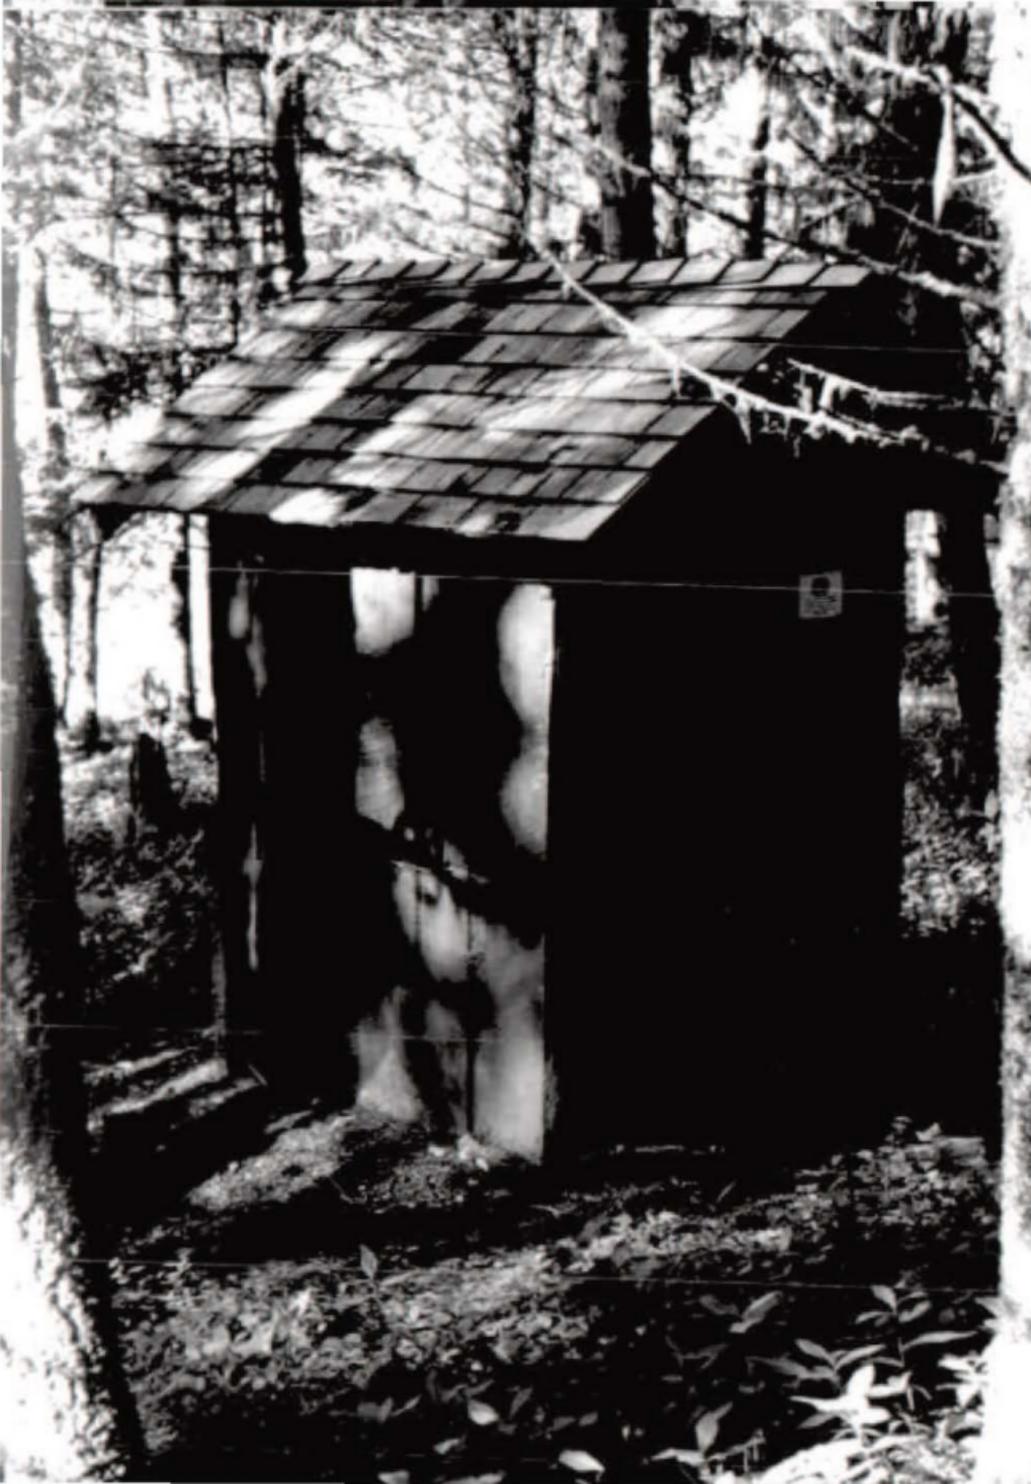
Kuntla Lake Campground
P. 1 to 1st

This wood frame outhouse is sided with 10" boards and 2" battens and roofed with wood shingles. Wire mesh encircles the lower 3' of the exterior walls. The heavy 4" x 4" purlins are exposed and extend approximately 18" beyond the front elevation, supporting the extended gable end. The door is constructed of vertical boards secured with an interior cross brace. NPS real property files indicate that Kintla Lake Campground pit toilet #656 was constructed in 1934 by CCC crews. This unnumbered outhouse conforms in design and materials to CCC-constructed buildings found elsewhere in the park and may be original.

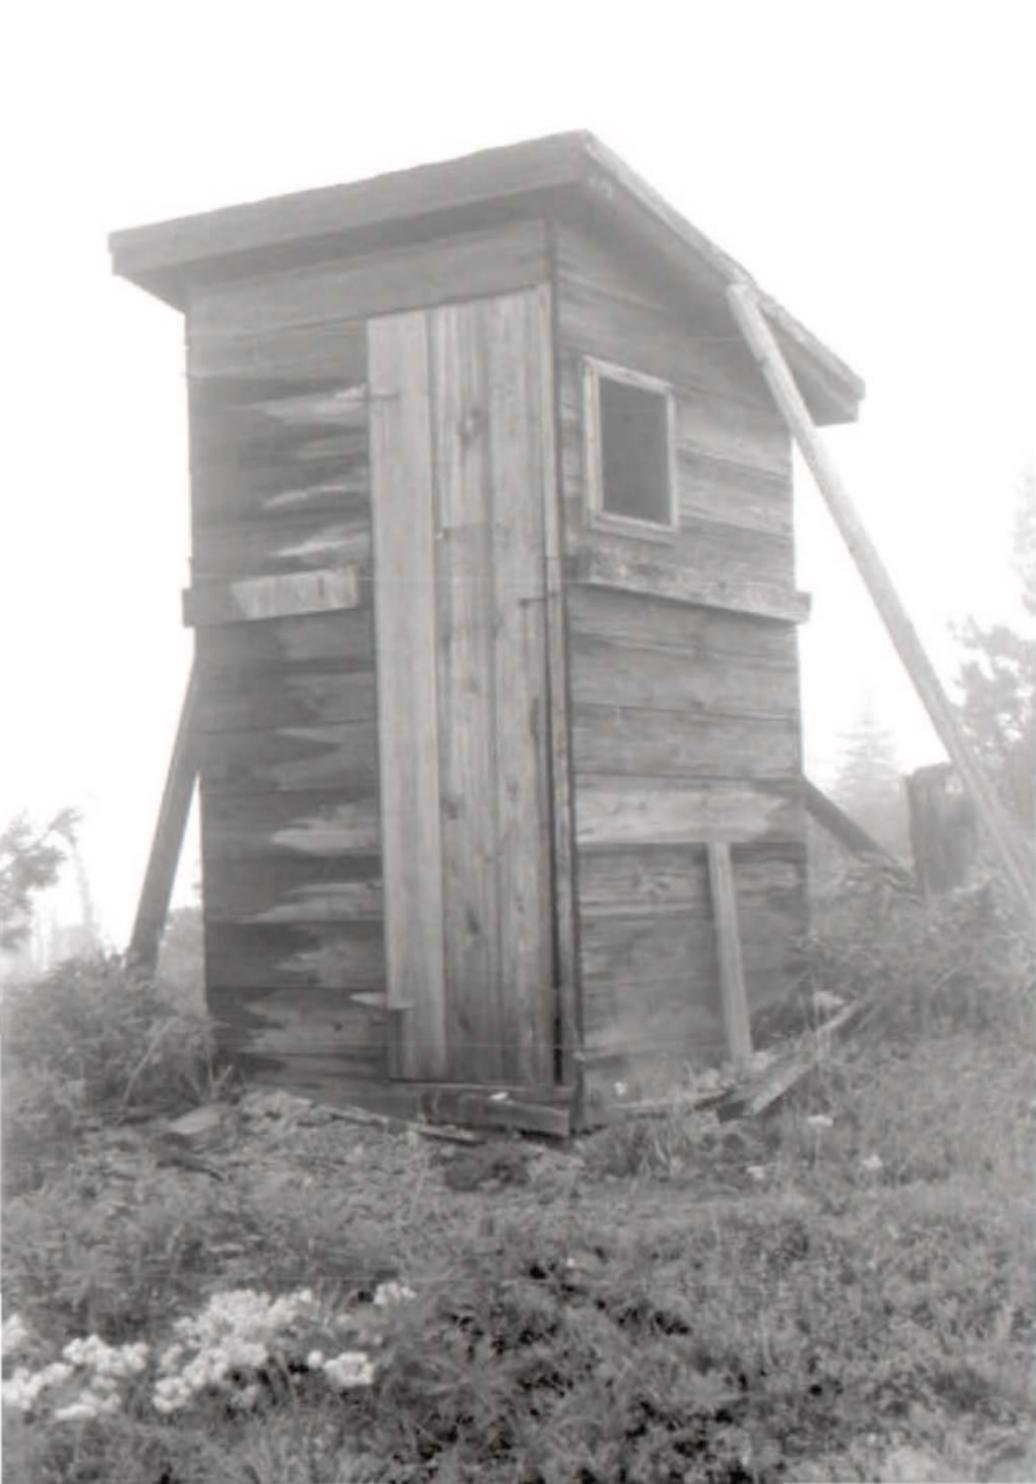
Luxemburg Lookout R. 5 To 1st
624

This wood-frame pit toilet is located 75' due south of the lookout, within a protective tree cover. Six-inch shiplap planks cover the exterior walls and wood shakes cover the shed roof. The door, constructed of vertical planks, is offset within the south elevation. Screened vents are located on the east and west elevations and a mesh screen covers the bottom 18 inches of the walls. This building is in fair condition and may date to the historic period. A square depression, infilled but retaining the original foundation boards, may indicate a previous location of the outhouse. A second pit toilet, an early version of the free-standing units, is constructed of badly warped 10" planks. The seat has collapsed.

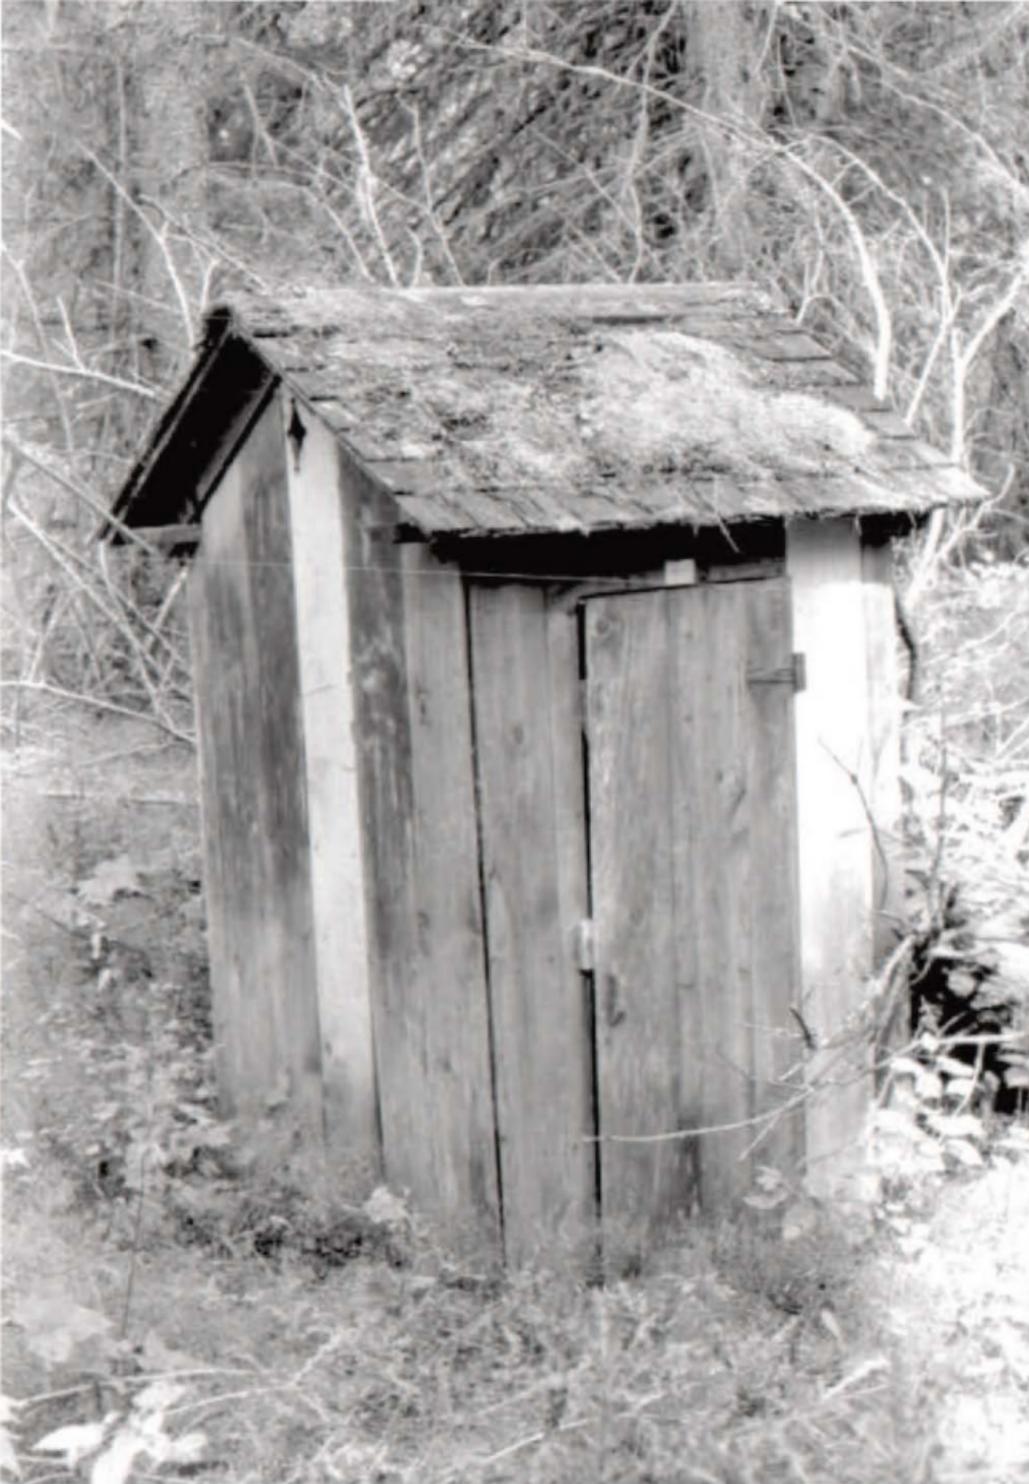
Myak Ramp Structure

This outhouse is not included in NPS real property files yet appears to be historic. It is located 75' west northwest of the fire cache within the protective cover of the forest that surrounds the open station site - just outside the district boundaries as currently defined. Eight-inch shiplap planks, vertical, cover the exterior walls. The door, also constructed of 8" planks, features long historic hinges and a handmade wood latch. Decorative holes have been cut with a jigsaw from the upper edge of boards within the gable ends, creating vents. Wood shakes, covered with moss, cover the gable roof (a roof design found more frequently on historic outhouses).

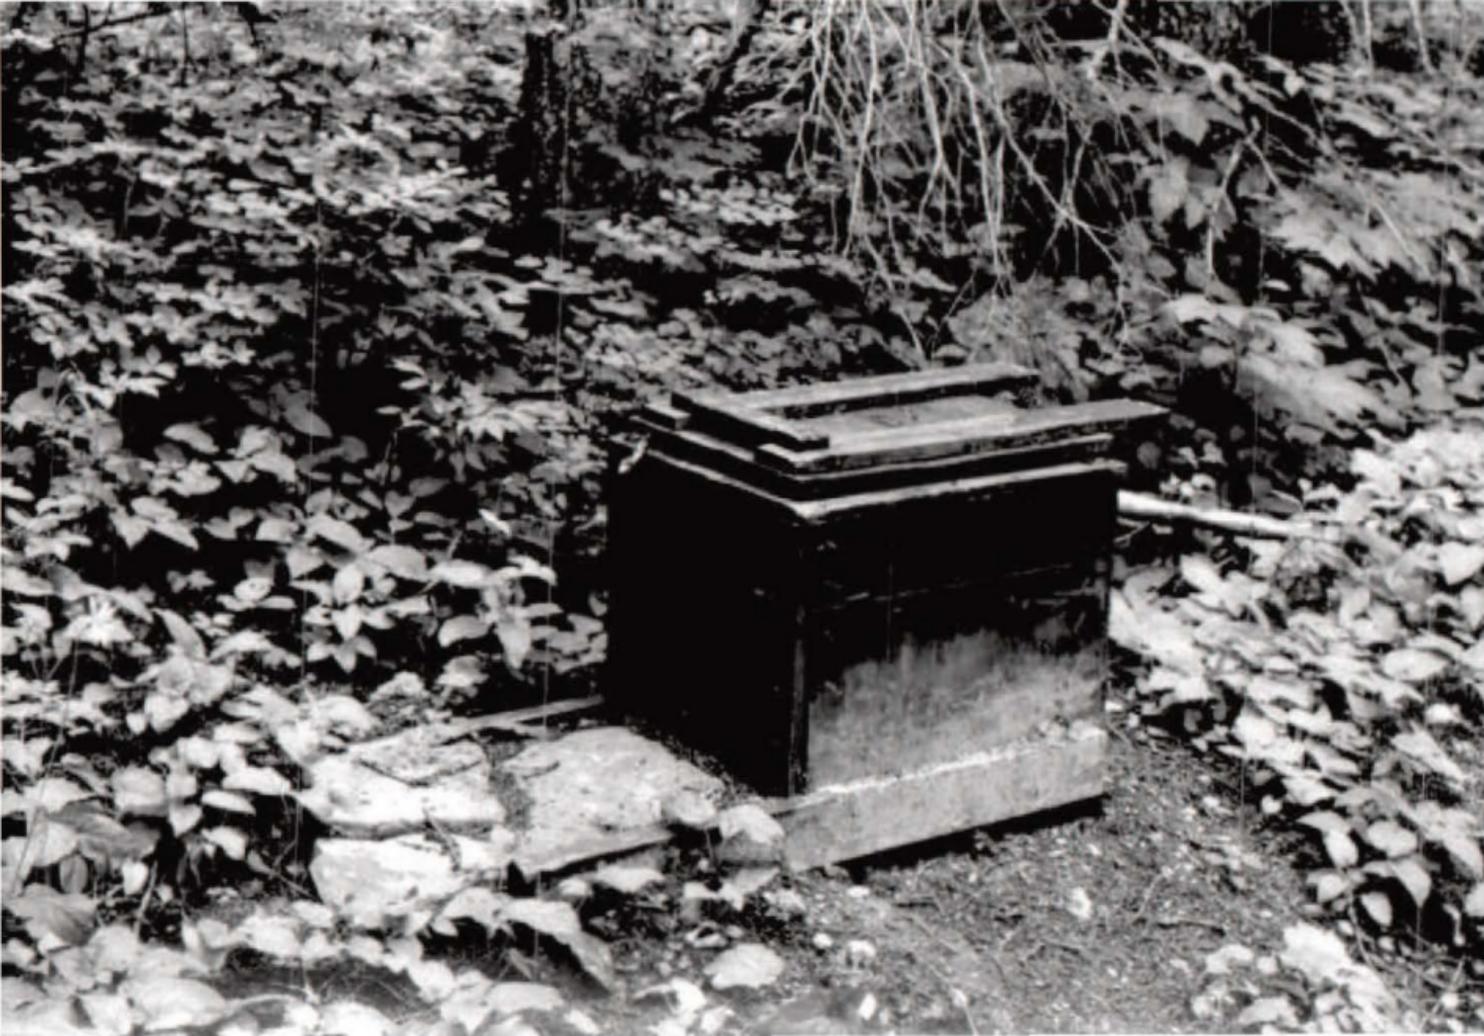
Quercus laevis Pestal Cubic Pit T.D. 1943
no number—

Historic pit toilet #590 has been removed and replaced with a modern free-standing toilet, sitting approximately two feet above the ground depression and encased with a wood frame. Flat stones, carefully fitted, provide a mud free footrest. The toilet is currently located approximately 20' southwest of the cabin, but is designed to be moved as needed.

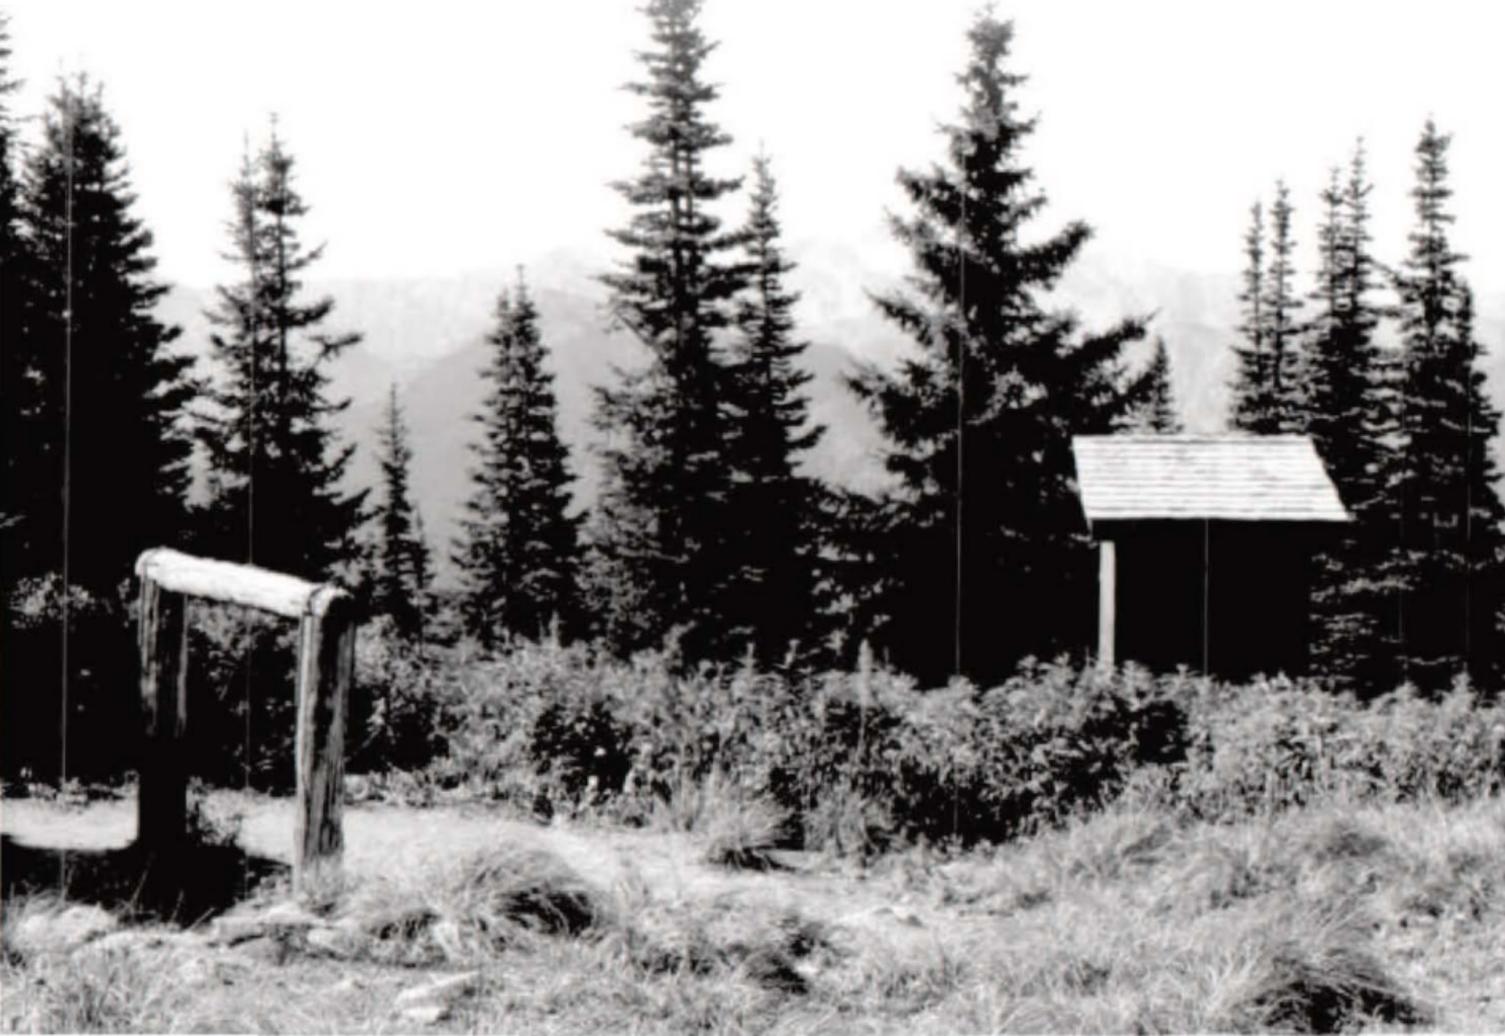
MIT Lockout Pa Tablet
at 10:30

This recently constructed outhouse is located approximately 35' north northwest of the Scalplock Mountain Lookout, at the edge of the open park where it commands a spectacular view. Seven-inch shiplap covers the exterior walls and wood shingles cover the shed roof. The wide eaves are enclosed in a characteristic modern design.
