NATIONAL REGISTER OF HISTORIC PLACES NOMINATION, GLACIER NATIONAL PARK

STRUCTURE NAME: Quartz Lake Patrol Cabin STRUCTURE NUMBER: 589

Quartz Lake Patrol Cabin (addendum), Flathead County, MT.

Building Interior

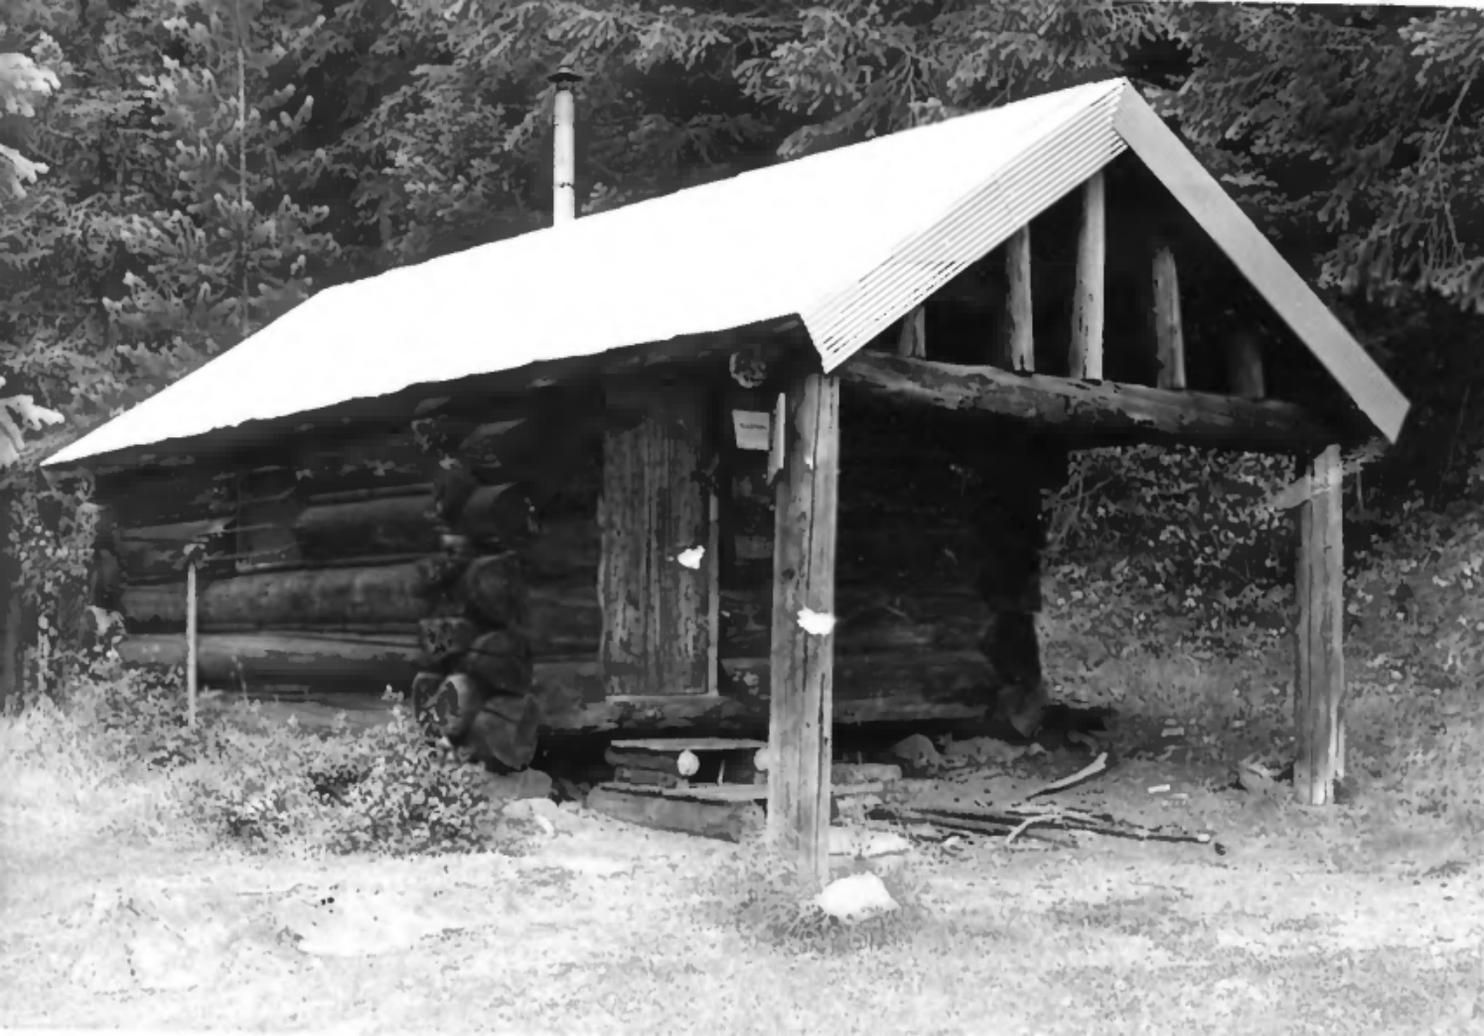
NAME: Quartz Lake Patrol Cabin
LOCATION: Glacier National Park, ^{MT} MT
PHOTOGRAPHER: Historical Research Associates
DATE OF PHOTOGRAPH: August 1982
LOCATION OF NEGATIVE: Rocky Mountain
Regional Office, National Park
Service, Denver, CO
PHOTO NUMBER: 1

The Quartz Lake patrol cabin, facing northeast towards the lake, is a one-story log structure set on stone corner piers, measuring approximately 12x18'. The saddle-notched logs are wood chinked and the cabin is approximately five logs high on each side. The roof has nine purlins, with the outer two side purlins set together, forming a double purlin. The outer log runs along the outside of the cabin, forming the roof eave. The cabin has a pitched gable roof with an 8' front extension supported by columns, a cross beam, and vertical logs. The west end of the gable roof features a metal chimney. On the south side of the cabin, logs extend through the gable end. Windows are covered with plywood and bars, to keep out bears. The pitched gable roof is covered with metal on wood sheathing. The columns at the extended roof are set on stone piers. The structure is in good condition with the exception of the corners on the northeast and southeast sides, where there is some rot in the crown ends, especially in the sides facing east. Metal has been added to one of the bottom log crown tips that has been broken off. The sill logs seem to be in good condition. The sod is up around the base of the building except at the front and back, where the cabin is open underneath. In 1930, the Quartz Lake patrol cabin was built to Landscape Drawing G913 specifications by local contractor Austin Weikert for a cost of \$613.44. Weikert was a local homesteader and builder whose log work can still be admired in many buildings in Glacier.¹ The Quartz Lake patrol cabin maintains good integrity and is a significant example of early backcountry rustic building in Glacier.

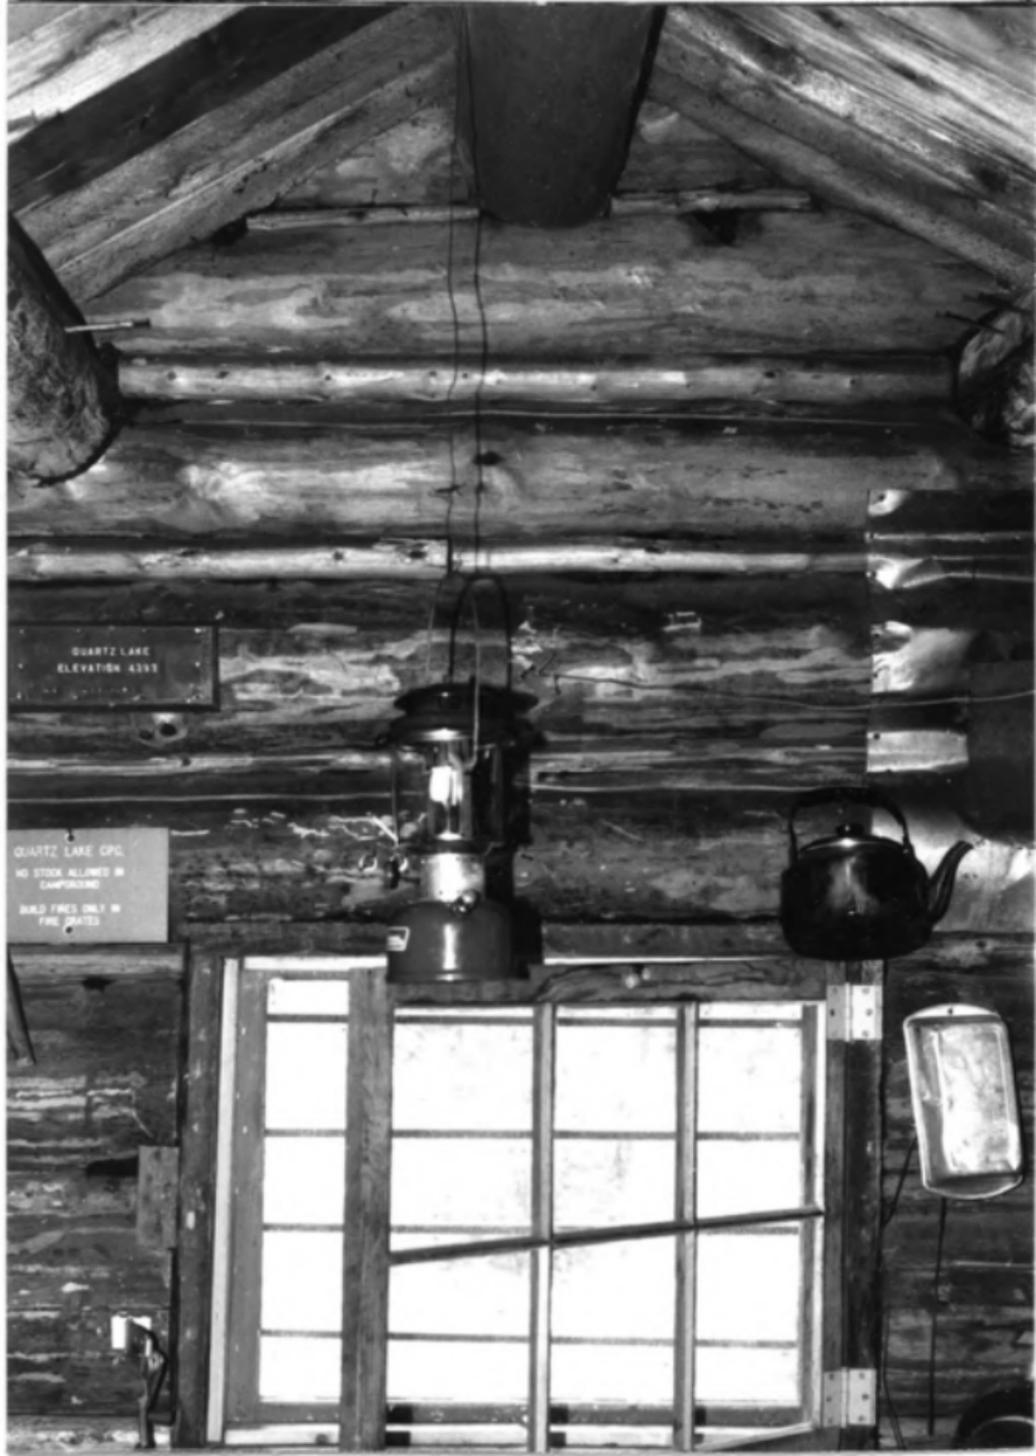
Quartz Lake Patrol Cabin
Flathead Co., MT, Glacier NP
Figure 1

"border" to the floor pattern. The trap door to the concrete-lined cellar is constructed of 5" planks, set flush with the floor, and is opened with a ring fit into a recessed metal plate; a second door, directly below the first, is opened with a rope handle. The ceiling is open to the roof, exposing the log purlins and 10" roof planks. Full logs, chinked with large full sapling, form the interior walls.

PHOTO NUMBER	STRUCTURE NAME AND NUMBER	LOCATION/DIRECTION OF VIEW
1	Quartz Lake Patrol Cabin (#589)	Interior-detail of wall/chinking
2	Quartz Lake Patrol Cabin (#589)	Interior-cupboard/table
3	Quartz Lake Patrol Cabin (#589)	Interior-bedding-storage cabinet

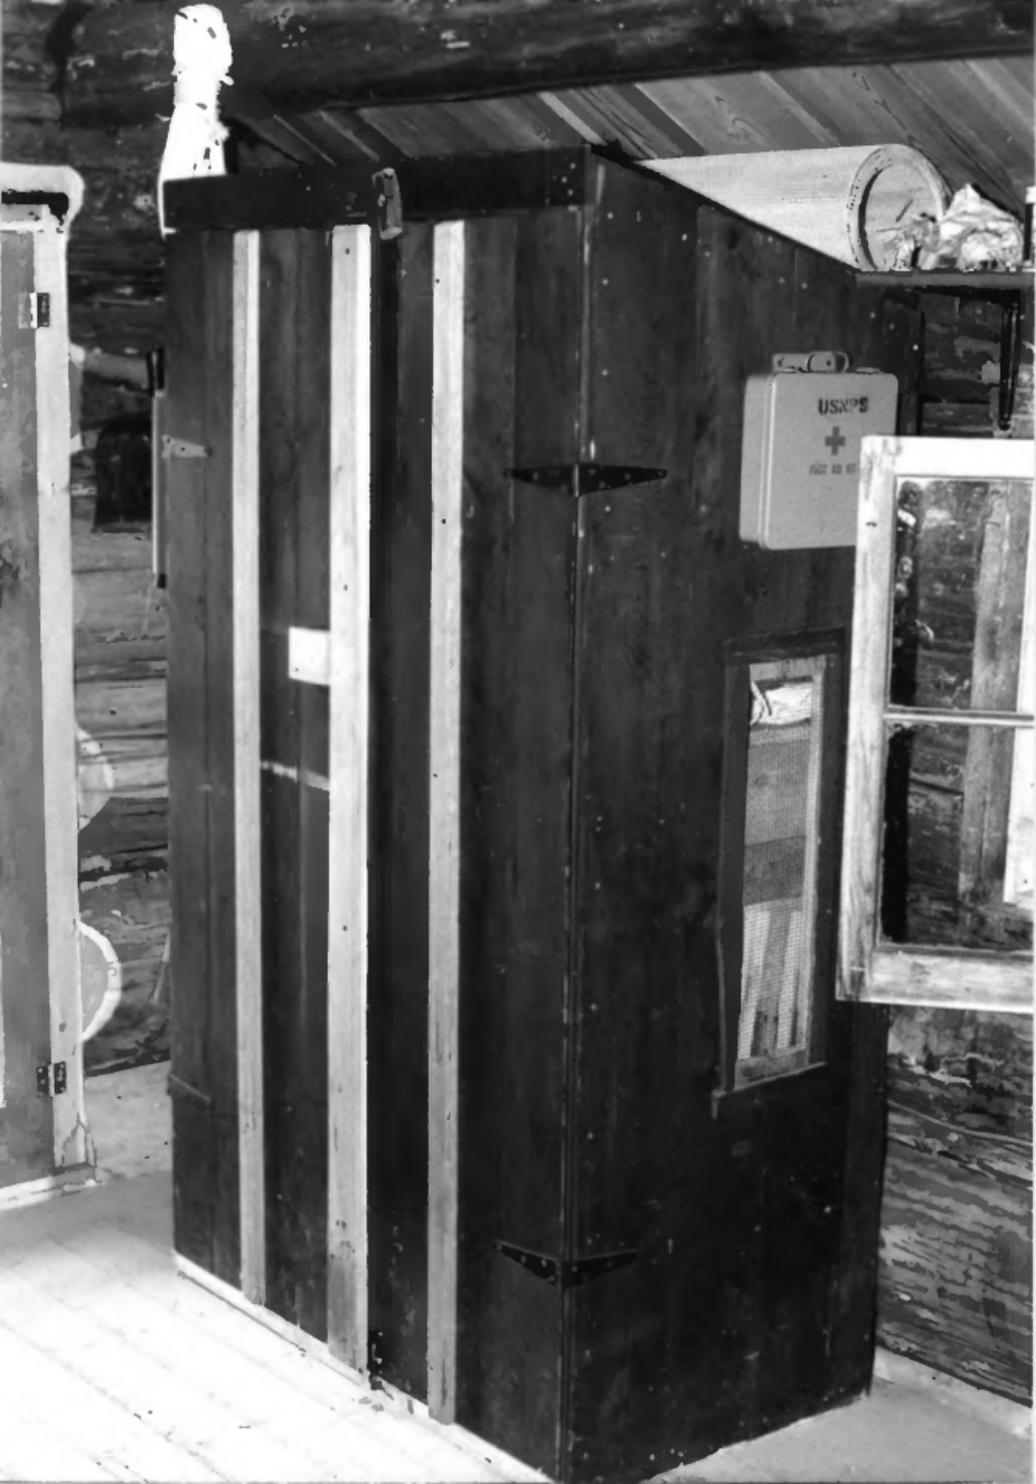
Figure 2

Furnishing include a wall-mounted cupboard with hinged table top/door (this appears to be a modern version of the traditional design; see photo #2), a large rodent-proof bedding cabinet (see photo #3), and ceiling hooks for Coleman lanterns. Suspended bedframes, as specified in original drawings, are located along the north and east walls: the beds are suspended by cables secured to two heavy metal hooks set in the nearest purlin. A wood slat bracket, bolted to the wall, provides additional support. Most cooking utensils are hung from nails pounded into the northwest corner, near the cookstove. The original stovepipe exit in the west (rear) wall has been sheeted over; the stove now vents through the ceiling.
