NATIONAL REGISTER OF HISTORIC PLACES NOMINATION, GLACIER NATIONAL PARK

STRUCTURE NAME: St. Mary Ranger Station STRUCTURE NUMBER: 150

St. Mary Ranger Station (addendum), Glacier County, MT.

St. Mary Ranger Station (#150), 1913

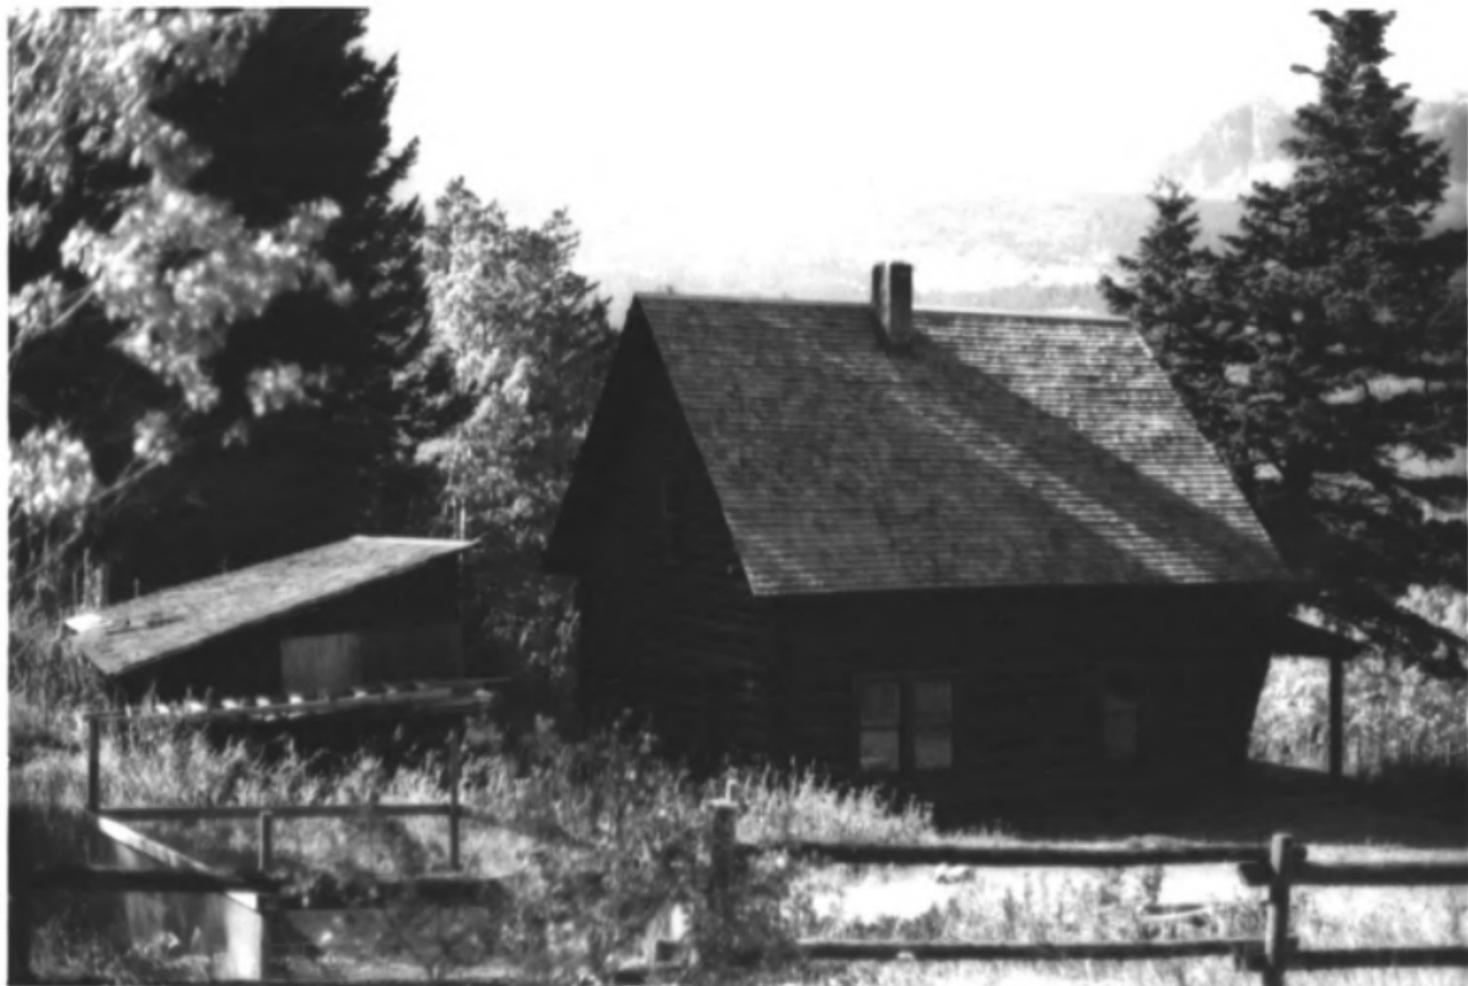
PHOTO #: 1

VIEW: East Side

The Old St. Mary Ranger Station is located on a level spot on a wooded hillside facing northeast over the east end of Upper St. Mary Lake. It measures roughly 27x27', is two-story (about 25' high), and is of log-on-log construction. The logs are split so that the inside faces roughly line up with each other. Corners are double saddle notched. Chinking is cement and oakum, although exclusively oakum in the early days. The roof is log and pole. The cabin roof is a regular gable of pole construction and is sharply inclined. Shingles are cedar. A brick stove chimney runs up through the center of the building. The windows are one-over-one double-hung, and there are front and rear doors. The interior partitions and walls are covered with unpainted beaded lumber. There is a large living room across the front, and a bedroom and kitchen across the rear. An enclosed, narrow stairwell leads to the second floor, which contains no partitions and was left rough except for a floor added over the subfloor. A full, shed-roofed front porch with pole supports and framing is a recent modification to the structure, but is compatible with its historic character. The 1½-story, full log wall design is unusual for a building of this modest scale in Glacier and unique among ranger station residences. Two 1½-story, log residences still exist on the west slope of the park (the Schoenberger and Doody homesteads) but this is the only known example on the east side. The construction is excellent, with well-matched and tightly fitted wall logs. The building is significant in the architectural history of Glacier National Park.

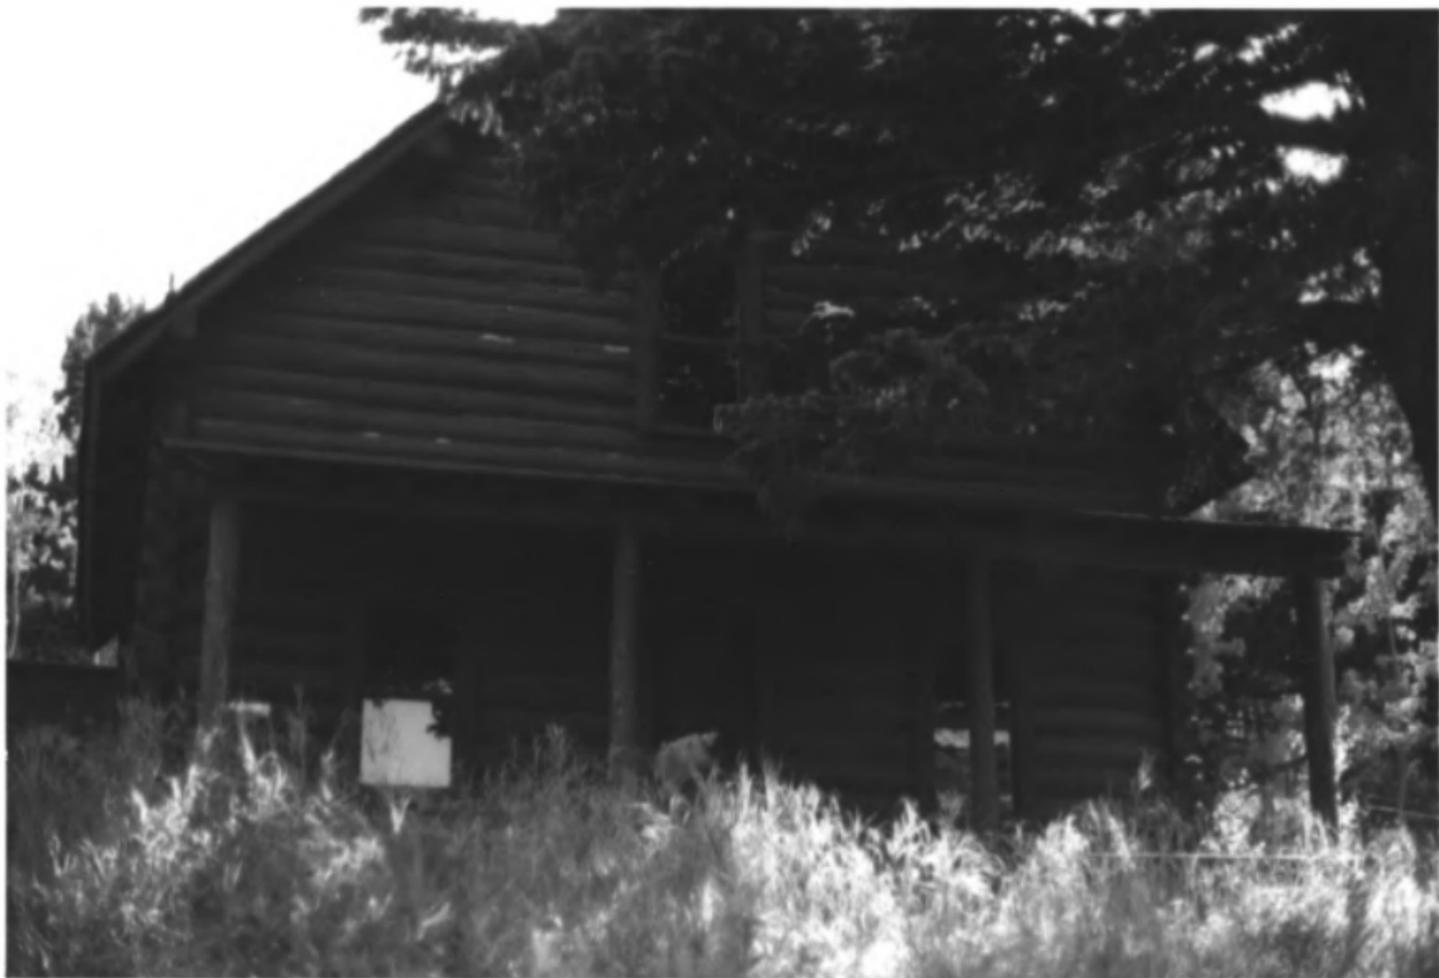
PHOTO #: 2

VIEW: North Side

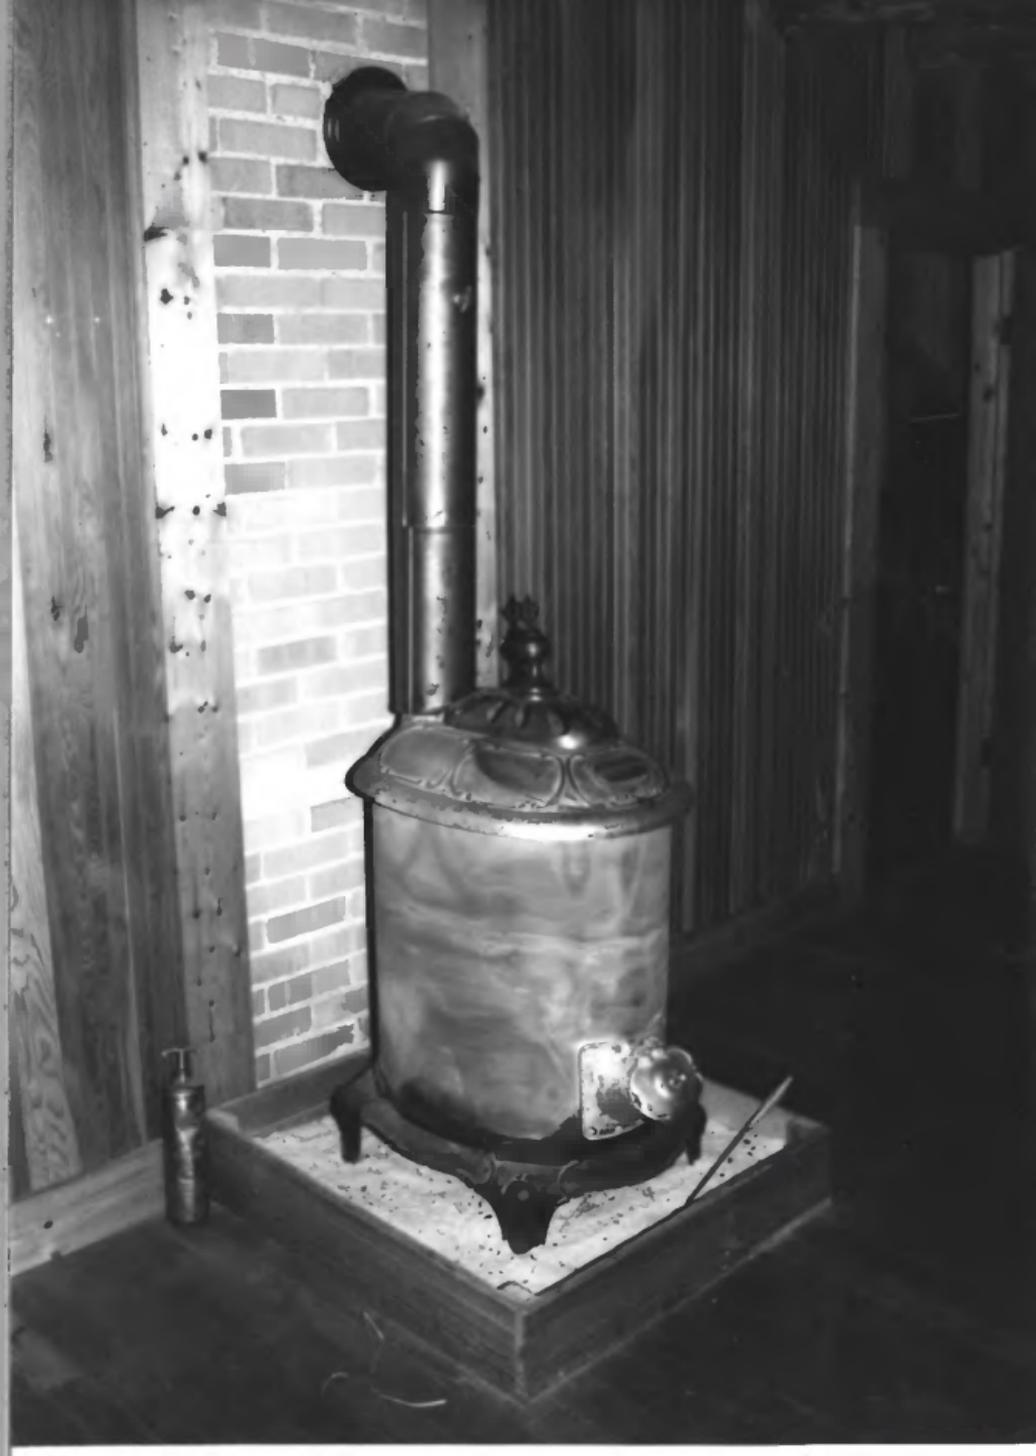
Photo #1

PHOTO NUMBER	STRUCTURE NAME AND NUMBER	LOCATION/DIRECTION OF VIEW
1	Ranger Station (#150)	Front room - stove
2	Ranger Station (#150)	Bedroom
3	Ranger Station (#150)	Kitchen - stove
4	Ranger Station (#150)	Kitchen - cupboard detail

Two-inch oak flooring, stained dark with a dull matte finish, covers the floor of the front room. Vertical 1" beadboard, varnished, covers all interior walls. Door surrounds, window surrounds, and floorboards are constructed of 4" knotty pine, finished with a crude butt joint. A brick stove chimney runs along the wall between the living room and kitchen and is used to vent a small antique wood-burning stove that rests on a modern "sand-box" heat-proof hearth. As throughout the ground level, stained 6" fir boards, secured above exposed log purlins, form a drop ceiling.
