NATIONAL REGISTER OF HISTORIC PLACES NOMINATION, GLACIER NATIONAL PARK

REGION: Rocky Mountain PARK/AREA NAME: Glacier National Park PARK NUMBER: 1430
 STRUCTURE NAME: Swiftcurrent Fire Lookout STRUCTURE NUMBER: 578
 LOCATION OF STRUCTURE: QUADRANGLE NAME: Ahern Pass
 Zone Easting Northing QUADRANGLE SCALE: 7.5-minute
 UTM A: 12 296810 5407100

Swiftcurrent Lookout (addendum), Flathead County, MT.

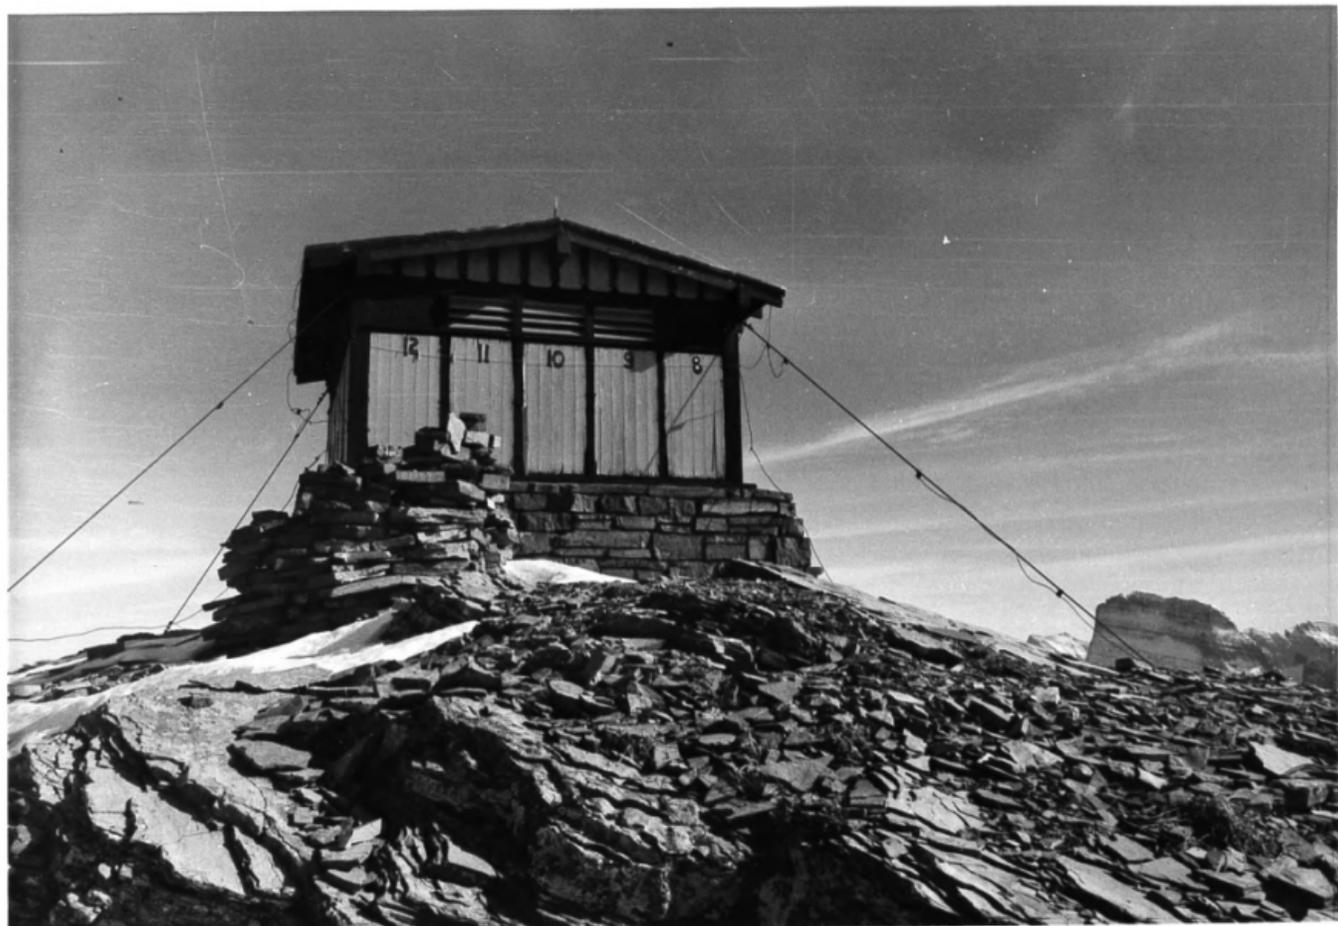
NAME: Swifcurrent Lookout
LOCATION: Glacier National Park, MT
PHOTOGRAPHER: Glacier National Park
DATE OF PHOTOGRAPH: 1982
LOCATION OF NEGATIVE: Rocky Mountain
Regional Office, National Park
Service, Denver, CO
PHOTO NUMBER: 1

The Swiftcurrent fire lookout is a two-story, 14x14, square plan structure, with 196 sq. ft. on each floor. The first floor is constructed of coursed ashlar stone, gathered locally. The sloping walls toward the second story are of heavy 2x8" timber. The structure has vertical framing with glass panels (2'5"x4'6") between on four sides. The gable roof has heavy timber framing, with a flagstone and mortar roof surface. The structure is in good condition and is unaltered in its original location. This lookout is a standard, wood frame, 14x14-ft. house set on a 10-ft. tower with catwalk. The basic plan, originally designed by the United States Forest Service, was often modified and revised by both Forest and Park Service engineers. The lookout has good integrity of materials, design, and workmanship.

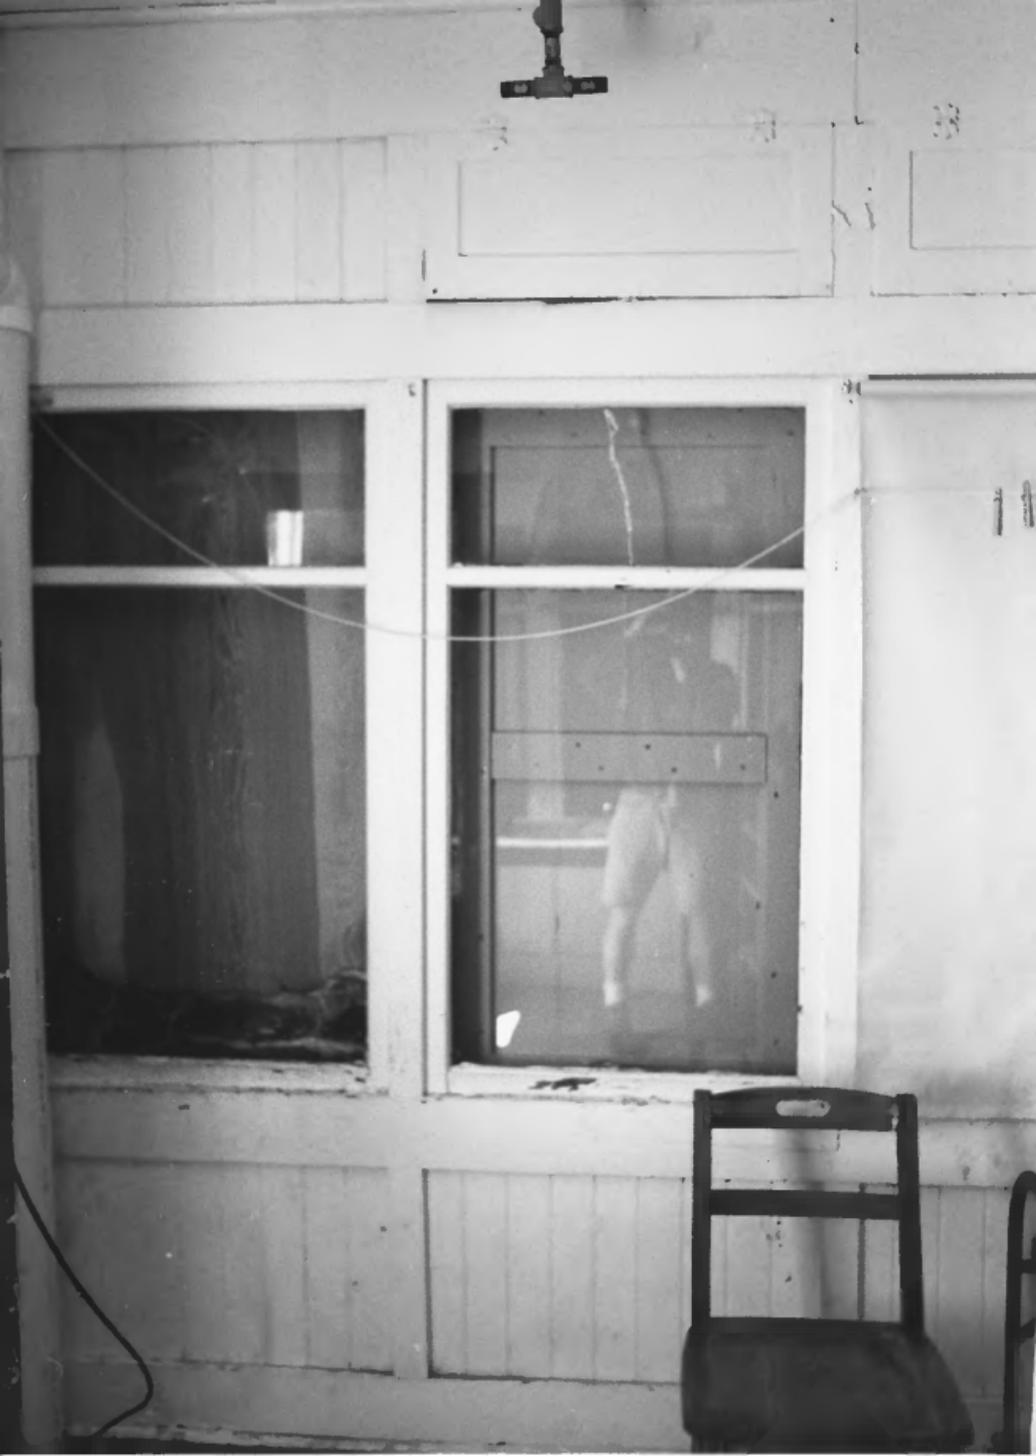
Swistcurrent L.O

As befits its function, pairs of large two-light windows dominate the interior of this small building. Two-inch floorboards, painted grey and paired with 3" baseboards (painted white), cover the floors. Slightly wider planks (3") (either shiplap or tongue-and-groove) cover the walls and ceiling. An 8" board runs along the junction of the walls and ceiling. These boards extend only a short distance between the baseboard and the window sill or the window sill and the ceiling; symmetrically spaced vertical "battens" create the appearance of wainscotting (see photo 1). A trap door, also constructed of 3" planks, provides access to the attic storage space. Two-inch boards frame all windows and the three-panel/one-light exterior door.

PHOTO NUMBER	BUILDING NAME AND NUMBER	DESCRIPTION
1	Swiftcurrent Lookout (#578)	Interior-south wall
2	Swiftcurrent Lookout (#578)	Interior-chair and bed

South wall interior

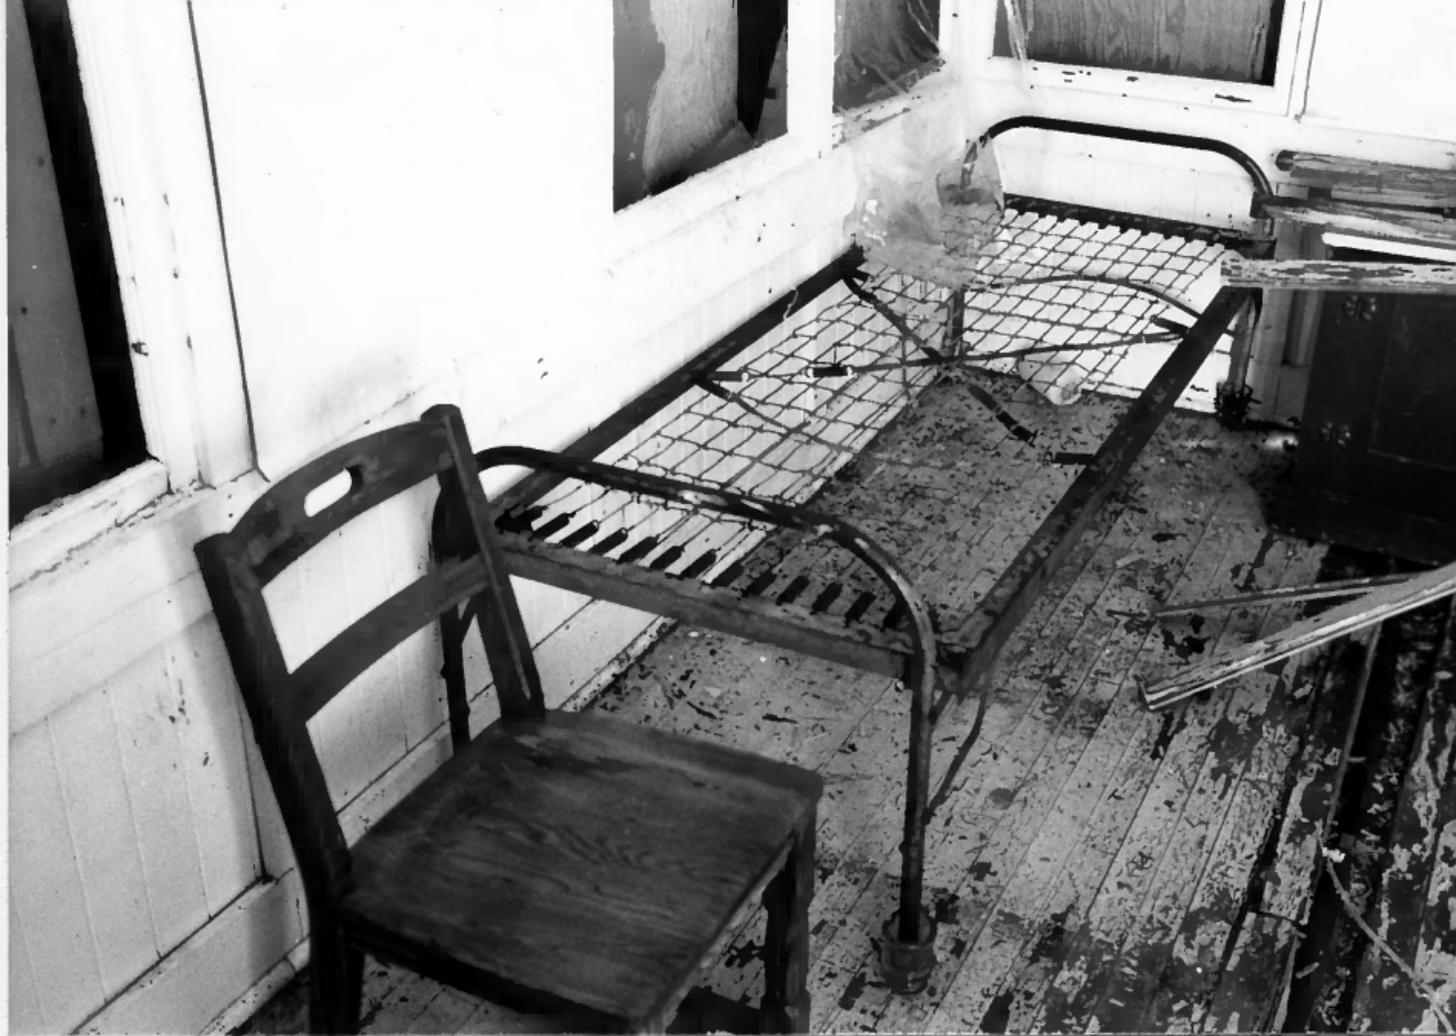
#2

Furnishings include three free-standing cupboard units constructed of 3" planks; 2 chairs; a bedframe; a table; a bookcase; fixtures for propane lights; and the centrally located fire finder. Modern shelves and bins have been constructed above the windows and hold a variety of household goods.

~~Ded~~ chain
