NATIONAL REGISTER OF HISTORIC PLACES NOMINATION, GLACIER NATIONAL PARK

STRUCTURE NAME: Upper Nyack Snowshoe Cabin STRUCTURE NUMBER: 622

Upper Nyack Snowshoe Cabin (addendum), Flathead County, MT.

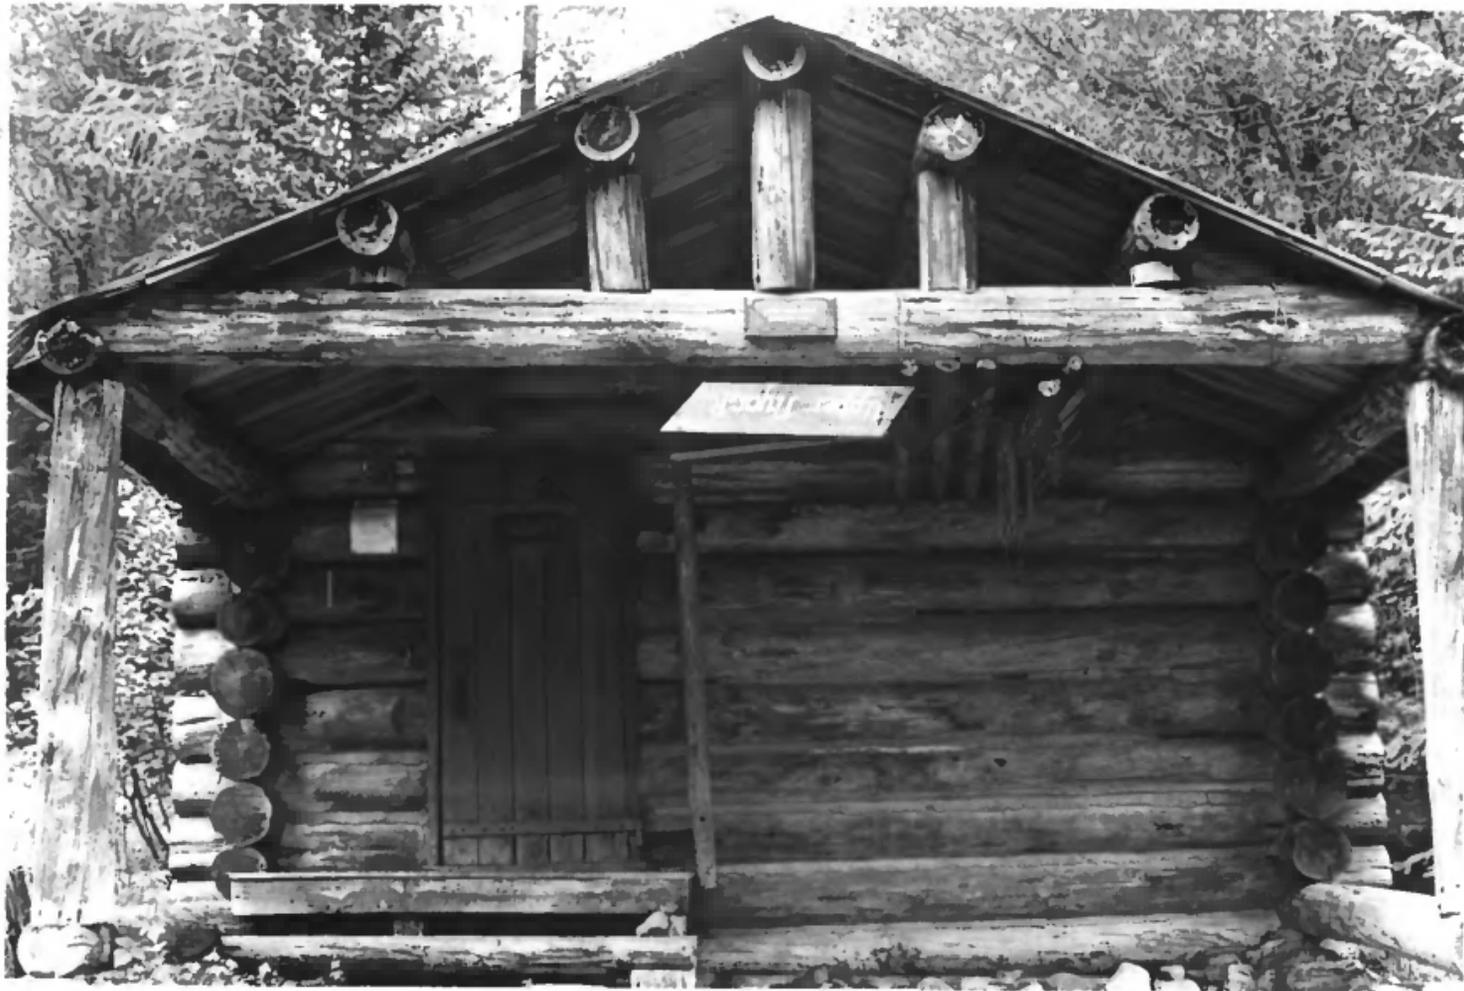
PHOTO NUMBER: 1

The Upper Nyack snowshoe cabin is a one-story log cabin, measuring 14x18' with a 6' porch extension. The structure rests on a log alignment and stone pad foundation. Logs are saddle notched, with square-cut crowns and some concrete chinking. The extended roof purlins are supported by vertical posts and a tie beam. The roof is covered with corrugated metal. The structure has a solid vertical wood door and wood-shuttered windows with metal bars and hinges. The condition of the structure is fair. Exterior chinking is needed, the sill logs are dry rotted, and there is rot in the purlin crowns. The cabin is a typical log snowshoe cabin with a gable roof extension that creates a front porch area. This basic, variable design evolved from the early snowshoe cabins in Yellowstone National Park. Most backcountry patrol and snowshoe cabins constructed in the 1920s were built by local carpenters at a cost of between \$350 and \$500. The Upper Nyack snowshoe cabin maintains good integrity and is a significant example of an early backcountry rustic building in Glacier.

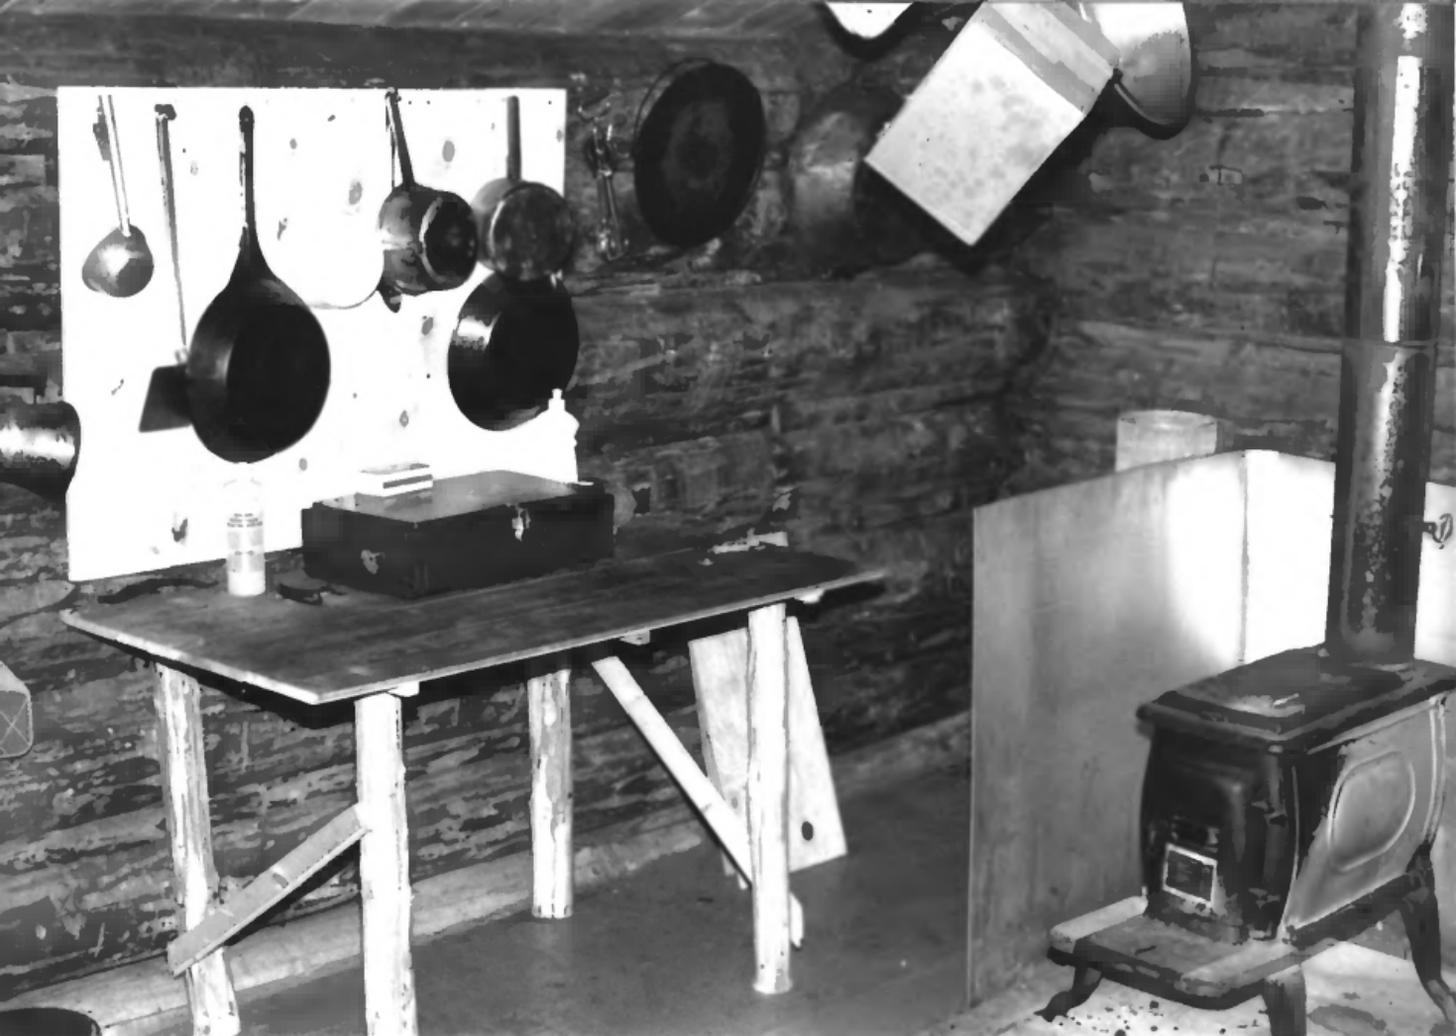
Figure 1

Fixed furnishings are standard backcountry issue: two free standing cabinets line the east wall; the unpaneled door of one swings down to form a table. The other cabinet door is constructed of vertical boards secured with interior horizontal braces. The two chairs are also painted olive. A second table, constructed of shiplap planks and predictably painted olive, is embellished with a painted checkerboard top. A third table, "handmade" of planks atop peeled lodgepole legs, holds a Coleman stove. The large bedding storage box is constructed of planks and features a heavy top and side vents. The wood stove set in the northeast corner is paired with a sheet metal hearth and a metal heat shield.

PHOTO NUMBER	STRUCTURE NAME AND NUMBER	LOCATION/DIRECTION OF VIEW
1	Upper Nyack Snowshoe Cabin (#622)	Interior-stove and handmade table
2	Upper Nyack Snowshoe Cabin (#622)	Interior-door and standard bed-storage box

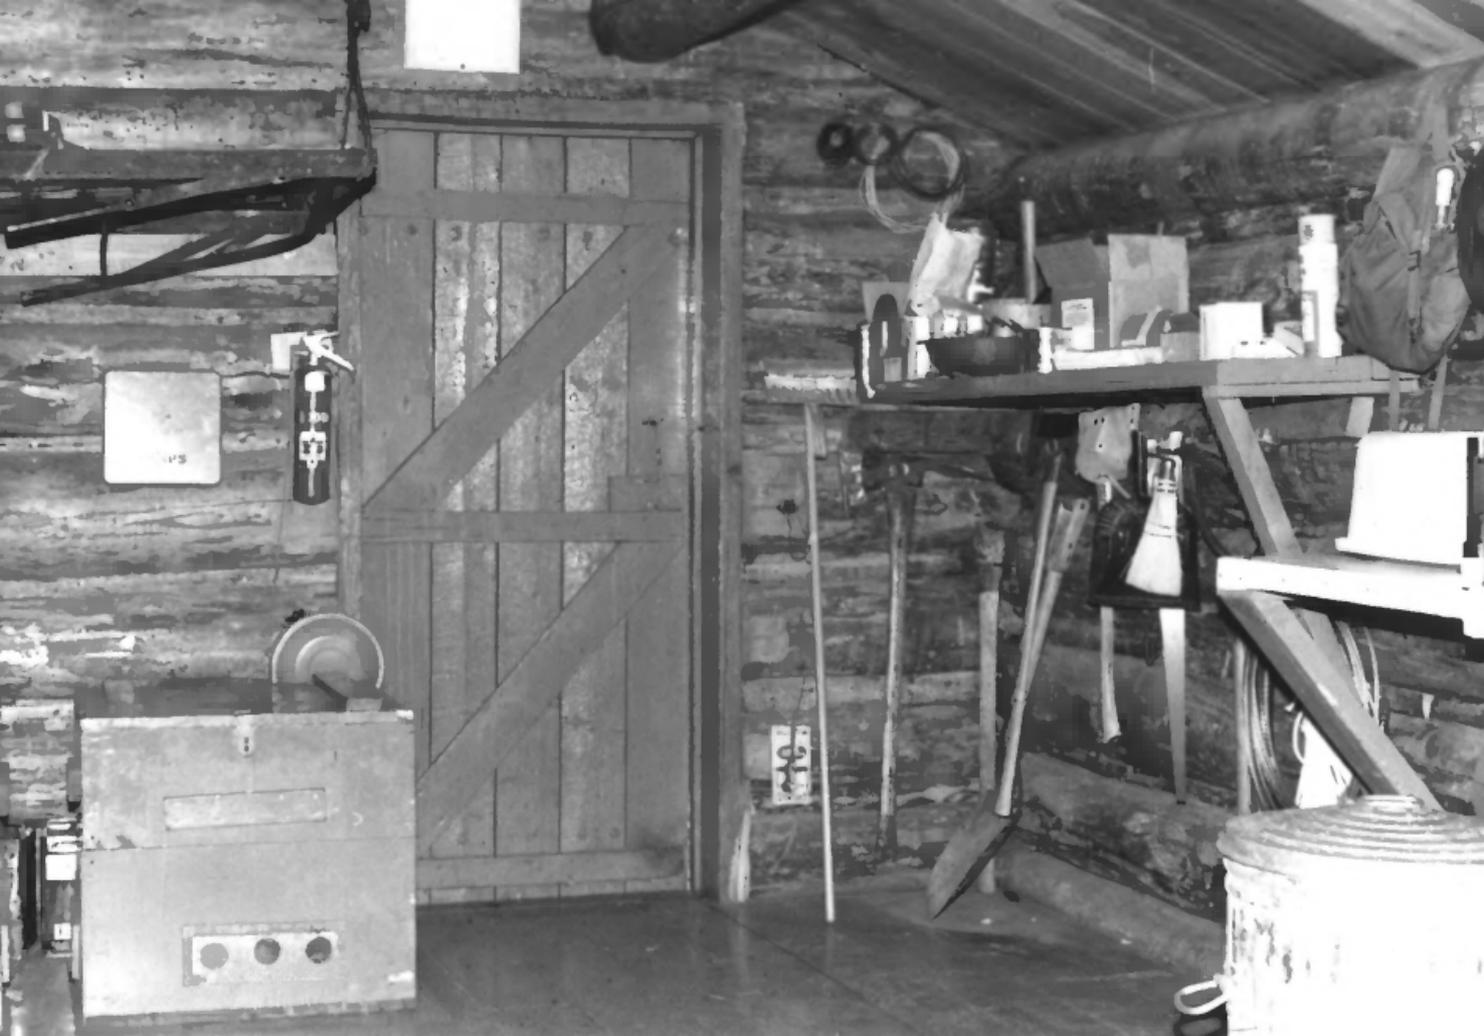
Figure 2

A substantial door, constructed of five 6" vertical boards secured on the interior with a double Z-brace and on the exterior by two horizontal braces, provides access to this one room log cabin, located a day's travel

Suspended bedframes, as specified in original drawings, are located along the west and south walls: the beds are suspended by cables secured to two heavy metal hooks set in the nearest purlin. A wood slat bracket, bolted to the wall, provides additional support. (This is one of few cabins in which this feature is extant.) Heavy shelving units, supported by dimensional lumber braces, line all available wall space and hold an assortment of cleaning supplies, trail and fire tools, snowshoes, and a Coleman lantern. A two-handled band saw hangs from a purlin.
