# HISTORICAL BASE MAP 1869

## GOLDEN SPIKE NATIONAL HISTORIC SITE UTAH

**HISTORICAL BASE MAP  
AND  
DOCUMENTED NARRATIVE  
1869  
GOLDEN SPIKE NATIONAL  
HISTORIC SITE  
UTAH**

BY  
F. A. KETTERSON, JR.

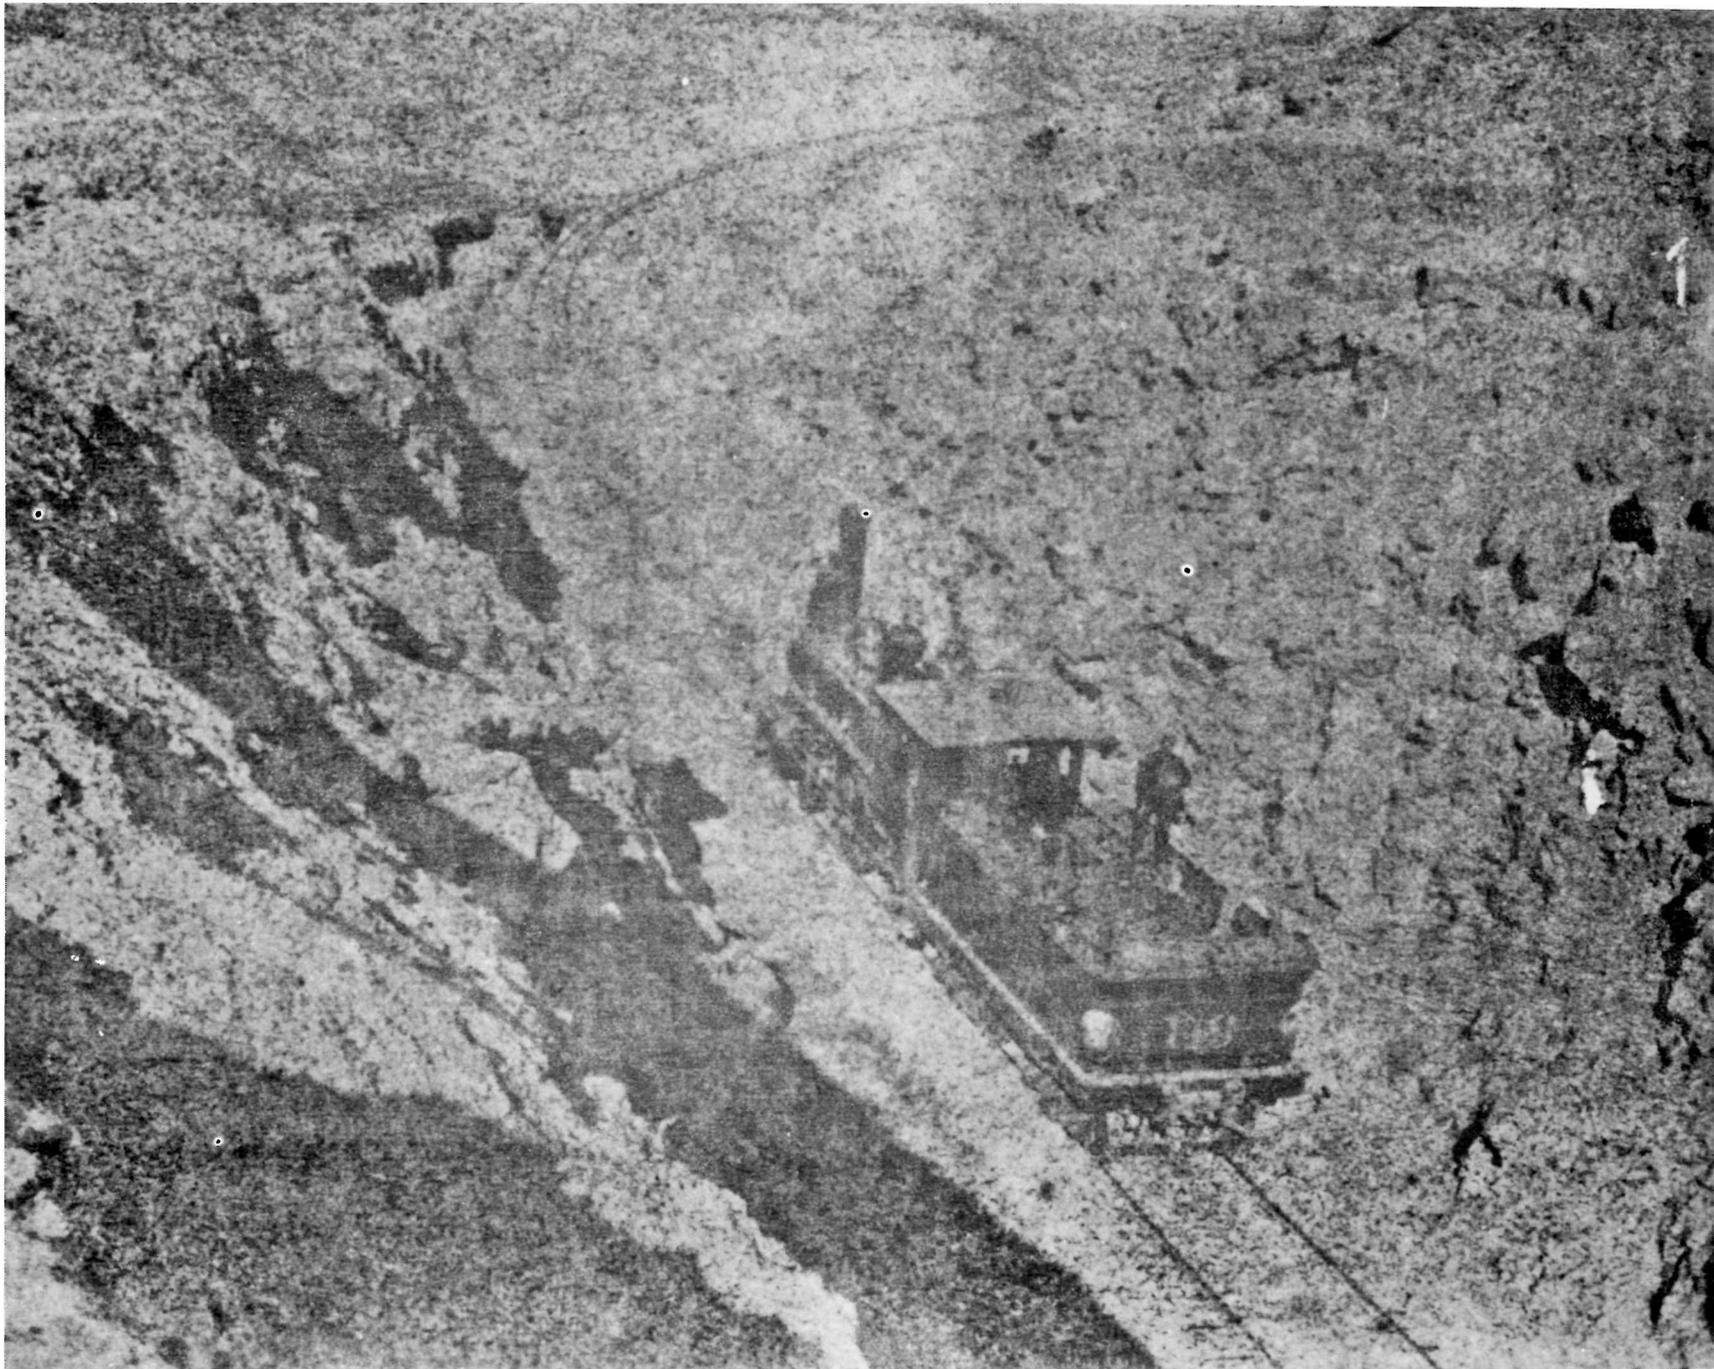
1. This view shows Union Pacific locomotive No. 119 in a rocky cut, possibly Carmichael's Cut on the east slope of the North Promontory Range. The picture was copied from an unidentified stereo view in the Union Pacific Railroad Museum in Omaha, Nebraska. The picture was probably taken by Andrew J. Russell early in May 1869.

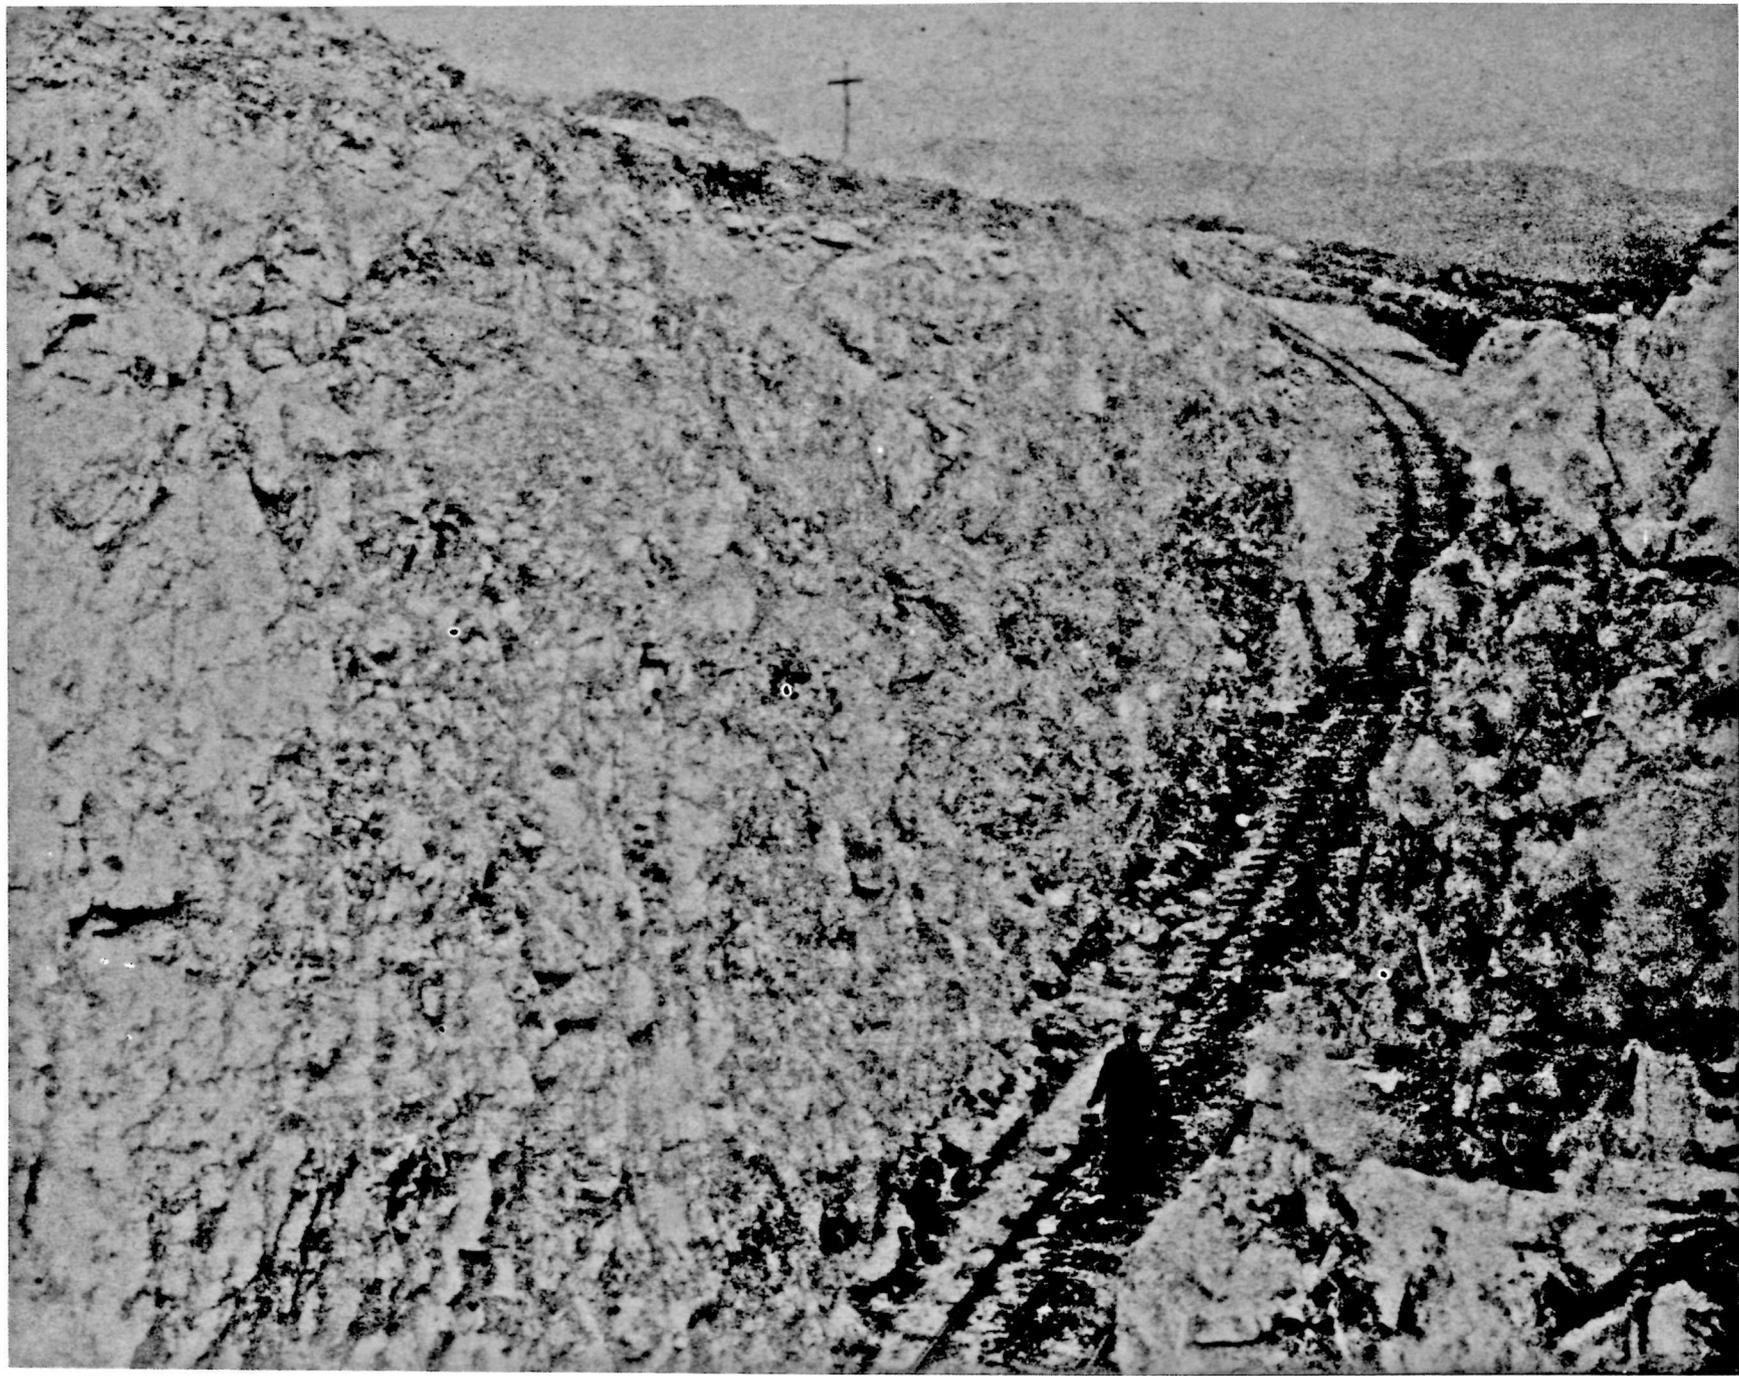
2. This view shows Carmichael's Cut on the east slope of the North Promontory Range. View is toward the east. The picture was copied from an A. J. Russell stereo in the Union Pacific Railroad Museum, Omaha, Nebraska. It was taken in the first part of May 1869.

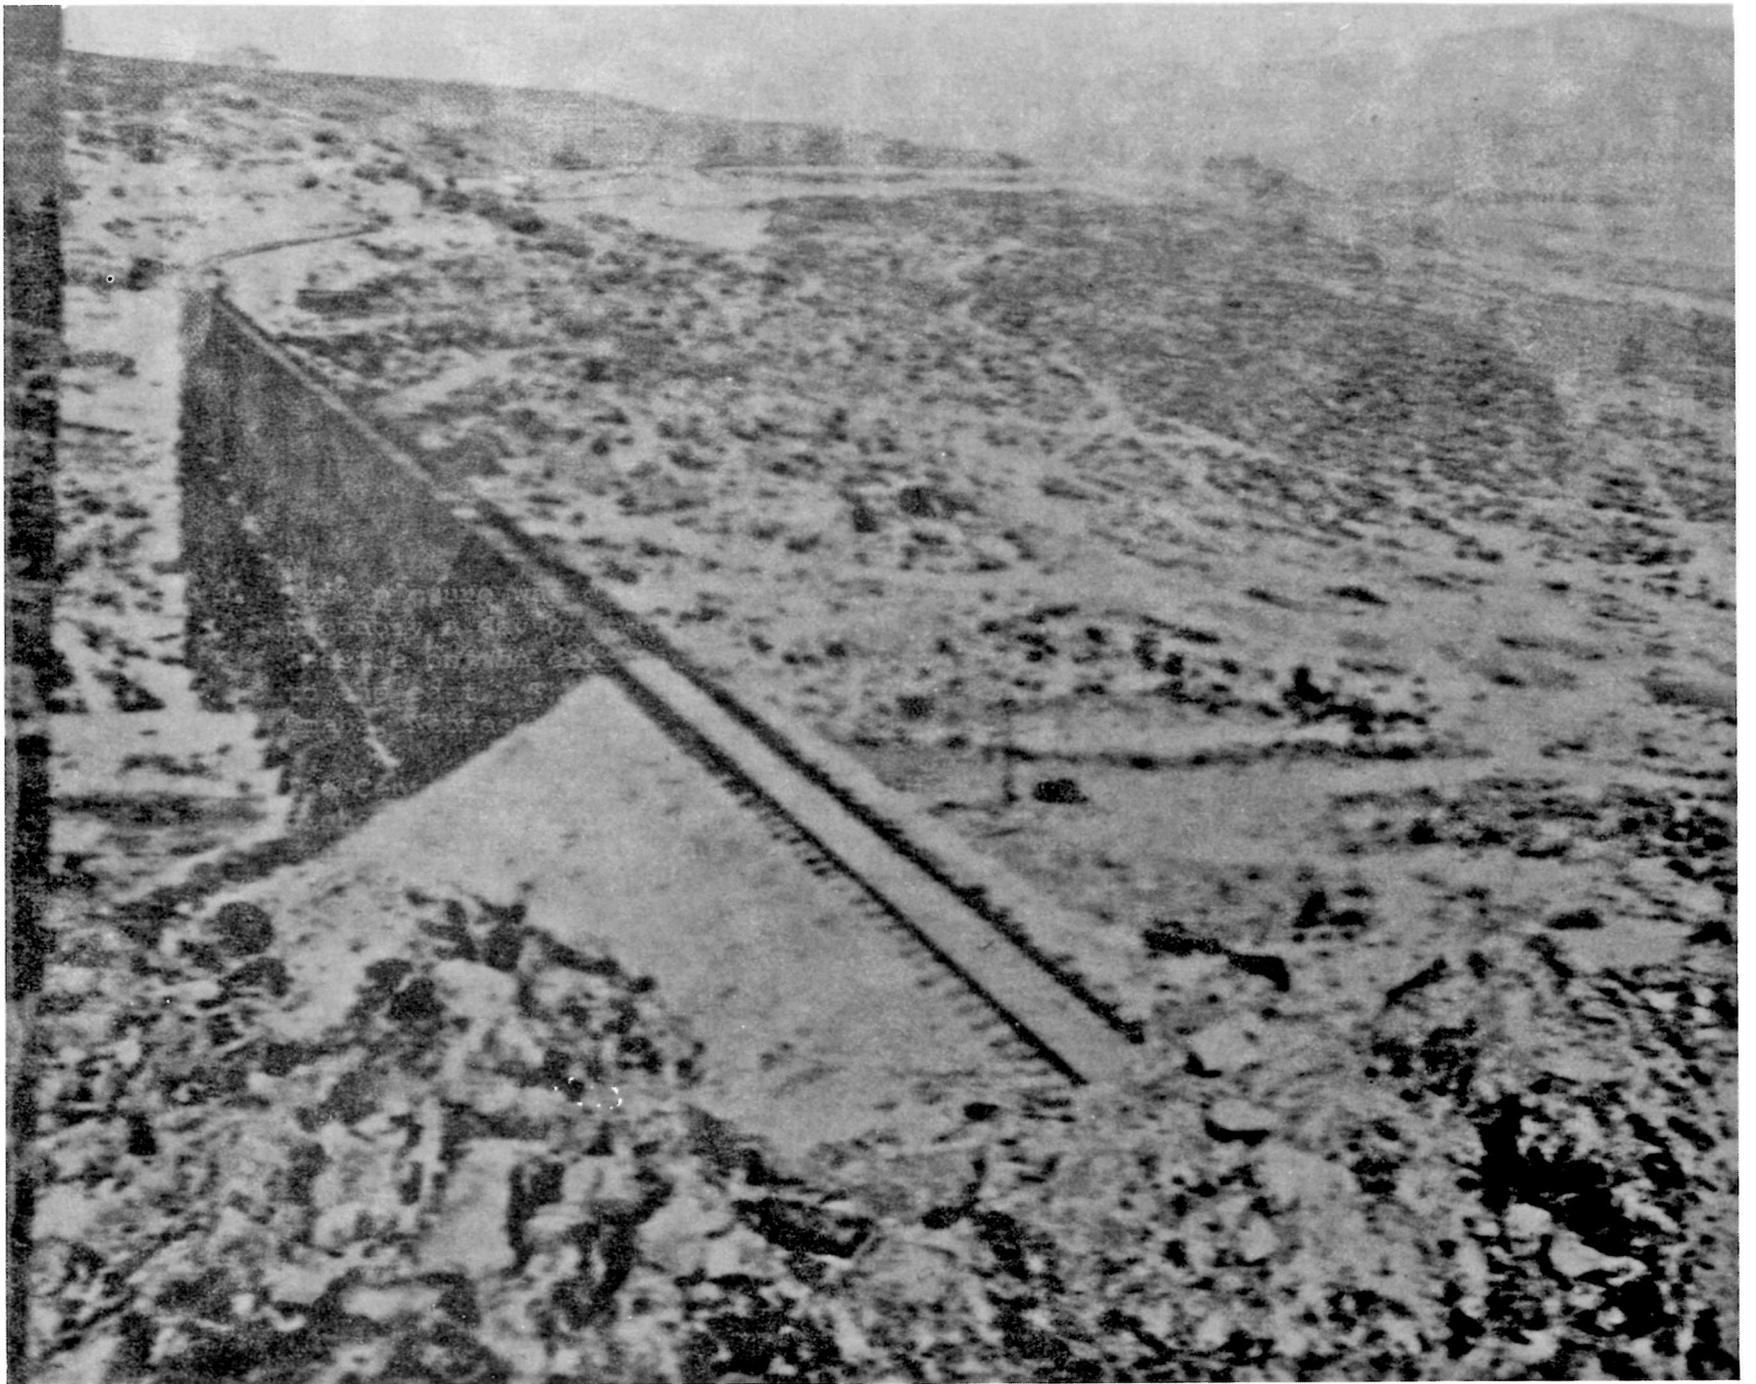
3. This picture was copied from a stereo view, made by Andrew J. Russell, probably a day or two before May 10, 1869, of the Union Pacific Great Trestle on the east slope of the North Promontory Range. The view is to the east. The stereo view is in the Union Pacific Railroad Museum, Omaha, Nebraska.

The Central Pacific grade, paralleling the Union Pacific, can be seen higher up the slope. Off the picture at the left and opposite the Union Pacific trestle the Central Pacific used a great fill to cross this drainage.

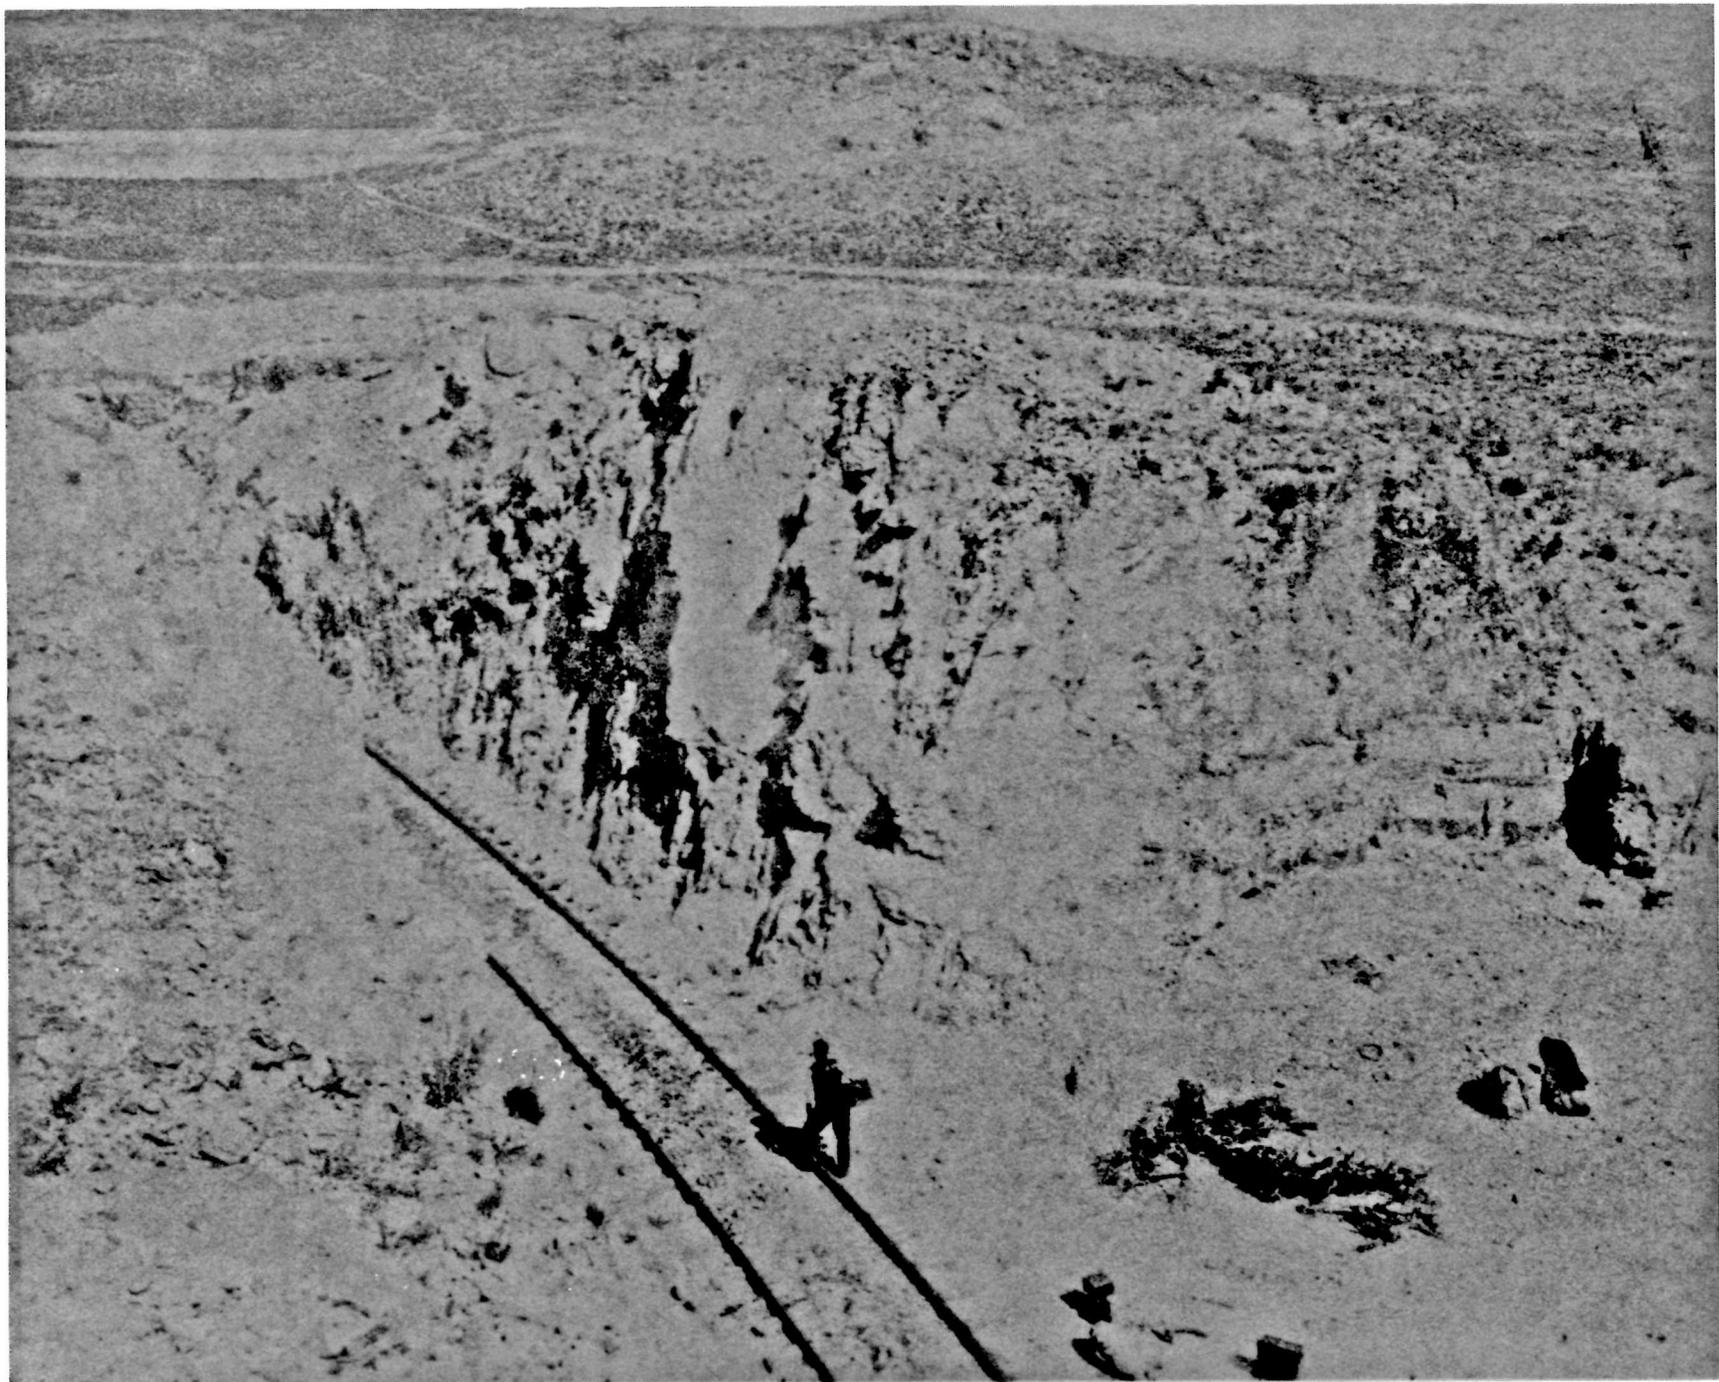
4. View looking east from top of Carmichael's Cut showing construction in early May 1869. This picture was copied from a stereo view by Andrew J. Russell, Union Pacific Railroad Museum, Omaha, Nebraska.

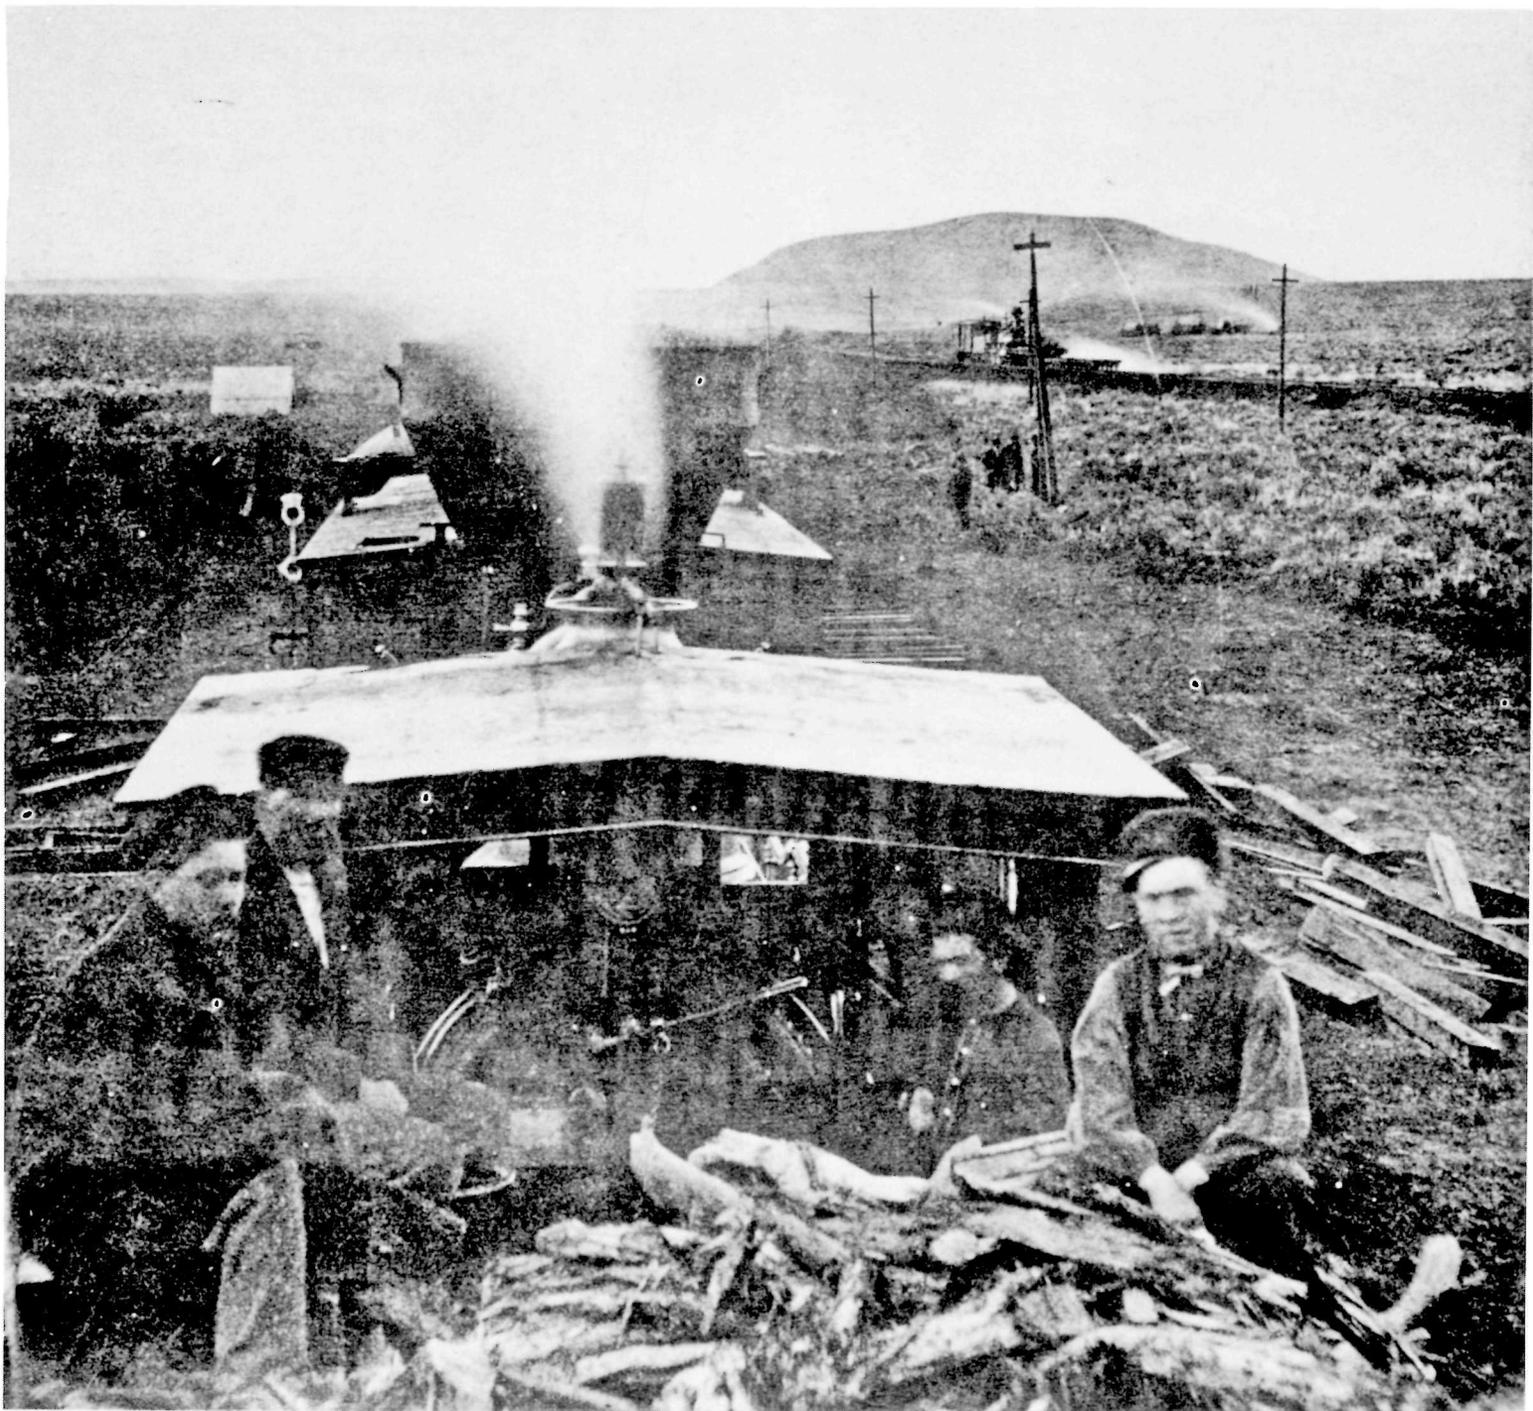
5. This picture was made from a stereo view taken by Alfred A. Hart on May 9, 1869. The view is toward the east at Promontory Summit over the cab and tender of a Central Pacific locomotive of the Jupiter type, and indeed it may even be the Jupiter. Extra square cut Central Pacific railroad ties can be seen at the sides of the track and workmen are at either side of the track. A tent shows on the left or north side of the track (another large one was nearby but does not show in this view). The locomotive to the right center on another track is a Union Pacific locomotive standing on the Union Pacific grade. This view shows how the two grades paralleled each other at Promontory Summit. The next day the east and west parts of the transcontinental railroad were joined just in front of the Central Pacific locomotive. Note the switch stand at the left of the track. The stereo view from which this picture was copied is in the Timothy Hopkins Collection, Main Library, Stanford University.

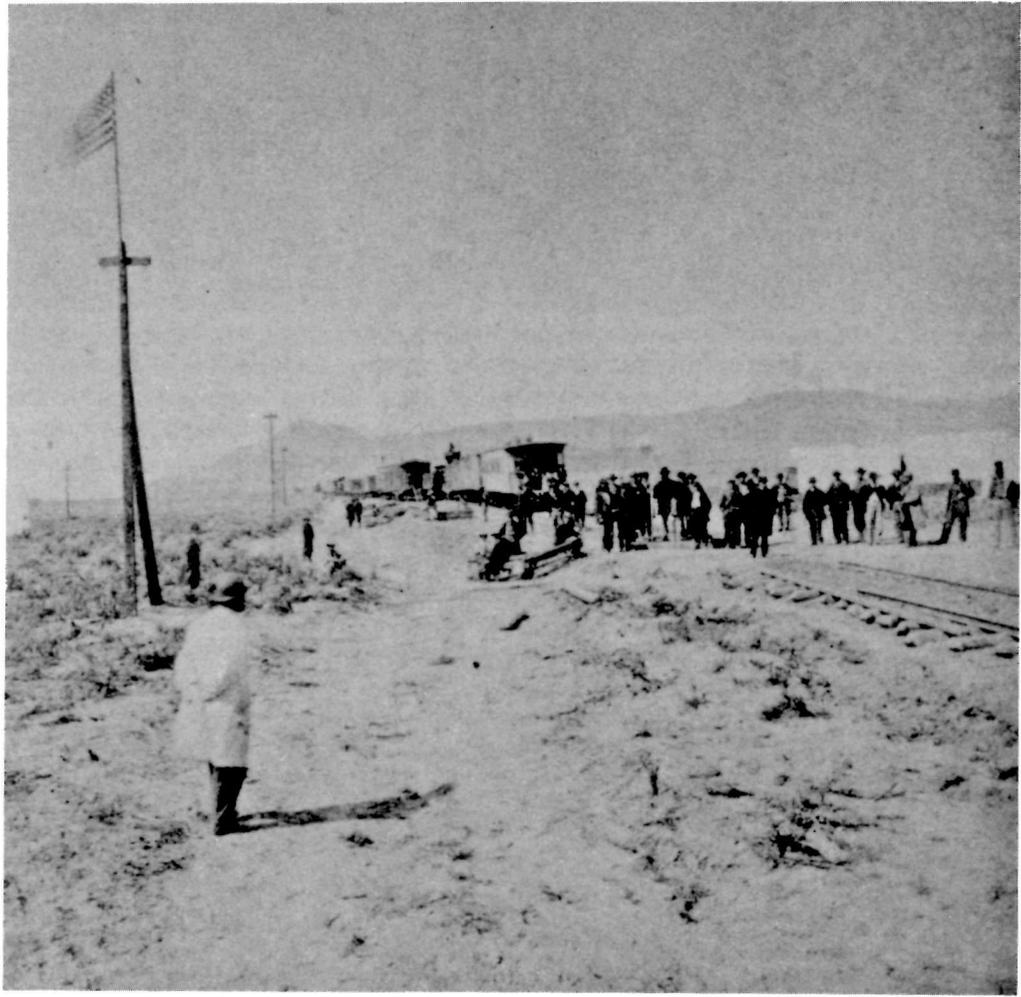
7. This picture was taken apparently on May 9 or early in the morning of May 10, 1869, because it shows the gap, where the men are standing, still separating the joining of the rails at Promontory Summit. The view is toward the west. The railroad equipment standing on the track is Central Pacific. This view was copied from an unidentified picture in the files of the Union Pacific Railroad headquarters at Omaha, Nebraska. Tents show on both sides of the track. The flag is on the south side of the track. The rough ax cut ties with pointed ends visible at the right are Union Pacific. The Central Pacific ties used at Promontory Summit and elsewhere on their track across the Utah and Nevada desert were cut and milled on the west slope of the Sierra. The milling of the ties from the timber was done at Truckee, California, near the Nevada line.

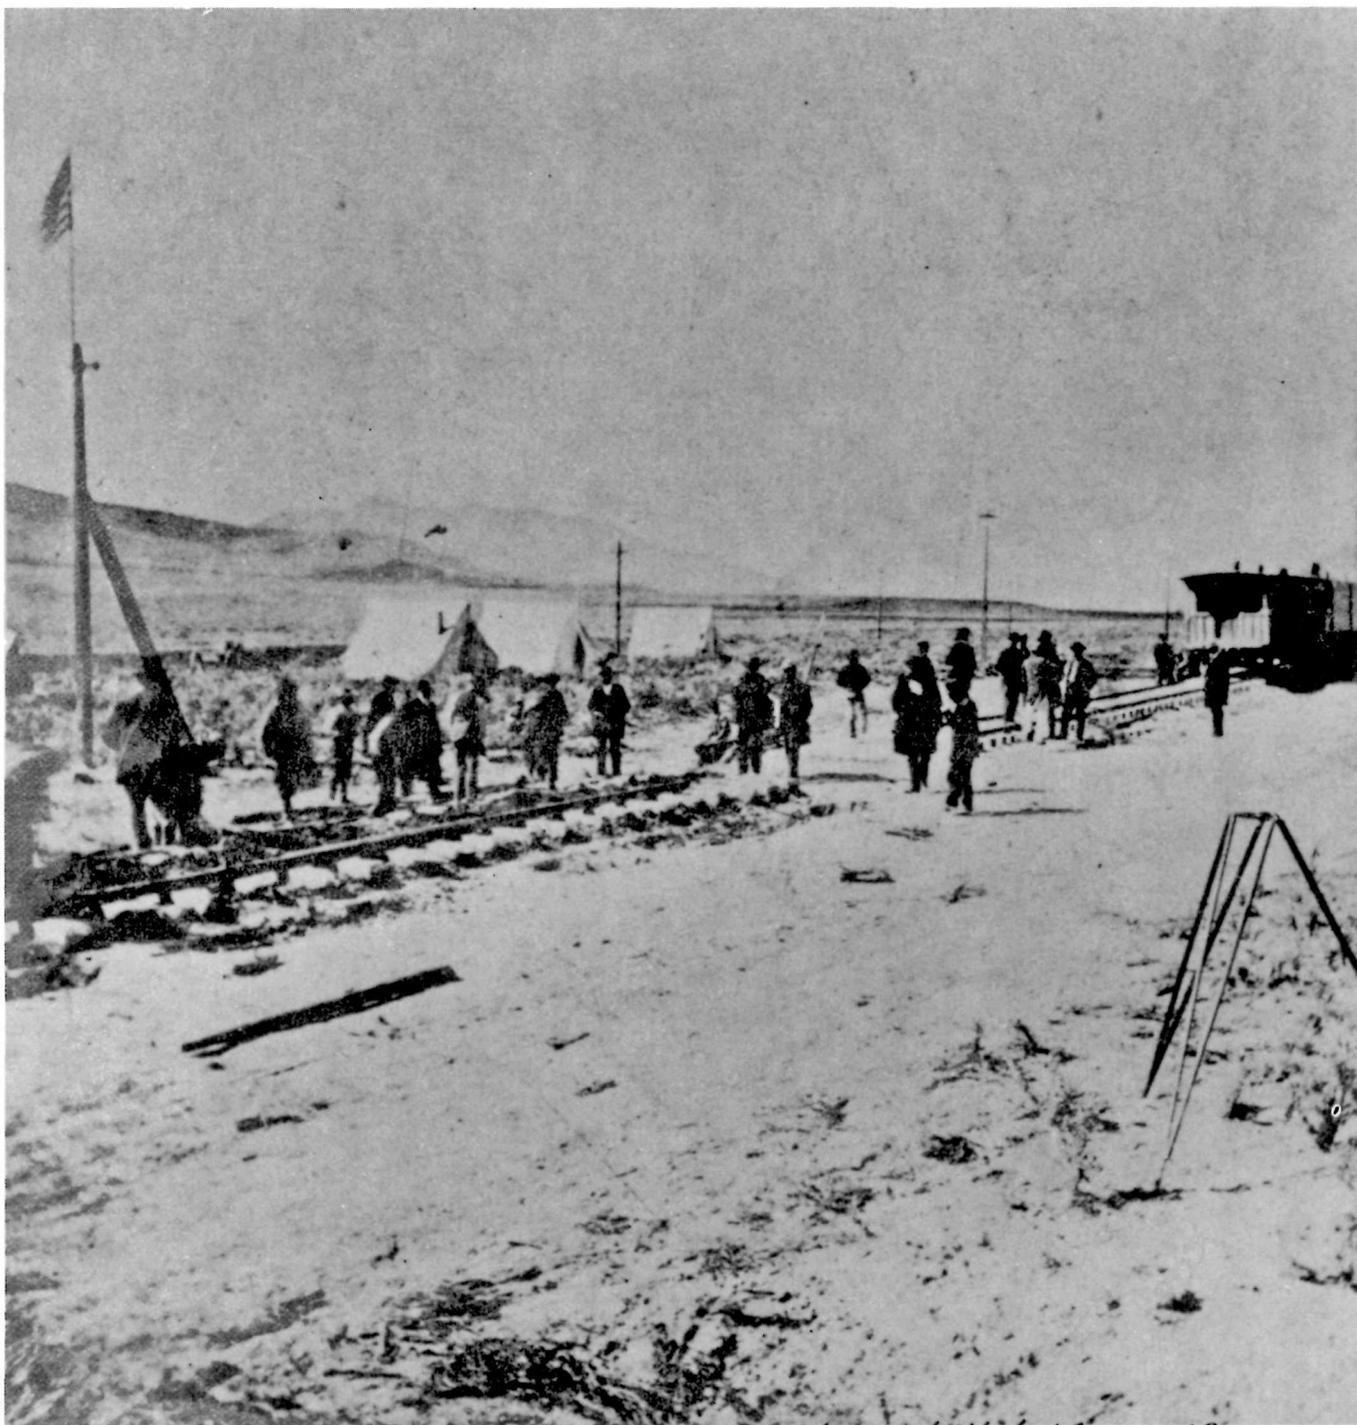
8. This picture shows the situation at Promontory Summit on the morning of May 10, 1869, before the gap in the two rail lines was closed for the ceremony at noon. The view is from east to west. The three tents and the flag staff affixed to one of the telegraph poles are on the south side of the track. The ax-hewn railroad ties with pointed ends are on the Union Pacific track, the sawed and squared ties beyond the gap in the track are on the Central Pacific track. This picture has been reproduced from one in the Utah Historical Society, where it is attributed to C. R. Savage, Photographer. A similar picture in the files of the Union Pacific Railroad Headquarters, Omaha, Nebraska, is unidentified.

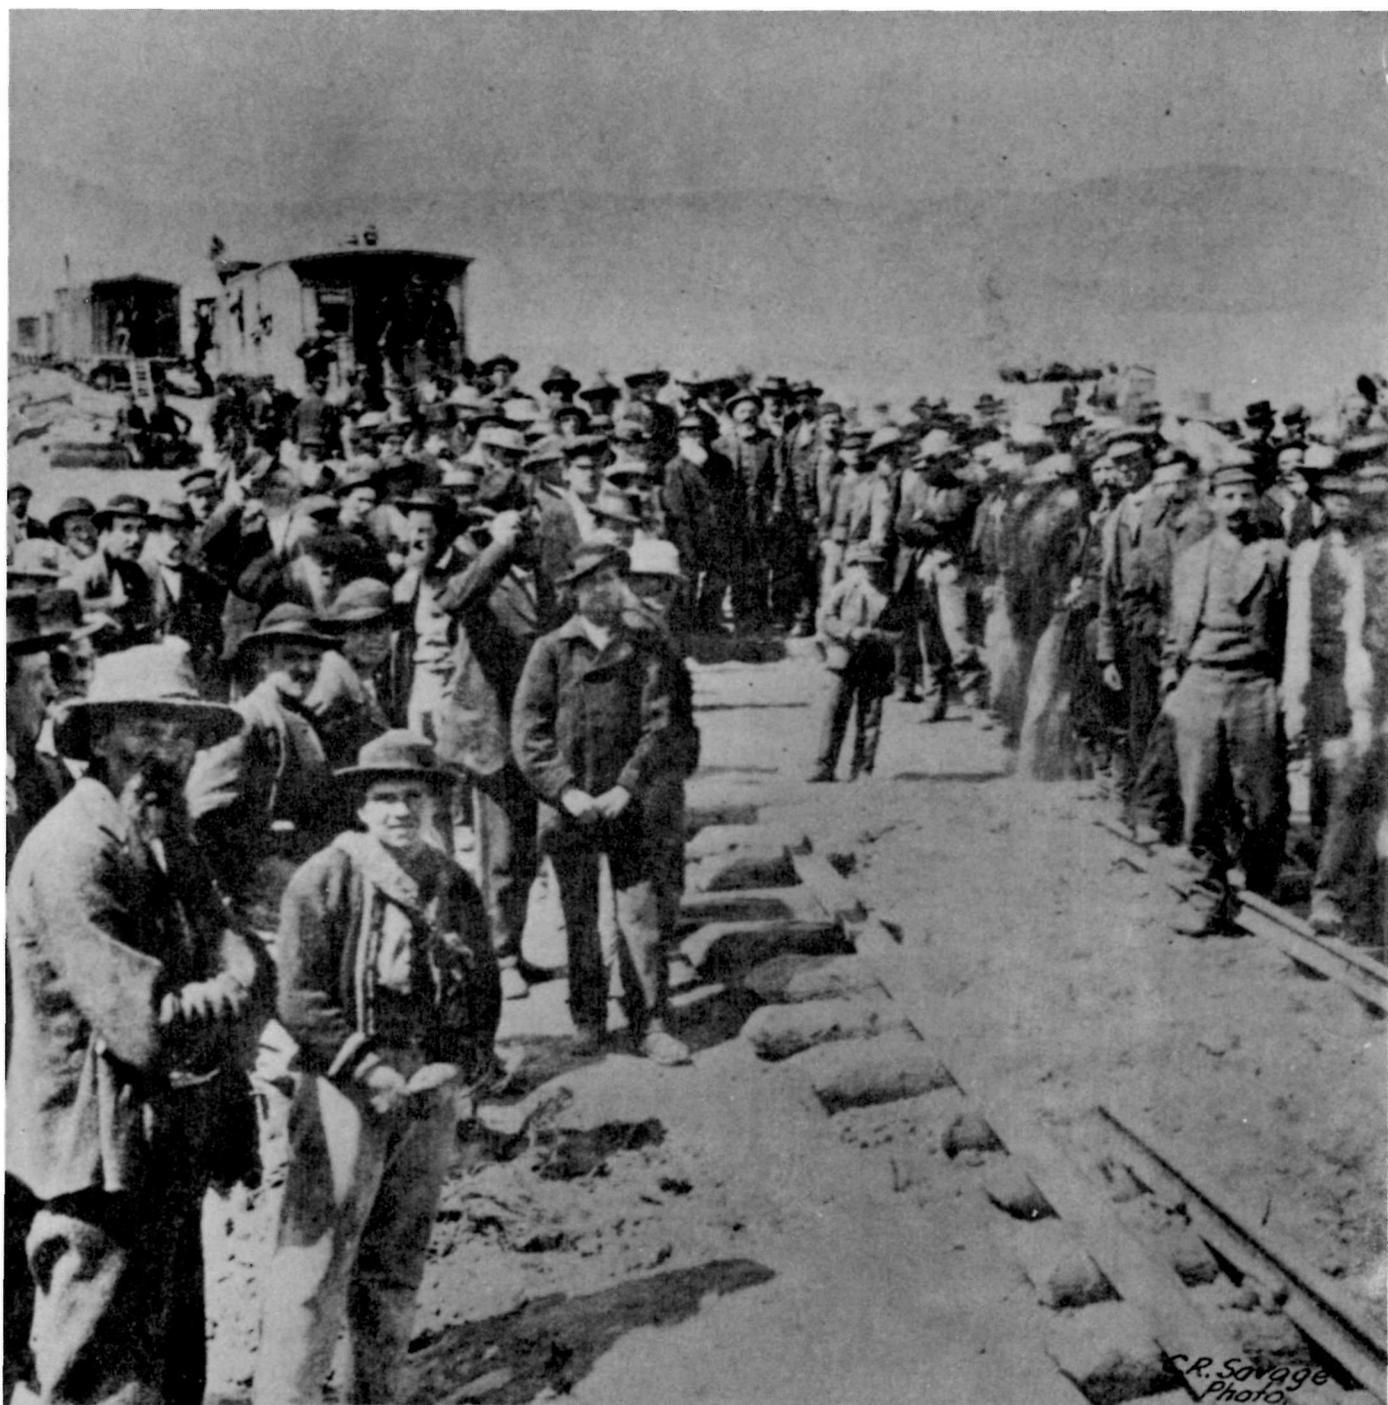
9. This view, from east to west, gives a closeup of the gap in the rails on the morning of May 10, 1869. This picture was taken apparently just before the gap was closed by Central Pacific track layers. The rough cut pine cross ties in the foreground are Union Pacific. At least one tent shows dimly on the north side of the track. This picture is reproduced from one in the Utah Historical Society attributed to C. R. Savage of Salt Lake City. An identical stereo view is in the Union Pacific Railroad Headquarters, Omaha, Nebraska, where the stereo card attributes the picture to Andrew J. Russell. We believe the latter probably is correct.

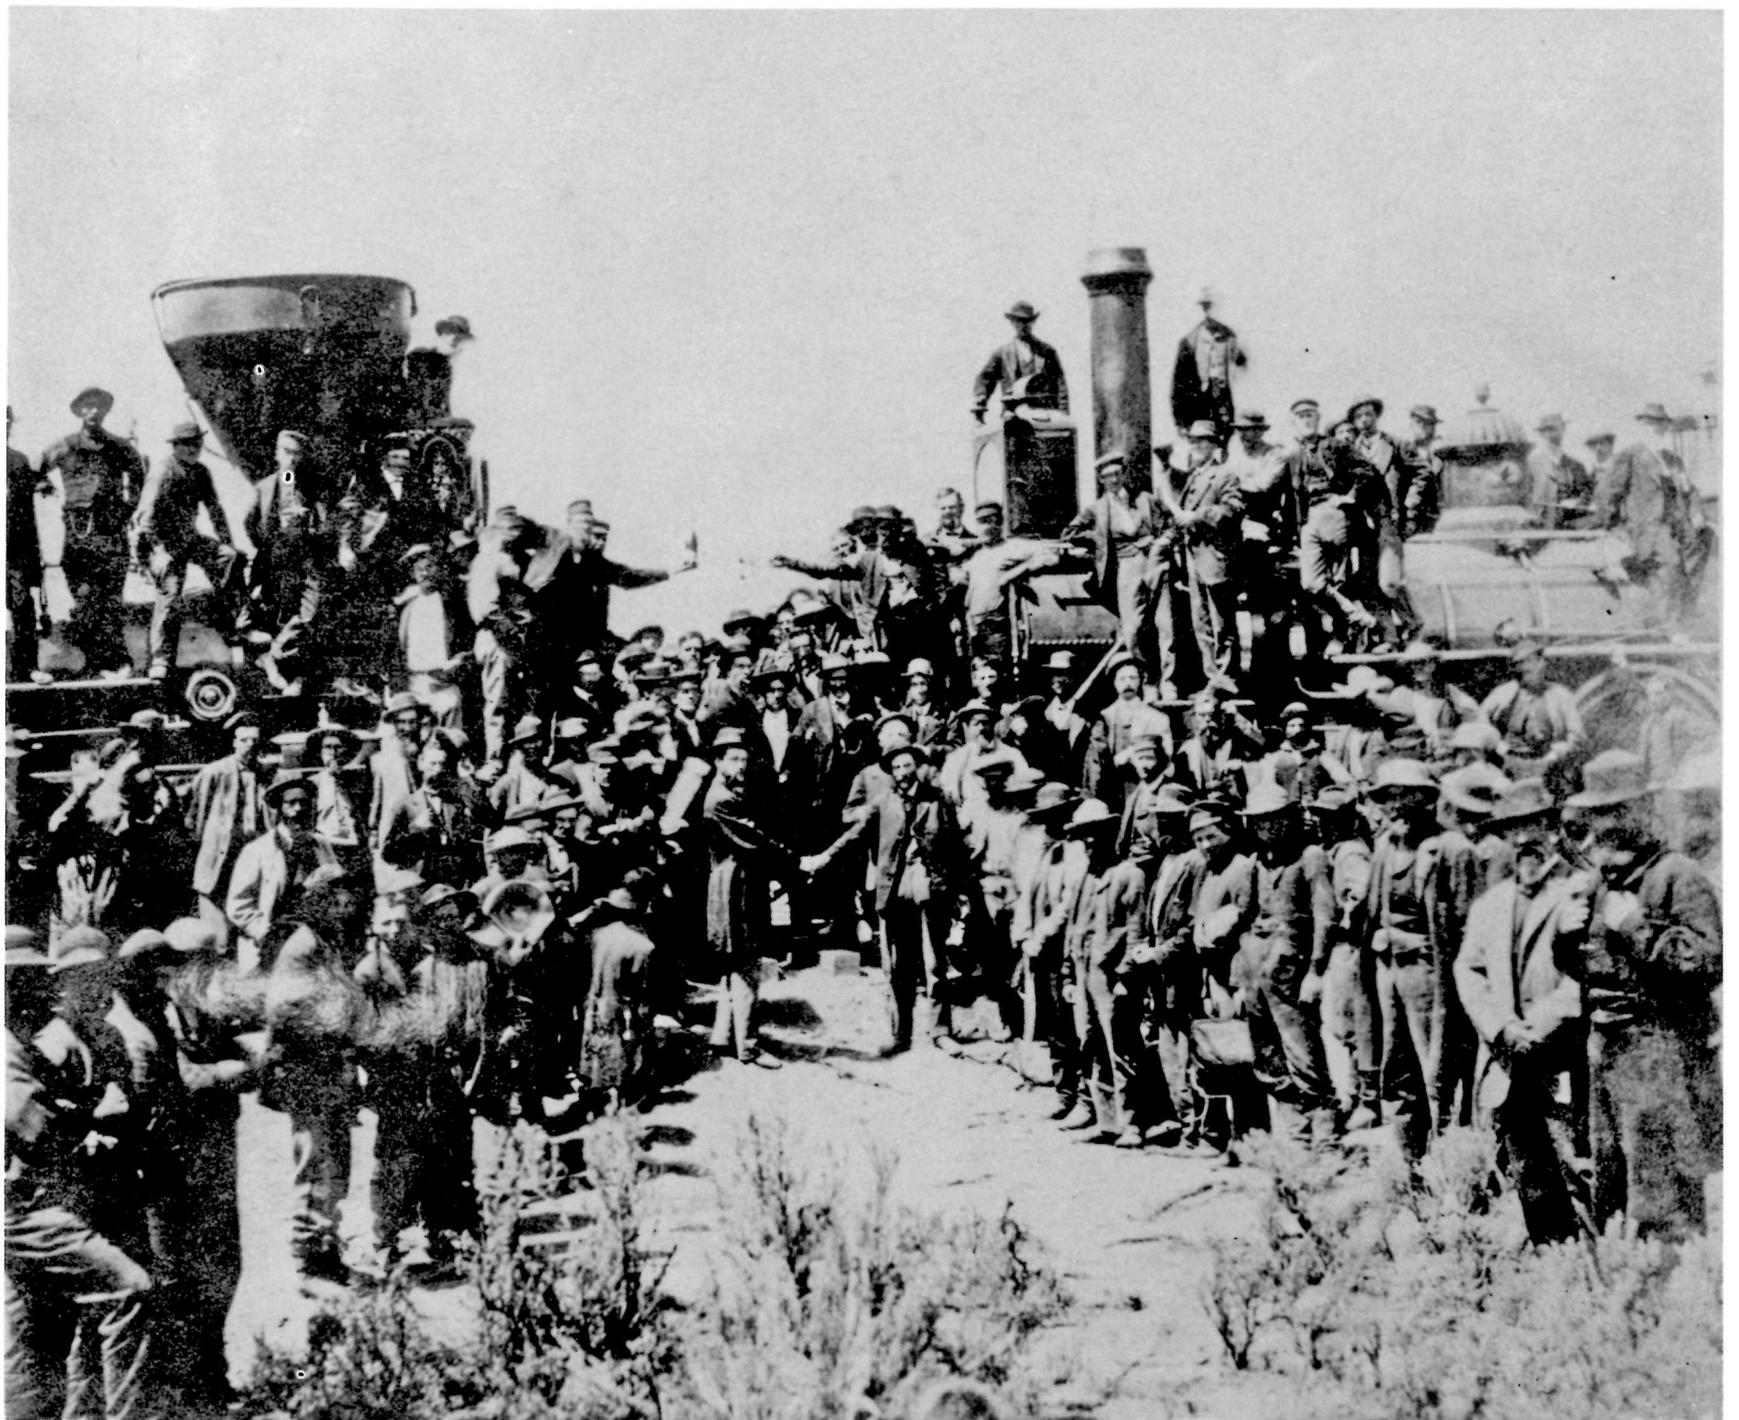
12. This is perhaps the most famous of all photographs taken at the driving of the Golden Spike ceremonies at Promontory Summit on May 10, 1869. It was taken by Andrew J. Russell, official photographer of the Union Pacific Railroad for the occasion. The view is from south to north. The two men in the center of the photograph shaking hands are, on the left, Chief Engineer Montague of the Central Pacific, and on the right, Chief Engineer Dodge of the Union Pacific. This picture was taken after the ceremony of driving the last spike, following which the two locomotives moved together until their pilots touched. Central Pacific locomotive Jupiter, No. 60, is on the left; Union Pacific locomotive #119 is at the right. The former was a wood burner, the latter a coal burner.

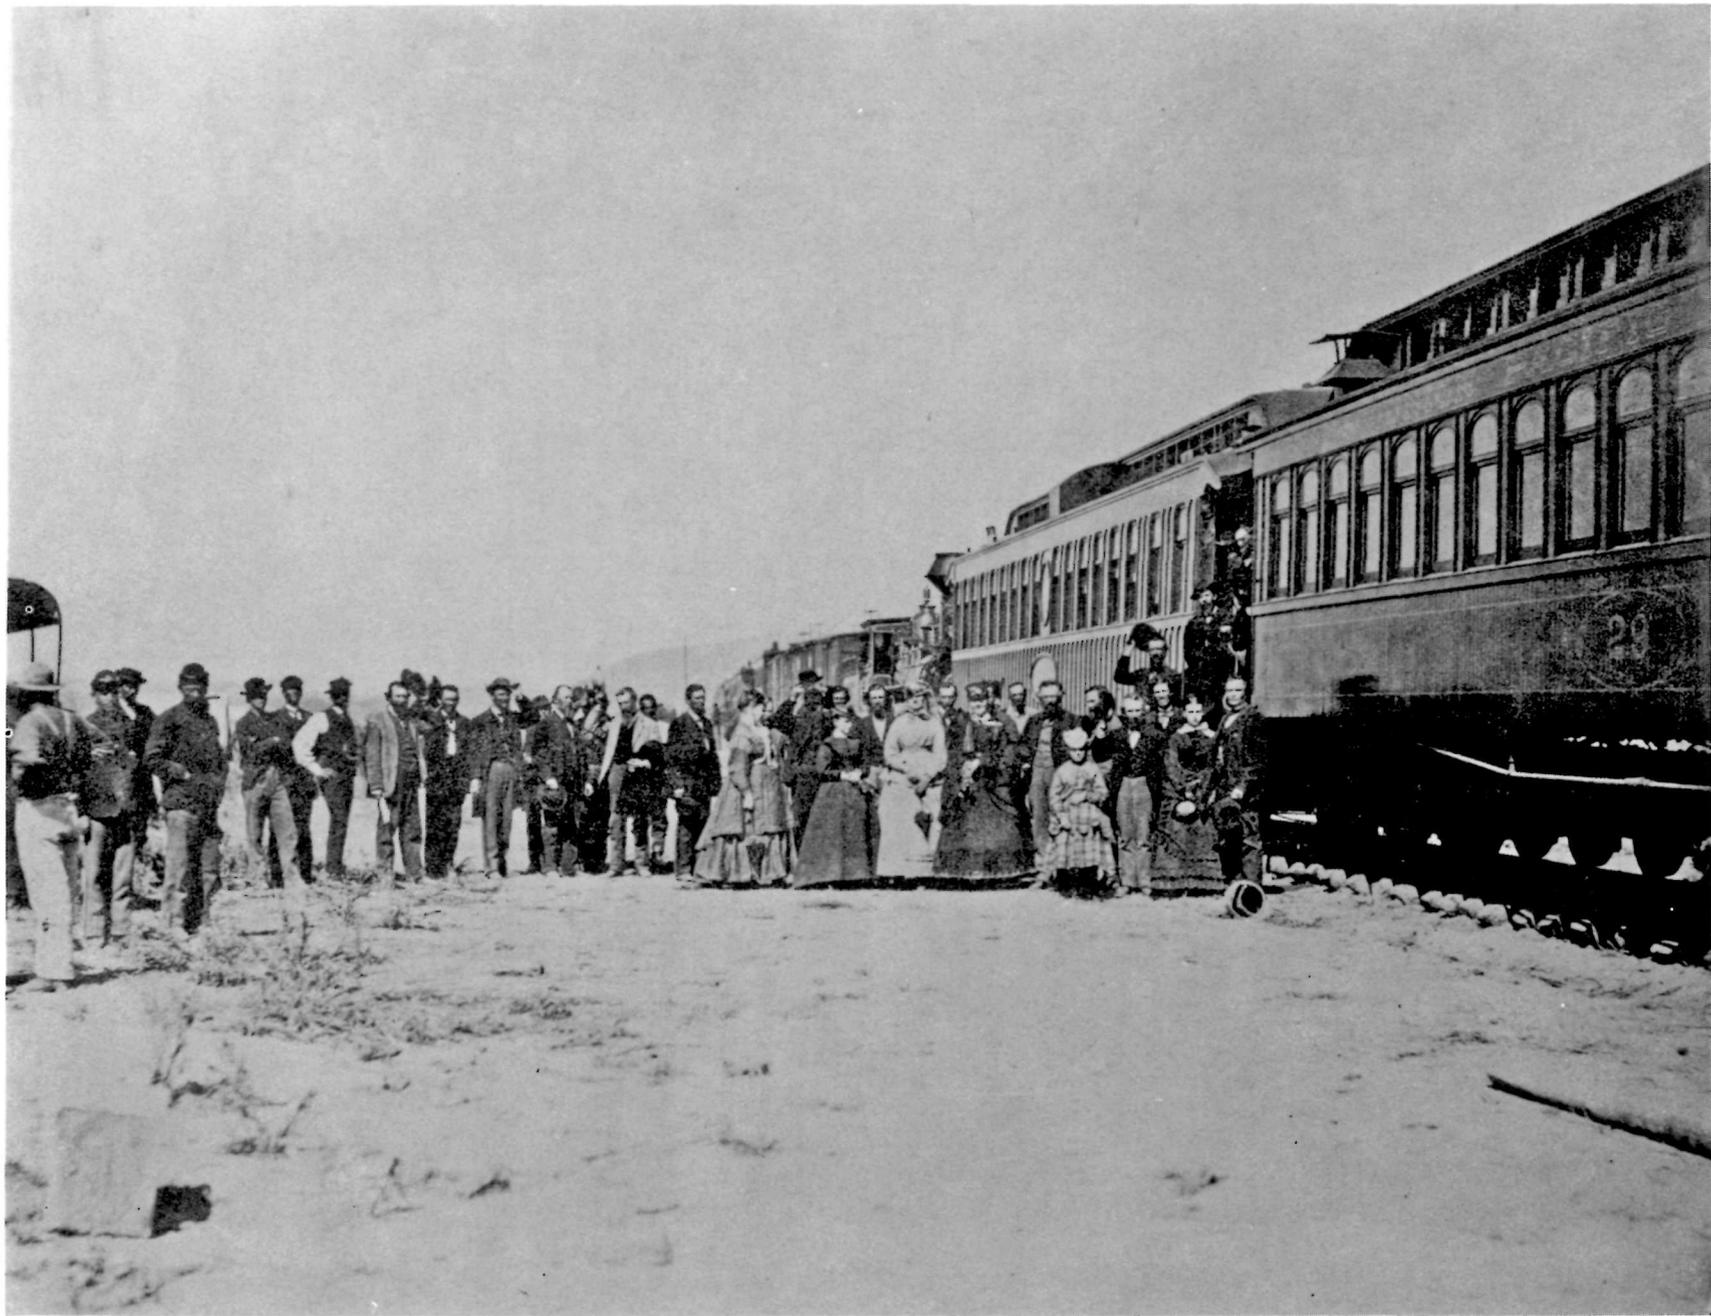
14. This picture was taken by Andrew J. Russell on May 10, 1869, at Promontory Summit, following laying the last rail and driving the last spike. It shows Union Pacific equipment on the Union Pacific track at right foreground. The picture appears to have been taken on the north side of the track looking to the east. The Union Pacific locomotive No. 119 and the Golden Spike and joining of the rails site would appear to be at the right and out of the picture. The coaches shown at right foreground, where the passengers are lined up for the picture, presumably is the equipment used to transport Durant's official Union Pacific party. A few soldiers and one local citizen appear at the left edge of the picture.
