# HISTORICAL BASE MAP 1869

## GOLDEN SPIKE NATIONAL HISTORIC SITE UTAH

**HISTORICAL BASE MAP  
AND  
DOCUMENTED NARRATIVE  
1869  
GOLDEN SPIKE NATIONAL  
HISTORIC SITE  
UTAH**

BY  
F. A. KETTERSON, JR.

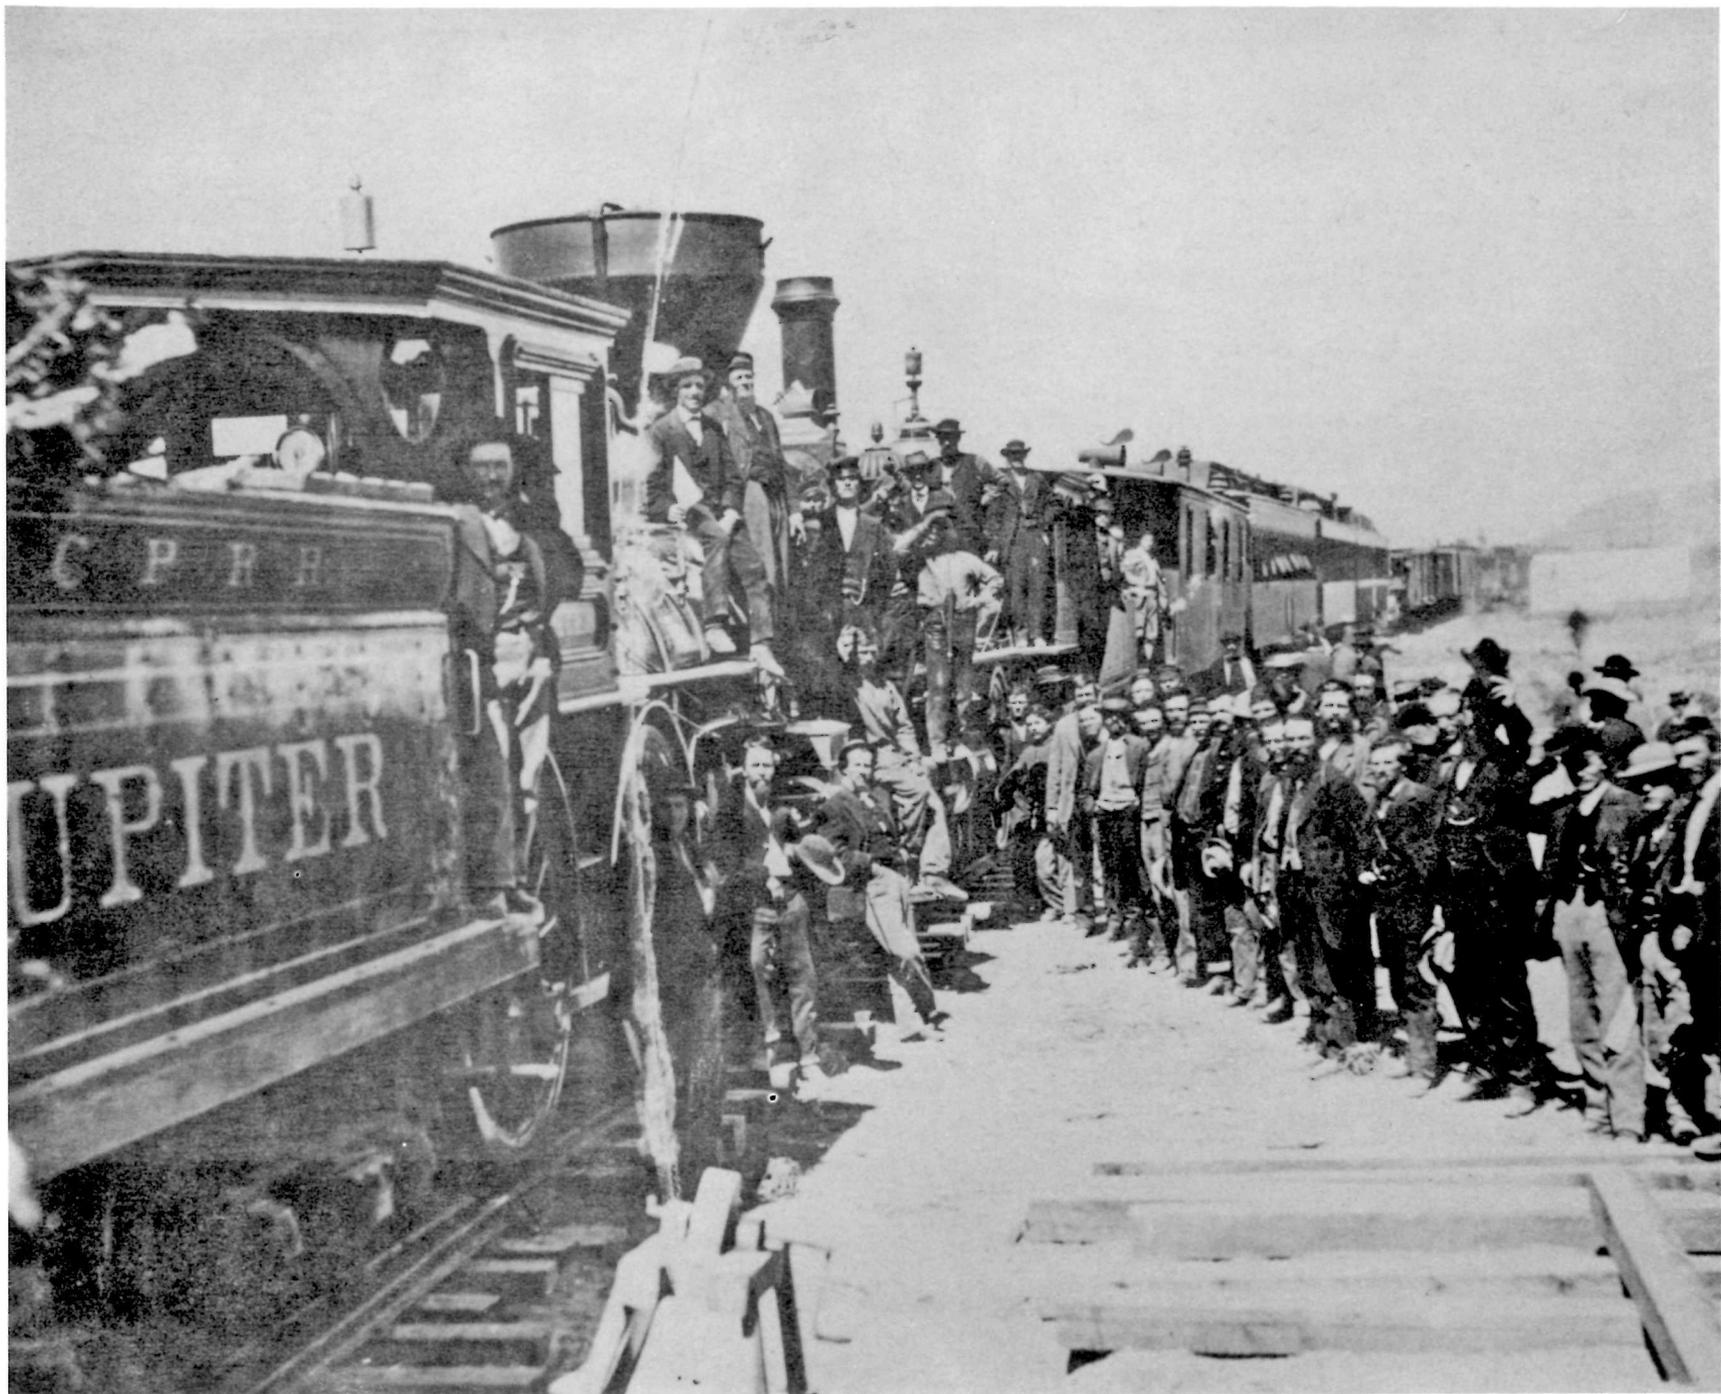
15. This picture was taken by Andrew J. Russell on May 10, 1869, at Promontory Summit, showing the two locomotives pilot to pilot when they moved up to touch each other after the Golden Spike ceremony. This view looks toward the east and is from the south side of the track. This is an unusual picture. The large 10x13 inch glass negative has been broken. It shows clearly many features of construction and decoration of the Central Pacific Jupiter locomotive, the condition of the track of the square-cut Central Pacific railroad ties, and especially of the long series of Union Pacific trains that had pulled up one behind the other stretching away eastward from the juncture point.

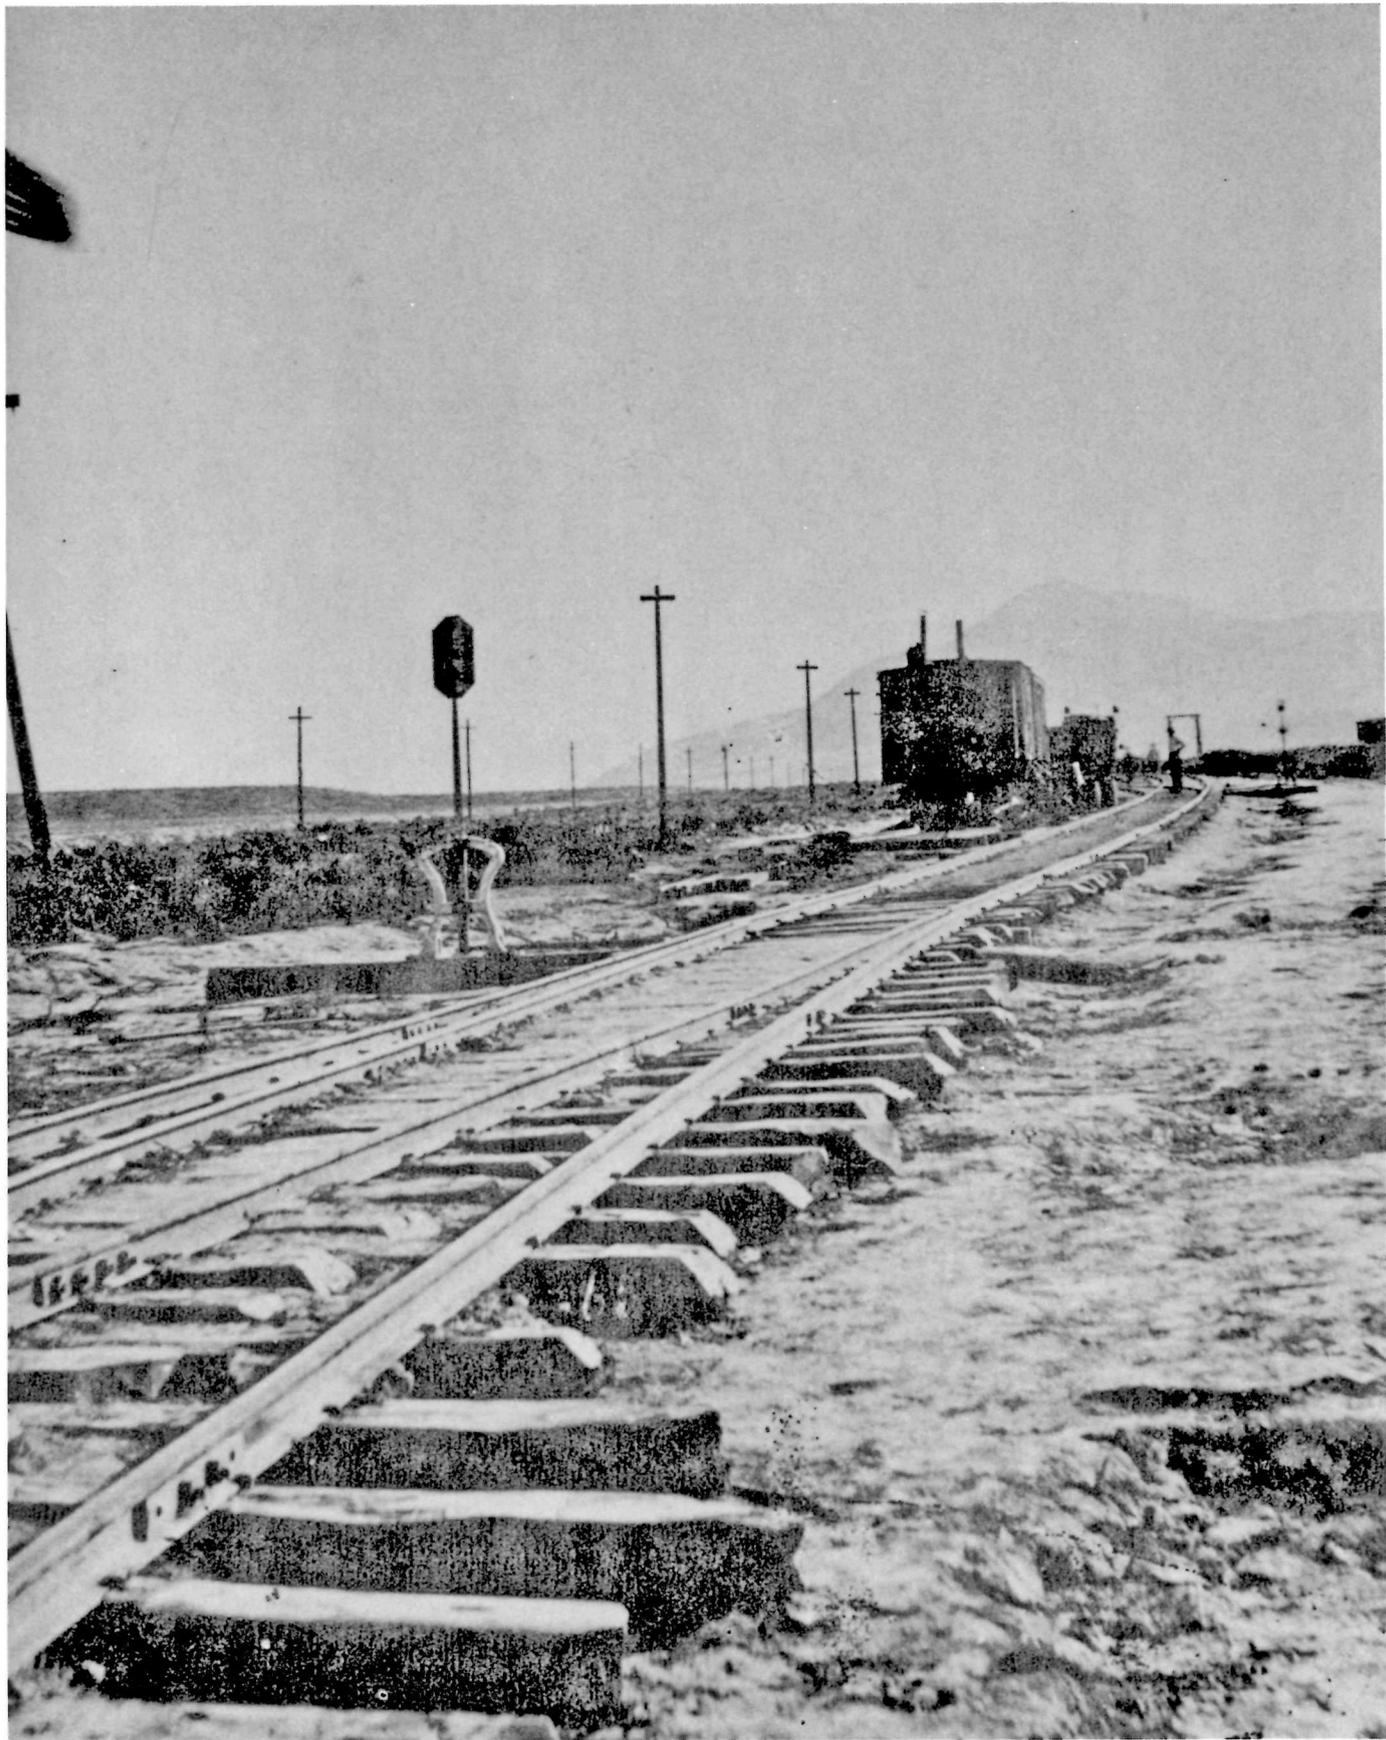
16. This photograph was taken by William Henry Jackson in July 1869, about two months after the Golden Spike ceremony. It is one of two that Jackson took at that time. One can tell from the rough cut nature of the ties in the foreground that they are on the Union Pacific part of the track. The view looks to the west. The square-sawed Central Pacific railroad ties can be seen in the track bed beyond the switch, and this point marks the original Golden Spike site of joining the rails on May 10, 1869. The Union Pacific grade can be seen on the left of the railroad track as a dim gray line embankment. It ran south of and parallel to the Central Pacific line across Promontory Summit. The picture has considerable historical significance since it shows the condition at Promontory Summit about two months after the Golden Spike ceremony. Two switch stands show, there is a siding track apparent in the foreground, and in the distance the end of a railroad car can be seen at the right margin of the picture. This is on a Central Pacific siding that had been built since May 10, 1869.

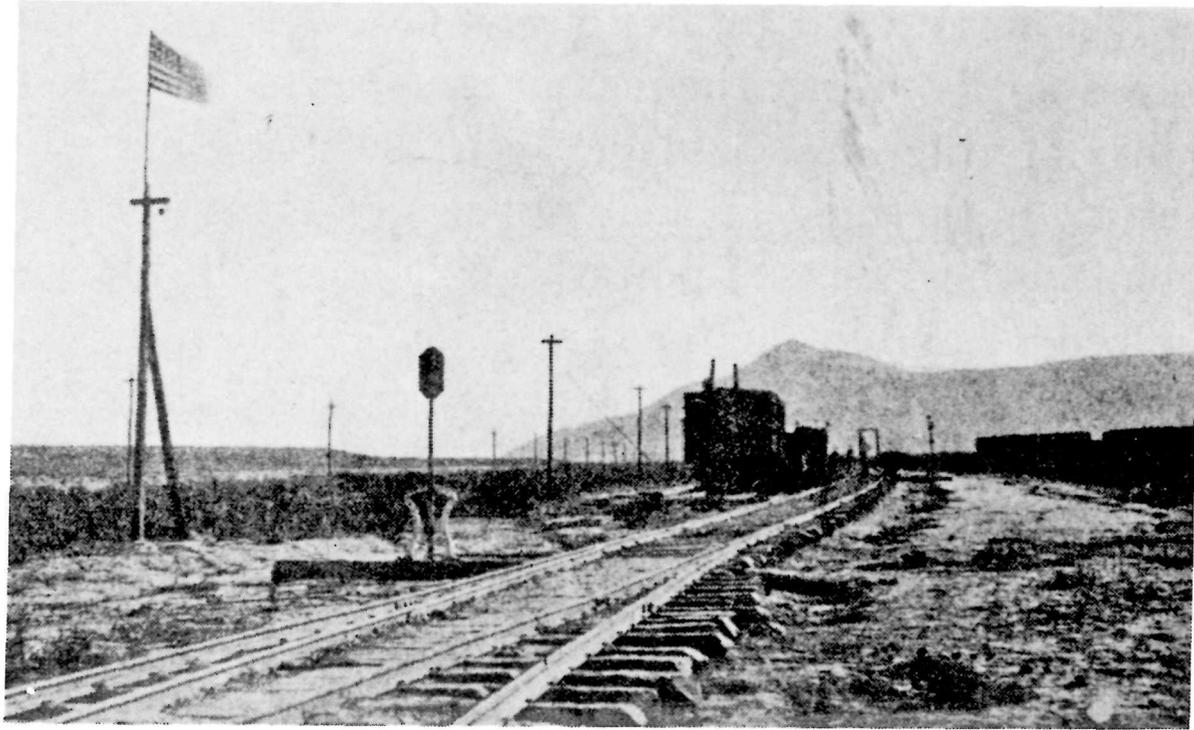
17. This is the whole or nearly full picture taken by William Henry Jackson in July 1869 at Promontory Summit. It is the same picture shown as Number 16, but has not been trimmed as much, shows more, and its axis is horizontal. It shows the flag staff in full at the left. The view is from the north side of the track and looks to the west. It shows a considerable extent of the Central Pacific siding on the north side of the main track and cars standing on it.

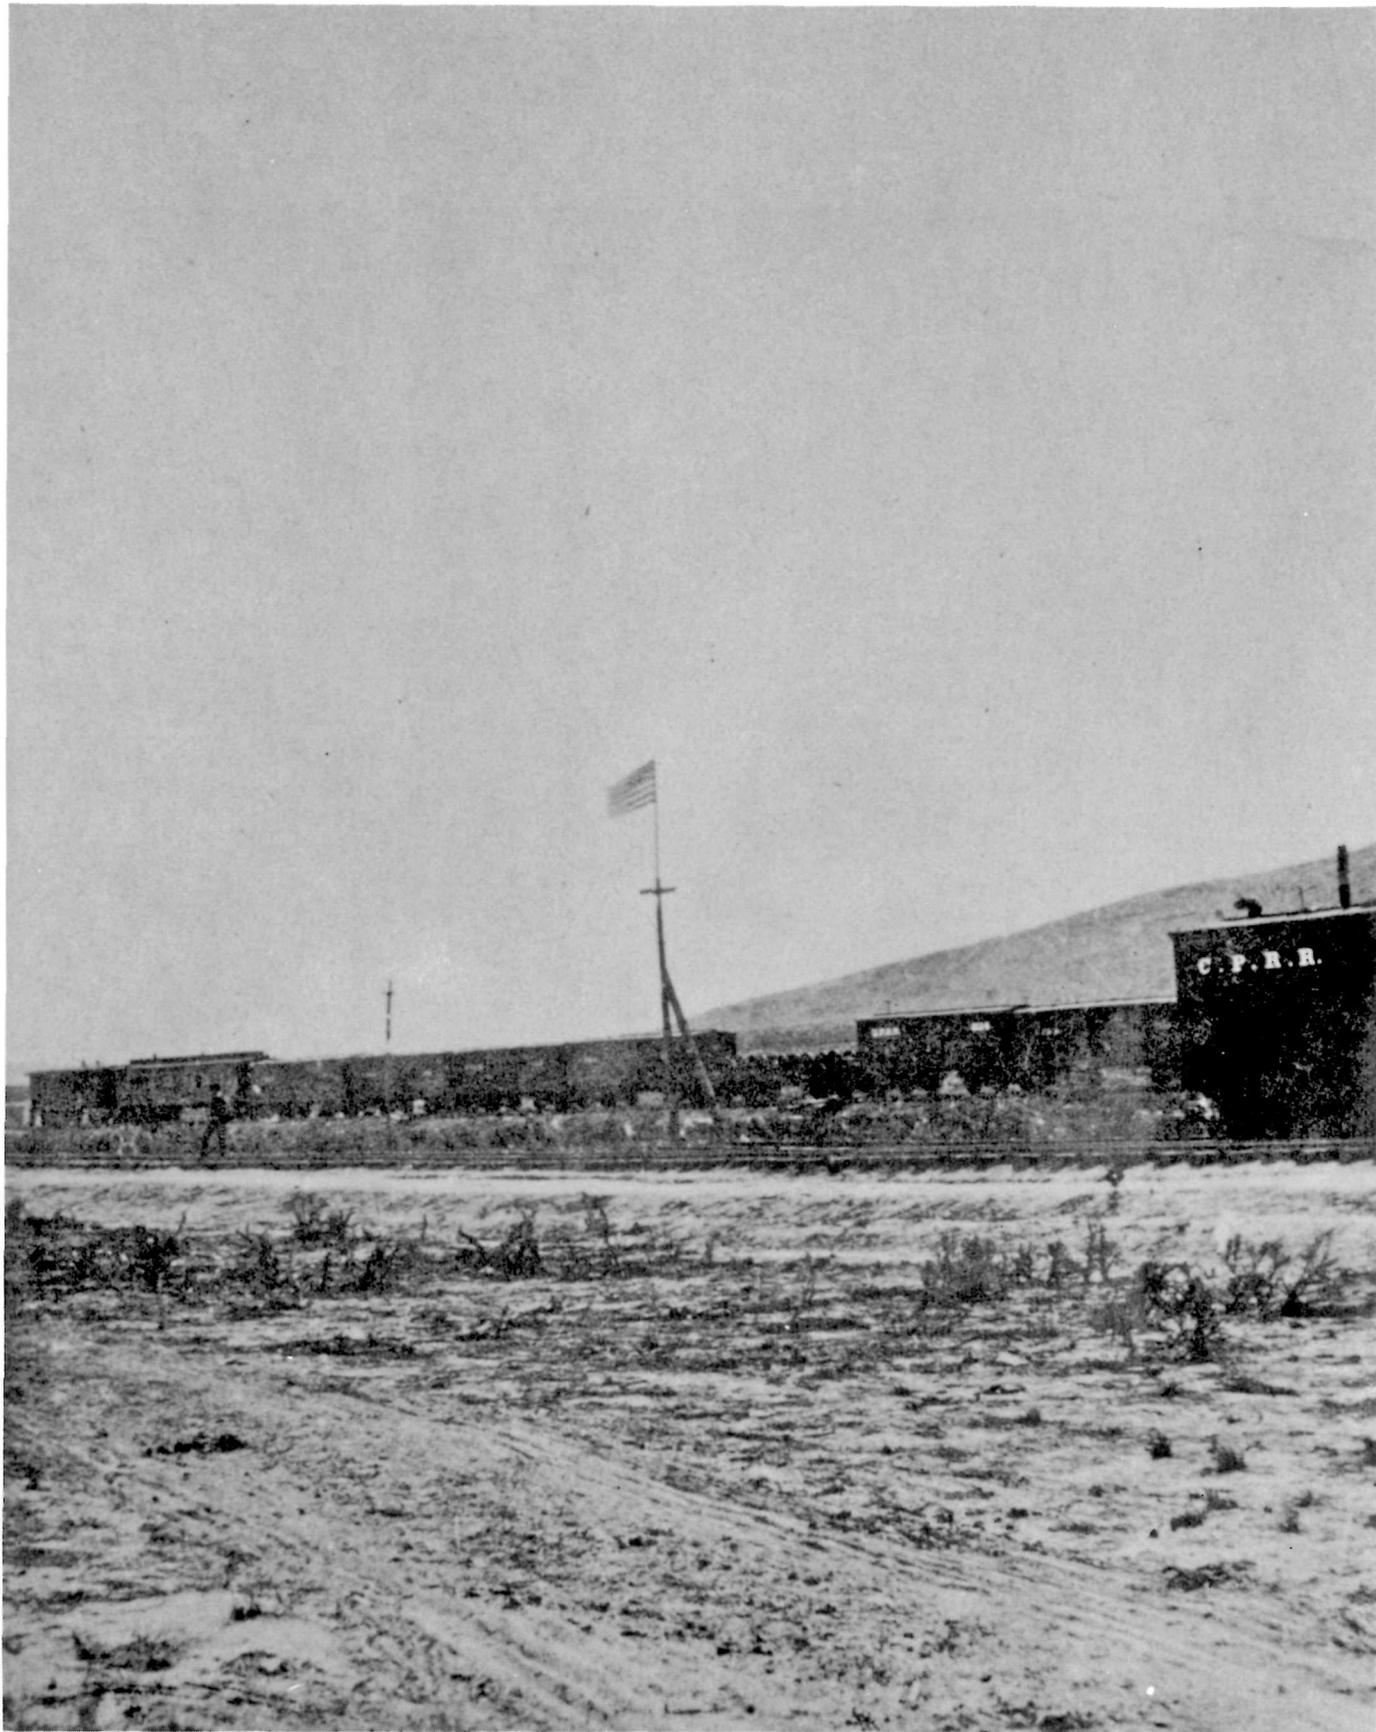
18. This is the second picture william Henry Jackson took at Promontory Summit in July 1869. Jackson stood on the north side of the track and pointed his camera southeast. The flag still flies from the same telephone pole to which it was affixed for the Golden Spike ceremony two months earlier. The nearest track is the Central Pacific. The one in view beyond on which boxcars, a flat car, and coach stand is the Union Pacific grade, now apparently used as a siding. The car at right front carries C.P.R.R. marking for Central Pacific Railroad; those on the far track are clearly marked UPRR, for Union Pacific.

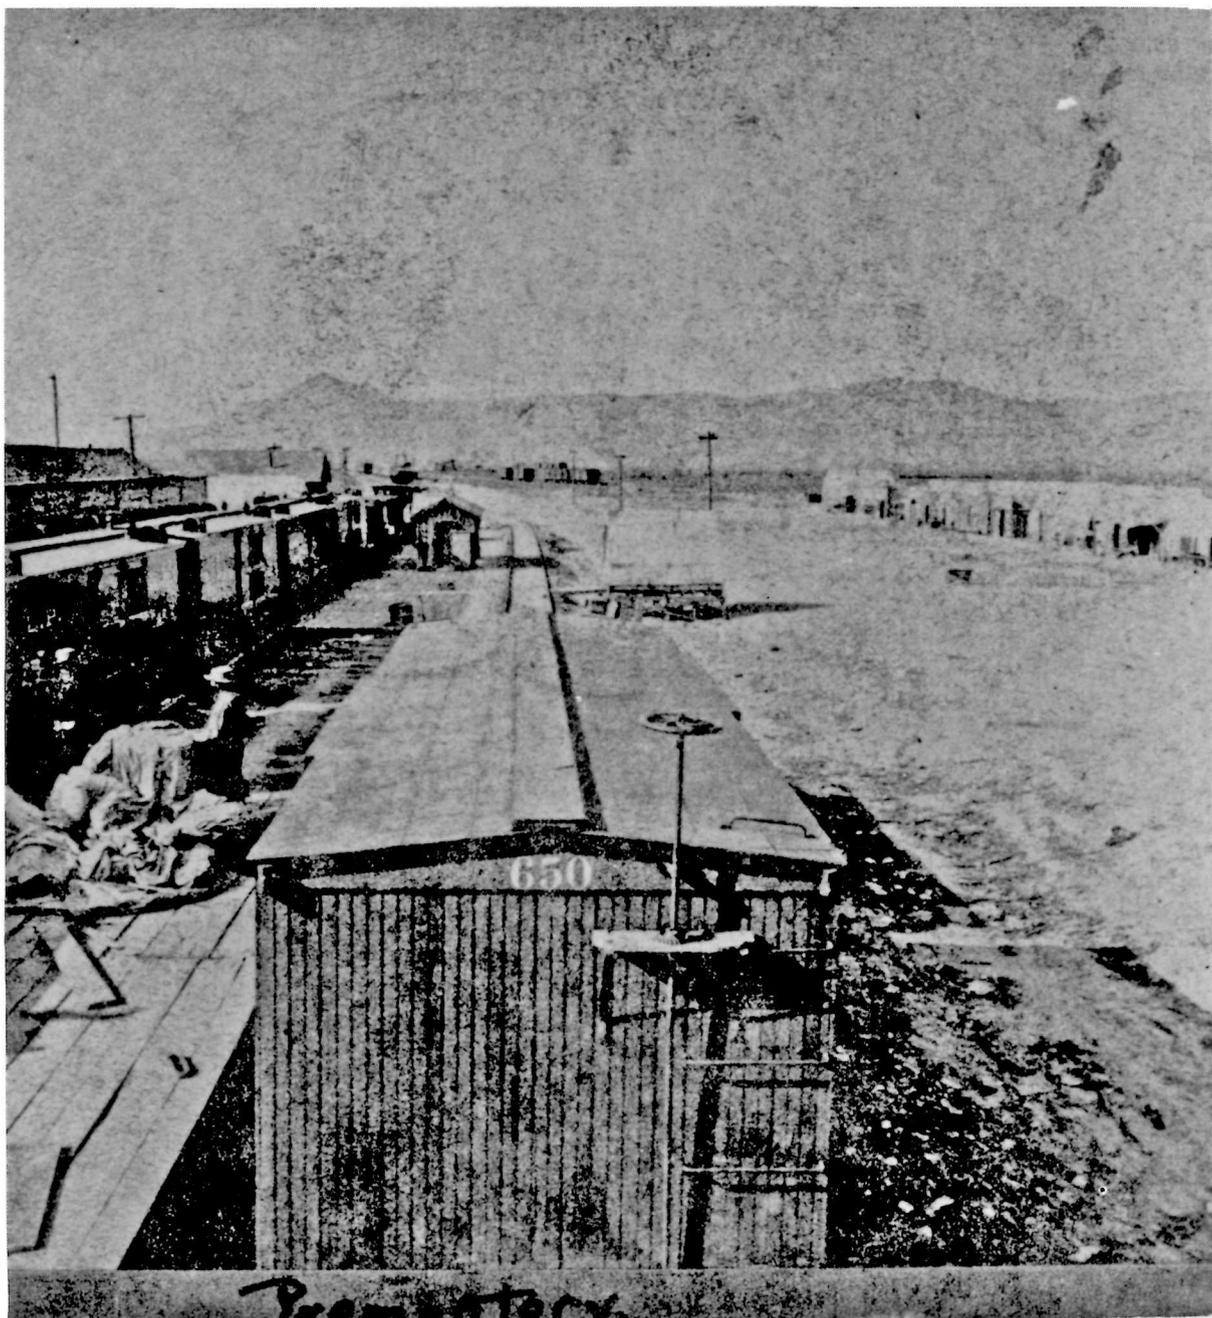
19. This is a view, looking west, of Promontory Summit at the Promontory station sometime late in 1869, 1870, or in 1871. It apparently was taken by Andrew J. Russell. This picture was copied from a **stereo** attributed to him in the Union Pacific Railroad Museum at Omaha, Nebraska. This picture is of great interest since it shows the town of Promontory that grew up at the Golden Spike site at what was probably the peak of its development and activity, or nearly so. The front line of stores and buildings of the town show at the right margin of the picture. This is on the north side of the track. The Central Pacific siding west of the town shows in the distance with rail equipment standing on it. The railroad depot, platform, and dining room show in left foreground. The dining facility is immediately adjacent to the track on the south side. Russell probably took this picture on the second trip over the railroad to the Pacific Coast which he made in 1870-1871. This picture discloses that the town grew up on the north side of the tracks, but that the depot facilities were mostly on the south side.

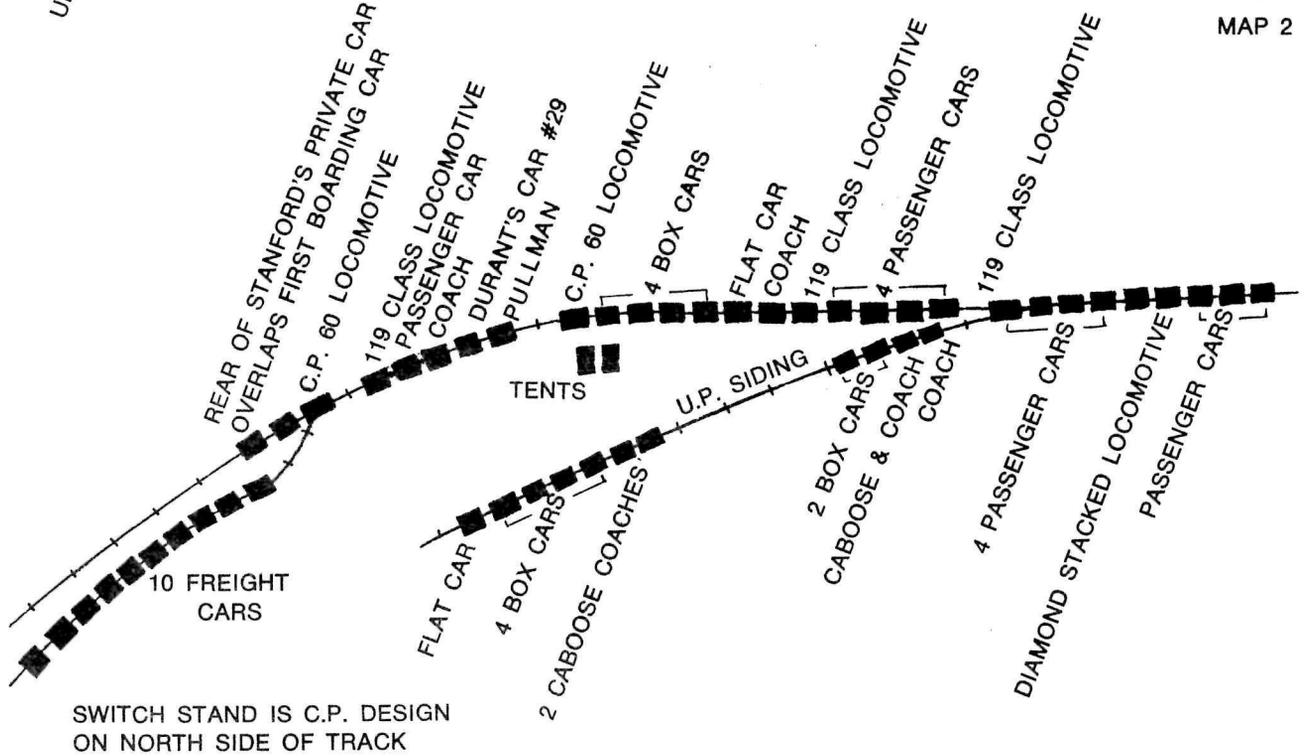
MAP 2

**CONDITION AT NOON 5-10-1869**

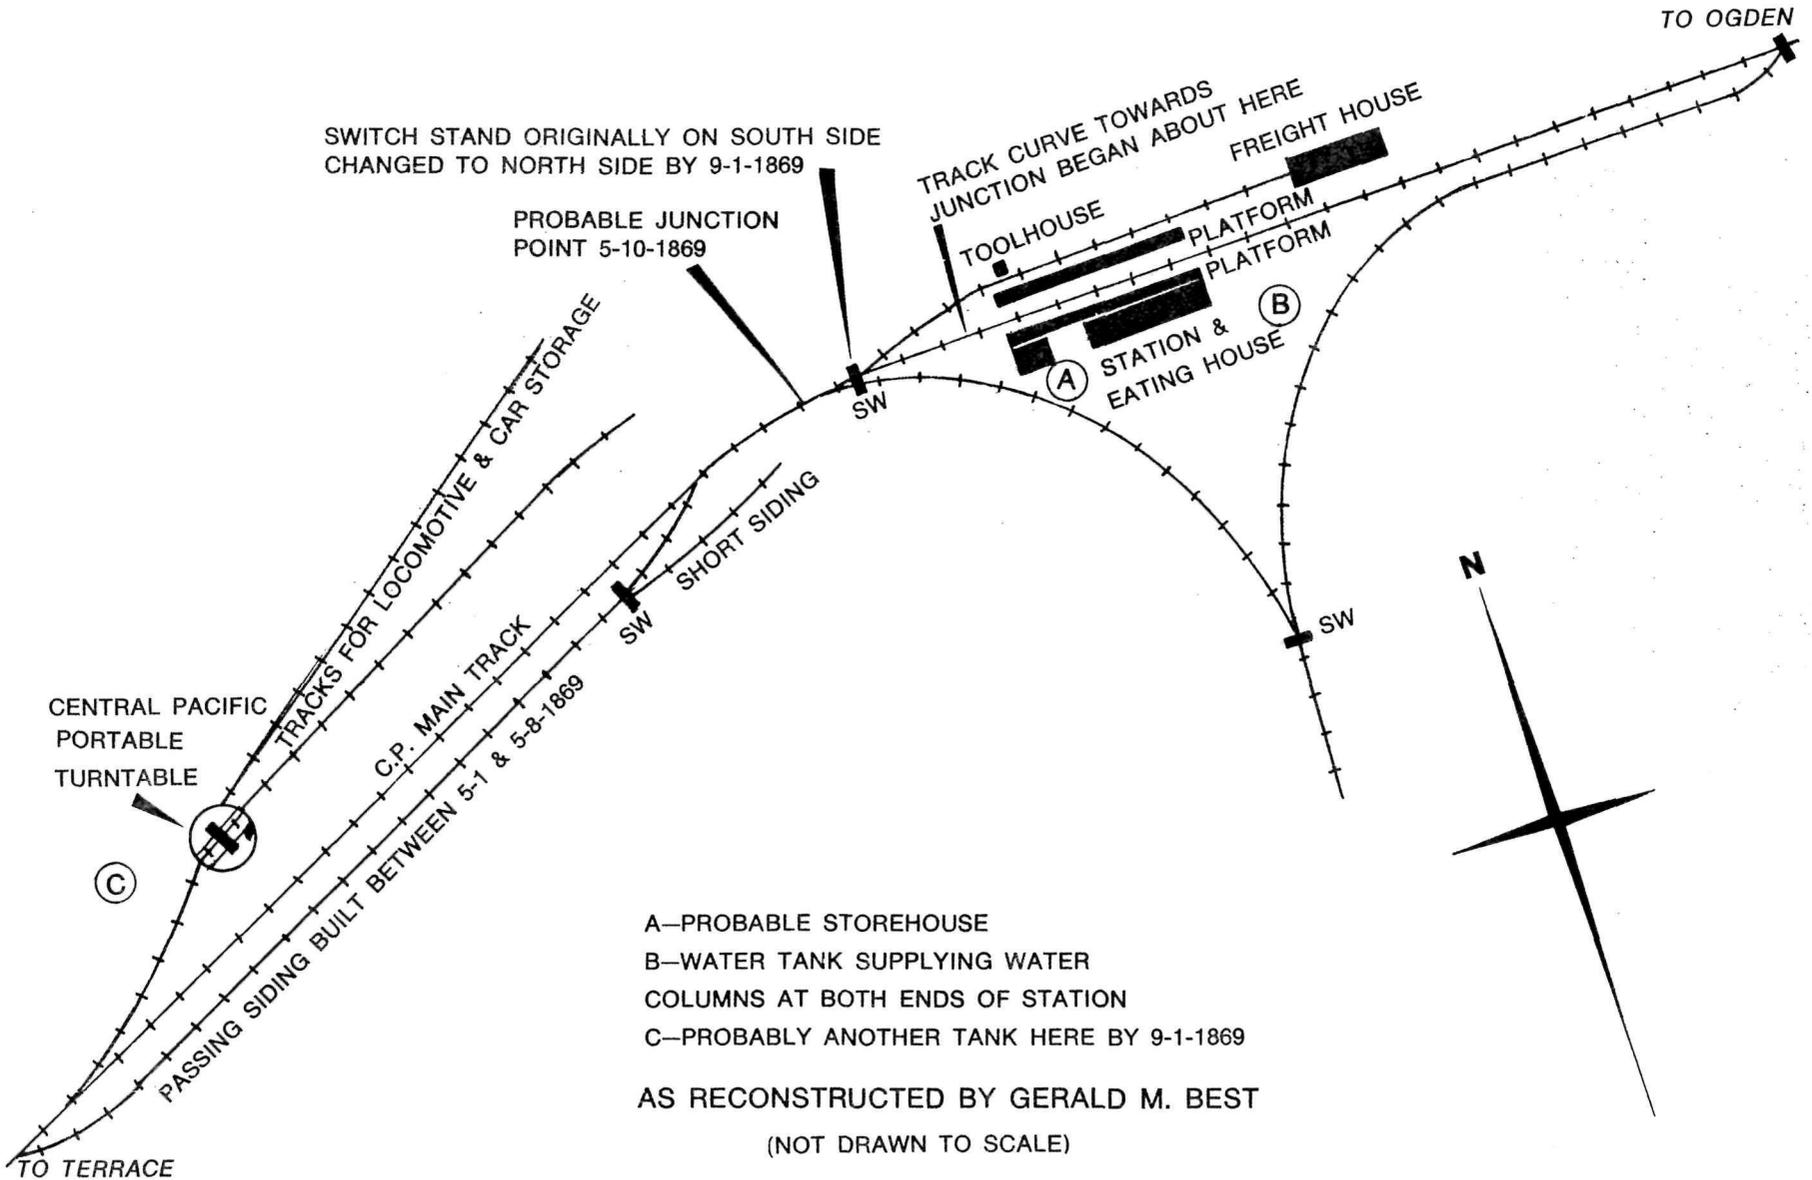
# PROMONTORY AS OF 9-1-1869

SWITCH STAND ORIGINALLY ON SOUTH SIDE  
CHANGED TO NORTH SIDE BY 9-1-1869

PROBABLE JUNCTION  
POINT 5-10-1869
