GRAND CANYON NATIONAL PARK ROADS
Grand Canyon National Park
Grand Canyon Village
Coconino County
Arizona

HAER No. AZ-35

GRAND CANYON NATIONAL PARK ROADS
GRAND CANYON NATIONAL PARK
HAER No. AZ-35

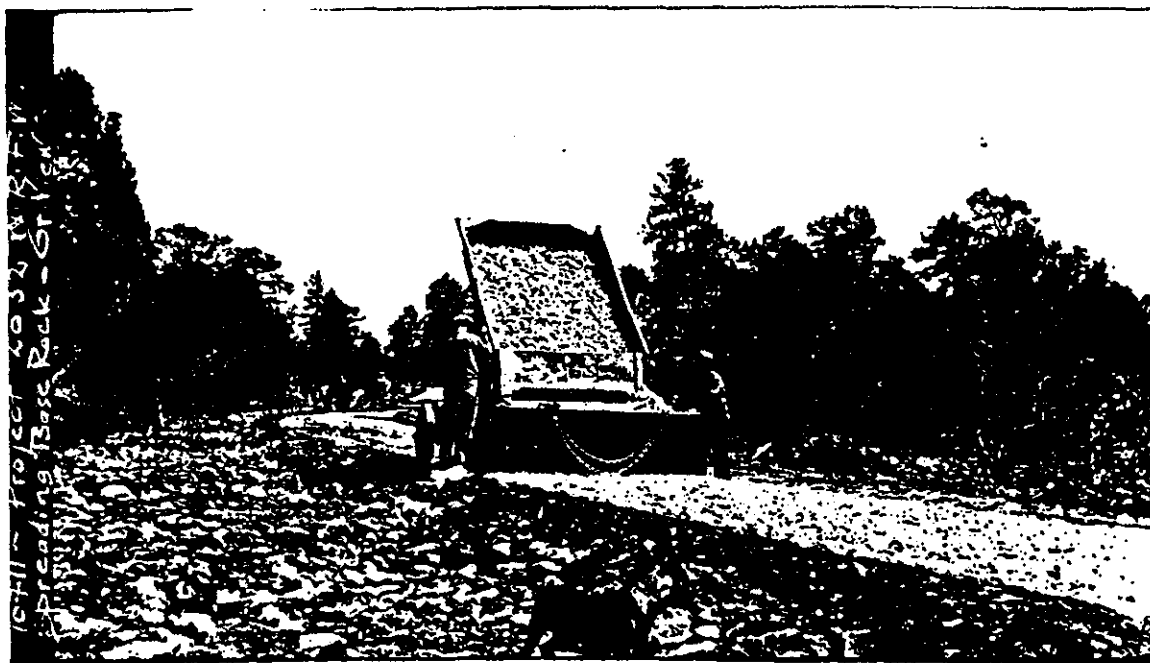
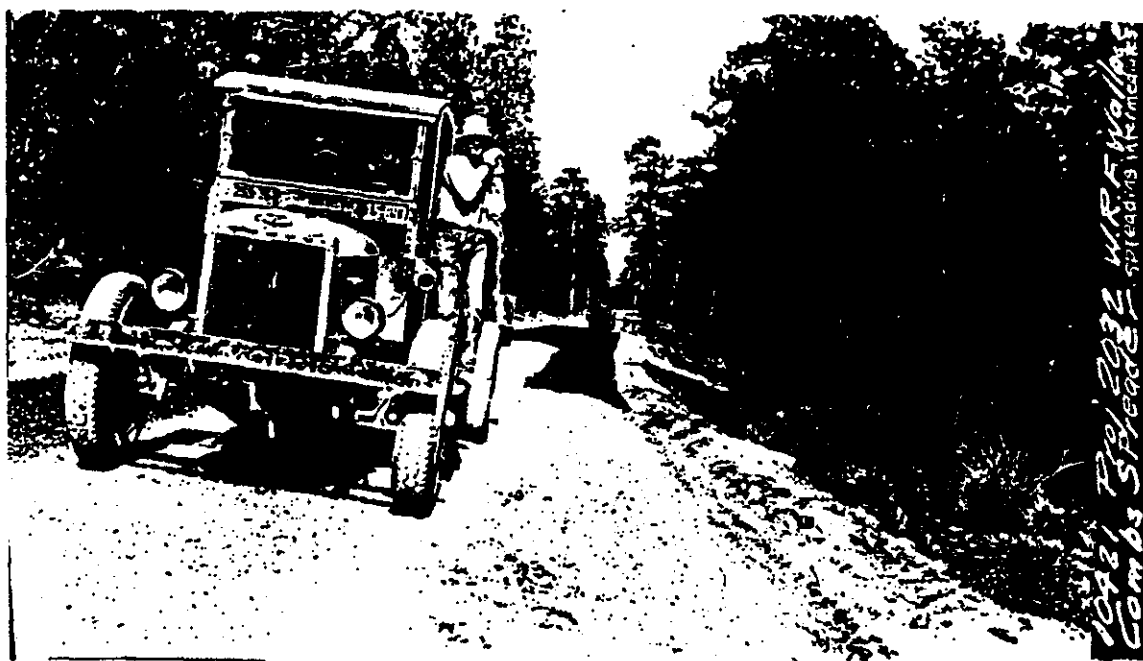
Figures 4 and 5. Subgrading (above) and surfacing (below) for 1927-28 South Entrance Road Construction. (Final Construction Report, GCNP Study Collection)

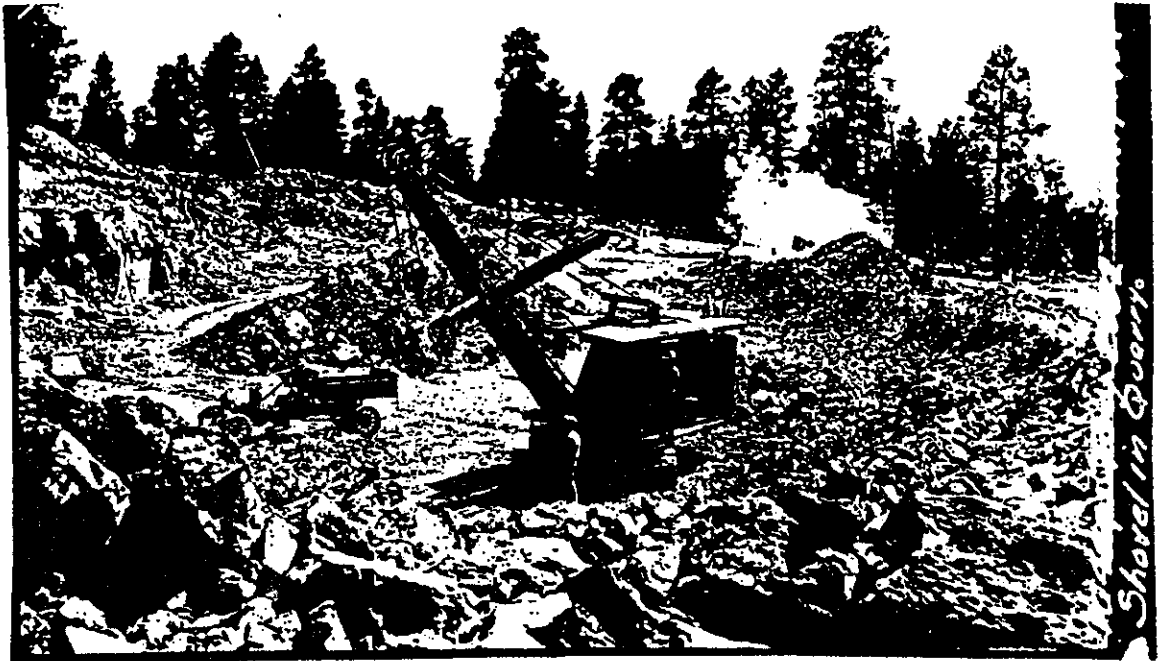
Figure 6. Quarry near town of Tusayan, used for 1927-28 South Entrance Road construction. (Final Construction Report, GCNP Study Collection)

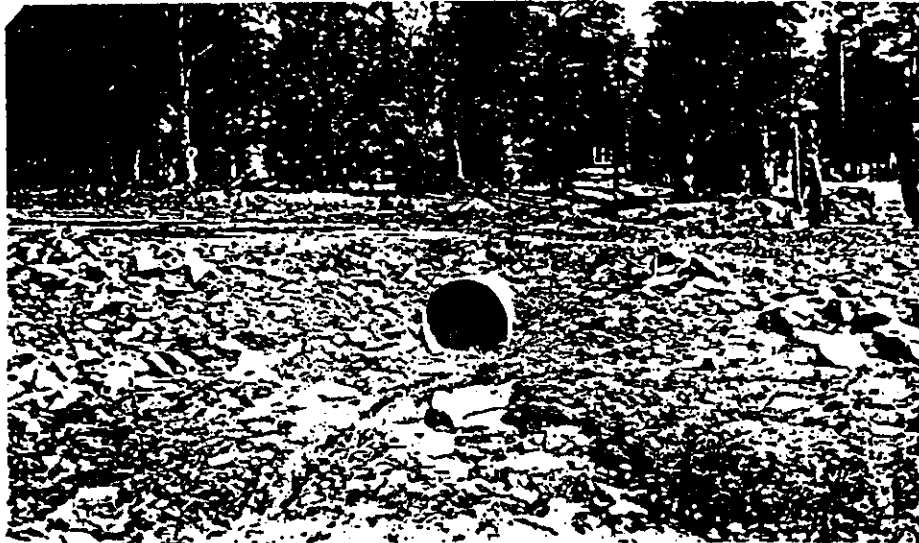
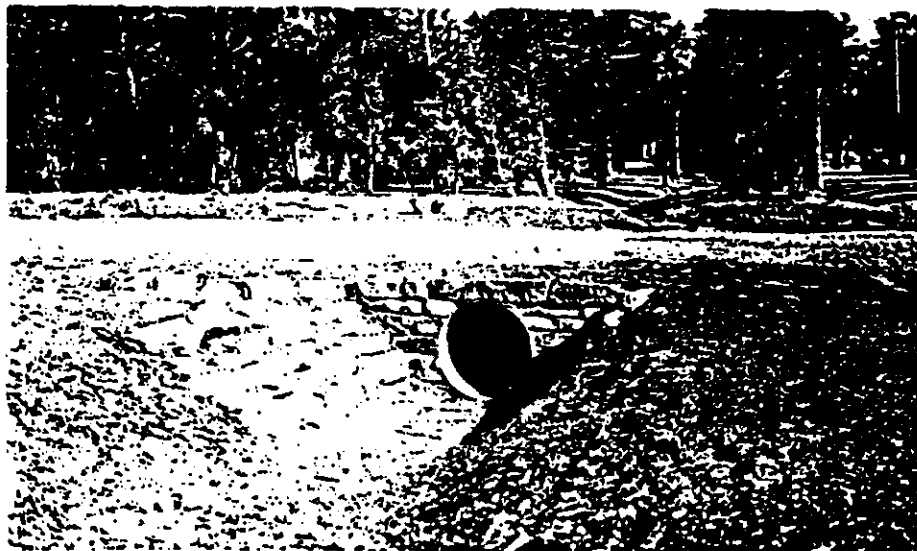
Figures 8 and 9. Example of culverts before (above) and after (below) C.C.C. headwall construction. (GCNP Study Collection)

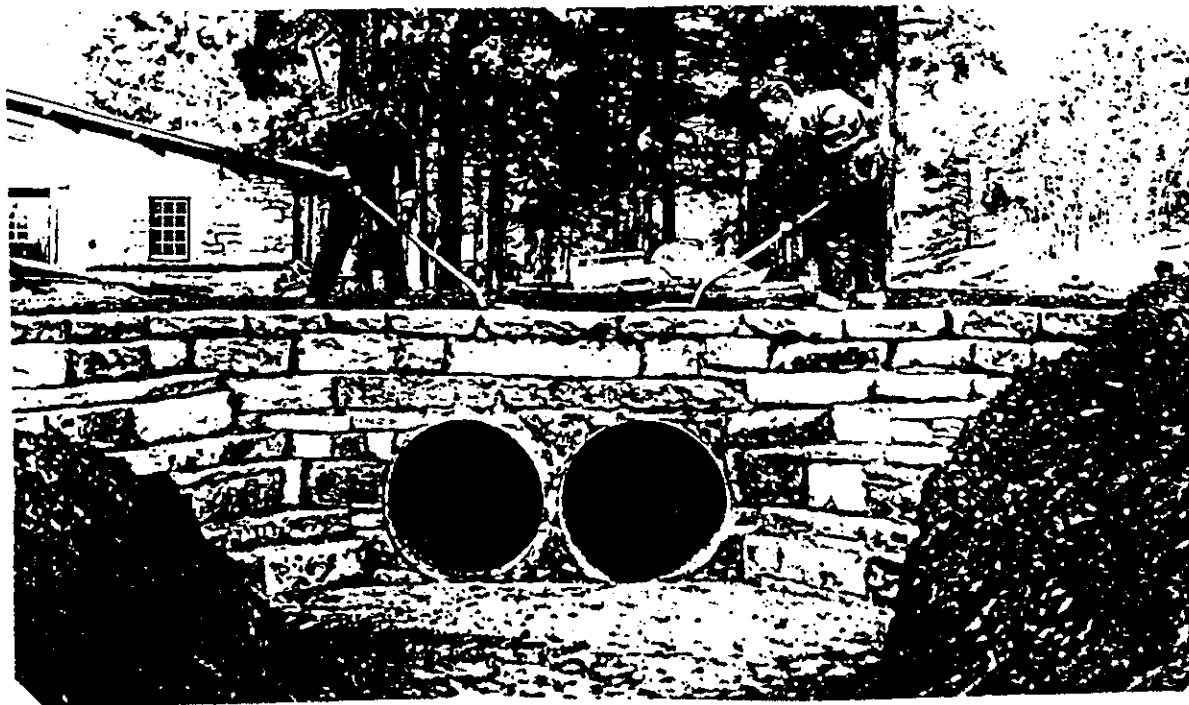
Figure 10. Example of fine masonry headwall near the Fred Harvey garage, built by C.C.C. crews between October 1933 and April 1934. (CCC reports, GCNP Study Collection)

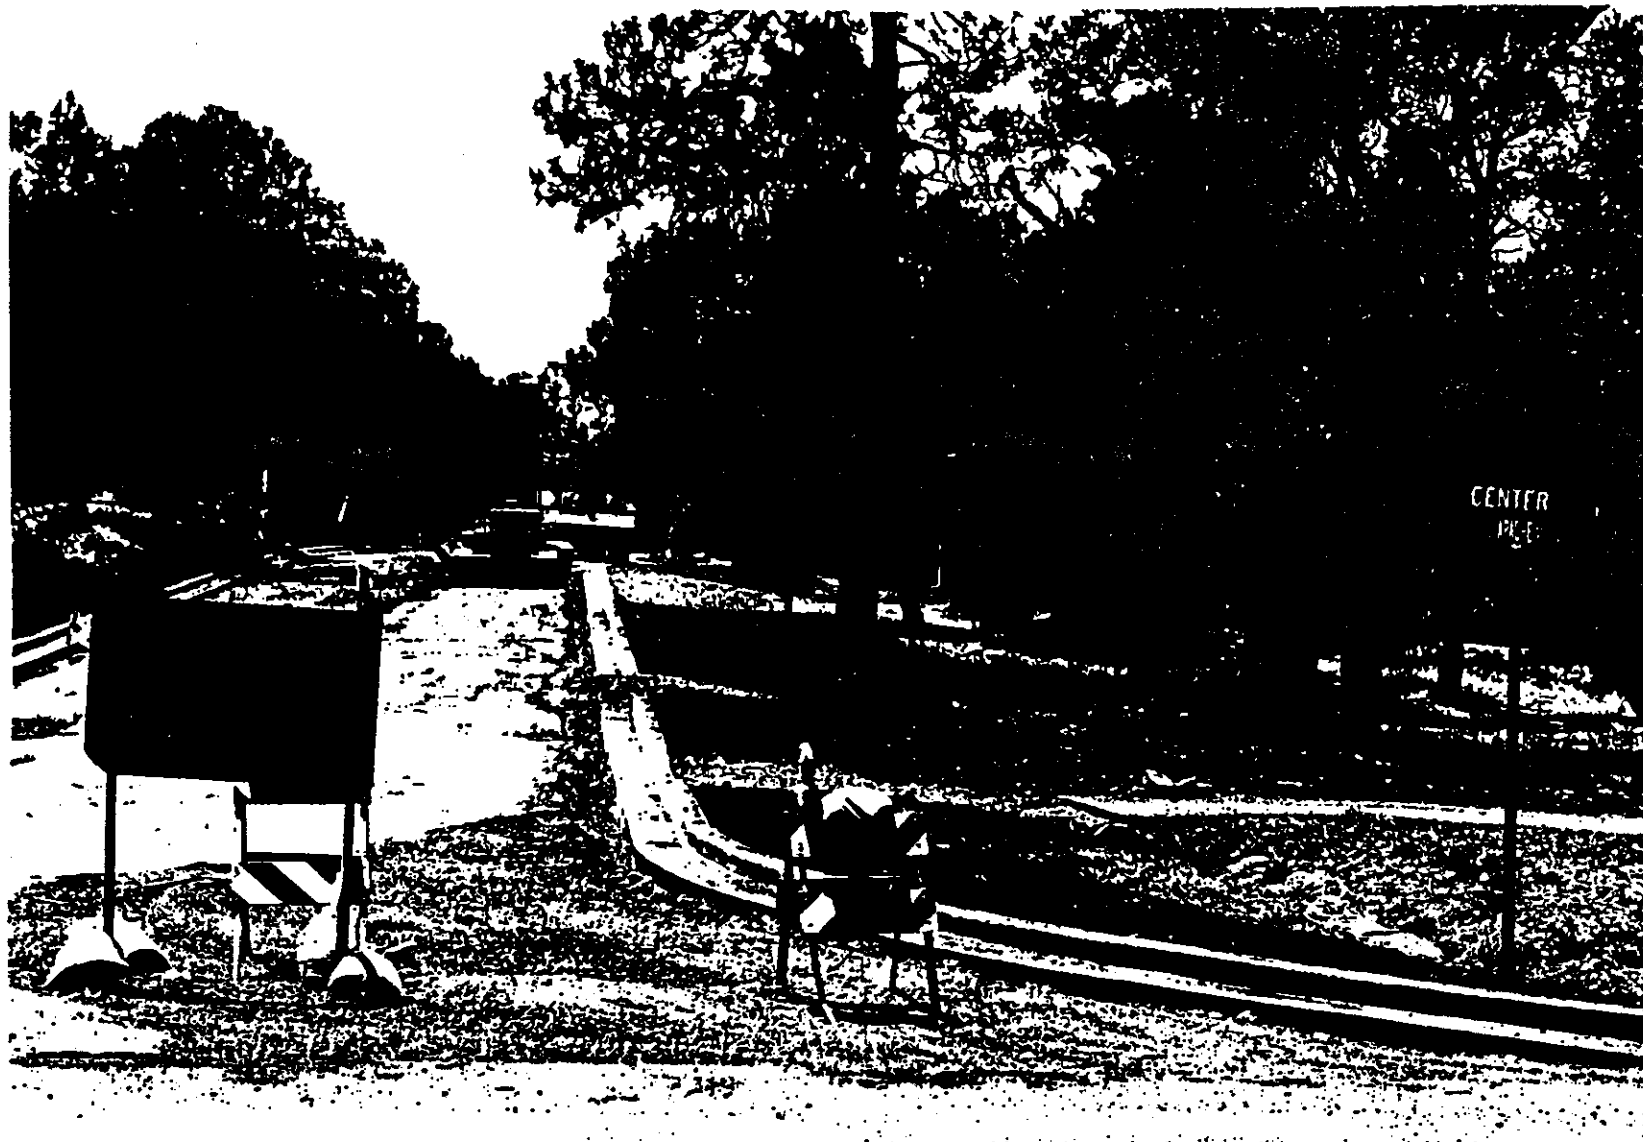
Figure 12. Road construction near Apache Street Headwalls #1 and #2. Top of Headwall #1 is beside the street sign. (GCNP Study Collection #16095)

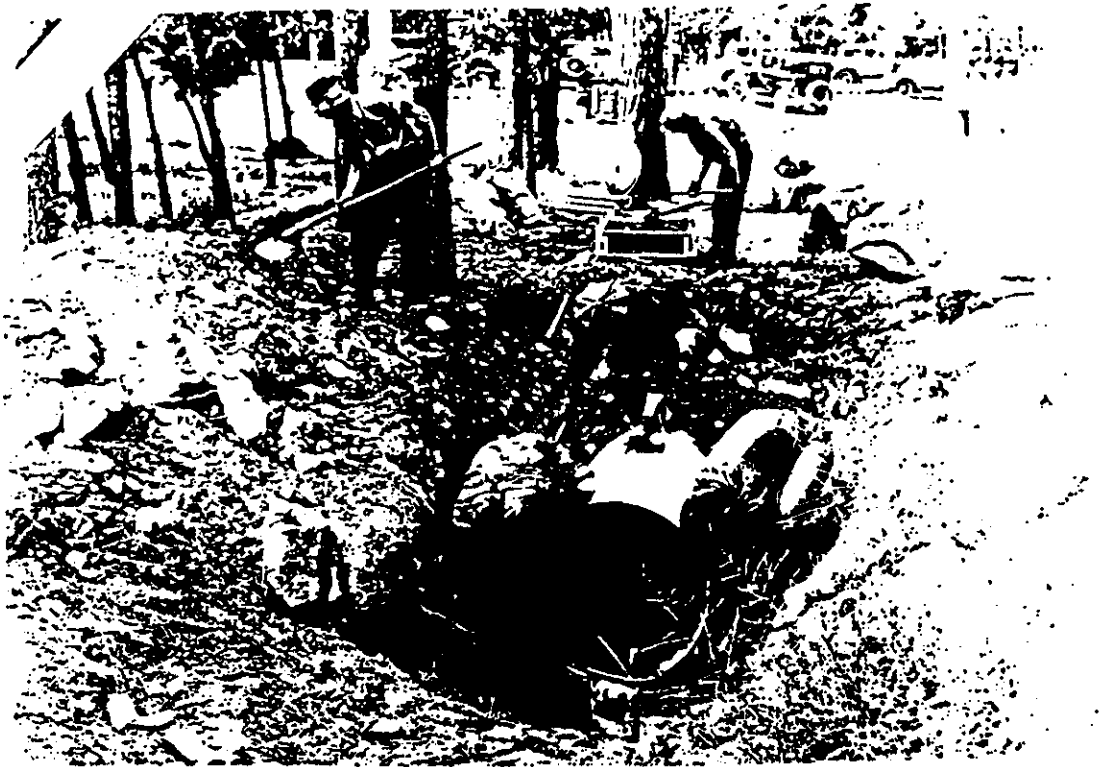
Figure 13. Village Loop Drive Headwall #1 under construction, September 1934. (CCC Reports, GCNP Study Collection)

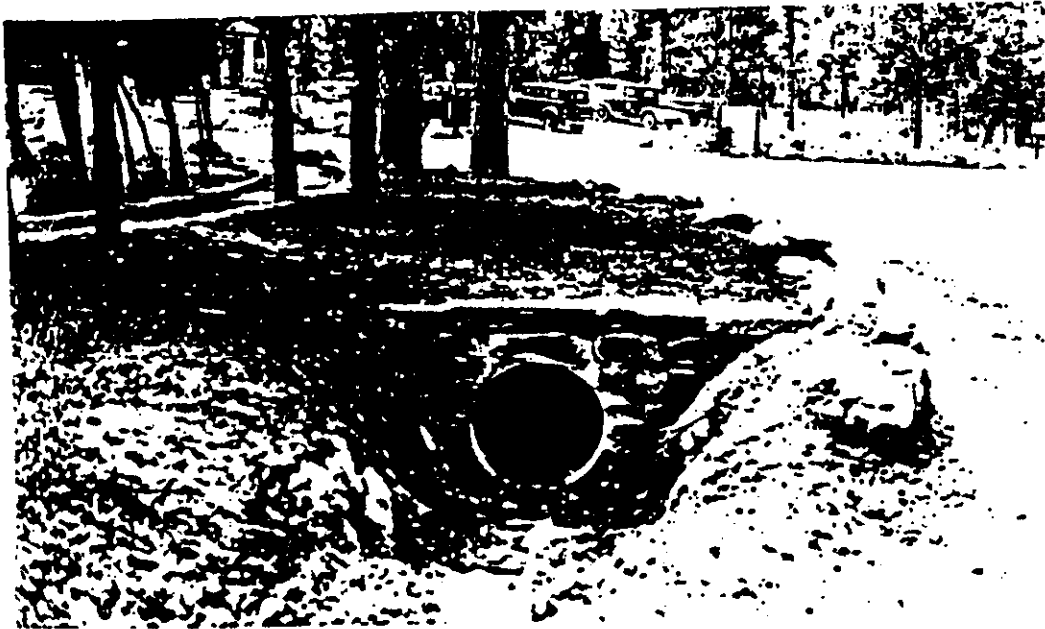
Figure 14. Village Loop Drive Headwall #1 completed, September 1934. (CCC Reports, GCNP Study Collection)

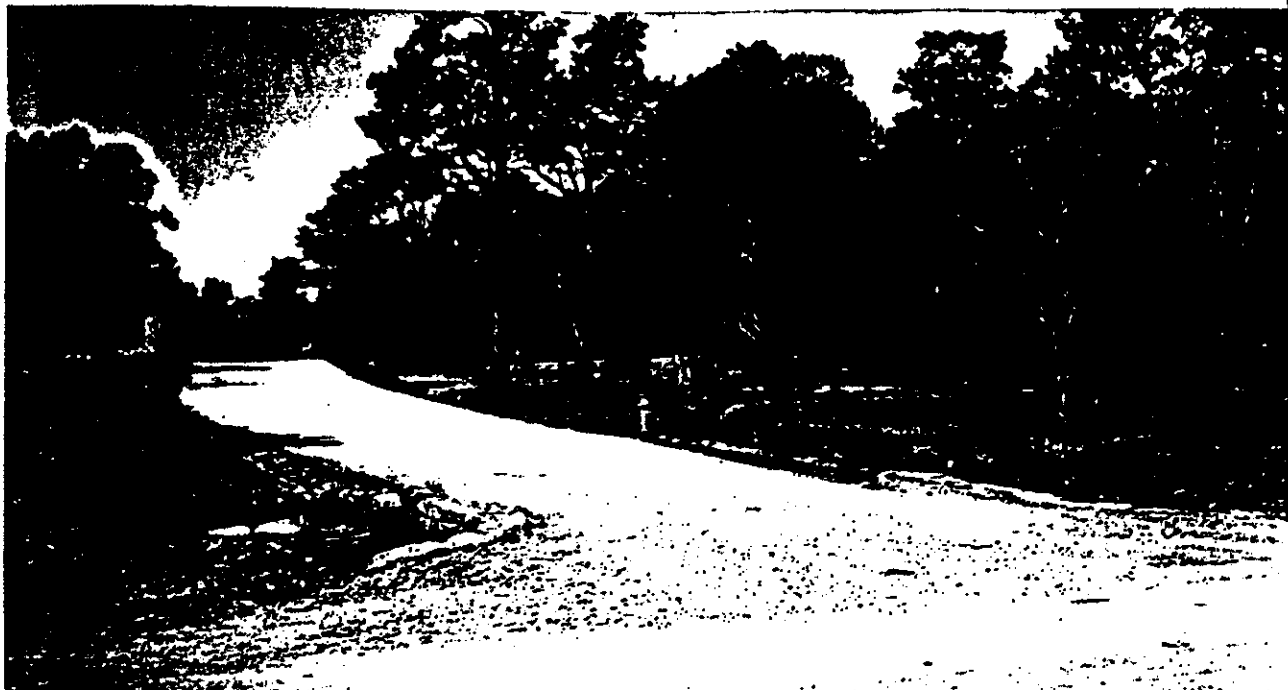
Figure 17. Avenue A (Apache Street) road grading, 17 July 1935. Apache Street Headwall #1 (right) and #2 (left). (GCNP Study Collection #2912)

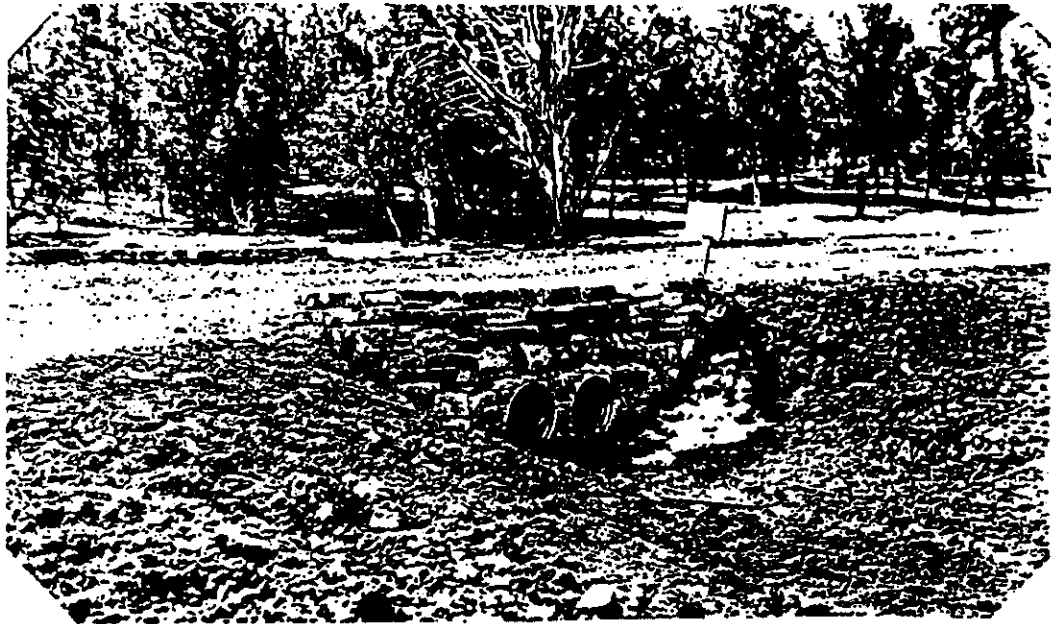
Figure 18. Boulder Street Headwall #1, February 1935. (CCC reports, GCNP Study Collection)

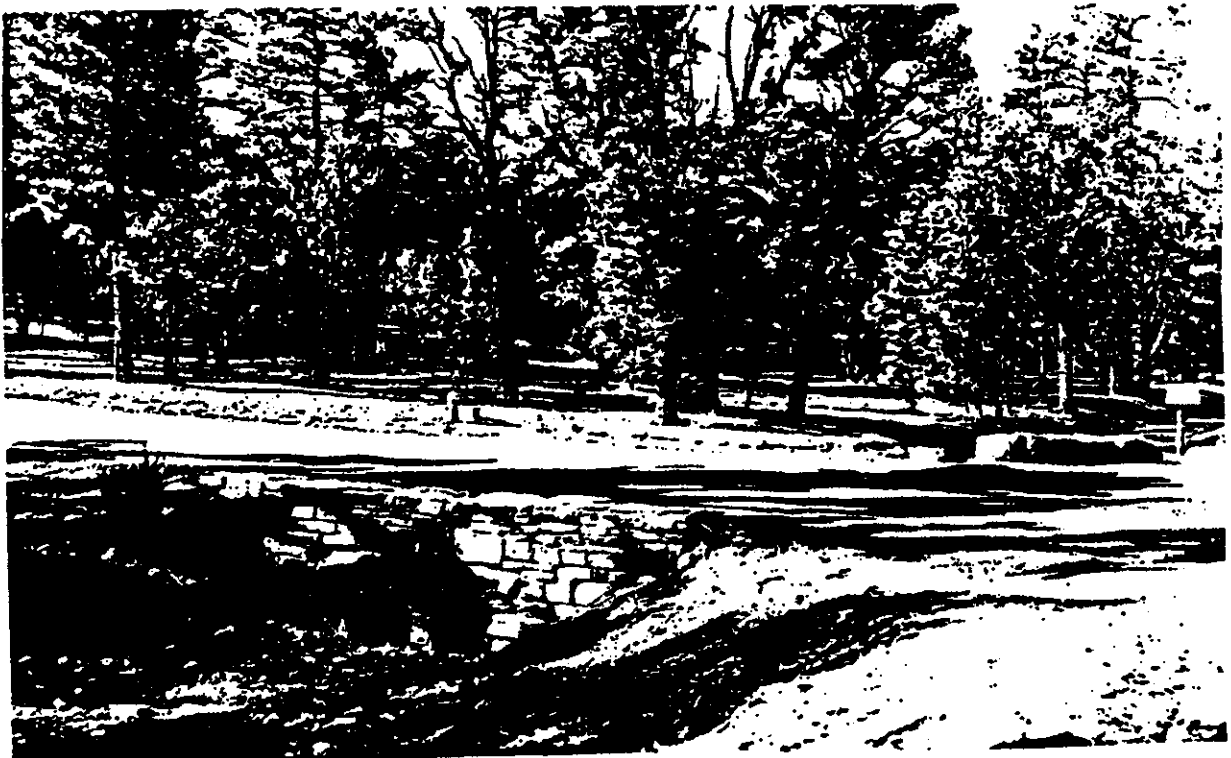
Figure 19. Headwall at southwest corner of Boulder Street and Center Road. The top of Boulder Street Headwall #1 is visible across the street. (From December 1936 Construction Report, GCNP Study Collection)

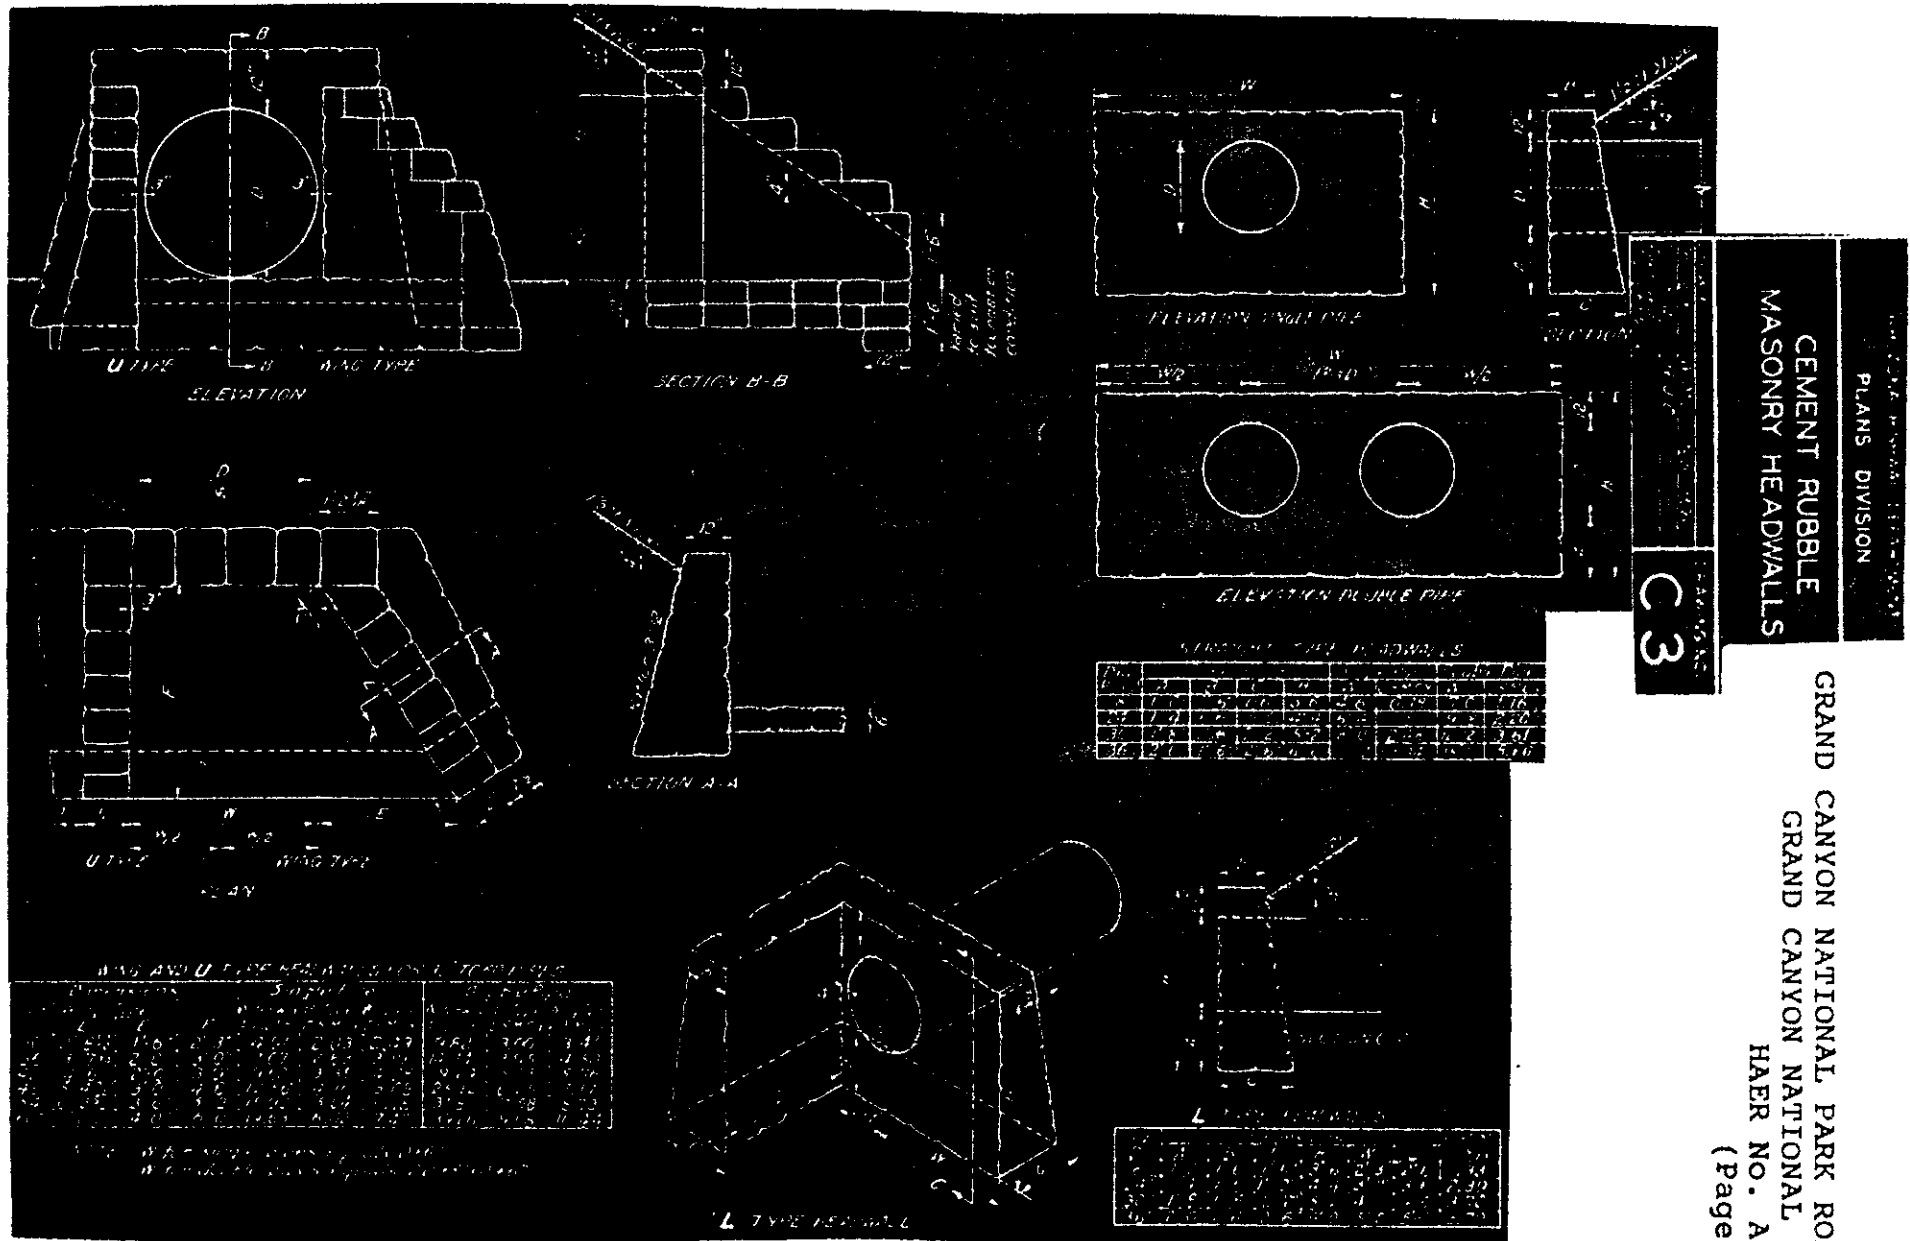
PLANS DIVISION
 CEMENT RUBBLE
 MASONRY HEADWALLS
 C 3

Figure 20. Plans of the Arizona Highway Department for masonry headwalls, 1936. (Plans and drawings cabinet, Railway Depot)
