National Park Service  
Cultural Landscapes Inventory  
2004

Kohrs Ranch House and Yard  
Grant-Kohrs Ranch National Historic Site

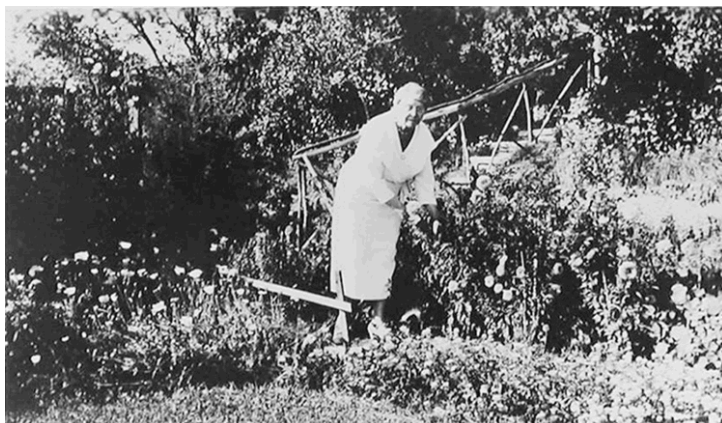
*Augusta Kohrs was largely responsible for the development and refinement of the Ranch House landscape. Note the stone stairs and rustic wooden handrail, built by Conrad Warren for Augusta in the 1930's (GRKO Bache 2).*

In 1934 Warren constructed a simple set of garden stairs from a pile of stones found on the west side of the house (Warren, GRKO 15600, 1984). Nine rectangular cut stone treads were placed on stacked risers dry-laid into the slope and aligned along a slight curve. A rustic style wooden handrail was built on the east side of the steps (1934). Also simple in construction, the handrail consisted of three wooden posts supporting a wooden railing and thin, decoratively crossed wooden balusters. While the extant stairs are original, the handrail is a reconstruction (1987).
