National Register of Historic Places  
Registration Form

historic name Zapata Ranch Headquarters

**Zapata Ranch Headquarters  
Mosca, Colorado**

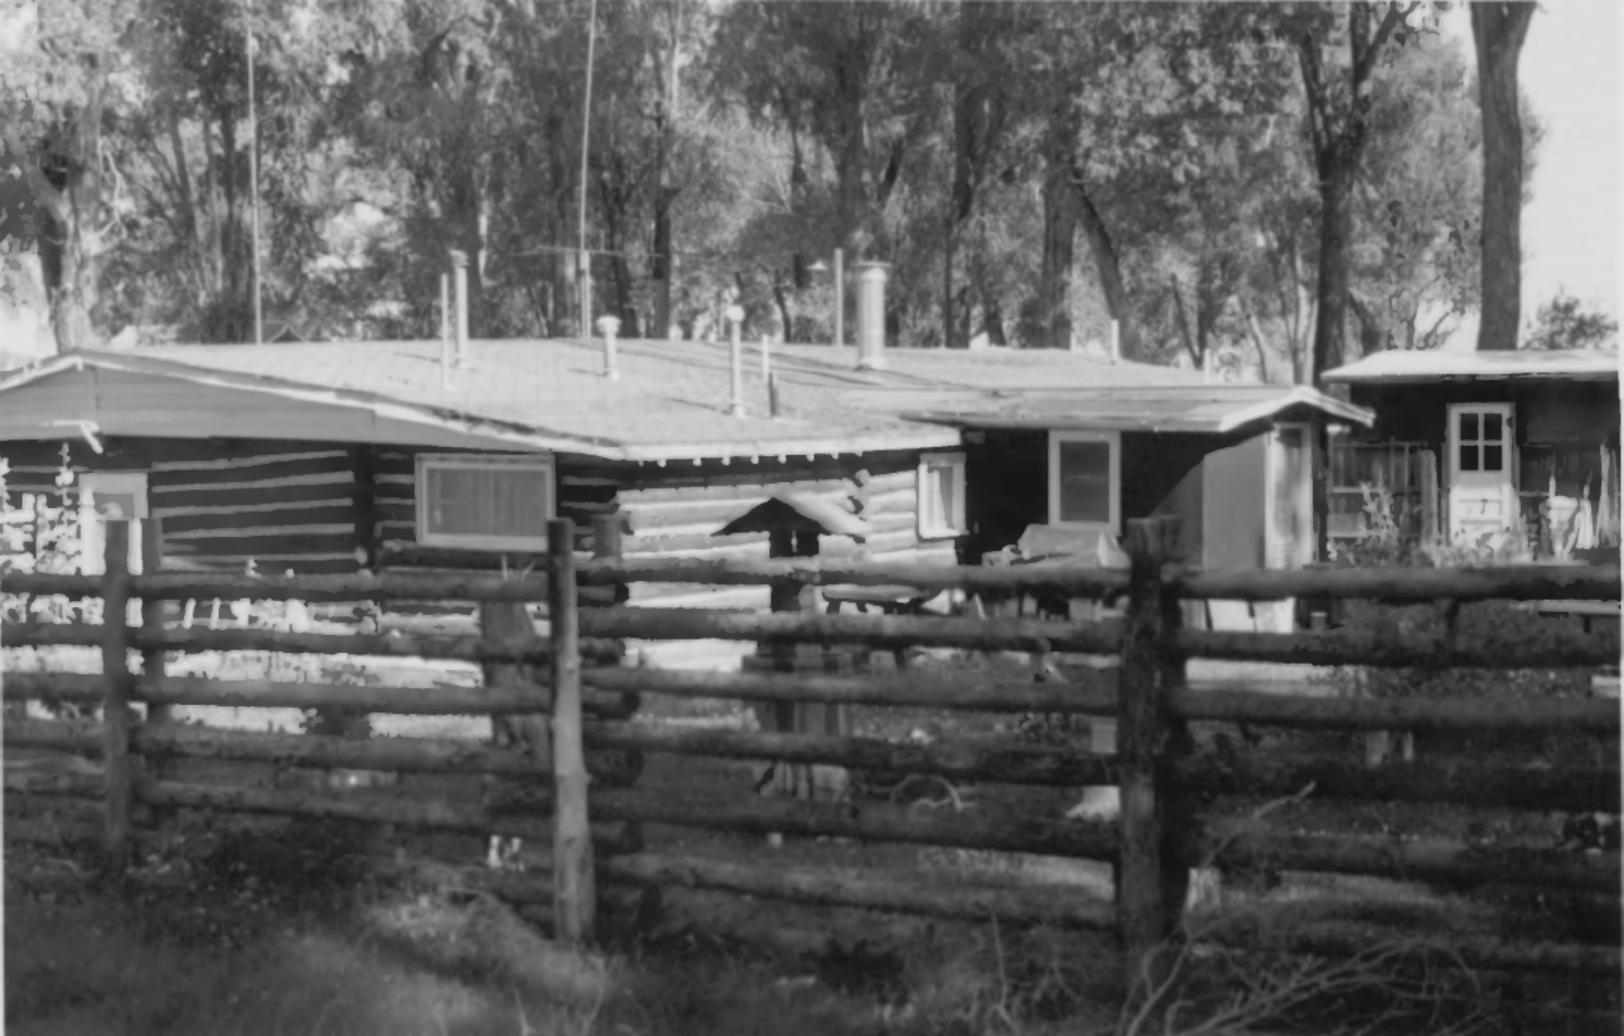
CARETAKER'S HOME - E. ELEV.

The east elevation is covered three-fourths of the way across by an enclosed shed roof addition. A gabled enclosed entry room extends out from a centered position. It has an entry door at the east end, and 6-over-6, double-hung windows, one each on the north and south sides.

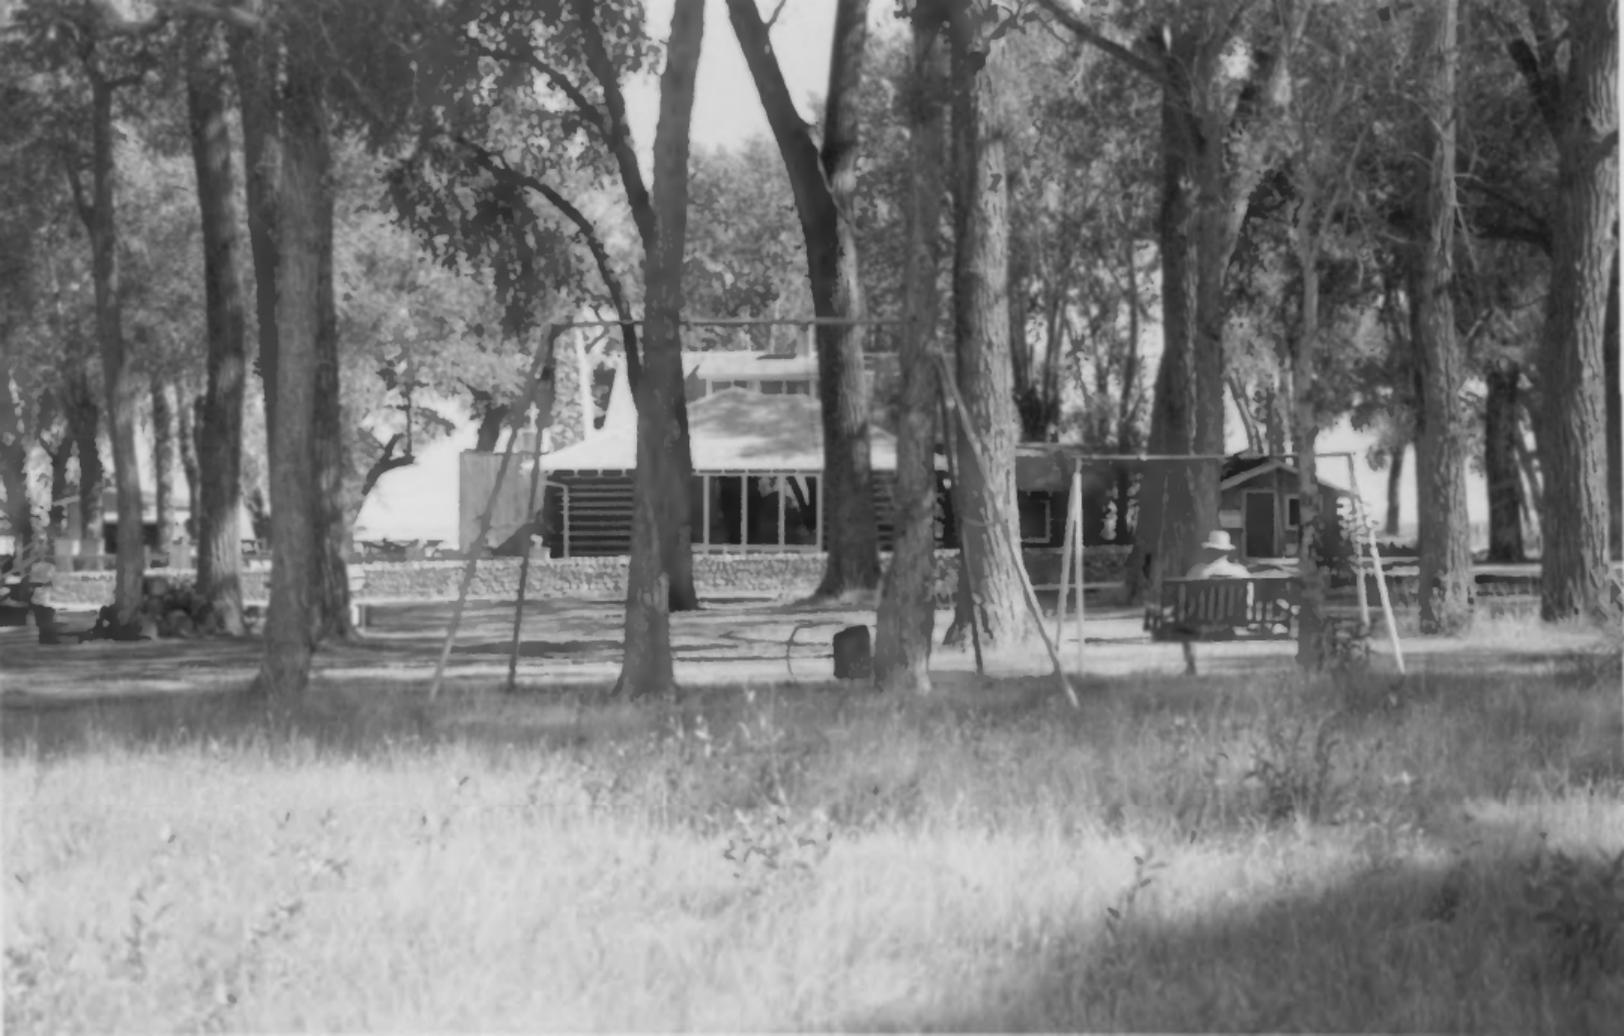
(RANCH HOUSE) INN - S. ELEV., RESTAURANT

The restaurant is housed in an addition on the south elevation which was built by the Stewarts in 1950. The front porch was removed to build the addition which was used as a living room from 1950 to 1988. The original front wall is still intact inside. The restaurant is of log construction with a hipped roof and exposed rafters. The east elevation has two sets of single light fixed windows. The south elevation has four adjoining long, rectangular single light windows which are centered in the south wall. The west elevation has a single light fixed window, large stone chimney, double exit doors leading onto a large wooden deck, and a small casement window. The ranch house behind the restaurant is much the same as it was during the ranching days of the Lingers. Interior spaces have been slightly changed. In 1950, a stone wall of rounded river rock was built which surrounds the ranch house yard and has not been altered.

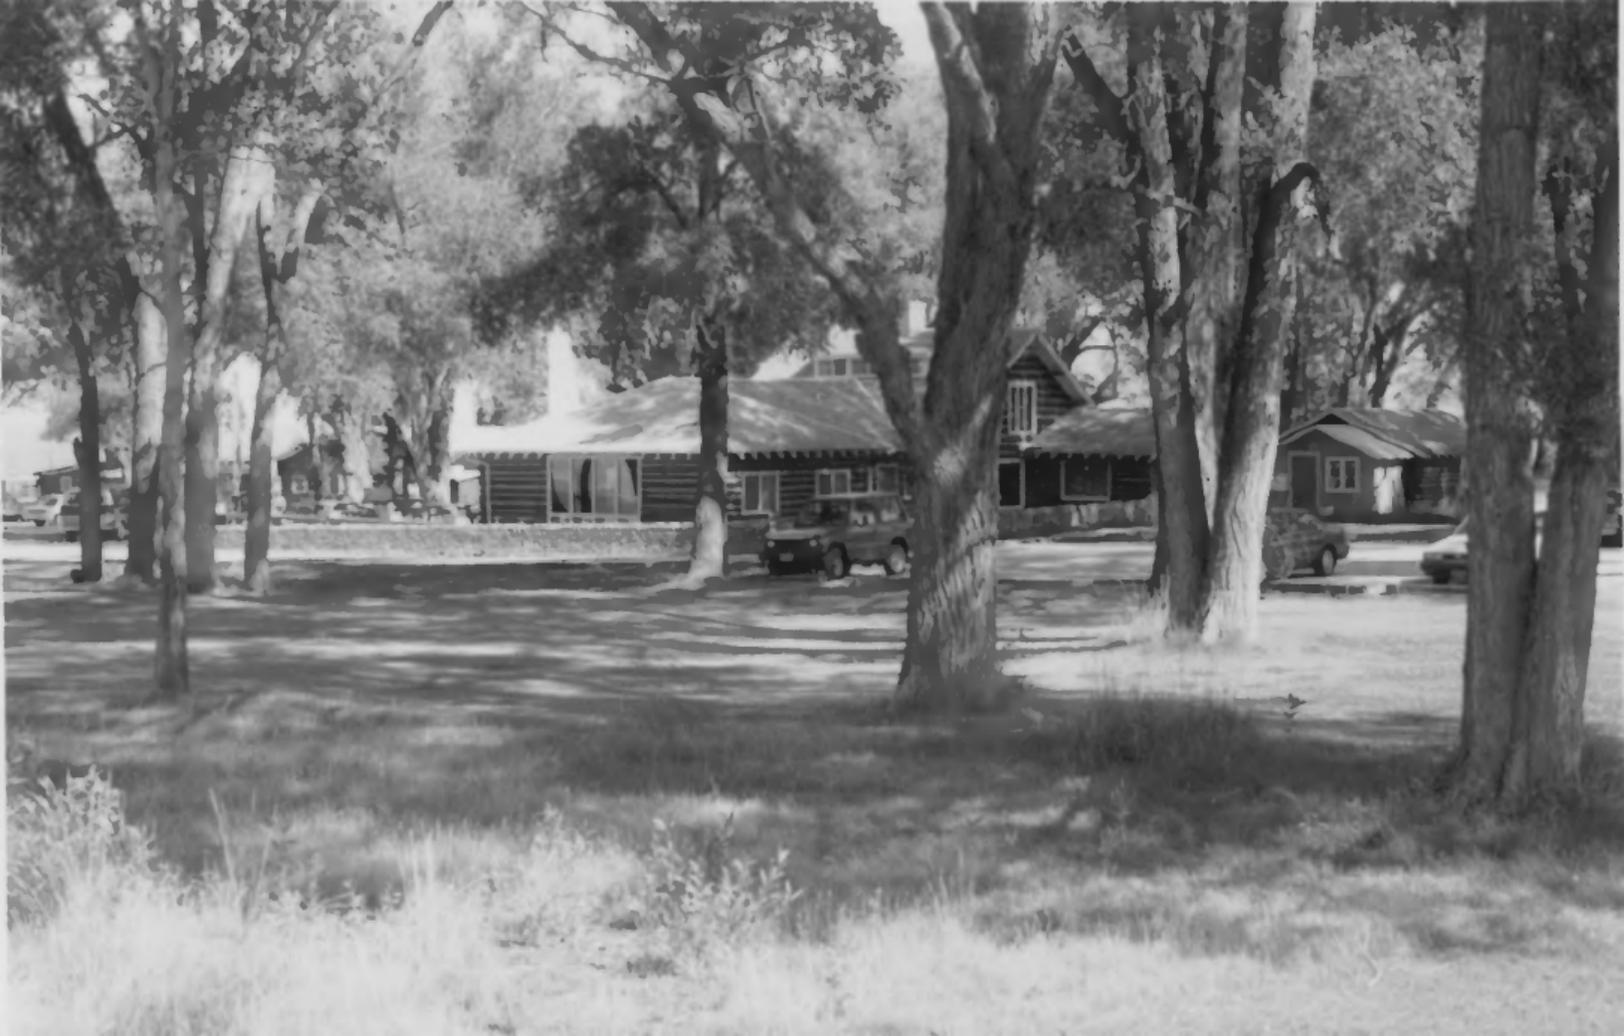
(RANCH HOUSE) INN - S.E. CORNER

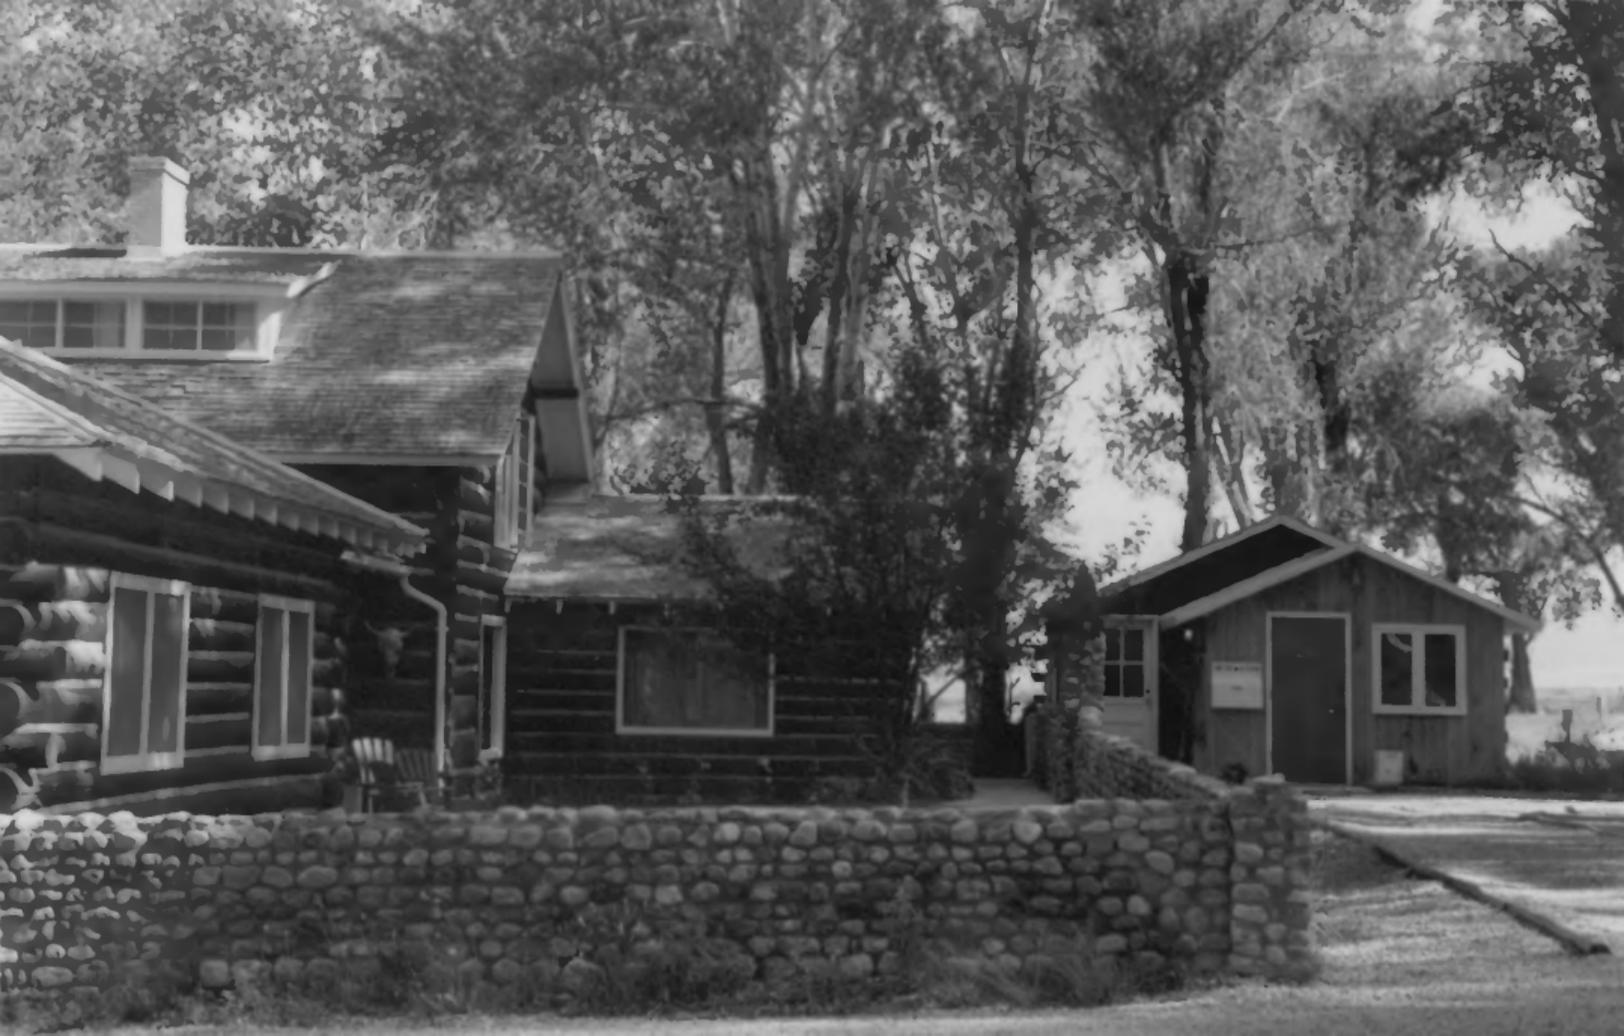
CONNECTION OF RESTAURANT ADDITION TO  
RANCH HOUSE. ORIGINAL STONE FENCE

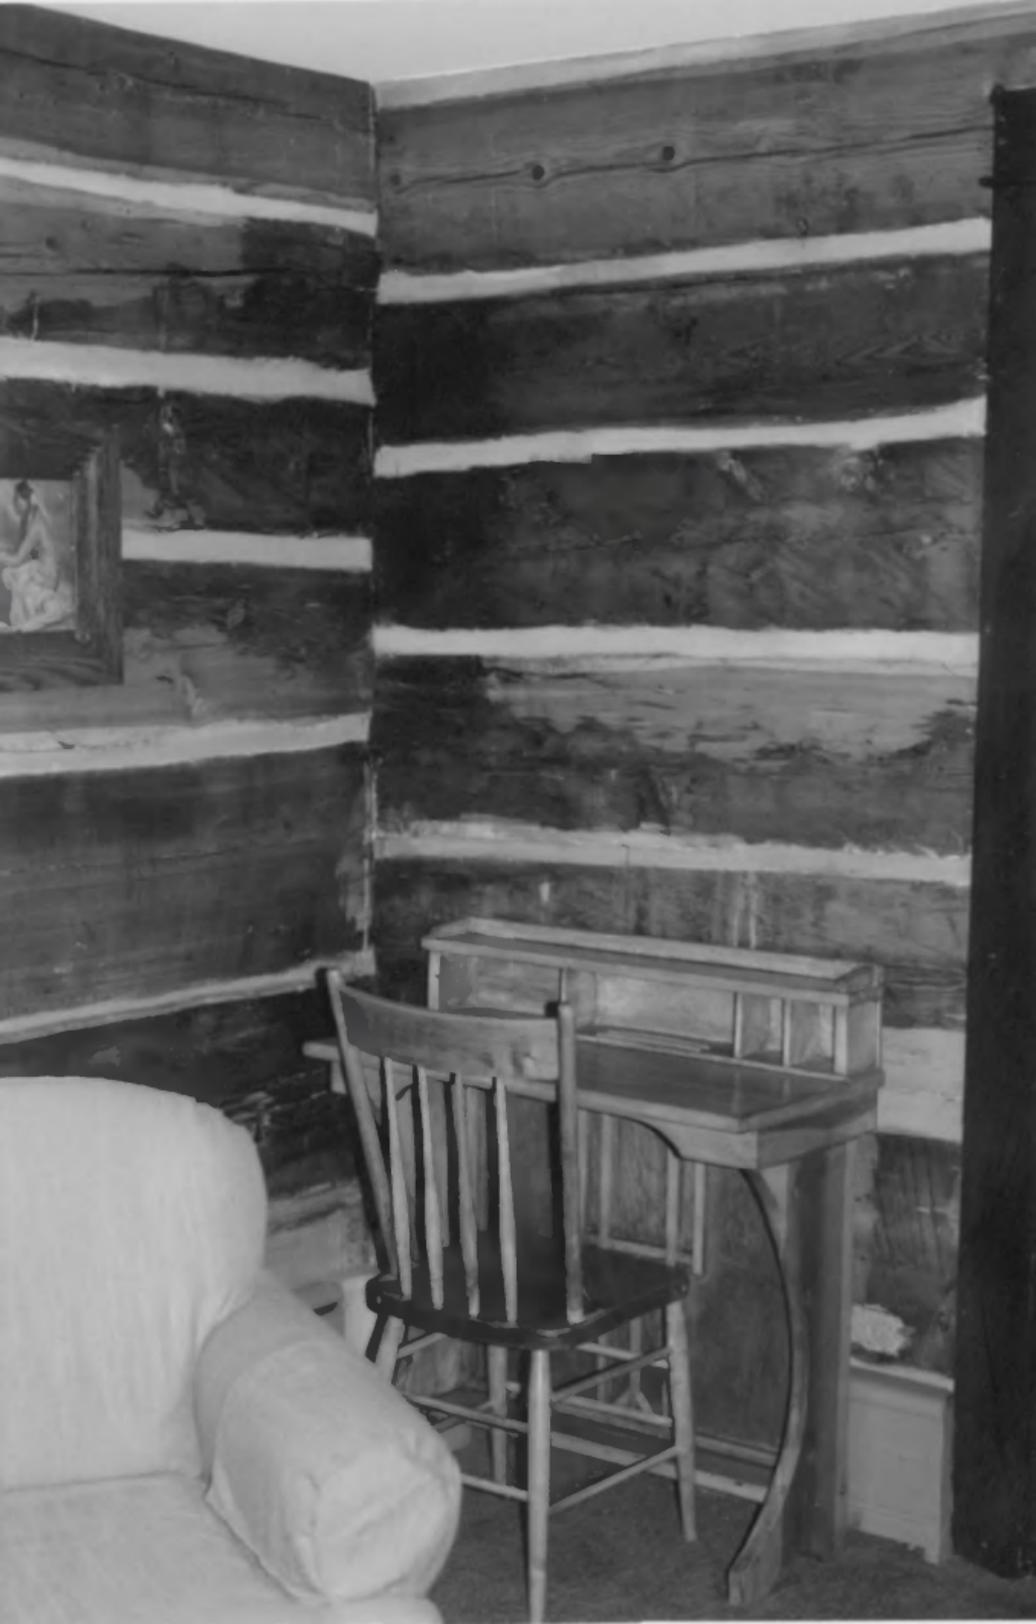
(RANCH HOUSE) INN LOBBY - INTERIOR

HAND-HEWN LOG WALL

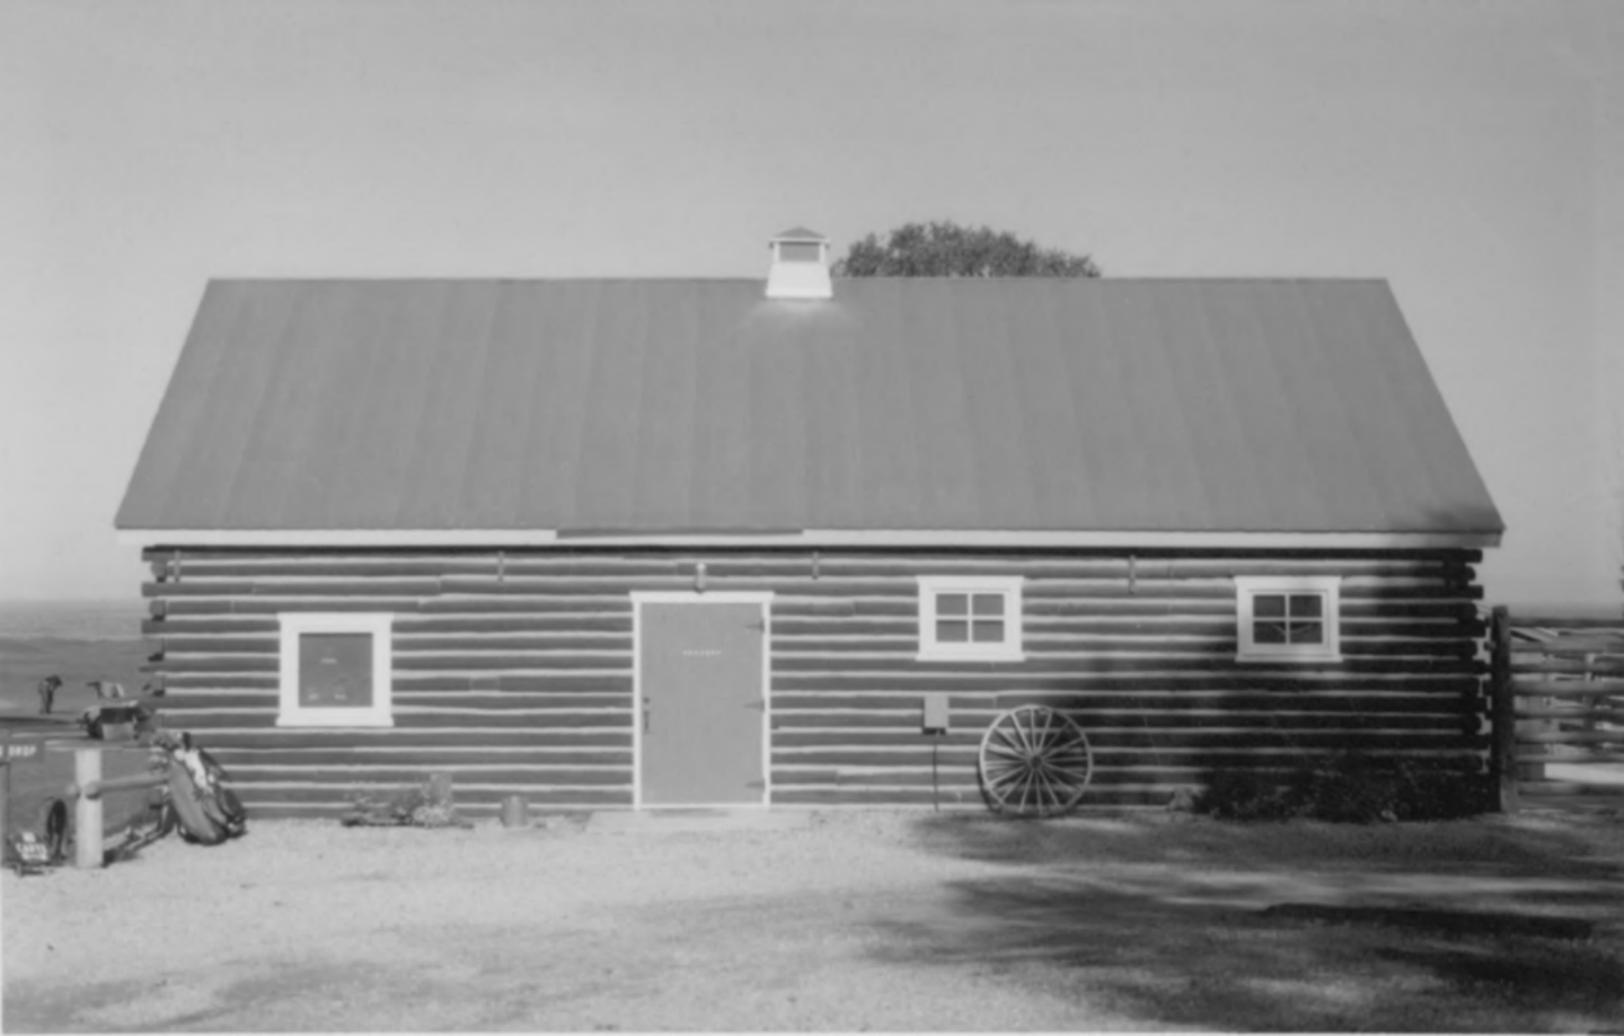
1878 HORSE BARN - E. ELEV.

The east elevation contains the main doorway which is slightly south of center. It is an unglazed, red painted wooden door with large metal hinges. Two original style four-light, awning windows are north of the door. A single-light pivotal window is south of the door.

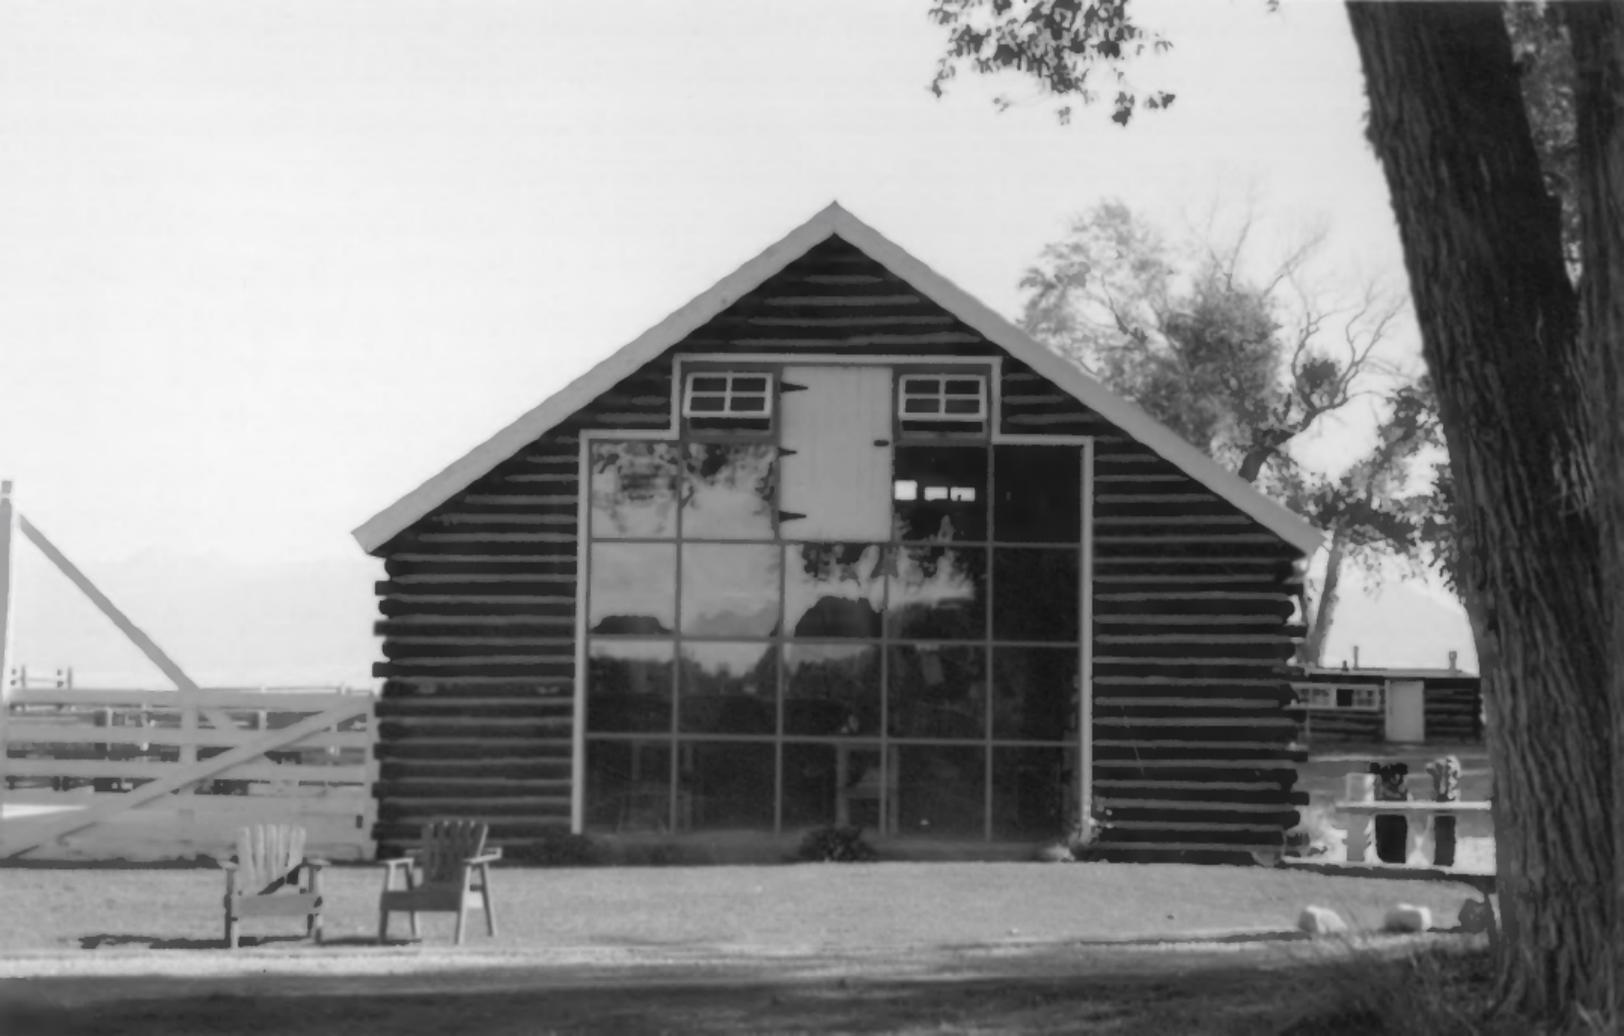
1878 HORSEBARN - S. ELEV.

Approximately three-fourths of the south elevation is a glass, multi-paned, fixed window. The loft door remains in its original position within the window area. The two four-light windows next to the loft door follow the original style windows. This wall was changed during the 1989 remodeling. This change and restoration was thoughtfully carried out. The south wall was most deteriorated due to exposure. It had a small door to the tack room in the southeast, which was removed and the loft door which remains. The barn was found to be four inches out of plumb, leaning to the west. Instead of shoring up the building to make restoration easier or removing the building, each window in the south wall was custom cut to accommodate the alignment.

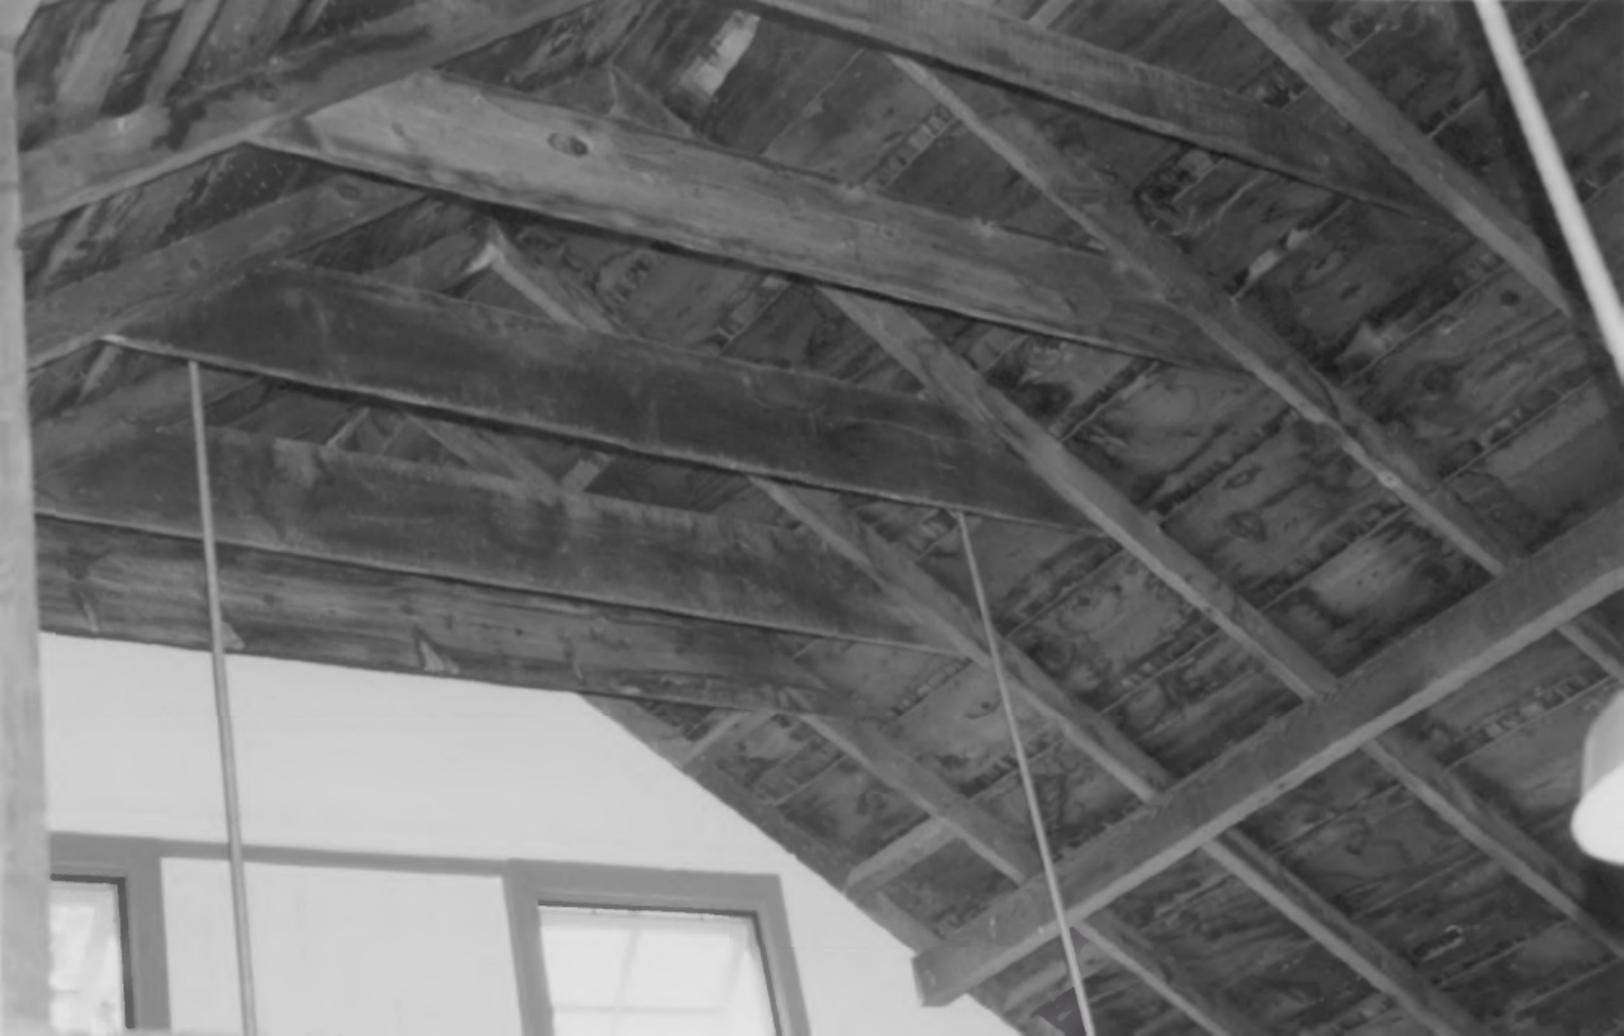
1878 HORSEBARN - INTERIOR ROOF STRUCTURE,  
S. END

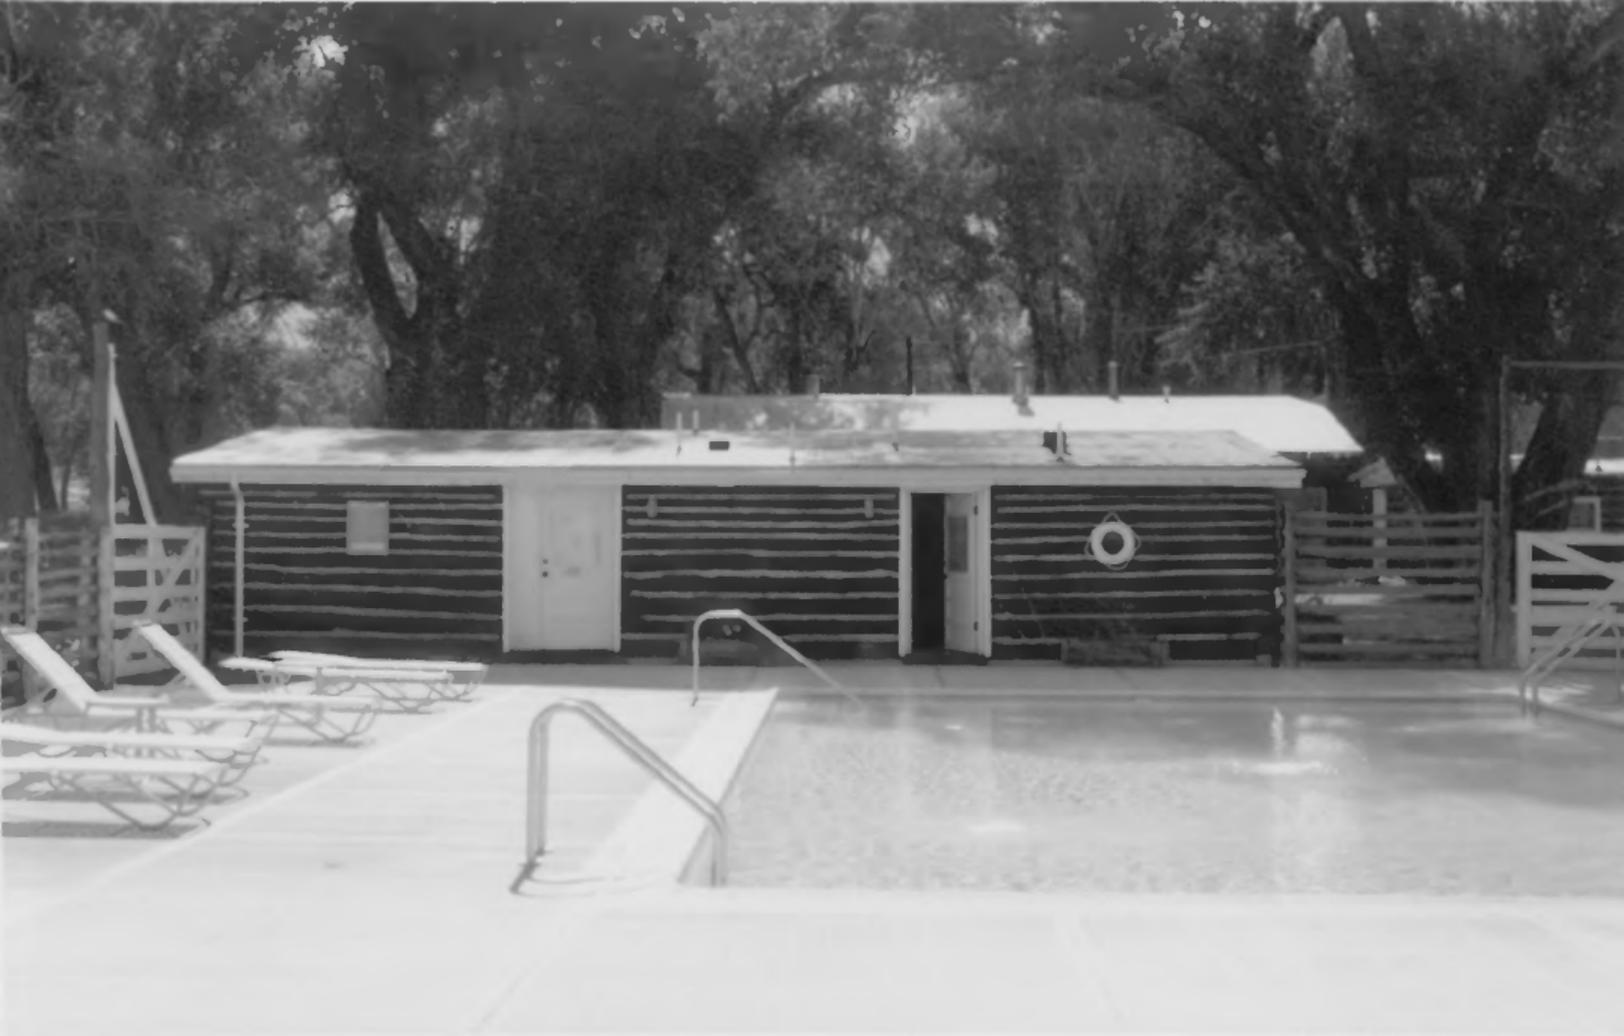
BATH/SAUNA - W. ELEV.

The west elevation faces the pool and has two doorways dividing the side into thirds. The doorway toward the north end is in an original doorway opening and has vertical boards covering part of the space to allow for a standard sized door. The north and south elevations each have one small new single-light, fixed window at the roof level toward the south end. The doorway and three other single light windows were installed in 1989.

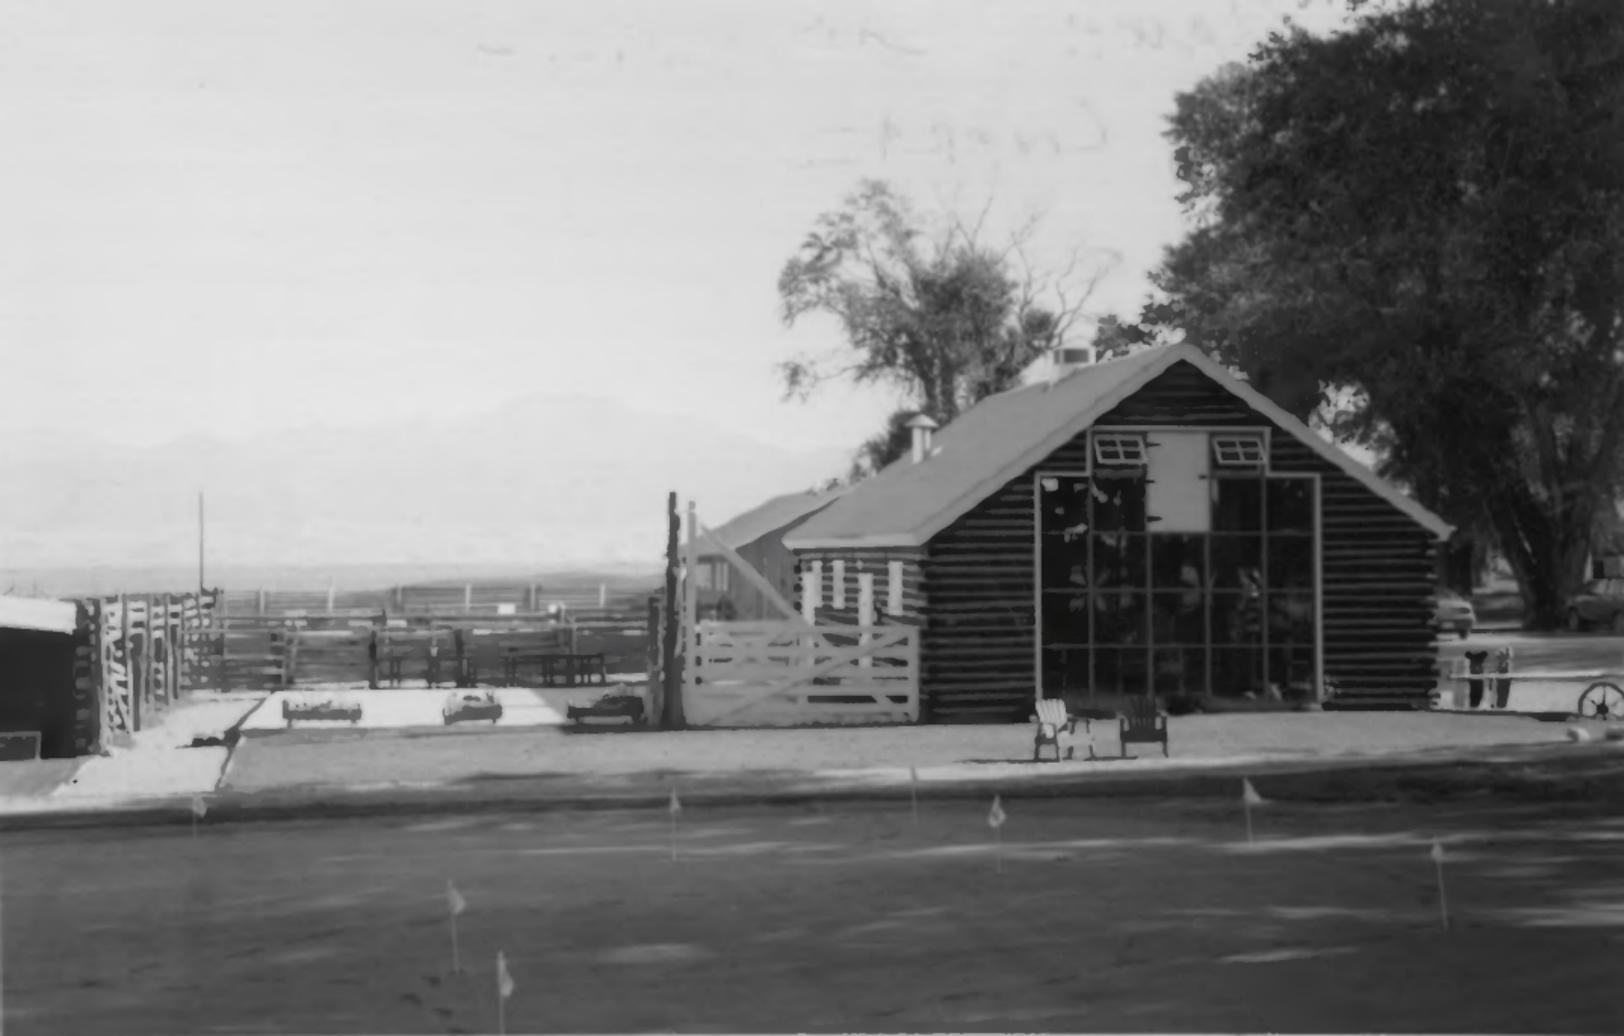
CORRAL AREA FROM S. SIDE, LOOKING N.

The cattle barn faces in toward the corral. Original fencing and gates dating from the 1920s adjoin its walls to form the enclosed corral area (see Photograph 12).

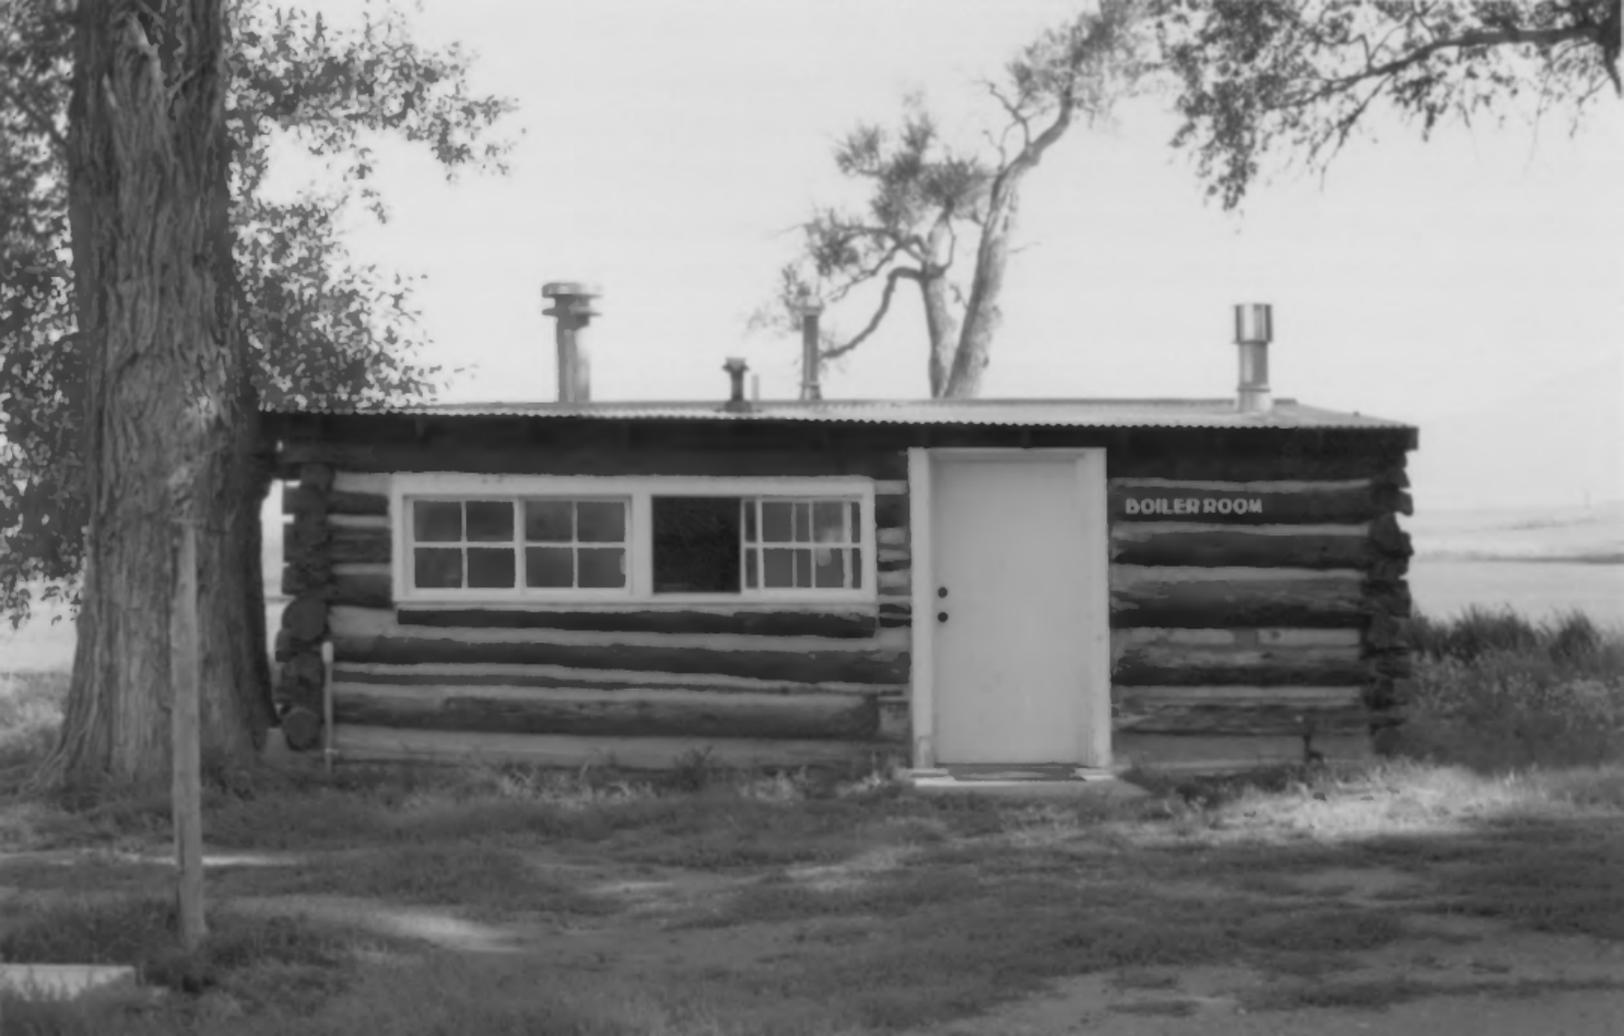
BOILER ROOM - S. ELEV.

The south elevation faces in toward the building complex. An unglazed wooden door was placed off-center to the east. Two sets of four-light windows are horizontally aligned. The two center windows open by sliding behind the fixed outer windows. This upgrade probably dates from Joe Lawrence and the Lingers.

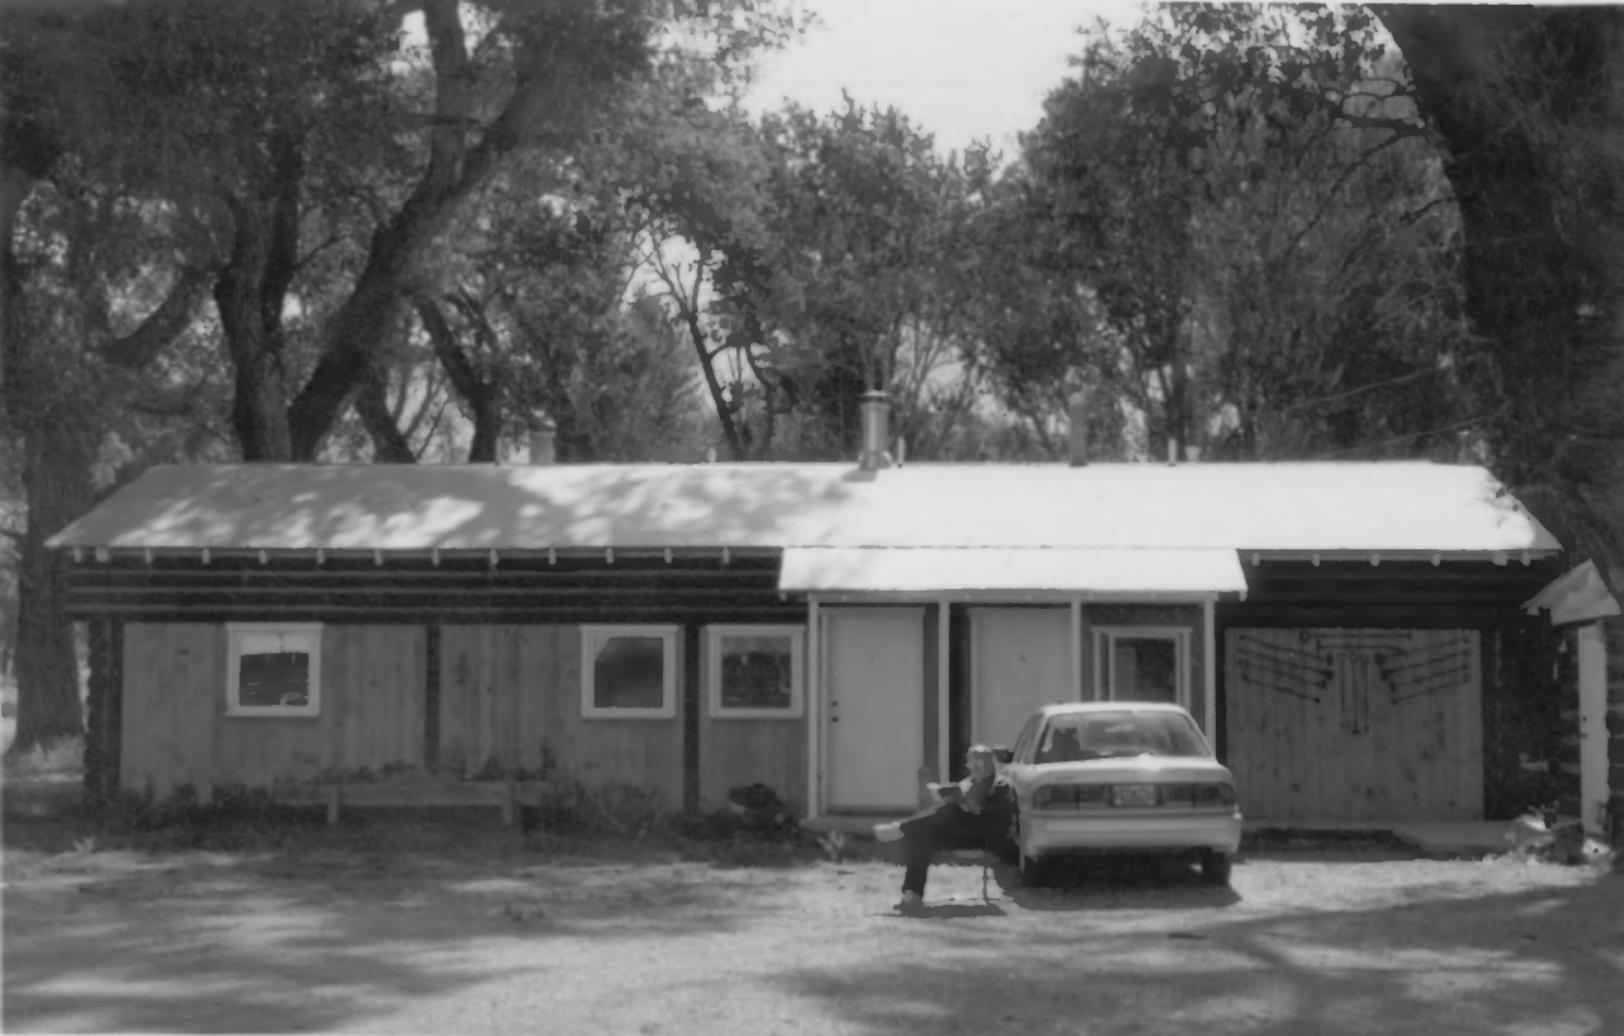
GUEST HOUSE/CARRIAGE SHED - W. ELEV.

The west half of the building was constructed in 1950 as a garage, and a new roof was put over the entire structure. The west elevation shows where there were once large garage doors. These doorways were enclosed in 1989 with vertical unpainted boards like those of the ranch house kitchen addition and the exercise rooms. The doorways to the two units are next to one another, south of center. There is an open entry porch with overhanging corrugated steel roof. The four windows on this elevation are single-light, casement windows. A display of branding irons hangs from the wall near the south end.

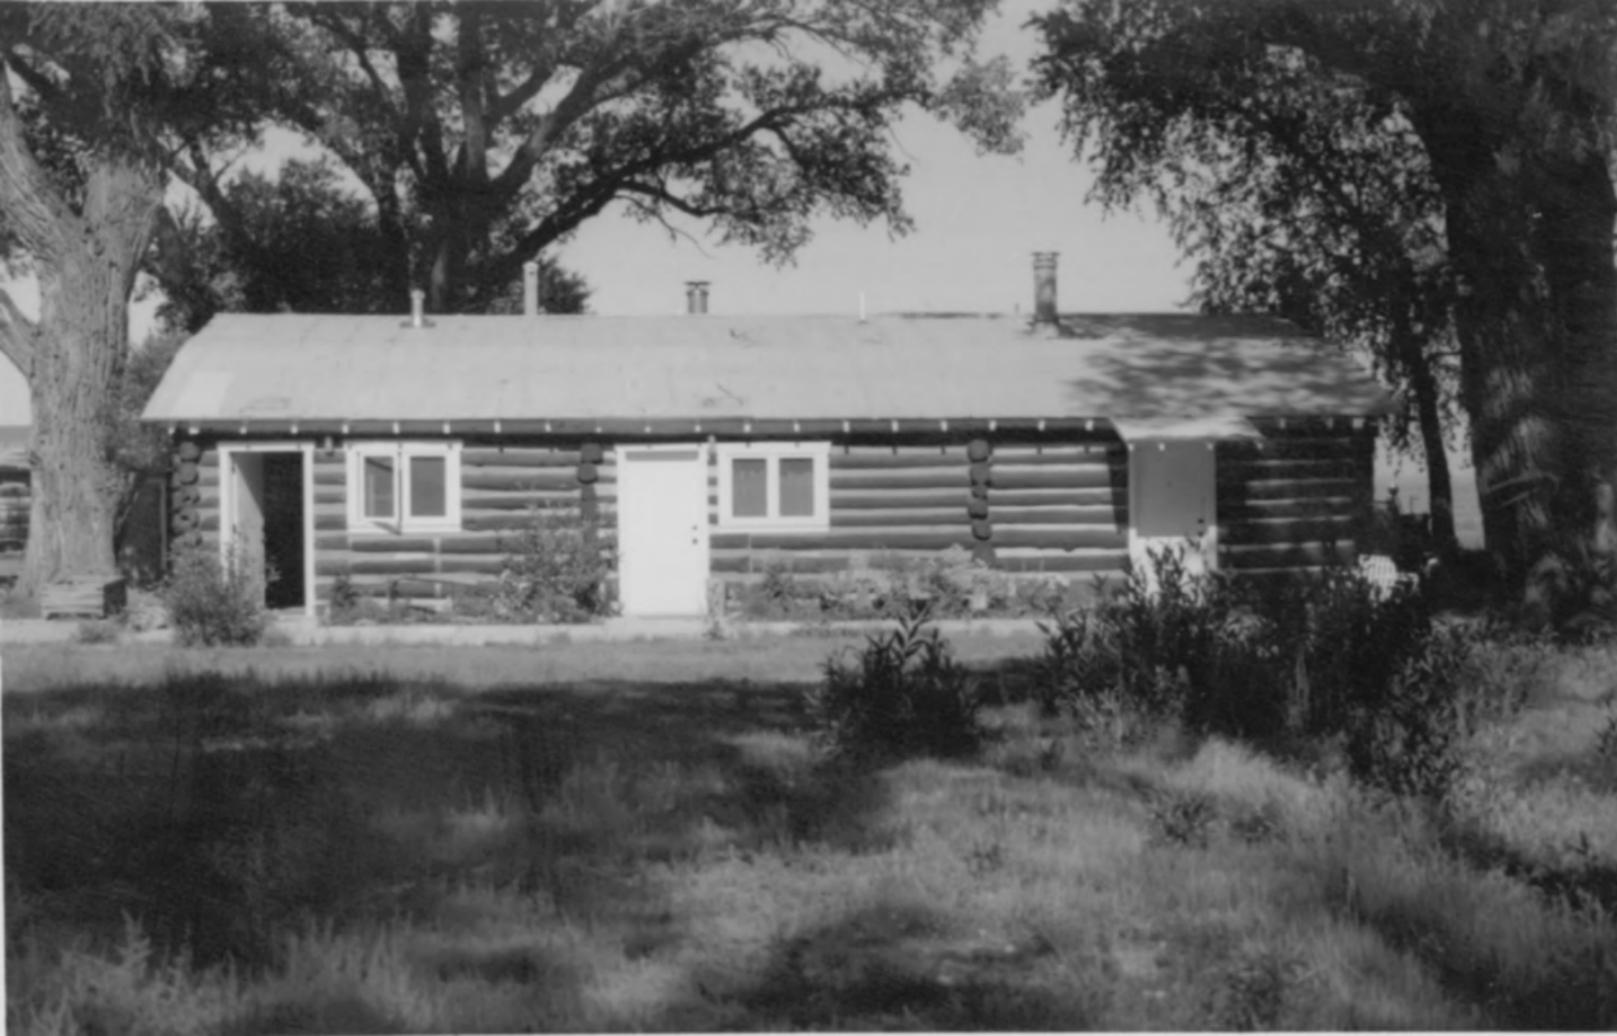
GUEST HOUSE/CARRIAGE SHED - E. ELEV.

The east elevation has three doorways, one to each unit. The doorway at the north end has a small overhanging roof. The two units toward the south each have paired single-light, casement windows which are attached at the outer edges and both open in the middle. The south elevation has two sets of paired four-light, casement windows to the west and one single light, casement window toward the east end.
