National Register of Historic Places  
Registration Form

historic name Zapata Ranch Headquarters

**Zapata Ranch Headquarters  
Mosca, Colorado**

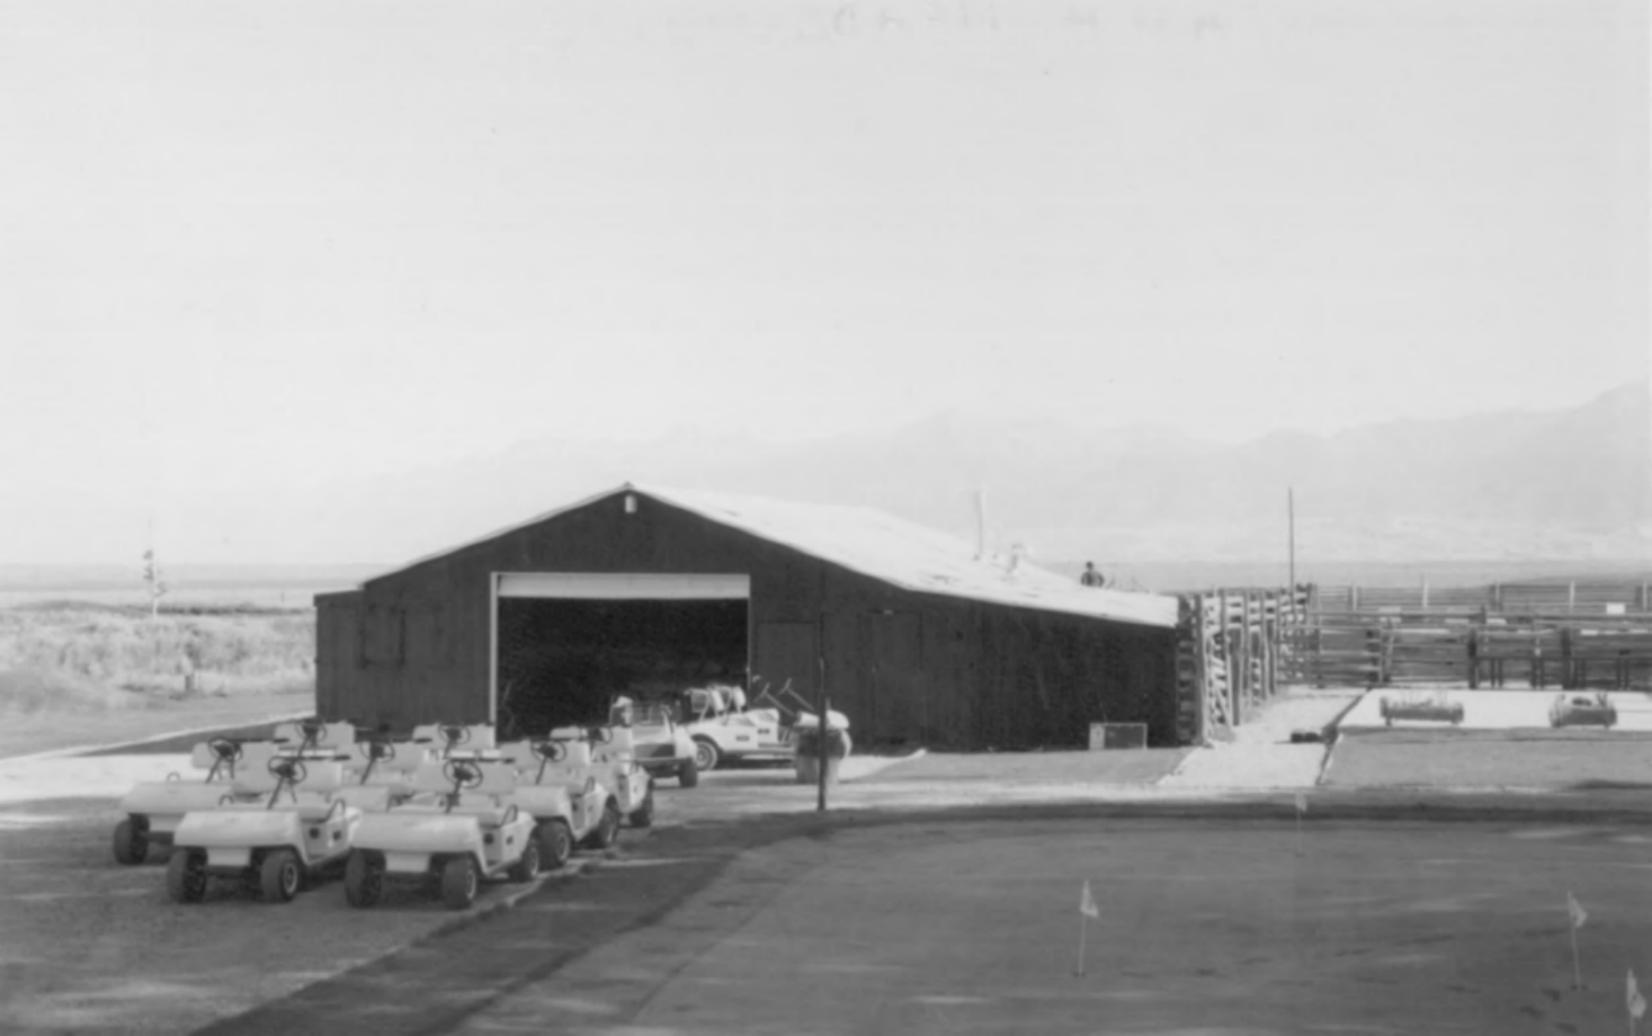
1912 HORSE BARN - S. ELEV. W-

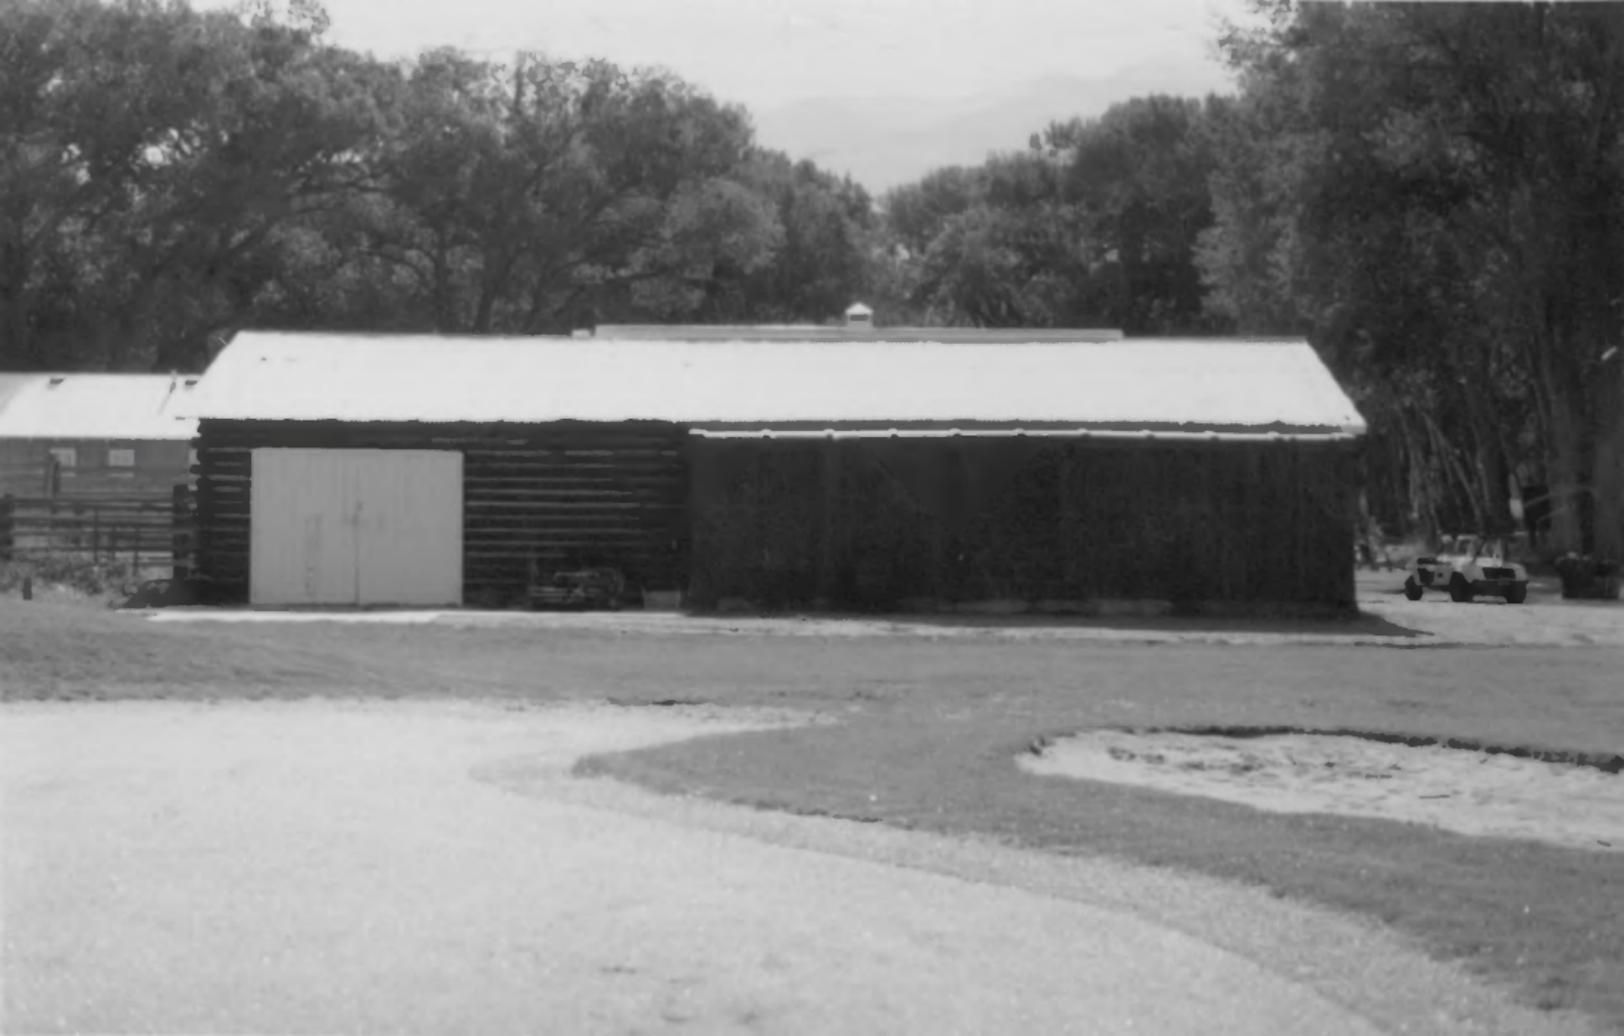
1950 HORSEBARN - W. ELEV. WITH BOXCAR

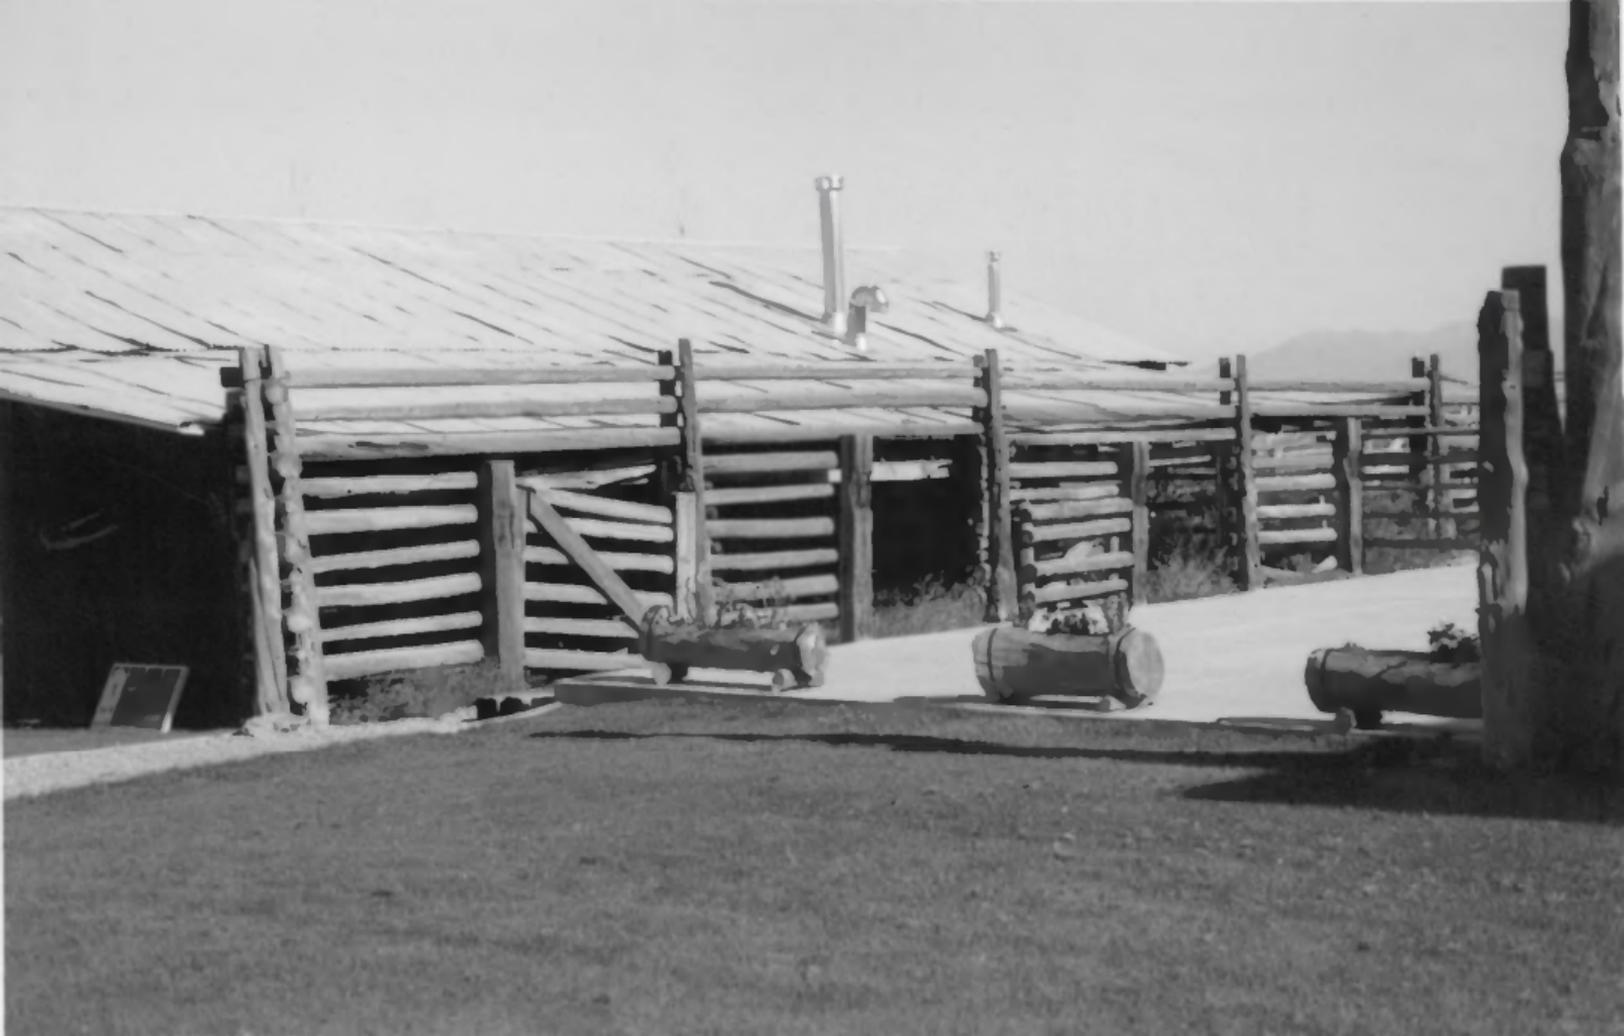
1950 HORSE BARN - E. Elev.

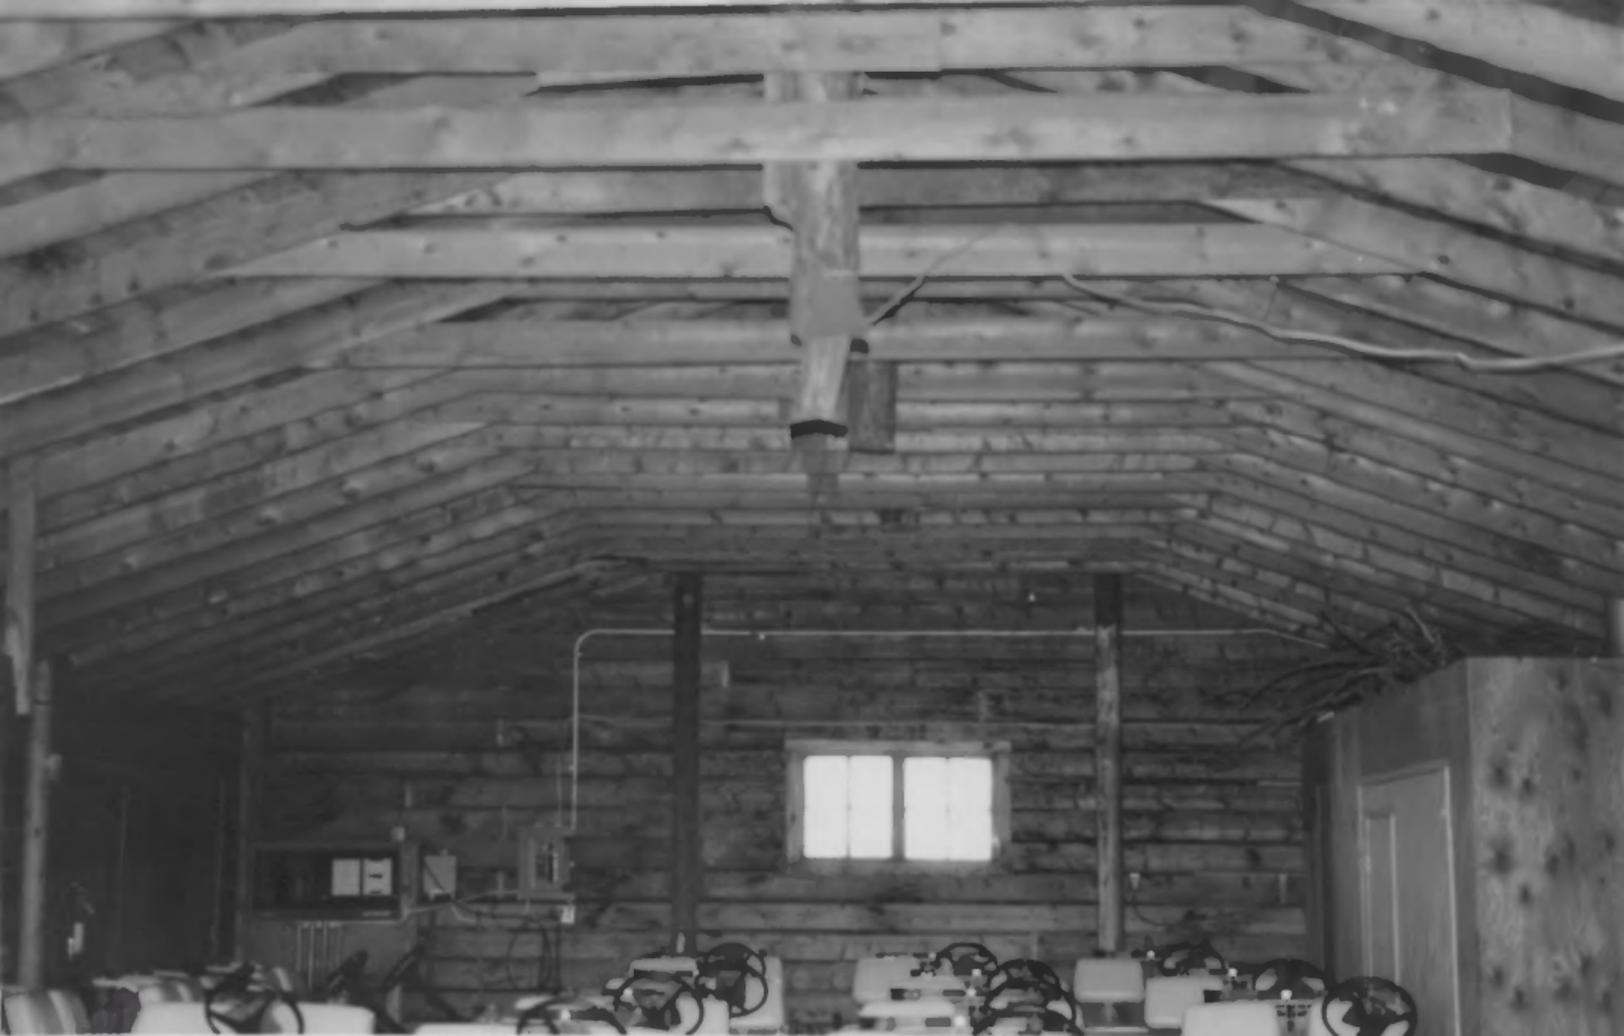
1915 HORSEBARN - INTERIOR TOWARD N. END

WITH ORIGINAL WINDOWS
