NPS – Great Smoky Mountains National Park
U.S. Department of the Interior

Infrastructure Inventory Elkmont GMP Amendment/ Environmental Assessment

T N & Associates, Inc.
124 Jefferson Circle
Oak Ridge, TN 37830

November 8, 2002

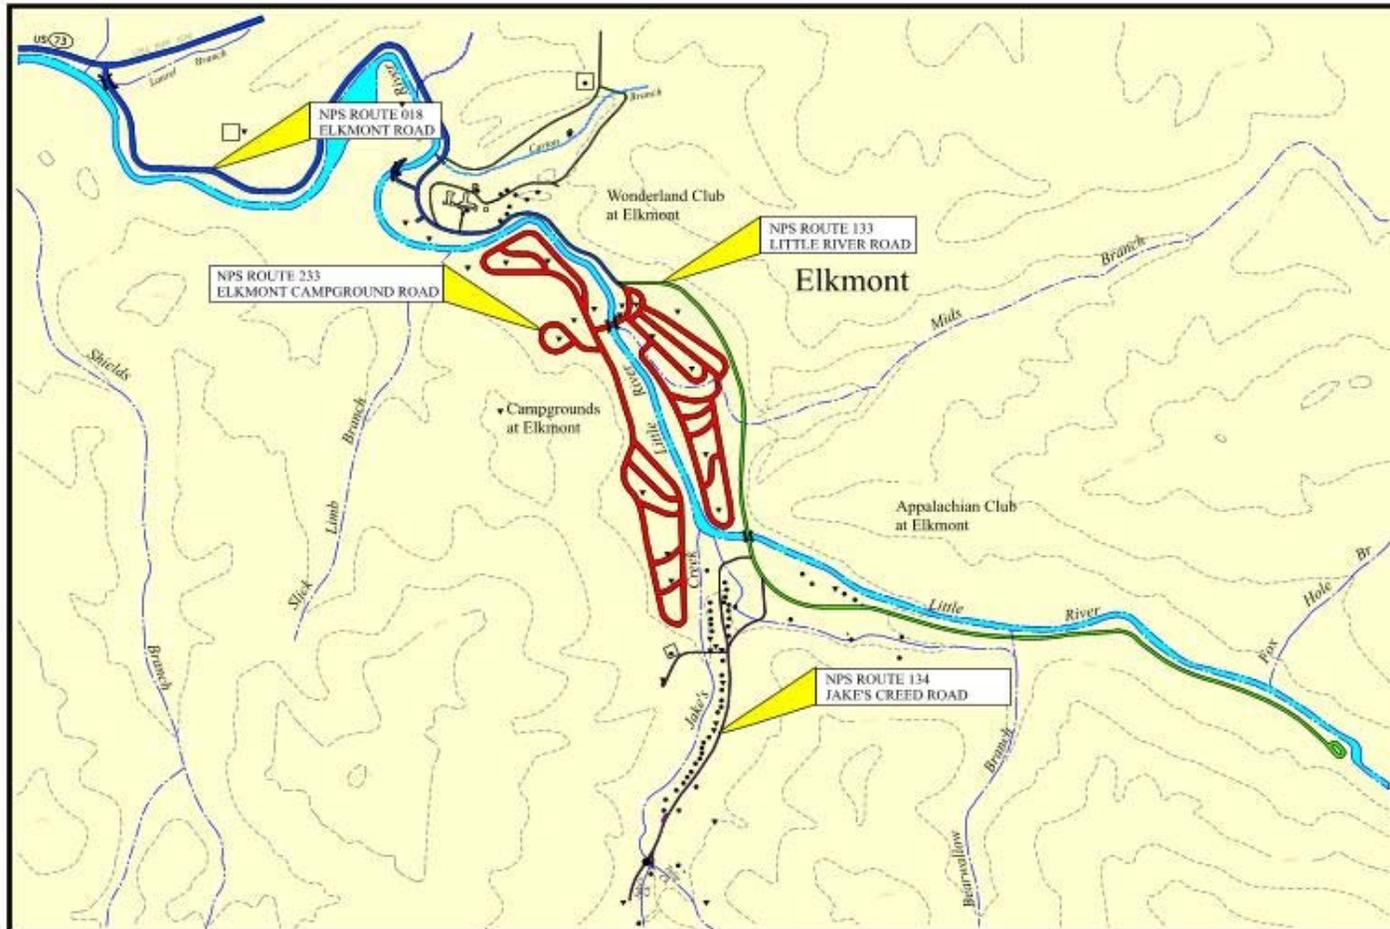
Figure 2. Elkmont Historic District Roads

The paved roads that access EHD are in fair to good overall condition. However, narrow, one-way roads running through the cabin areas are deteriorating and in need of resurfacing.

The main road leading into Elkmont is National Park Service (NPS) Route 18, Elkmont Road, which extends from SR-73 (Fighting Creek Gap Road) to the Elkmont campground. Elkmont Road is a 2-lane, paved road 1.46 miles long. The road has one 3,055-square-foot parking area. The road surface is in fair condition with minimal cracking and some rutting. Roadway drainage is good.

NPS Route 233, the campground loop from the end of Elkmont Road, is approximately 6.92 miles long and in good overall condition. The road surface is in good condition with minimal cracking.

NPS Route 133 (Little River Road) is 1.64 miles from Elkmont Road to the Little River Trail trailhead. Approximately half (0.79 mile) of this road is unpaved. One parking area of approximately 1,936 square-feet is located along this road. The road surface is in fair condition with minimal cracking and some rutting. Roadway drainage is good.

NPS Route 134 (Jakes Creek Road) also accesses EHD; it is 0.71 miles long from where it begins at NPS Route 133. The road surface is in fair condition with some cracking and rutting. Roadway drainage is good. See Table 1 for a summary of the roads servicing EHD and Figure 2 for road locations.

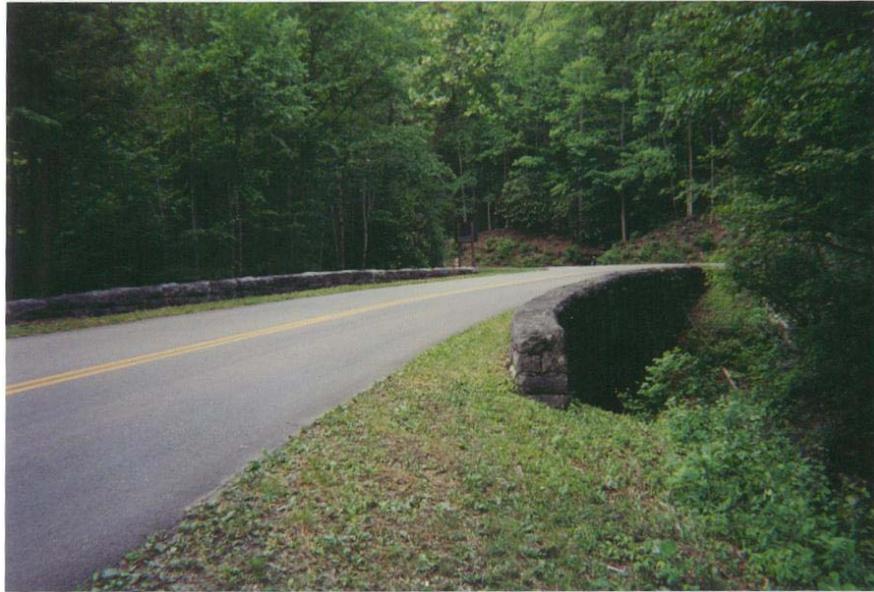
Figure 3. Elkmont Road over Laurel Branch

Four bridges provide public access in EHD. These bridges are in good condition and have a life expectancy of 20 to 40 years under current loading conditions. Three of the four bridges are on Elkmont Road and have paved decks (see Figures 3, 4, and 5). The fourth bridge is located in the cabin area and spans Jakes Creek. This bridge has a timber deck and is open to the public (see Figure 6).

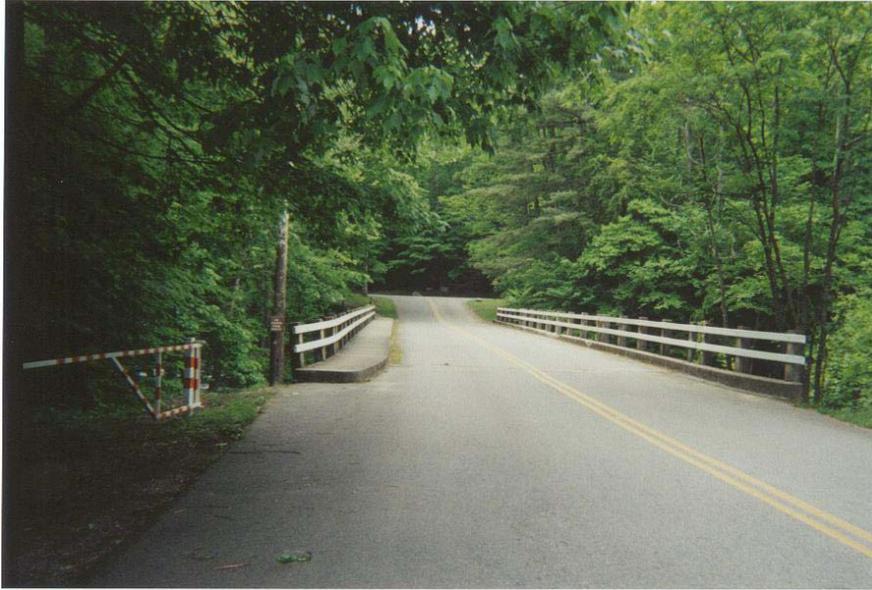
Figure 5. Elkmont Campground Road over Little River

Elkmont Campground Road over Little River	5460-048P	0.1 mi. from NPS Route 18 (Elkmont Road)	Concrete	1965	06/06/2000	The bridge is structurally sound but has some problems that need correcting in the near future. With corrective action and regular maintenance, a useful life of approximately 35–40 years can be expected.
Elkmont Road over Little River	5460-047P	0.1 mi. north from NPS Route 133	Not Applicable	1938	06/06/2000	The bridge is in fair to good overall condition. With corrective action, a useful life of approximately 25–30 years can be expected.
Abandoned Road over Little River	5460-076S	0.1 mi. from NPS Route 18 (Elkmont Road)	Wood/Timber	1959	06/06/2000	The bridge is in poor condition and in need of rehabilitation. The bridge is not open to vehicular traffic, use will continue to be restricted.
Residential road over Jakes Creek	5460-077S	0.1 mi. from Jakes Creek Road; turn right on gravel road after mailboxes	Wood/Timber	1984	06/06/2000	The bridge is in good overall condition. With regular maintenance, a useful life of approximately 25–30 years can be expected for this structure under current loading conditions.

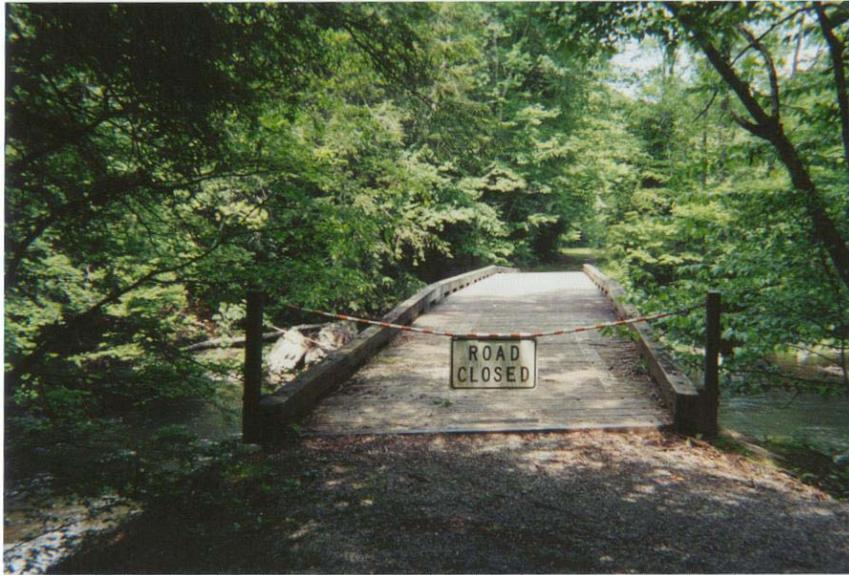
Figure 7. Bridge on Abandoned Road over Little River

A fifth bridge within EHD is in poor condition and in need of rehabilitation; however, the bridge is located on a closed road (see Figures 7 and 8). The bridge spans the Little River and has a timber deck. Problems include widespread, severe rusting of structural steel, several damaged members and missing connectors, a damaged lower chord splice plate, separation of the southeast wingwall from the abutment, scour at the east pier that undermines the footing, and moderate settlement and erosion at the east approach.

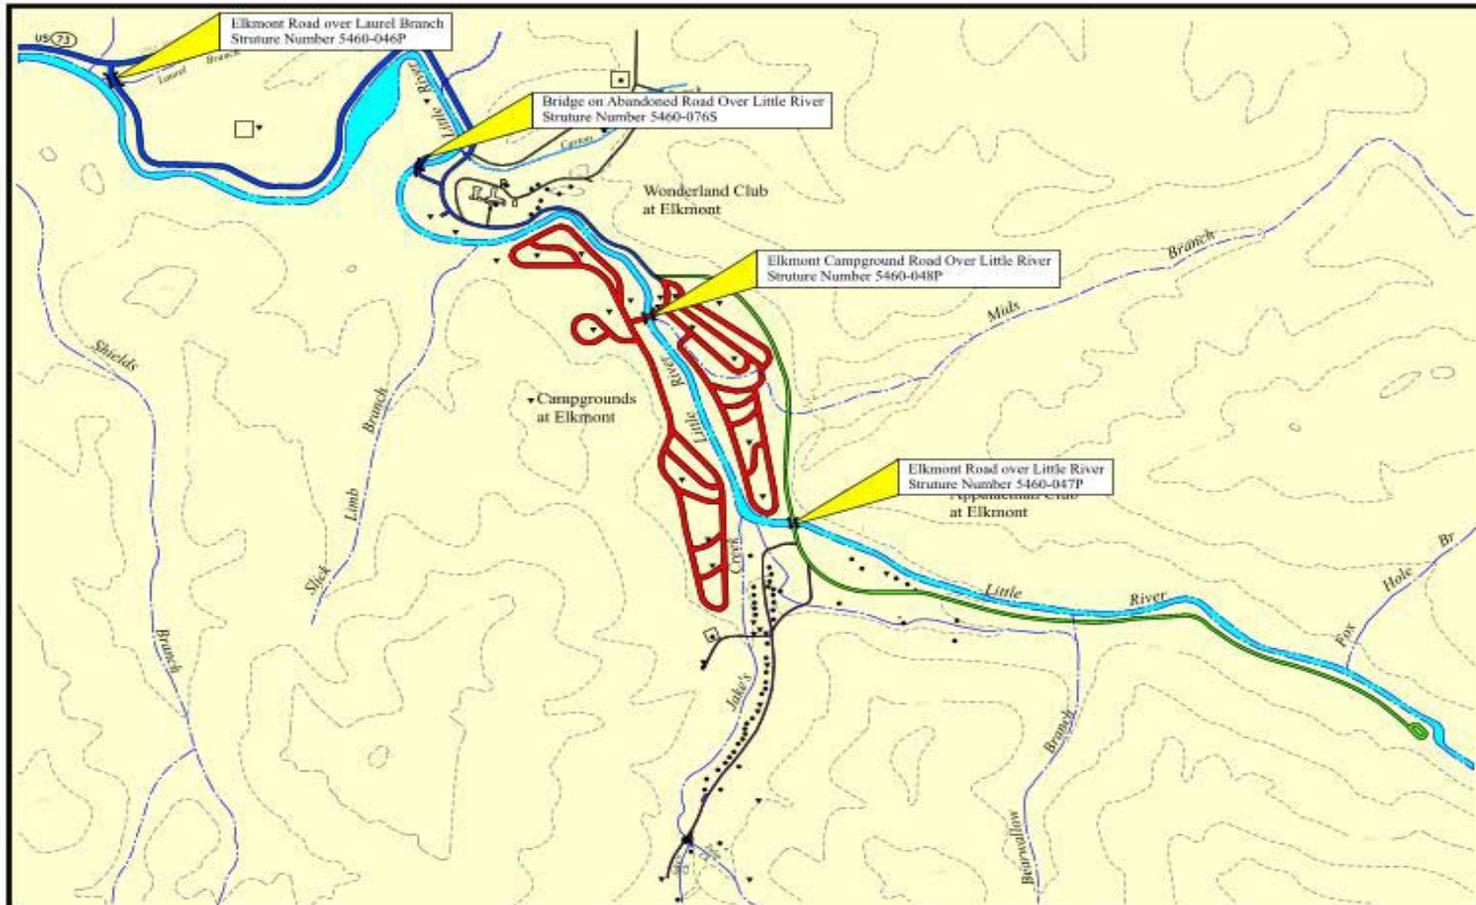
Figure 9. Elkmont Historic District Bridge Locations

Table 2 is a summary of bridge type, location, structure numbers, construction date, inspection date, and conditions. Figure 9 shows bridge locations within EHD.

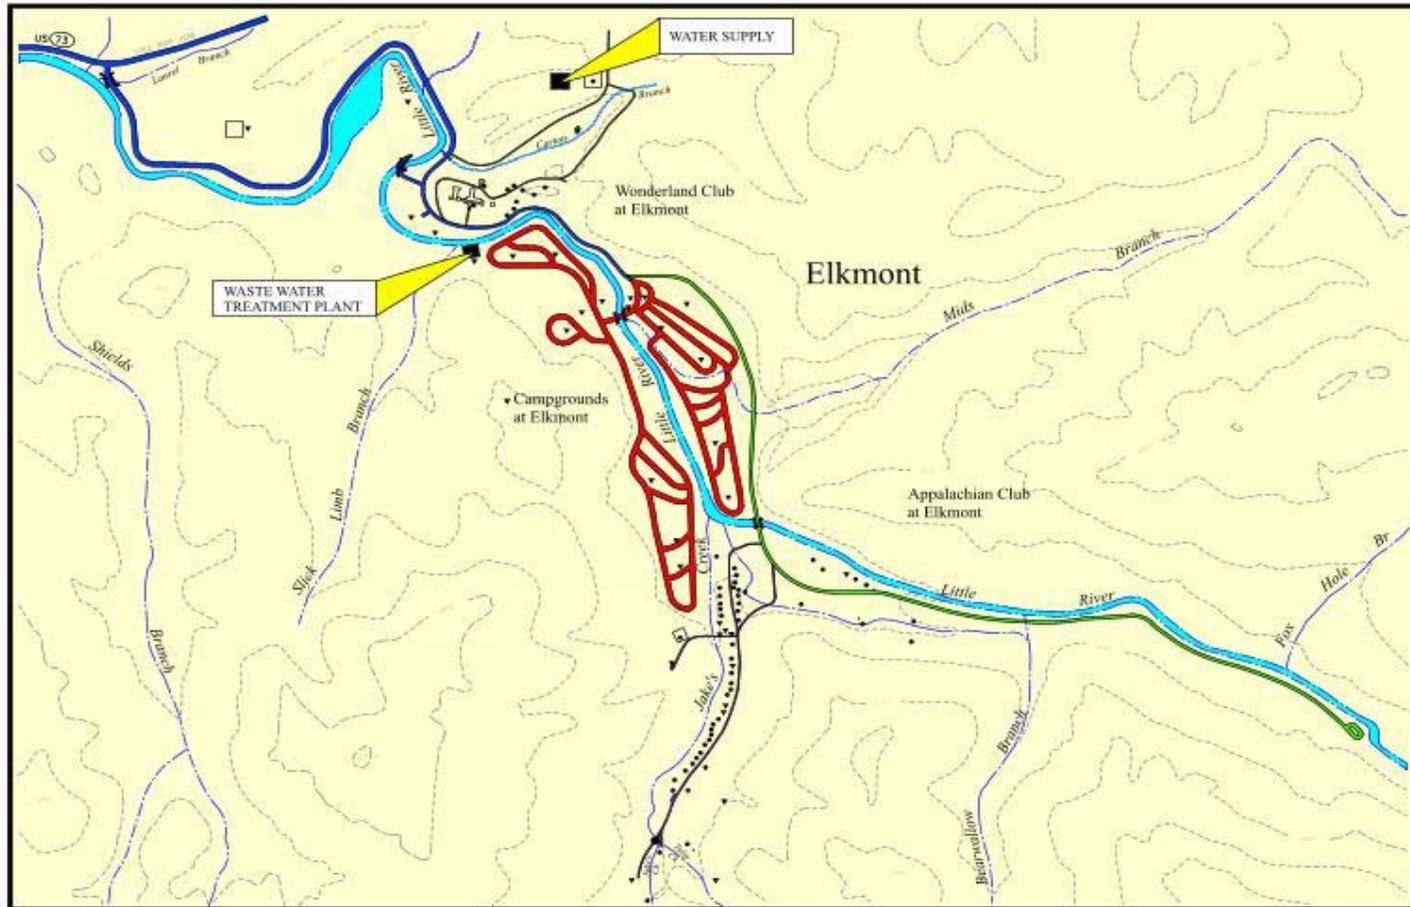
Figure 10. Water Supply and Wastewater Treatment Plant

A sewage treatment plant serves Elkmont campground (see Figure 10). At the present operating capacity, the plant runs 24 hours a day but with operators at the plant for one shift only. The campground and plant is shut down from December through March. A chlorine treatment method is used to treat sewage from the campground. The sewage is aerated in a 35,000-gallon aeration-tank before being sent through a clarifier. Clarification tanks have a 17,500-gallon capacity. Next the water is sent through a filter. Sodium hypochlorite is then added to treat the water. Prior to discharge, sodium sulfate is used to dechlorinate the treated water.

A well above Elkmont Cemetery provides water to the Elkmont campground, four apartments and one residence house (see Figure 10). A 5-horsepower pump delivers water into three nearby holding-tanks. The pump is capable of delivering 60 gallons per minute to the holding tanks. A 45,000-gallon concrete tank and two 27,800-gallon fiberglass tanks store water. The water is treated with chlorine prior to distribution to the campground. Approximately 30 gallons per month of chlorine is used to treat the water supply. During peak season approximately 22,240 gpd is distributed to the campground and residence. The water plant operates year round.

Water is gravity-fed to the campground and residences from the storage tanks via an underground piping system. The piping system crosses underneath the Little River. The 6-inch-diameter water pipe is buried 2 feet below the streambed. A 1993 memorandum from the NPS Denver Service Center indicates that the entire water conveyance system is in severe need of repair and replacement. The memo states that approximately 9,000 linear feet of conveyance need to be replaced. An inspection conducted by the Tennessee Department of Environment and Conservation in 2001 found the inside of the concrete water tank to deteriorating. Consequently the inside of the water tank was refinished in May 2002. Other deficiencies noted in the inspection were a major leak of unknown origin and the need for a backflow prevention valve in the equine water trough. Each of these deficiencies have been addressed. The refinishing of the tank interior and the addition of the fiberglass tanks are the only major improvements to the system since 1993.

The addition of a 15,000–35,000-gallon flow equalization basin (holding-tank) may enable the plant to treat and discharge at the permitted volume of 35,000 gallons per day. The maximum capacity of the plant (with the addition of a holding-tank) is 35,000 gallons per day.

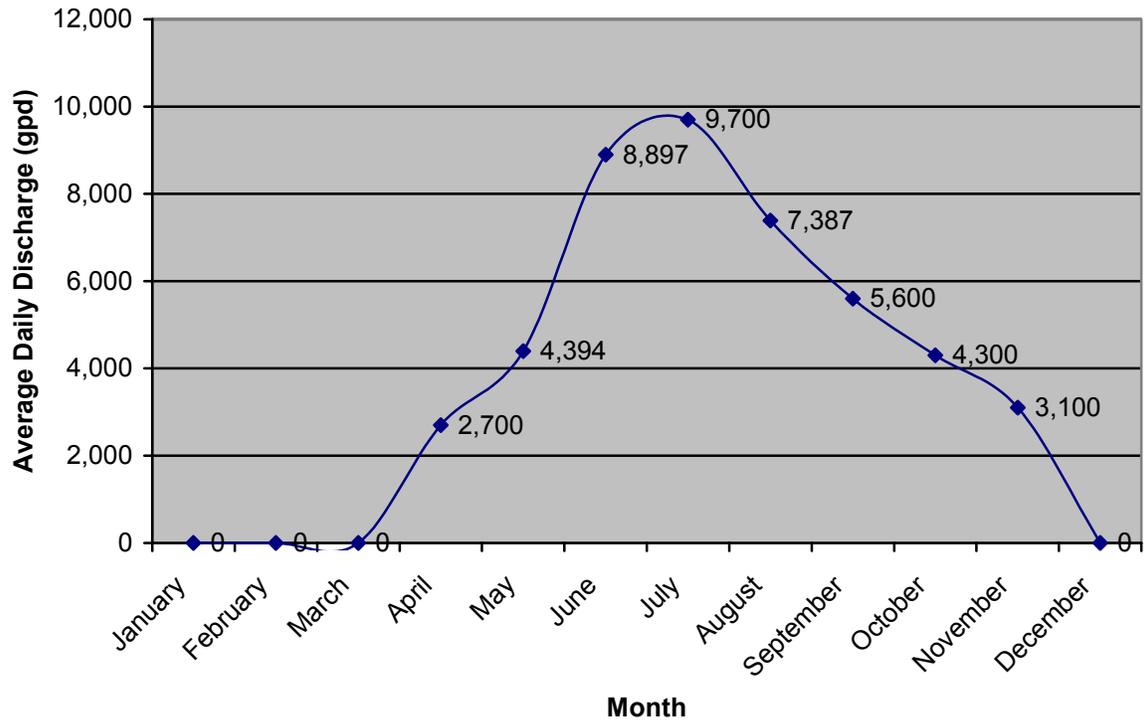
Figure 11. Average Daily Discharge

Currently the plant discharges approximately 10,000 gpd during peak season. The flow rate during peak flow is approximately 17,000–18,000 gpd during peak flow. Figures 11 and 12 demonstrate average daily and average monthly flow rates. The plant operates at approximately 90 percent capacity during peak flows. Under existing conditions the plant can operate at 20,000 gallons per day. The surge of solids during peak flow coupled with the lack of a flow equalization basin (holding-tank) limits the plant capacity. The filter and pumps are designed for a maximum capacity of 35,000 gallons per day.

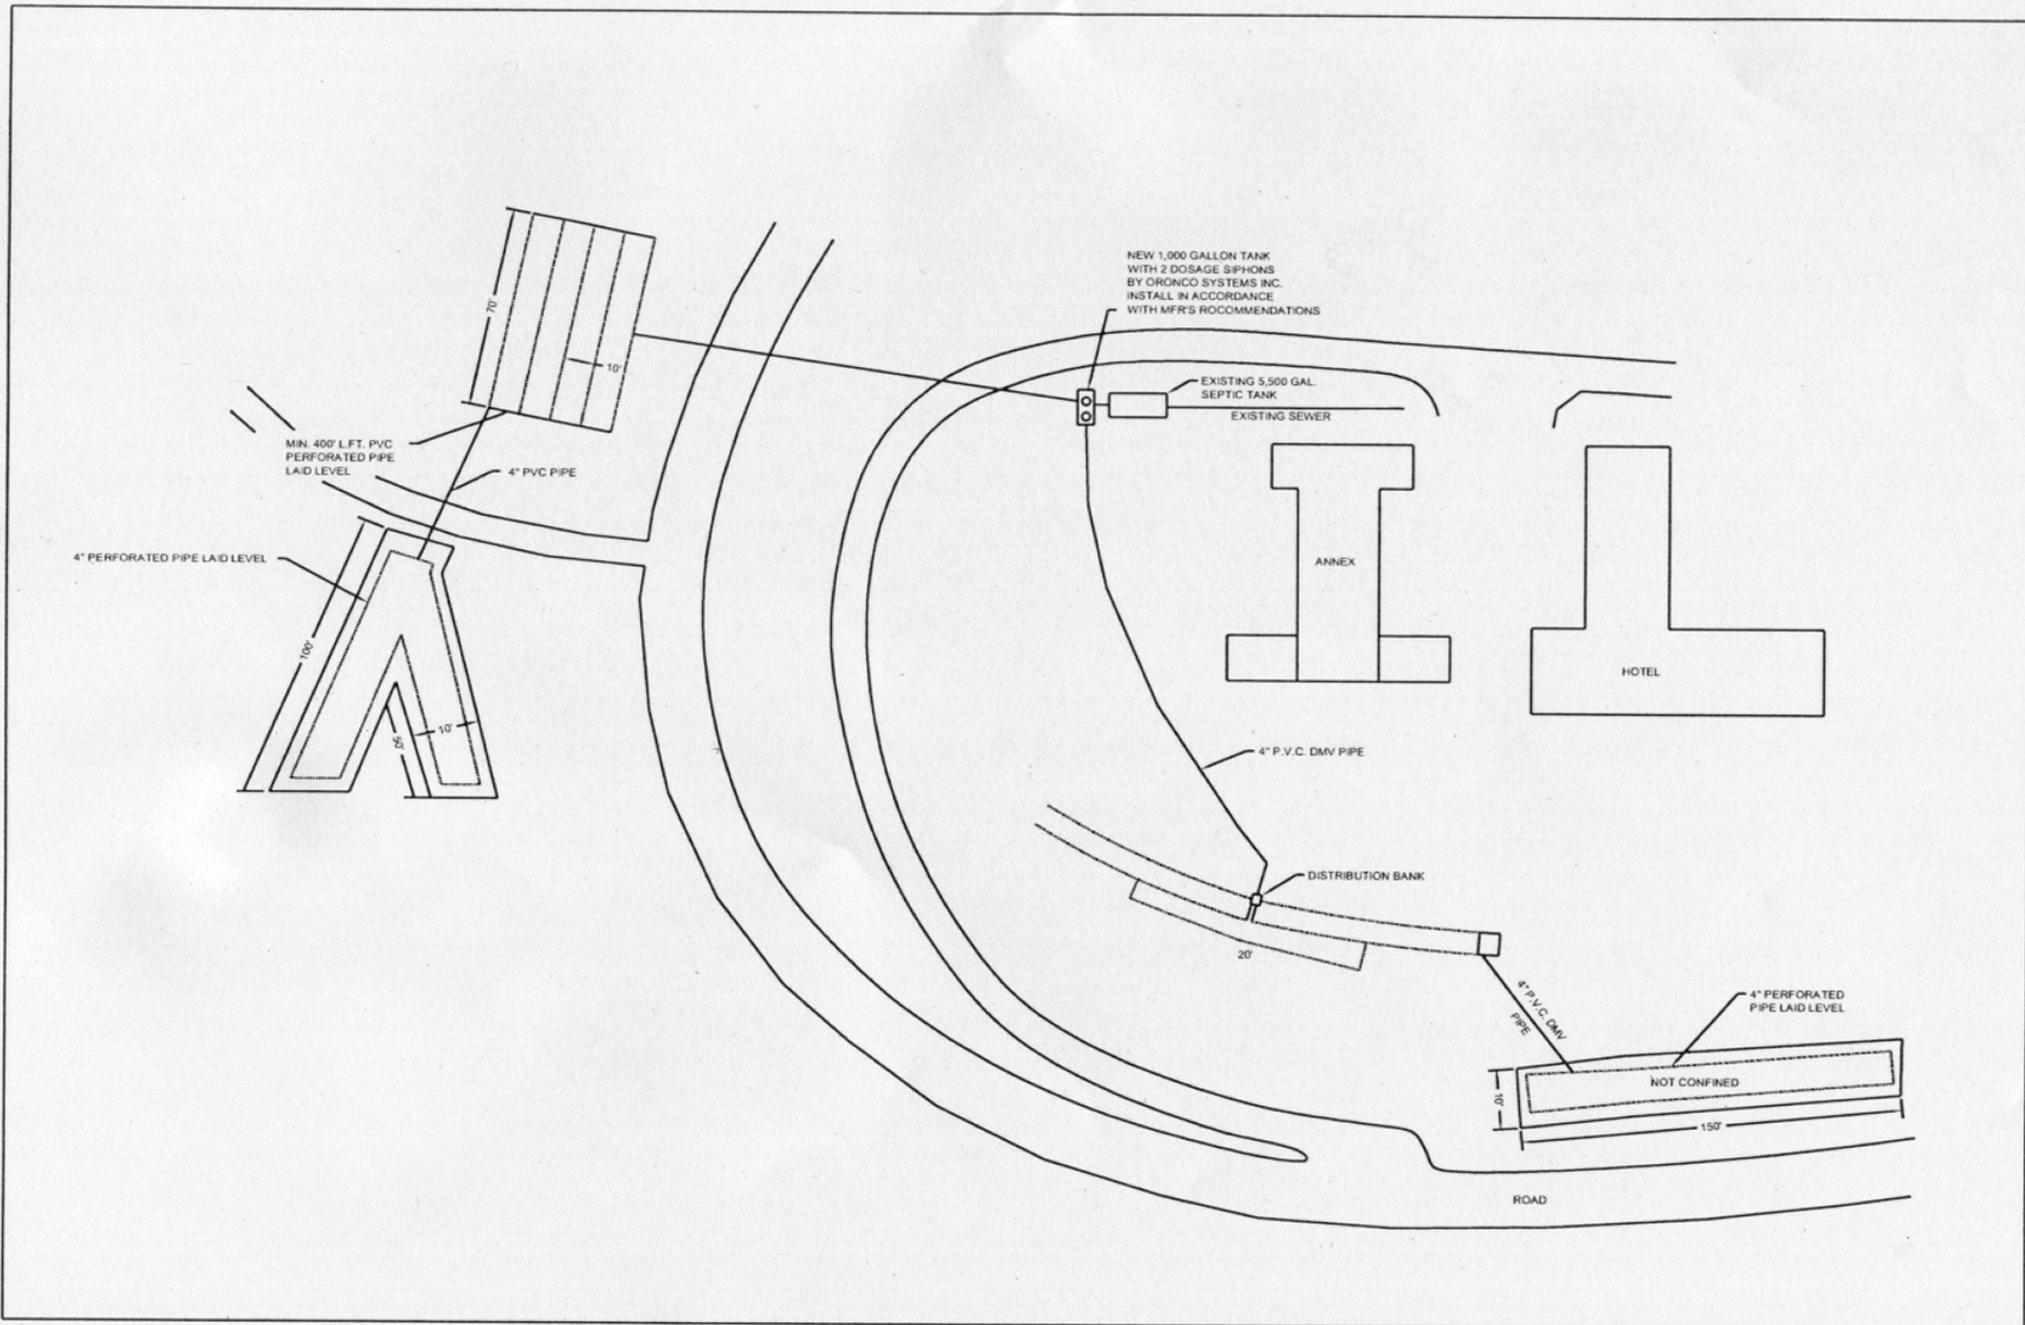
FIGURE 13 - WONDERLAND SEPTIC SYSTEM

A 1,000-gallon septic tank and leach field services the Wonderland Hotel, annex, and cabins in EHD (see Figure 13). The septic system at the Wonderland has not been used in many years and specific condition of the septic tank and pipes can not be determined without excavating the pipes and septic tank. However, the general condition of the system can be inferred from historical records. These systems have proven to be inadequate. Many leaks and overflows have occurred in these septic systems over time. In 1984, NPS rejected a plan to add five bathrooms to the Wonderland Hotel, stating that the septic system was incapable of handling the additional load.

A sewage treatment plant at Elkmont handles sewage from the campground. The treatment plant is permitted to discharge 35,000 gallons per day into the Little River, but plant capacity is limited by the amount of sewage holding capacity. Upgrading the plant by installing a holding tank may enable the plant to operate at 35,000 gpd. This would allow an addition 250–300 persons to be connected to the system. The septic system at the Wonderland Club has proven to be inadequate. Much of the Appalachian Clubhouse septic system has been removed. A detailed investigation needs to be conducted in order to determine the existing condition and capacity of the Wonderland Club and Appalachian Club septic systems.
