Historic Structures Report Little Cataloochee, North Carolina

Jim Hannah Cabin
Will Messer Barn
Dan Cook Cabin and Apple House

Great Smoky Mountains National Park **1976**

JUNE 1976

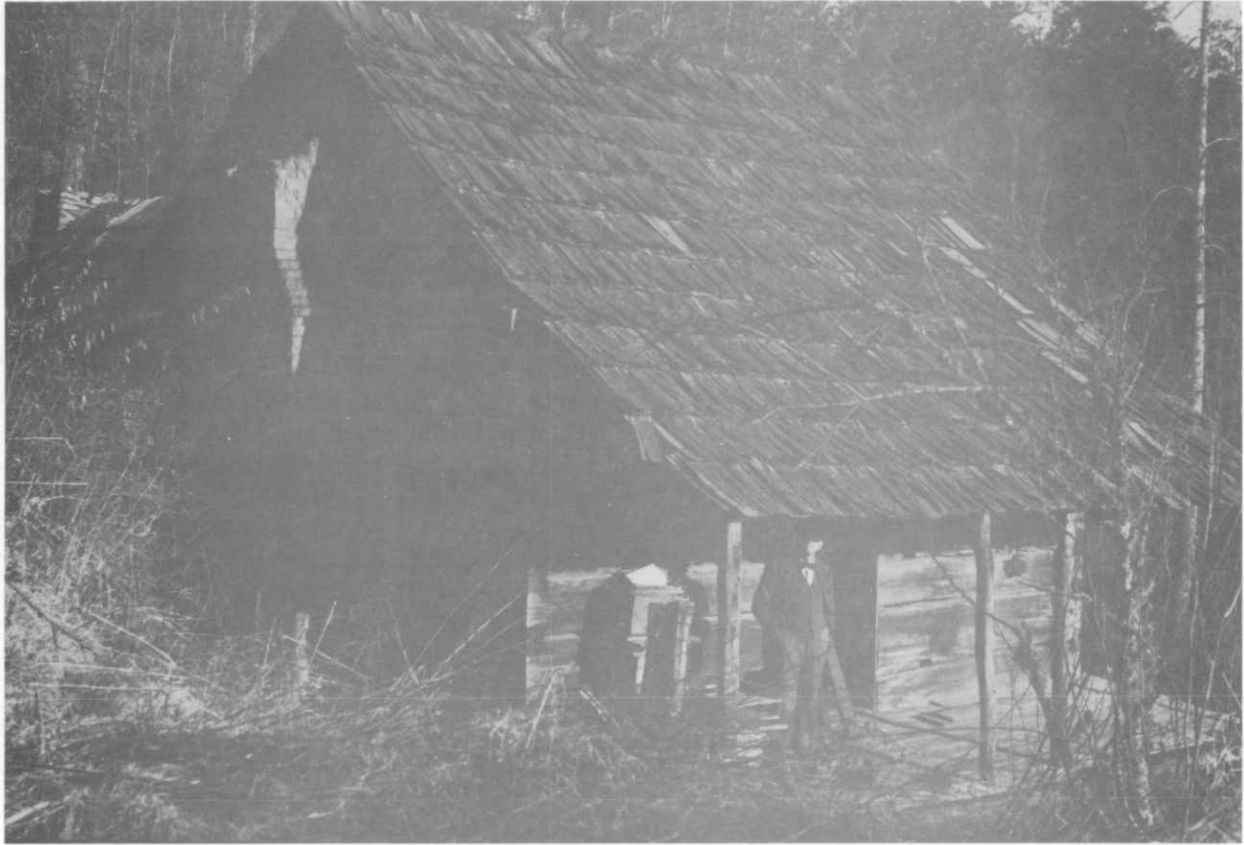
Figure 2.

Northwest end of the sill, front of Hannah
Cabin, August 1975. Photo shows the
deterioration of the sill.

The condition of the southwest wall is good. The logs, 11 to 19 inches to face, are sound. There has been some settling, however, due to the deterioration of the northwest end of the sill (see Fig. 2).

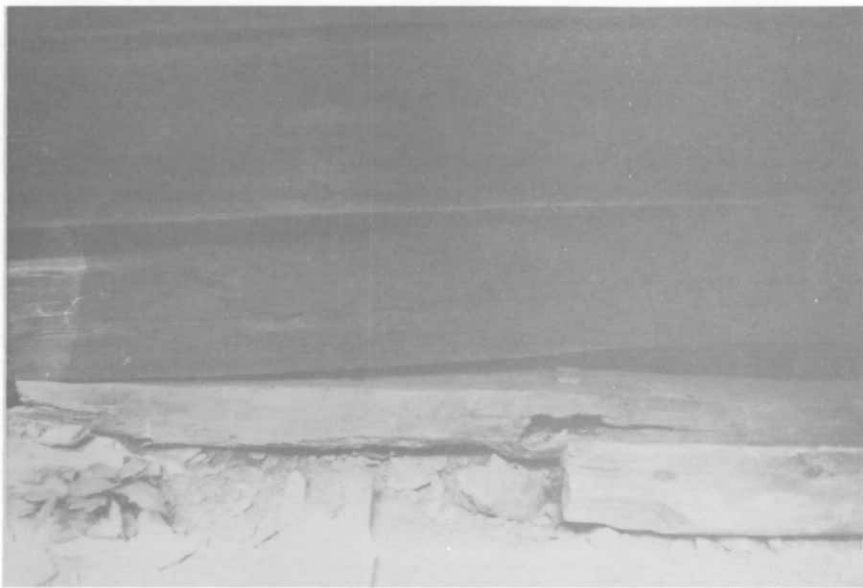
Figure 3.

Southeast elevation of Hannah Cabin,
April 1975.

The southeast wall is also in good condition. With the exception of the first log, where deterioration is evident from the inside, the logs, $9\frac{1}{2}$ to $17\frac{1}{2}$ inches to face, are sound (see Figs. 3-4).

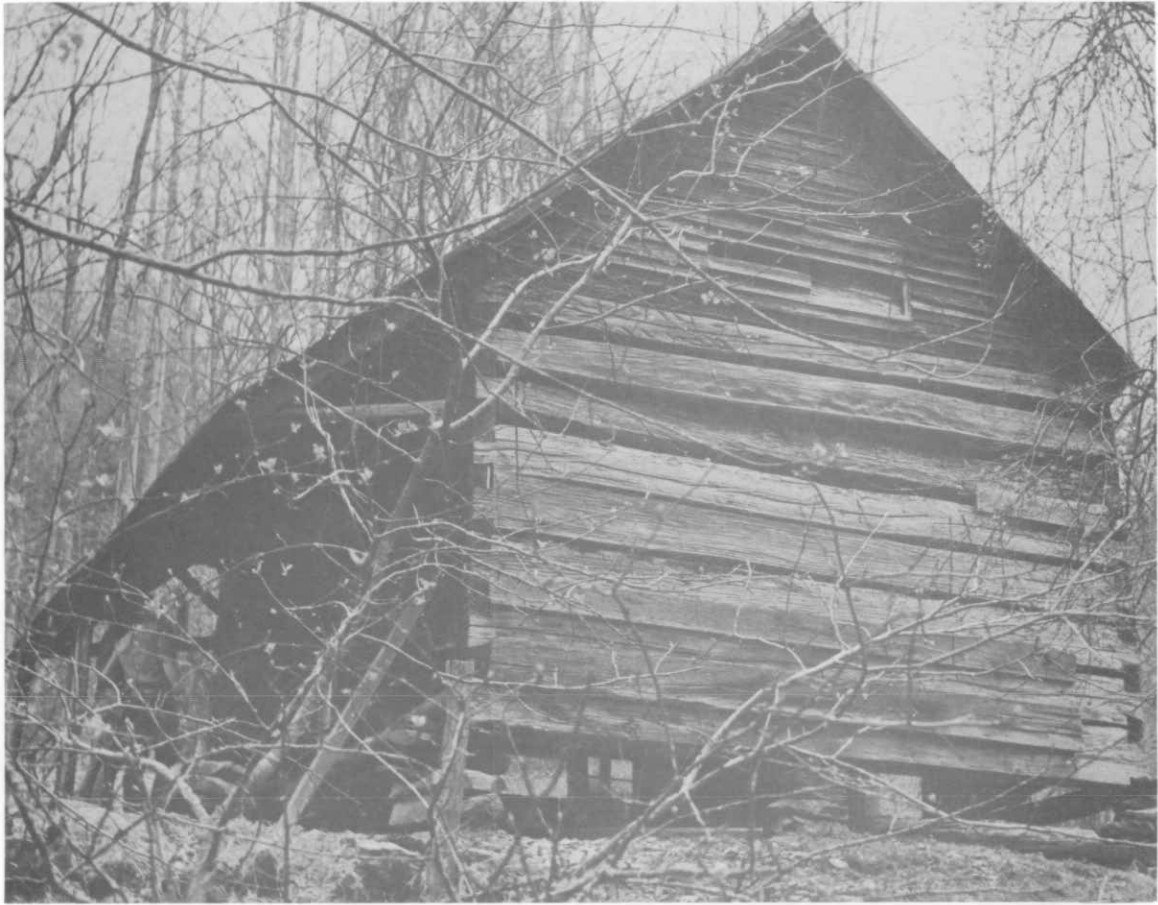
Figure 4.

Southwest corner, interior of Hannah Cabin,
August 1975. The first floor joist rested
on the front sill in the opening to the
right of the center of the photo.

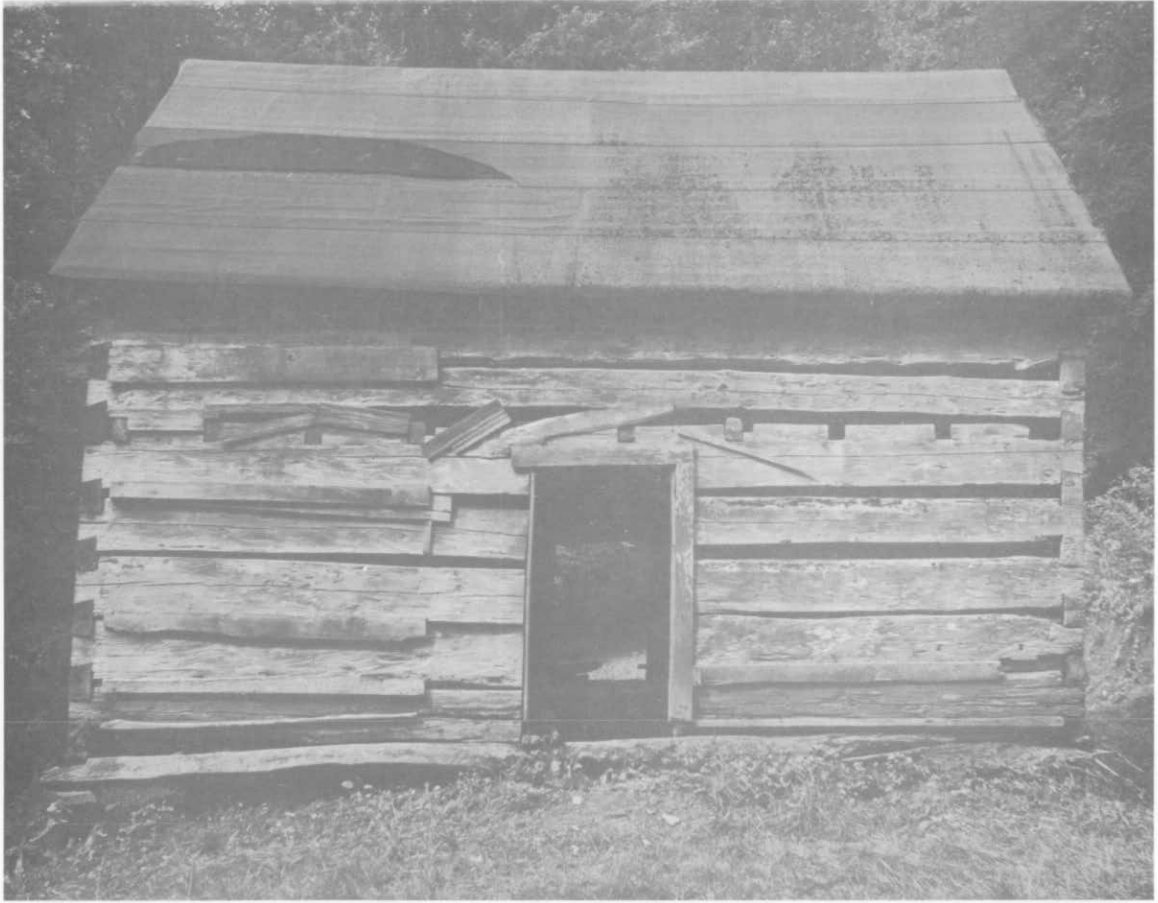
Figure 6.

Northwest end of rear sill of Hannah Cabin, August 1975. This photo also shows the deterioration of logs 1 and 2.

The northeast (rear) wall is in fair condition. Most of the logs, $9\frac{1}{4}$ to 16 inches to face, are sound, but the first log to the south of the doorway is deteriorating, and the first and second logs to the north of the doorway are badly decayed and need to be replaced. The northwest corner has settled due to the rotting of the sill, which also needs to be replaced (see Figs. 5-6).

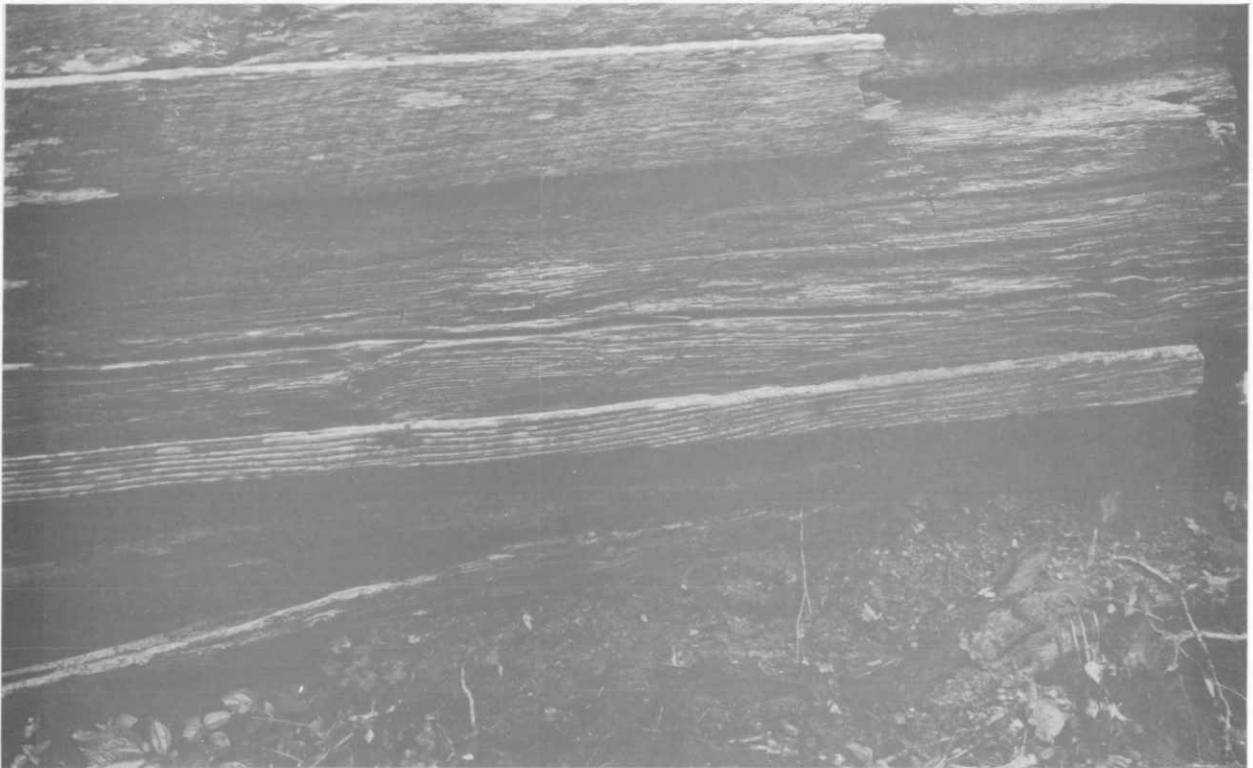
Figure 7.

Northwest elevation of Hannah Cabin,
from the rear, August 1975.

The northwest wall is in very bad condition. Few of the logs, $9\frac{1}{2}$ to 17 inches to face, are sound. Logs 1, 2, and 4 to the north (left) of the chimney opening and logs 1, 2, 3, 4, and 5 to the south (right) of the chimney opening are all badly decayed and need to be replaced. This wall should be braced immediately (see Figs. 7-8).

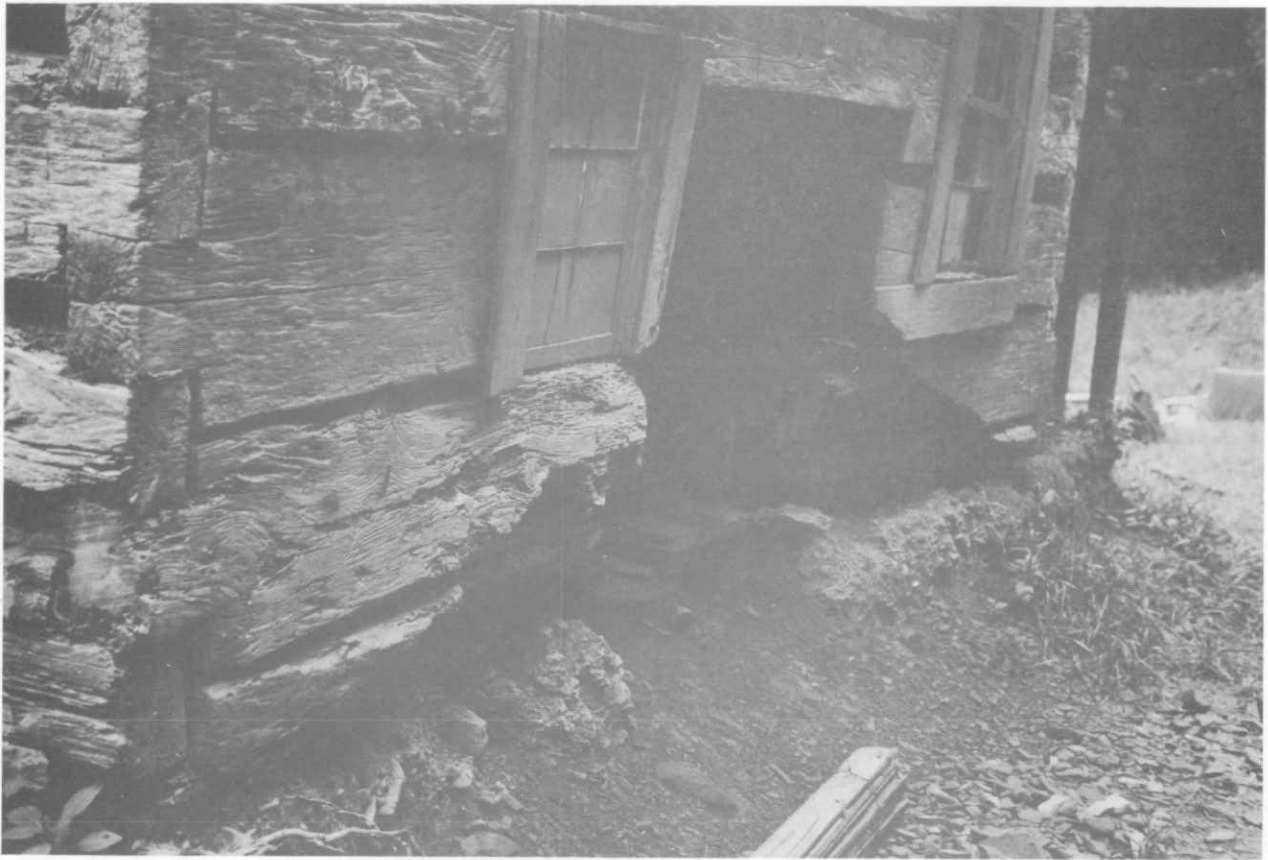
Figure 8.

Northwest elevation of Hannah Cabin,
from the front, August 1975.

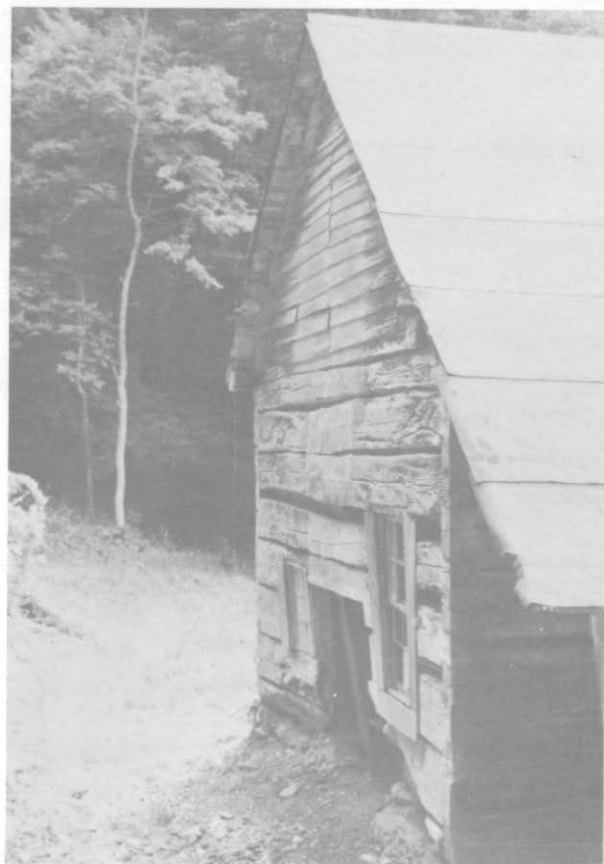
Figure 9.

The front door opening is 3 feet 2 inches by 5 feet 11 inches. The frame, once fastened to the logs with locust pegs, and the casing are missing. The door, which opened inward, is 3 feet 1½ inches by 5 feet 8 inches. It is of hand-dressed boards and is still there, though not in place, and is in good condition (see Fig. 9).

Front door of Hannah Cabin, August 1975.

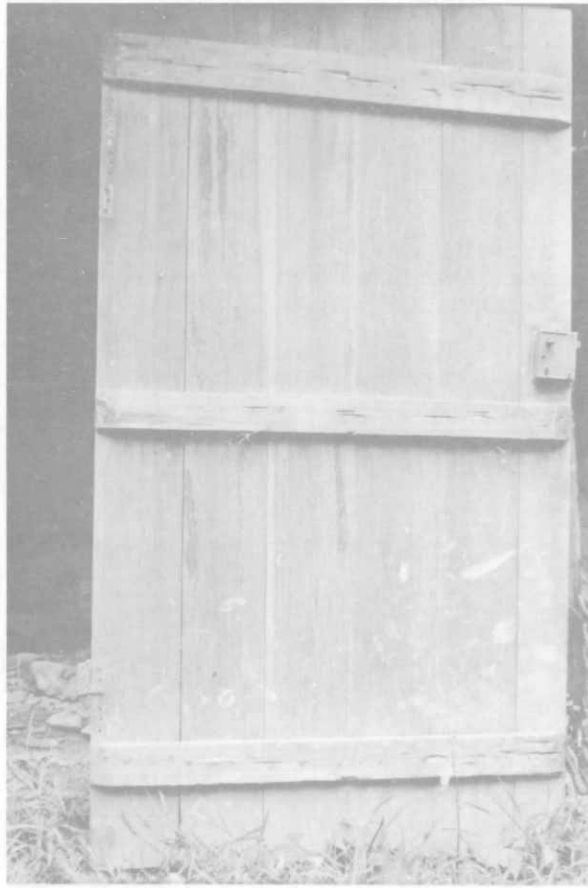
Figure 10.

There are two windows in the northwest wall of the cabin, one on each side of the chimney opening. The window between the chimney and the front wall is a 6 lights over 6 lights double-hung sash, 2 feet 3 inches by 3 feet 9 inches. The trim is ½ inch by 7 inches. Most of the panes are missing, and the frame and sash are in poor condition and need to be replaced.

The window between the chimney and the rear wall is a 6 light, single sash, 2 feet by 2 feet 4 inches. The trim is ½ inch by 7 inches on one side and ½ inch by 4 inches on the other. The trim above and below the window is missing (see Fig. 10).

Windows on northwest side of Hannah Cabin,
August 1975.

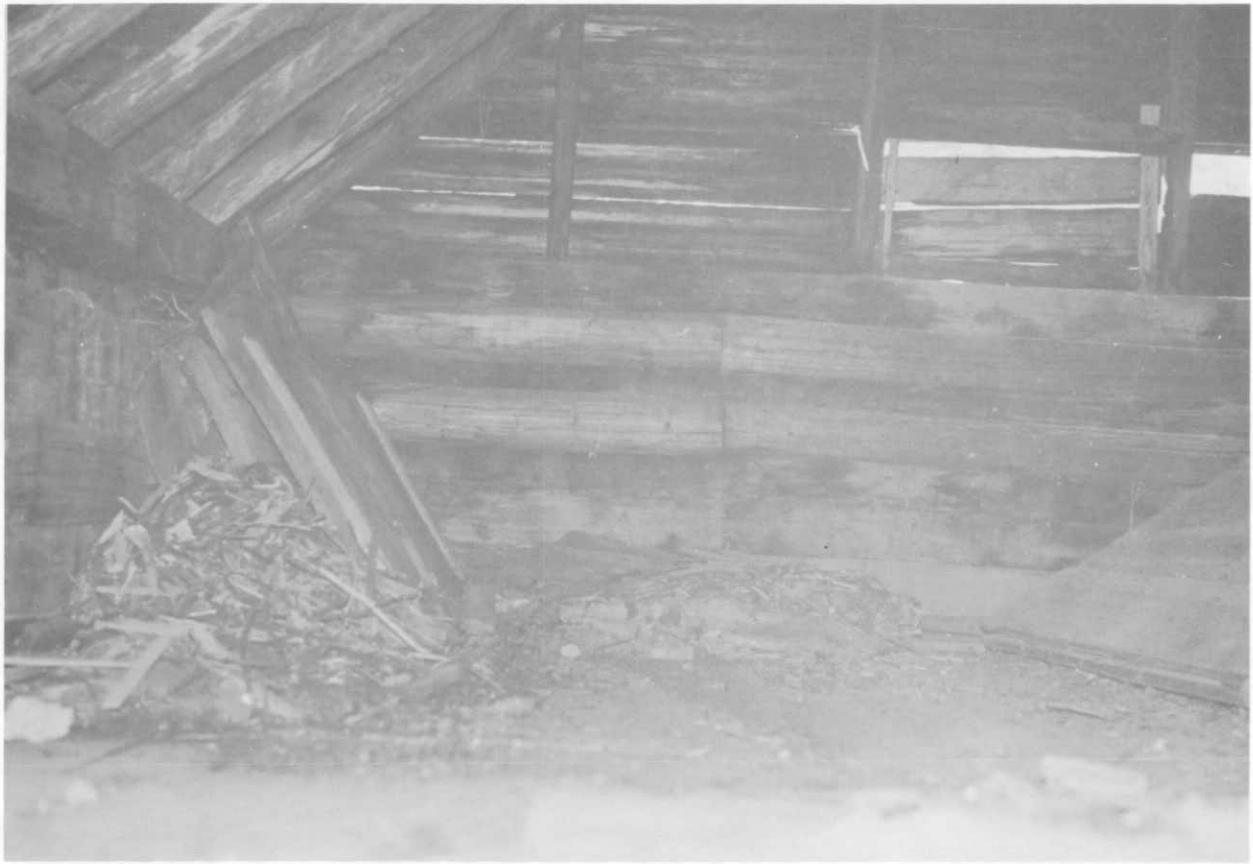
Figure 12.

One of the distinguishing features, the chimney on the northwest side, is no longer in place. It collapsed sometime after 1950, and Park Service personnel subsequently used the debris to fill in a depression some 30 feet to the rear of the house. In so doing, the grade where the chimney stood was lowered by 17 inches or more, removing any evidence as to the nature and depth of its foundation. The bricks, some of which are visible, should be recovered and stored.

Chimney of Hannah Cabin, ca. 1948.
This photo is among the Hiram C. Wilburn
Papers in the Haywood County Library.

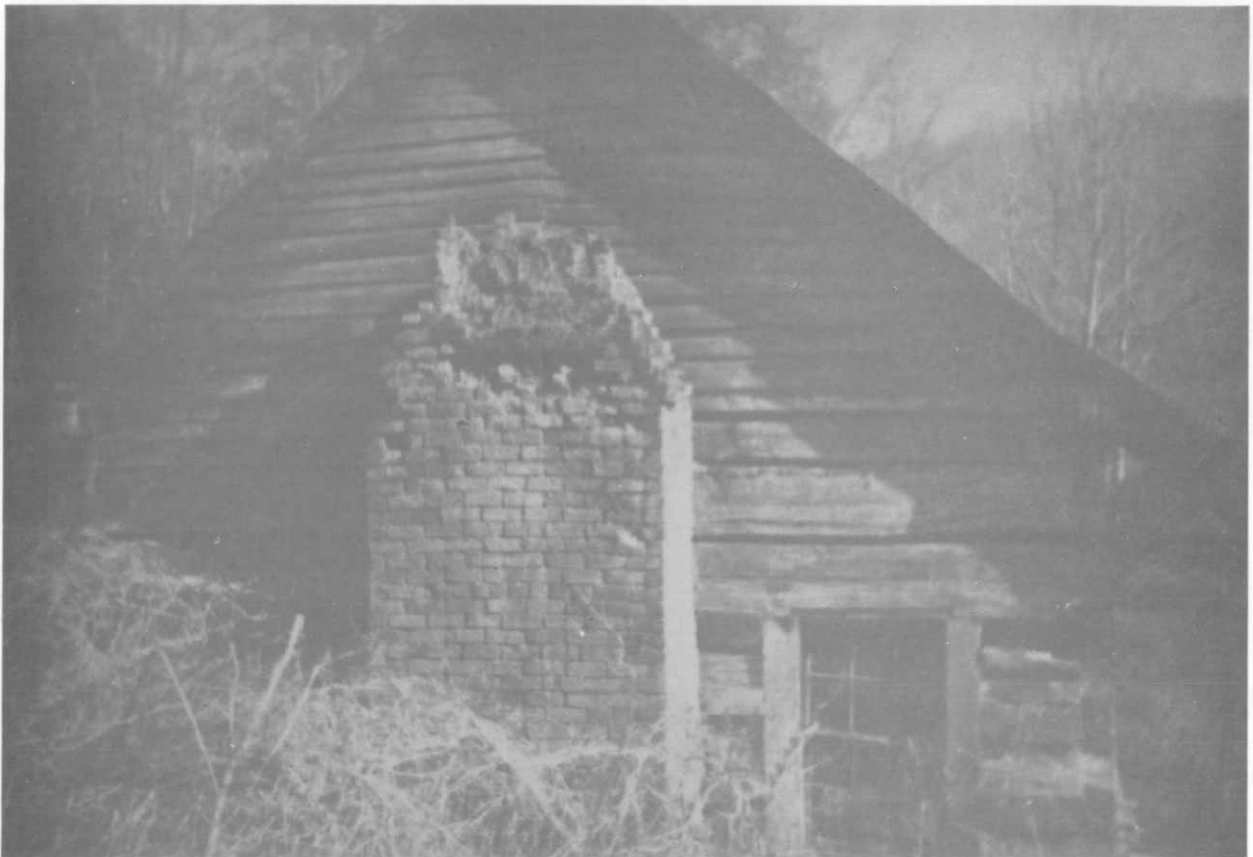
Figure 13.

Interior, southwest wall, Hannah Cabin,
August 1975. This photo shows the hewn
ceiling joists and the rived hemlock
over the chinks.

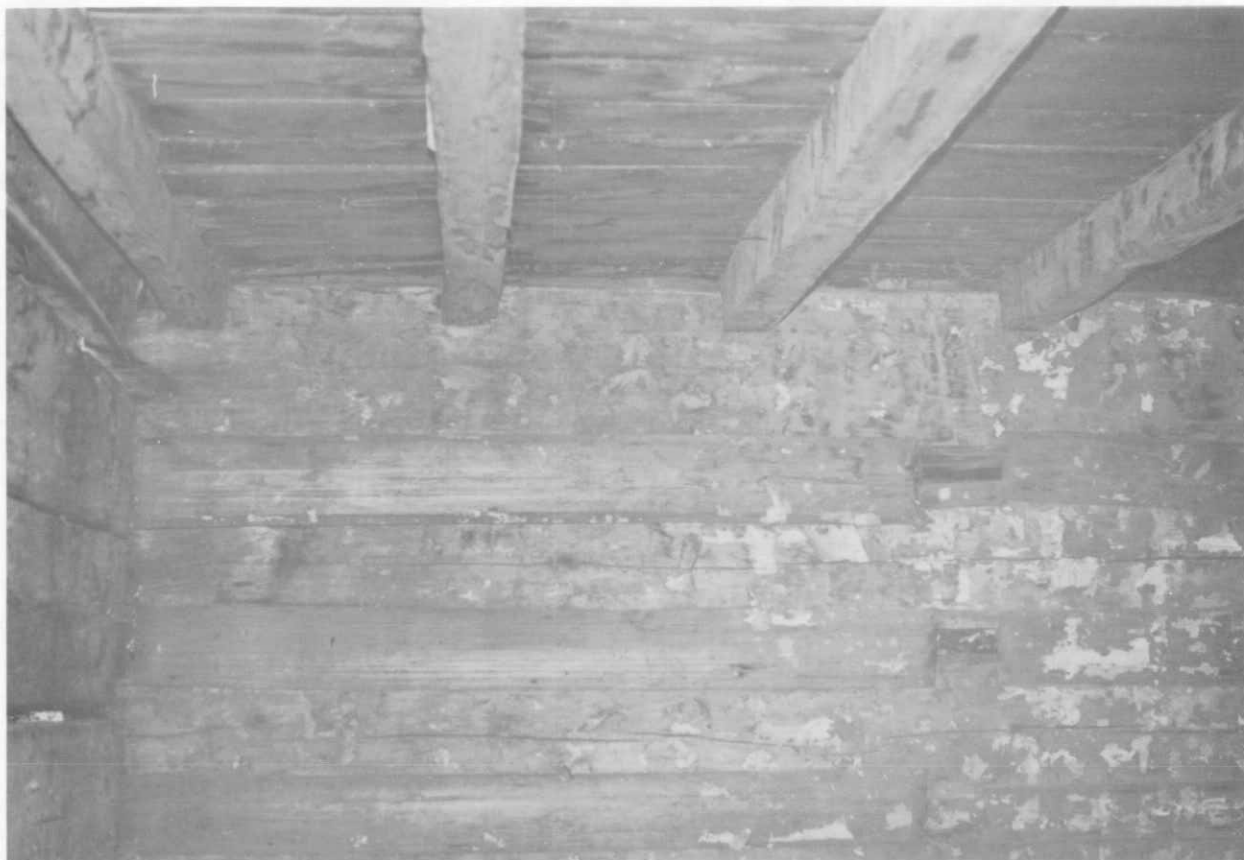
Interior of Hannah Cabin, December 1937.

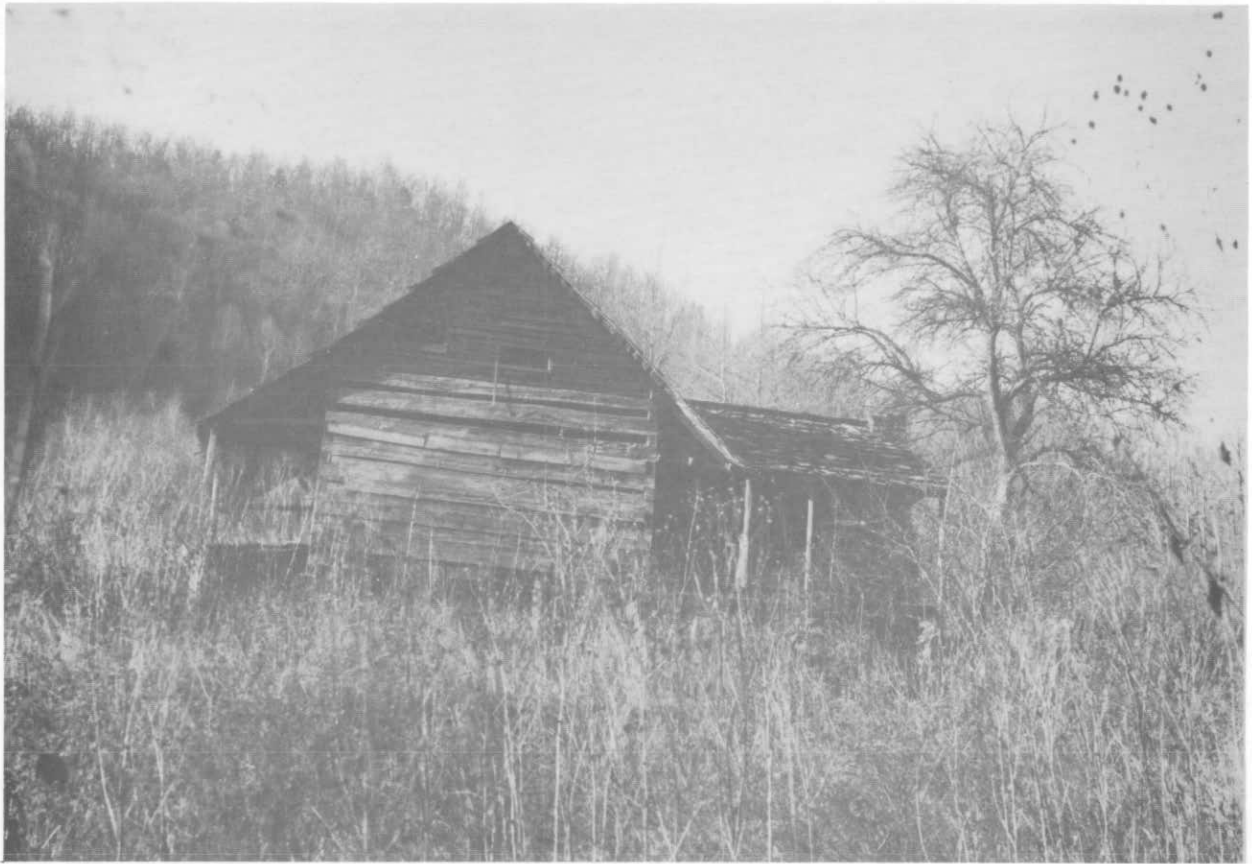
Figure 16.

Hannah Cabin, from the northeast, 1948.
This photo, showing the cabin after the
kitchen ell had been razed, is among the
Wilburn Papers in the Haywood County Library.

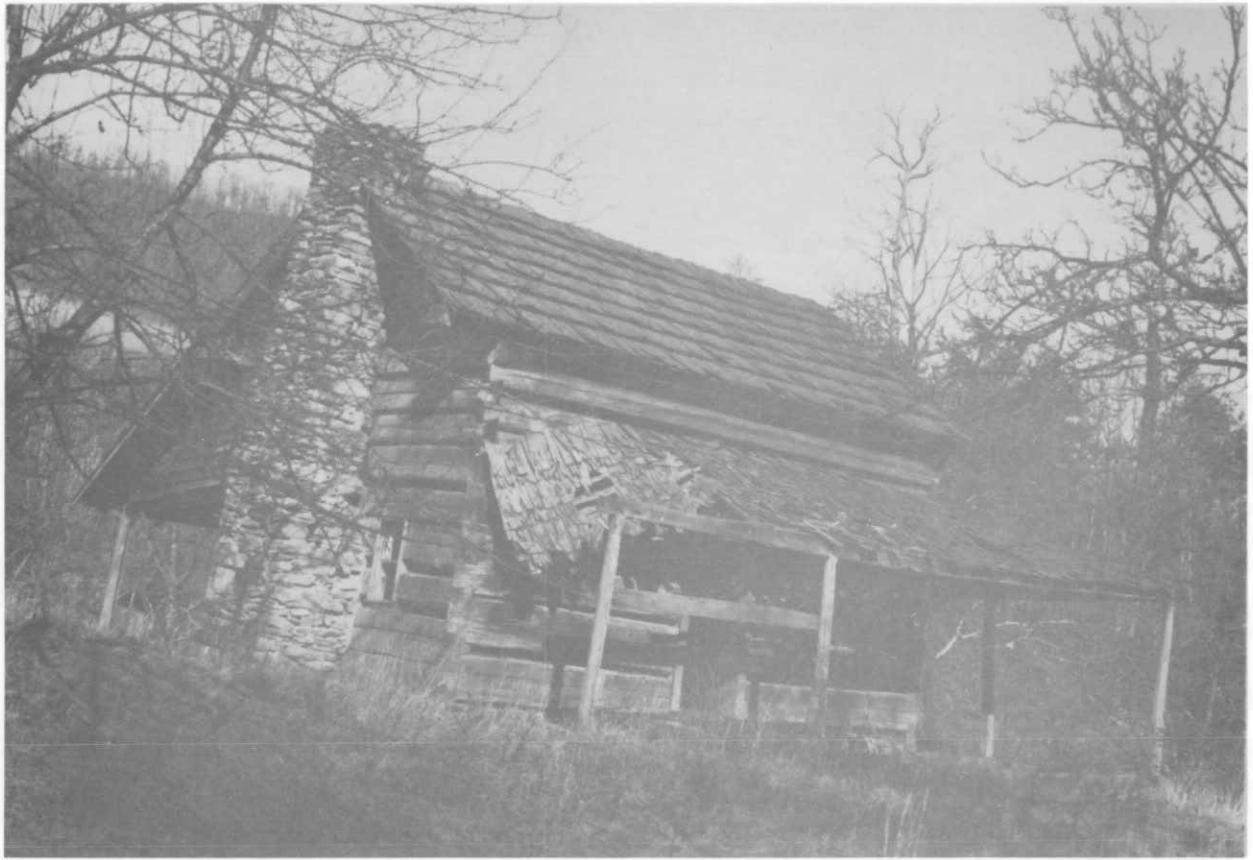
Exterior of Cook Cabin, June 1935.

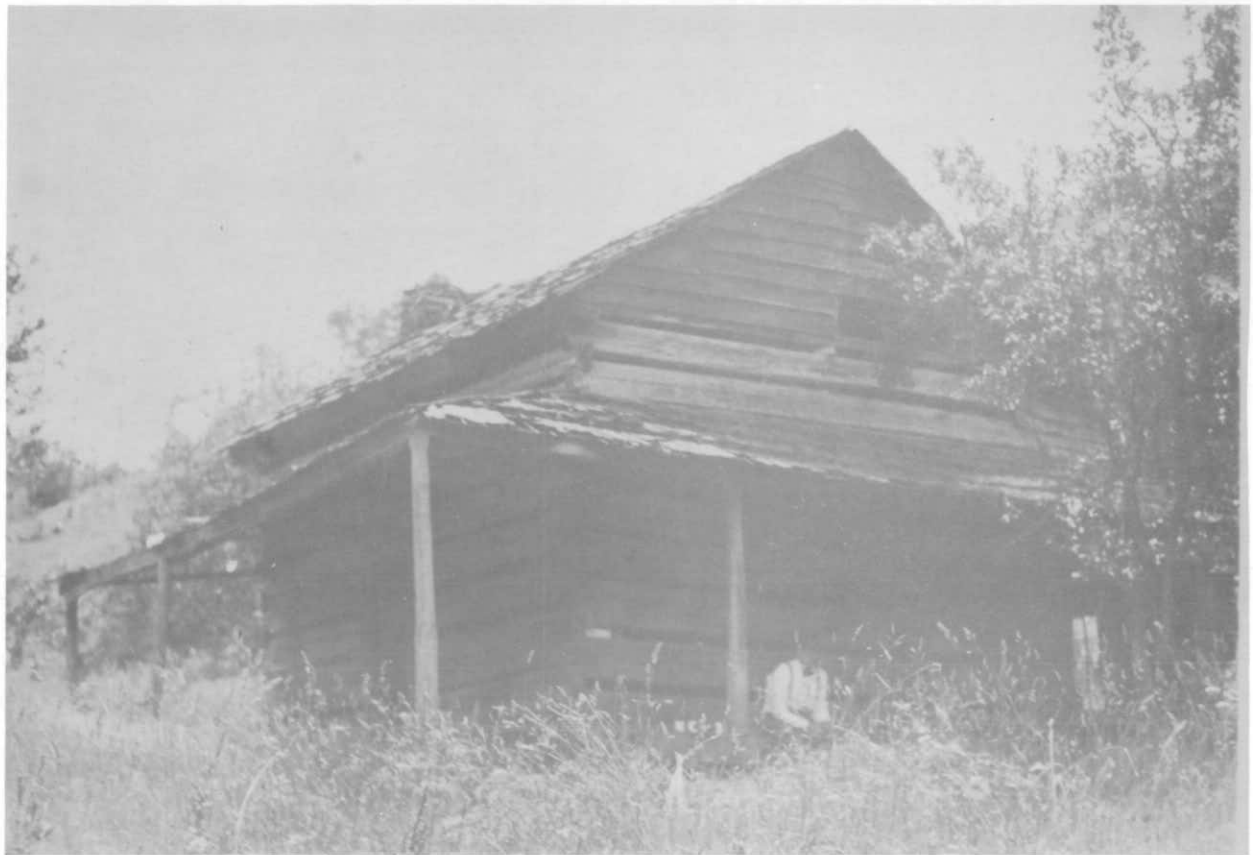
Figure 19.

Exterior of Cook Cabin, June 1935.
This photo shows the stone chimney
and the rear window on the southwest
wall.

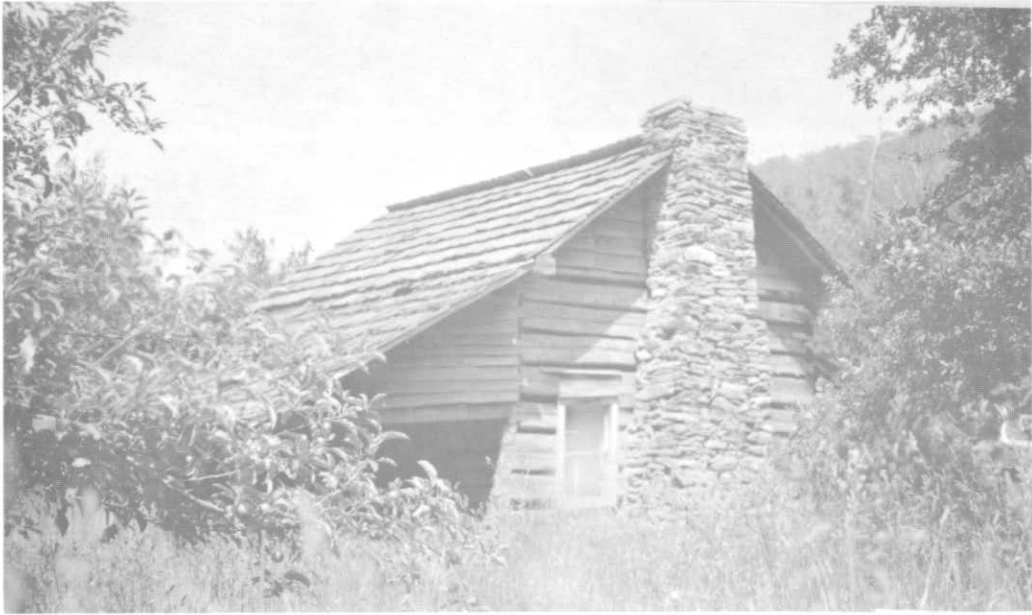
Southeast elevation of Cook Cabin,
February 1975. This is the last photo
taken of the cabin prior to its collapse.

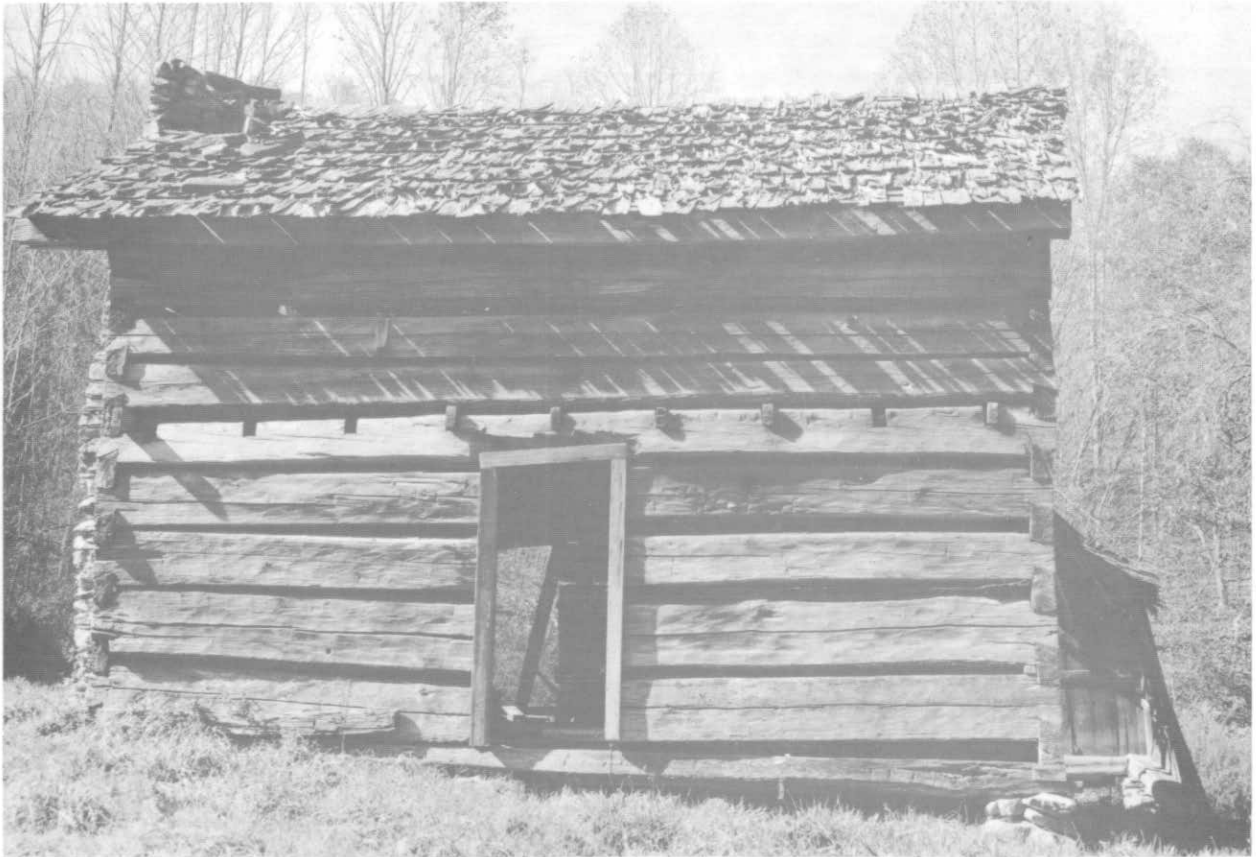
Figure 21.

Northeast side of Cook Cabin, August 1975.
This photo shows the bottom log on the
northeast wall, square-notched and hewn
flat. It is broken at the center.

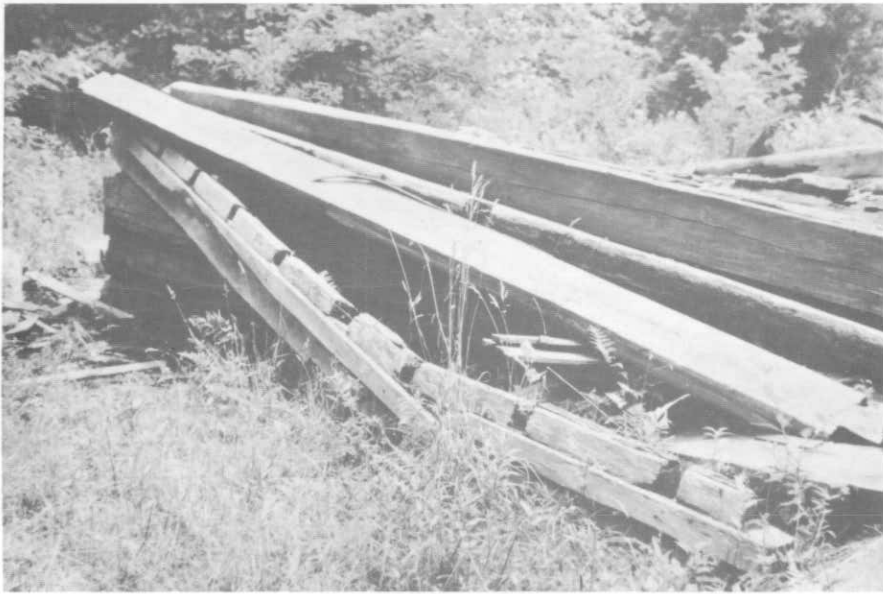
Figure 23.

Cook Cabin, from the northeast, August 1975.
This photo shows the stairs which were located
in the southwest corner on the ground floor.
It also shows the deterioration on the inside
of the front wall logs.

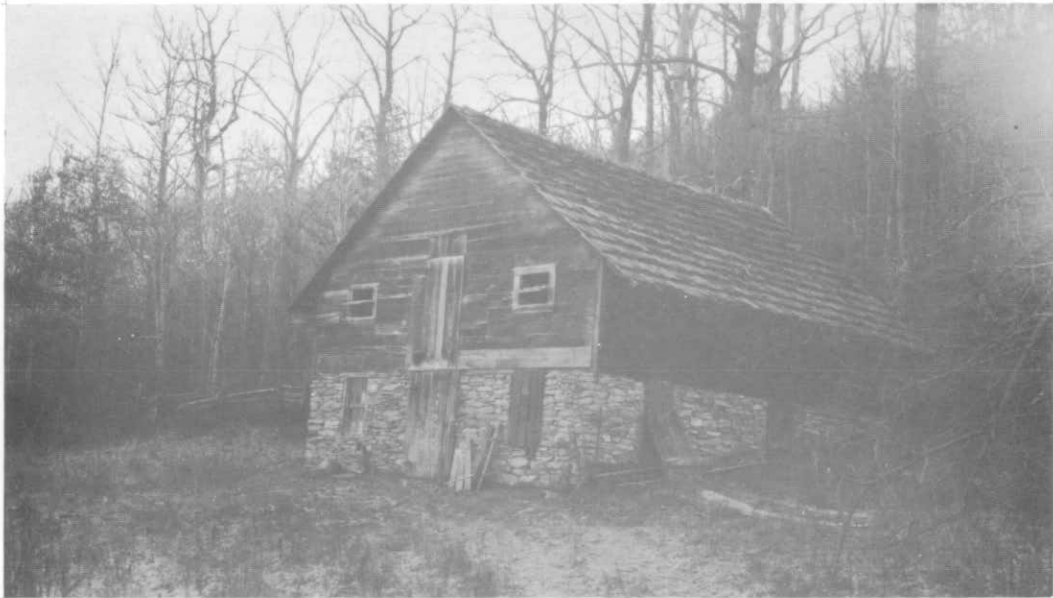
Figure 25.

Cook Place Apple House ruins, from the west,
April 1975.

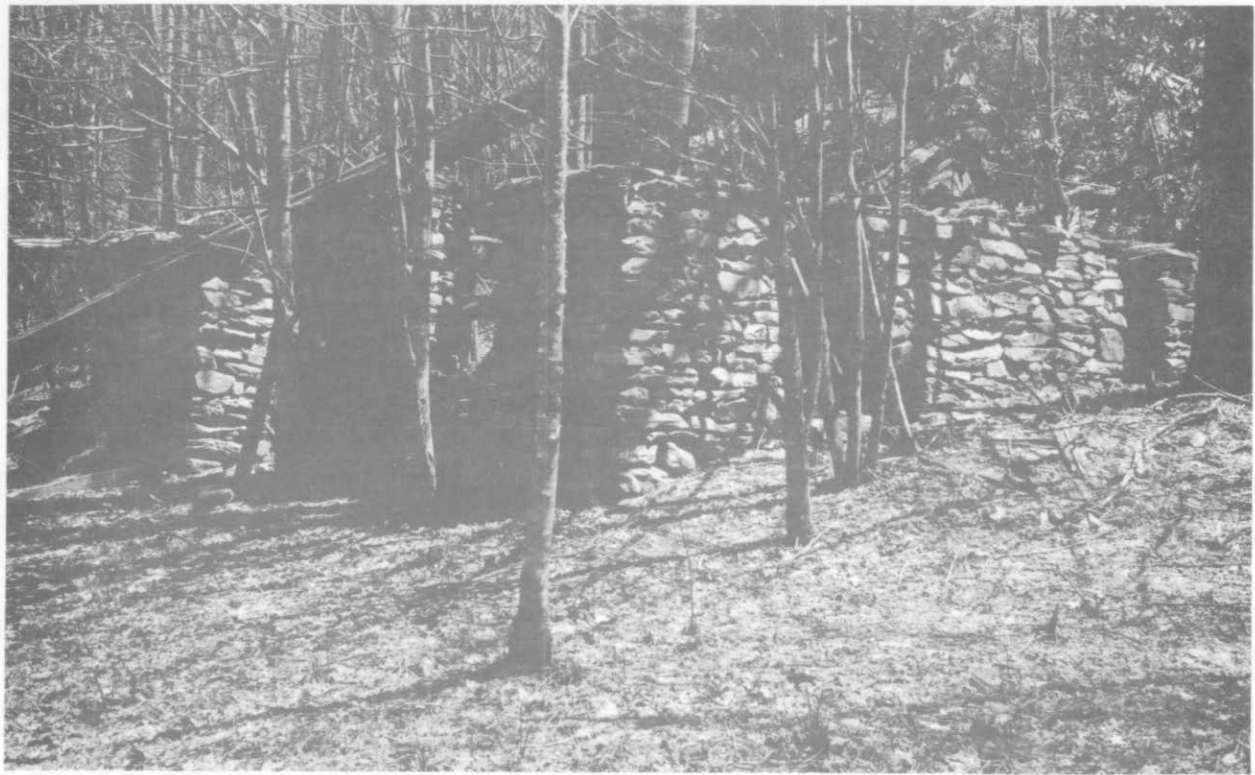
Figure 26.

Cook Place Apple House ruins, from the north,
August 1975. This photo shows the collapsed
north corner, now covered by dirt and forest
litter.

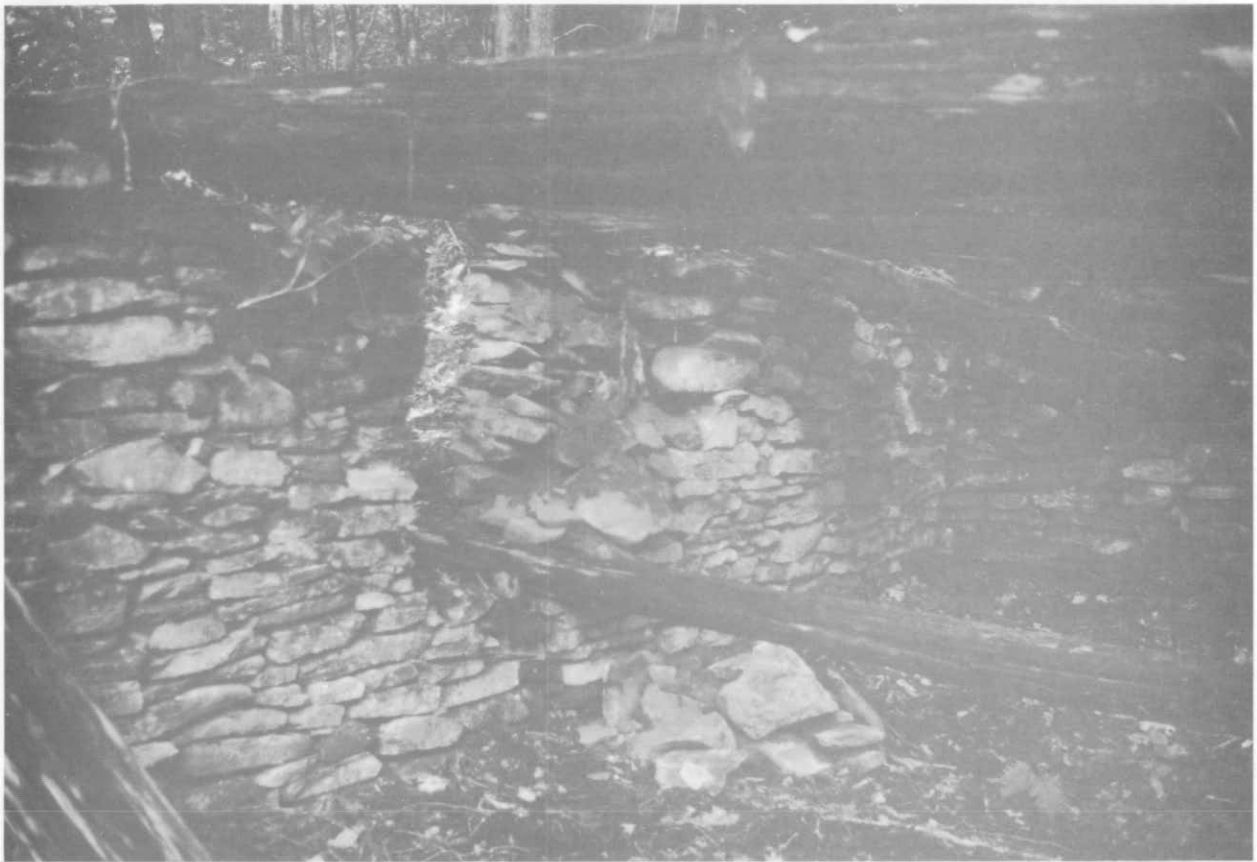
Figure 28.

Ruins of Cook Place Apple House, from the southwest, April 1975. This photo shows the joists which once supported the floor of the upper story. The sill along the top of the southwest wall is missing.

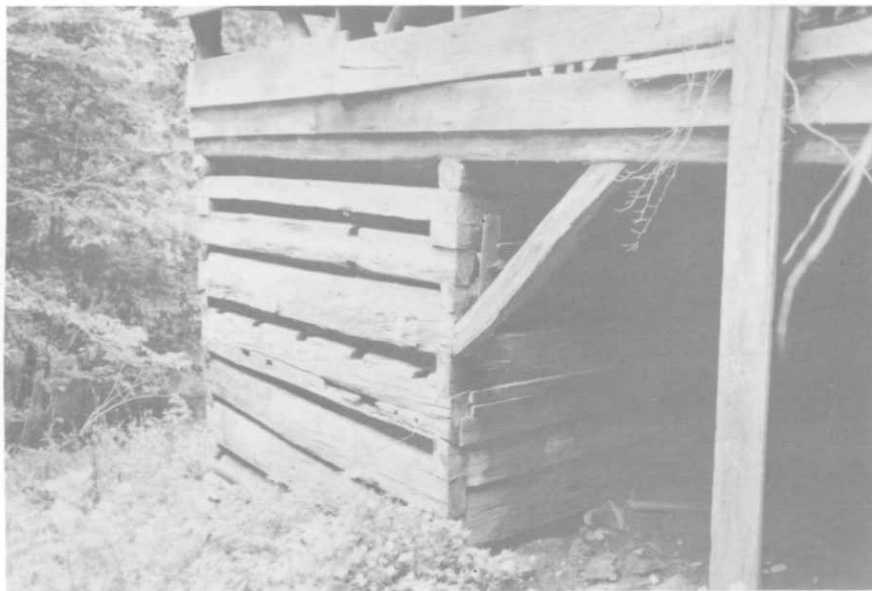
Figure 34.

Southwest corner, log portion of Messer Barn, August 1975. This photo shows the west and south walls of the center stall on the ground floor.

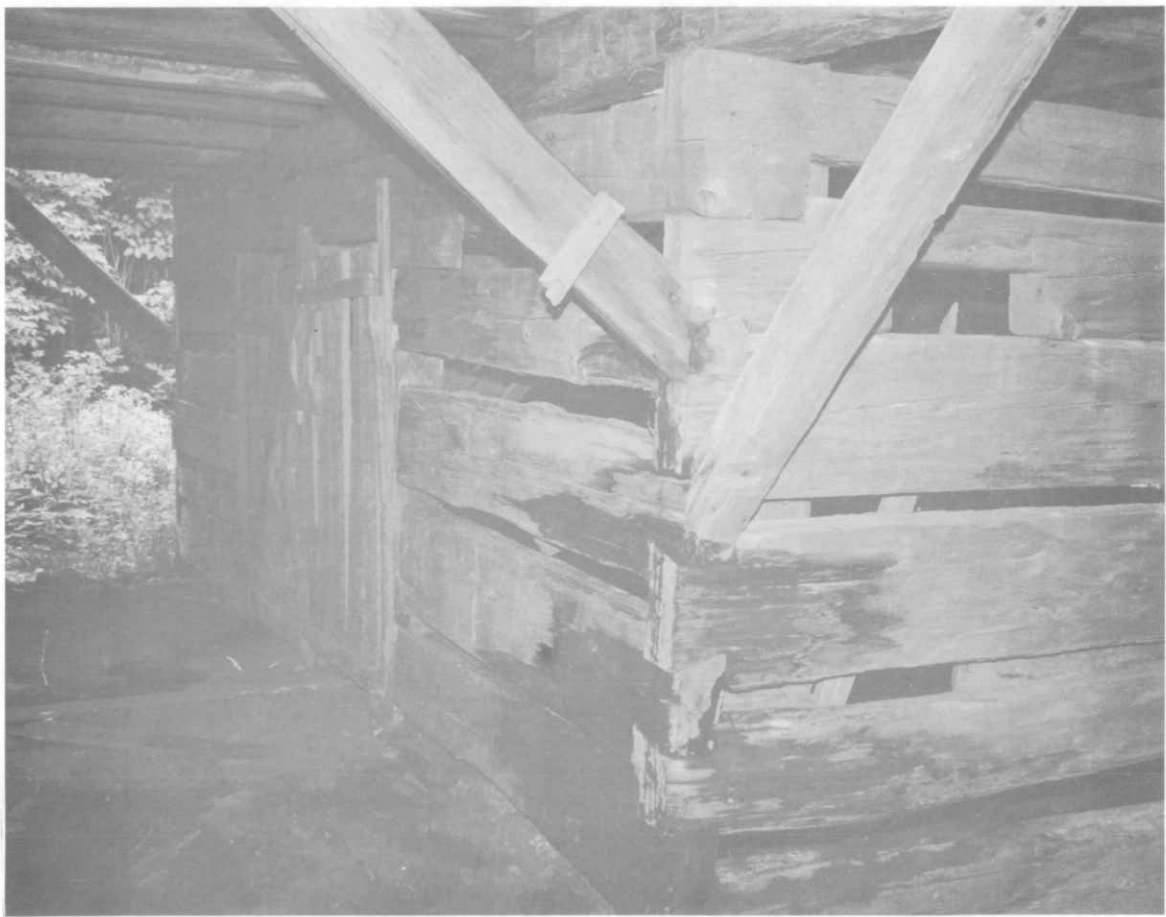
Figure 36.

East wall, log portion of Messer Barn,
August 1975. This photo shows the
deterioration of the first, second, and
third logs.

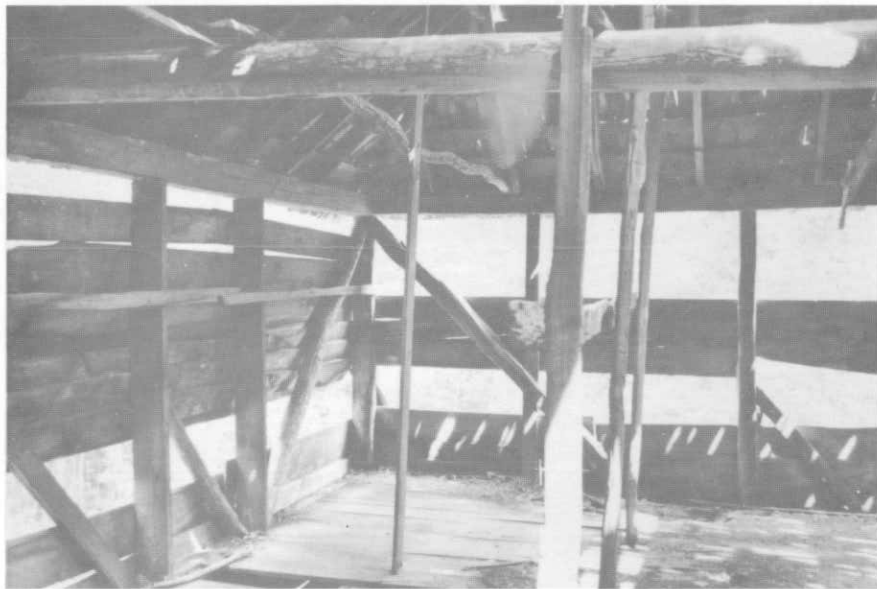
Figure 38.

The roof framing consists of rafters and plates (see Fig. 38). The rafters, 2 inches by 6 inches, 20 feet in length, are spaced 2 feet 8 inches on center. The hip ridge poles are round poles, 6 inches to 8 inches in diameter, and 12 feet in length. The lower ends of the rafters are nailed to the plates.

Rafters, Messer Barn, August 1975.

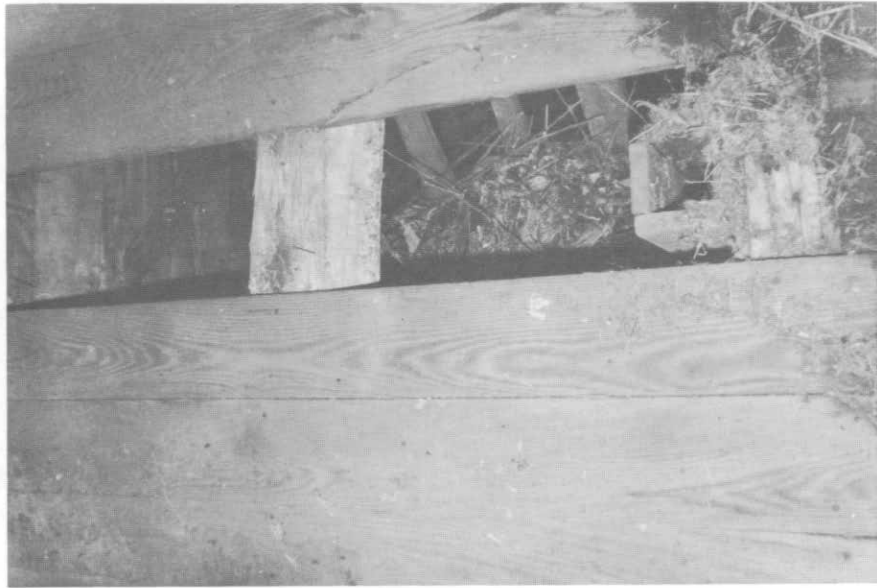
Figure 45.

The northeast stall measures 10 feet 3 inches by 9 feet 7 inches. Opening onto this stall is a door leading from the open shelter area beneath the loft, a grain chute, 4 inches by 4 inches, made of 1 inch boards and extending downward from the loft to the feed trough, and an opening (6 feet by 11 inches) in the loft floor through which hay was dropped. To the left of the door and mounted on the west wall is a feed trough, 5 feet 4 inches long, 18 inches wide, and $8\frac{1}{2}$ inches deep. Above it is a hay rack. Both the trough and the rack are in good condition (see Fig. 45).

Hay rack, interior of north stall, Messer
Barn, August 1975. This photo shows the
split boards placed over the chinks in
the north and west walls.
