National Park Service
Cultural Landscapes Inventory
2007

Bar BC Dude Ranch
Grand Teton National Park

Inventory Summary

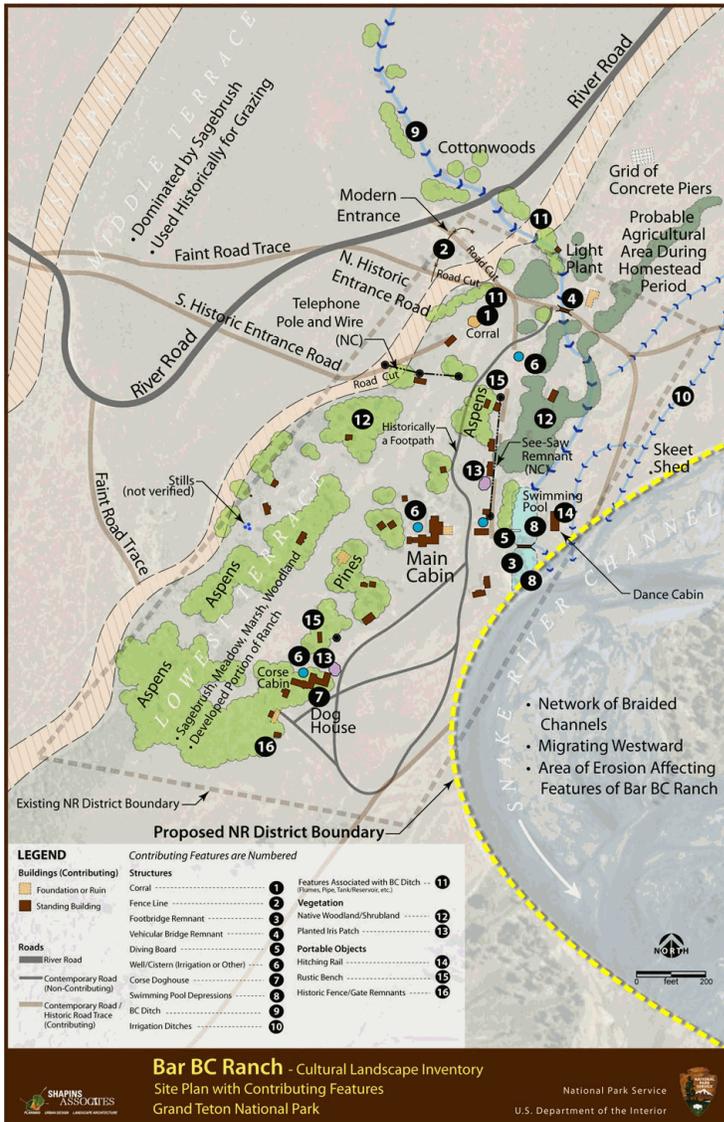
Core Bar BC Dude Ranch area with contributing landscape features. Source: Shapins Associates.

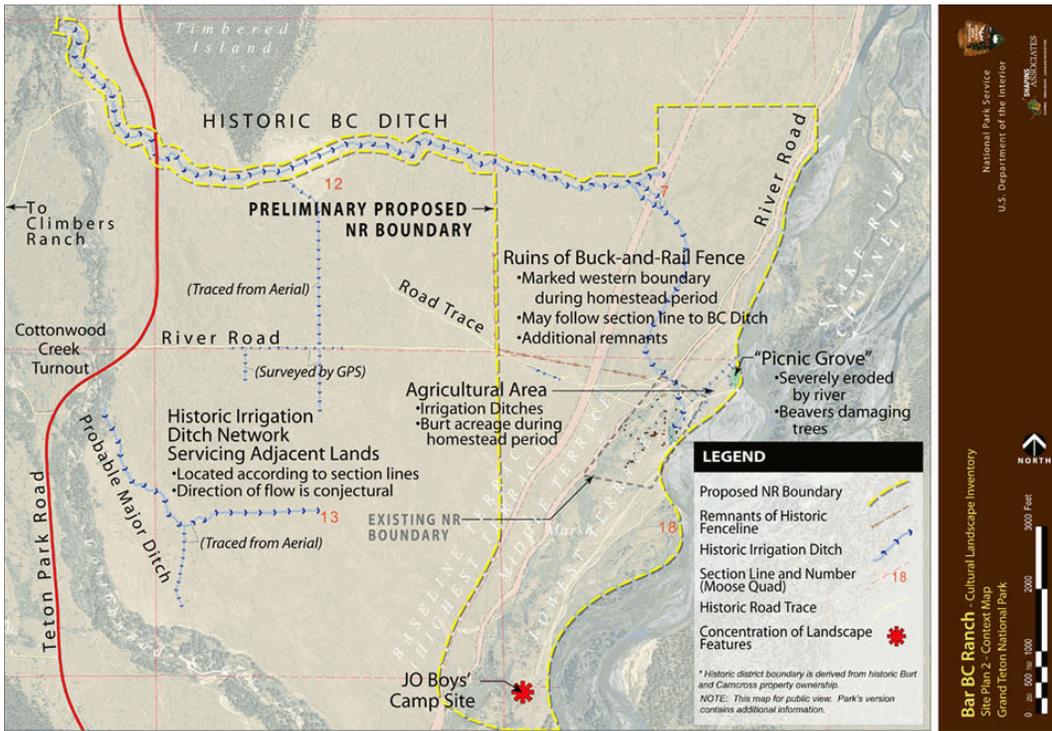
Site plan showing proposed district boundary (yellow) and major landscape features. Source: Shapins Associates.

This CLI recommends expanding the Bar BC Dude Ranch Historic District boundary from the existing 38 acres to 763 acres in order to include key contributing landscape elements within the district (See Site Plan with proposed boundaries in yellow). This CLI addresses all lands within the proposed district

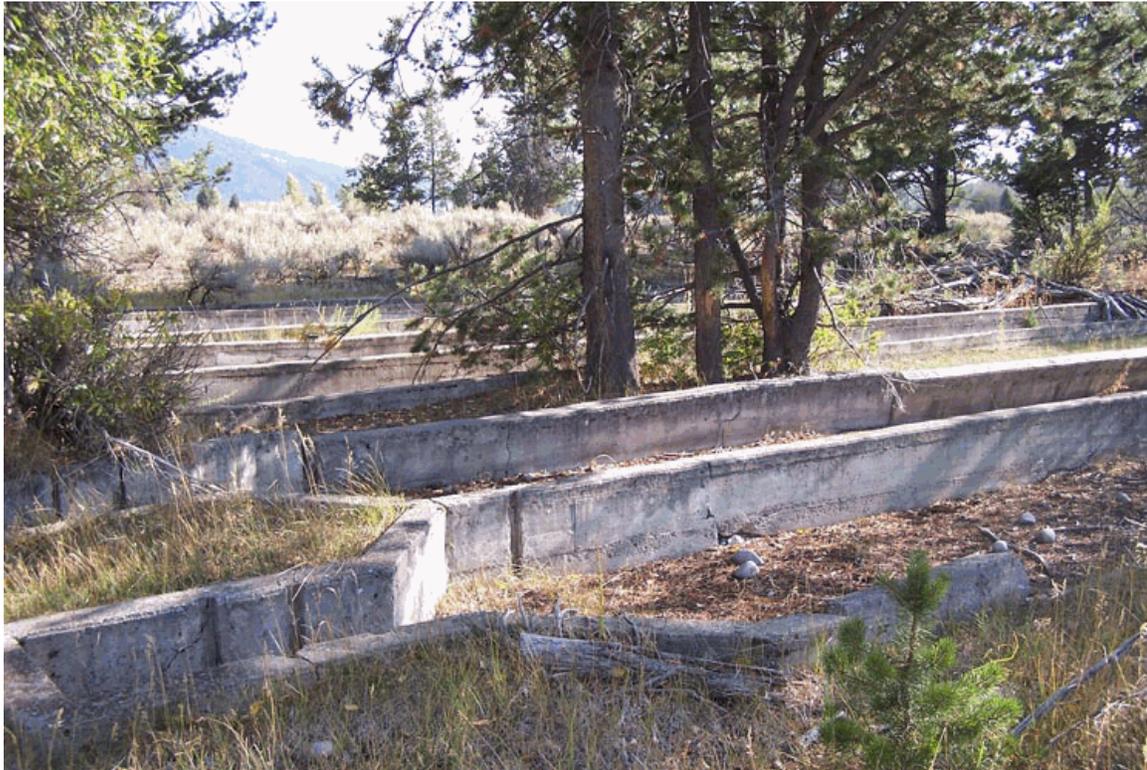
Ruins of a fish hatchery at the JO Boys' Ranch site, about 1/2 mile south of the main dude ranch complex. Source: Shapins Associates, 9/2006.

About a mile south of the ranch center was the JO Boys’ Camp. This CLI found little information on the buildings at the JO. Today the ruins of a fish hatchery and footings from at least one other structure are present.

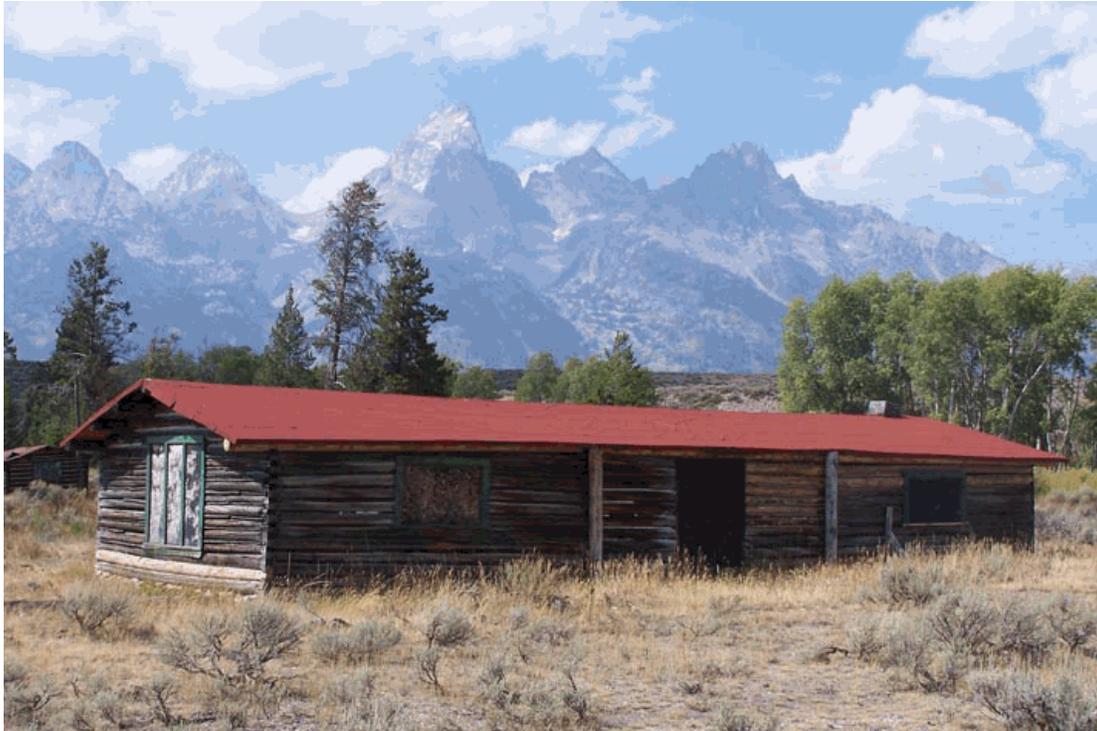
*The dance cabin has undergone significant stabilization and repair work since 2000.
Source: Shapins Associates, 9/2006.*

| AD 2003 - 2004 | Stabilized | Michigan Volunteers stabilized the Dance Cabin. They replaced rotten logs and leveled the structure, which had sagged at one end more than fifteen inches (Scott 2005, 149). |

Other notable buildings include the saddle shed (# 1372), which is in good condition due to stabilization work in 2003, and the dance cabin (# 1375), which has benefited greatly from stabilization. Northeast of the dance cabin is the skeet trap. Another very small structure is a doghouse in the Corse cabin cluster. One small building (# 1391) adjacent the main cabin was the first cabin built. Originally it was used as a mess house. Struthers Burt thought it ironic that “millionaires” slept in this cabin, which at one time reeked of cooked food (Burt 1924, 137).

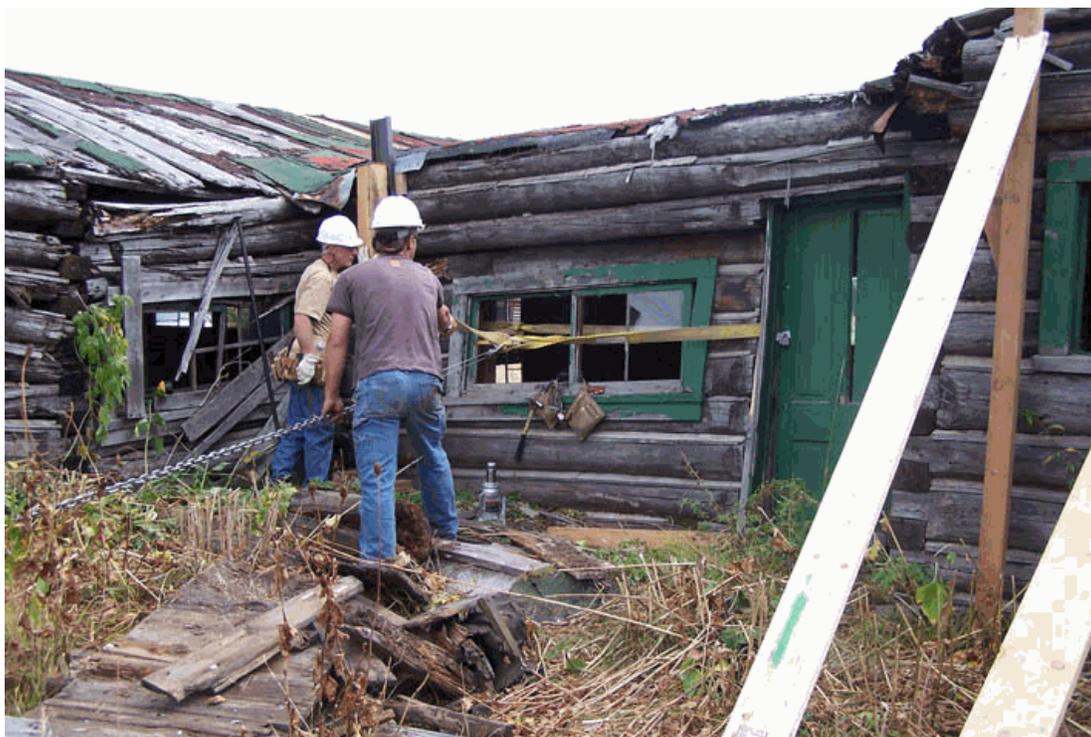
Stabilization work on the northern section of the main cabin. Source: Shapins Associates, 9/2006.

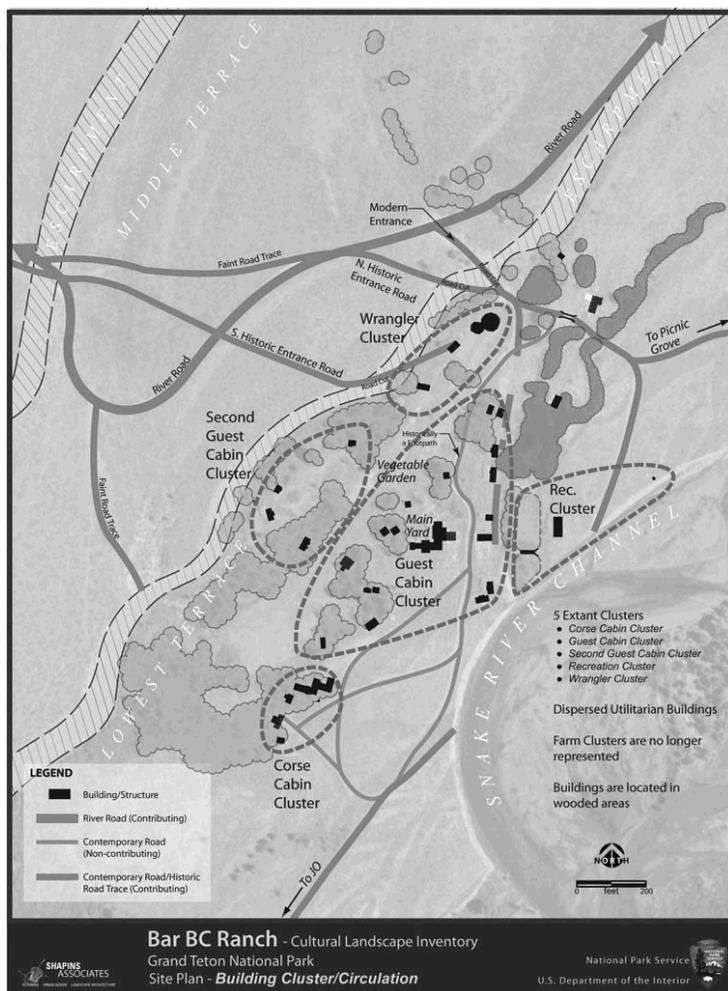
Building Cluster/Circulation Diagram. Source: Shapins Associates.

The separation of land uses and the phased development of the dude ranch over time led to the establishment of several loosely defined building clusters. Some of these clusters have lost structures over time, yet overall the historic cluster arrangement is evident to this day.

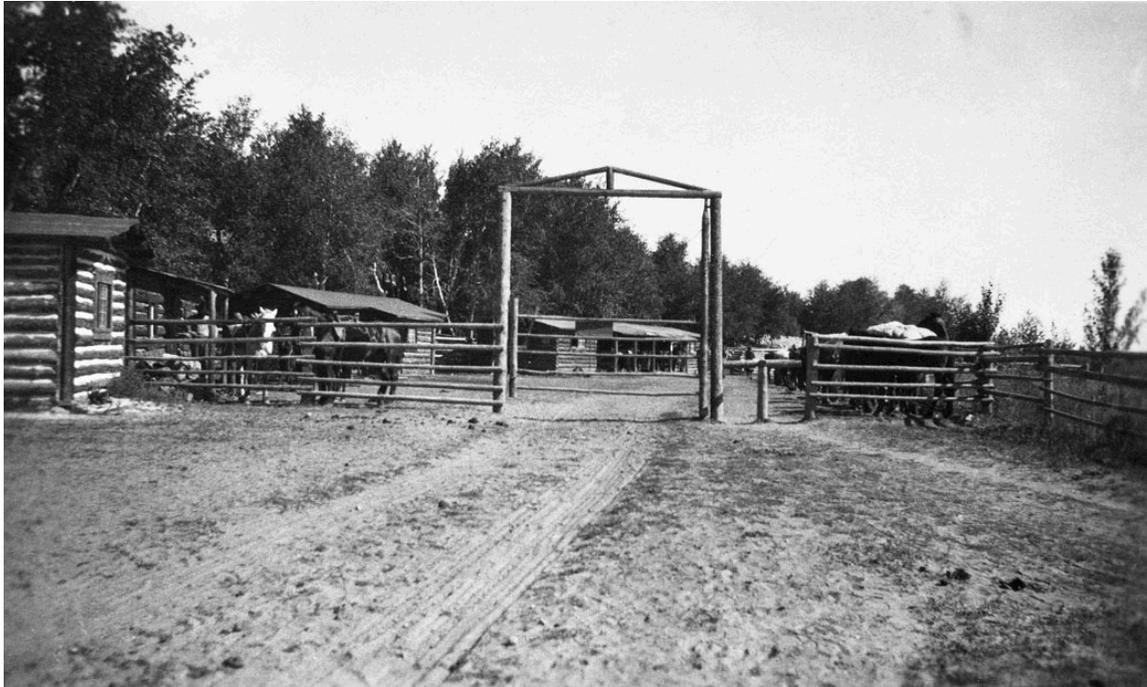
Looking north into the Wrangler zone, "date unknown. Collection of the Jackson Hole Historical Society and Museum (1958.0304.01).

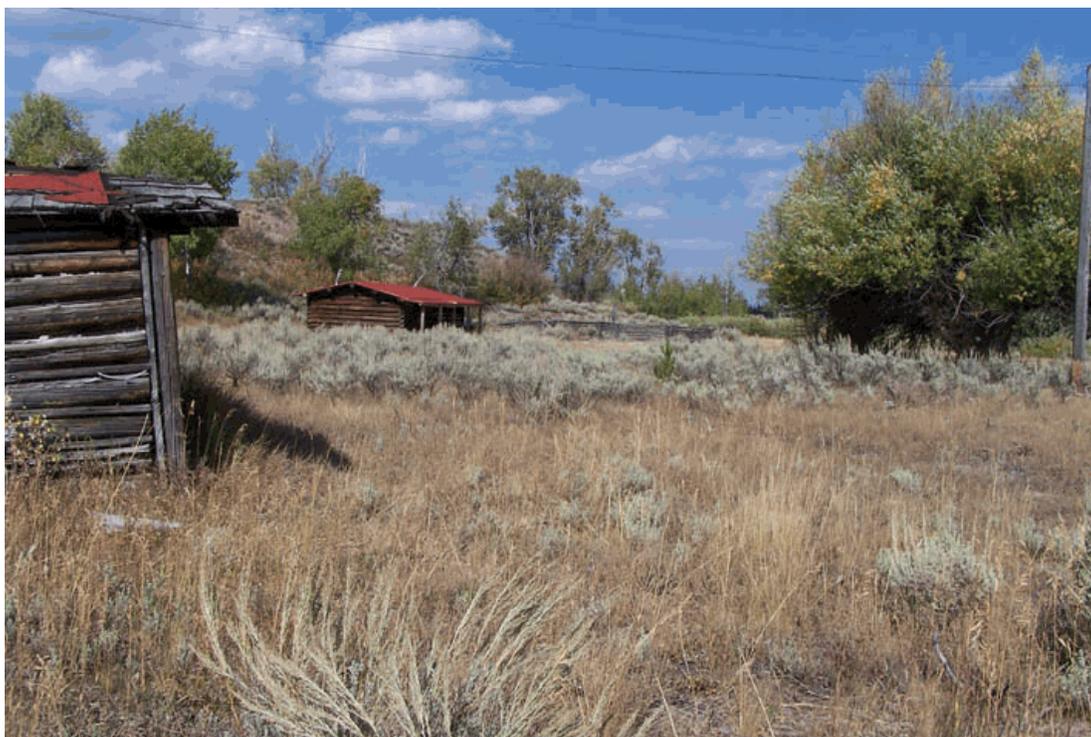
Looking north into the Wrangler zone today. Some structures in this cluster (store, tack shed) have survived, while others disappeared over time. Source: Shapins Associates, 9/2006.

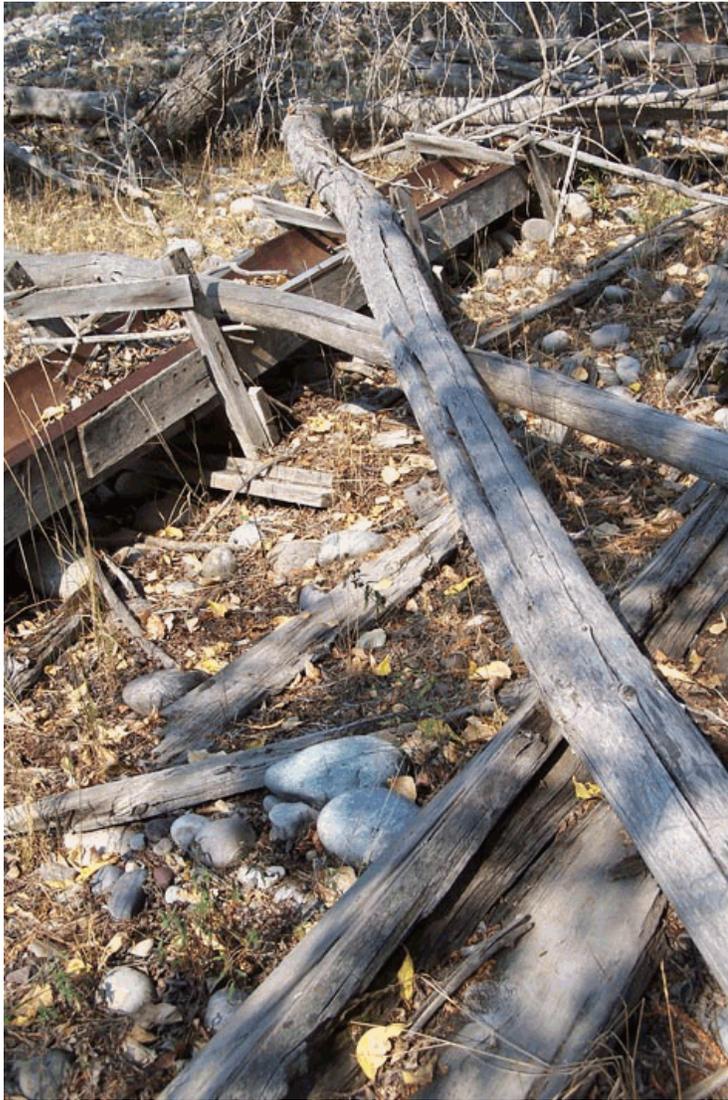
Remnants of two flumes along BC Ditch from different periods lying side by side on escarpment between middle and highest terrace. Source: Shapins Associates, 9/2006.

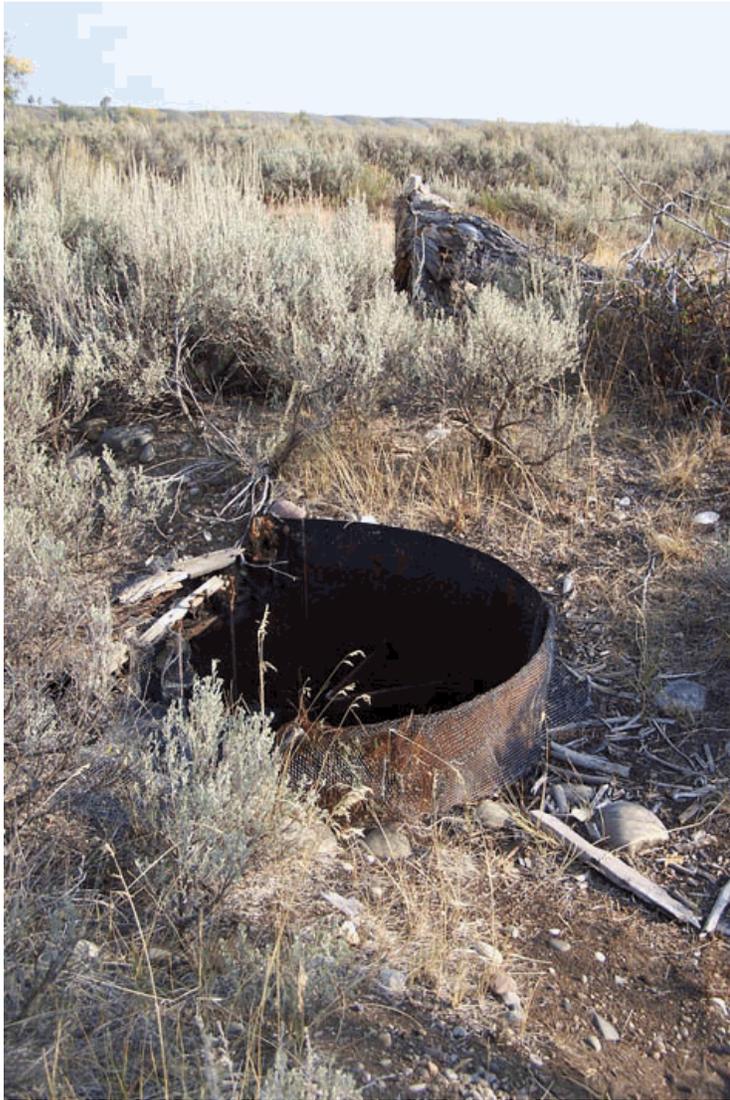
A water settling tank adjacent to the BC Ditch, perched at the edge of the escarpment separating the lowest and middle terrace. Source: Shapins Associates, 9/2006.

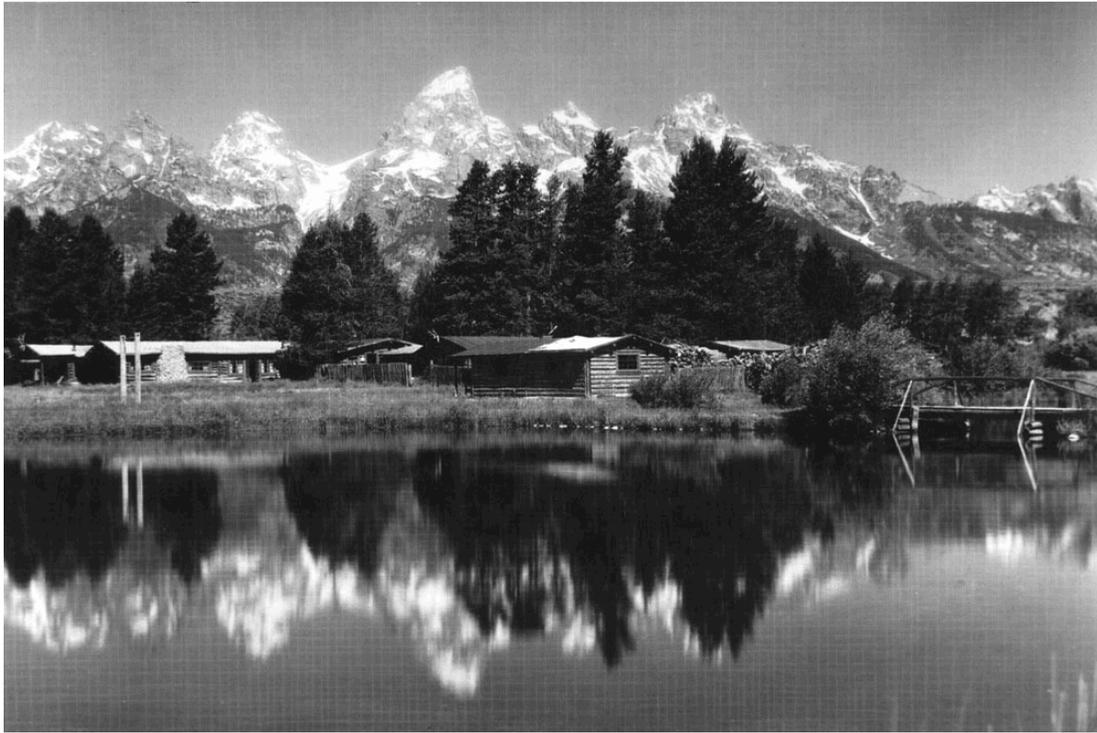
Looking west across the swimming pool to the main cabin. The pool was filled with water from the BC Ditch. Date unknown. Collection of the Jackson Hole Historical Society and Museum, Harrison R. Crandall, photographer (1958.2440.001).

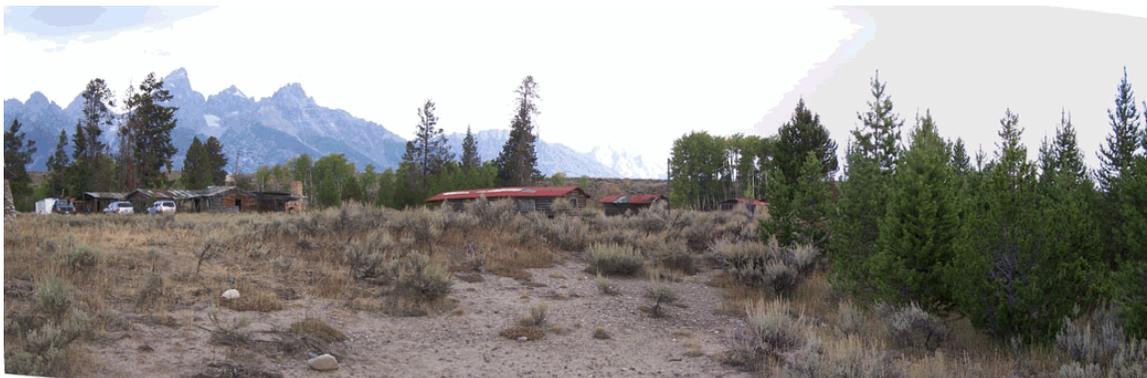
Looking west across the dry swimming pool today. Footbridge is not visible because many pines have grown up along the pool's edges. Source: Shapins Associates, 9/2006.

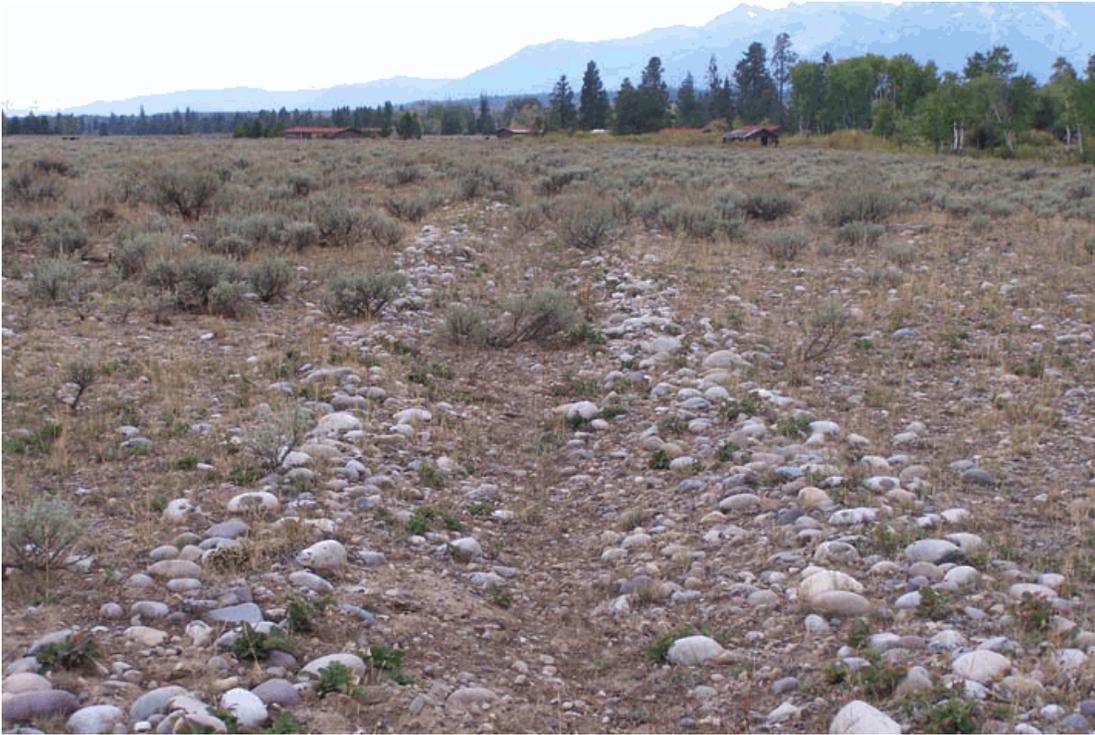
An irrigation ditch. This area (north of the ranch buildings) was probably used to raise crops while Struthers Burt was homesteading the property. Source: Shapins Associates, 9/2006.

Remnants of ditches and laterals were also found on the land north of the ranch complex and in the vicinity of the skeet trap. These appear to be evidence for the irrigation of the crop land that was required to homestead the land, and would have been part of the Burt acreage. Additional ditches east and southeast of the pool are visible in the historic birds-eye photograph.

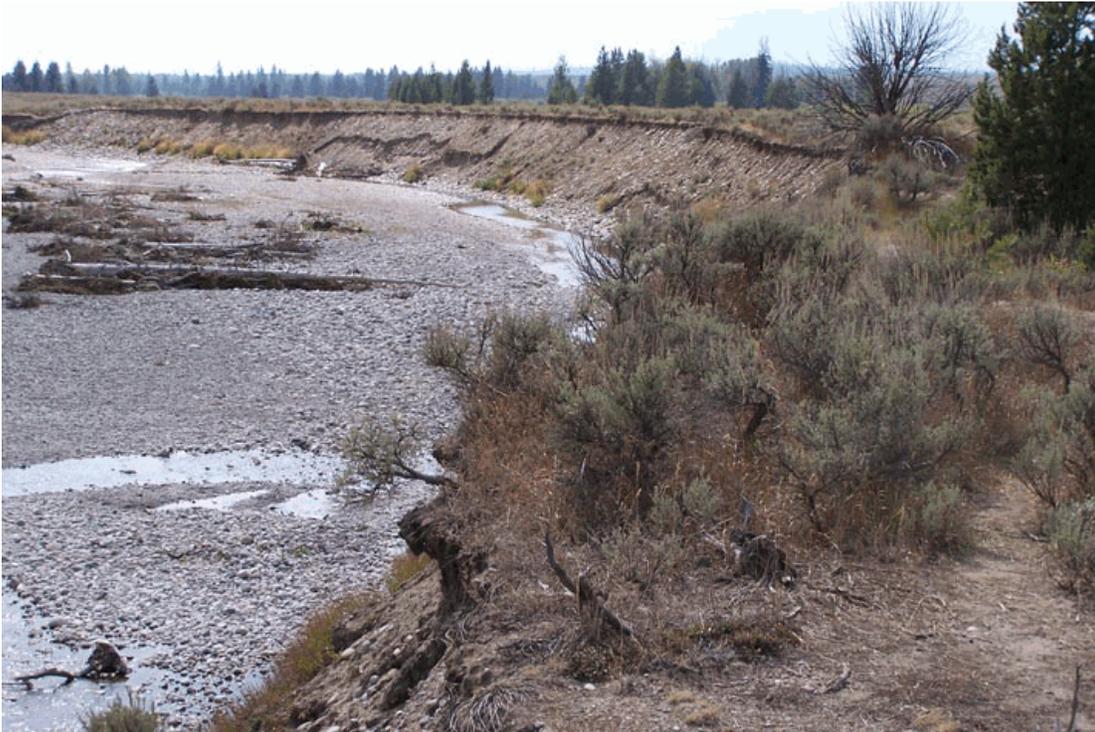
*The Snake River is now migrating westward and eroding land once part of the dude ranch.
Source: Shapins Associates, 9/2006.*

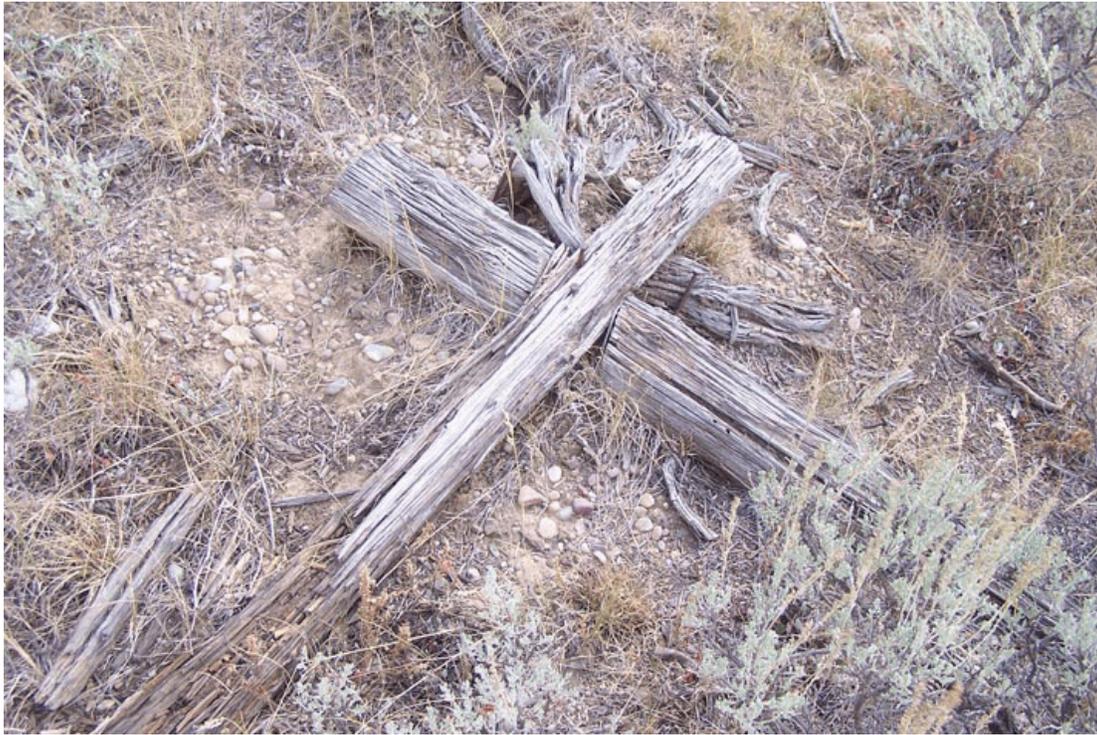
Remnant of buck-and-rail perimeter fence. The historic fenceline can still be followed. It runs along a section line and marked the western limit of the ranch. Dates to homestead period. Source: Shapins Associates.

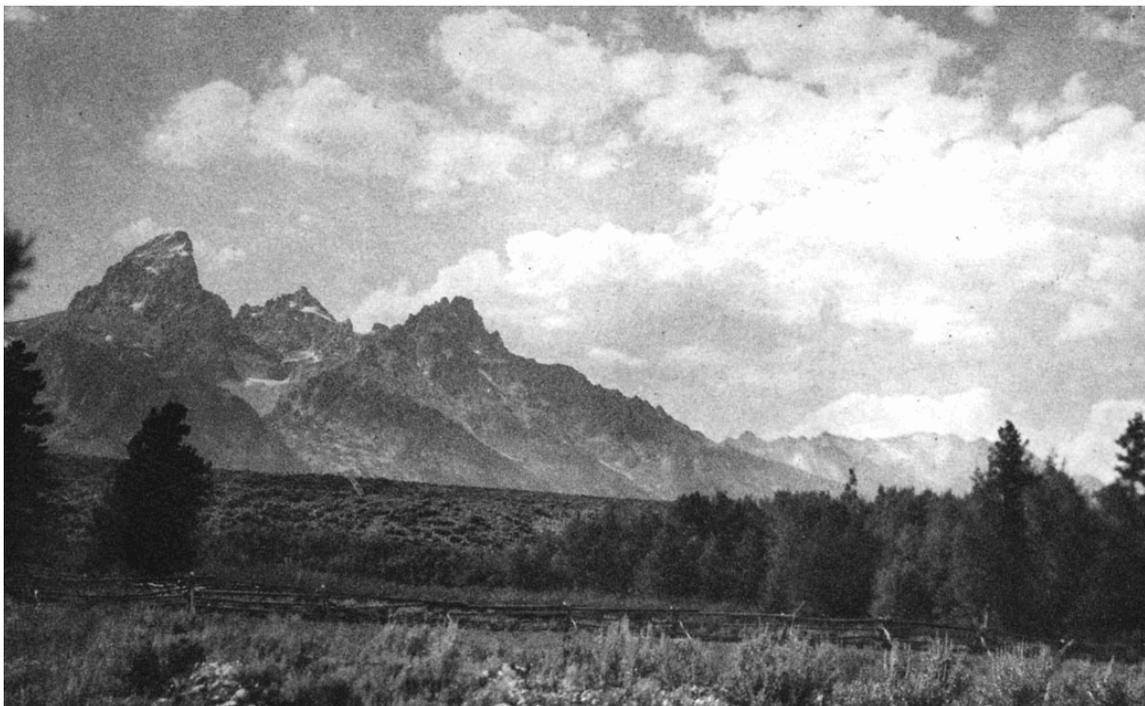
*View west to Tetons from Bar BC (2nd terrace near BC Ditch?). Buck-and-rail perimeter fence is in foreground. From title page of *Diary of a Dude Wrangler* by Struthers Burt, 1924.*

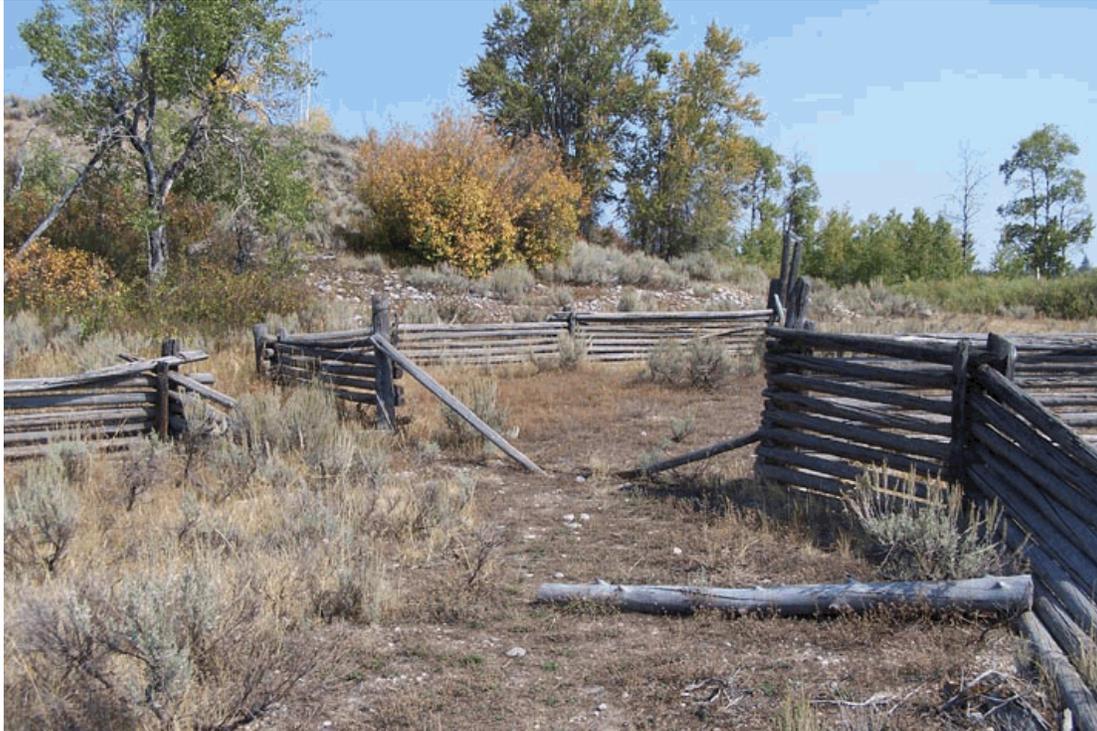
*Located by the main entry road at the base of the escarpment, the corral is in fair condition.
Source: Shapins Associates, 9/2006.*

deterioration has advanced somewhat, but the corral is still in fair condition.

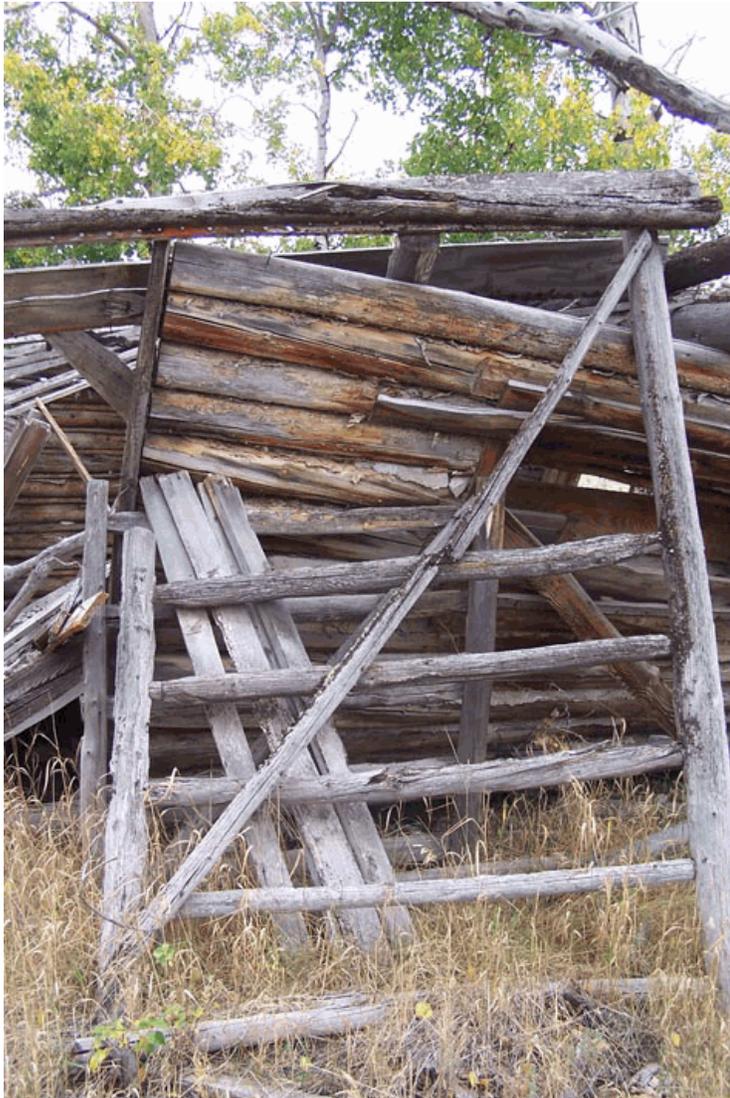
Remnants of a historic gate and fence were found at the southern edge of the complex, leaning against the work shed in the Corse building cluster. Source: Shapins Associates, 9/2006.

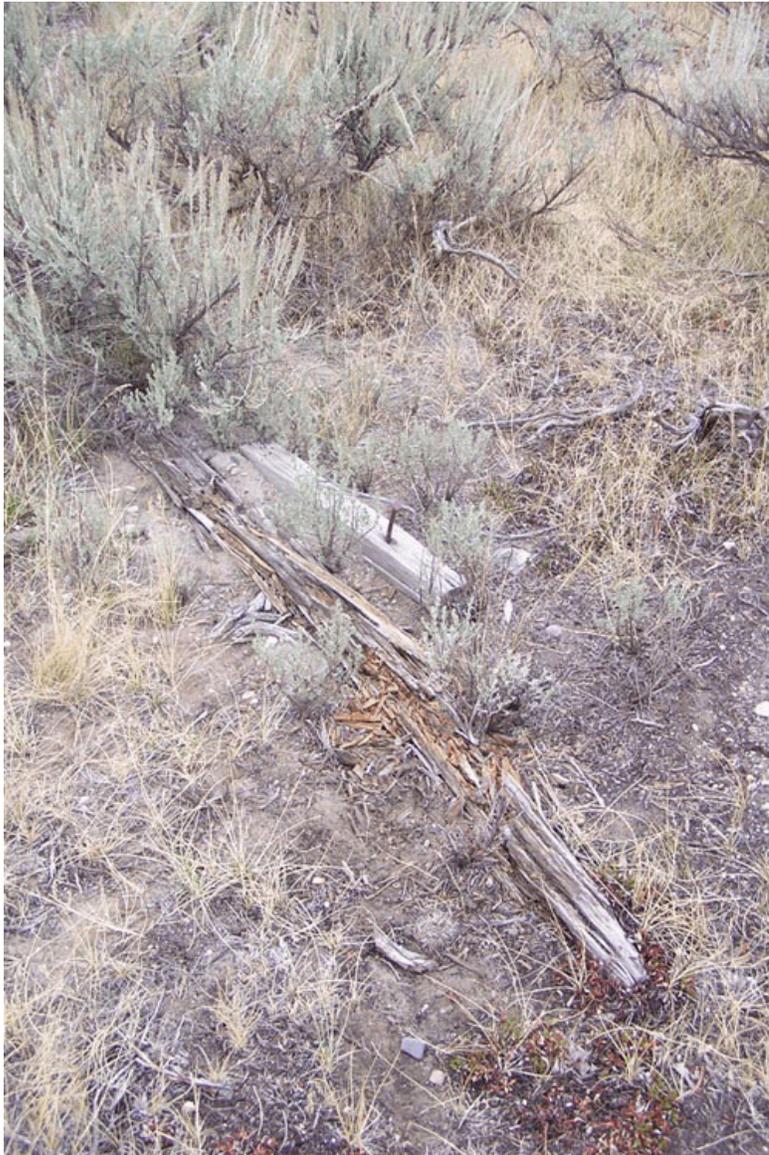
The historic see-saw is now practically indistinguishable. Source: Shapins Associates, 9/2006.

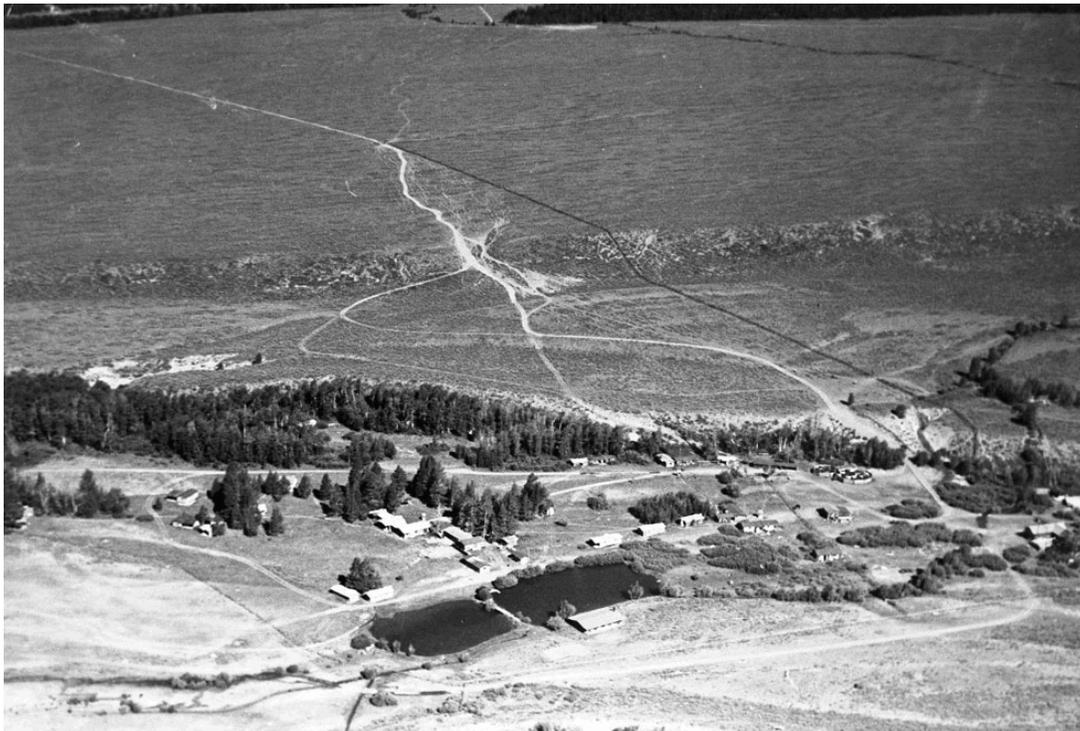
Historic aerial view of the Bar BC dude ranch, looking northwest across all three natural terraces. Straight line that splits off road is historic buck-and-rail fence. Collection of Jackson Hole Historical Society and Museum (1958.2805.001)

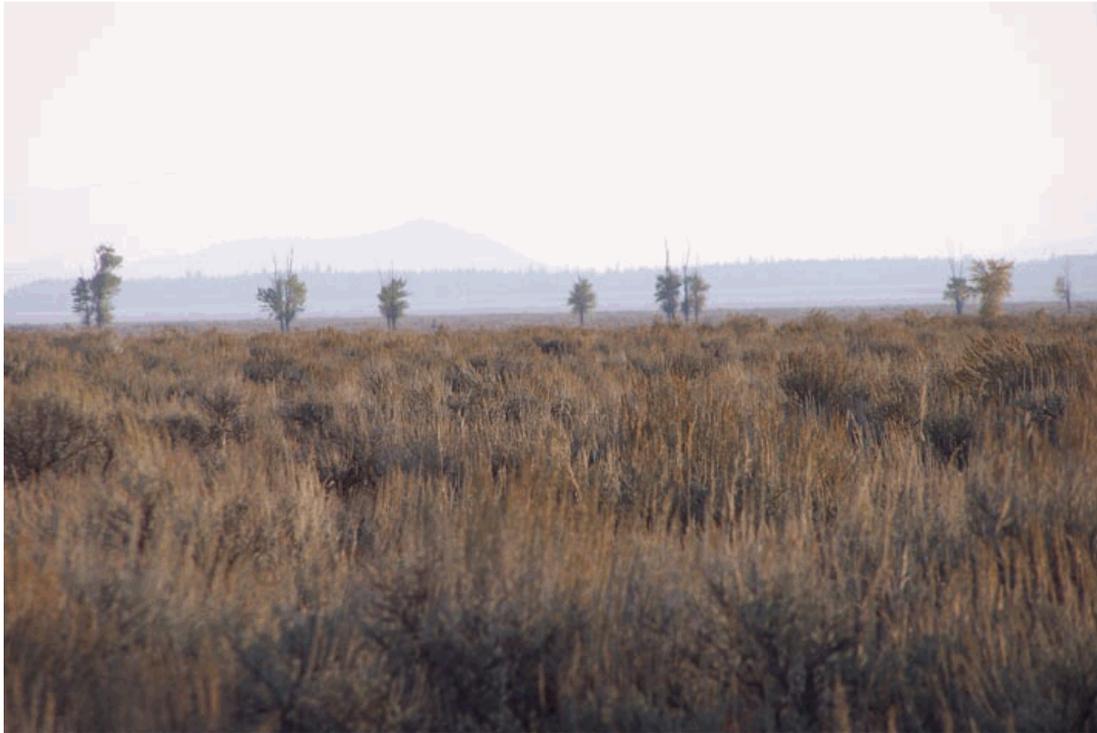
A broken line of cottonwoods marks the course of the historic BC Ditch as it cuts across Baseline Terrace, which is otherwise characterized by the sagebrush community. Source: Shapins Associates, 9/2006.

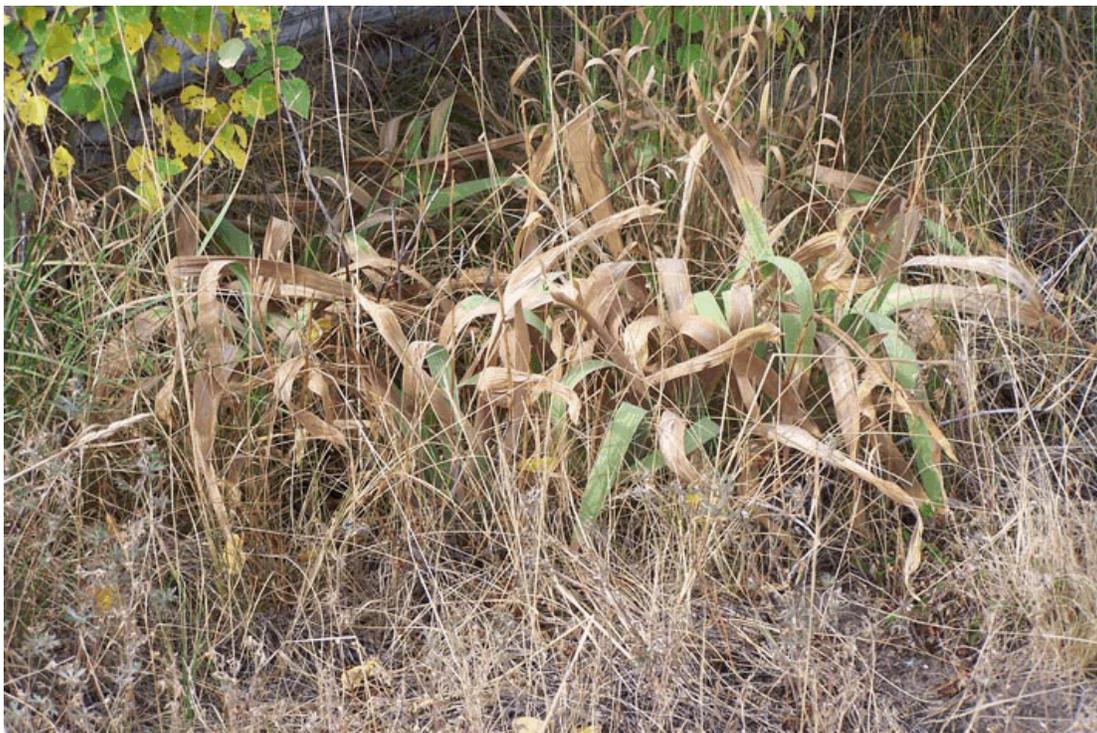
Surviving clumps of iris near certain cabins present the only obvious evidence of planted vegetation. Source: Shapins Associates, 9/2006.

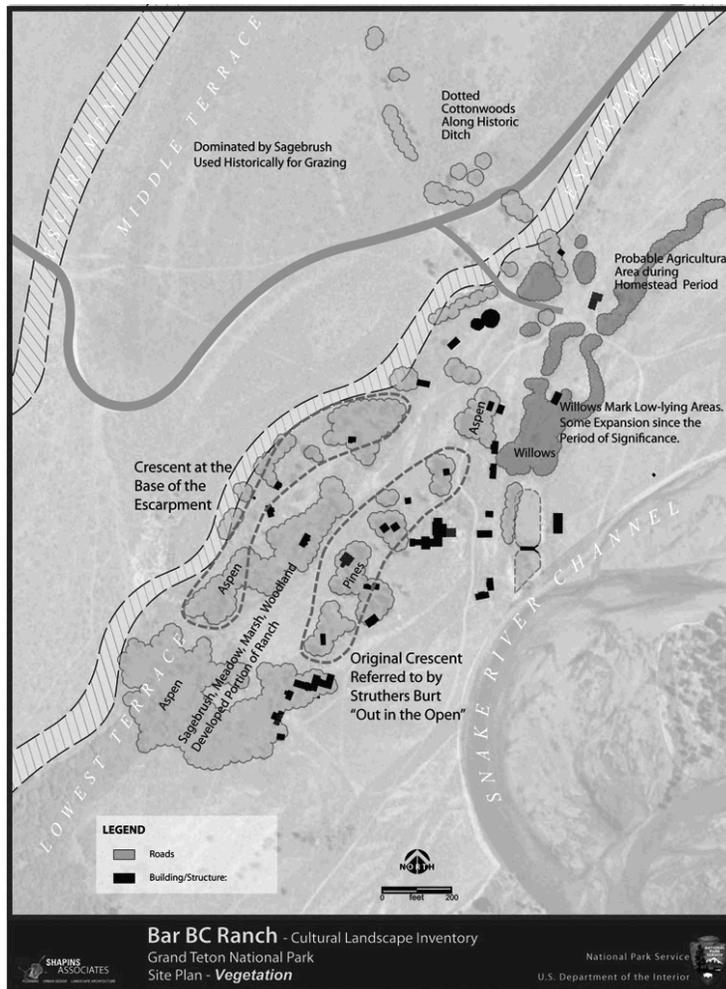
Vegetation Diagram. Source: Shapins Associates.

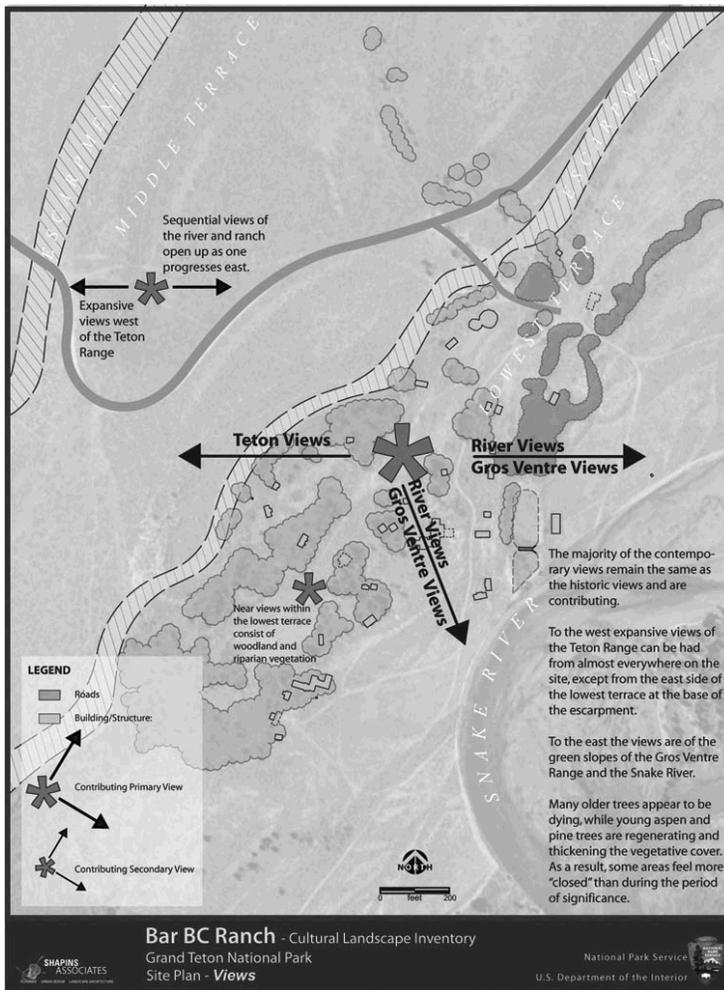
Views and Vistas Diagram. Source: Shapins Associates.
