National Park Service  
Cultural Landscapes Inventory  
2007

Jackson Lake Lodge  
Grand Teton National Park

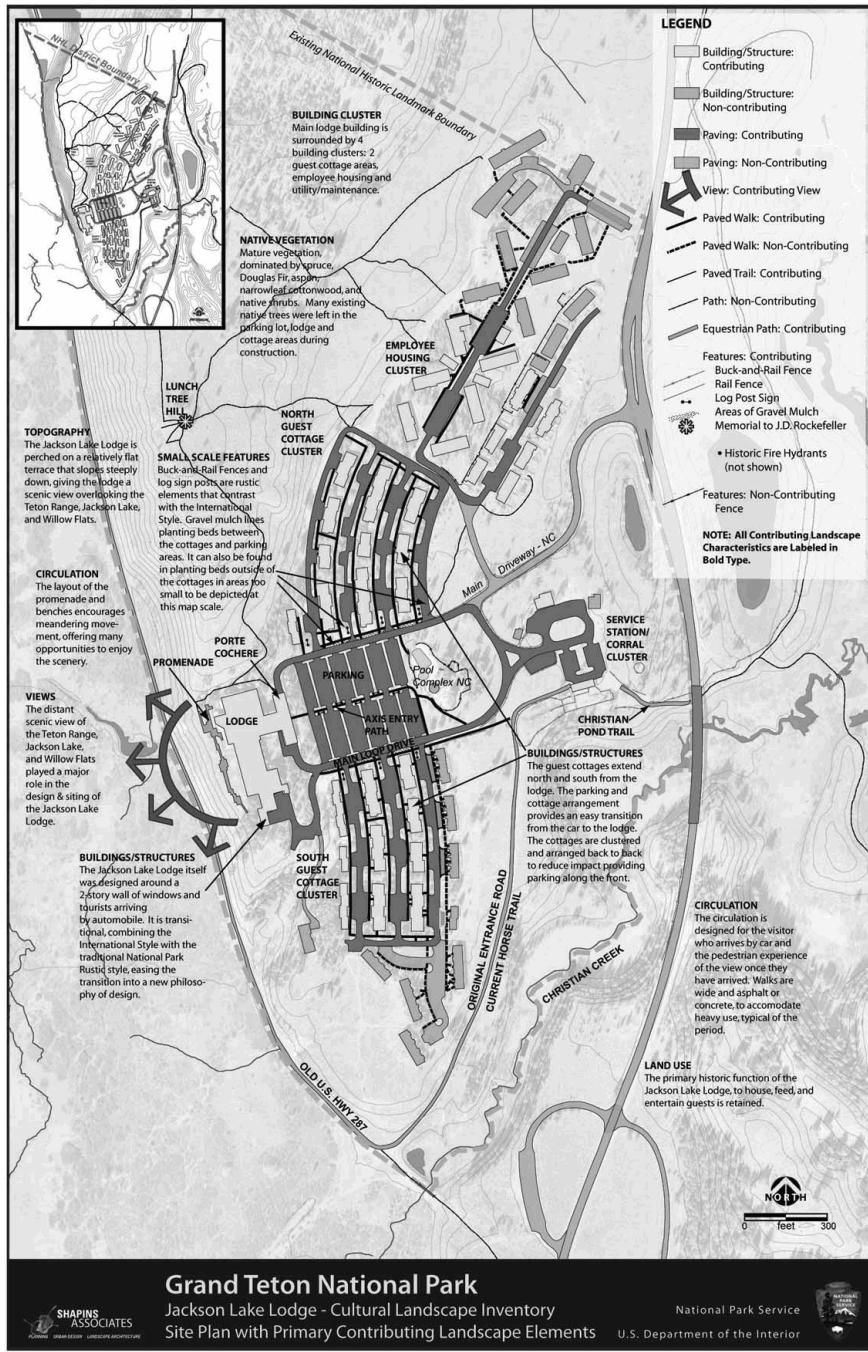
Jackson Lake Lodge site plan with primary contributing landscape elements. Source: Shapins Associates.

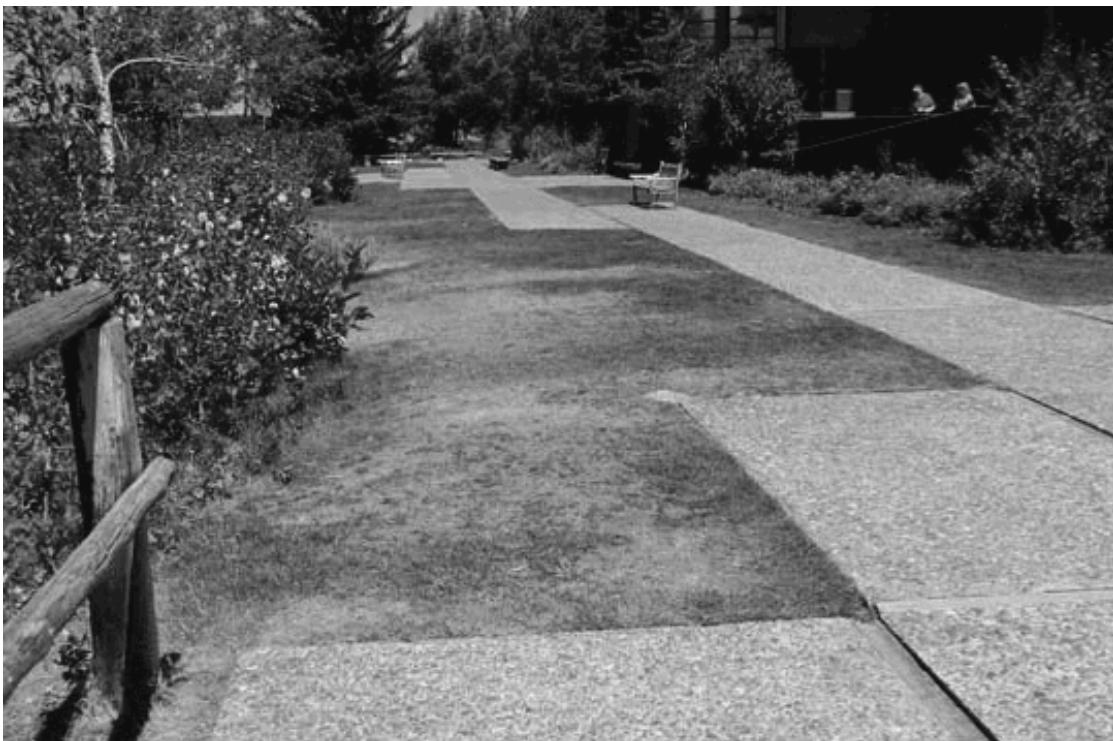
*Though strictly geometric, the configuration of the promenade encourages a meandering stroll through the space, offering many opportunities to enjoy the view (Shapins Associates 2006).*

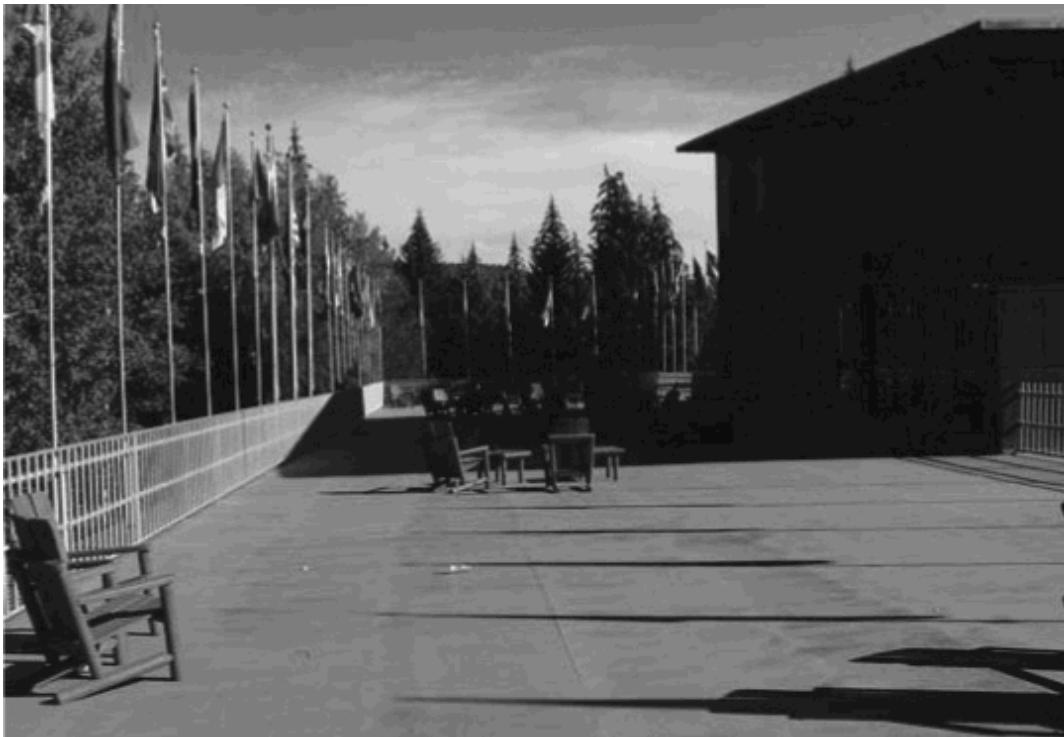
*The large rectangular sun deck over the porte-cochere is now entirely surrounded by flags but originally featured just three (Shapins Associates 2006).*

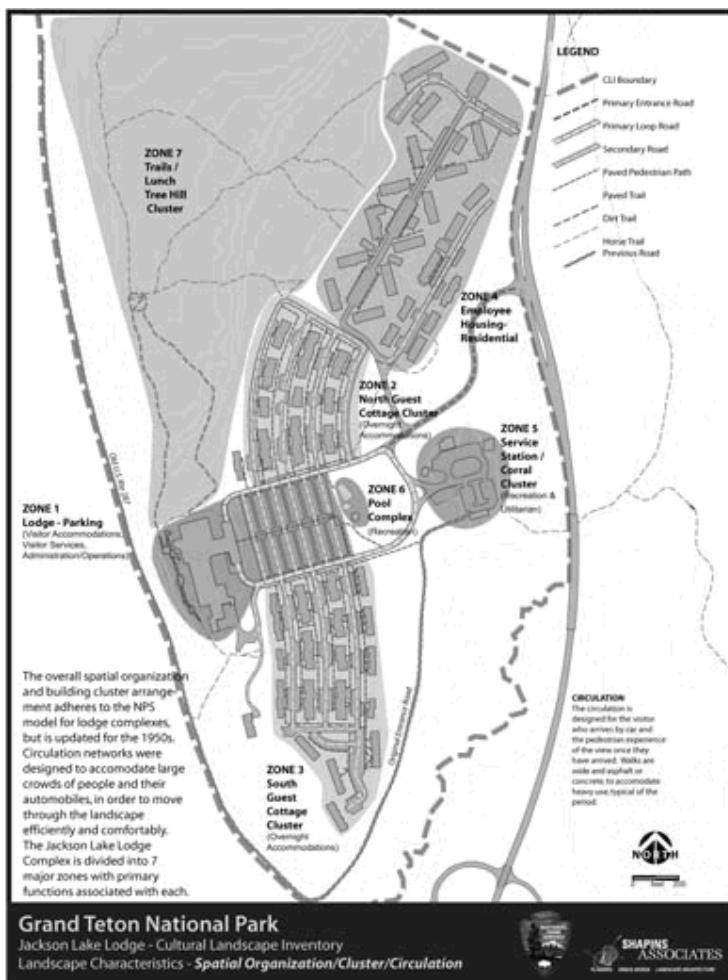
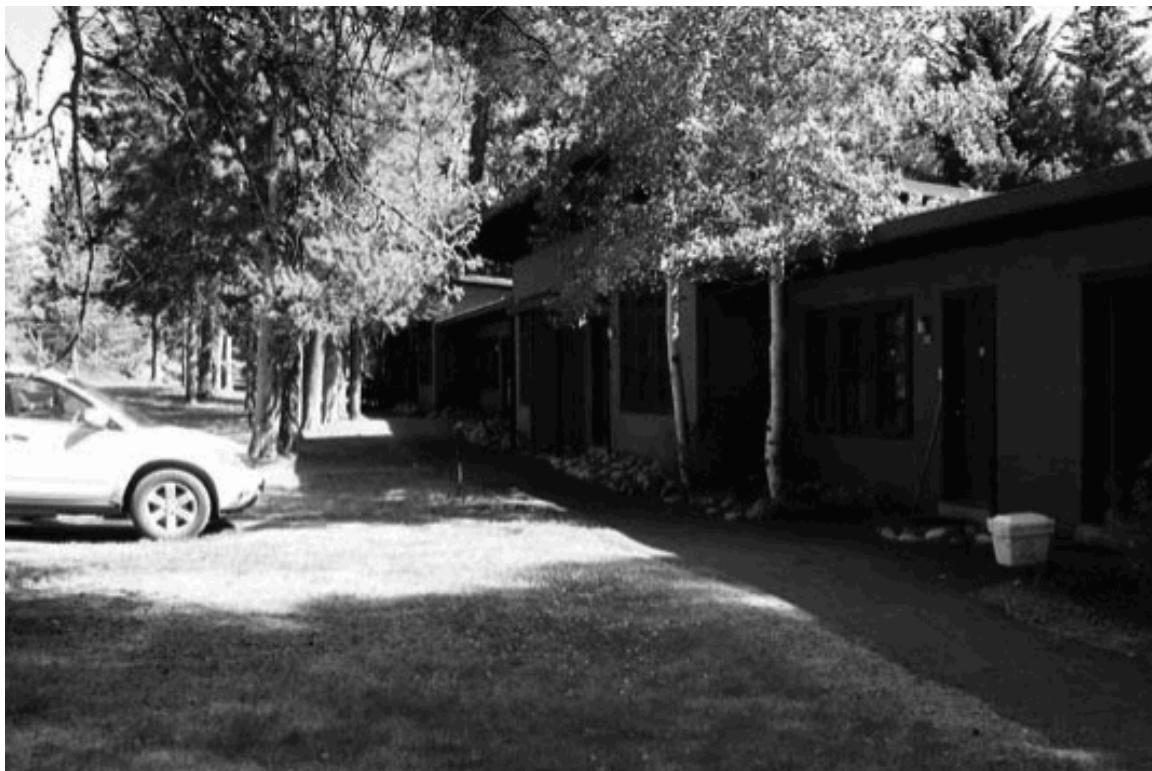
*The guest cottages are clustered to reduce impact and arranged as motor courts, providing a convenient transition from private automobile to overnight lodging (Shapins Associates 2006).*

North and south of the main parking area are the two clusters of guest cottages. Typically, many overnight guests at NPS lodges from earlier periods would stay in Rustic cabins. These cabins would be arranged on the landscape in a picturesque manner. By contrast, at Jackson Lake Lodge visitors stay in guest cottages. Groups of 4 to 10 guest rooms are arranged side-to-side and back-to-back and combined into one cottage building. Generally, individual rooms are identifiable by the alternating directions of overhanging shed roofs (Reed and Wallace 2002). The cottage buildings are lined up in rows, which generally trend north to south. Most cottage buildings are oriented to two parallel drives. Buildings that feature only one row of guest rooms are oriented to one driveway.

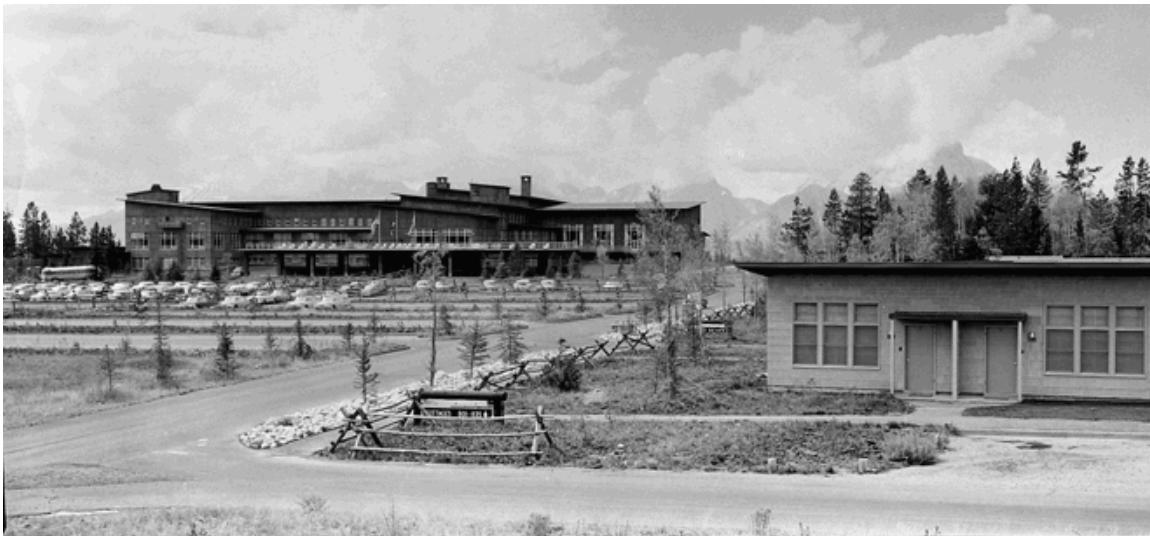
*Buck-and-rail fences were used originally in the parking islands. Log directional signs, areas of cobble mulch, and trees preserved during construction are also visible. (GTLC Archives, c. 1954-1956).*

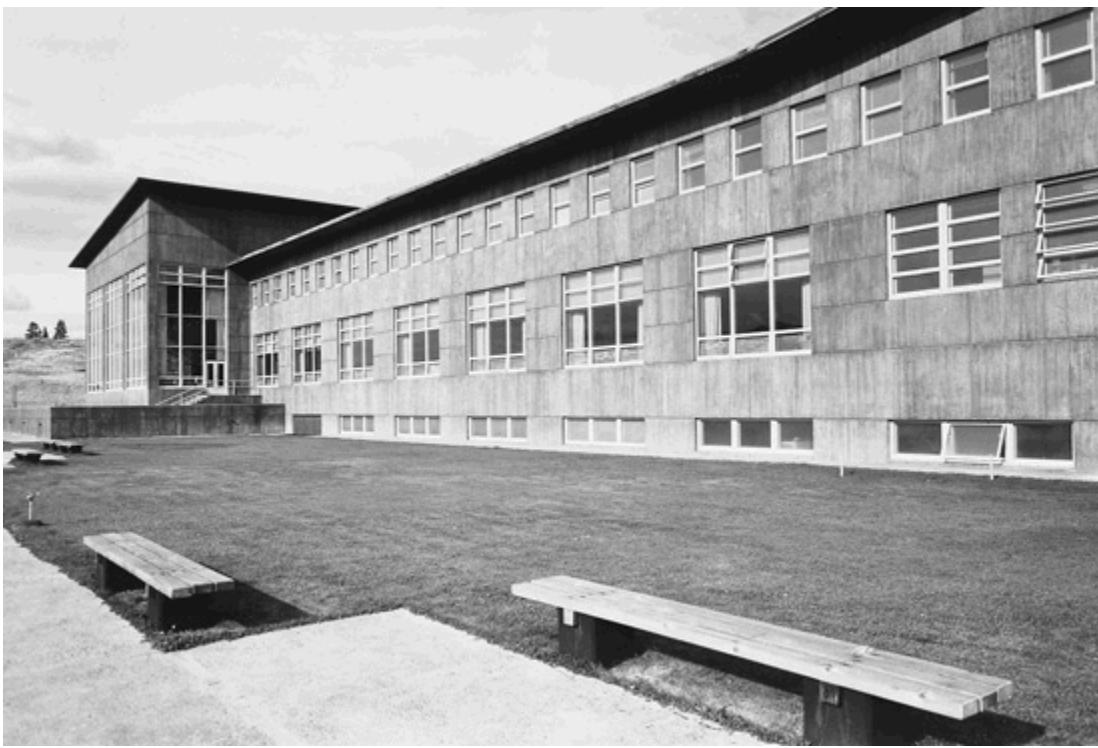
*Permanent benches were planned as part of the viewing terrace composition. Their materials and clean lines echo the modern design for the promenade (GTLC Archives, c. 1959-1960).*

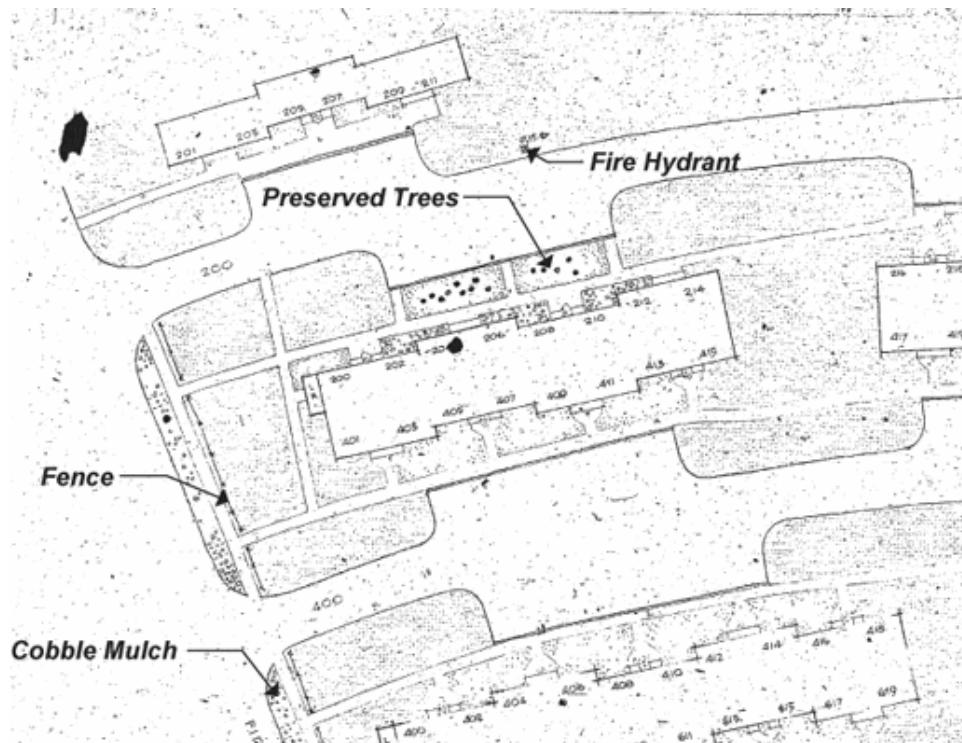
*Detail of Landscape Improvements, "drawn by Spencer & Lee Architects, 1958. Note buck-and-rail fence, preserved trees, cobble mulch, fire hydrant. (NP-GT-8055).*

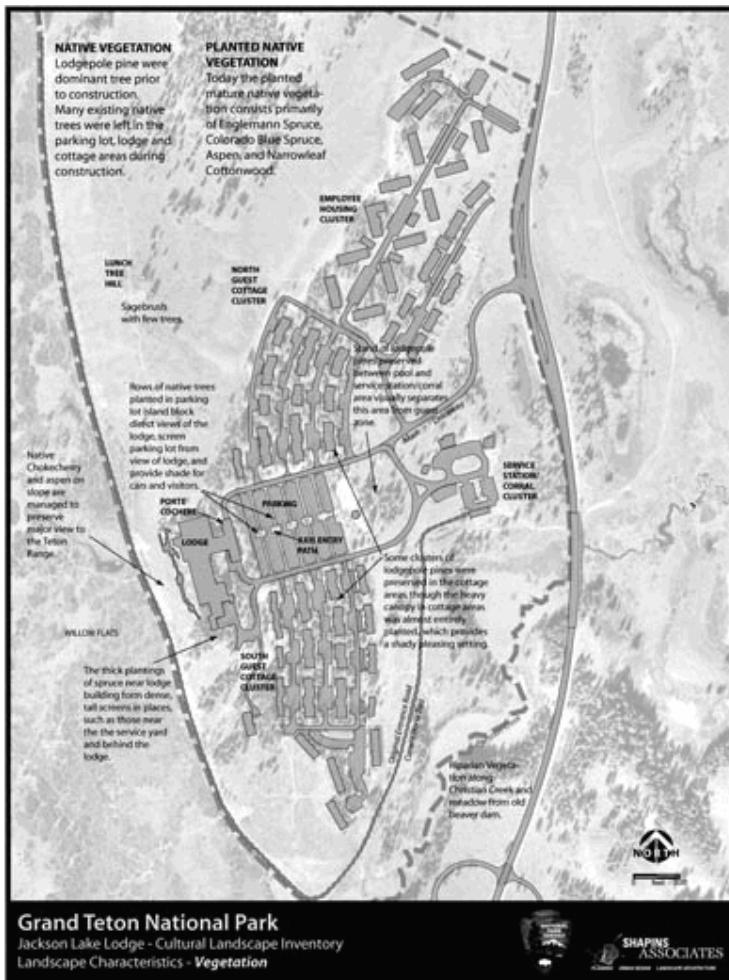
Site plan of vegetation at Jackson Lake Lodge. Source: Shapins Associates.

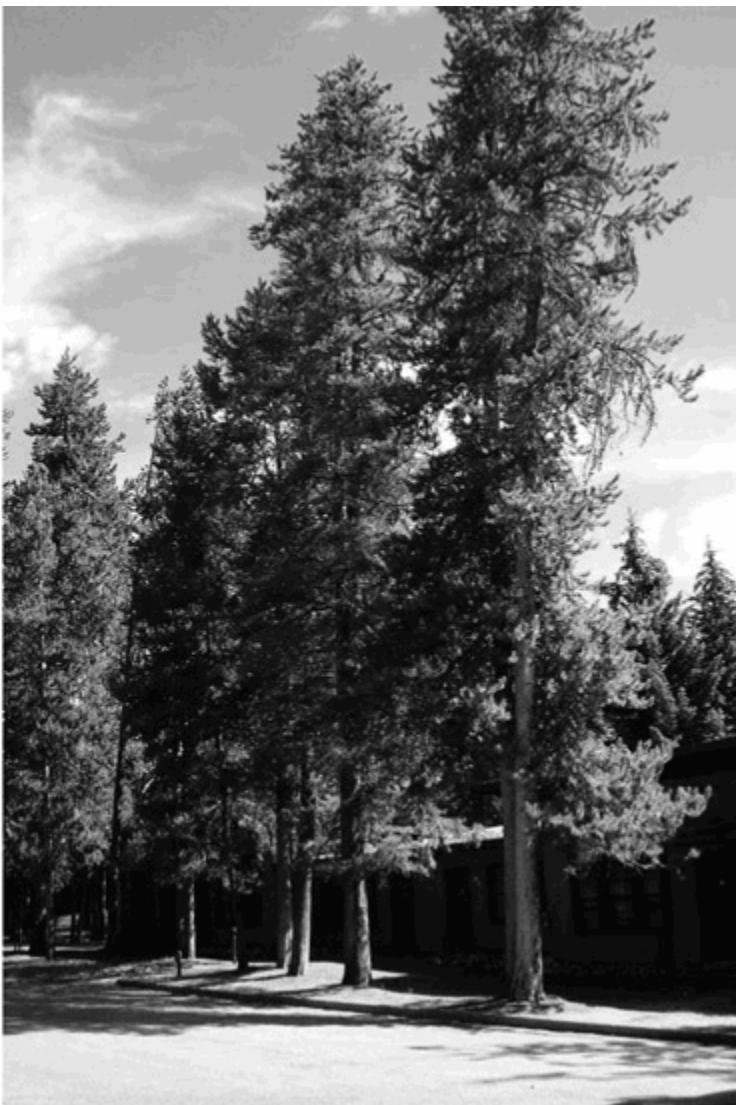
*Native trees such as Englemann spruce and aspen were planted throughout. Many existing lodgepole pines, such as these in the north guest cottage cluster, were preserved during construction (Shapins Associates 2006).*

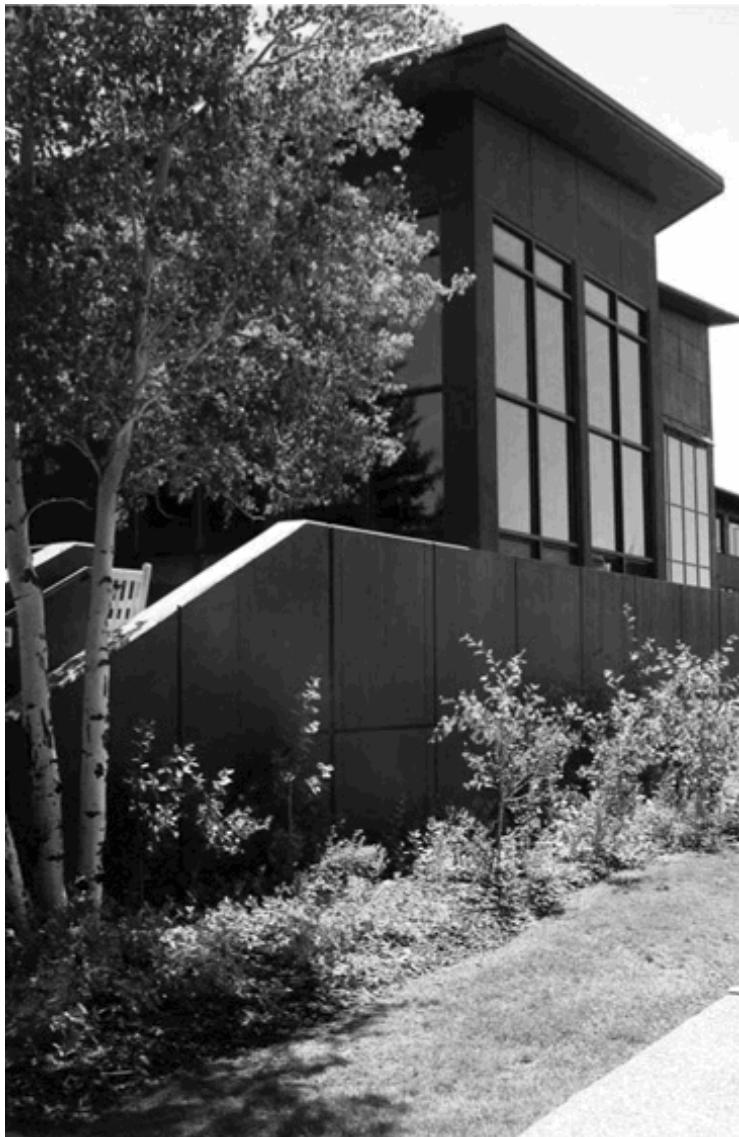
*Landscaping around the lodge building utilizes native vegetation and turf. This general planting scheme appears to date to the historic period (Shapins Associates 2006).*

Vegetation surrounding the lodge building is similar to that of the guest cottage areas, an ornamental mix of lawn, native shade and ornamental trees, and foundation plantings of native ornamental shrubs. Historic documentation is slim, but this appears to conform to the general

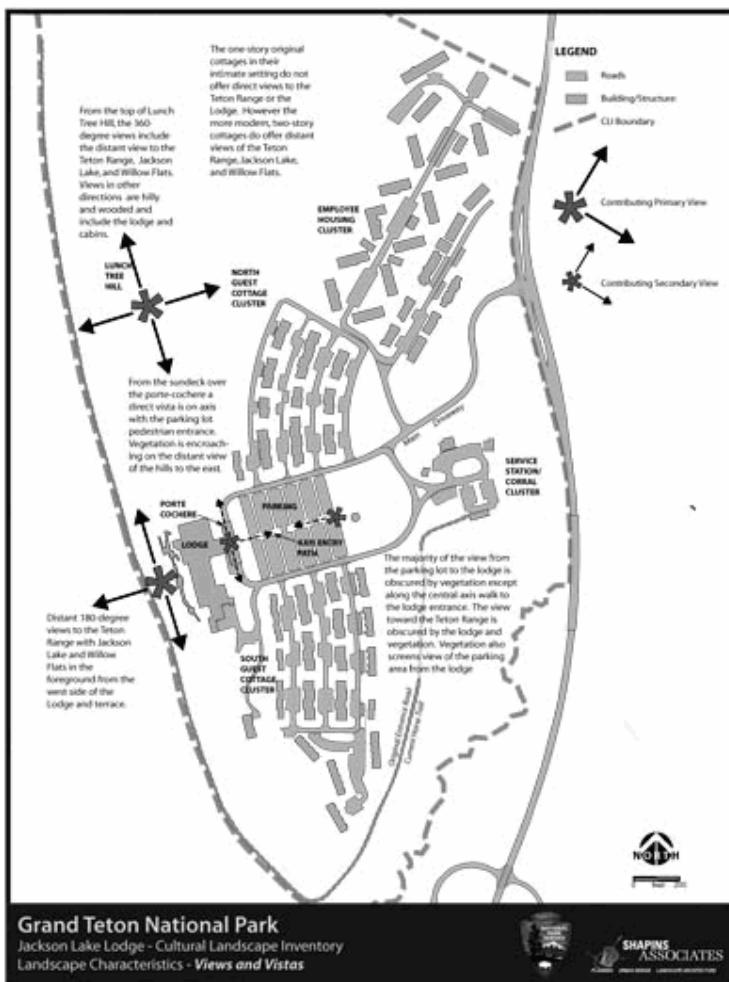
*Views and vistas at Jackson Lake Lodge. Source: Shapins Associates.*
